Re: An Application by Newfoundland and Labrador Hydro (Hydro) pursuant to Subsection 41(3) of the Act for the approval of the replacement of a circuit breaker, insulators, synchronous condenser shaft seals and resistance rings, and level 2 condition assessments of the synchronous condensers, at the Wabush Terminal Station – Revisions

Appendix B: Voith 2015 SC1 and SC2 Annual Inspection Report and Recommendations

Voith 2015 SC1 and SC2 Annual Inspection Report and Recommendations

Nalcor Energy - Churchill Falls (Labrador) Wabush Terminal Station	
SC1 and SC2 Annual Inspection Report	PDM 2-01731078
	Revision -

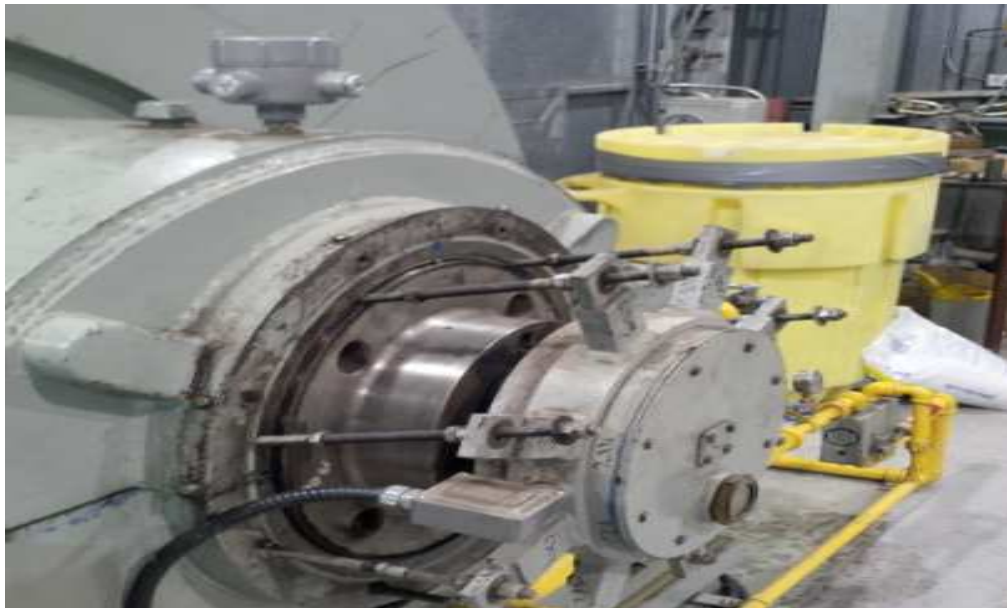
The thrust bearing temperature should be monitored closely on start-up of the unit, further adjustments may be necessary to locate the electrical magnetic center if a temperature spike is noted. All Belleville washers should be replaced on the thrust bearing adjuster.

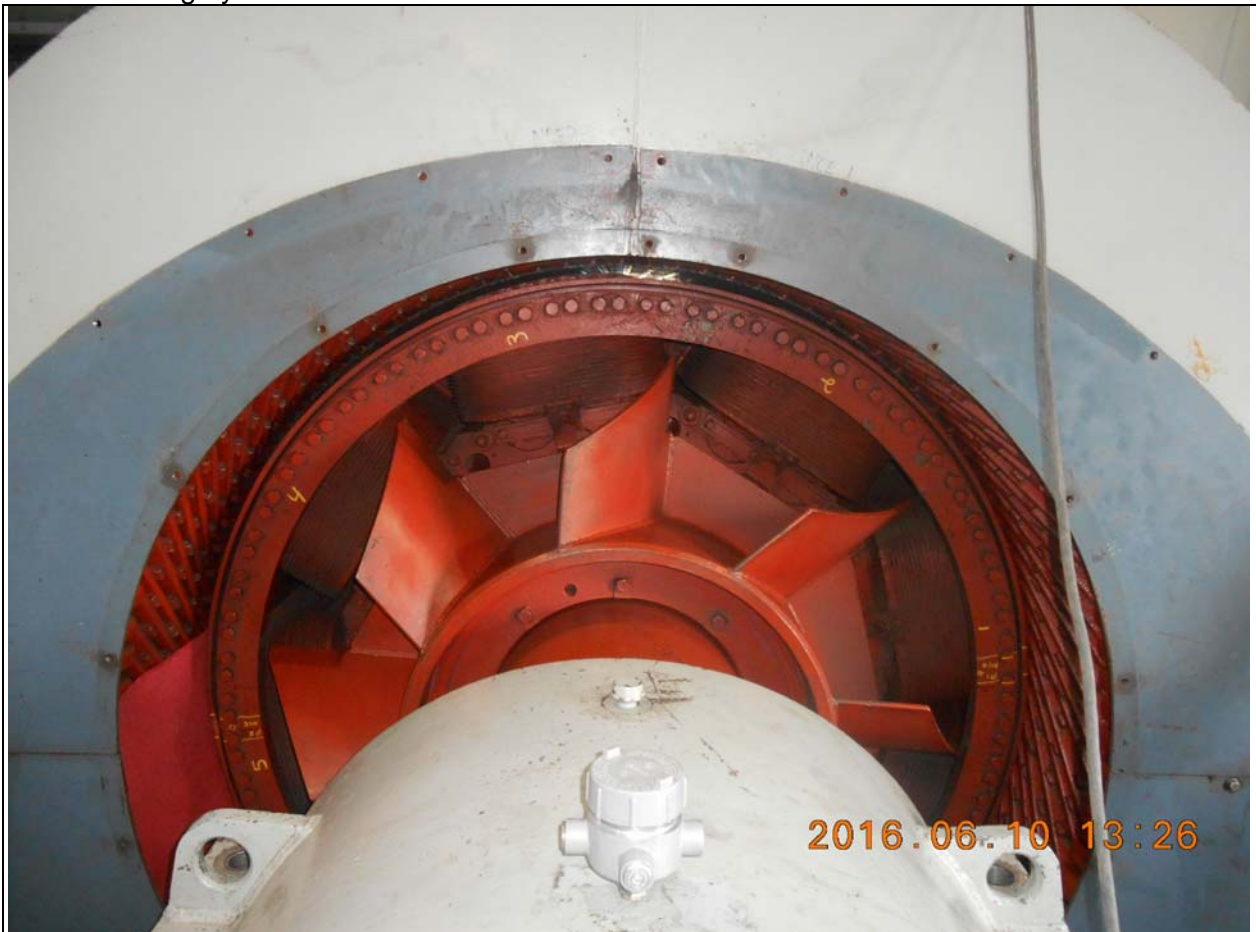
Unit SC1 is in serviceable condition, with no findings that would curtail its operation within normal parameters. Internally, the Stator winding end turns and Rotor poles are covered in a light film of oil and dirt. This does not affect unit performance significantly but does affect the insulation integrity over the life of the unit.

Fig. 2: Overview of Non-Collector End - Light Dirt on Stator Winding End Turns and Rotor Poles

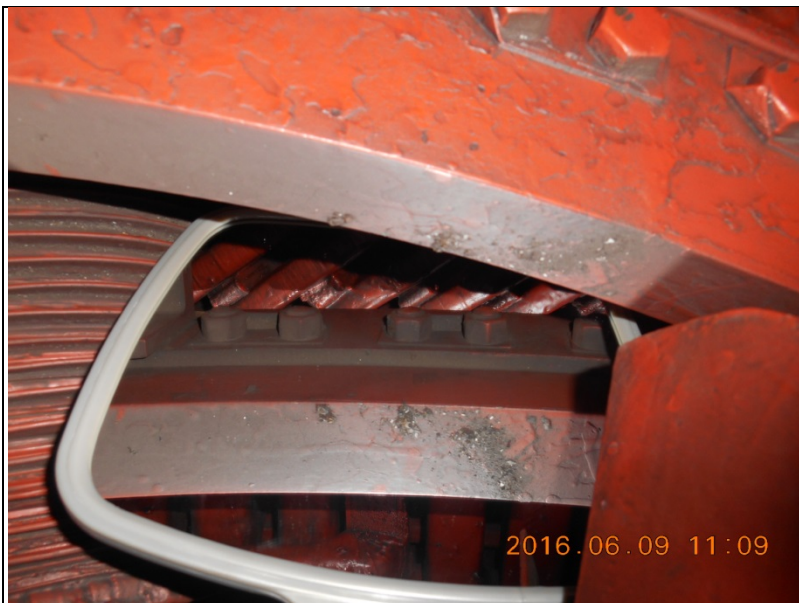
A thorough visual inspection of the Damper Windings was completed. No issues were noted on the collector end damper winding, although there was some minor paint loss around the circumference and an accumulation of light dirt.

Fig. 10: Inspecting the back side of the damper winding with a mirror

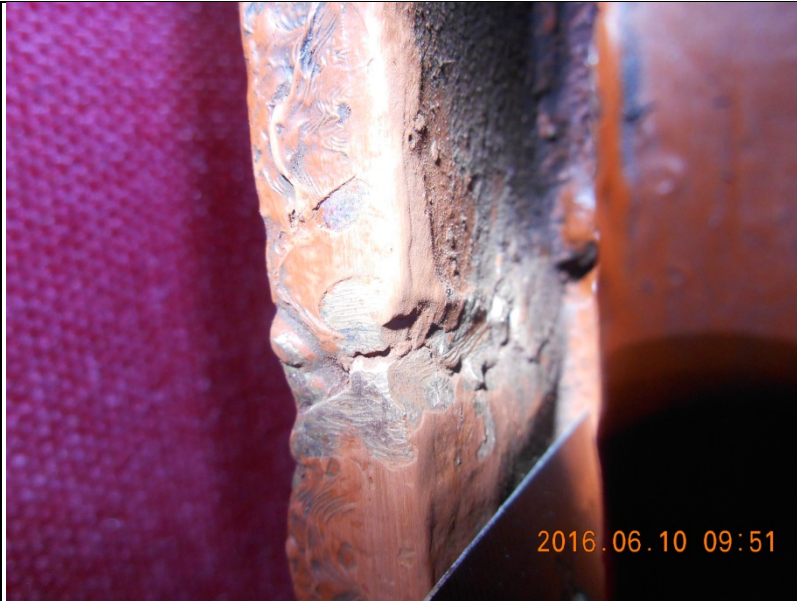
The paint was removed in this area to reveal the existing weld repair. The 'crack' is actually the overlap of the weld, and appears visually to be intact.

Fig. 13: NCRE Damper winding - Paint removed to investigate the area.

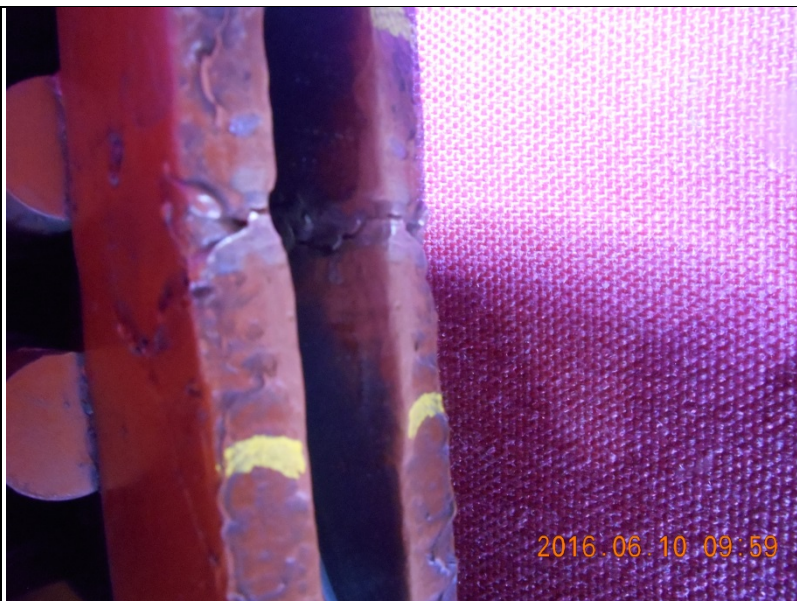
Second photo of the area using a mirror to show more of the weld repair.

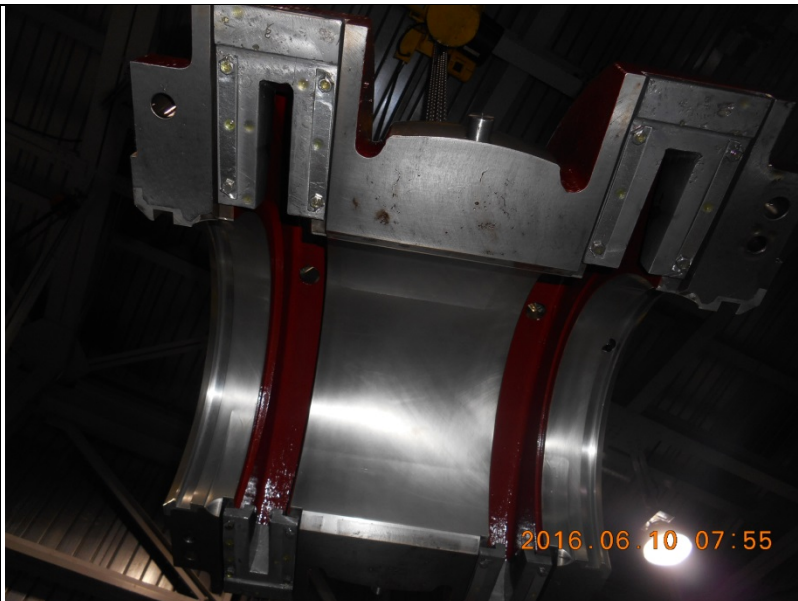
The NCRE bearing upper half is clean with no issues noted.

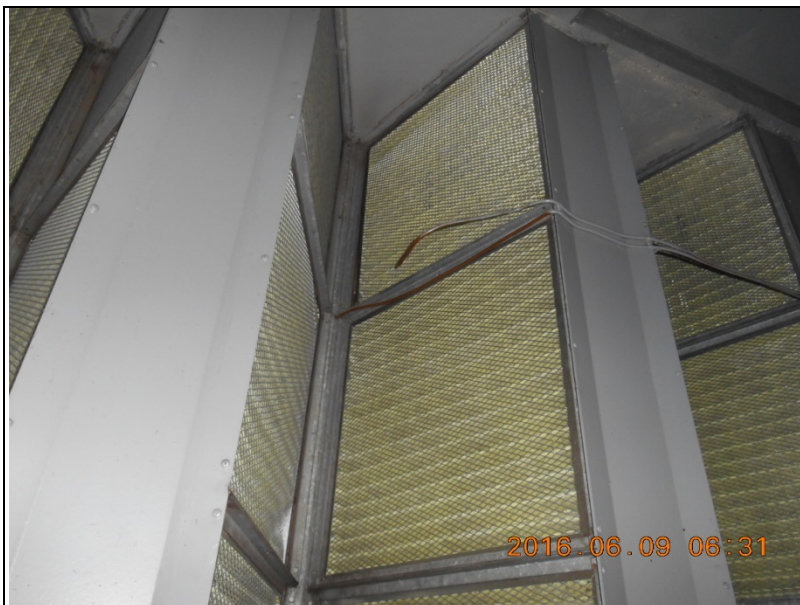
The air filter media is clean and does not require changing at this time

Continue to monitor the condition of the air filters and replace them as required.

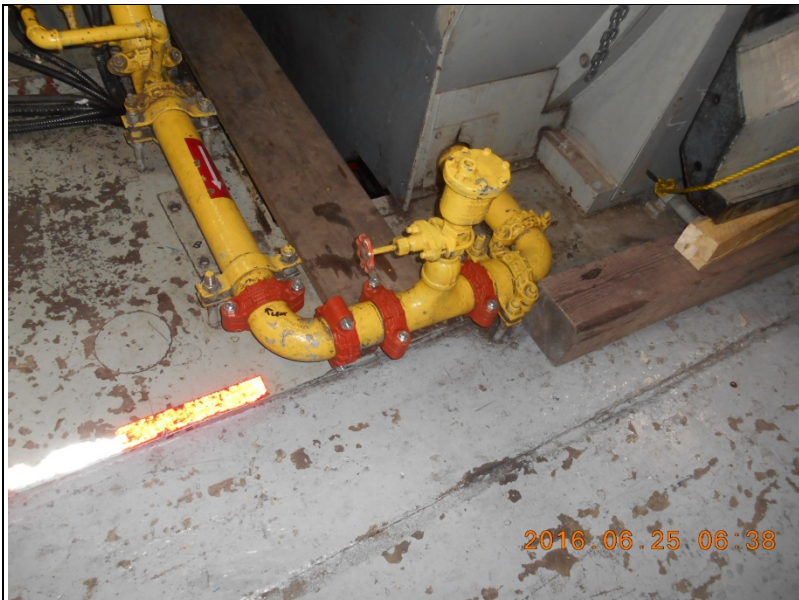
There were a number of leaks in the Collector End 3" pedestal drain, which is constructed using sections of pipe and Victaulic couplings. Nalcor purchased new coupling assemblies and grommets that were installed during the outage.

The three couplings downstream of the first four seen in this photo were also replaced after the customer identified a second leak from this area.

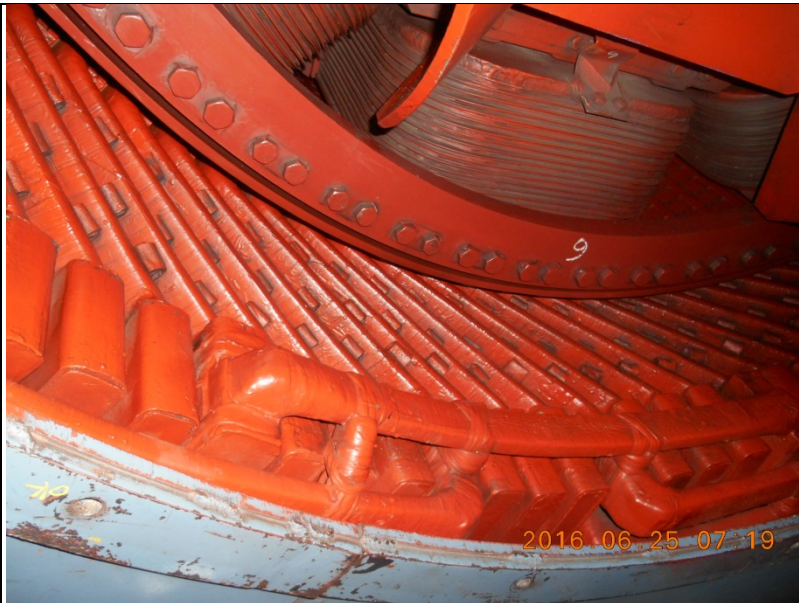
Fig. 5: Stator end turn and coil extension condition

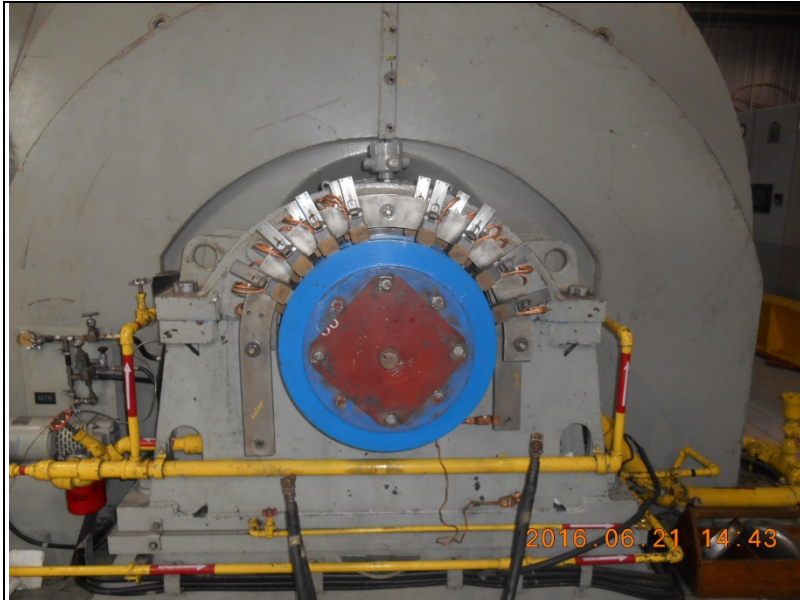
The brush rigging assembly is in good condition. All brushes appear to be in good condition and spring tension on the retainers is an average of 3.5lbs which is sufficient for proper brush pressure. The minimum spring pressure is 3lbs.

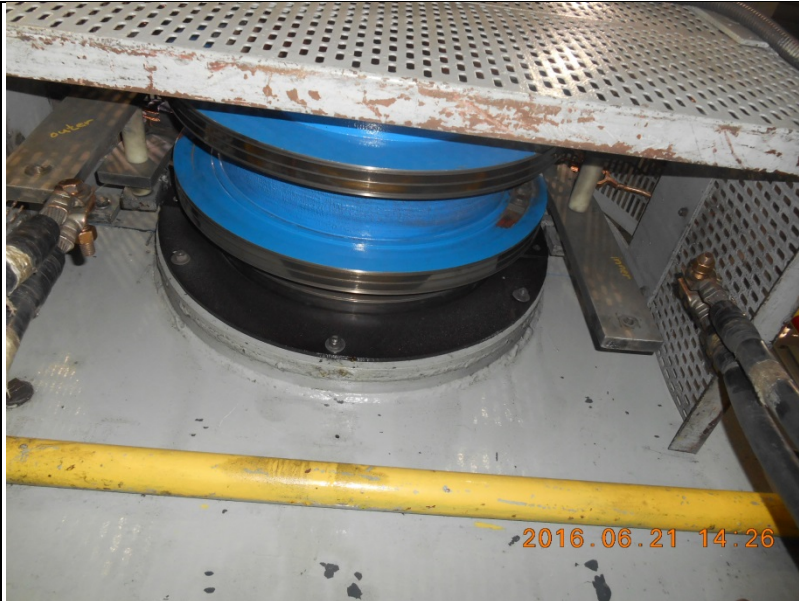
The collector rings are in good condition with no evidence of burnishing or physical damage. The bore copper studs are tight.

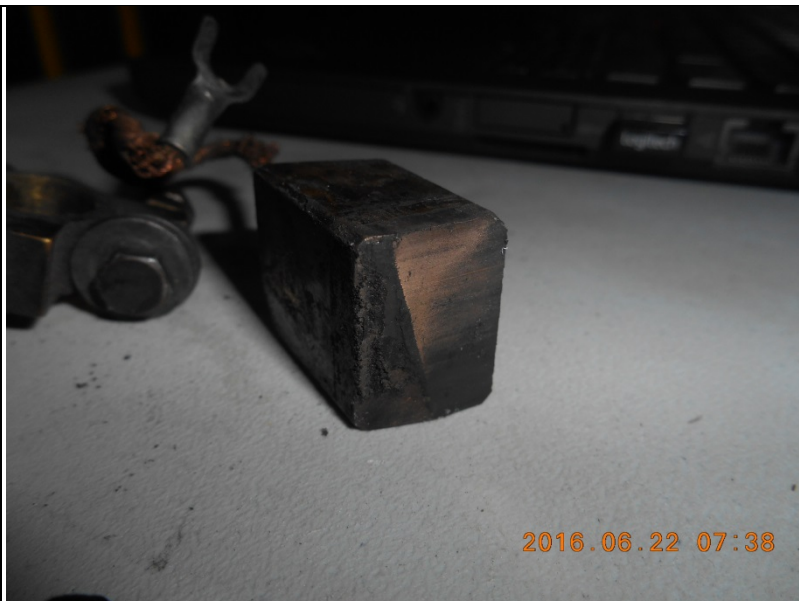
The ground brush assembly is in good condition. The brush itself requires replacement at this time. A new brush was taken from stock.

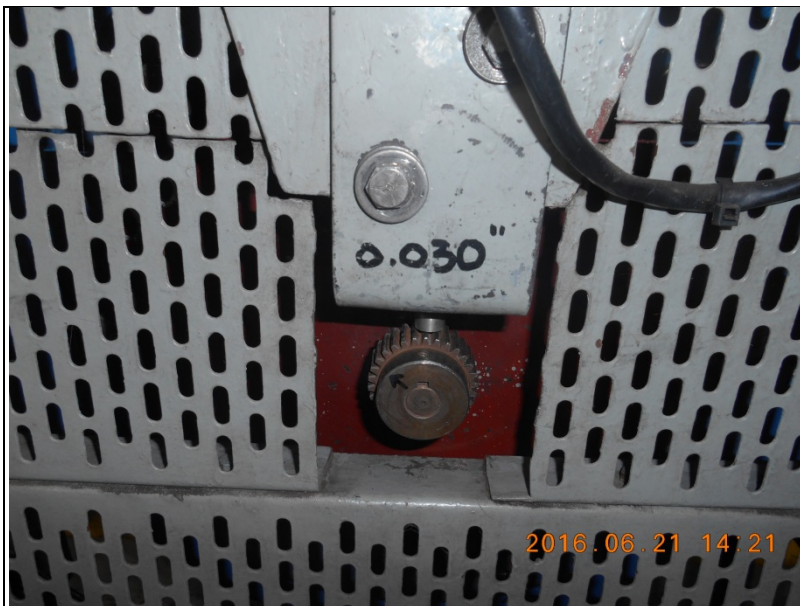
Speed probe measurement was found to be 0.030" before removal of the guards. With the hi-lift system running, the gap measures .021" in the same position and .028" when the shaft was manually rotated 180 degrees.

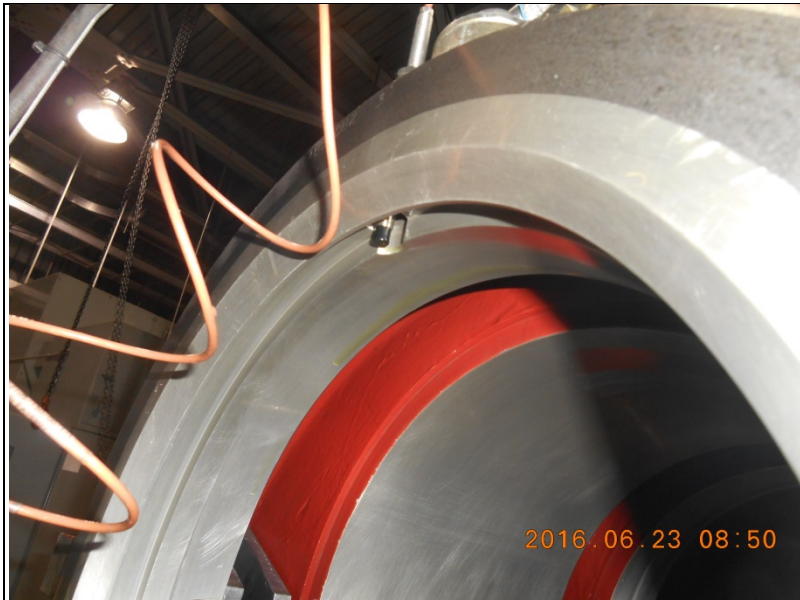
The speed probe was found to be loose and had turned to the point it was making contact with the shaft. It was backed out and the jam nut re-tightened.

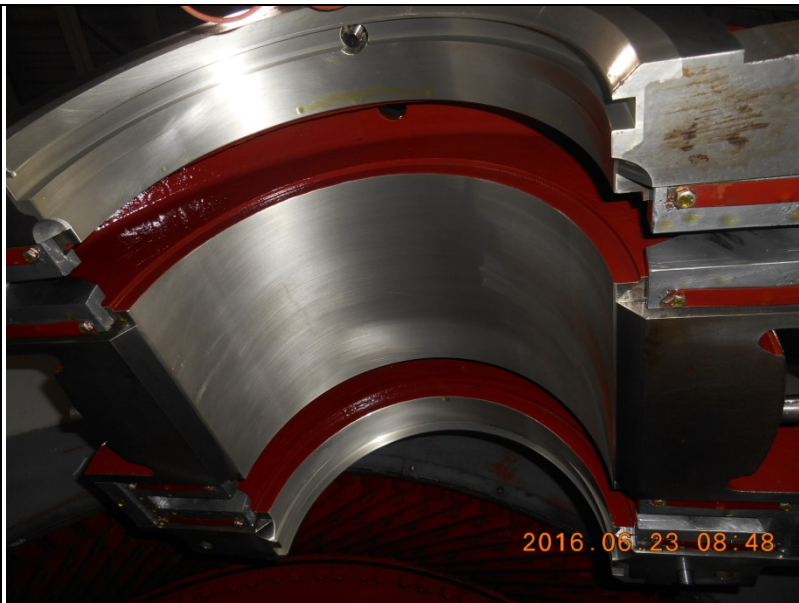
The NCRE bearing upper half is clean with no issues noted.

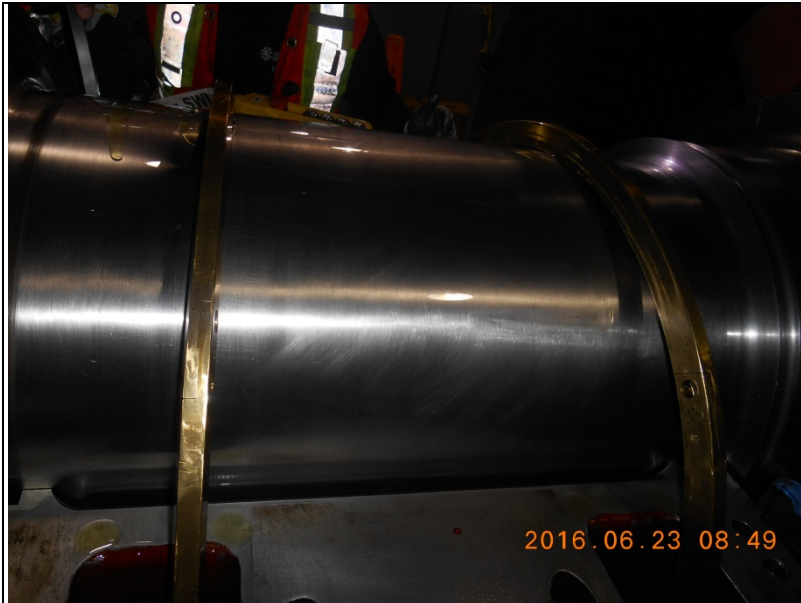
The NCRE journal was found to be in good condition with only light surface scratches. The punch marks on the oil rings are flush with no high-spots.

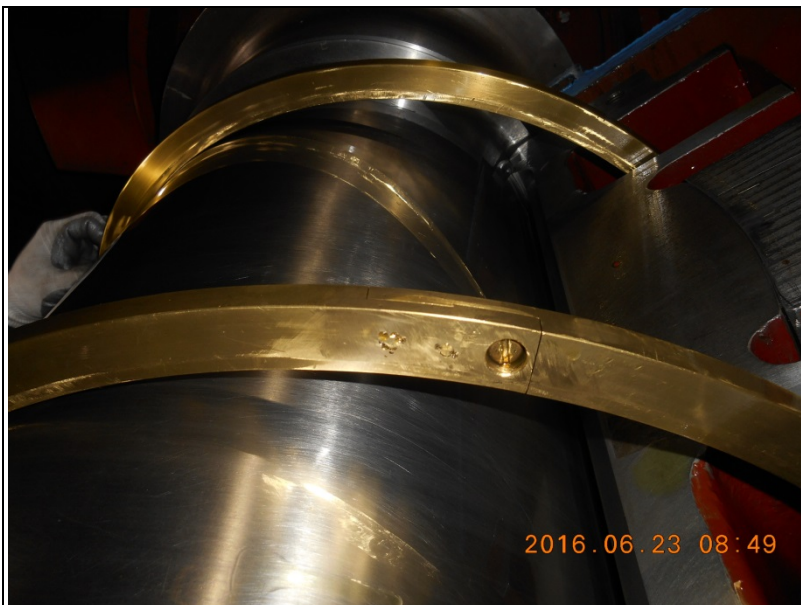
The NCRE oil rings appear worn with rub marks noted around the circumference. Removal and installation of the rings required additional peening to retain the connecting screws.

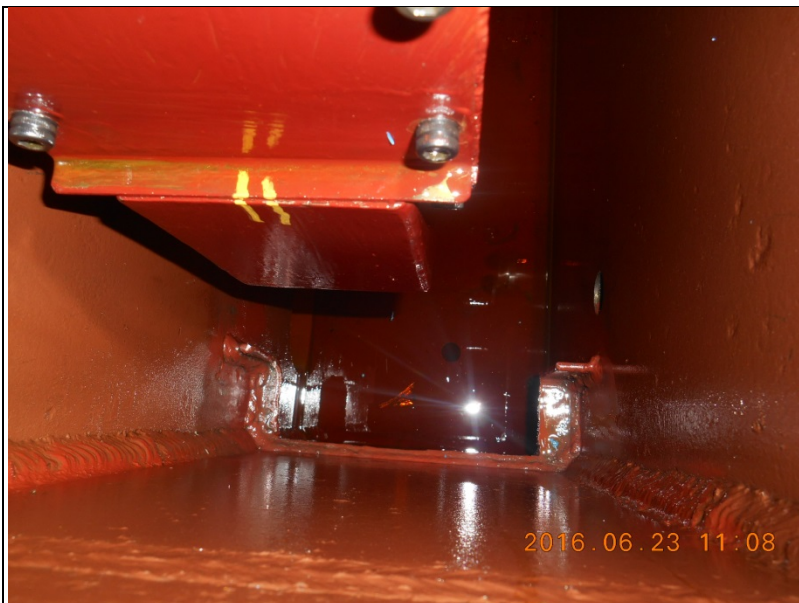
Babbitt found in the bottom of the collector end bearing pedestal sump

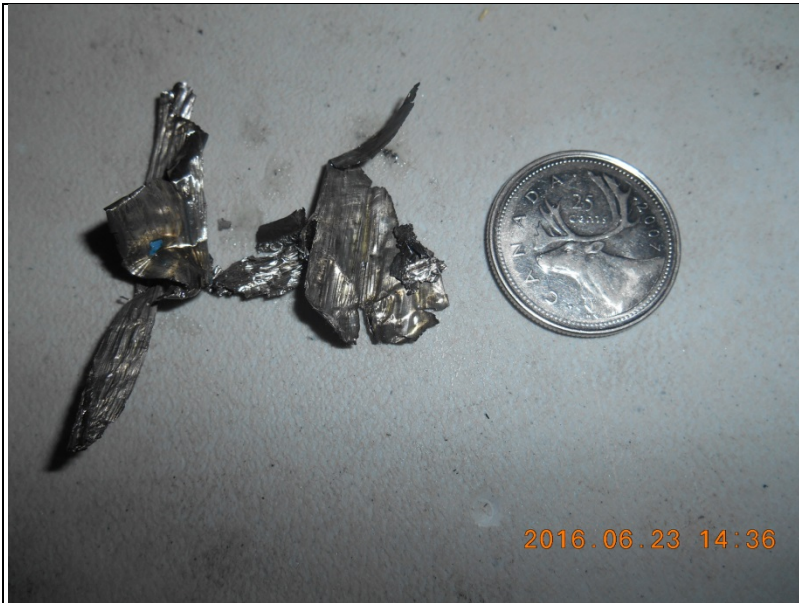
Total quantity of babbitt found in the sump, buside a quarter for comparison

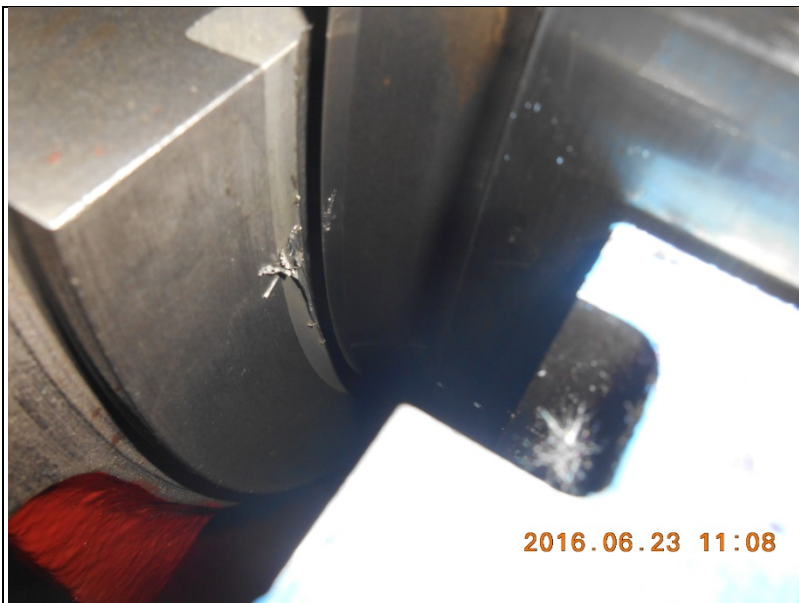
Source of the babbitt where the shaft vertical face has made contact with the bearing.

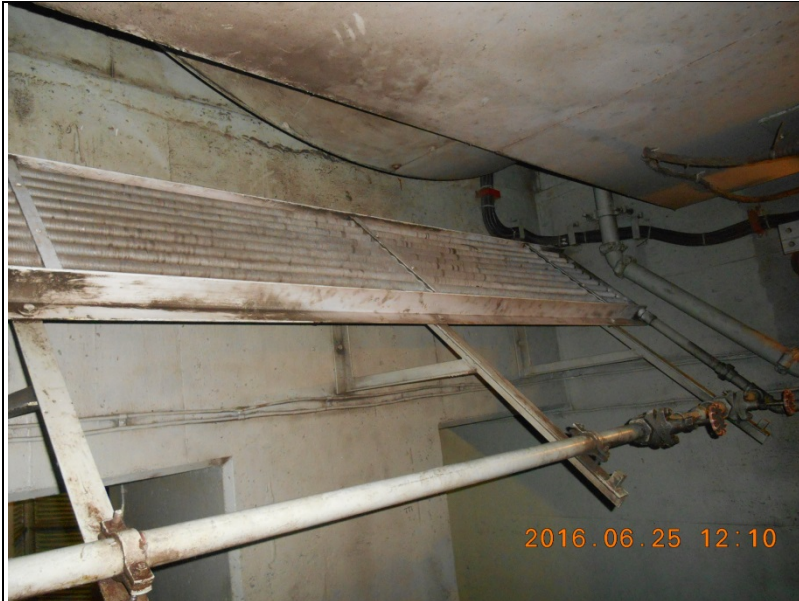
The oil coolers appear to be in good condition. Some fins are bent. Both coolers have a film of oil and dirt.
