**Analysis of
Newfoundland Island Interconnected System
Power Supply Adequacy for the
Winter of 2018-19**

**The Board of Commissioners of Public Utilities
Newfoundland and Labrador**

The Liberty Consulting Group

August 30, 2018

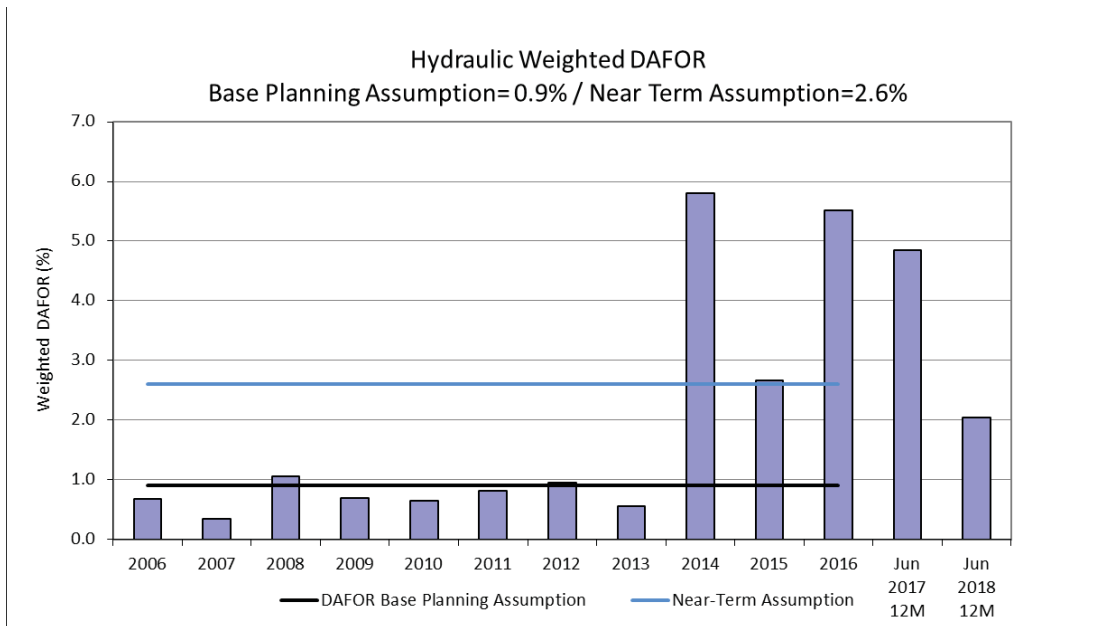
Figure 1: Hydraulic Weighted DAFOR

1 Considering the individual units' performance, the assumed Hydro generation base planning
 2 DAFOR was materially exceeded for Bay d'Espoir Unit 1 and Bay d'Espoir Unit 2. Also, there
 3 were exceedances compared to base planning assumption for Bay d'Espoir Unit 7 for the
 4 current period.

6 The Bay d'Espoir Unit 1 DAFOR of 8.67% and Unit 2 DAFOR of 12.41%, exceeded the base
 7 planning assumption of 0.9% and the near-term assumption of 3.9% for an individual Bay
 8 d'Espoir unit. This was due to Units 1 and 2 being removed from service on November 4, 2017
 9 as a result of a leak in Penstock 1, which provides water to both units. A consultant was
 10 engaged in the process to provide engineering analysis and recommendations to return the
 11 penstock to reliable service. Extensive inspection and testing was completed, which resulted in
 12 the damaged section being replaced. All additional suspect areas were also cleaned and
 13 refurbished and additional backfill was placed over a section of the ruptured area as this had
 14 been part of the approved capital plan resulting from the 2016 leak. Findings from the final

1 root cause report are being implemented and the Board approved Condition Assessment work⁶
 2 is currently underway. The penstock was returned to service on December 8, 2017.

3
 4 The Bay d’Espoir Unit 7 DAFOR of 1.80% exceeded the base planning assumption of 0.9% and is
 5 less than the near-term assumption of 3.9% for an individual Bay d’Espoir unit, as a result of the
 6 unit being unavailable from July 3, 2017, to July 9, 2017, due to a failure in the collector
 7 assembly. An investigation was completed, and it was determined that there was a flash over
 8 between the slip rings, which was caused by excessive brush wear. As a result of the
 9 investigation, improvements to the preventive maintenance (PM) program have been
 10 implemented across the hydraulic generation fleet of assets. As a result of this event, all brush
 11 gear assemblies had an additional inspection completed prior to December 1, 2017 and no
 12 issues were found.

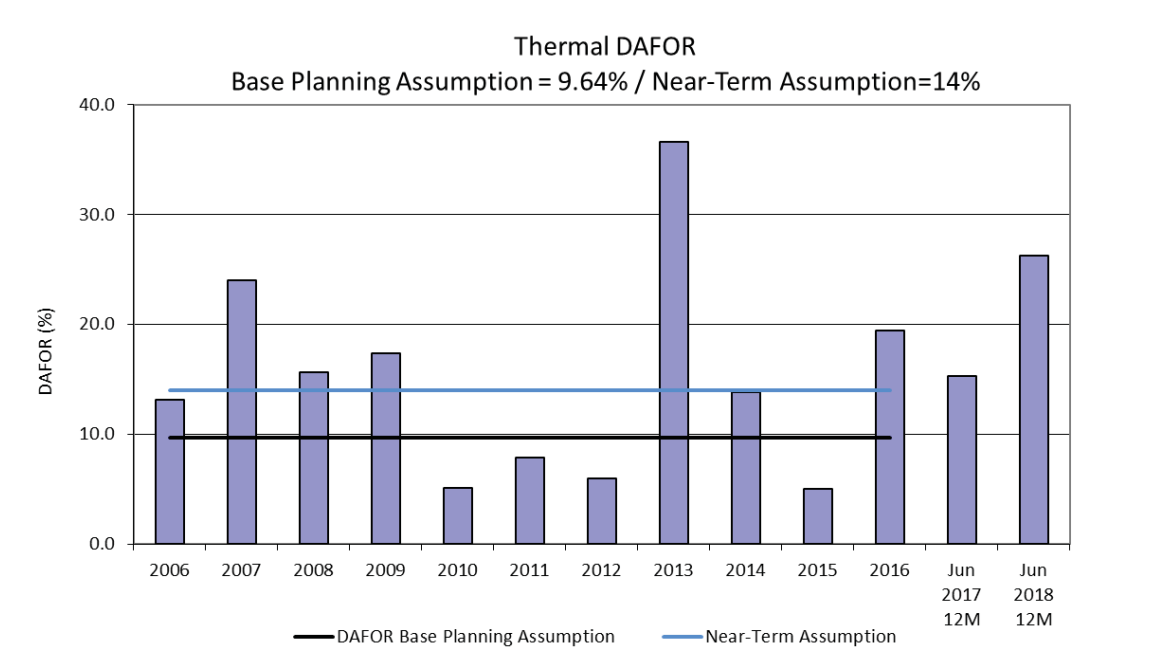
Figure 2: Thermal DAFOR

1 For the 12-month period ending June 31, 2018, the weighted DAFOR of 26.22% for all thermal
 2 units is above the assumed Hydro generation base planning DAFOR value of 9.64%, and the
 3 near-term assumption of 14.00%.⁷ Unit 1 DAFOR was 32.30% and Unit 2 DAFOR was 26.62%.
 4 The performance for both Units 1 and 2 was above the base planning assumption of 9.64% and
 5 the near-term assumption of 15% (Unit 1) and 10% (Unit 2). Unit 3 DAFOR was 16.60%, which
 6 is above the base planning assumption of 9.64% but below the near-term assumption of 18.0%.

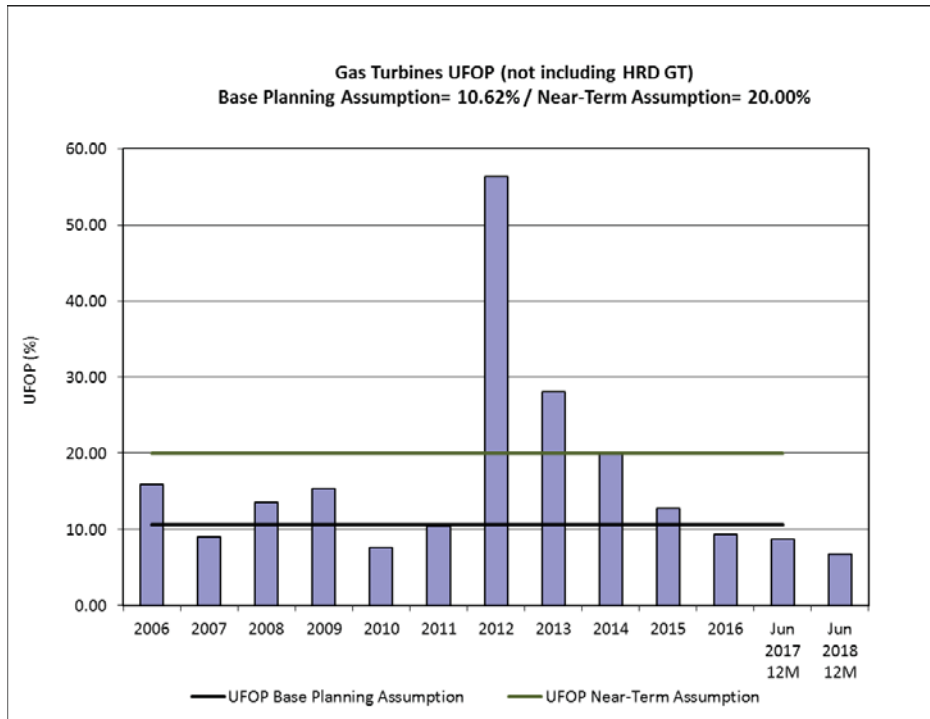
Figure 3: Gas Turbine UFOP – HWD/HVY/SVL Units

1 On September 16, 2017, the Happy Valley gas turbine tripped when attempting a black start of
2 the unit to support an unplanned outage in the Happy Valley area. Hydro's investigation found
3 that the cause of the trip was related to the operation of a voltage protection relay in the
4 terminal station. Upon review of the relevant procedures, drawings and settings it was
5 determined that a setting change was required to the protection relay. The setting was
6 changed and the unit was returned to service on September 21, 2017. During the investigation,
7 it was found that prior to the trip the power turbine had developed higher than normal
8 vibration, though it was not the cause of the trip. Further investigation of the higher than
9 normal vibration found the source to be a high temperature exhaust gas leak from the power
10 turbine. Repairs were made and vibration levels returned to normal on October 7, 2017.

11
12 On October 15, 2017 the Happy Valley gas turbine experienced a trip while operating at near
13 full load. Hydro's investigation determined that the trip was the result of the failure of an
14 emergency fuel shut-off valve solenoid. The failure of the solenoid caused the 3-way valve to
15 divert a portion of fuel away from the engine, as is its design. The reduced fuel flow was not
16 able to sustain the required load and resulted in the unit shutting down. A replacement
17 solenoid was sourced and repairs made with the engine released for service on November 9,
18 2017.

19
20 On May 13, 2018 the Hardwoods gas turbine tripped while operating in synchronous condense
21 mode due to a system under voltage and current phase imbalance. The alternator experienced
22 excessive vibration when attempting to restart the Unit on May 14, 2018. Extensive mechanical
23 and electrical testing was conducted on the alternator to determine its condition, with no
24 damage found prior to returning it to service on June 2, 2018.

25
26 On June 13, 2018 the Hardwoods gas turbine tripped due to excessive alternator vibration
27 while being returned to service after a planned maintenance outage. Inspection of the Unit
28 determined that cause of the vibration was a loss of lube oil due to a faulty check valve in the
29 lube oil supply piping to one of the alternator bearings. The bearing which had the faulty check

1 valve was found to be damaged and required replacement with a spare bearing. The Unit was
 2 released for service on June 30, 2018.

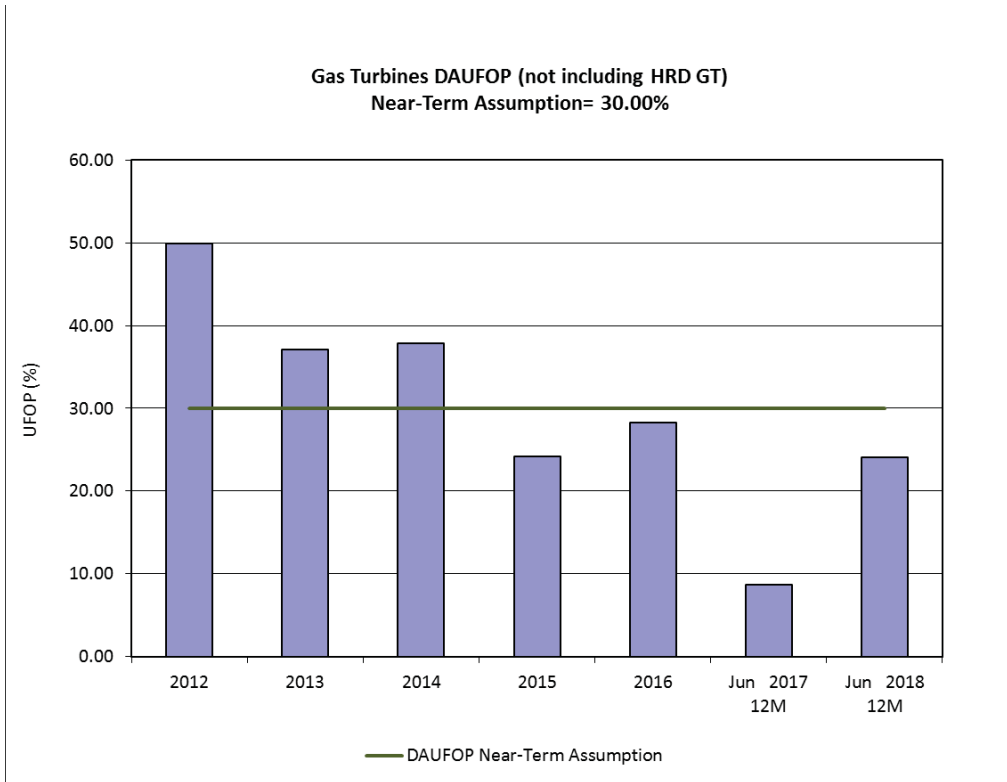
Figure 5: Gas Turbine DAUFOP – HWD/HVY/SVL Units

1 The Stephenville gas turbine DAUFOP for the period was impacted by the unavailability of End A
2 as a result of an exhaust bellows failure at Hardwoods gas turbine End A on December 28, 2017.
3 End A was unavailable at this time due to issues with the power turbine rear bearing which
4 requires the bearing to be replaced. Hydro decided to remove the bellows from End A at
5 Stephenville and install it at Hardwoods End A to return that Unit to full capacity. It is currently
6 expected that the Stephenville gas turbine will be returned to full capacity in August 2018.
7
8 The Hardwoods gas turbine DAUFOP for the period is impacted by the unavailability of End A
9 due to an exhaust bellows failure on May 28, 2018. End A remains unavailable with a planned
10 return to service at the end of July 2018.
