# Asbestos Materials Reassessment

Holyrood Thermal Generating  
Station  
Holyrood, Newfoundland and  
Labrador

January 29, 2016

Pinchin File: 02-02-01506

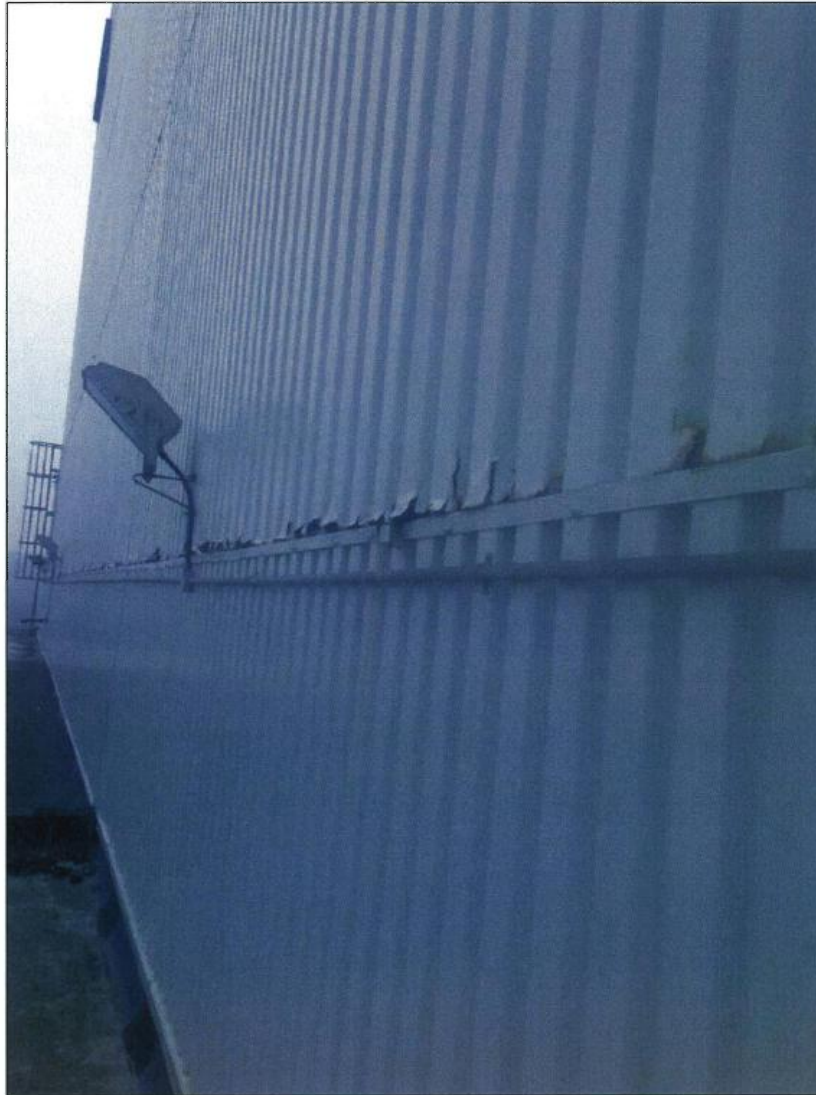
The main plant building (above the 8 foot elevation), the stage 2 pump house (above the 15 foot elevation) and the warehouse (underlying more recently installed exterior clad) are covered with a metal sheet material called Galbestos. Analysis of this material during the initial survey indicated that the backing of the non-friable tarpaper contained chrysotile asbestos. It was noted during the reassessment that the exterior siding is deteriorating and beginning to rust in multiple areas on the Site Building. This is especially evident on roof elevations on the 7<sup>th</sup> and 5<sup>th</sup> floors. These areas would be considered in **FAIR** condition. All other siding is present in **GOOD** condition.

Photo 1: Galbestos siding in **FAIR** condition.
