Undertaking 82

The level 1 condition assessment completed by AMEC for the Holyrood Thermal Generation Station (HGTS) dated January 28, 2011 was filed under Exhibit #44 of the Muskrat Falls Review.

Pages 11-121 to 11-137 of this report relate to the findings regarding the level 1 assessment of the Gas Turbine at the HTGS. This is attached as Undertaking 82 Attachment 1.

11.2.5 Asset 7202 – Gas Turbine Genset

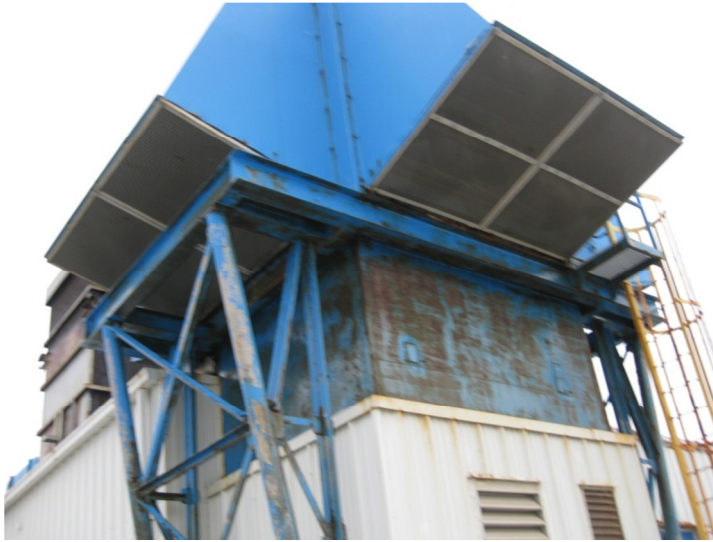
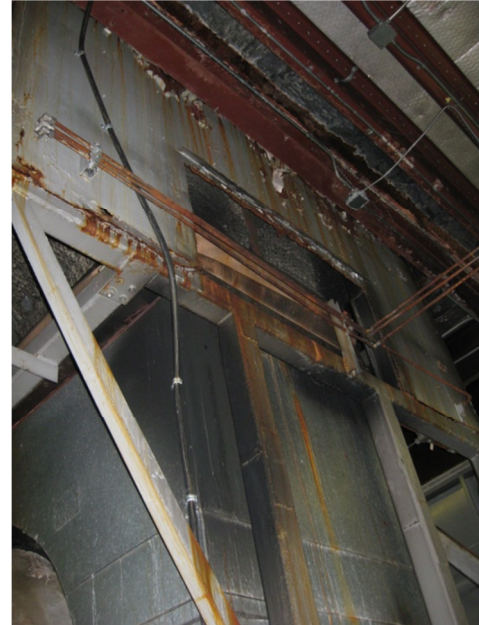
FIGURE 11-38 GTG EXHAUST STACK & DUCT

1273	7202	7311	0	GAS TURBINE SYSTEM	GAS TURBINE AUXILIARY SYSTEMS	GAS TURBINE AUXILIARY SYSTEMS	GTG Exhaust	10	13	Leaks – end of life.	1	4	D	High	4	C	High	Loss of generator, machine damage, safety – personnel.	Refurbish or replacement asap.
1273	7202	7311	0	GAS TURBINE SYSTEM	GAS TURBINE AUXILIARY SYSTEMS	GAS TURBINE AUXILIARY SYSTEMS	GTG Lube Oil and Rad	11	13	Mechanical, leak/fire.	10	3	B	Medium	3	B	Medium	Short loss of generator, equipment damage, safety – personnel.	Refurbish or replacement asap.
1273	7202	7311	0	GAS TURBINE SYSTEM	GAS TURBINE AUXILIARY SYSTEMS	GAS TURBINE AUXILIARY SYSTEMS	GTG Fuel Oil Receipt, Piping, Feed	12	13	Mechanical failures.	3	2	C	Low	3	C	High	Temp loss of generator, unit damage, safety – personnel.	Refurbish or replacement asap.
1273	7202	7311	99003602	GAS TURBINE SYSTEM	GAS TURBINE AUXILIARY SYSTEMS	AIR INLET PLENUM CHAMBER	GTG Air Intake	13	13	Leakage salt air.	2	3	C	High	3	B	Medium	Loss of generator, unit damage.	Refurbish or replacement asap.

BU # 1	Asset # 2	Asset # 3	Asset # 4	Asset 2/3	Asset 3/4	Description	CAP#	Appendix #	Capital Item	Date	Priority
1273	7202	0	0	GAS TURBINE SYSTEM	GAS TURBINE SYSTEM	GAS TURBINE SYSTEM	1		No capital investment.		
1273	7202	7058	0	GAS TURBINE SYSTEM	GAS TURBINE POWER TURB & G/B	GAS TURBINE POWER TURB & G/B	2	13	Overhaul of power turbine, gearbox.	2011	1
1273	7202	7308	0	GAS TURBINE SYSTEM	GAS TURBINE AVON JET ENGINE	GAS TURBINE AVON JET ENGINE	3	13	Overhaul gas turbine.	2011	1
1273	7202	7309	0	GAS TURBINE SYSTEM	GAS TURBINE GENERATOR	GAS TURBINE GENERATOR	4		Refurbish generator.	2015+	3
1273	7202	7310	0	GAS TURBINE SYSTEM	GAS TURBINE ELECT & CONTROL	GAS TURBINE ELECT & CONTROL	5	13	Replace electrical equipment for gas turbine.	2010	1
1273	7202	7310	333927	GAS TURBINE SYSTEM	GAS TURBINE ELECT & CONTROL	GAS TURBINE DCS CONTROL	6		No capital investment.		
1273	7202	7311	0	GAS TURBINE SYSTEM	GAS TURBINE AUXILIARY SYSTEMS	GAS TURBINE AUXILIARY SYSTEMS	7	13	Replace the exhaust stack.	2011	1

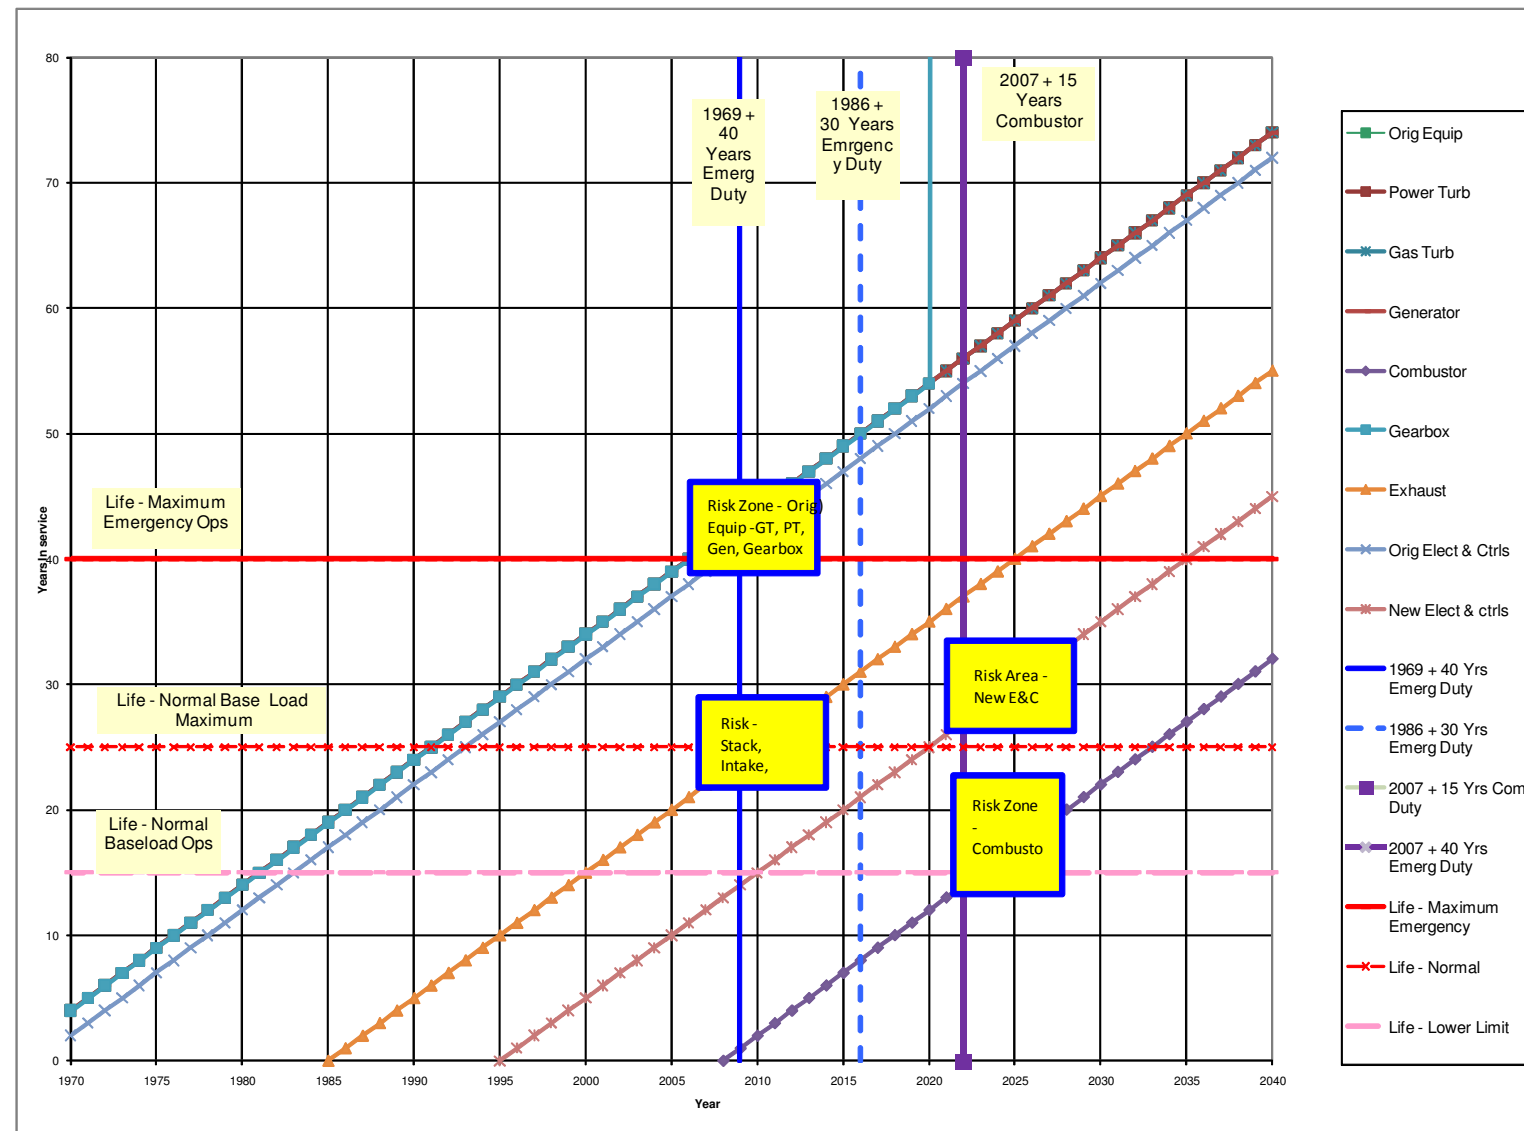
FIGURE 11-39 LIFE CYCLE CURVE – GAS TURBINE GENSET (PHYSICAL AGE BASIS)

The curves, as well as the condition assessment, indicate the unit is in need of a significant and immediate overhaul and refurbishment or replacement. Its remaining life (RL) is less than the desired life (DL) which is 2020. The importance of a near term overhaul or replacement is highlighted by the critical system role that the unit needs to play in black starting the Holyrood units in the event of a system failure. The stack is physically in need of refurbishment or replacement. The intake likely needs a better filter media. The fuel system and coolers need repairs and better ambient protection. The gearbox seals continue to be an issue and a fire safety hazard. The gas turbine has not been overhauled for a considerable period, and recent inspections as well as the life cycle curve for a marine environment suggest that this necessary.
