Re: An Application by Newfoundland and Labrador Hydro (Hydro) pursuant to Subsection 41(3) of the Act for approval of the Restoration of Unit 1 Turbine and Generator at the Holyrood Thermal Generating Station

AND IN THE MATTER OF an Application by Newfoundland and Labrador Hydro pursuant to Subsection 41(3) of the *Act*, for the approval of the refurbishment of Unit 1 Turbine and Generator at the Holyrood Thermal Generating Station.

Holyrood Unit 1 Forced Outage
Results of Phase 1 Inspection and Recommendation for Further Inspection

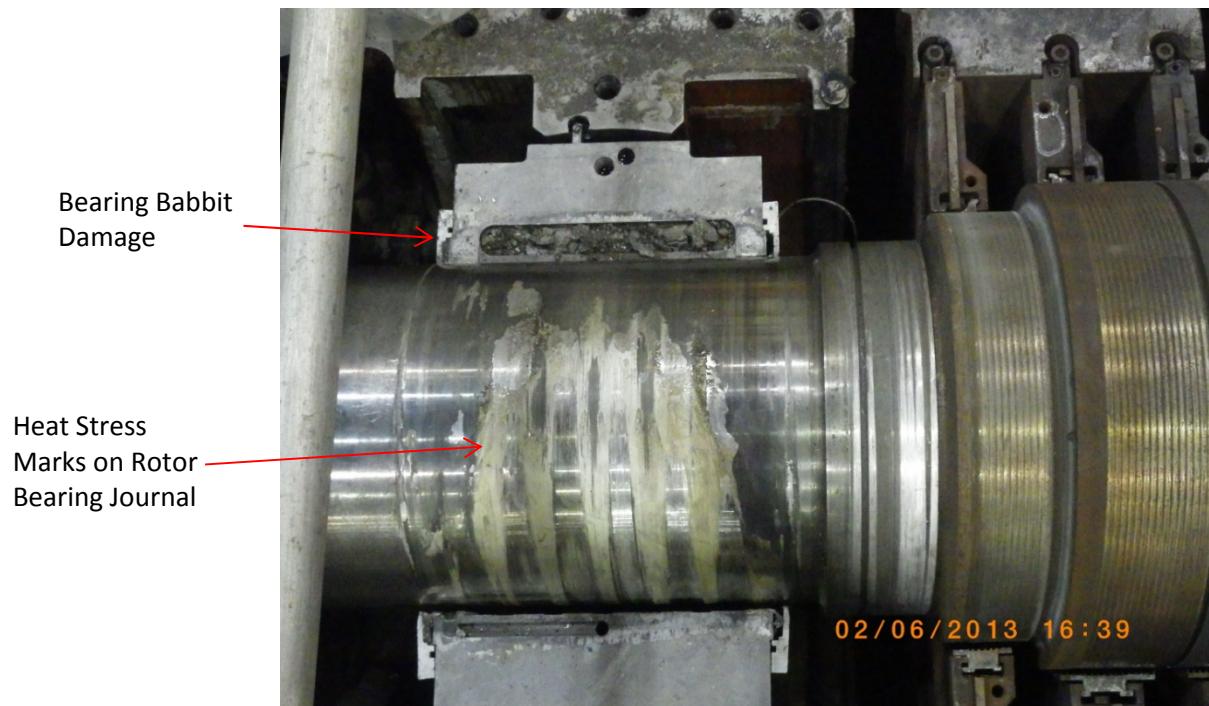
Figure 1. Typical Bearing and Journal Damage

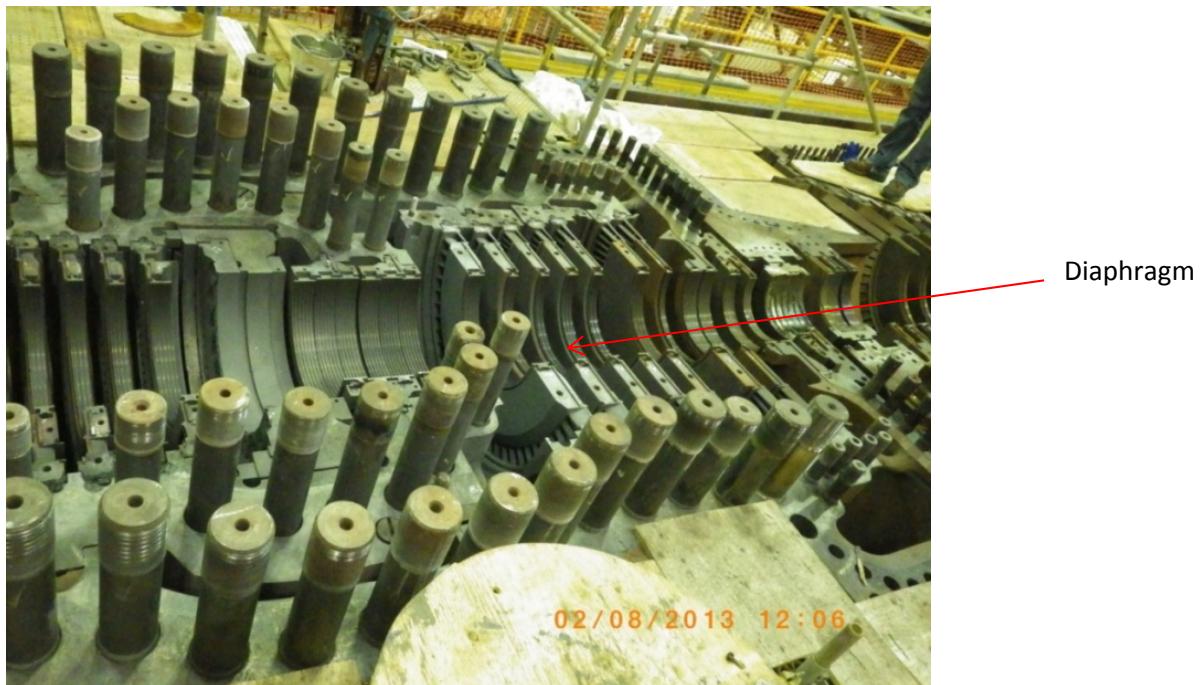
Following the removal of the inner and outer top section turbine casings, it was discovered that the turbine rotor had moved radially and axially towards the generator during the failure event on January 11, 2013. This movement resulted in contact between the rotor and the diaphragm spill strips and inter stage packing, causing damage and clearance issues (see Figures 2 and 3 below). The rotor was then removed from the turbine and installed in a

Figure 2. Steam Turbine HP Bottom Casing with Rotor Removed

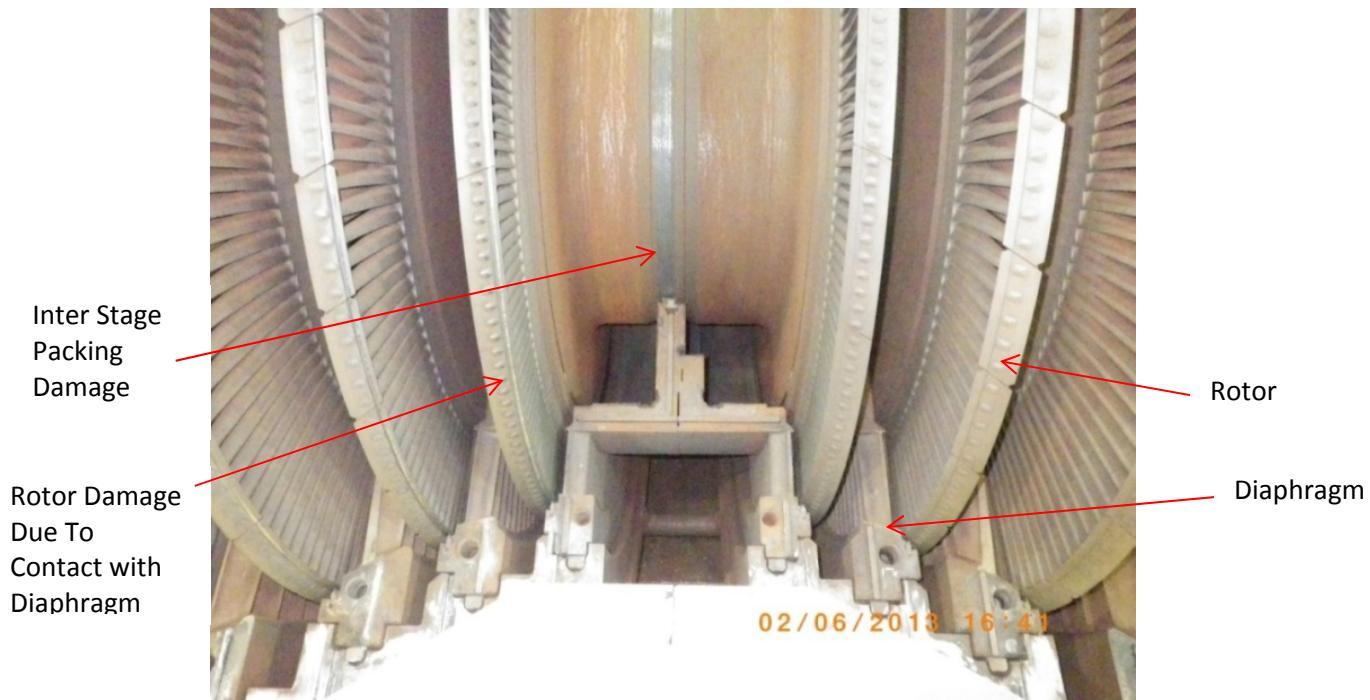
portable lathe to check for run out. There were no significant run out issues noted during the inspection. However, numbers 2 and 3 bearing journal surfaces had heat stress and hardness issues that will require machining and stress relieving during Phase 3. After the turbine rotor was removed, the turbine diaphragms were also removed and non-destructive testing was completed on the diaphragms to check for cracks. No cracks were discovered.

Figure 3. Steam Turbine Rotor & Diaphragms

1. Complete turbine rotor and diaphragm repairs;
2. Repair or replace the failed components of the oil lubrication system including the DC lubrication oil pump set;

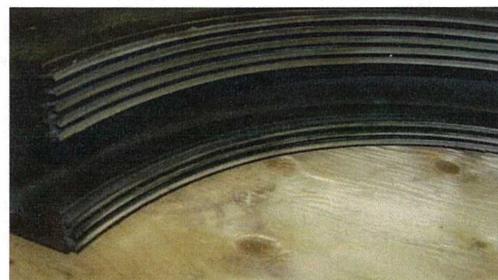
T5 Outer Oil Deflector – The T5 outer oil deflector, Upper and Lower half, is heavily rubbed and will need to be repaired. The lower oil deflector clearance is “0” and the upper oil deflector as found clearance was .113” and the as built upper clearance in 2012 was .022”. This indicates .091” wear in the deflector.

T5 oil deflector U/H

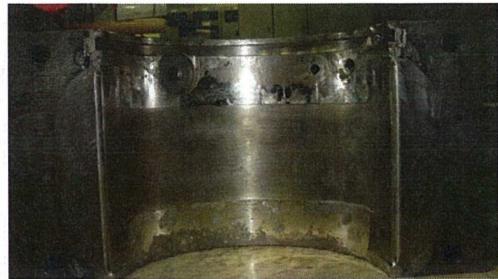
T5 Bearing – A feeler check of the clearance between the shaft and the T5 journal showed a clearance of .070", and the as built bearing clearance vertical was .018", showing .052" wear in the bearing bore. T5 Bearing oil bore, indicates the shaft to be approximately .068" low. This number is approximated as the closing oil bores at T5 were not recorded at the last or previous outages on this unit. This number is based on the assumption the oil bores are nearly equal L, R, B. The as found was L=11.233", R=11.268", B=11.182".

T5 Bearing U/H

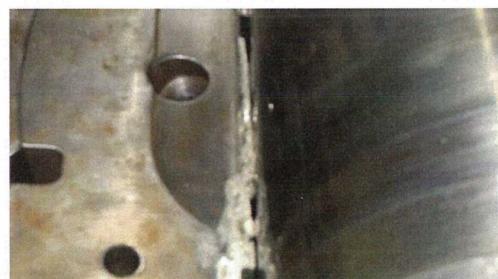
T5 Bearing L/H and Journal as found Left Side

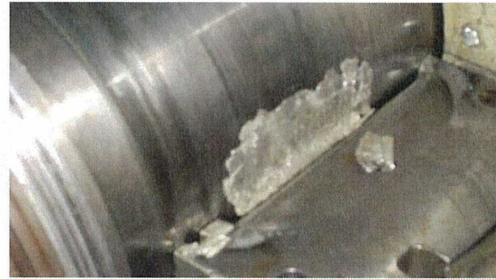
T5 Bearing L/H and Journal as found Right side

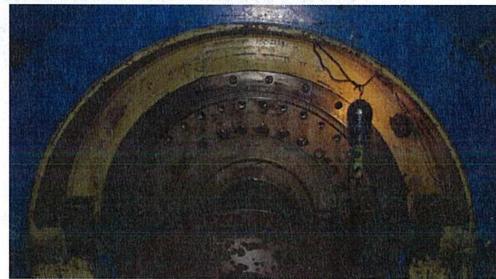
CE Hydrogen Seal Casing – the radial alignment of the H2 seal casing was taken and compared to the as assembled alignment prior to disassembly of the casing. Feeler check of the casing shows the shaft is .044" low in the bore. Casing should be centered to the shaft. $L=.192"$, $T=.2325"$, $R=.184"$ are the as found readings. The gas side oil deflector upper half and lower half are heavily rubbed. The H2 Seals has slight rubbing on the I.D. and seals can be moved in the bore.

CE Hydrogen Seal Casing prior to removal

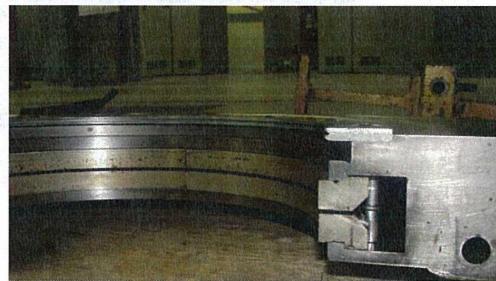
CE H2 Seal Casing U/H hard rub on Gas side Oil Deflector

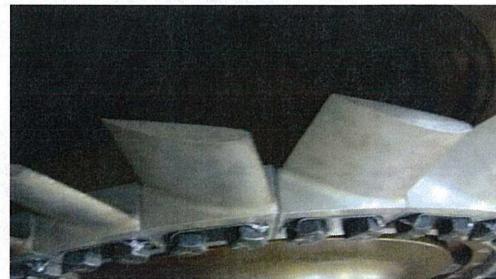
CE Fan Blades – the CE Fan Blades do not appear to have rubbed and are in good condition as is the Fan Shrouds. The Fan Blade radial clearances were recorded prior to removal of the shrouds or the blades. The lower blade radial clearance was found to be .032" as compared to the as assembled clearance in 2012 of .075". This indicated the shaft is low in the bore at the CE .043". This compares favorably with the H2 Seal Casing and reasonable with the T5 Bearing clearance and the rotor position.

CE Fan Tips Typical

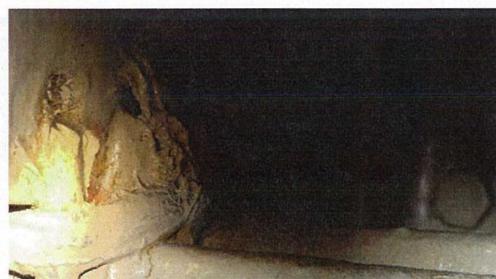
CE End Windings – No visual indication of Mechanical or Electrical damage to the CE ending windings due to this event. There are signs of greasing, indicating some bar movement has occurred.

CE End Windings Greasing

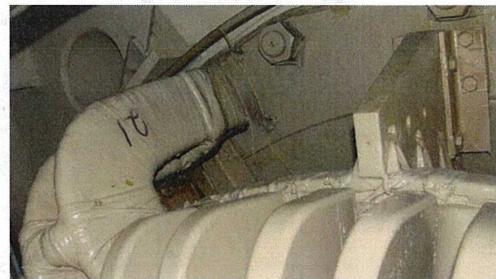
CE End Winding Greasing

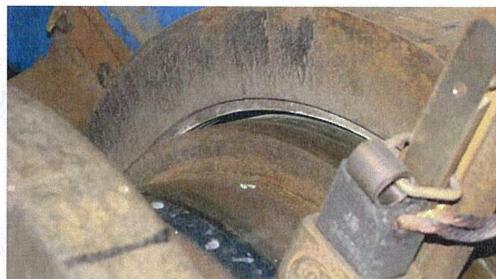
T4 Outer Oil Deflector – The T4 outer oil deflector, Upper and Lower half, is heavily rubbed and will need to be repaired. The lower oil deflector clearance is "0" and the upper oil deflector as found clearance was ".145" and the as built upper clearance in 2012 was ".024". This indicates ".121" wear in oil deflector bore.

T4 Outer Oil Deflector prior to removal

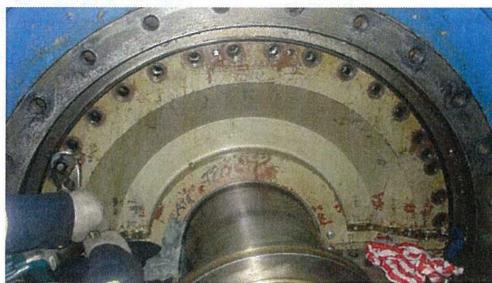
TE Hydrogen Seal Casing – the radial alignment of the H2 seal casing was taken and compared to the as assembled alignment prior to disassembly of the casing. Feeler check of the casing shows the shaft is .109" low in the bore. Casing should be centered to the shaft. L=.195", T=.295", R=.177" are the as found readings. The gas side oil deflector upper half and lower half are heavily rubbed. The H2 Seals has slight rubbing on the I.D. and seals can be moved in the bore. The TE H2 Seals had a large gap between the seals and the shaft on initial inspection. The clearance was well above the normal and could have been the source of gas leakage at TE.

TE Hydrogen Seal Casing Prior to removal

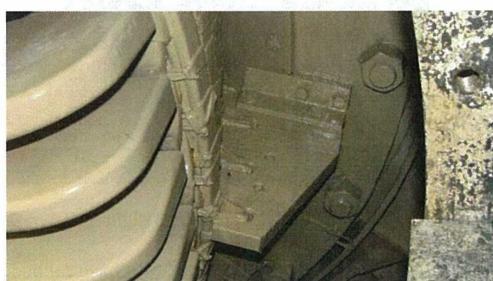
TE End Windings – No visual indication of Mechanical or Electrical damage to the TE ending windings due to this event. There are signs of greasing, indicating some bar movement has occurred.

TE End Winding Greasing

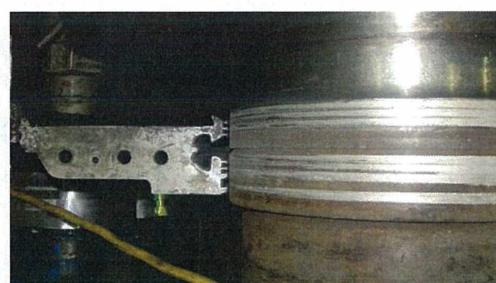
T3 L/H outer oil deflector R/S

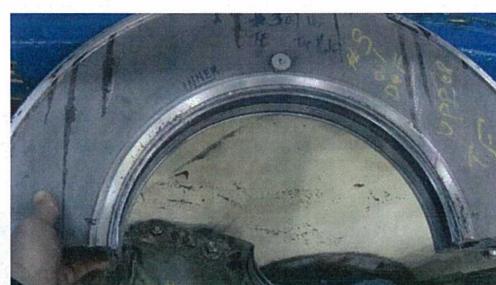
T3 Inner oil Deflector U/H

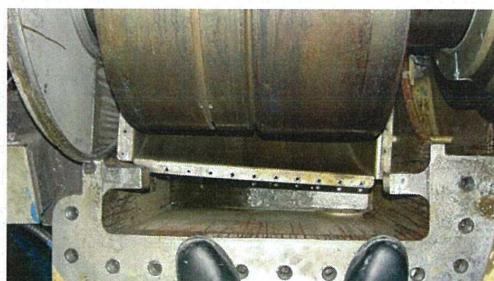
Lower half coupling guard lying in bottom of sump and Babbitt in bottom of sump

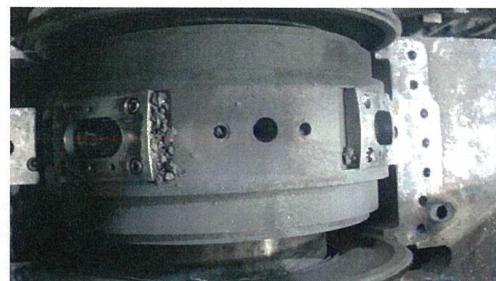
T2 U/H Bearing prior to removal

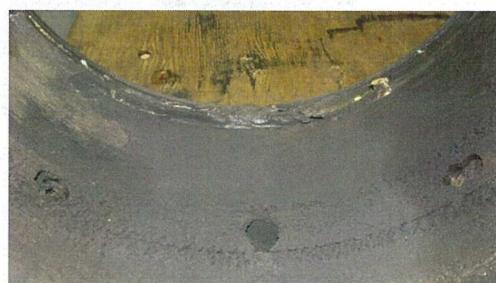
T2 U/H Bearing Bore

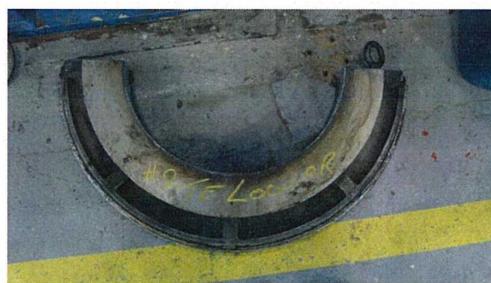
T2 L/H Inner Oil Deflector

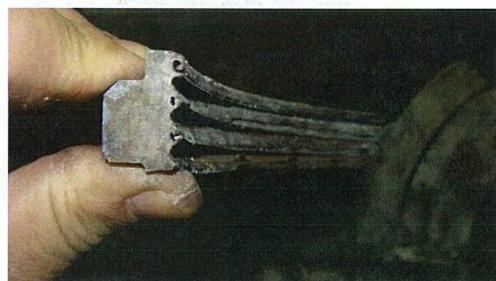
N1 Upper Packing Gland – the upper packing gland was removed to allow removal of the Front standard cover. Upon removal, the R1 ring of packing fell out as the springs were severely damaged from the fire at the front end of the unit. The packing is severely damaged from rubbing as is R2 packing upper half. The Lower half R1 and R2 packing are also severely damaged. Once the gland was removed, you can see that the

R1 Packing Ring - damaged

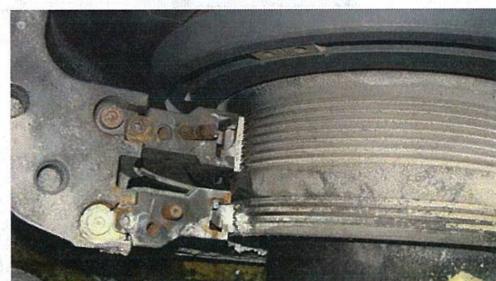
N1 Packing Gland L/H Left Side

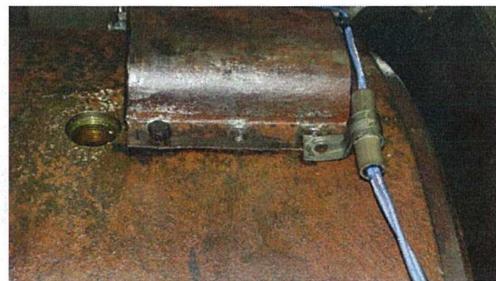
Thrust Bearing Flow Diverter

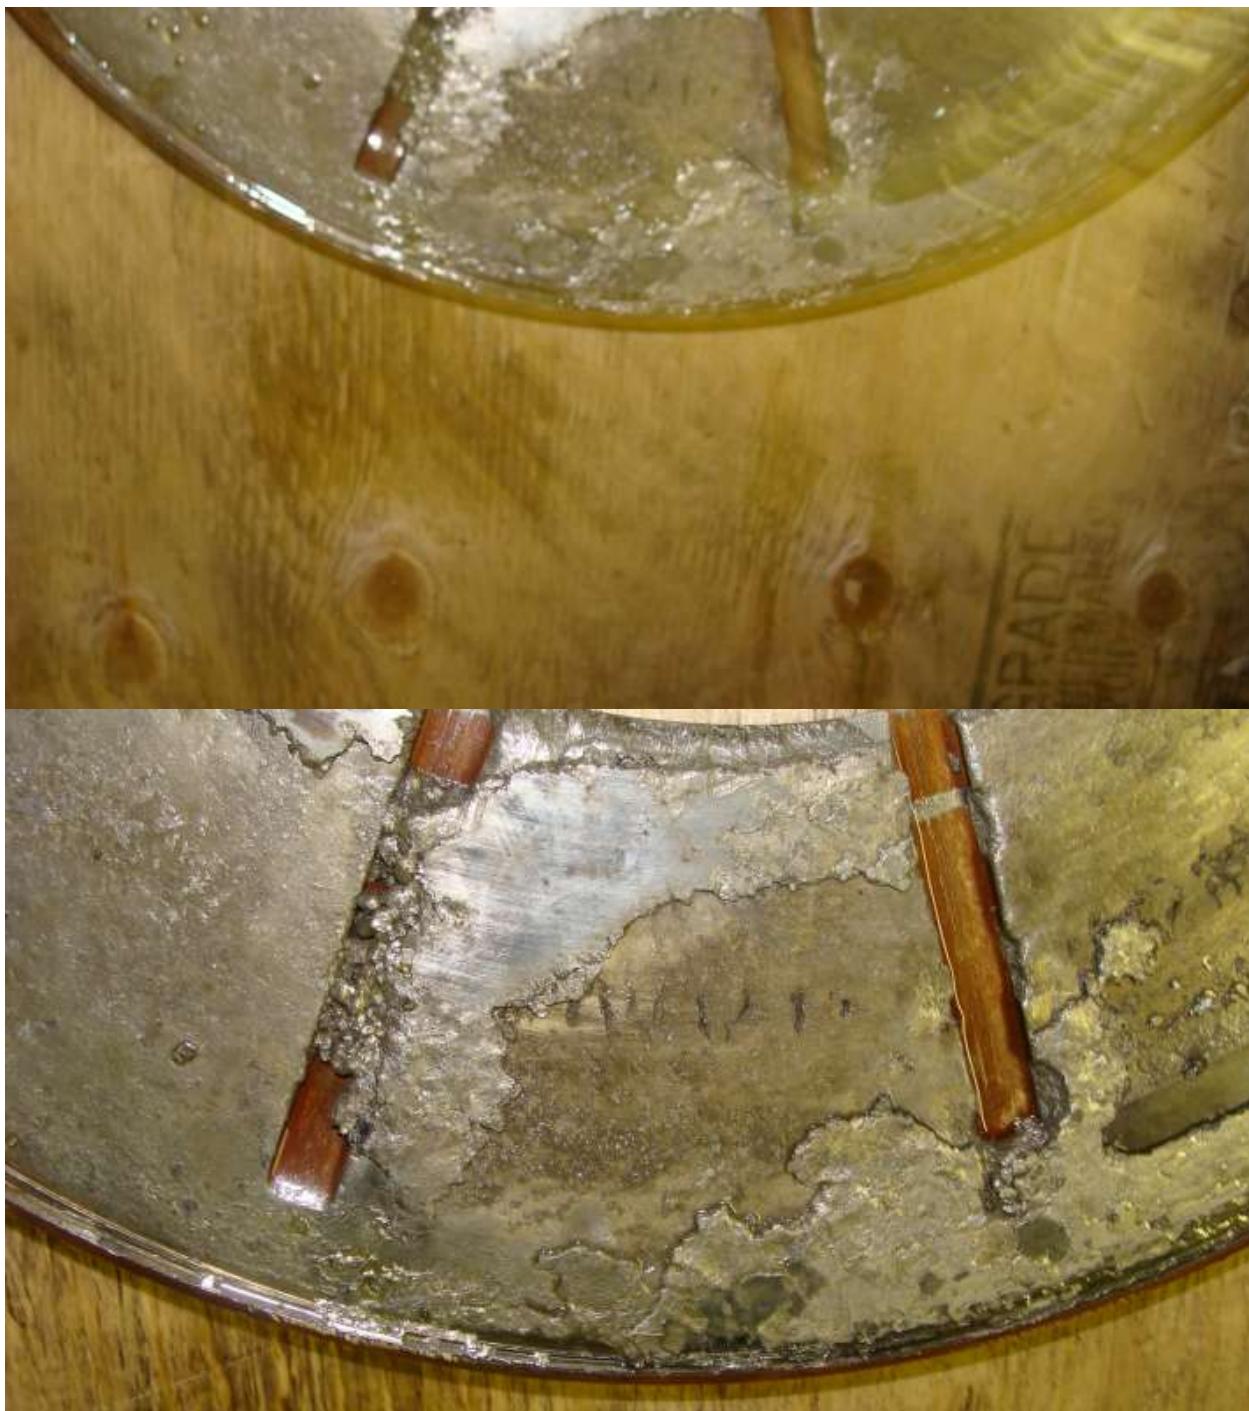
Damage to active side thrust plates

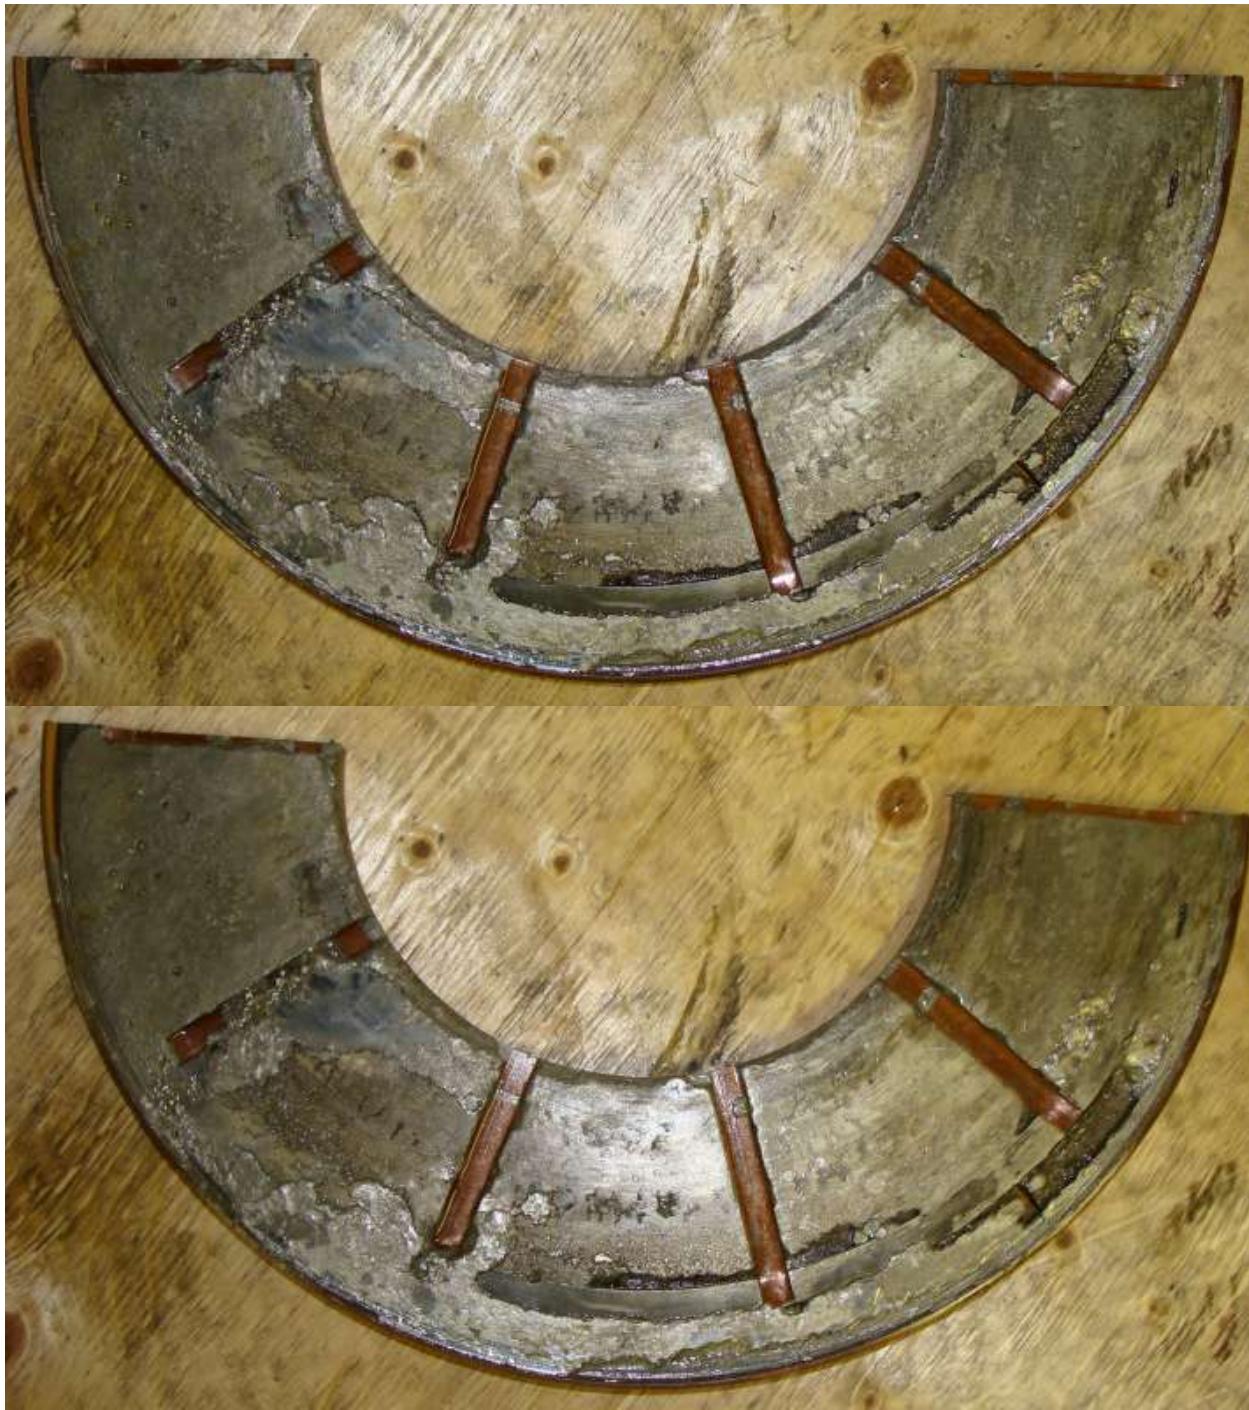
Thrust plate damage

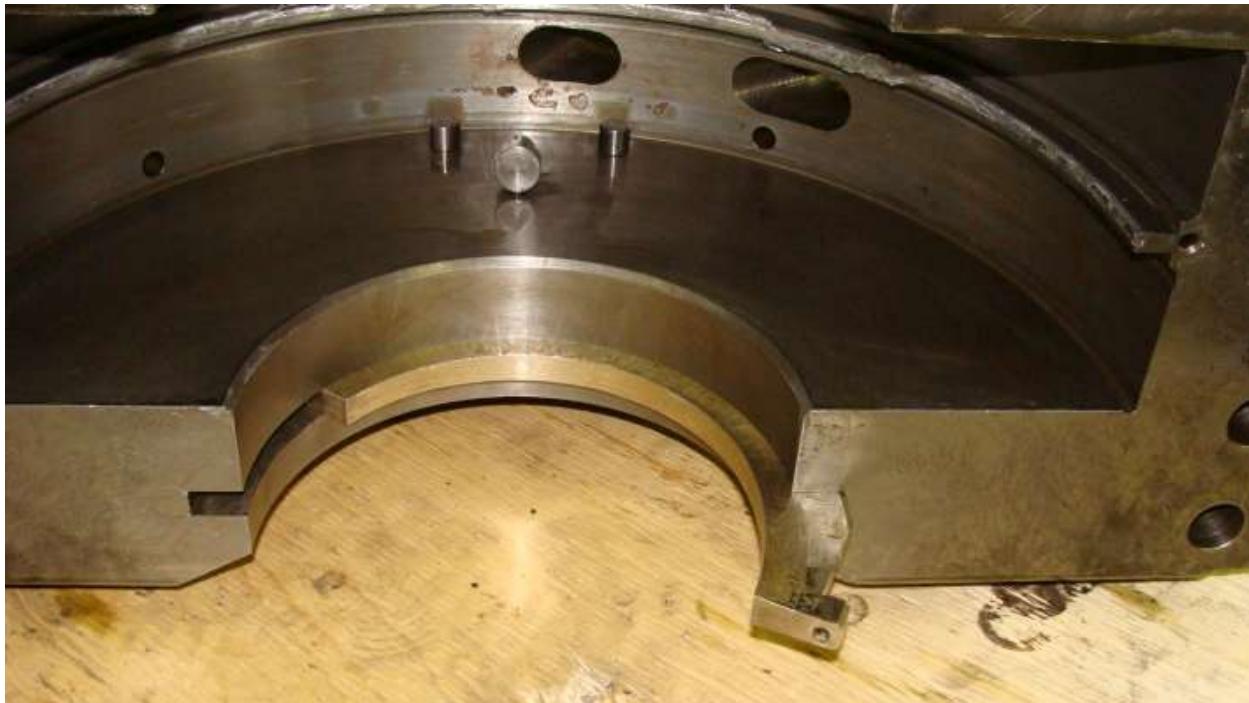
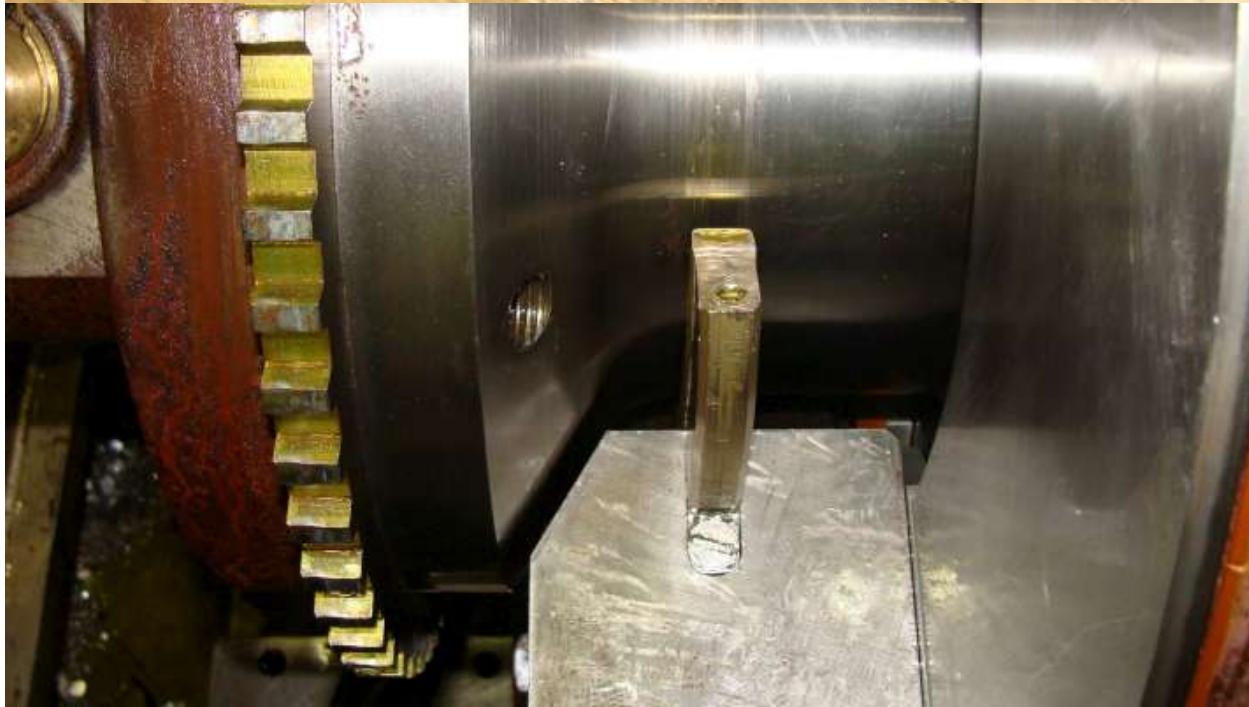
Seal ring rolled, keeper damaged

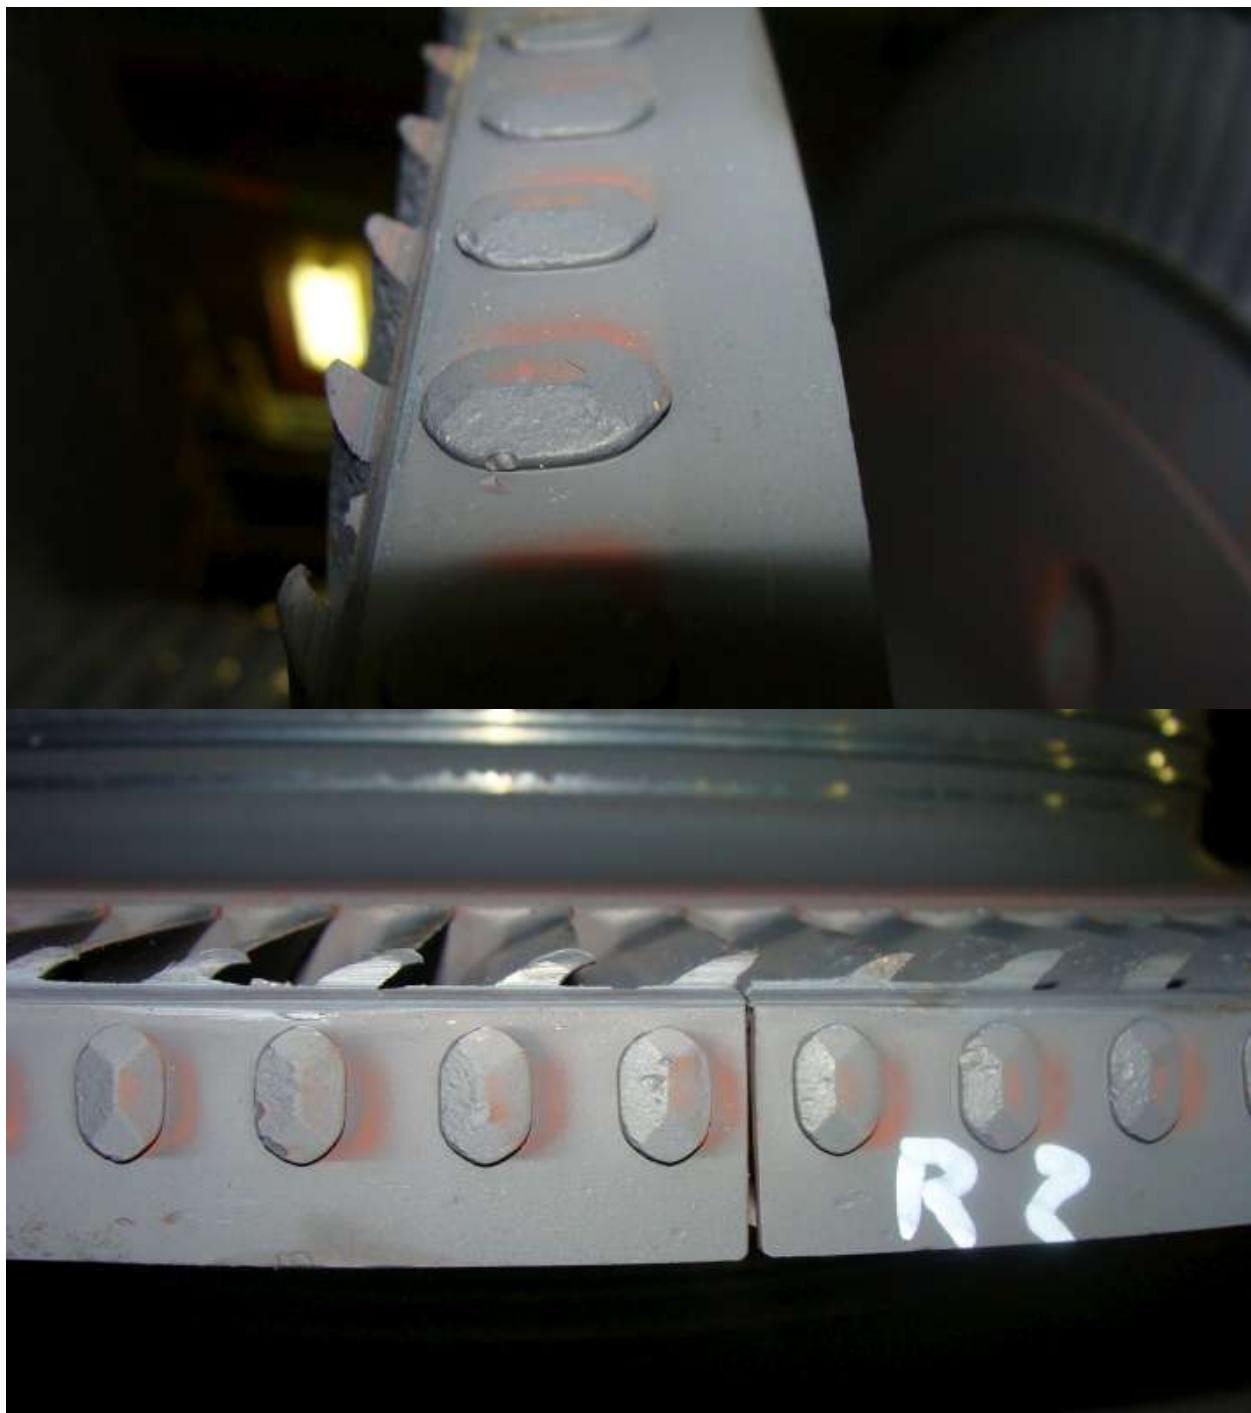
Row 2 partially missing cover material

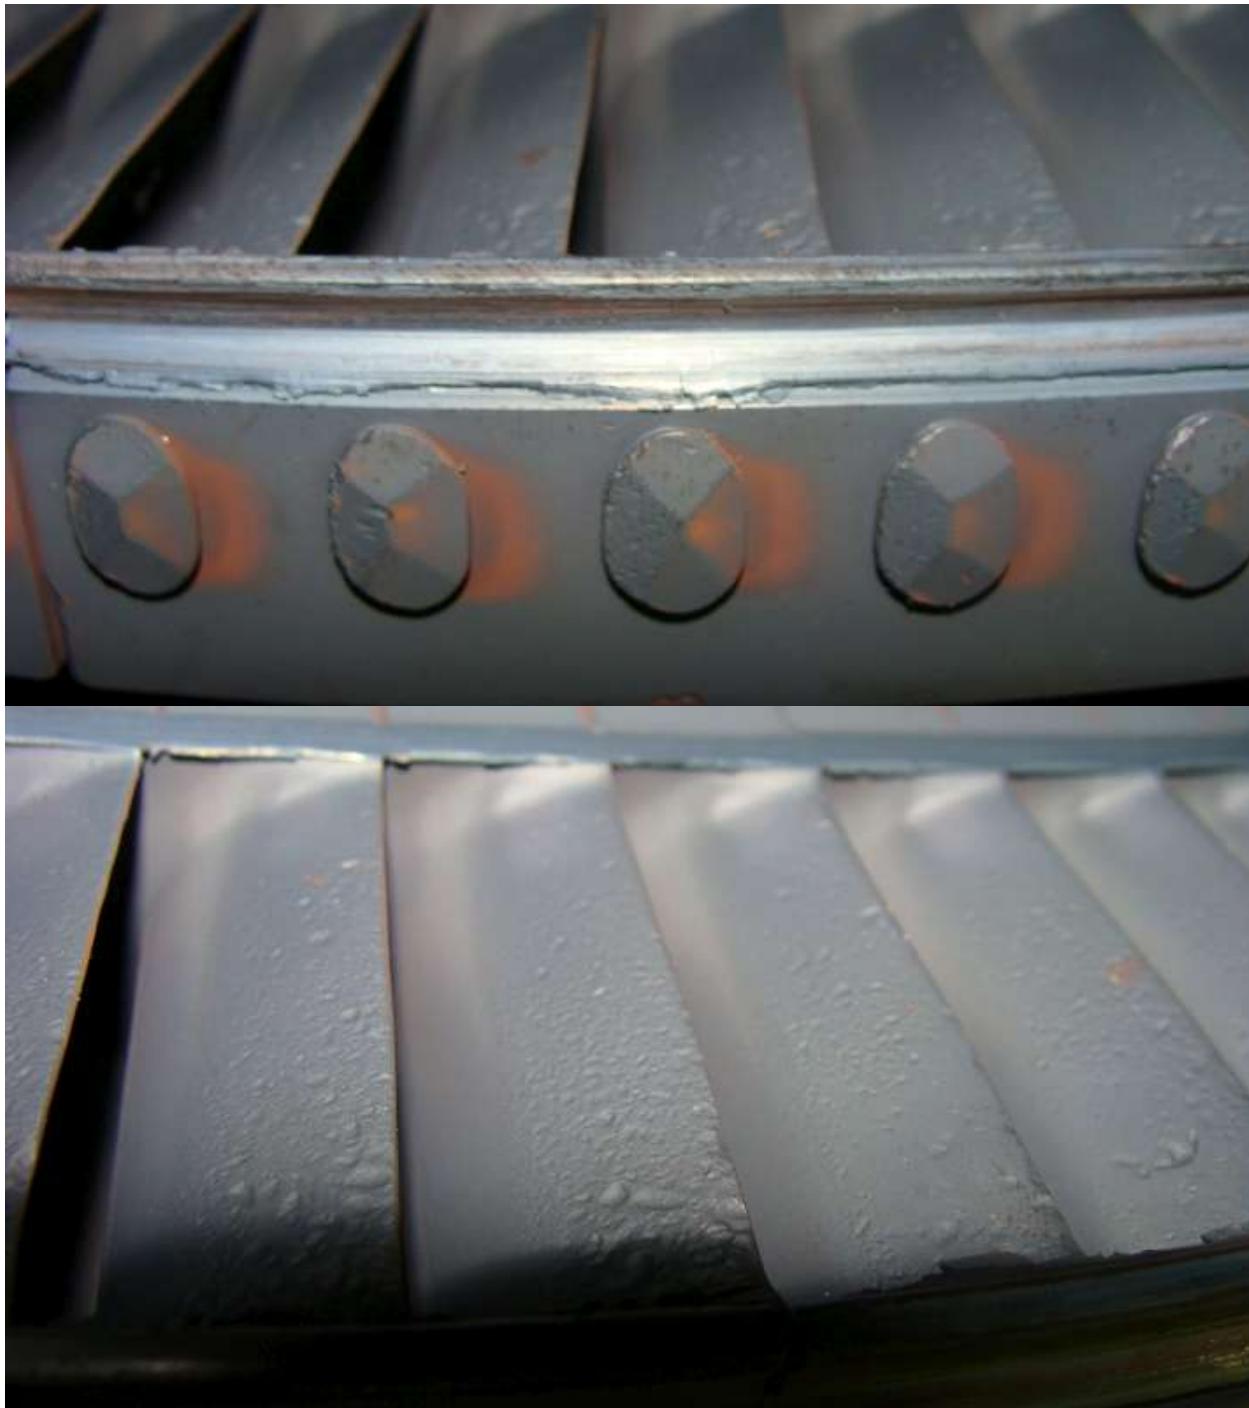
Row 3 blade root rub and inlet condition

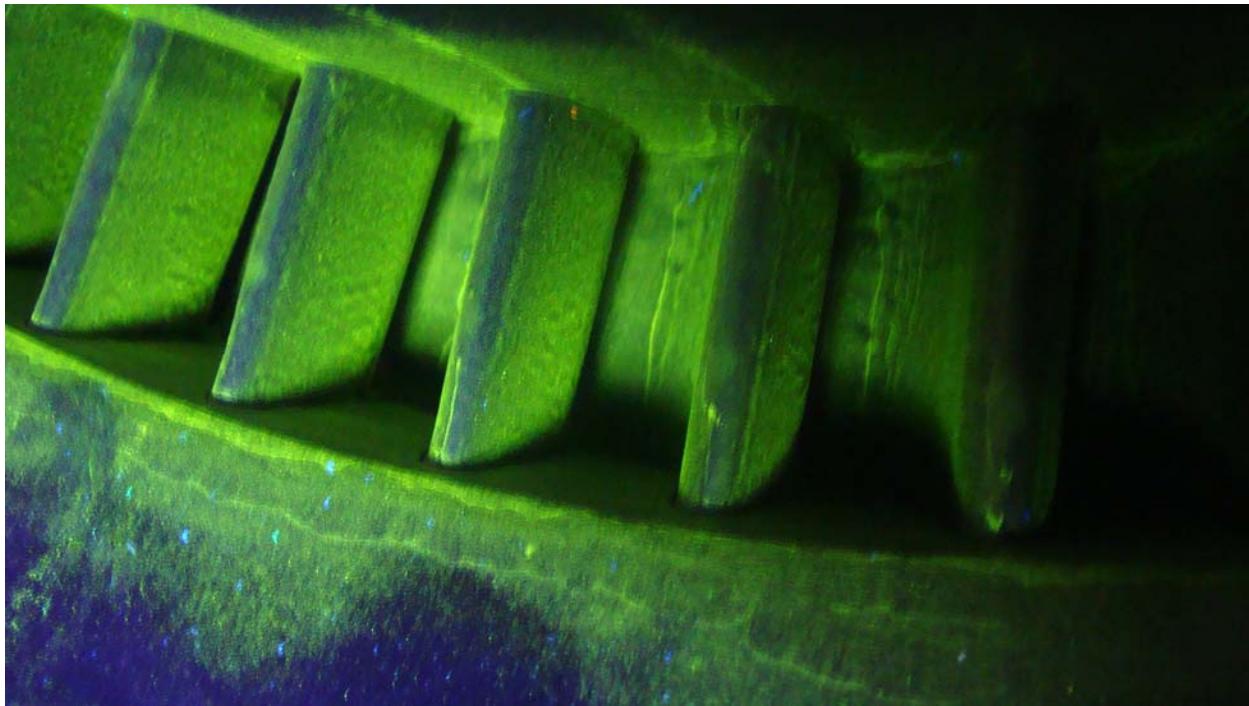
During the NDE lines were found on the Stage 2 and Stage 3 diaphragm blades. These lines were caused by previous weld repairs.

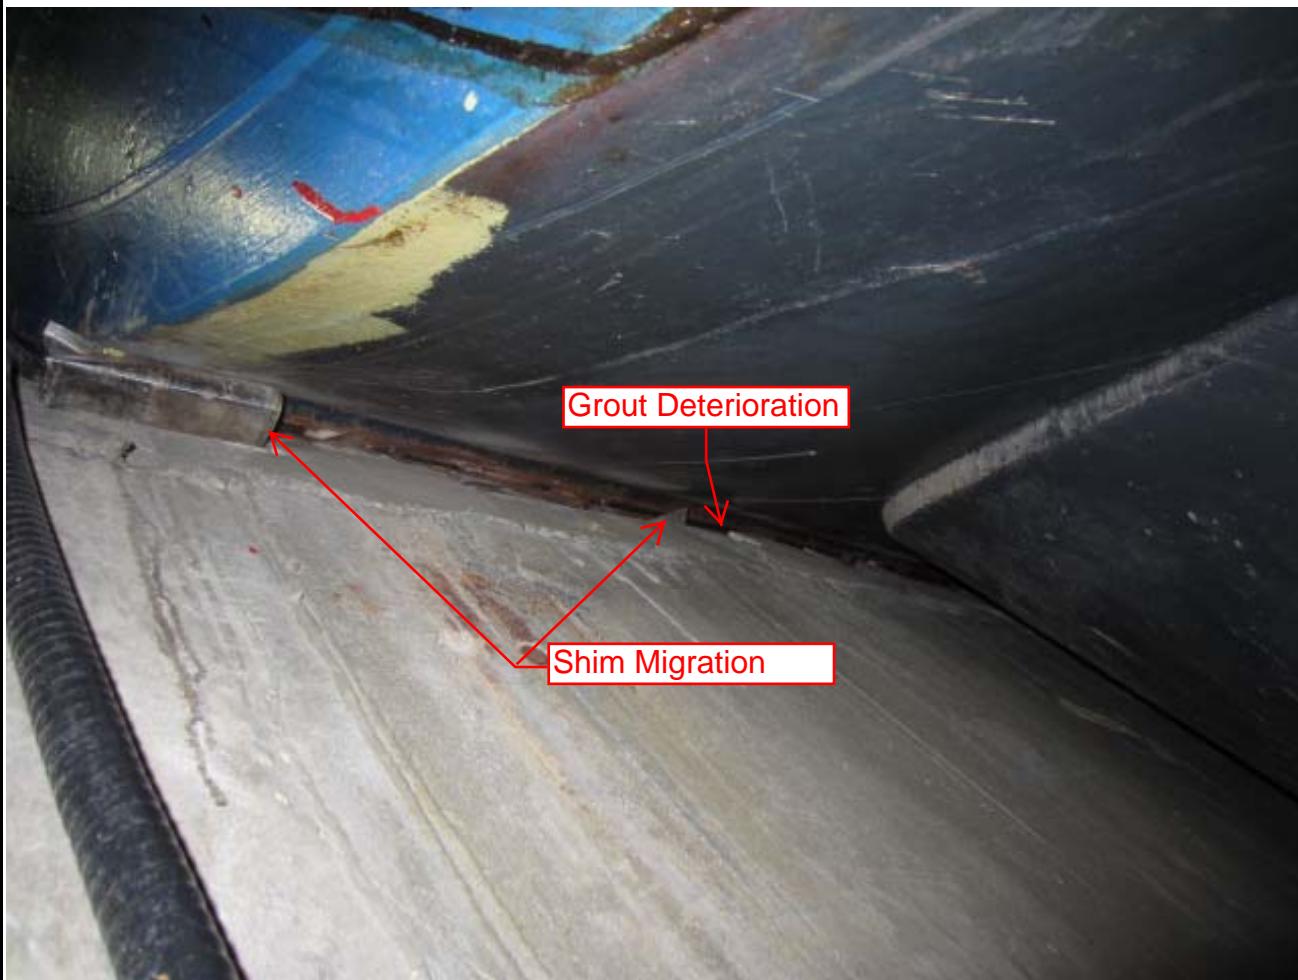
The front left foundation plate had 3 shims migrated, and approximately 50% of the thin vertical grout layer deteriorated.

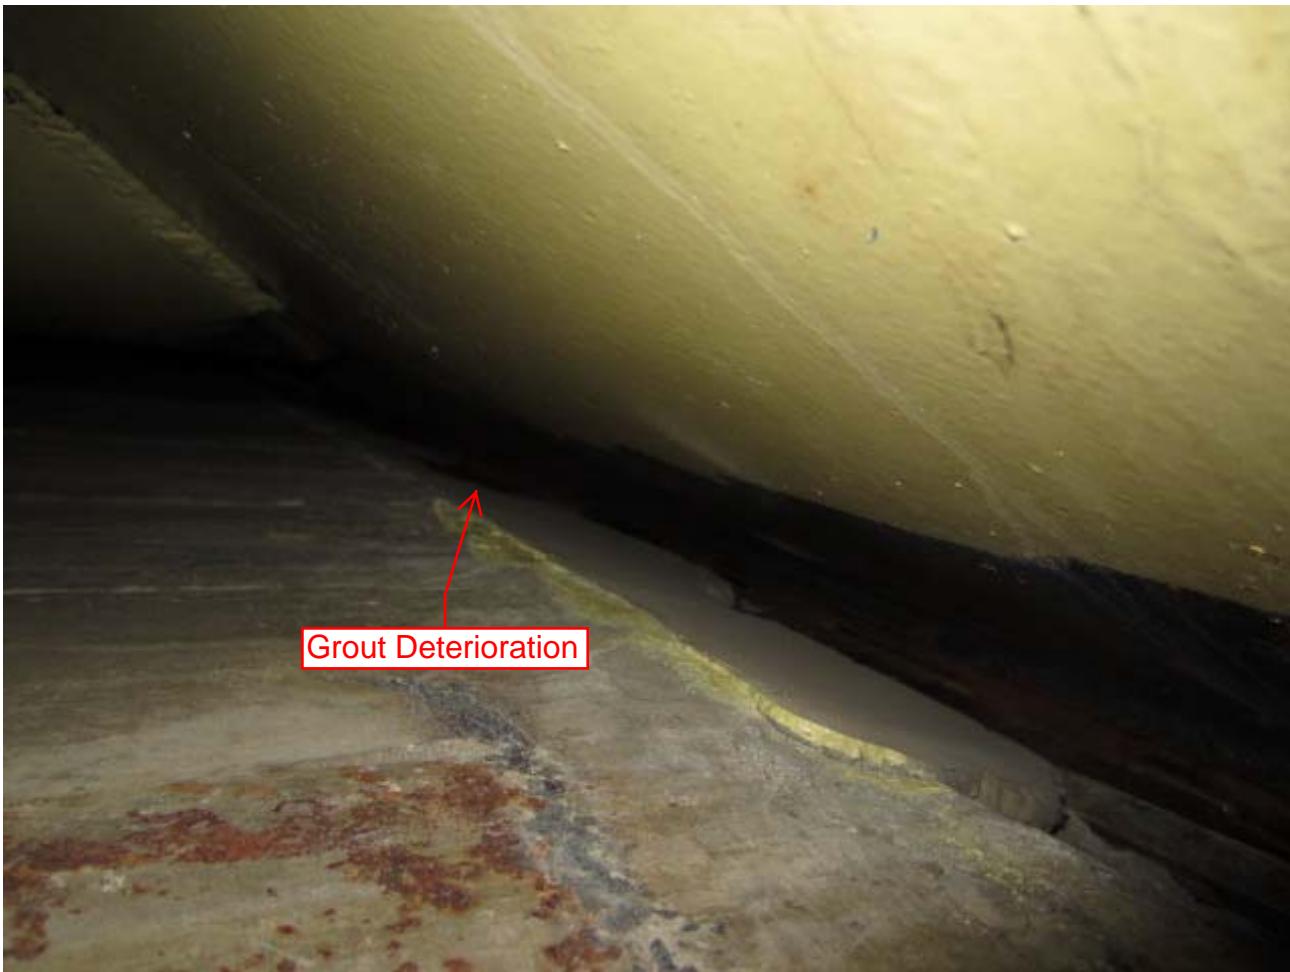
The front right foundation plate had no shim migration, and approximately 25% of the thin vertical grout layer deteriorated.

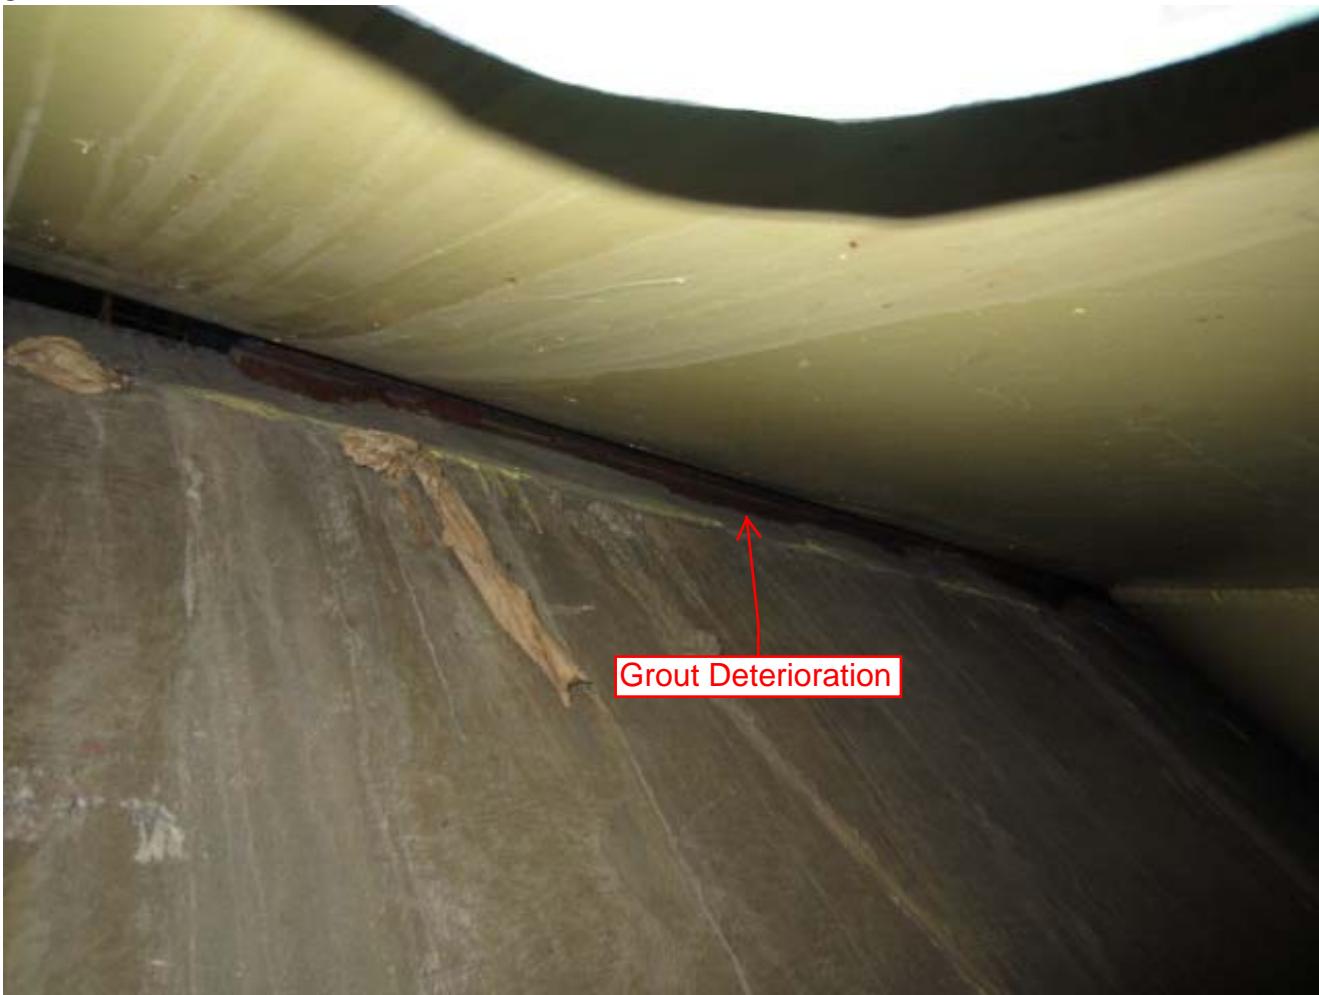
The rear left foundation plate indicated that 1 shim has migrated. Approximately 50% of the thin vertical layer of grout has deteriorated.

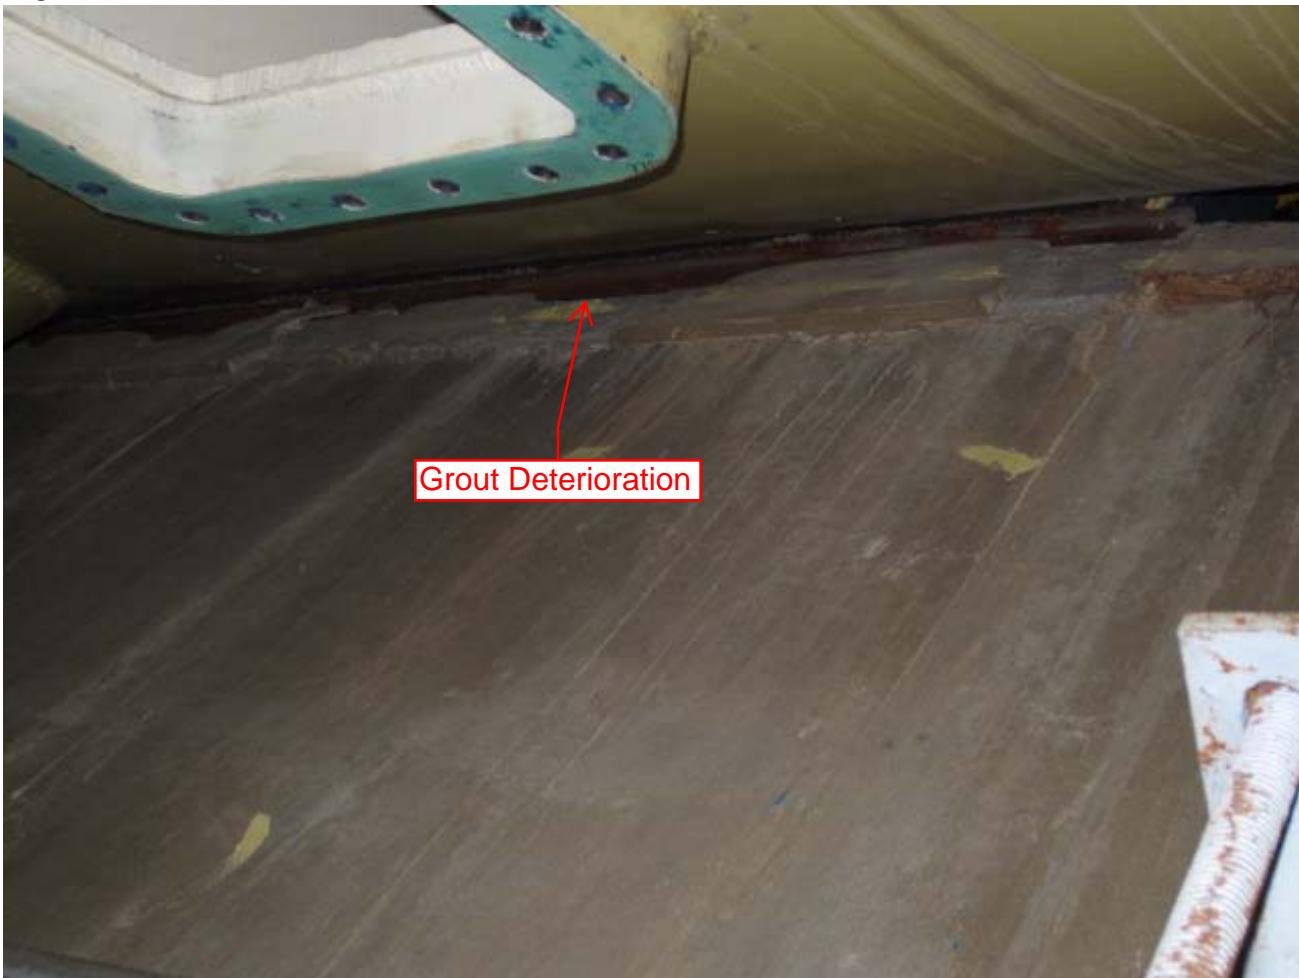
The rear right foundation plate indicated that 3 shim have migrated. Approximately 60% of the thin vertical layer of grout has deteriorated.

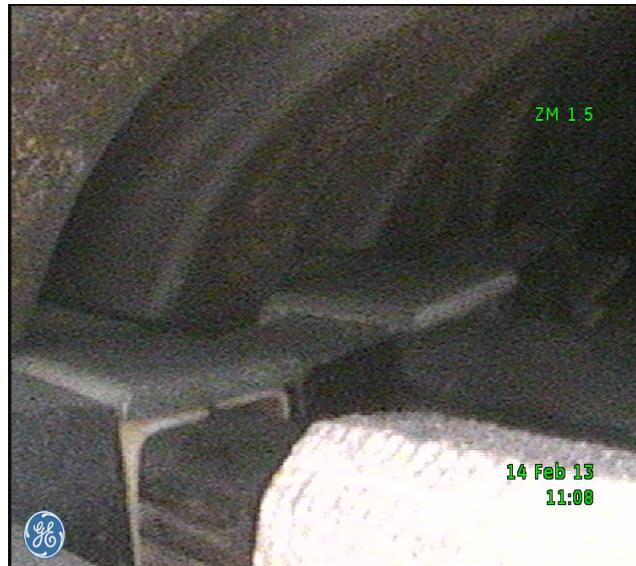
Seems resin has run down the coils & been contaminated. Note debris at base of coils.
