Holyrood Thermal Generating Station

Gas Turbine Condition Assessment & Options Study

December 19, 2011

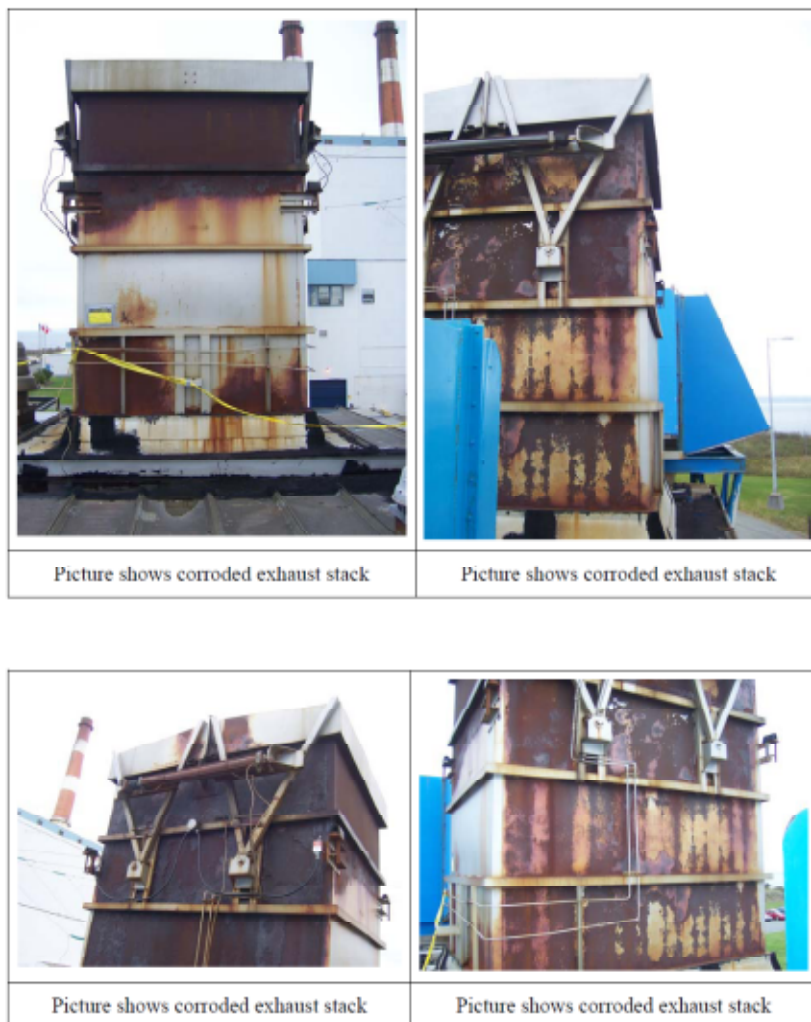
FIGURE 2-7 CORRODED EXHAUST STACK (GAS TURBINE PLANT)

Exhaust Stack: The exhaust stack is extensively corroded with leaks into the building and into the turbine, and should be replaced.

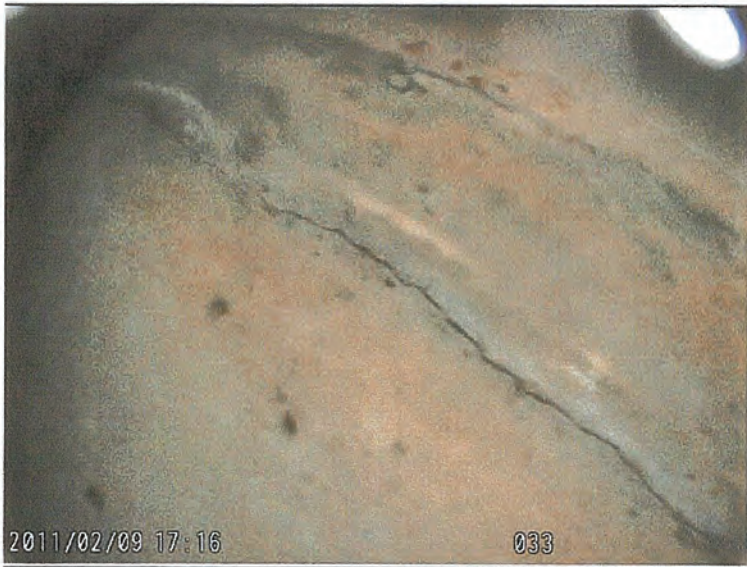
Photo 1. Showing crack around circumference of the PT cone.

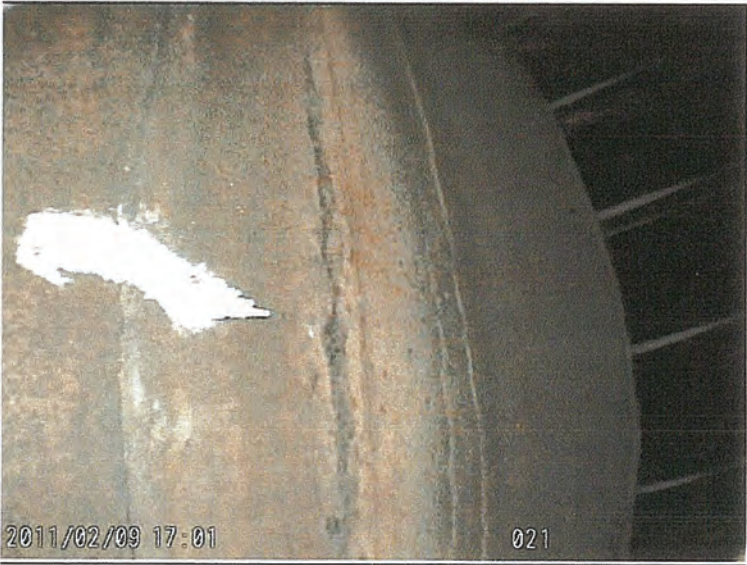
Photo 2. Showing crack around circumference of the PT cone.

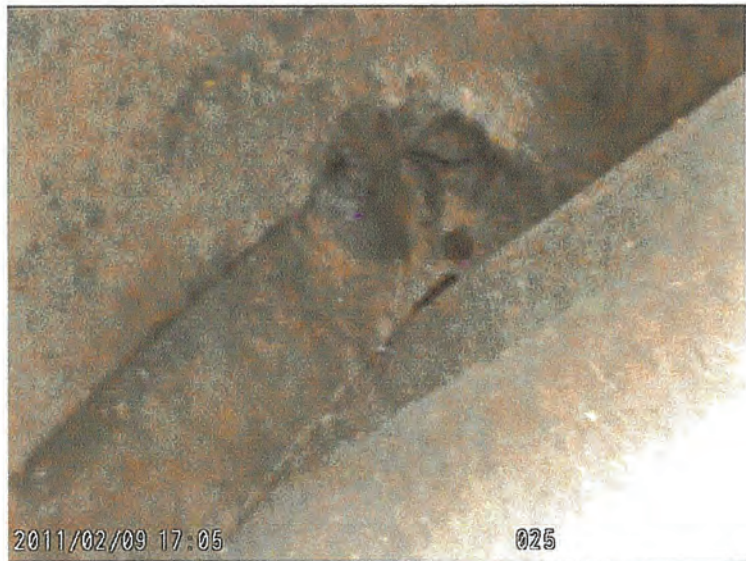
Photo 3. showing weld repair on cone spoke inner edge.

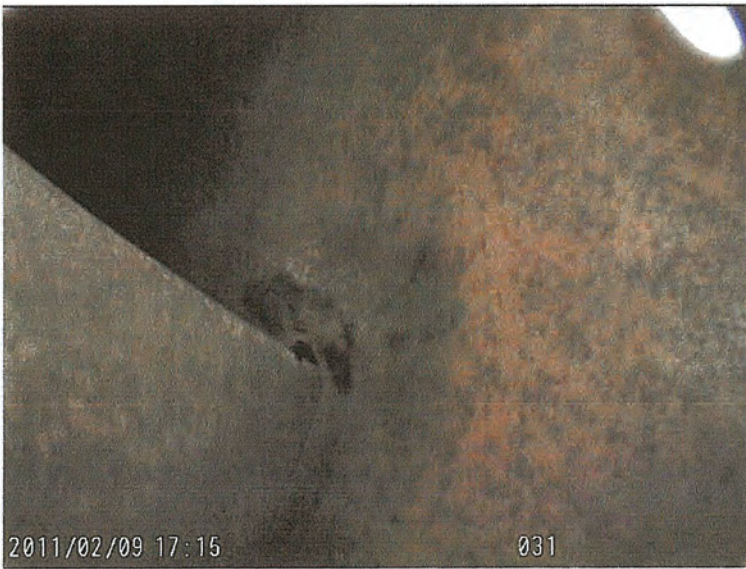
Photo 4. showing weld repair on cone spoke inner edge.

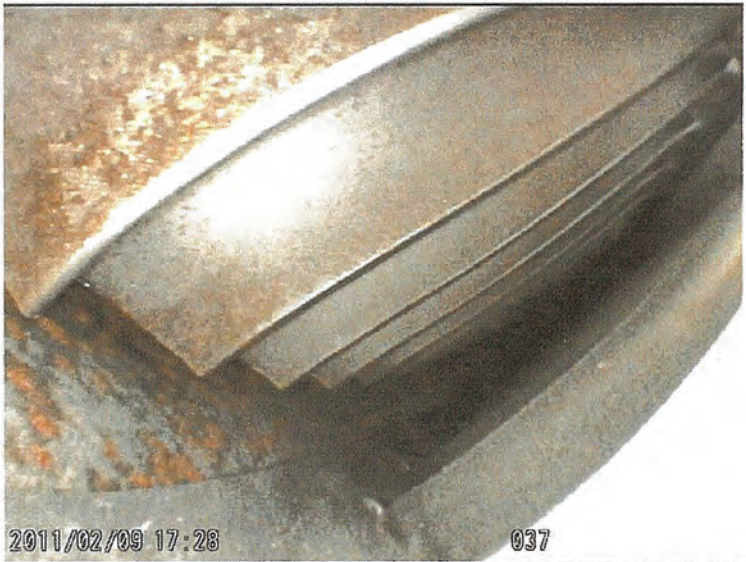
Photo 5. Showing corrosion of the nozzle blade track and on Rotor blade.

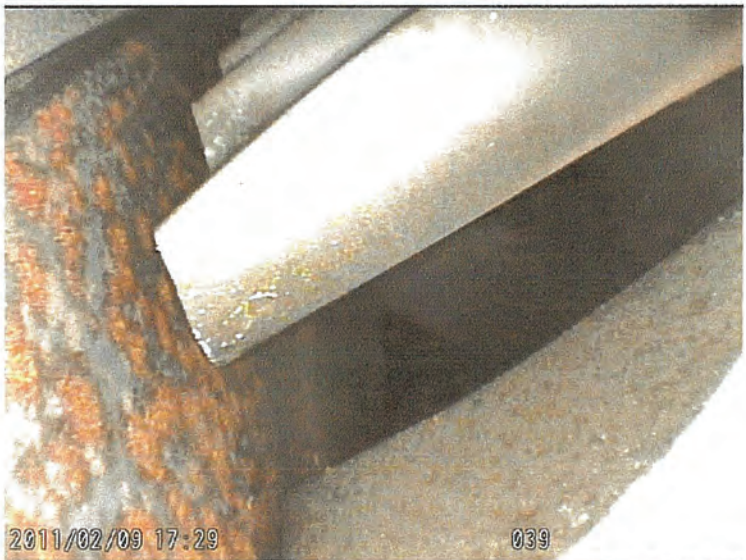
Photo 6. Showing corrosion of the nozzle blade track and on Rotor blade.

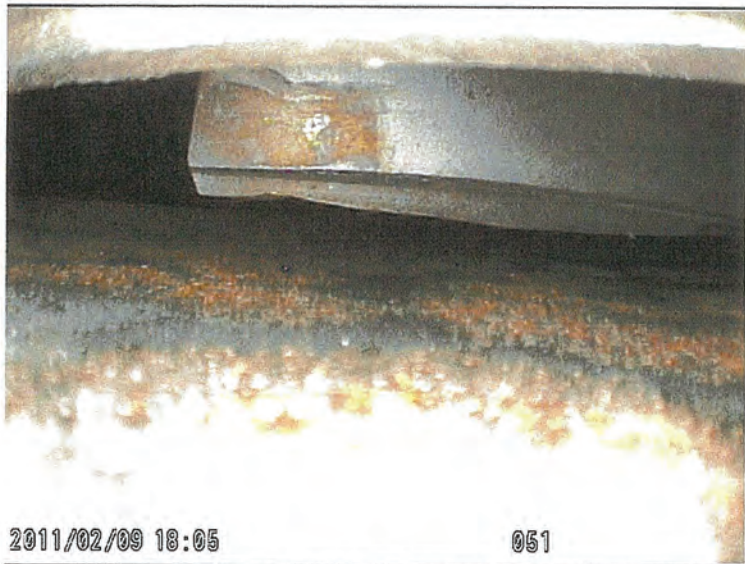
Photo 7. Showing worn blade tips.

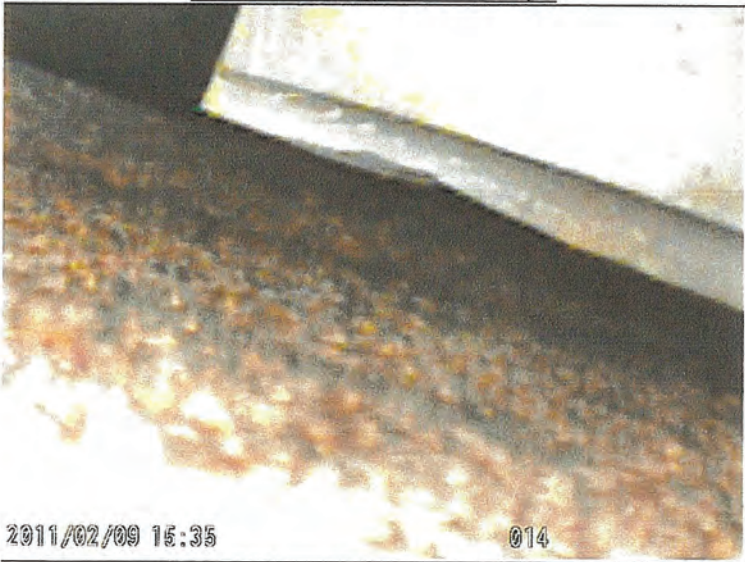
Photo 8. Showing worn blade tips. Note similar profile to Photo 7.

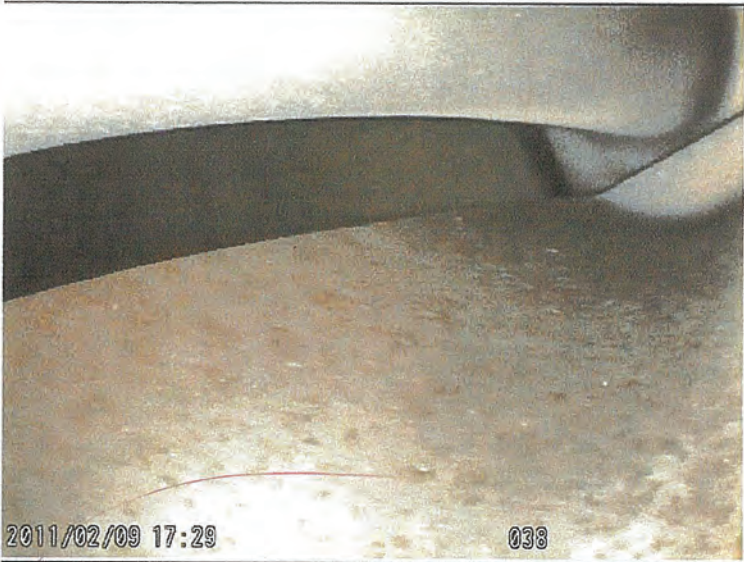
Photo 9. Showing corrosion on blades.

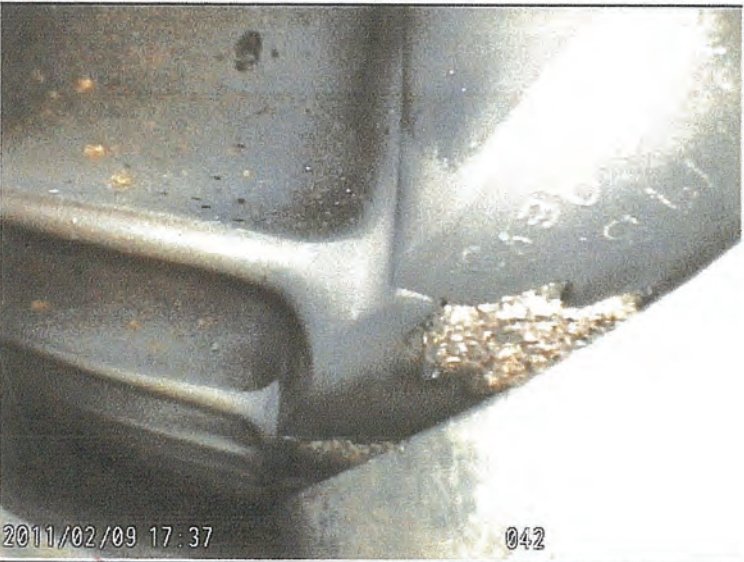
Photo 10. Showing fir tree root corrosion

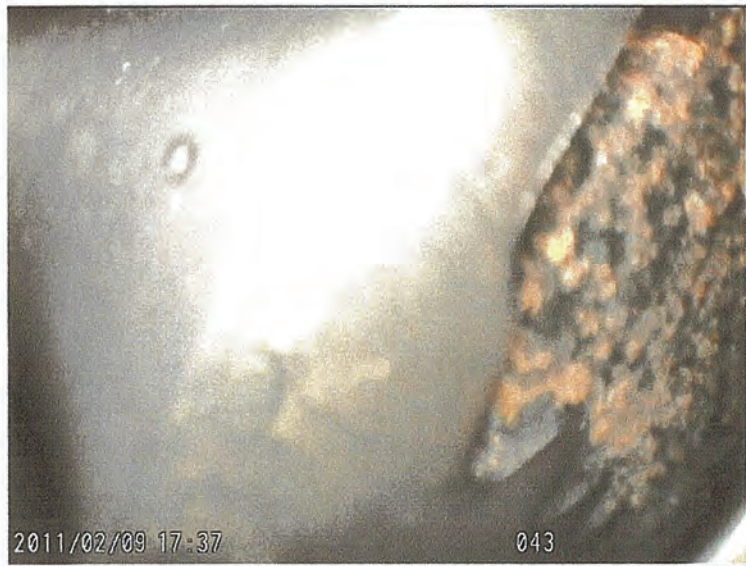
Photo 11. Showing fir tree root corrosion. Note propogation of corrosion under the blade shoulder.

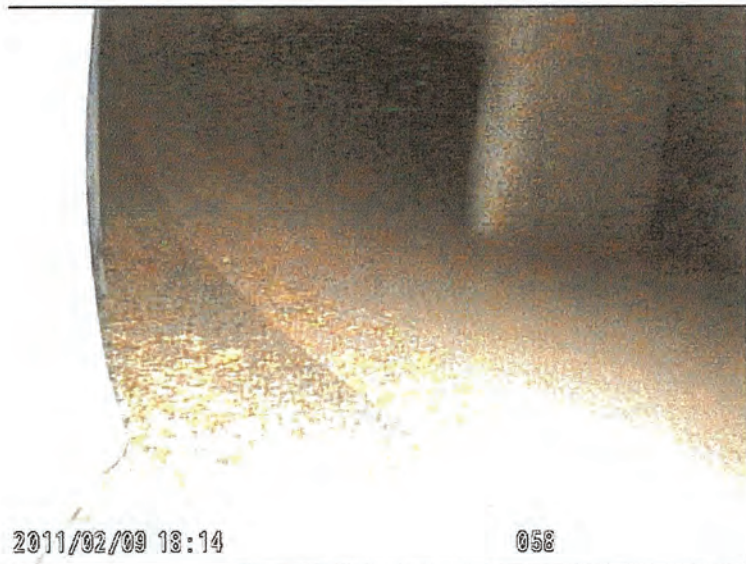
Photo 12. Corrosion of volute.

- Gas Turbine Unit
 - Power turbine disk replacement (9 month manufacturing lead time);
 - Power turbine damaged blades replacement (one or more) or significant repair;

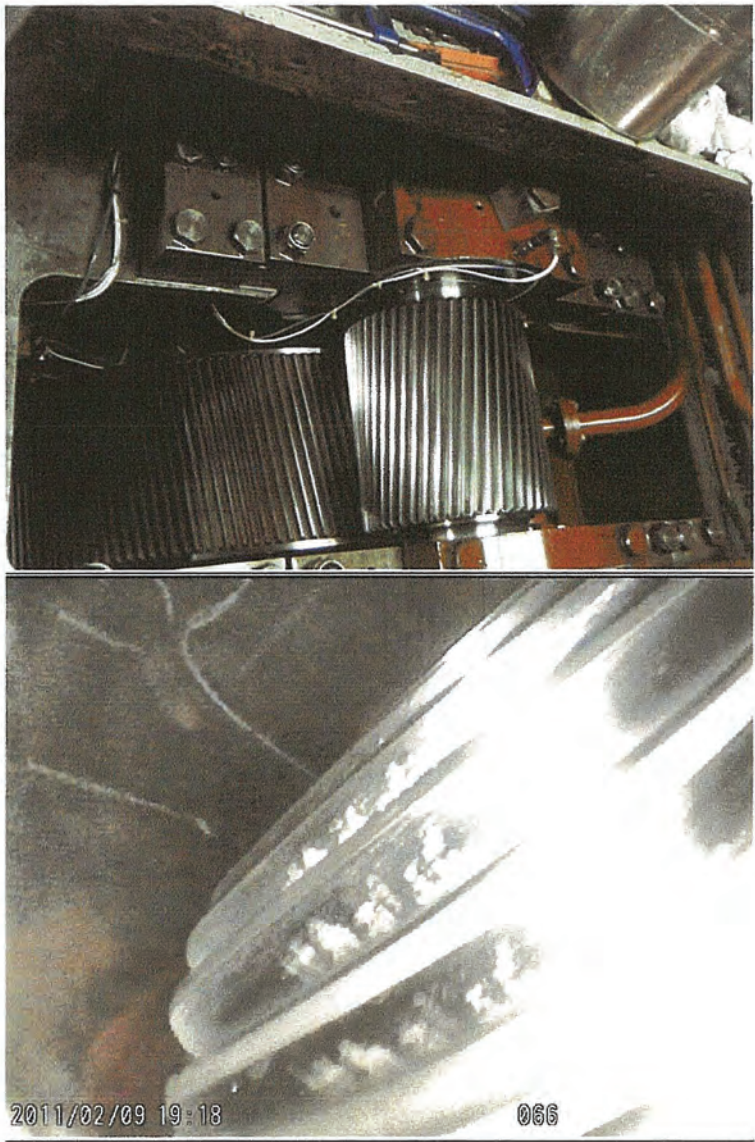
Photos 13 & 14 showing gearwheel condition.

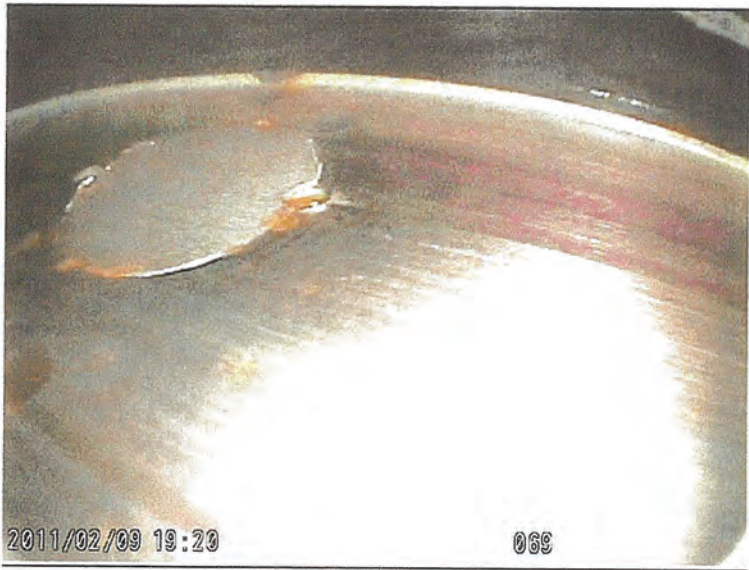
Photo 15. Showing gearwheel dowel pin.

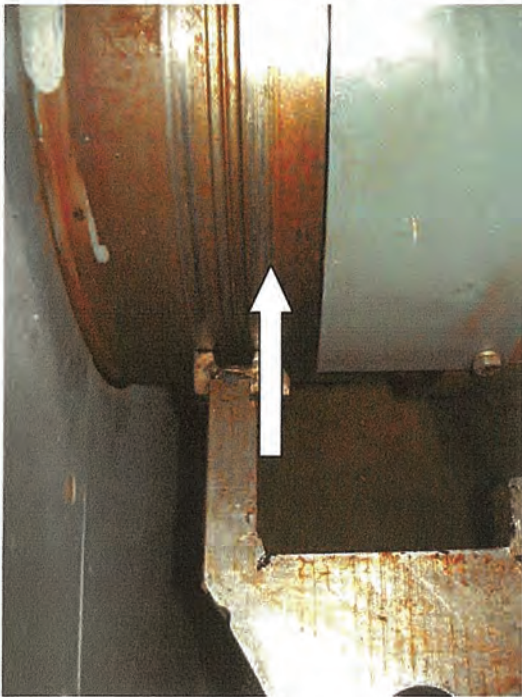
Outboard labyrinth seal and shaft seal
(grooves wear marks)

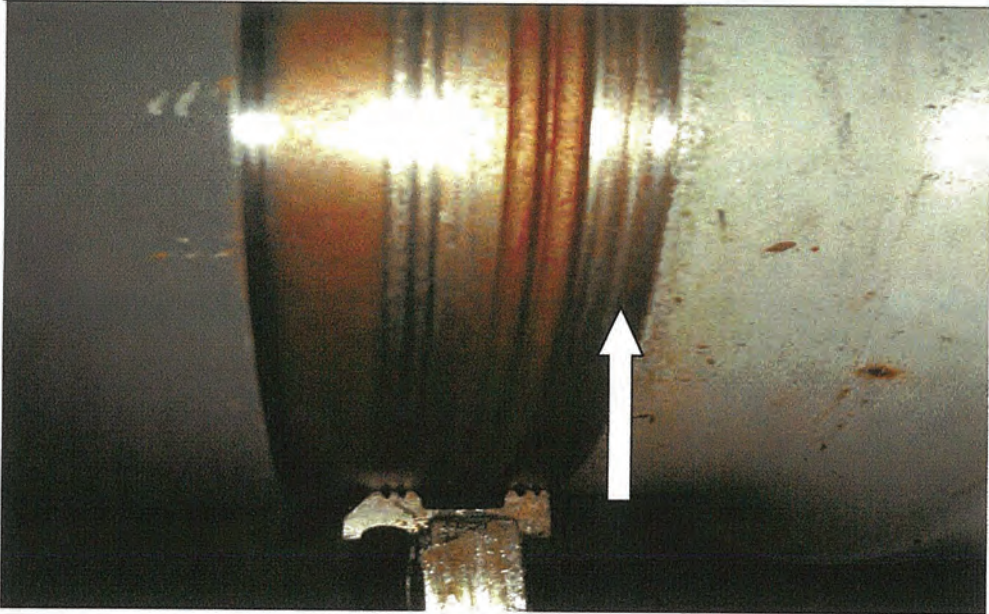
Inboard labyrinth seal and shaft seal (grooves wear marks) paint removal indicates thermal expansion

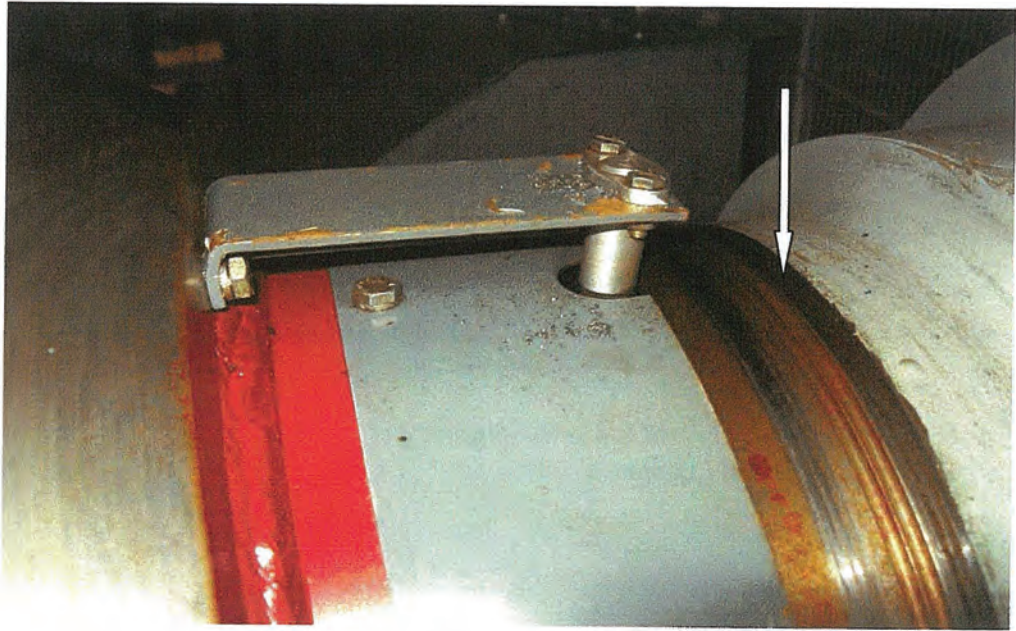
Inboard oil wiper setup and shaft seal condition (grooves wear marks)
Same thing applied on the outboard end but in reverse direction

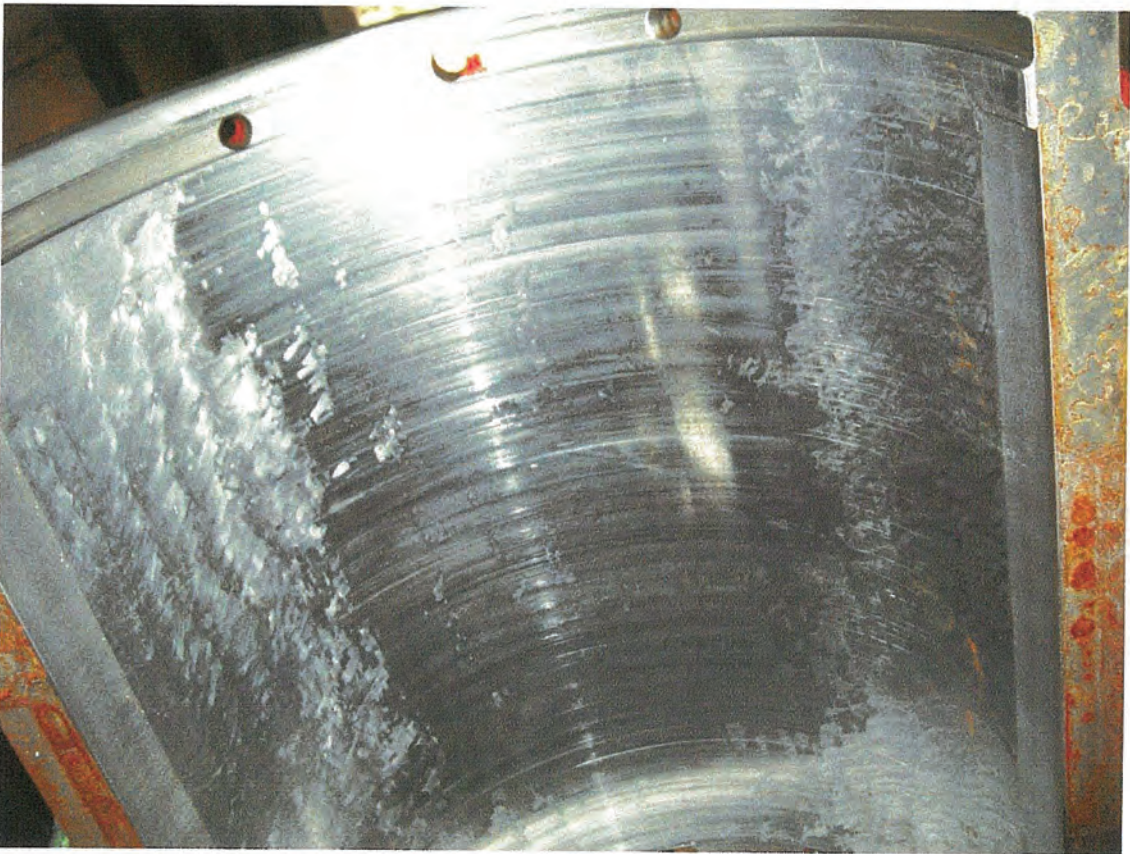
Babbitt liner of bottom half bearing

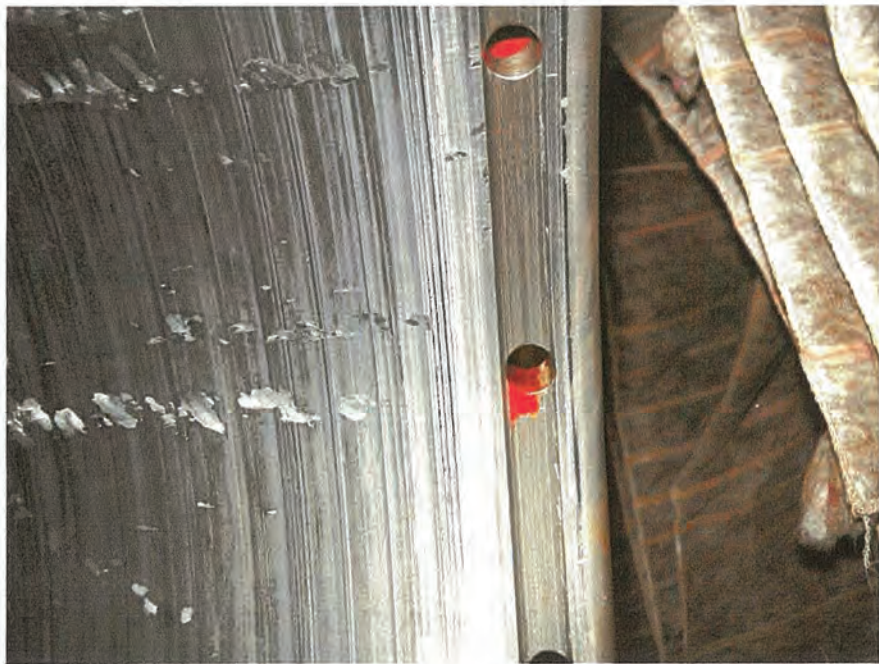
Close up of Babbitt liner bottom half bearing

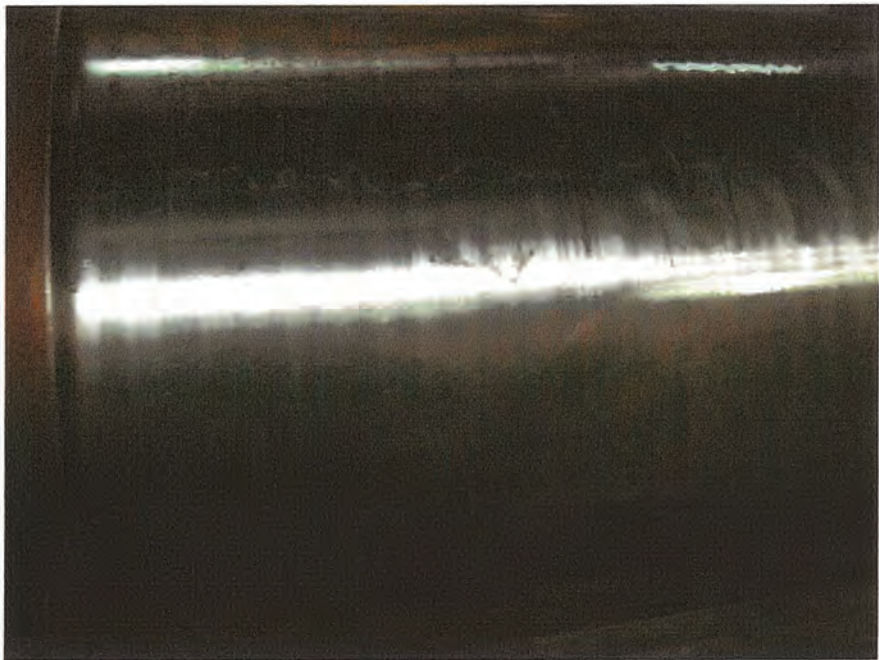
Shaft journal condition (marking of sitting idle for long period of time)

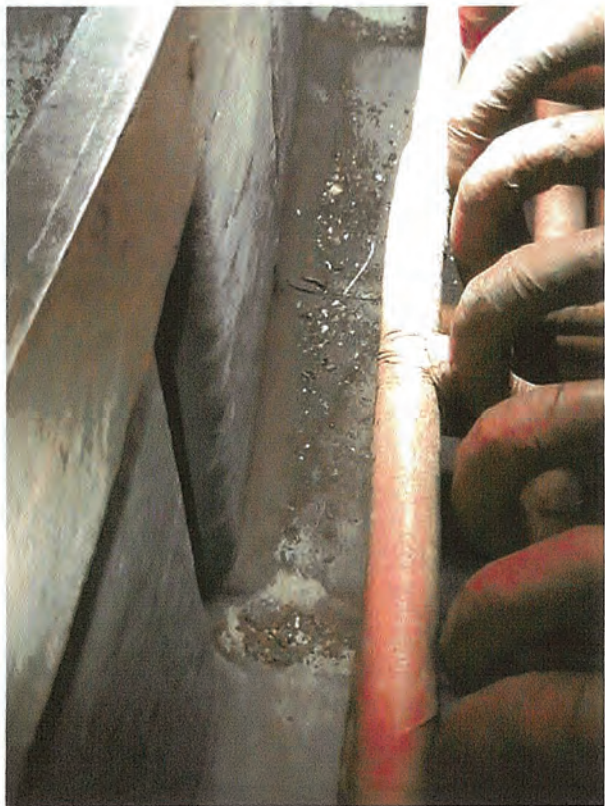
Rust flakes present in bottom of stator enclosure.

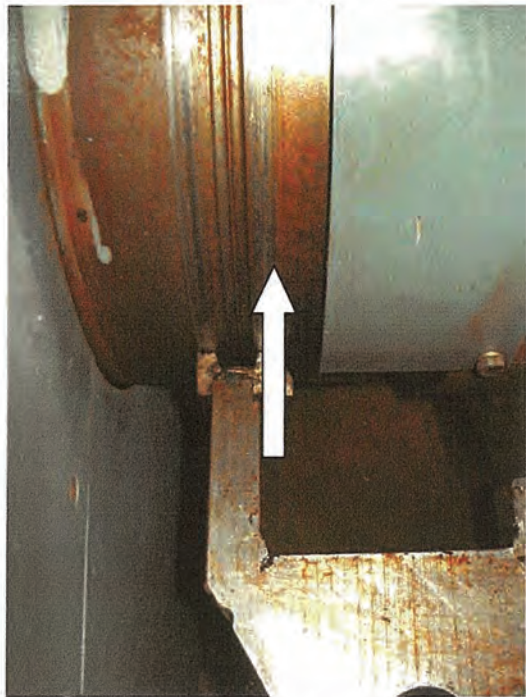
Outboard labyrinth seal and shaft seal (grooves wear marks)

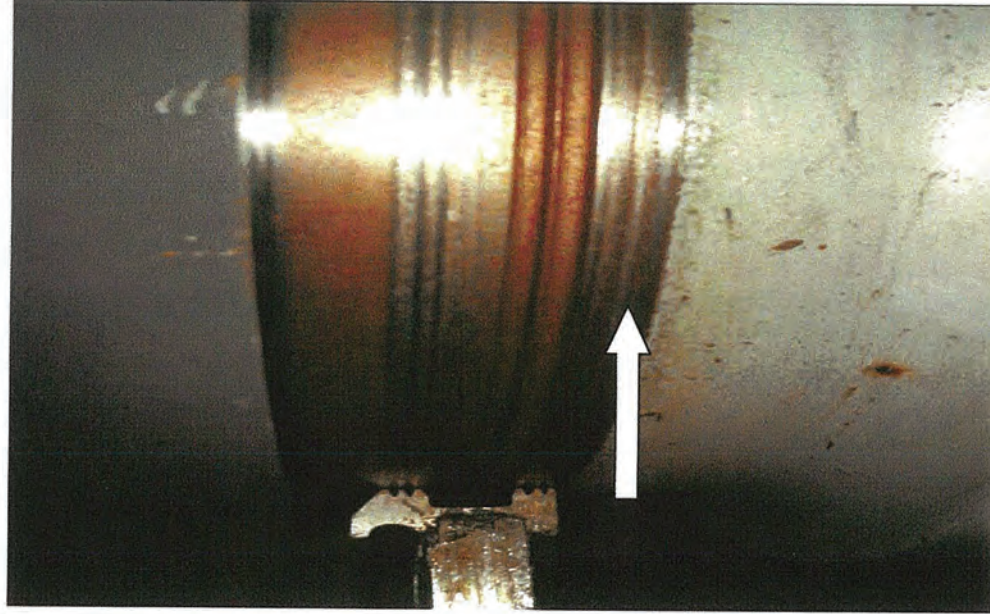
Inboard labyrinth seal and shaft seal (grooves wear marks) paint removal indicates thermal expansion

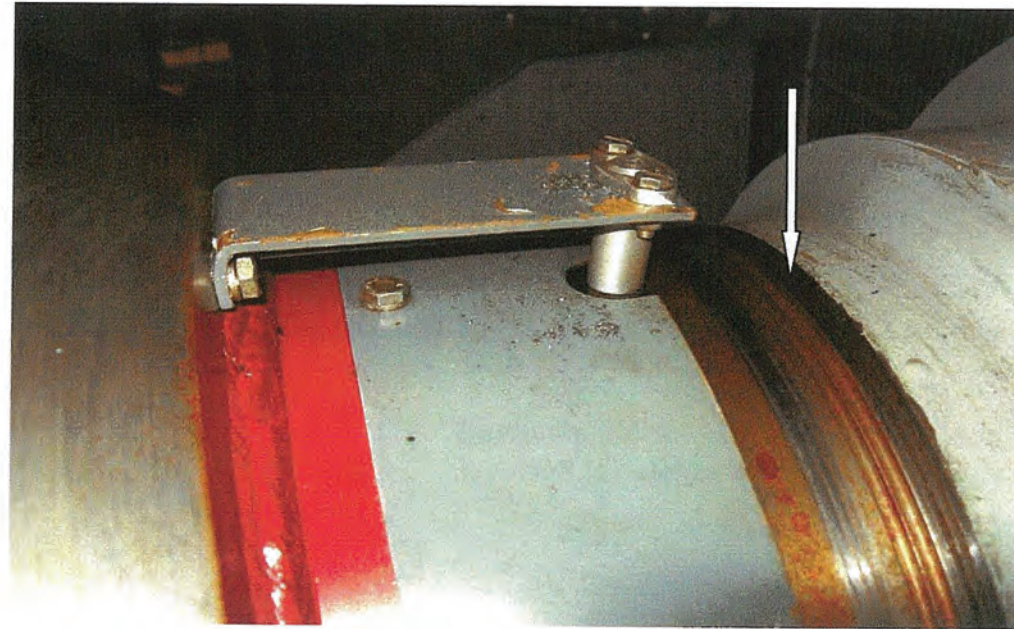
Inboard oil wiper setup and shaft seal condition (grooves wear marks)
Same thing applied on the outboard end but in reverse direction

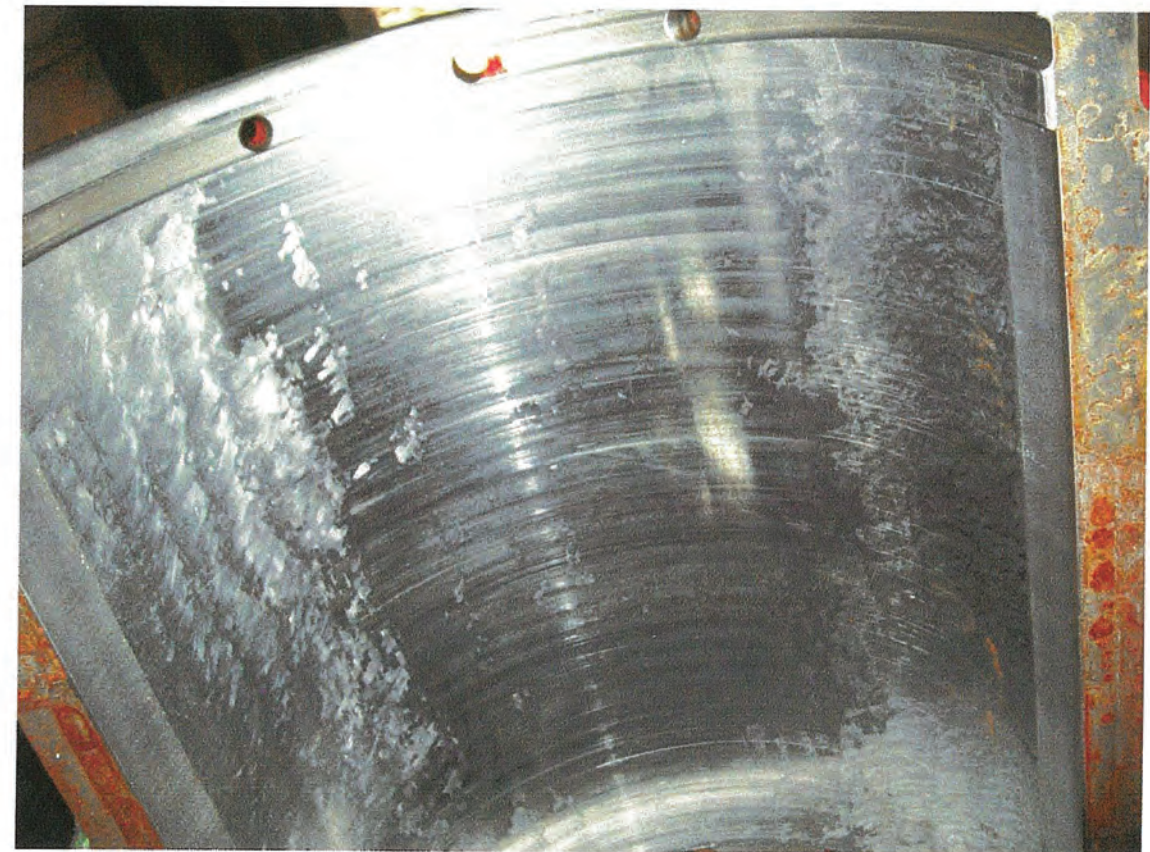
Babbitt liner of bottom half bearing

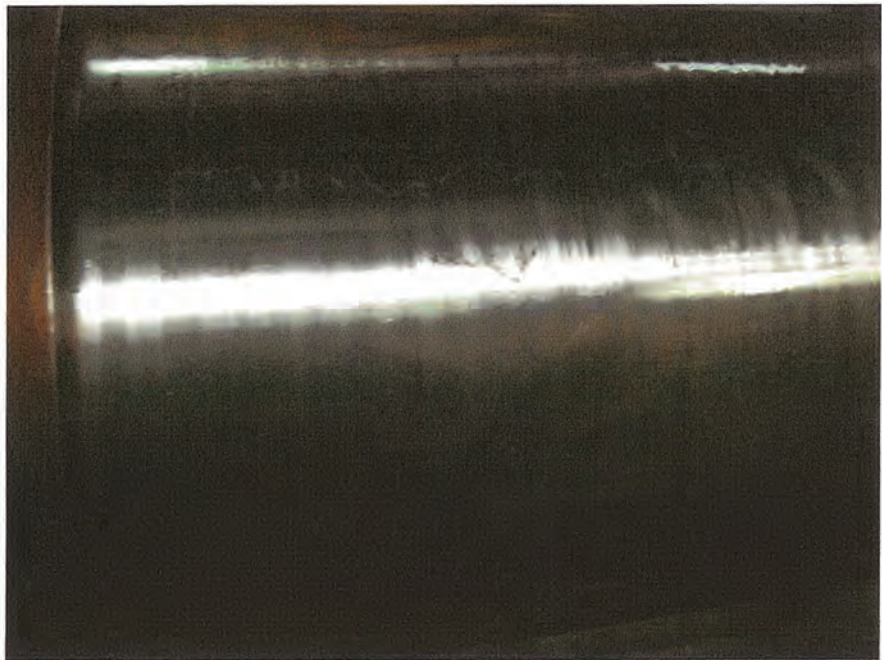
Shaft journal condition (marking of sitting idle for long period of time)

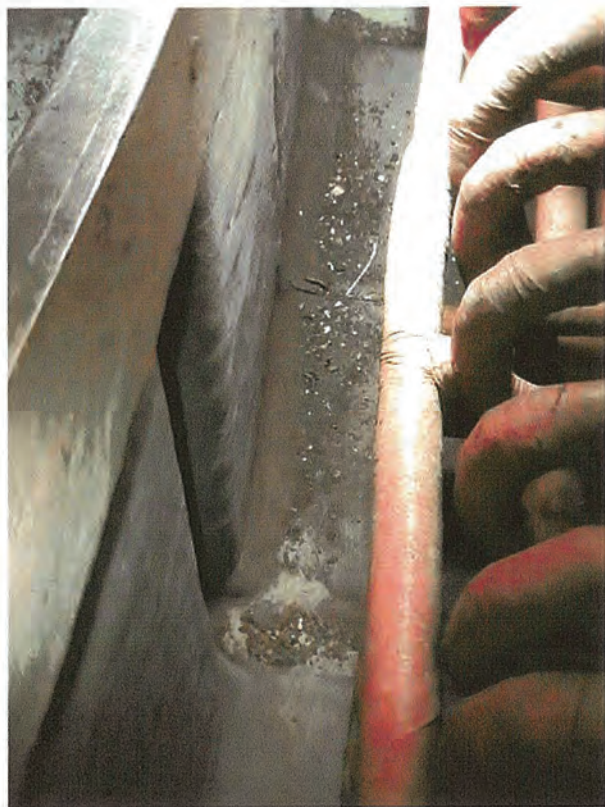
Rust flakes present in bottom of stator enclosure.

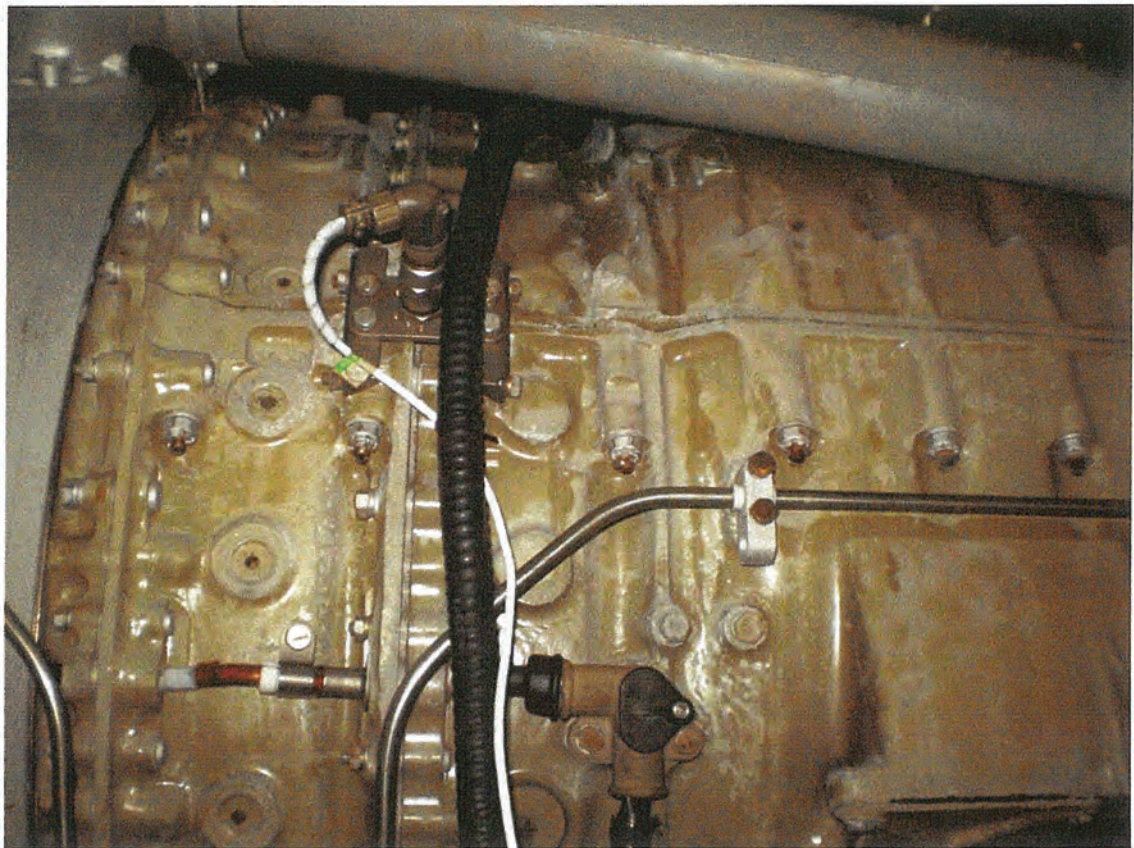
Light to medium loss of coating and corrosion to outer surfaces of the compressor casing
