1 **Q. Re: Tab 4.4 - Rebuild Distribution Lines Update – Stainless Steel Pole Mounted**
2 **Transformer Hanging Brackets**

10
11 Attachment B includes the metallurgical report titled Failure Analysis of a Transformer
12 Bracket dated January 6, 2004.

16
17 Attachment D includes the report titled Transformer Mounting Bracket Failures Analysis
18 Report dated April 24, 2008.

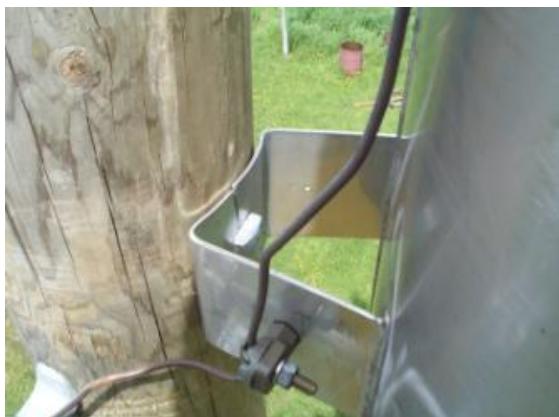
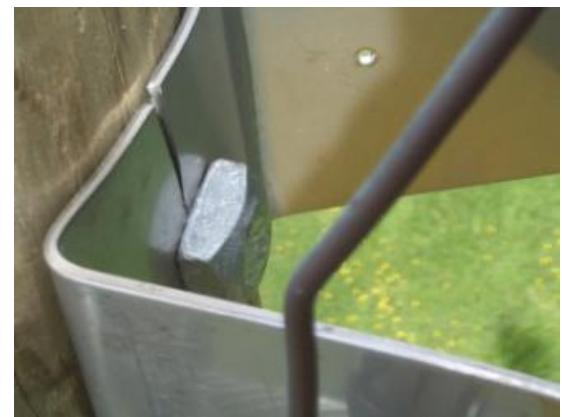
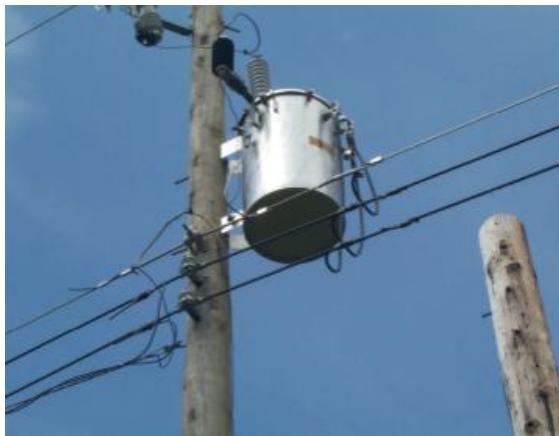
The following is a message from our Port Aux Basques area and pictures of a broken lower transformer bracket. The transformer referred to below that fell from the pole in February was a Moloney transformer and we are awaiting their report on the incident. We have expressed concern on a number of occasions on the thickness of the stainless steel brackets. This again raises our concern.

>From: Green, Wayne
>Sent: July 15, 2003 4:17 PM
>To: Rose, Clifton
>Subject:
>
>Cliff:
>
>The pictures attached are of a stainless steel transformer that was installed in February 2003. This unit was installed in the same location where the other transformer fell from the pole in February 2003. The transformer was removed from the pole July 15/03 and stored at the Port Aux Basques storage yard.
>
>* Transformer type: ABB
>* Transformer size: 50 KVA
>* Manf. date: Nov. 2002
>* Weight: 330 KG.
>
>Any questions give me @ 4803.
>
>Wayne

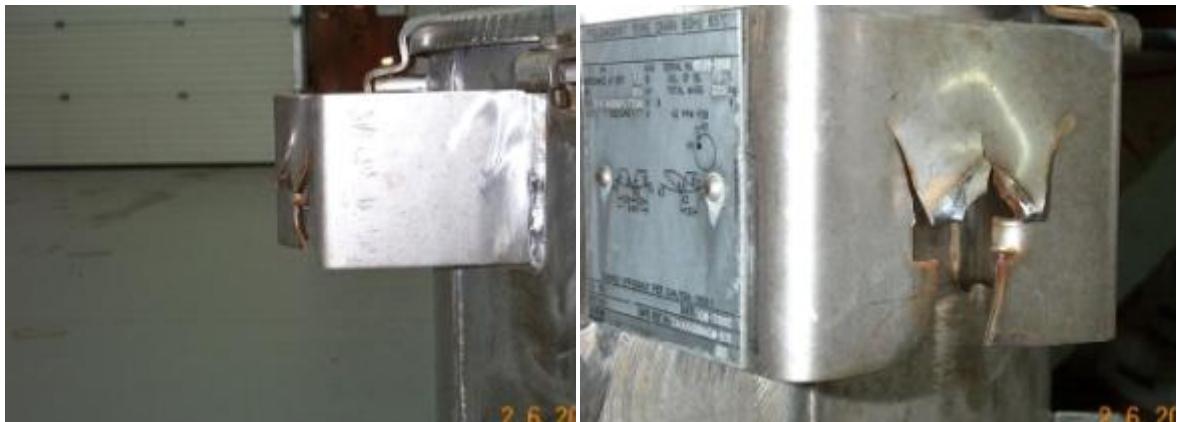
We have a 50 kVA transformer that was manufactured in 06-2002 with a failed upper hanger bracket as shown in the attached pictures. The serial number of the unit is 49598-008. The lower bracket does have a crack, but did not fail to the same degree as the upper bracket. The transformer was installed in a pole in an area that is subjected to high winds. A crew working in the area discovered the condition and removed the transformer before total failure of the bracket.

Newfoundland Power has discussed this issue previously with ABB following complaints from field staff saying the brackets were flexing in the wind. A similar failure occurred in 2003 (complaint # 17616) where the thickness of the bracket was questioned. In that instance the lower bracket failed and it was recommended to use a washer where the bracket does not fit the pole exactly. The use of a washer on the upper bracket is not possible due to the design of the bracket. We need to develop a better solution. The existing bracket design in stainless steel has shown it will not withstand the wind loading in our environment. What alternatives are there to this ongoing problem?

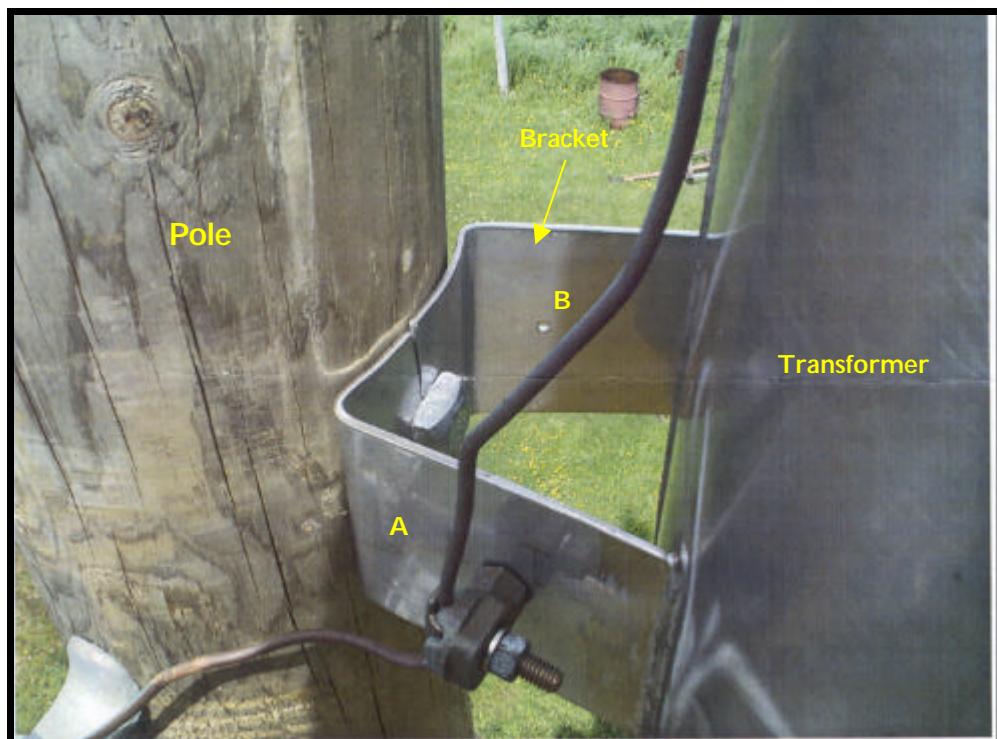
PICTURE N°1

The part sent for metallurgical expertise is a metallic mounting bracket used to hang a distribution transformer to a wood pole (Picture n°1).

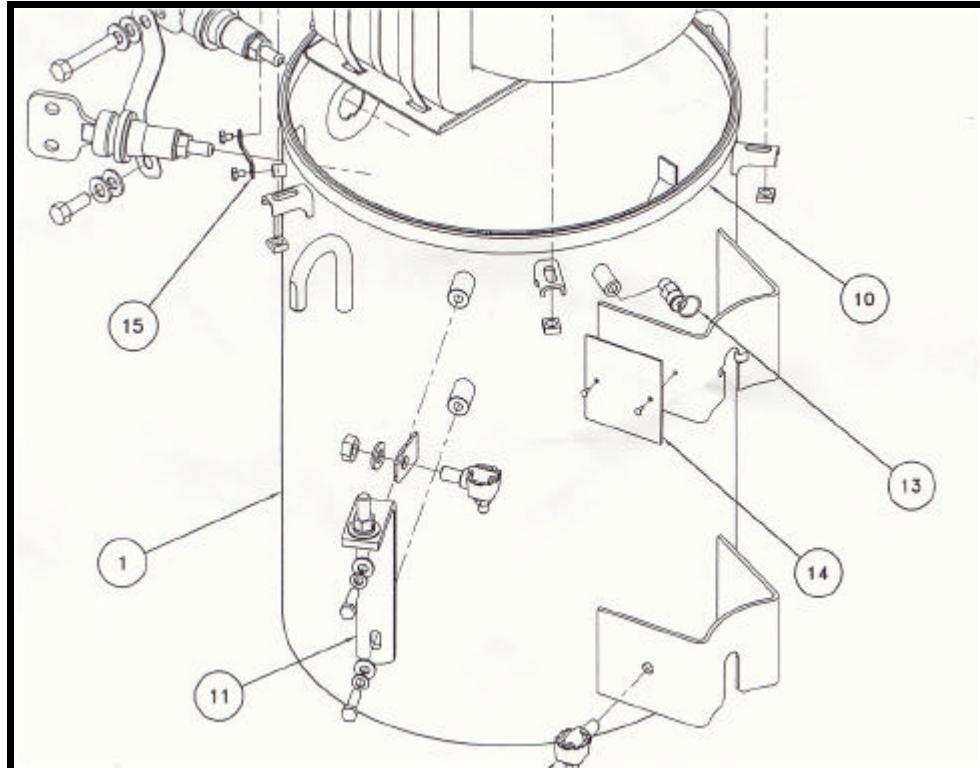
FIGURE 1
Lower Portion of the Transformer Assembly Drawing

According to A.B.B., transformer and bracket manufacturer, transformer itself weights about 350 kg. It is supported by two brackets as shown on figure 1. It was also explained that the upper bracket usually supports the transformer weight and the lower one minimizes the lateral movements.

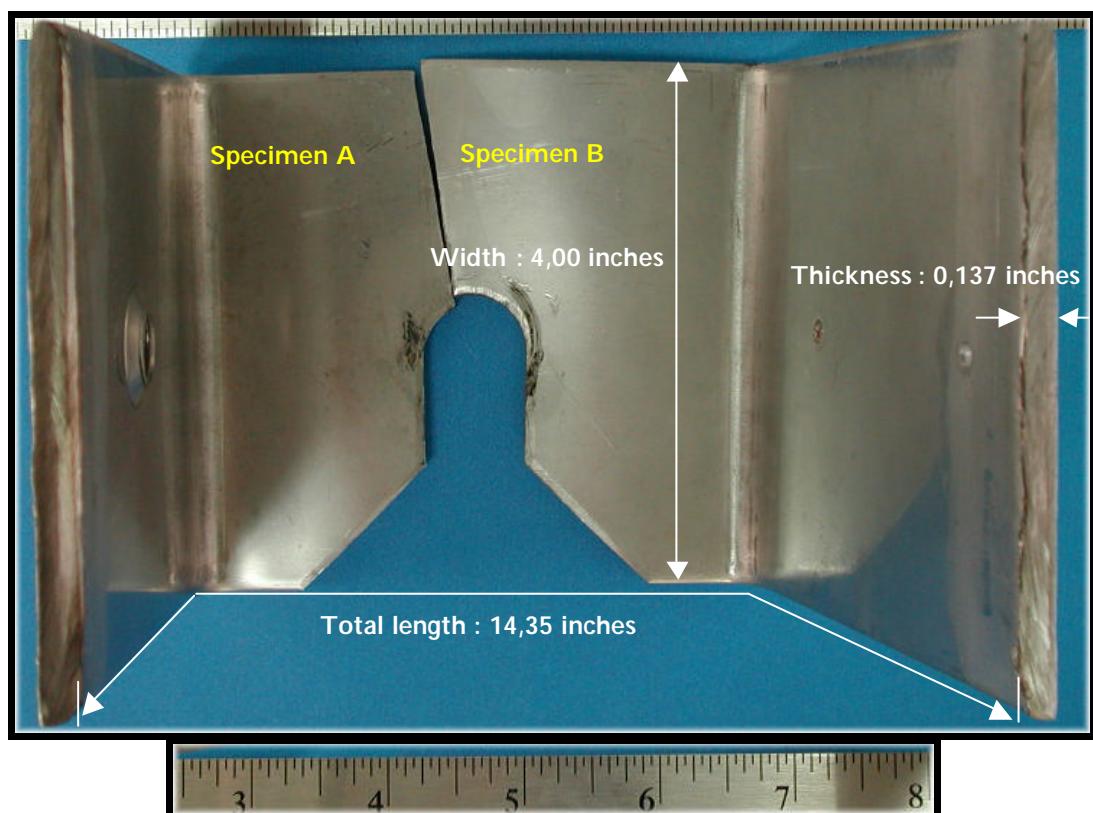
**TABLE 1** Sample Dimensions

The sample width, thickness and overall length were measured to compare with the drawing specifications. Results are presented on picture n° 2 and in table 1.

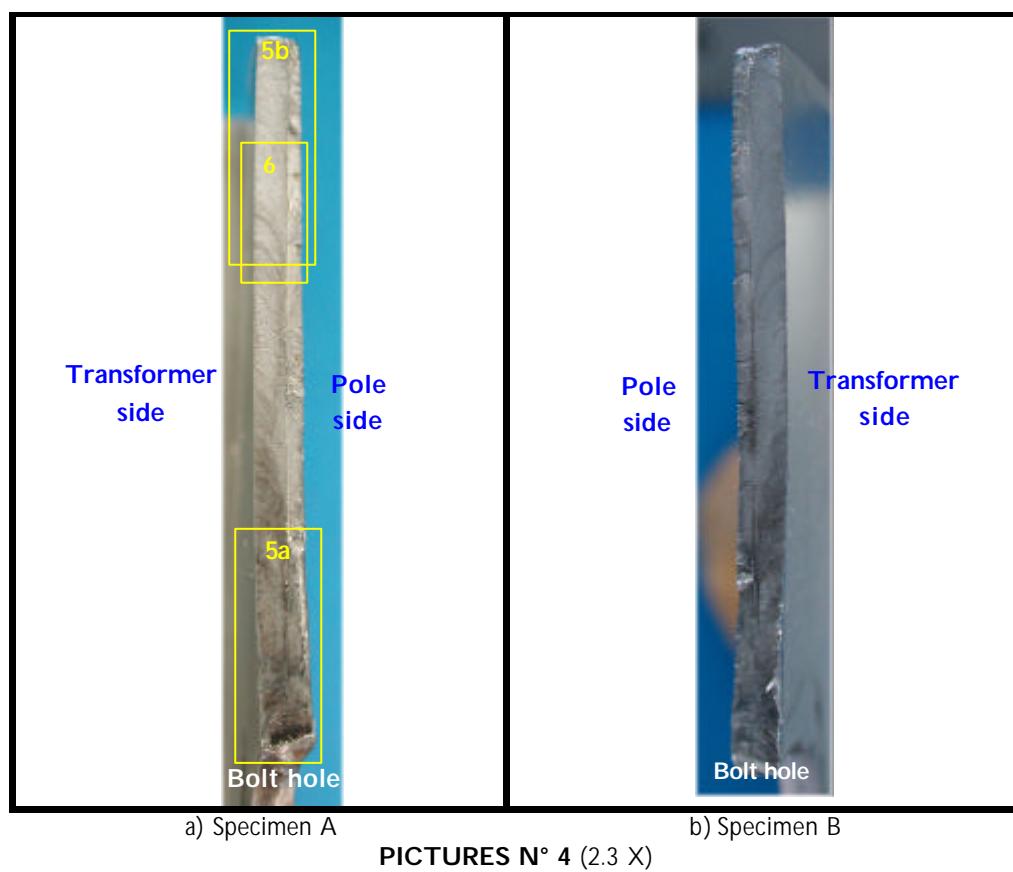
Both parts have a fractured surface containing similar informations since one is a mirror image of the other (Pictures n° 4).

Preliminary observations of the ruptured surfaces gave much information. First of all, both surfaces show two distinct regions dividing the plate thickness. The region emerging to the plate surface transformer side, is called region I. The region emerging to the plate surface pole side, is called region II (See pictures n°1 and n° 3 for general views). It can be noticed that region II makes about half the plate thickness near the bolt hole (Bottom of pictures n° 4.) However, at the top of the pictures it makes about $\frac{1}{4}$ of the plate thickness. This can clearly be observed from pictures n° 5 taken at higher magnifications.

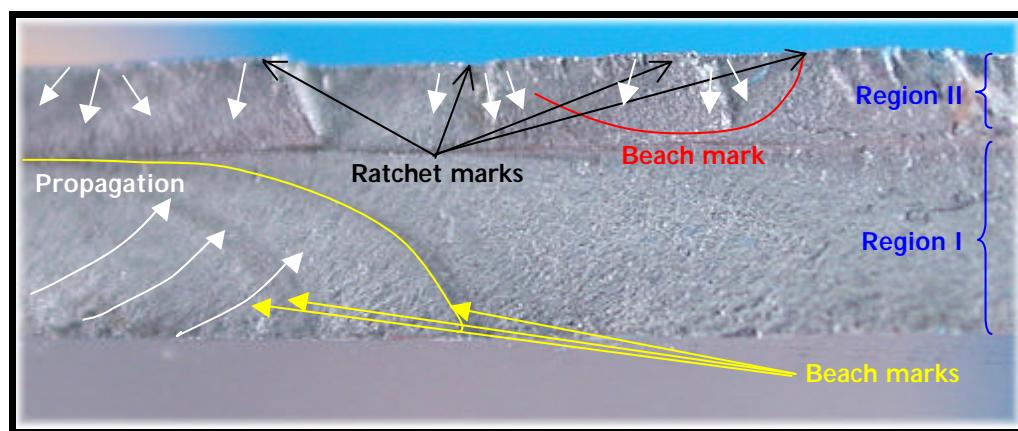
Another feature that clearly characterizes the fractured surfaces is the presence of beach marks (Pictures n° 4, 5 and 6).

Beach marks are an undeniable indication that failure proceeded by fatigue. They are created when there is a change in the stress frequency, amplitude or mean value. Hence, it can be stipulated that the bracket was subjected to irregular dynamic stress. The stress intensity causing fatigue failure can be very low. For steel, it is estimated that any stress higher than 40% of the alloy ultimate resistance can initiate fatigue. For an annealed 316 L stainless steel plate this would be in the range of 3 400 psi.

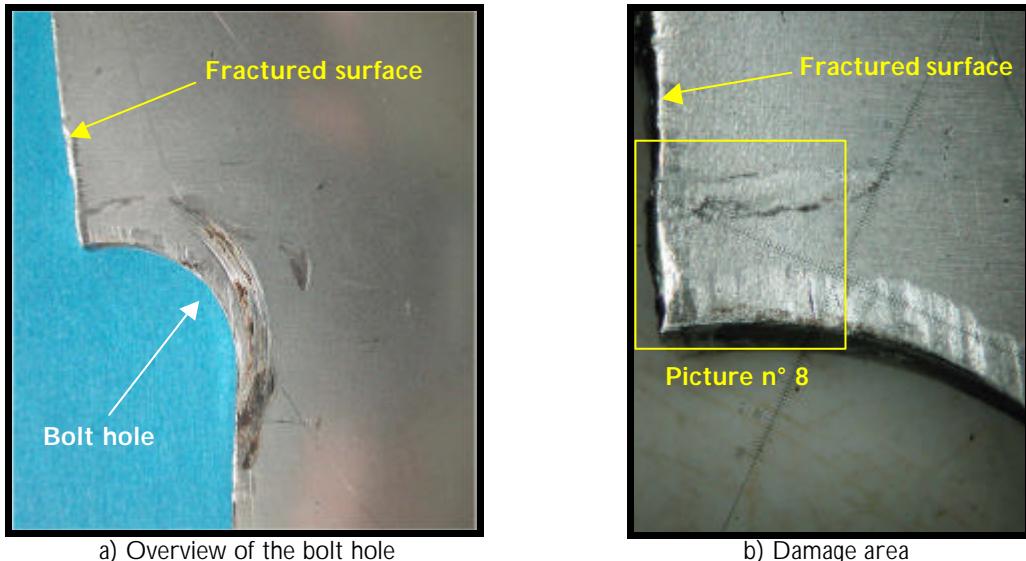
PICTURES N° 7
Sample B, Transformer Side (Face I)

Stereoscopic observations were made using magnifications between 10 and 63. Sample B was first examined around the bolt hole for signs of weakness. New evidences were revealed as will be described (Pictures n° 7).

a uniform print on the plate. This is an indication that the stress transferred to the plate was not homogeneous. Moreover, applying a high torque could have induced localized tension stress on the plate pole surface. Especially if the bracket did not exactly fits the pole shape (Figure 3).

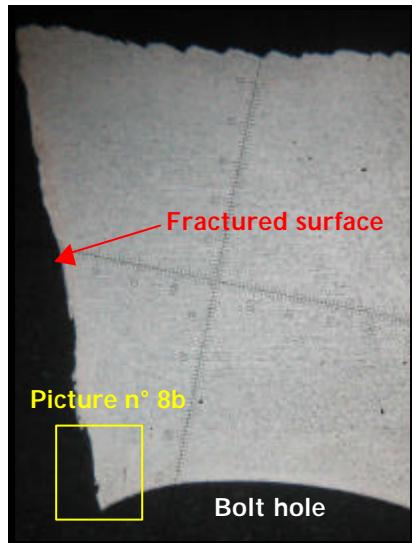
The scratches and deformation observed on the plate transformer side probably accelerated the second step of failure. Any surface discontinuity acts as a stress raiser from which fatigue cracks are more susceptible to initiate. To verify this hypothesis, a section was cut perpendicular to the ruptured surface and observed by optical microscopy (Pictures n° 7b and n° 8).

a) Sample overview (6X)

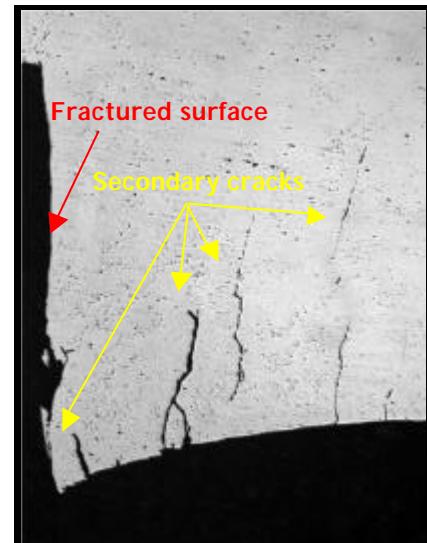
b) secondary cracks (30X)

Many secondary cracks were observed. This is an indication that failure initiated in the bolting region. This area was highly stressed. Metallographic observations of the sample were also performed to reveal any sign of material defects (Pictures n° 9).

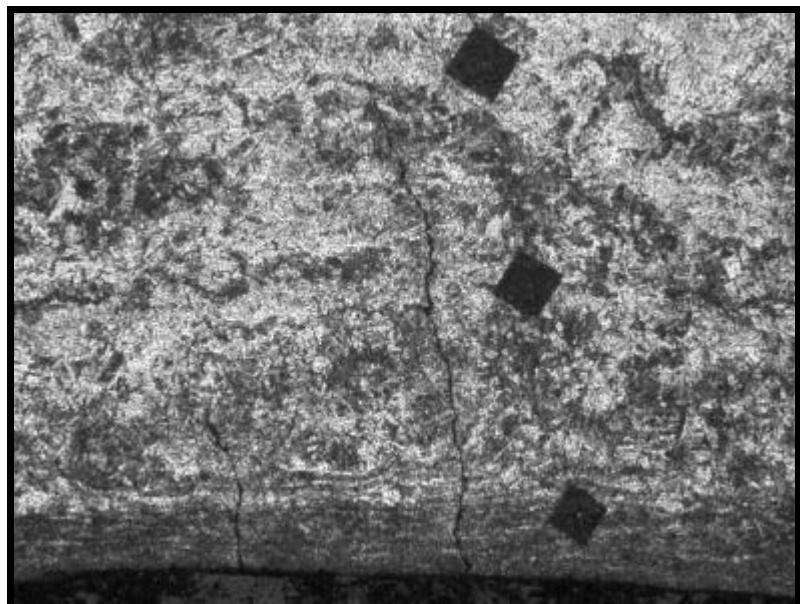
PICTURE N°10 (120X)
Microstructure in the Plate Plane Near the Bolt Hole

The samples were polished and etched with marble. Their microstructure is typical of a type 316L stainless steel. It is composed of one phase only, austenite. When looking at a plan parallel to the plate surface, picture n° 9a, the grain are equiaxed and the structure is homogeneous. However, the microstructure of the transversal section bears sign of sheet forming. Its banded structure is typical of laminated products. One particularity could also be confirmed by metallographic examination. The material around the bolt hole was significantly deformed (Picture n° 10).

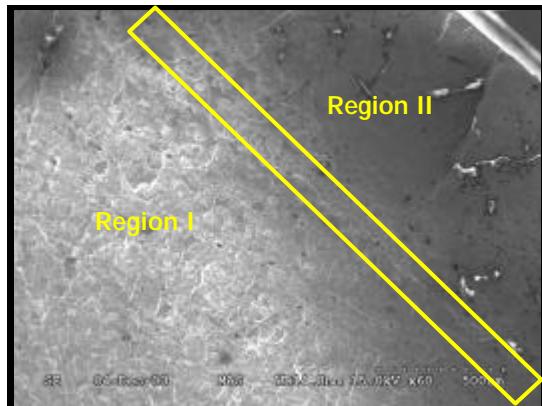
The existence of a region that failed under a ductile mode was also revealed by scanning electron examination. In fact, the line that separates region I from region II is entirely composed of micro voids (Pictures n° 11)

a) Micro void line between regions I and II

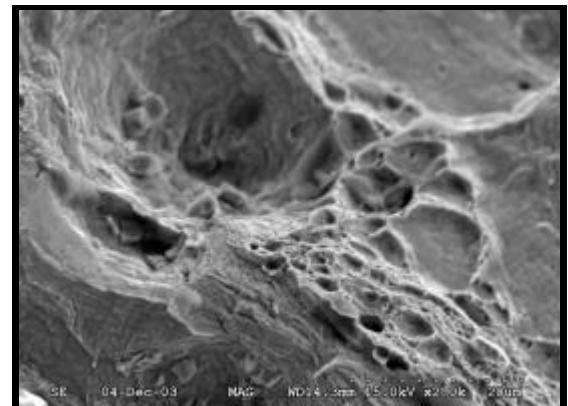
b) Closer look at micro voids

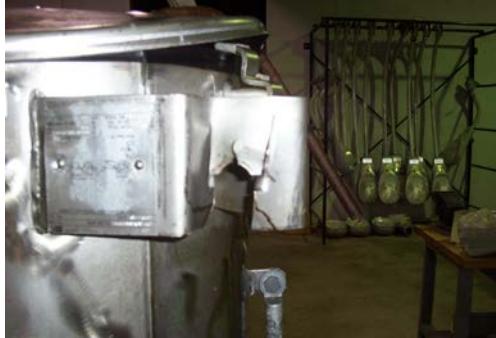
3.5 Reported in February 2008

A 50 Kva transformer made of stainless steel 316L that was manufactured in March 2003 was discovered with upper and lower mounting brackets distorted. The mounting brackets were made of 10 GA (0.140") thickness SST 316L. Total weight of the transformer: 330 kg

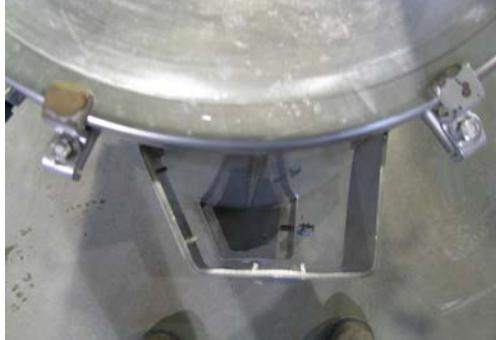
3.6 Reported in March 2008

A 25 Kva transformer made of stainless steel 316L that was manufactured in March 2003 was discovered with upper and lower mounting brackets distorted. The mounting brackets were made of 10 GA (0.140") thickness SST 316L. Total weight of the transformer: 200 kg
