10    A.    Please see Hydro's response to IC-NLH-006, Attachment 1 - Site Recommendations,  
11           IC-NLH-006 Attachment 2 – Air Intake Inspection Report, IC-NLH-006 Attachment 3 -  
12           Gas Turbine Capital Plan, and NP-NLH-13, Attachment 1 - Stantec Condition  
13           Assessment Study Report.

# Site Recommendations

**Customer: Newfoundland Labrador Hydro**

**Project Number: Alba 4927**

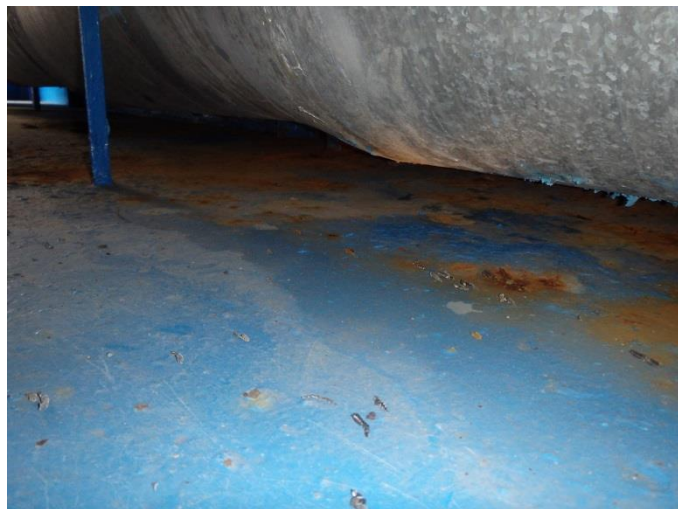
Photo 3 – General overview of Inlet Air System A looking West.

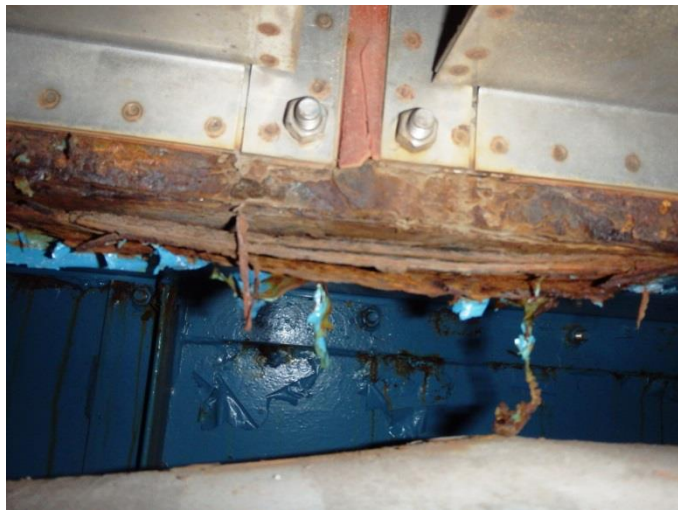
Steel deck plating is in poor condition with heavy pitting noted, mainly focused to the deck directly located below the cyclomatic filtration unit (photo 5). Coating breakdown and scale up to 10mm mainly focused below the cyclomatic filtration unit and at connection between deck plate and vertical (photos 4, 6 and 8).

Photo 6 – Coating breakdown and light scaling in Southeast corner, located below cyclomatic filtration system.

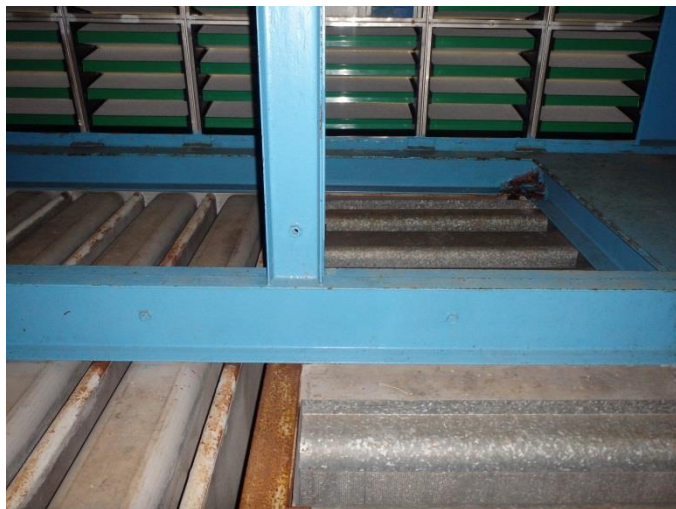
Studs and nuts were noted to be missing from the vertical sections of the I-beams inside of the upper plenum (photo 11). This shows studs missing from the vertical sections however the horizontal sections are bolted tightly together. This was found to be the case for the whole vertical section of I-beam.

Photo 11 – Coating breakdown on horizontal structural beams. Studs missing from vertical sections of I-beams.

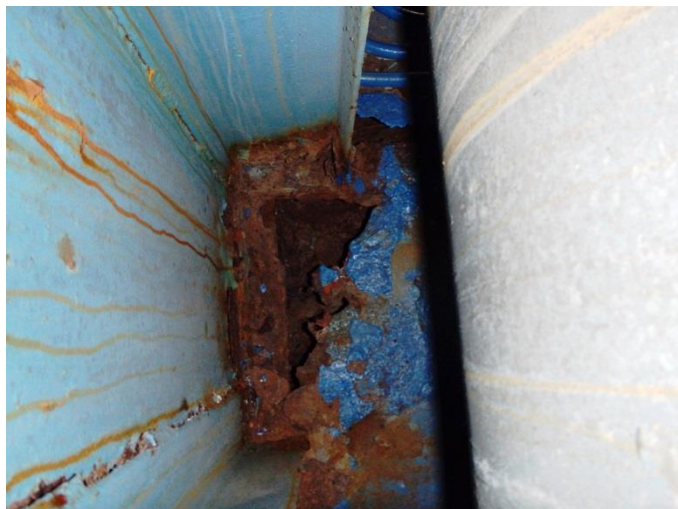
Photo 22 – Coating breakdown and light scaling on steel deck plating.

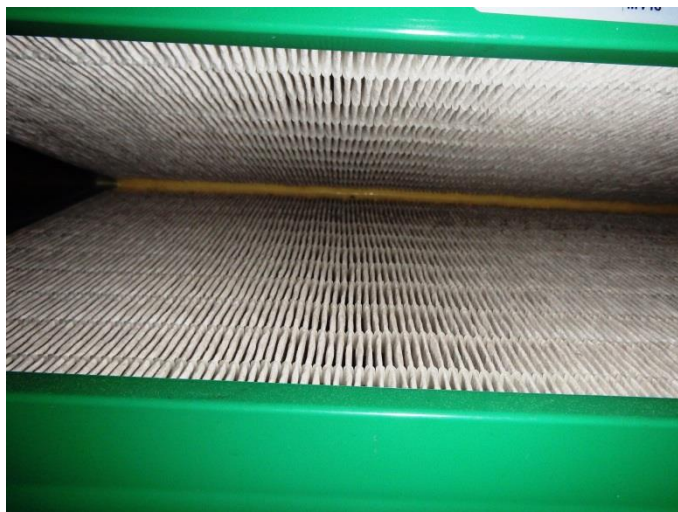
Equipment inside of Inlet air filter room East is in overall good condition. One note which was made during the inspection was that the filters located inside of A were found with more residue on them than those of B. This was talked through with the Nalcor representative aiding EMIS technicians in their inspections. One conclusion that we could draw from this was that A is located within closer proximity to the road than B, possibly drawing in more unwanted contaminants to the filters than B located further from the road (photo 25).

Photo 25 – Overview of filter in fair condition. This was typical of all filters in Inlet Air Filter System A.

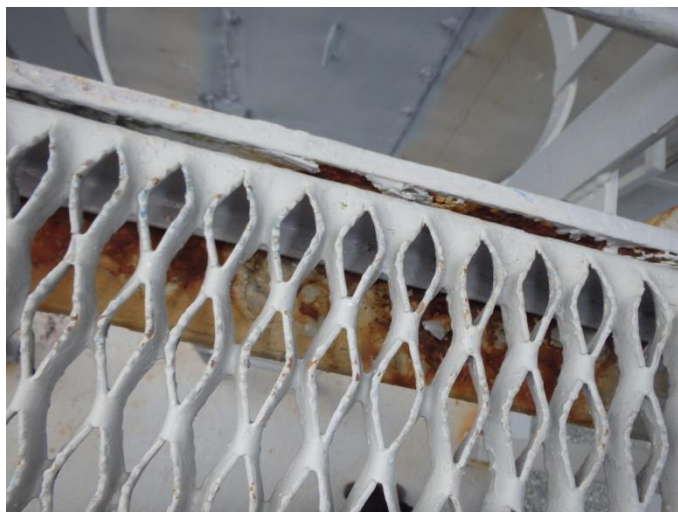
Photo 29 – Small levels of coating breakdown and surface corrosion on top level platform.

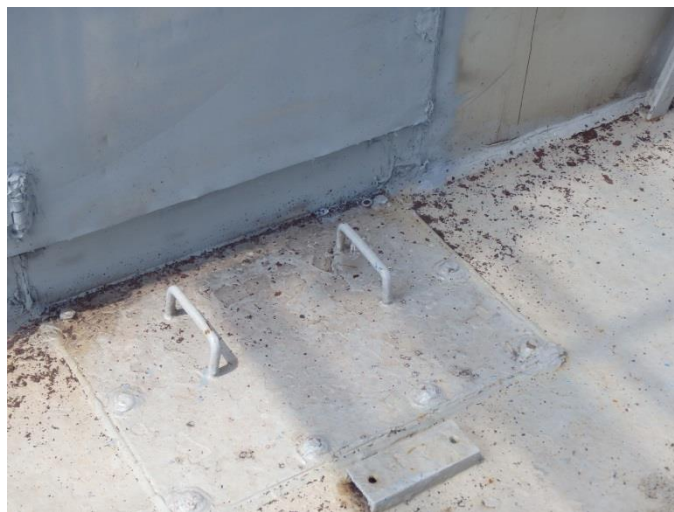
Photo 30 – Hatch handle at deck level with no warning, causing tripping hazard with potential to harm.

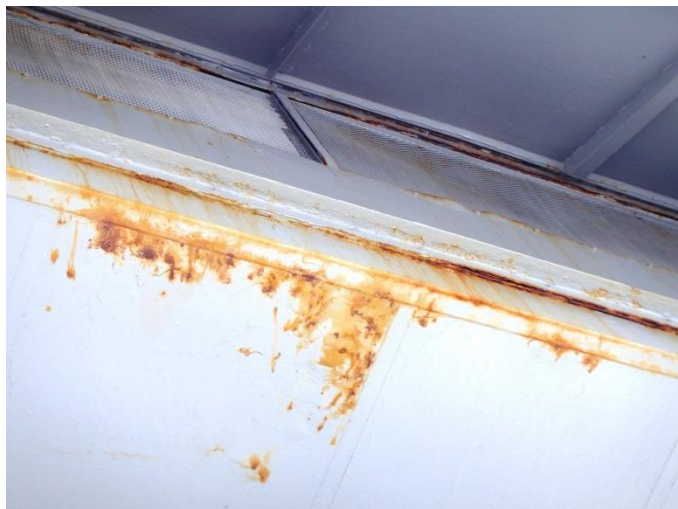
Photo 35 – Coating breakdown noted on underside of inlets, West side.

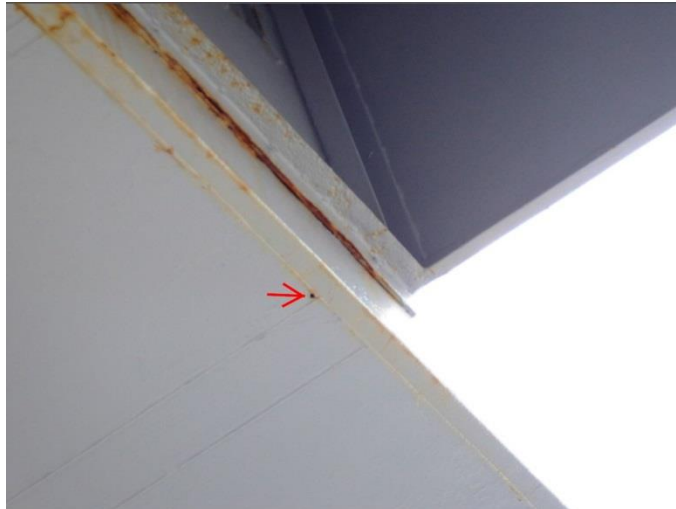
Inlet Air system A was found to be in overall fair condition throughout the inspection (photo 3). The inlet air structure is constructed of structural steel plate and supported by concrete foundations. Foundations are in good condition with no visible signs of cracking or deterioration noted. All exterior structural steel was found to be in good condition. As mentioned earlier, coatings on both Inlet air systems were done in 2013. Because of this, coatings on the exterior of the inlet system were noted to be in fair condition. Isolated areas of coating breakdown were also noted. From inspection, it could be told that coatings were installed in poor weather allowing previous corrosion to leak through to the new top layer of coatings (photo 35). Steel cladding surrounding inlet air system are in fair condition throughout with coating failures noted in isolated areas. One hole noted on the West side underside of vent (photo 36).

Hole, as shown in photo 36, located from exterior visual inspection, could not be confirmed on top side due to condition of top side deck plate (found to be worst condition than indicated from exterior visual). As seen in photo 23, there is an additional deck plate located below this top plate giving support, however, further investigation would be recommended for this.

Photo 36 – Hole noted on underside of inlets west side.

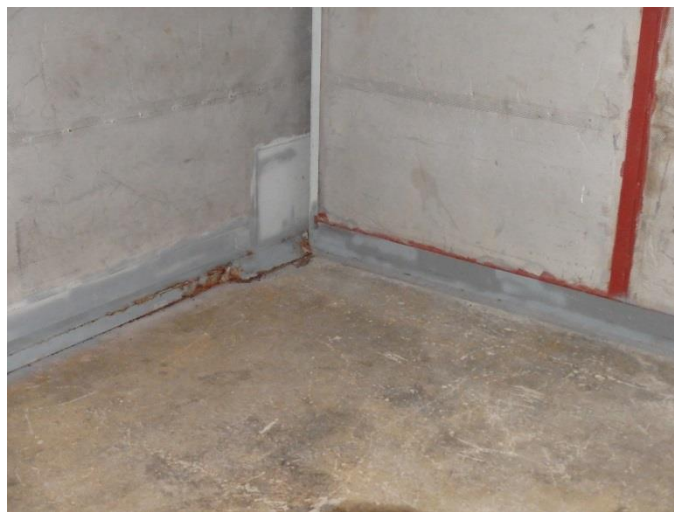
Photo 38 – Low levels of coating breakdown inside lower Plunem (confined space).

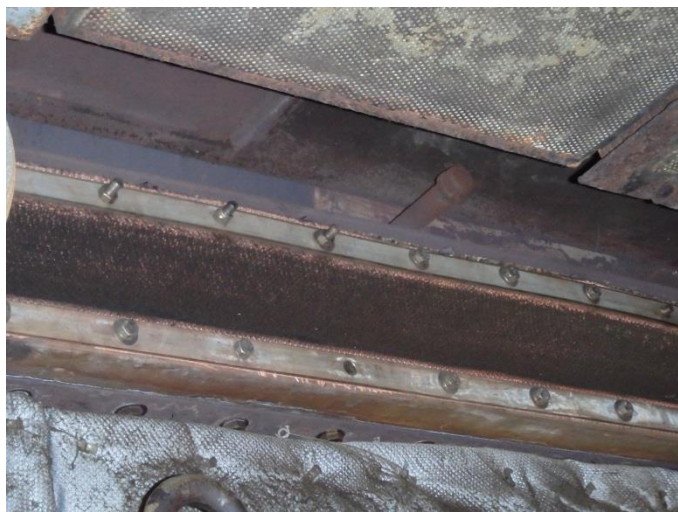
In the turbine room itself, one stud was found to be missing from the South side mesh shielding (photo 41).

Photo 41 – Missing stud located.

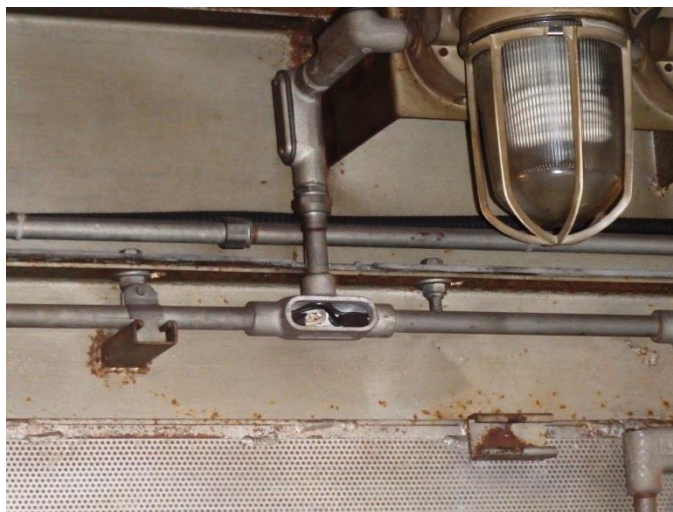
Photo 42 – Electrical connection box with no cover.

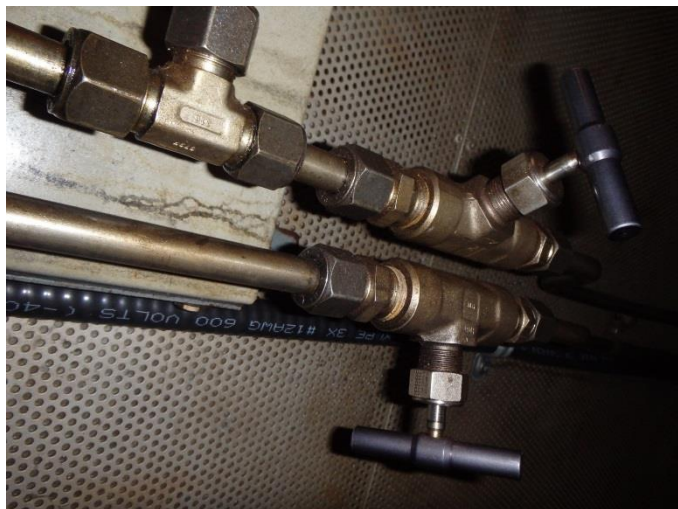
Photo 43 – Section of piping identified with air leak.

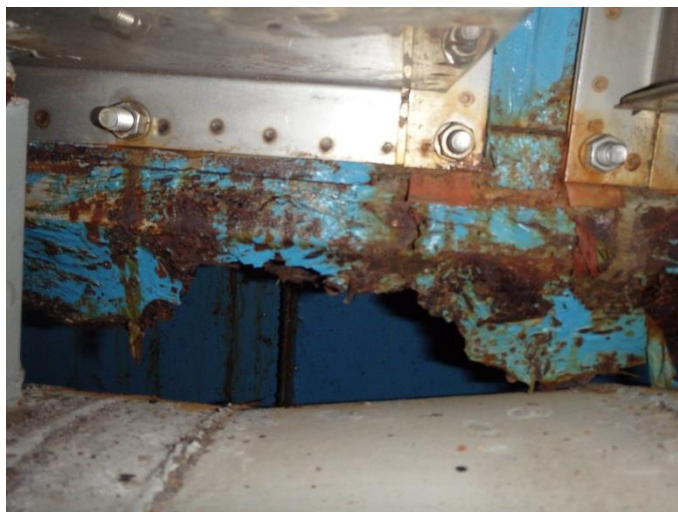
Photo 5 – Coating breakdown/corrosion on base plate of cyclomatic filtration unit, West side air filter room.

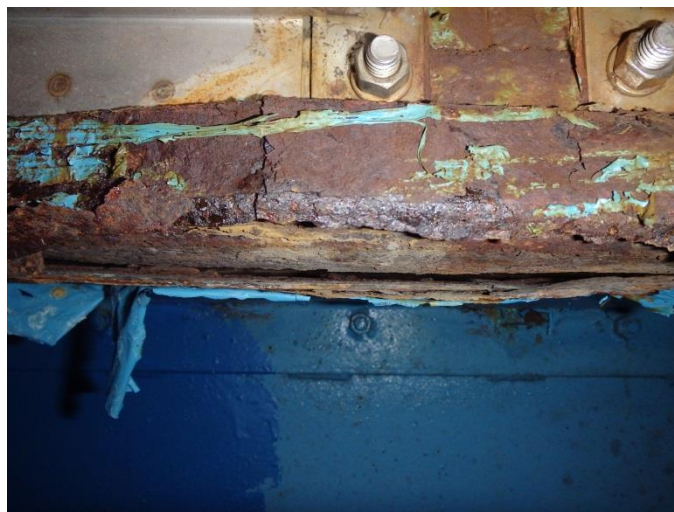
Photo 6 – Coating breakdown/corrosion on base plate of cyclomatic filtration unit, West side air filter room.

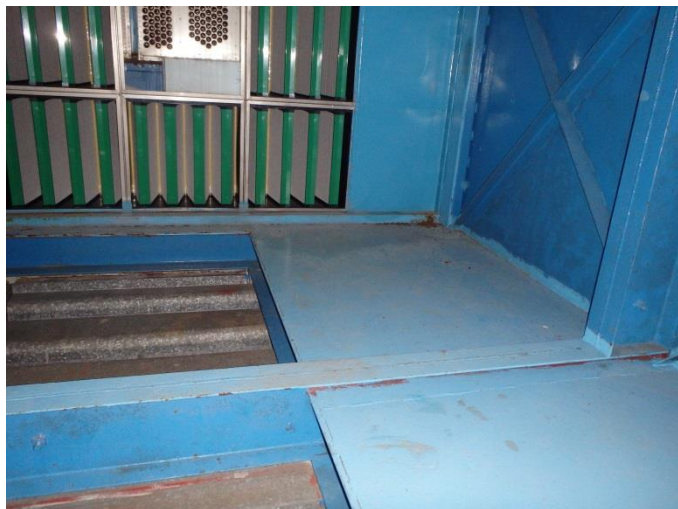
Photo 11 – Coating breakdown at connection between horizontal floor level I-beams and deck plating.

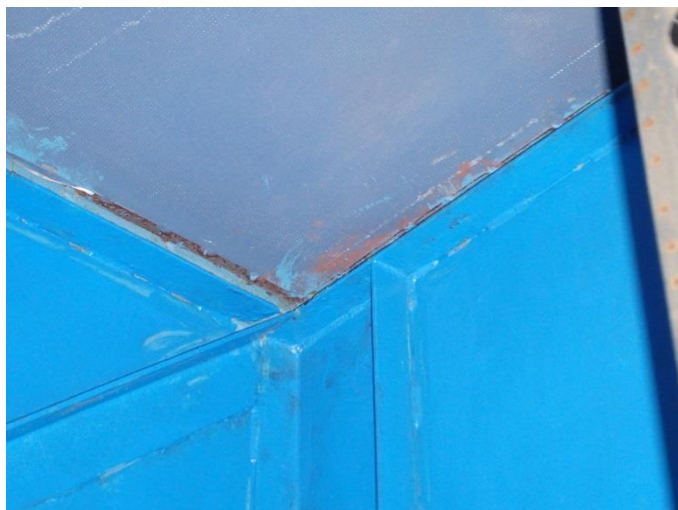
Photo 13 – Isolated coating breakdown and surface corrosion at connection between vertical wall panels and ceiling.

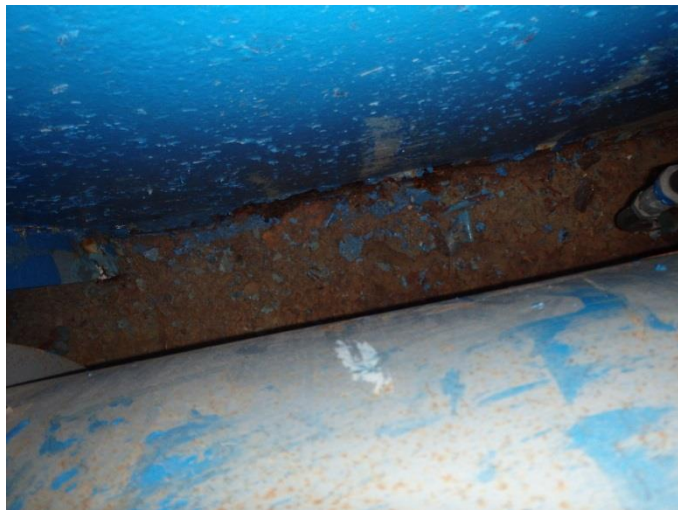
Photo 15 – Coating breakdown/corrosion on deck plating in East side air filter room.

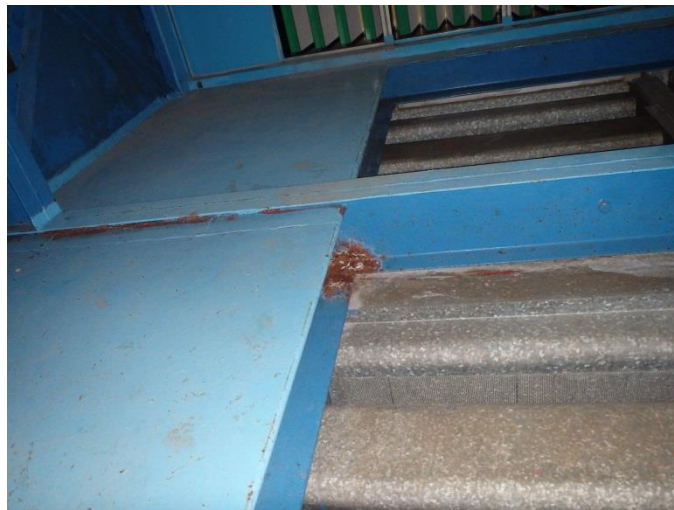
Photo 16 – Isolated coating breakdown at connection between 2 I-beams located inside of emergency air filter system.

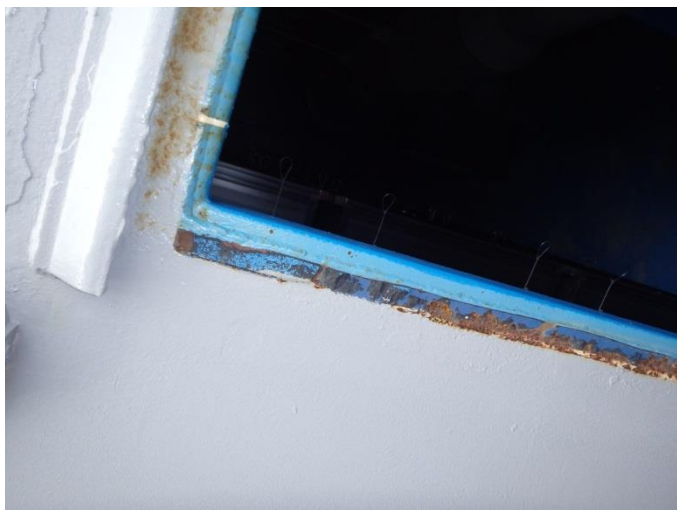
Photo 17 – Deterioration on East side hatch door seal.

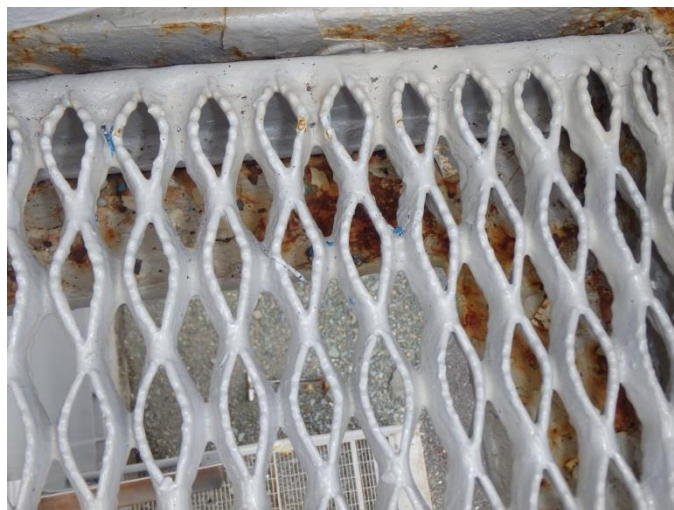
Photo 18 – Coating breakdown on horizontal sections of top platform structural beams.

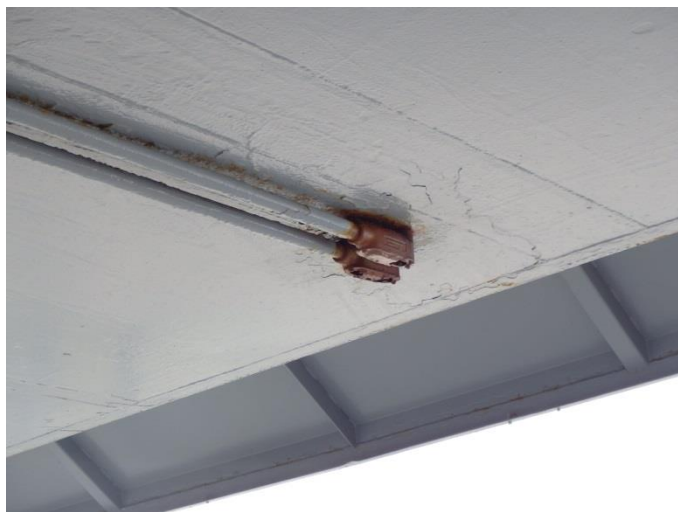
Photo 21 – Electrical boxes in poor condition on East side of Inlet Air System B.

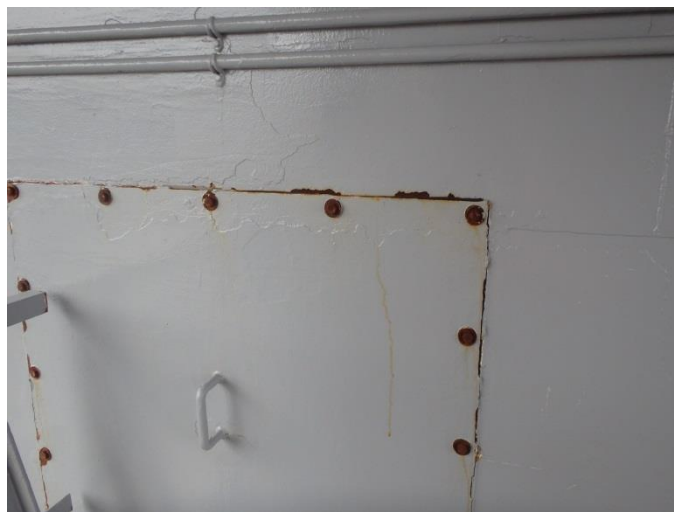
Photo 22 – 100% coating breakdown on stud for hatchway door located on middle platform South side.

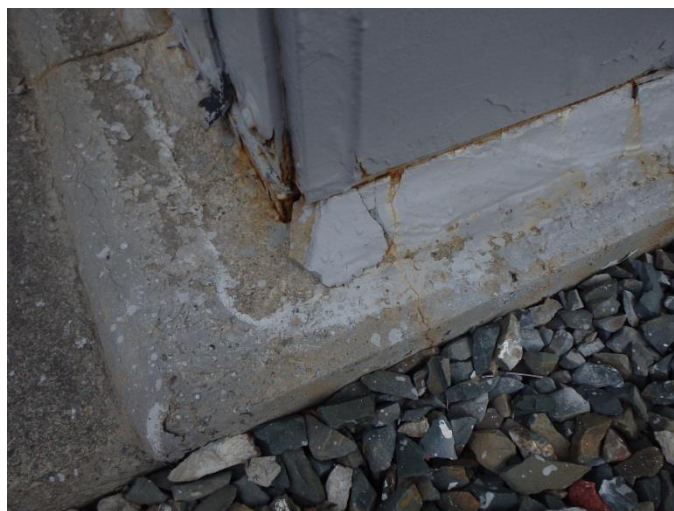
Photo 28 – Isolated area of deterioration at Northwest corner of concrete base.

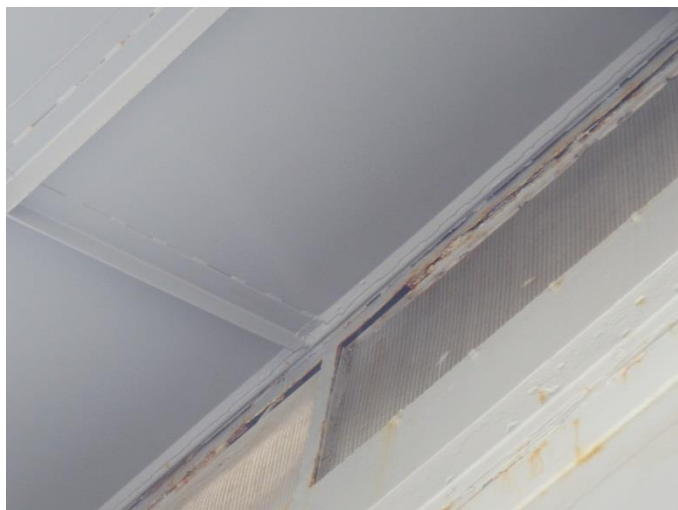
Photo 29 – Damaged section of mesh.

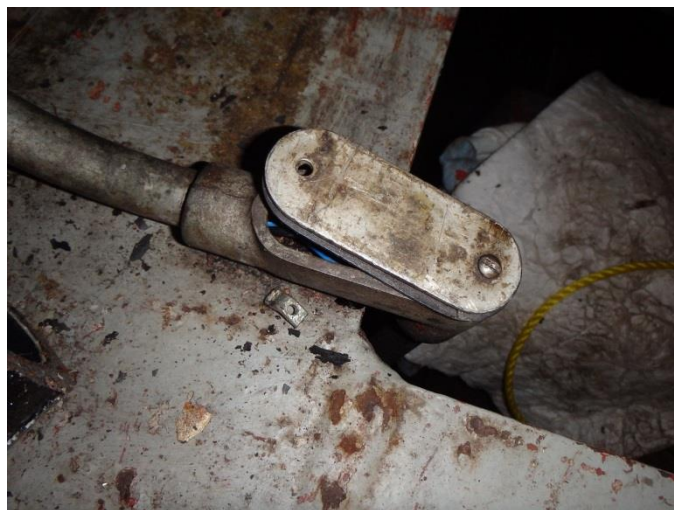
Photo 30 – Electrical connection in poor condition.

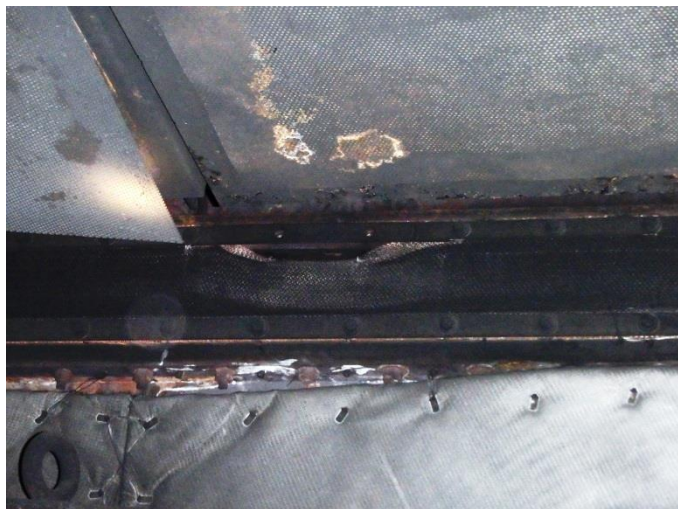
Photo 31 – Damaged section of mesh.

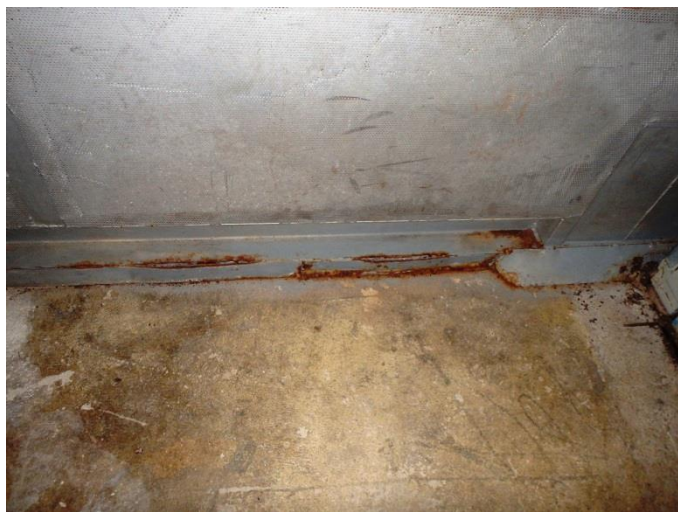
Photo 33 – Isolated areas of corrosion.

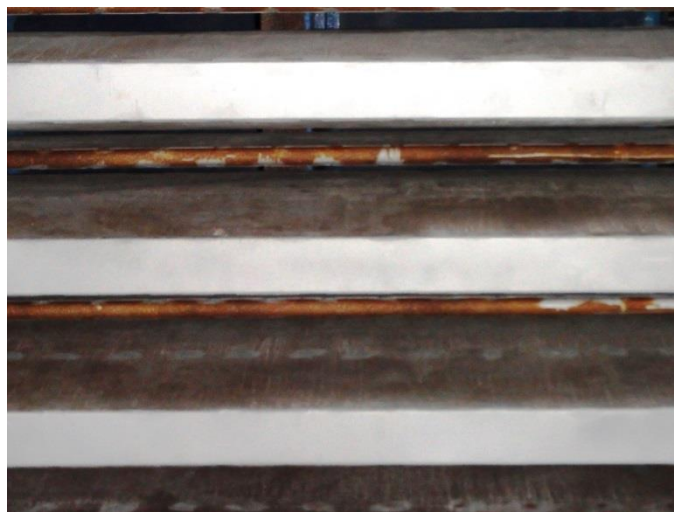
Photo 34 – Coating breakdown and surface corrosion on vertical members.

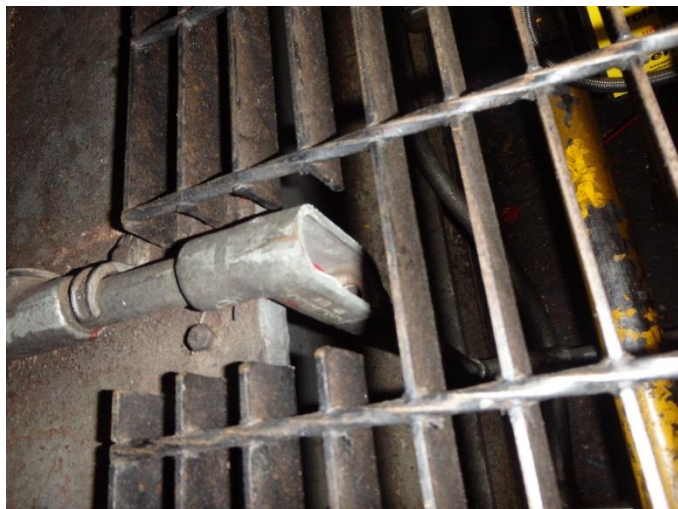
Photo 35 – Electrical connection in poor condition.

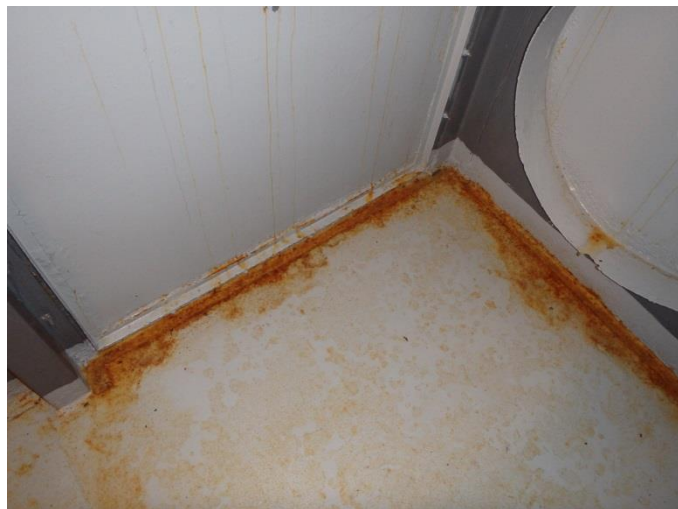
Photo 3 – Rust staining and very amount of coating breakdown noted.

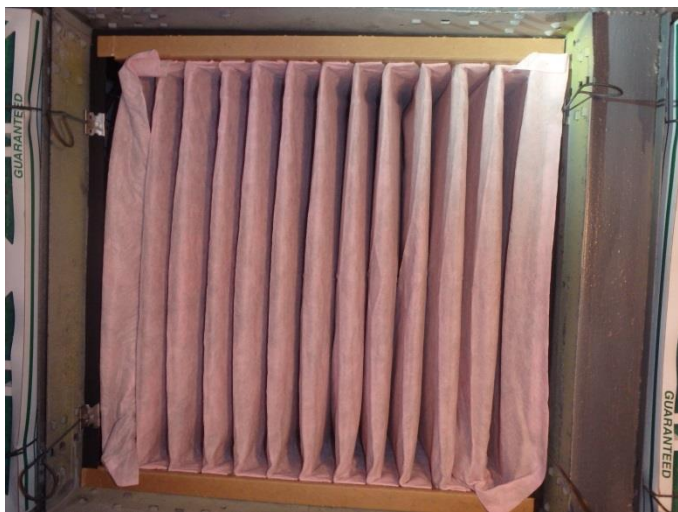
Photo 5 – Filter found in good and clean condition.

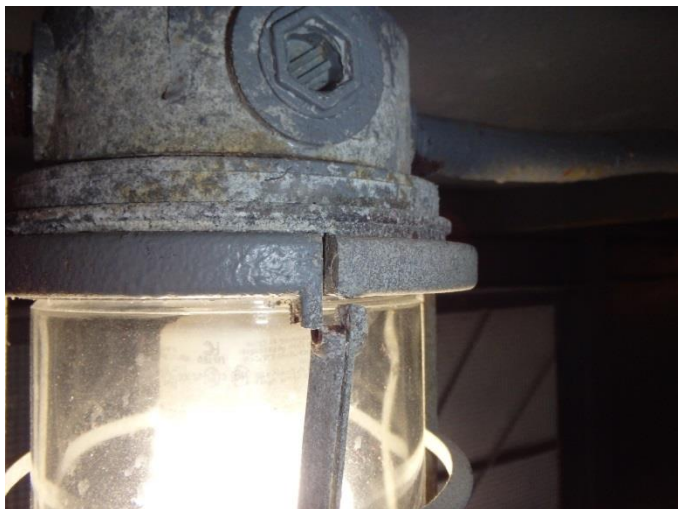
Photo 7 – Broken connection found located at light.

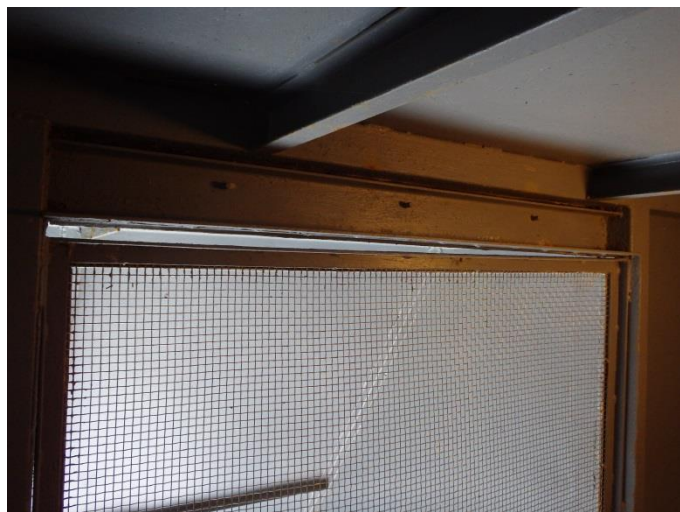
Photo 9 – Gap noted at top of mesh, allowing for water ingress.

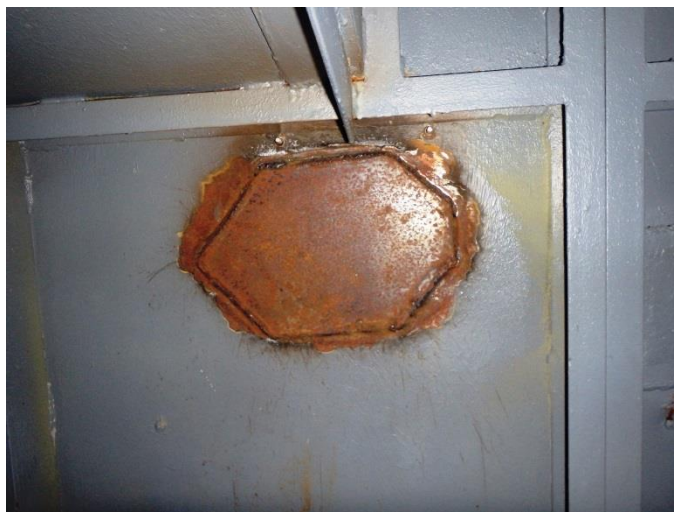
Photo 14 – Corrosion noted on steel insert plate.

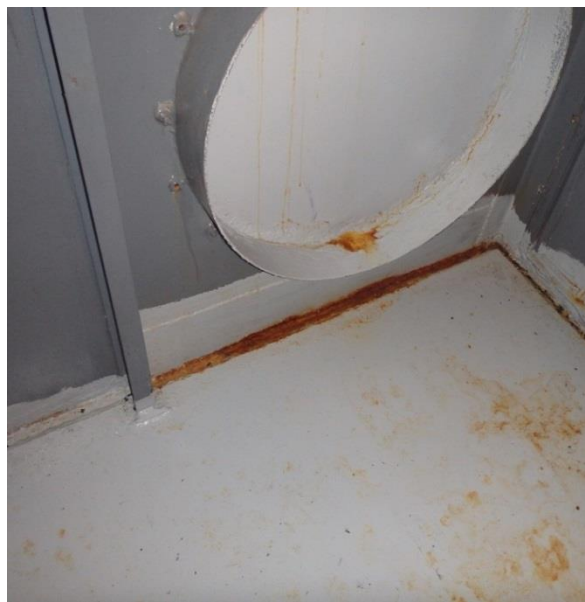
Photo 16 – Rust staining with low levels of coating breakdown noted on deck plating.

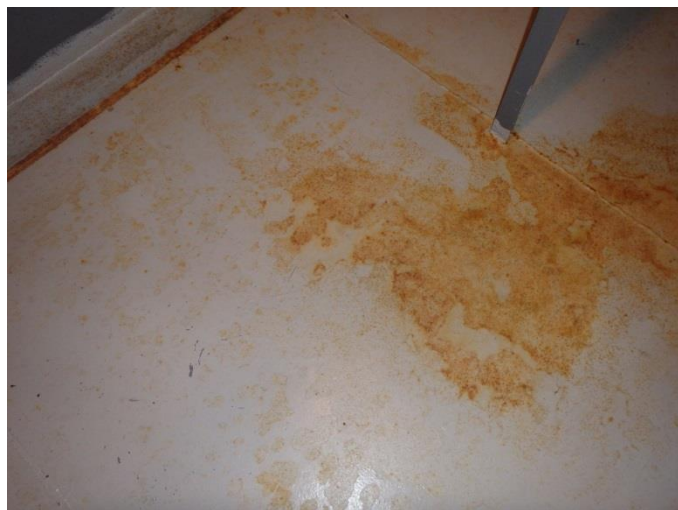
Photo 17 – Rust staining noted on deck plating.

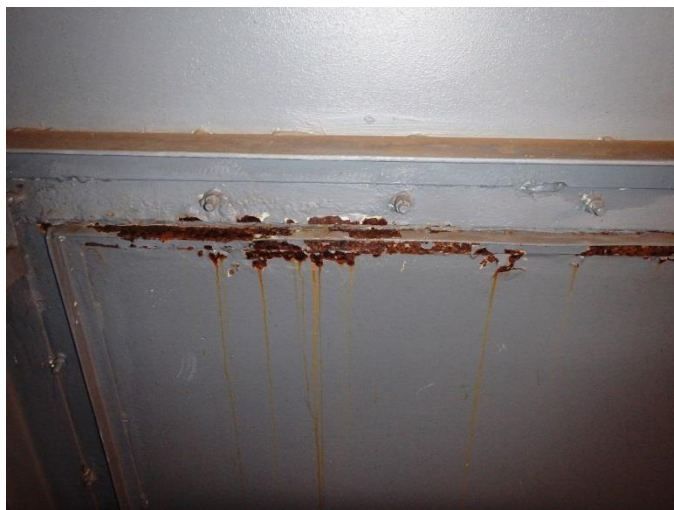
Photo 18 – Coating breakdown and low levels of scaling noted on top section of East side hatch way access panel.

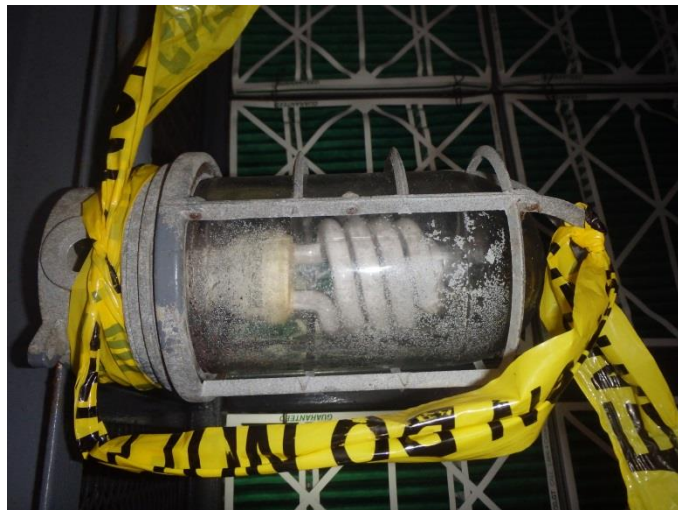
Photo 19 – Light found to be in poor condition with broken supporting member.

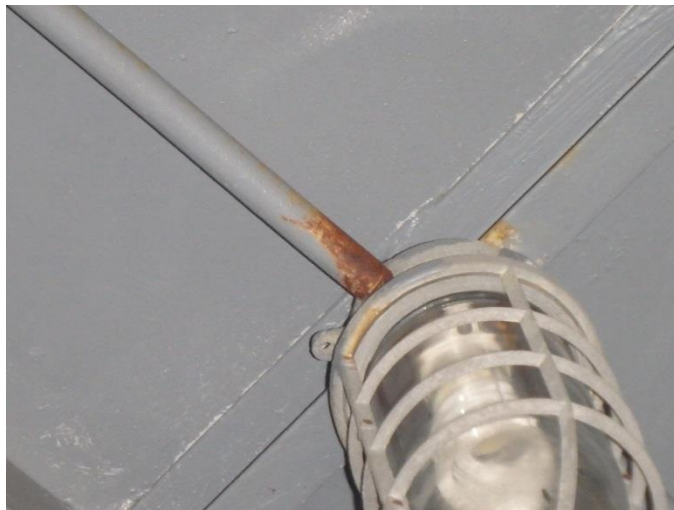
Photo 20 – Coating breakdown noted on electrical wire casing.

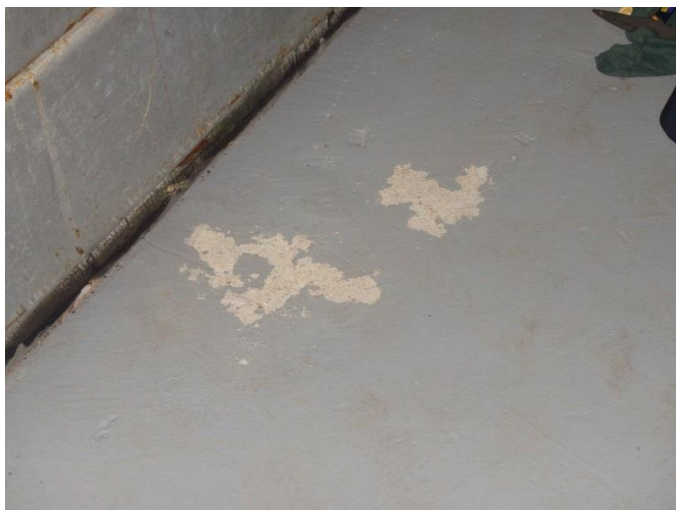
Photo 21 – Light coating breakdown noted on floor.

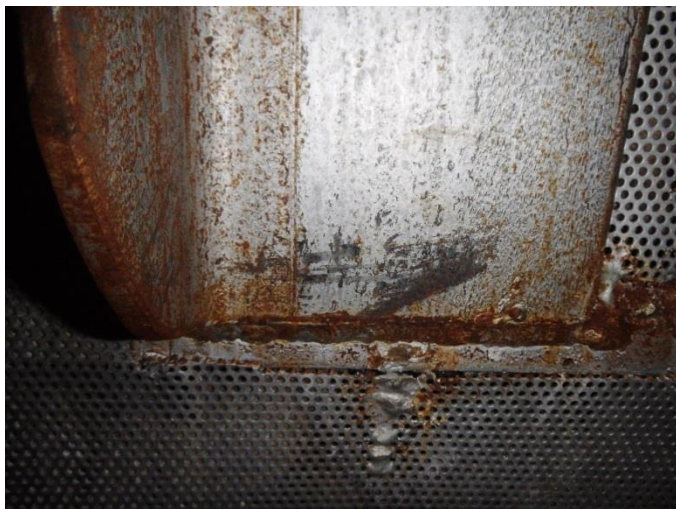
Photo 23 – Condition of weld for lifting lug prior to MPI inspection.

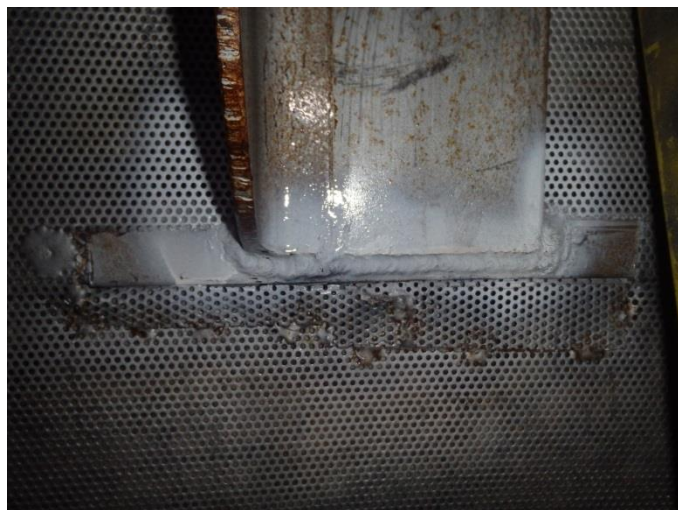
Photo 25 – No indications noted on bottom weld.

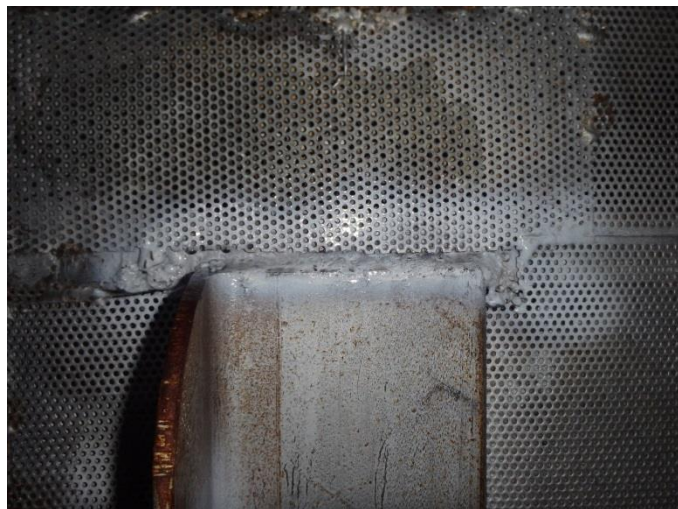
Photo 27 – No indications noted on top weld.

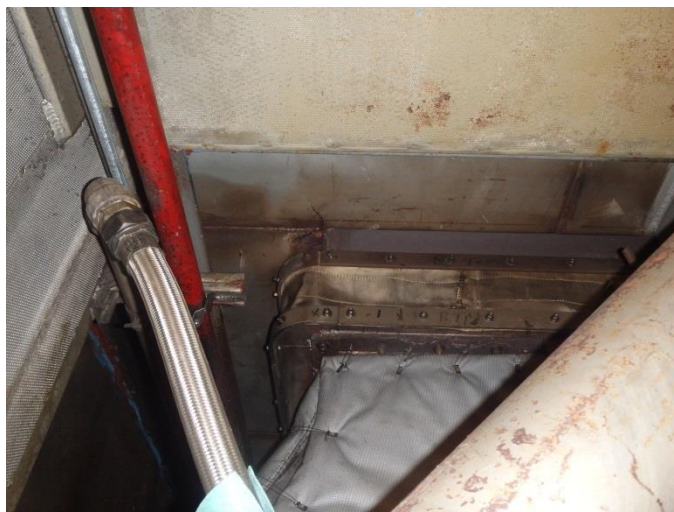
Photo 30 – Overview of fracture found present South corner of Turbine room, bottom section of Exhaust A.

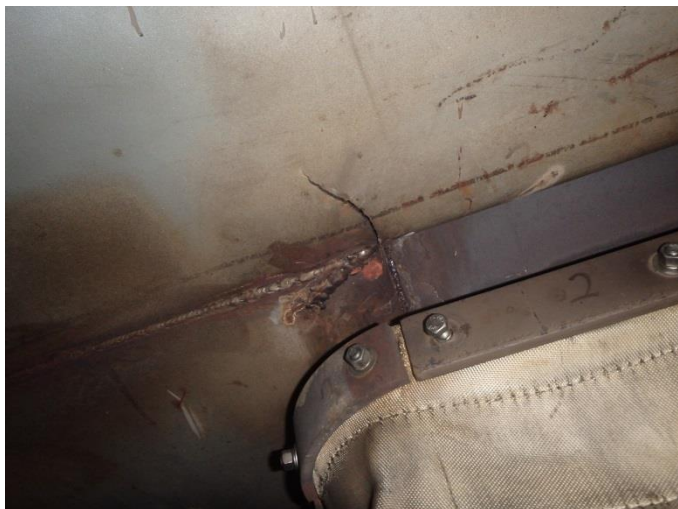
Photo 31 – Close up of Fracture noted on bottom section of Exhaust A.

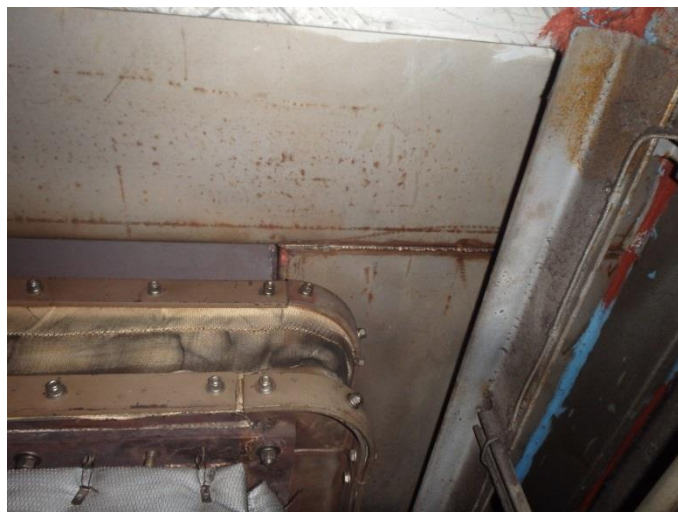
Photo 33 – Overview of fracture found present South corner of Turbine room, bottom section of Exhaust A.

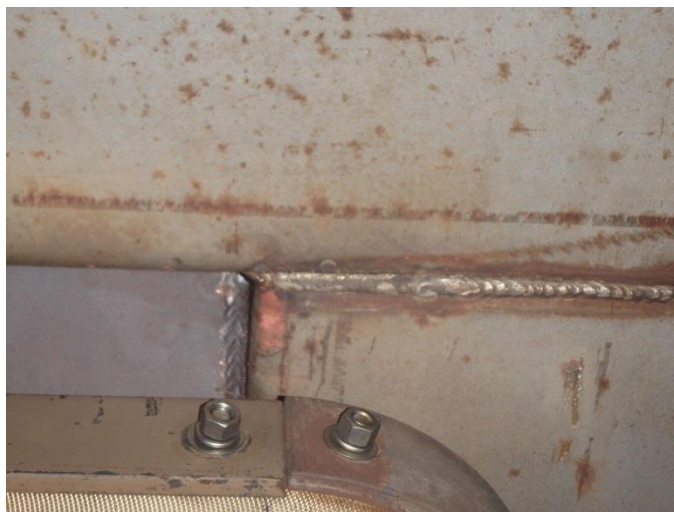
Photo 34 – Close up of fracture noted on bottom section of Exhaust A.

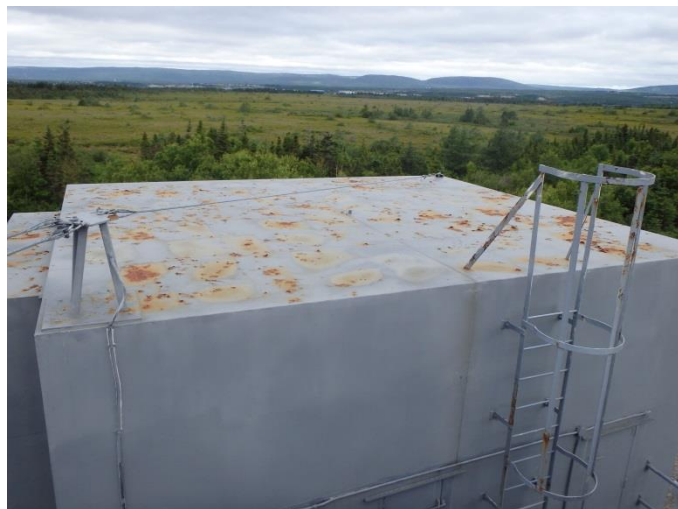
Photo 35 – Roofing steel plating in fair condition with coating breakdown and scale noted.

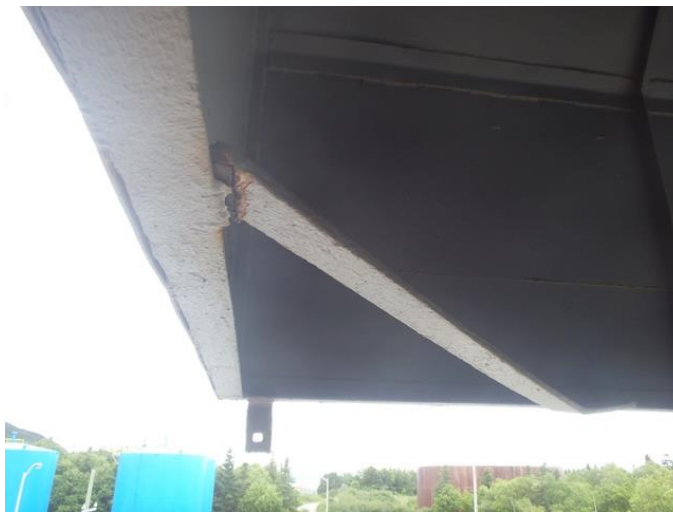
Photo 42 – Broken weld on supporting member, potential falling object hazard.

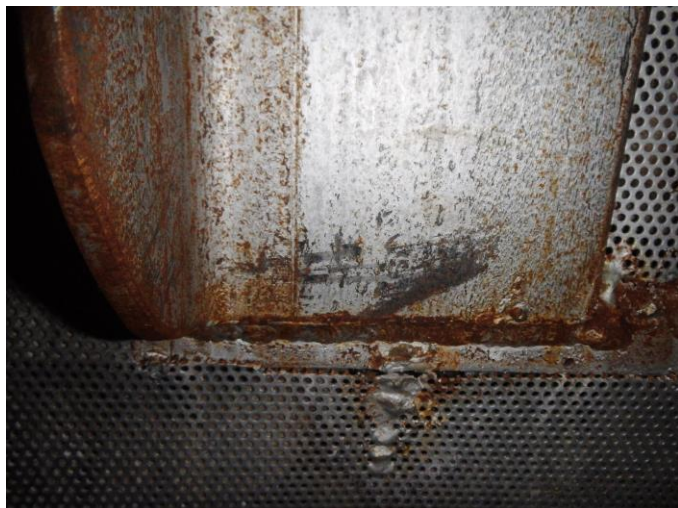
Photo 1 – Condition of weld prior to inspections

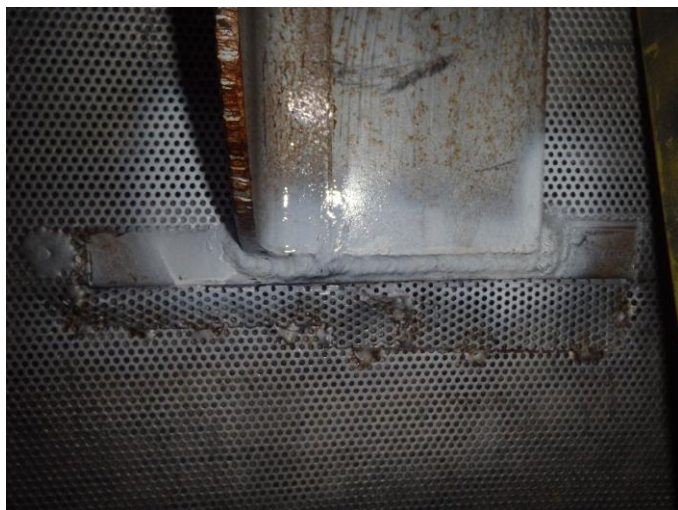
Photo 3 – No indications noted on bottom weld.

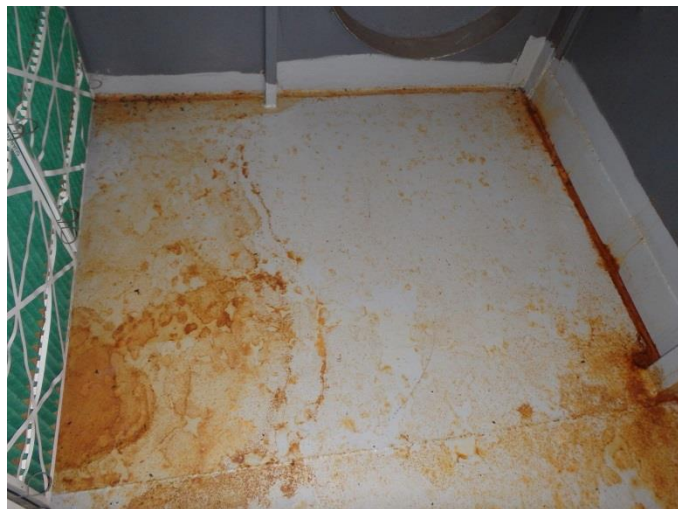
Photo 3 – Rust staining and isolated areas of coating breakdown.

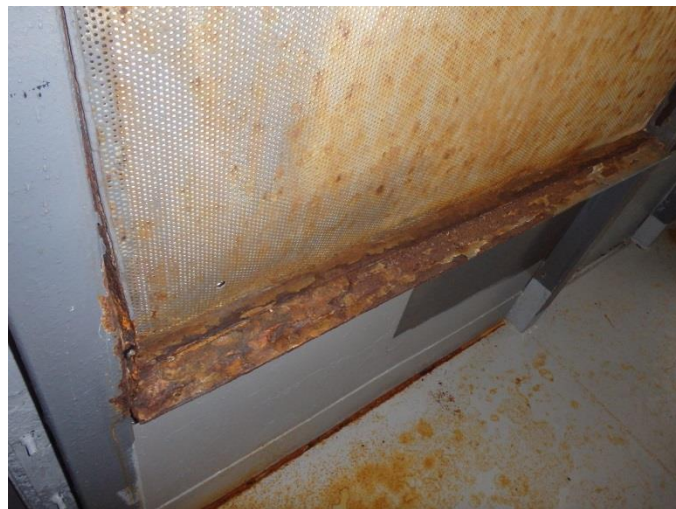
Photo 4 – Coating breakdown and scale noted on lower mesh ledge.

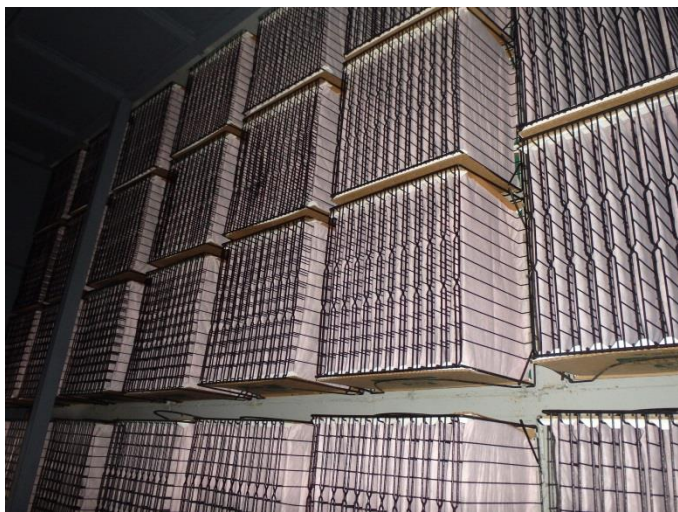
Photo 9 – Filters found to be in good condition.

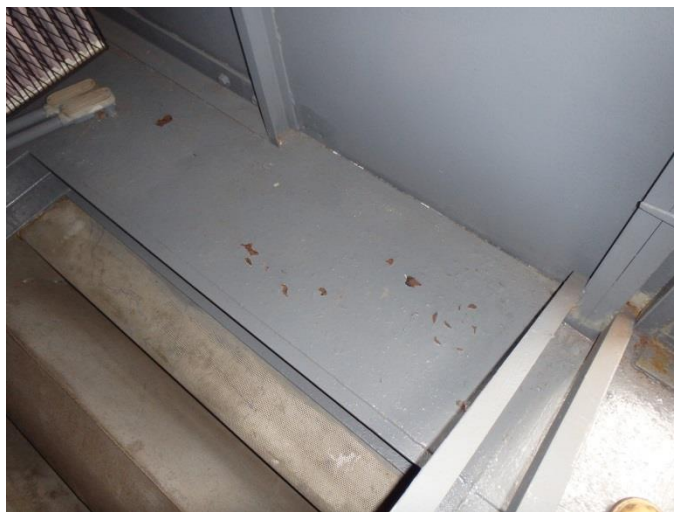
Photo 10 - Isolated spots of coating breakdown on steel deck plating.

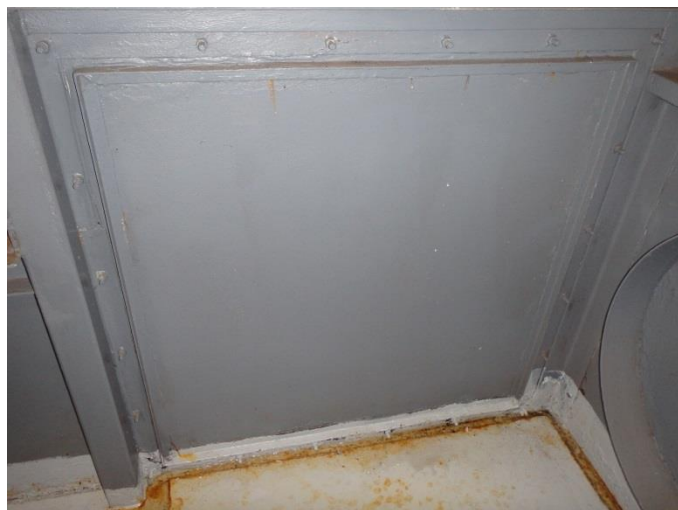
Photo 13 – Rust staining on deck plating and 4 x pin holes noted on top weld of access hatch door.

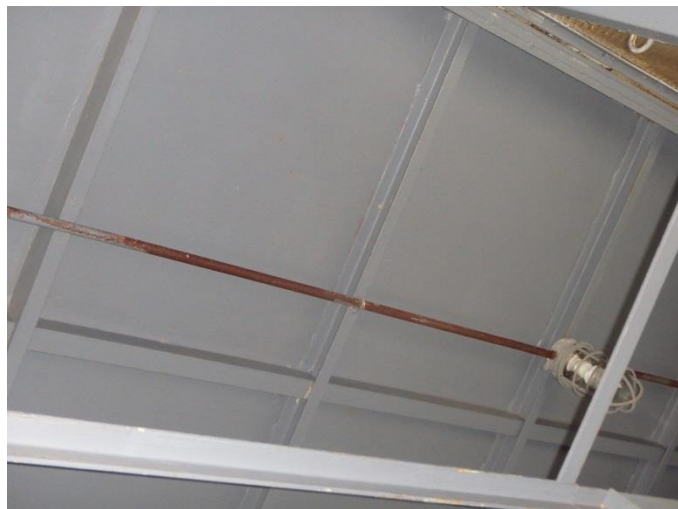
Photo 15 – Coating breakdown noted on electrical wire casing.

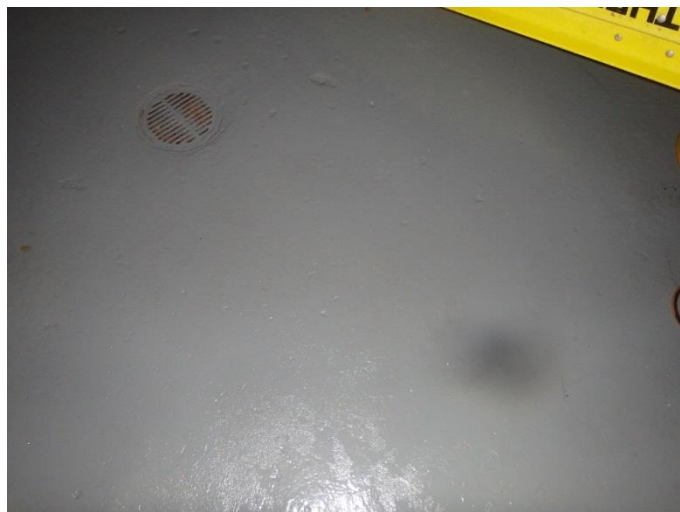
Photo 17 – Coating on deck of lower plenum in good condition.

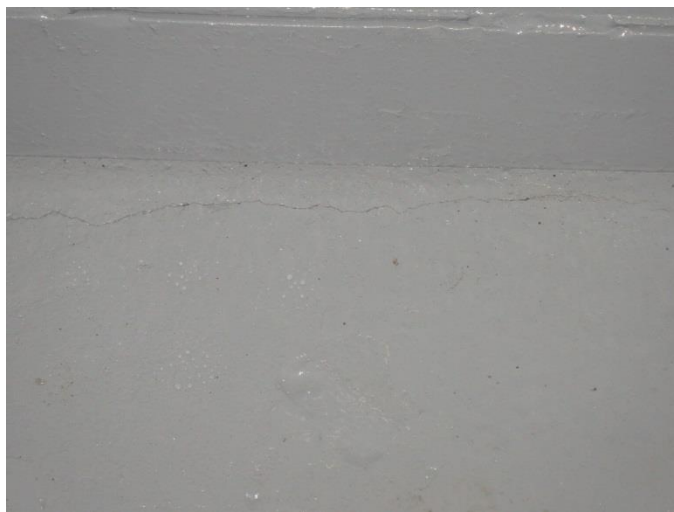
Photo 18 – Small fracture noted in concrete floor of lower plenum.

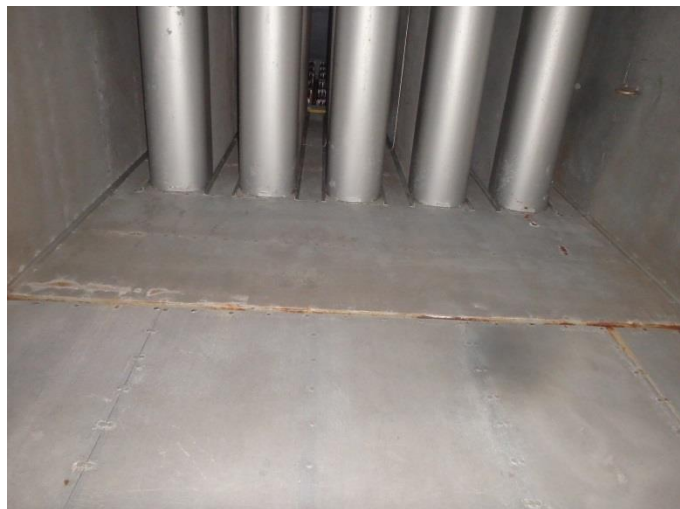
Photo 19 – Top section of lower plenum in good condition with no signs of coating breakdown or corrosion.
