10    A.    Please see Hydro's response to IC-NLH-006, Attachment 1 - Site Recommendations,  
11           IC-NLH-006 Attachment 2 – Air Intake Inspection Report, IC-NLH-006 Attachment 3 -  
12           Gas Turbine Capital Plan, and NP-NLH-13, Attachment 1 - Stantec Condition  
13           Assessment Study Report.

# Site Recommendations

**Customer: Newfoundland Labrador Hydro**

**Project Number: Alba 4927**

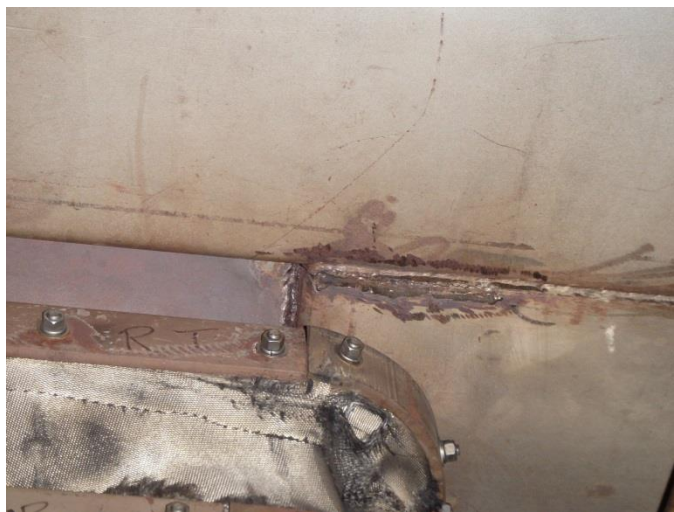
Photo 22 – Fracture noted at bottom of Exhaust B.

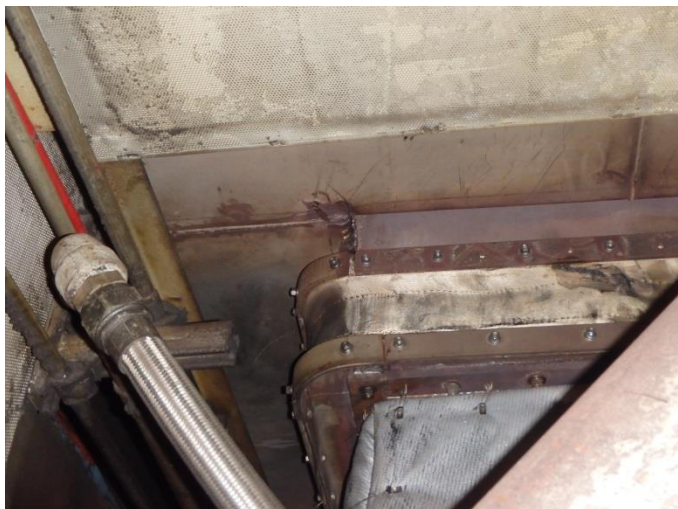
Photo 23 – Fracture noted at bottom of Exhaust B.

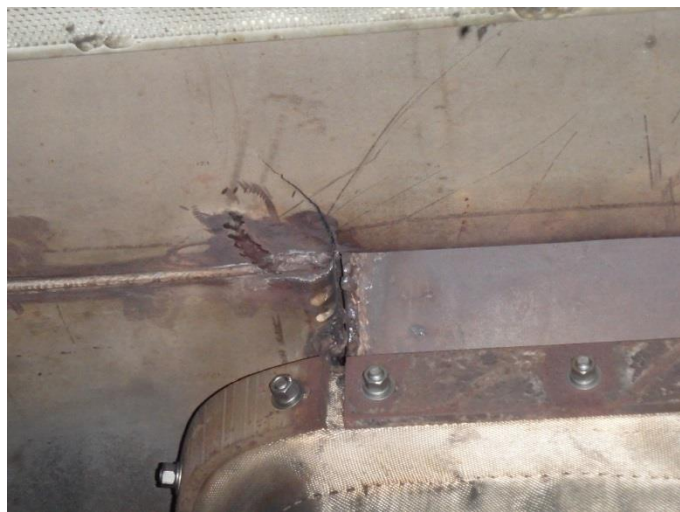
Photo 25 – Fracture noted at bottom of exhaust B.

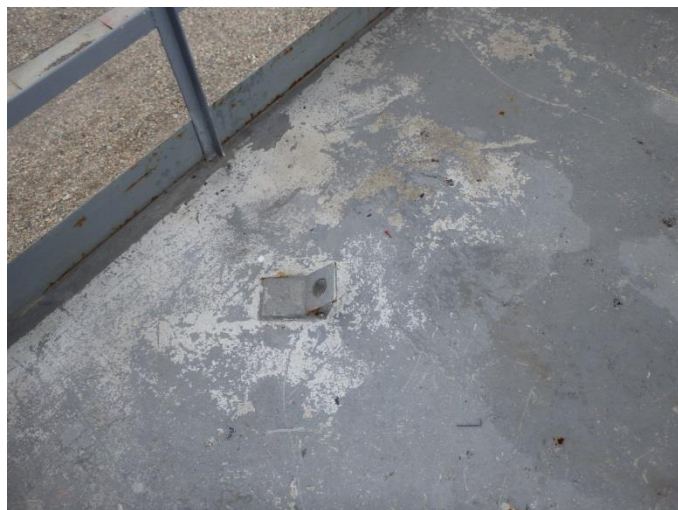
Photo 29 – Tripping hazards on middle access platform.

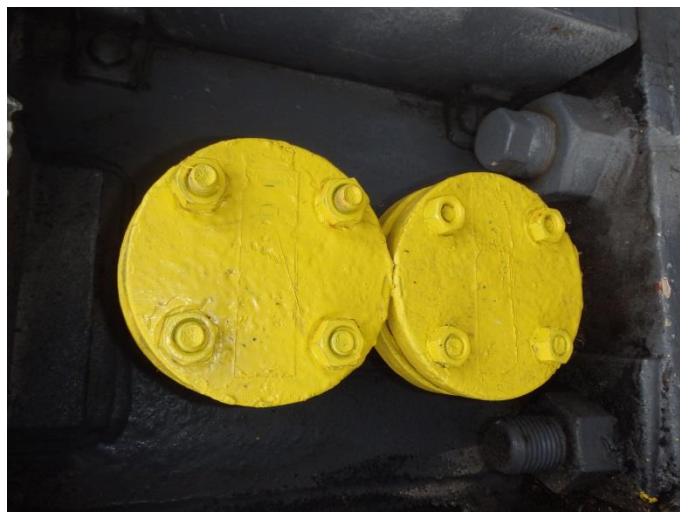
Photo 33 – Lack of protrusion noted on nozzle connection.

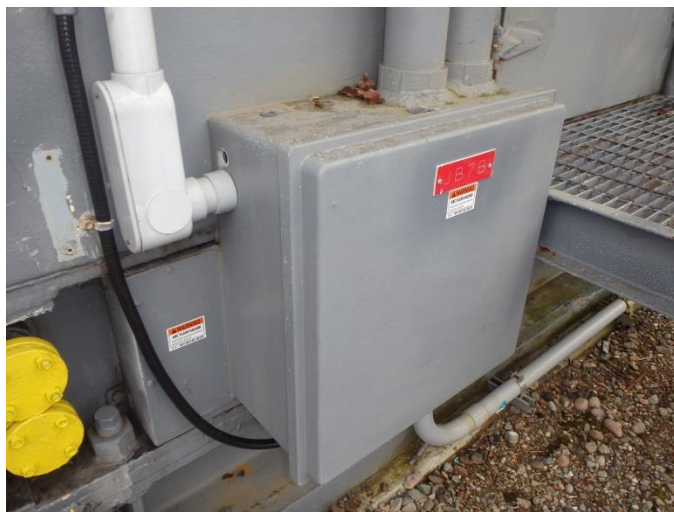
Photo 34 – Hole noted on South side of arc flash box allowing for water ingress.

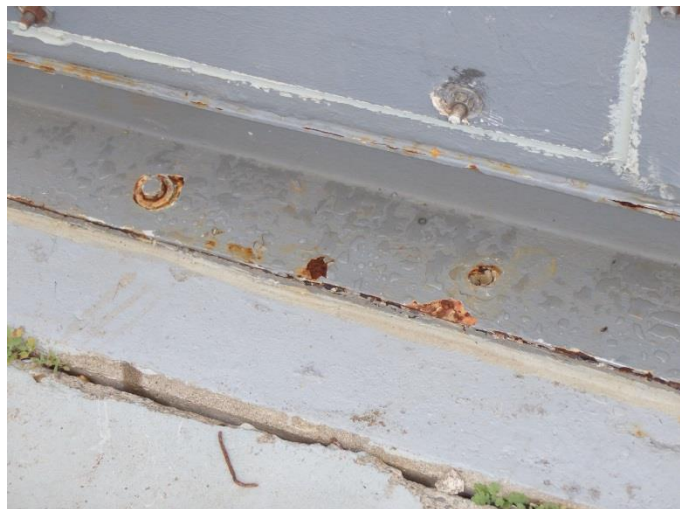
Photo 35 – Missing anchor bolt below main access doors on South side.

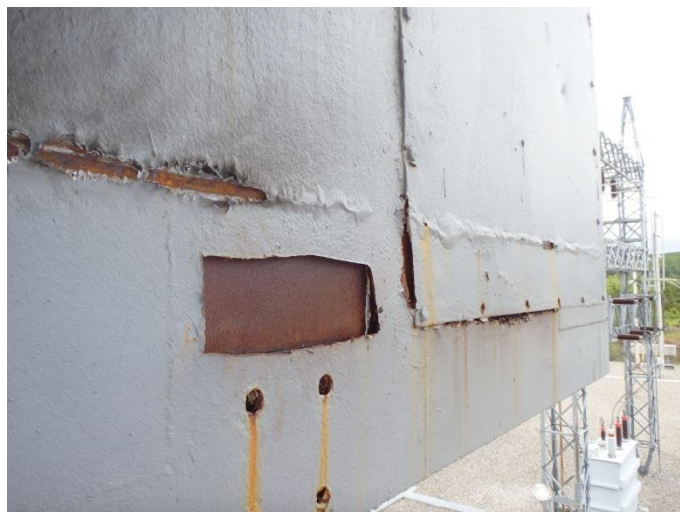
Photo 37 – Corrosion on steel insert plates.

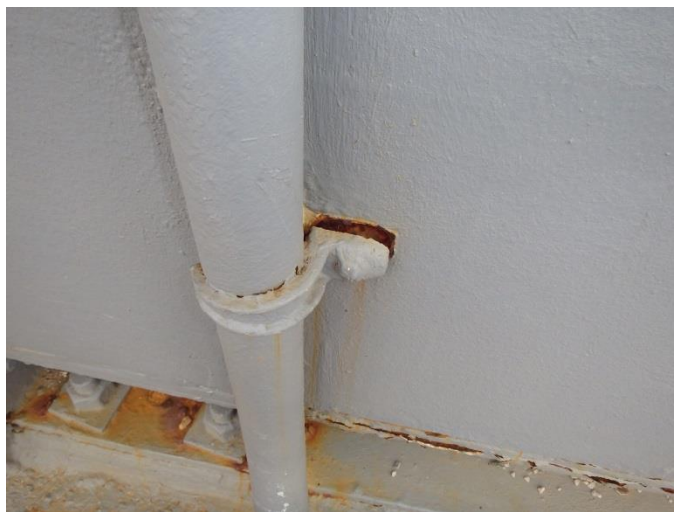
Photo 38 – Loose connection.
