Board Order No. P.U. 3(2014)
Investigation and Hearing into Supply Issues and Power Outages on the
Island Interconnected System

NEWFOUNDLAND AND LABRADOR HYDRO

Events of January 2013

January 11, 2013 Power System Outage Report

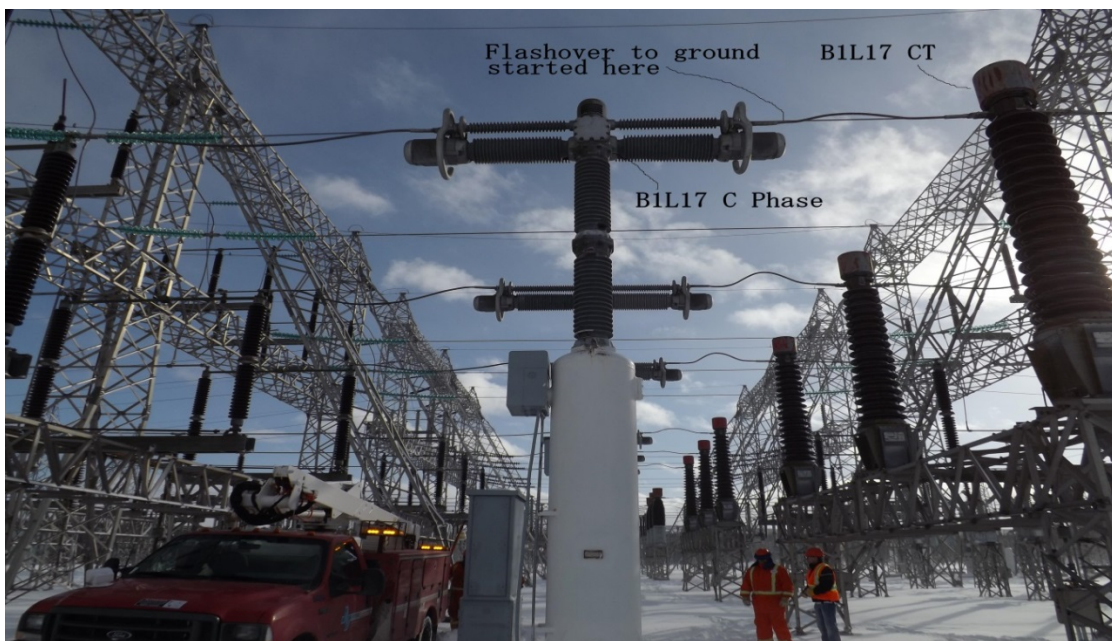
Figure 2-5a: Holyrood Breaker - B1L17 C Phase

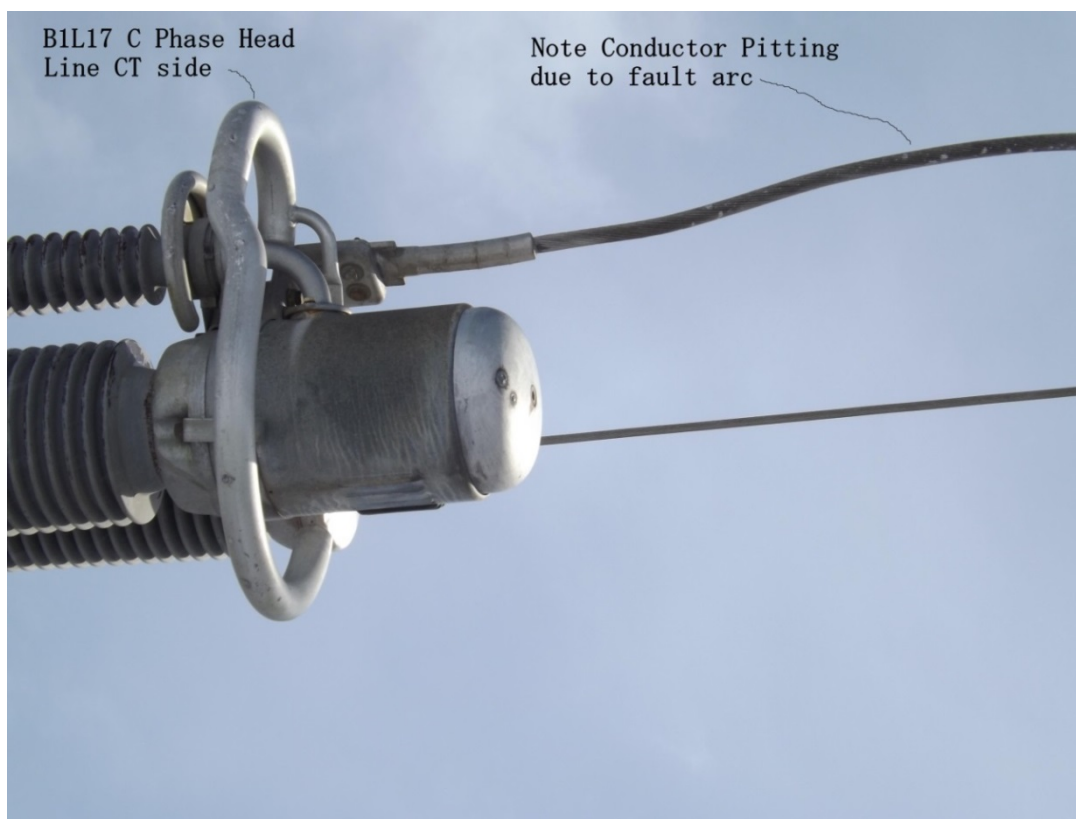
Figure 2-5b: Holyrood Breaker - C Phase Conductor

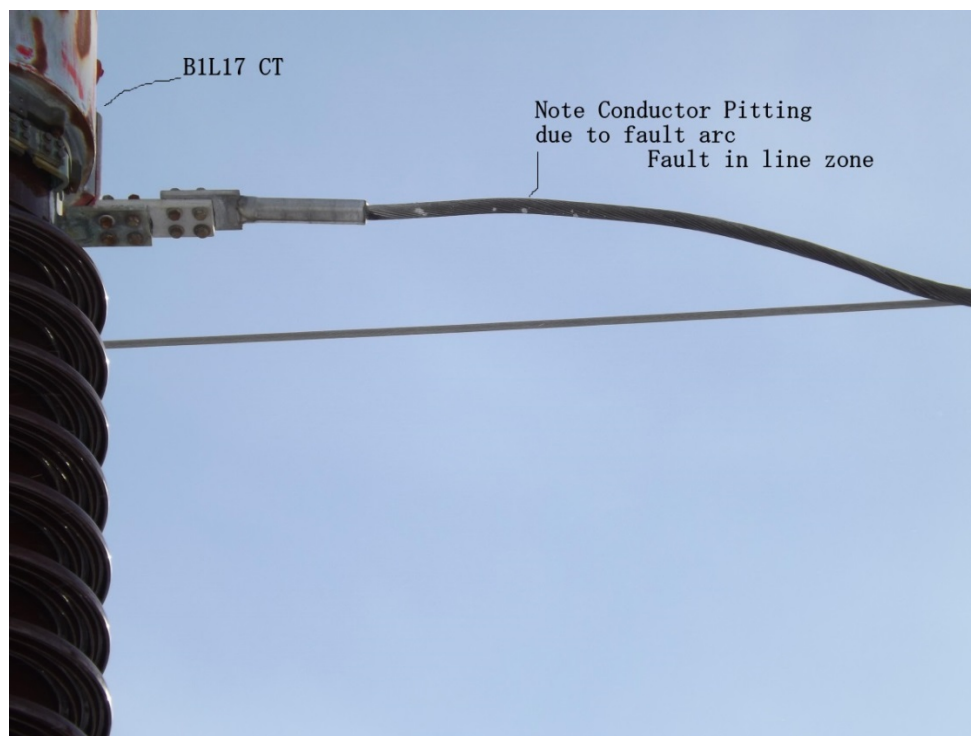
Figure 2-5c: Conductor Between Breaker B1L17 to B1L17 CT

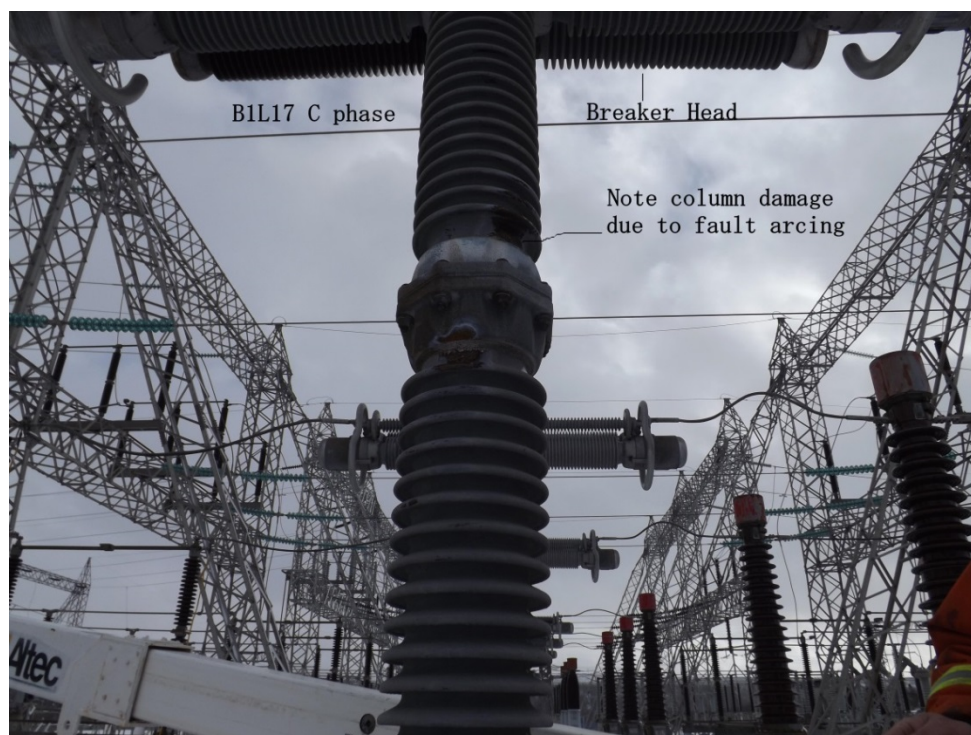
Figure 2-5d: B1L17 Vertical Column Arcing Damage

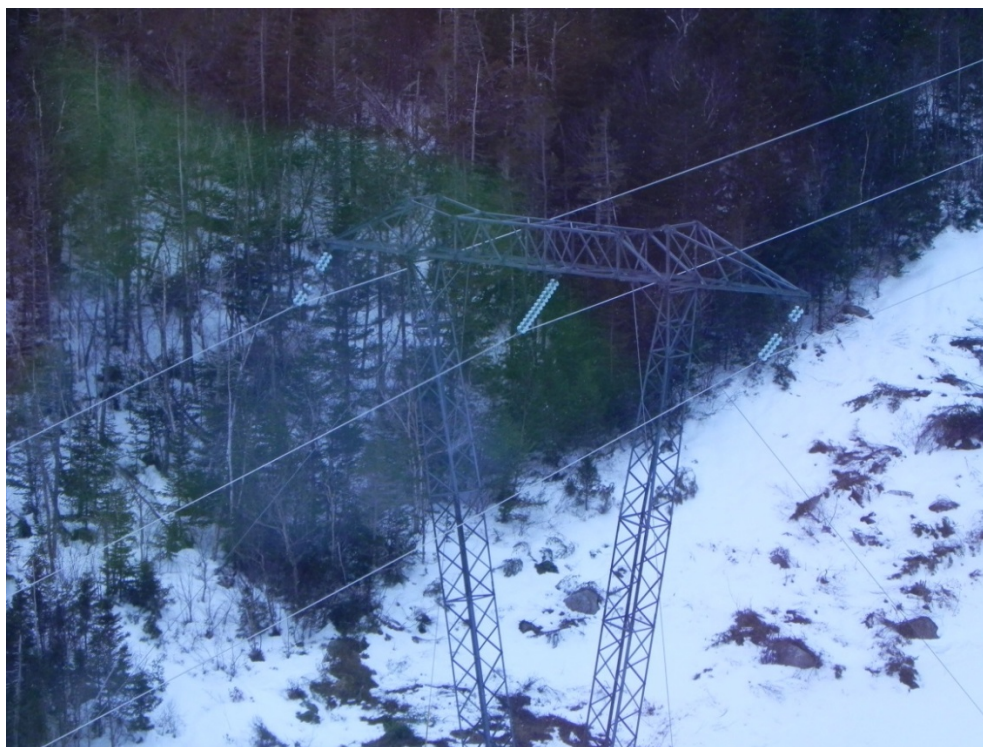
Figure 2-9a: Picture of TL217 Structure 282 with Damaged Insulators

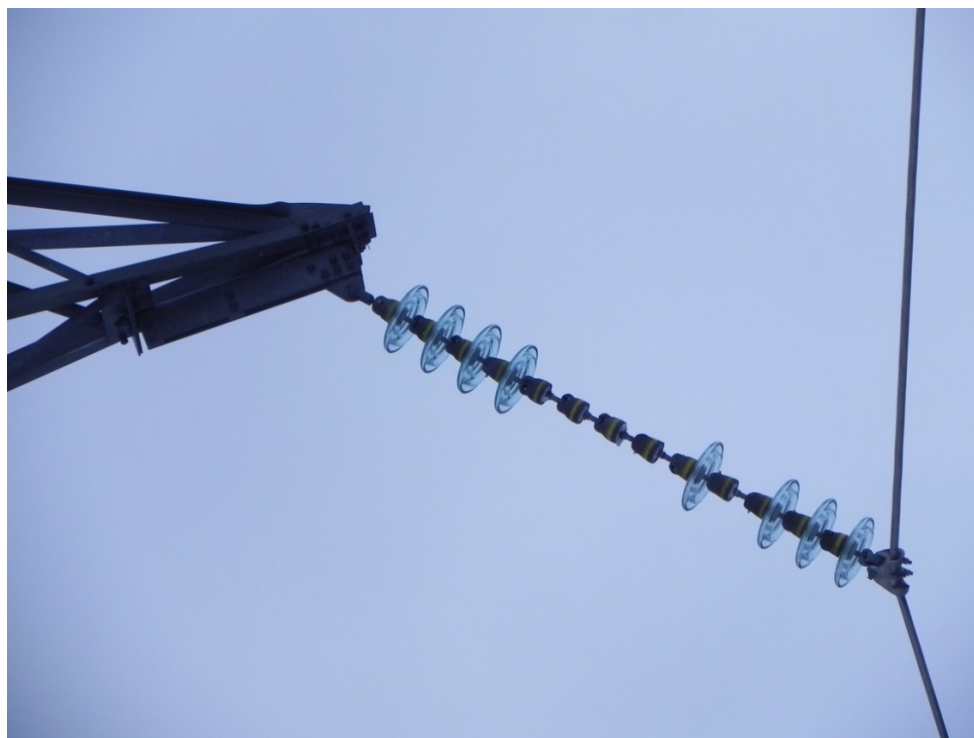
Figure 2-9b: Picture of TL217 Structure 282 Showing Damaged Insulators (one of two strings)

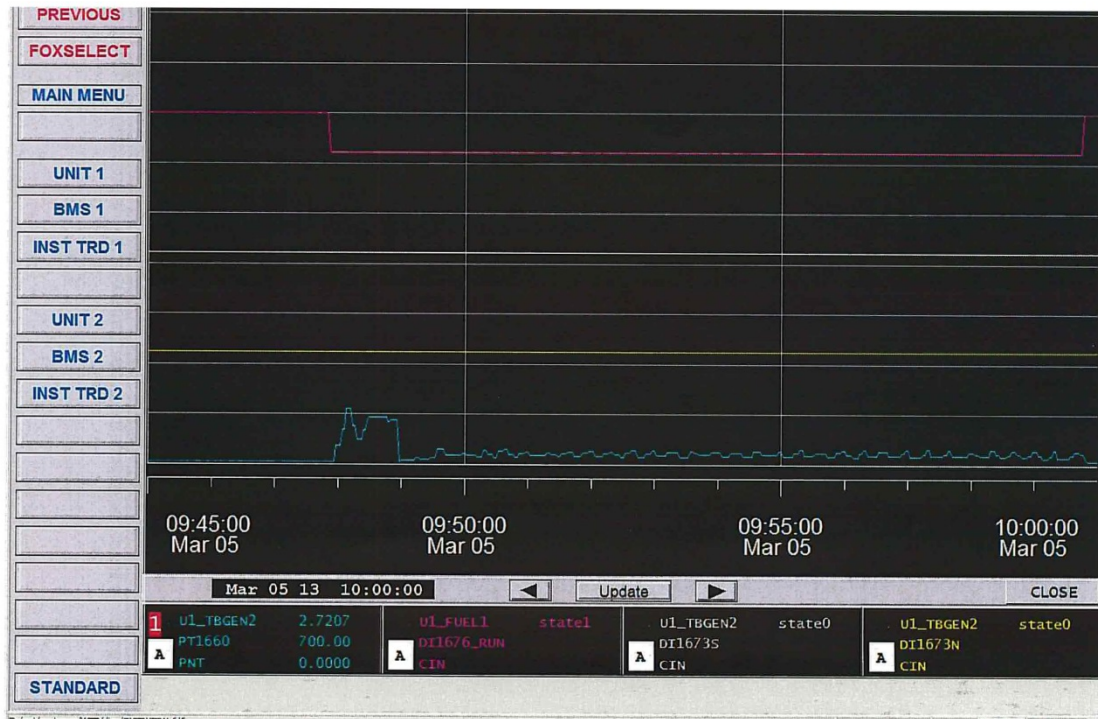
Figure 2: DC lube oil pump test from March 5, 2013. Note the falling magenta line indicates starting of the DC lube oil pump. There is an increase in pressure (blue) for a short time before pressure crashes and cycles

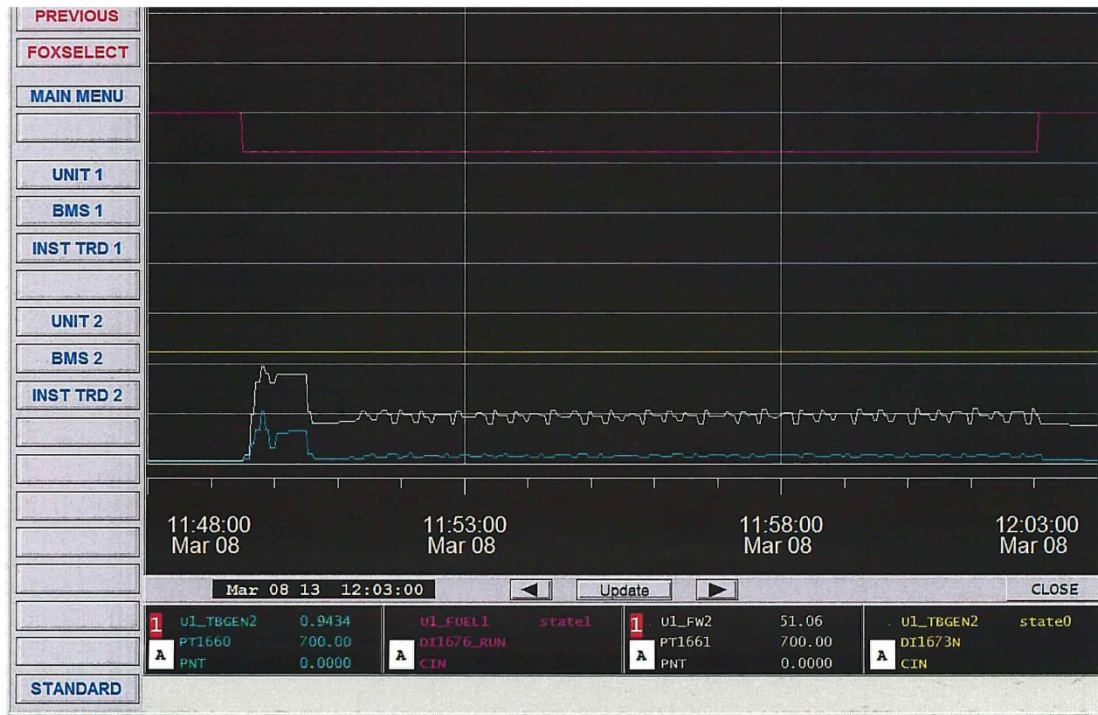
Figure 3: DC lube oil pump test with tank control valve wide open. Magenta is the start/run status of the DC lube oil pump. White is the lube oil pressure in the tank (expect higher value as there is approximately 42 feet of vertical head between the tank and the turbine-generator). Blue is the pressure in the front standard of the turbine-generator. Note the same cyclic pattern in the pressure trend as in Figure 2.

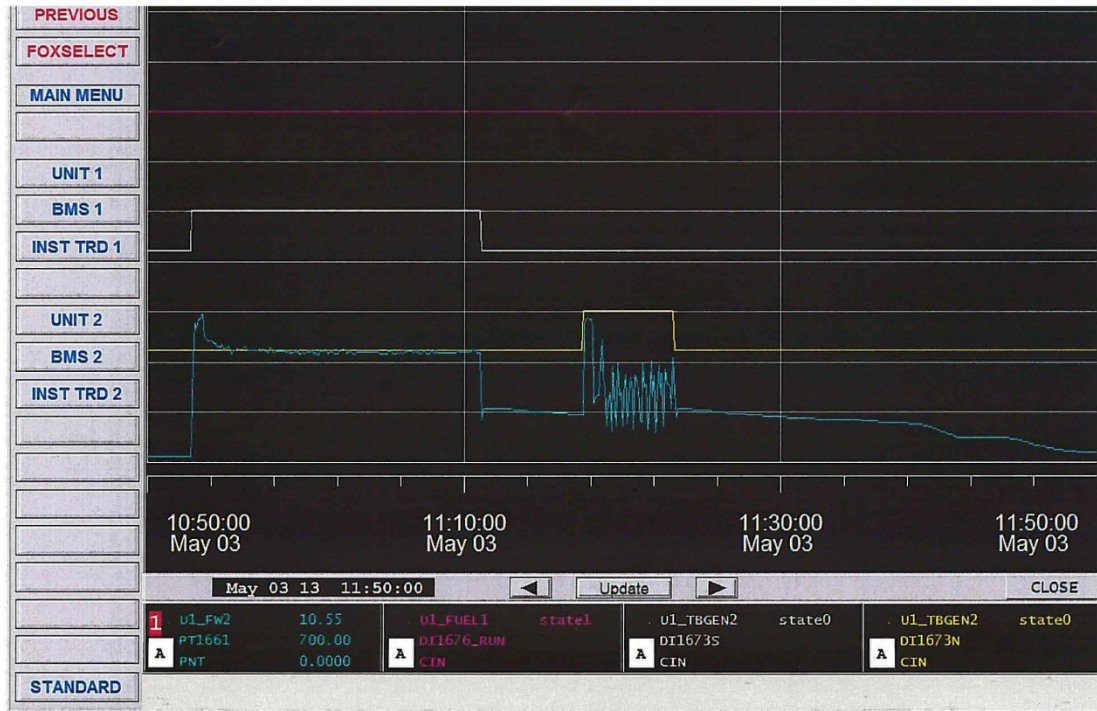
Figure 4: Test of DC Pump when coupled to AC South motor. Note that a test of AC pump South (white) provides normal and stable lube oil pressure (blue). When the AC North motor (yellow) is ran while coupled to the DC pump a similar cyclic pattern is exhibited as when DC motor and pump are ran together.
