NEWFOUNDLAND AND LABRADOR HYDRO

Generation Availability

March 2014

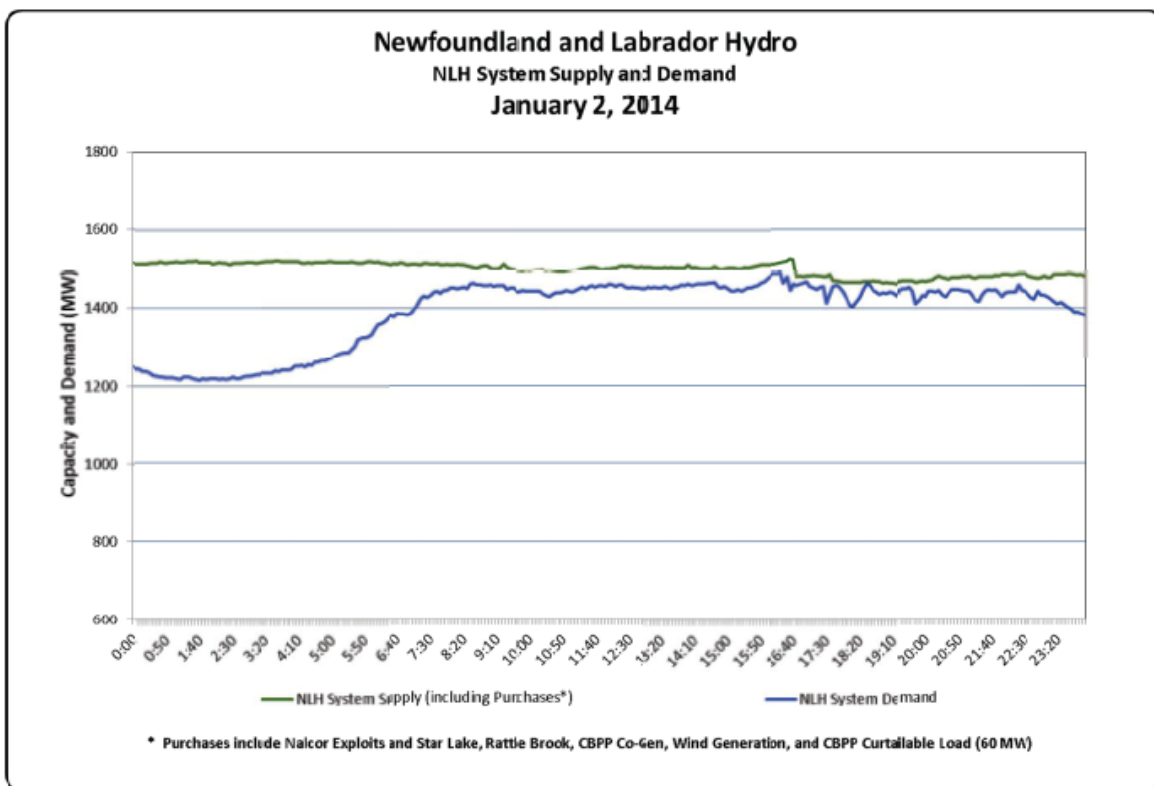
Figure 3: Hydro System Supply & Demand – January 2, 2014

- the increased system peak due to severe weather conditions;
- the impact of severe weather conditions on certain generating assets (Granite Canal, Exploits River);
- the availability of spares (Holyrood 4kV motors); and
- the age of some equipment within some of the generating assets (Holyrood Unit 3 FD fan motor).

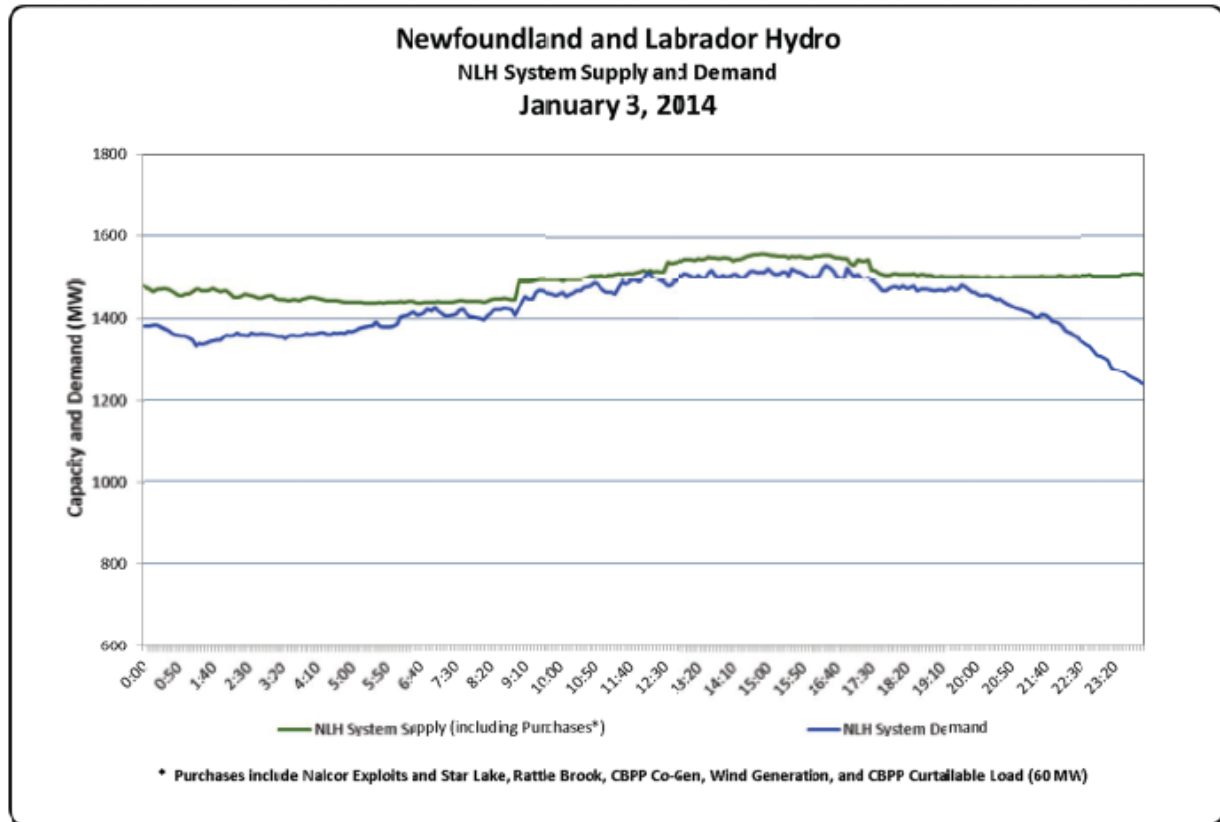
Figure 4: Hydro System Supply & Demand – January 3, 2014

JANUARY 3, 2014		
DATE	EVENT	COMMENT
January 3, 2014	Wind Turbine Out of Service of 54 MW	Wind turbine generators tripped due to high winds and transmission system conditions. Required manual reset. High winds and site access delayed restart. Returned to service January 6 to 8, 2014.

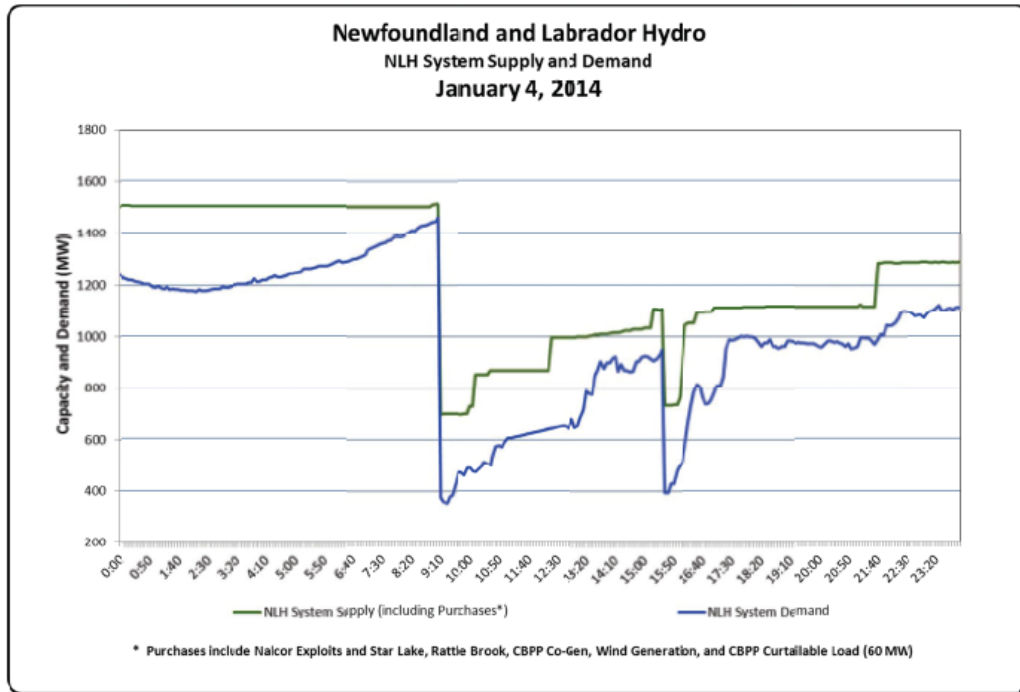
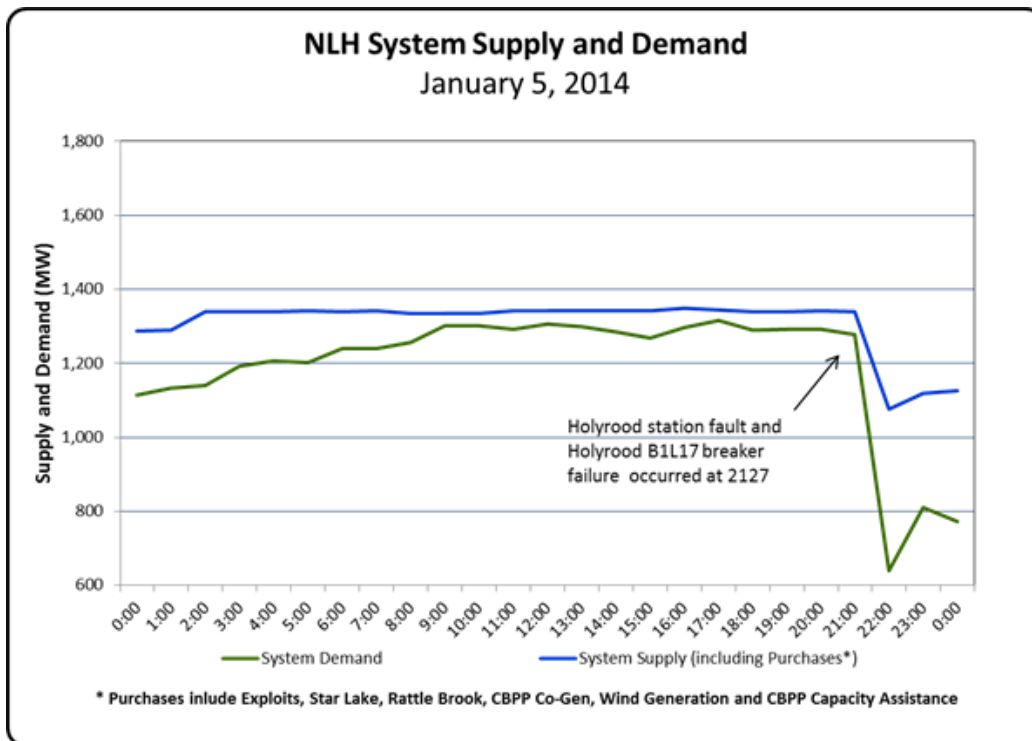
The following charts show the system reserve on January 4 and January 5, 2014 during the system incident. The chart for January 4, 2014 shows the reducing reserve early in the morning up to the first system disruption. The January 5, 2014 chart shows that the reserve varied between a minimum of 30 MW at 0830 hours to a maximum of 438 MW following the separation of the east and west systems at 21:27 hours with the disturbance on the power system that originated at the Holyrood Terminal Station. The increased reserve immediately following the disturbance up to the end of the day was a result of the time required to restore generating equipment, transmission equipment and customer load. In particular, due to the limitations in transmission line power transfer capability serving the Avalon Peninsula, customer load could not be completely restored until generating equipment at Holyrood and transmission lines were restored over the next several hours.
