NEWFOUNDLAND AND LABRADOR HYDRO

Transmission Availability

March 21, 2014

AMEC Americas Limited

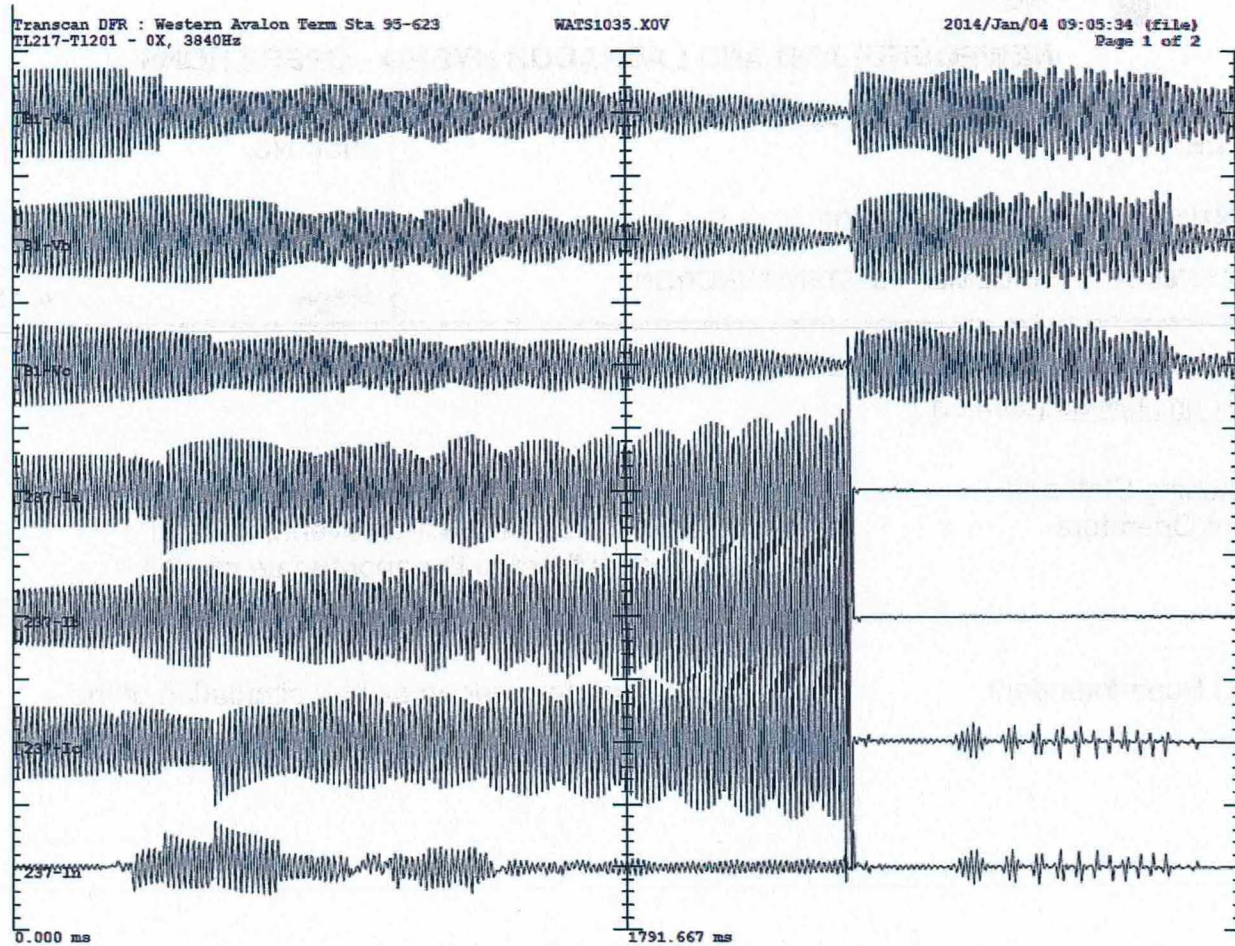
Figure 1: Loss of Stability of Power System following fault on transformer T1 at Sunnyside

Traces from Western Avalon station show bus voltages (top 3 traces) rapidly decline and the currents on line TL237 (second set of 3 traces) oscillate and become unstable.

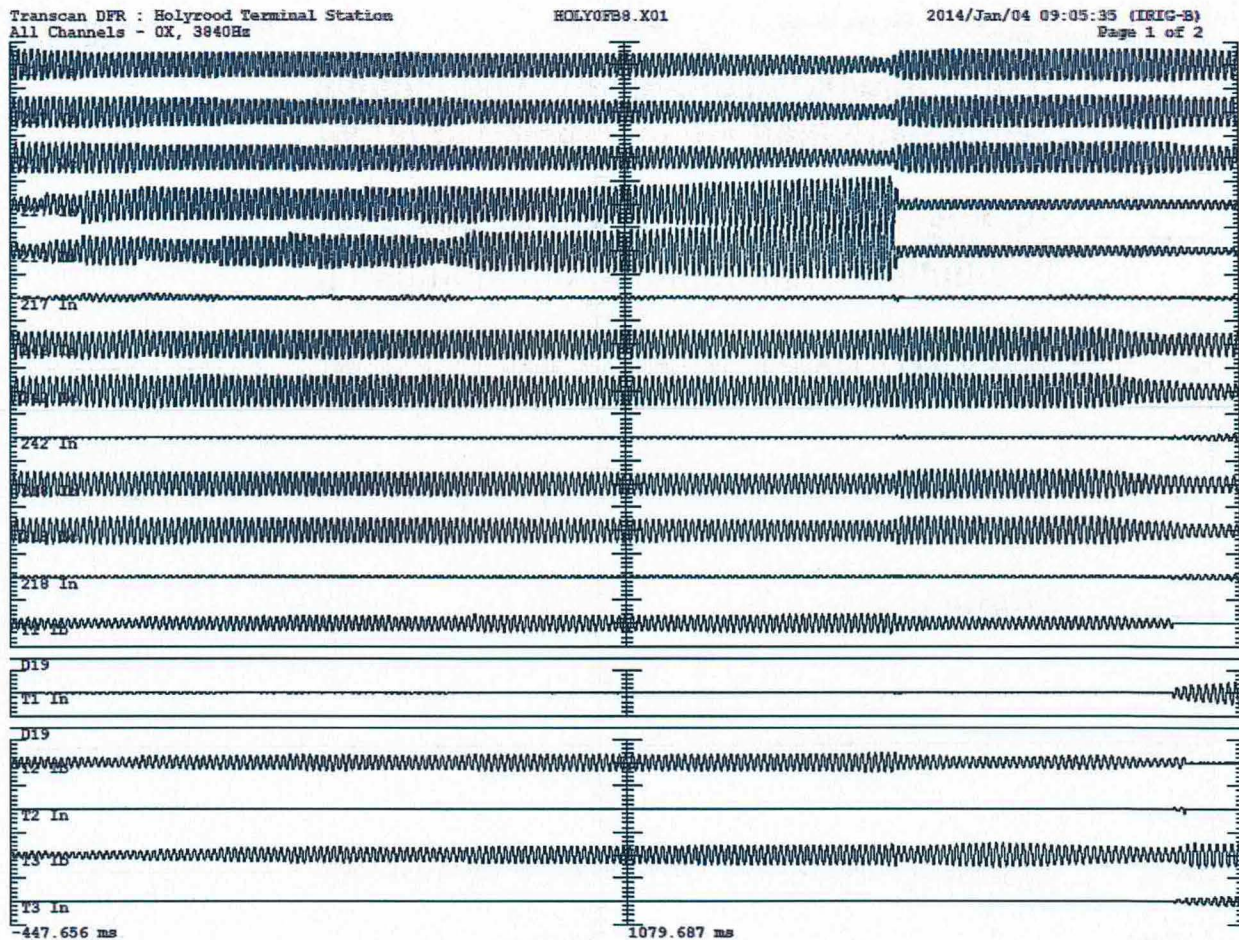
Figure 2: Holyrood Generator #1 Trip at 9:05:37 Jan. 4, 2014

Traces from Holyrood generating station show current in B phase and neutral current for each of the three generating unit transformers (bottom 6 traces). Unit #1 shows neutral current increase when the unit trips off while the current in B phase goes to zero. This is as expected because C phase failed to open. Note that when unit #2 trips off both the B phase current and the neutral current goes to zero; unit #3 trips after trace ends as shown above so there is an increase in the B phase current and the neutral current.

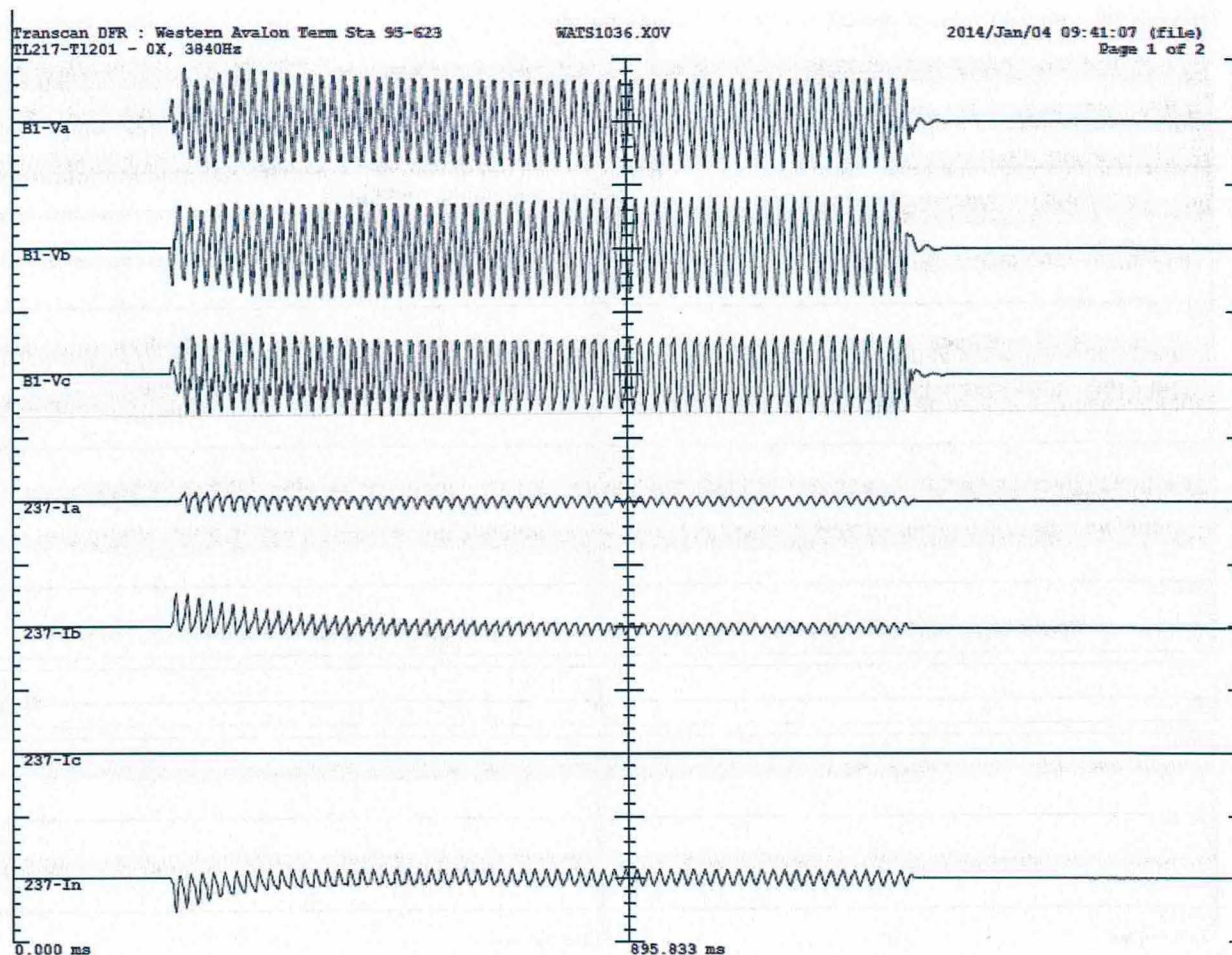
Figure 3: Circuit Breaker B1L37 at Western Avalon closes on two phases only 9:41 Jan. 4, 2014

- c. Breaker B1L37 at Western Avalon closed on only 2 phases and after 1.2 seconds re-opened during Jan 5 – 6 outage events (on 7 occasions). This certainly led to delays in restoration. A number of the close operations occurred prior to the transformer T5 tap changer failure and the closure would have energized the all the 230/138 kV transformers at Western Avalon including transformer T5. It is unclear what if any contribution this would have had on the failure of the transformer. A work permit was issued for Hydro maintenance personnel to investigate B1L37 on Feb. 13th. The breaker operated successfully at that time. Type: Brown Boveri air blast DCVF Built 1968

Traces from Western Avalon for TL237 (bottom 4 traces) show current in 2 phases only plus neutral current when breaker B1L37 is closed. Condition lasts for approximately 1.2 seconds.

1. A thorough review is recommended to assess the acceleration and modification of the existing ACB refurbishment/replacement program, particularly the continued use of these breakers in critical areas on the bulk power system.

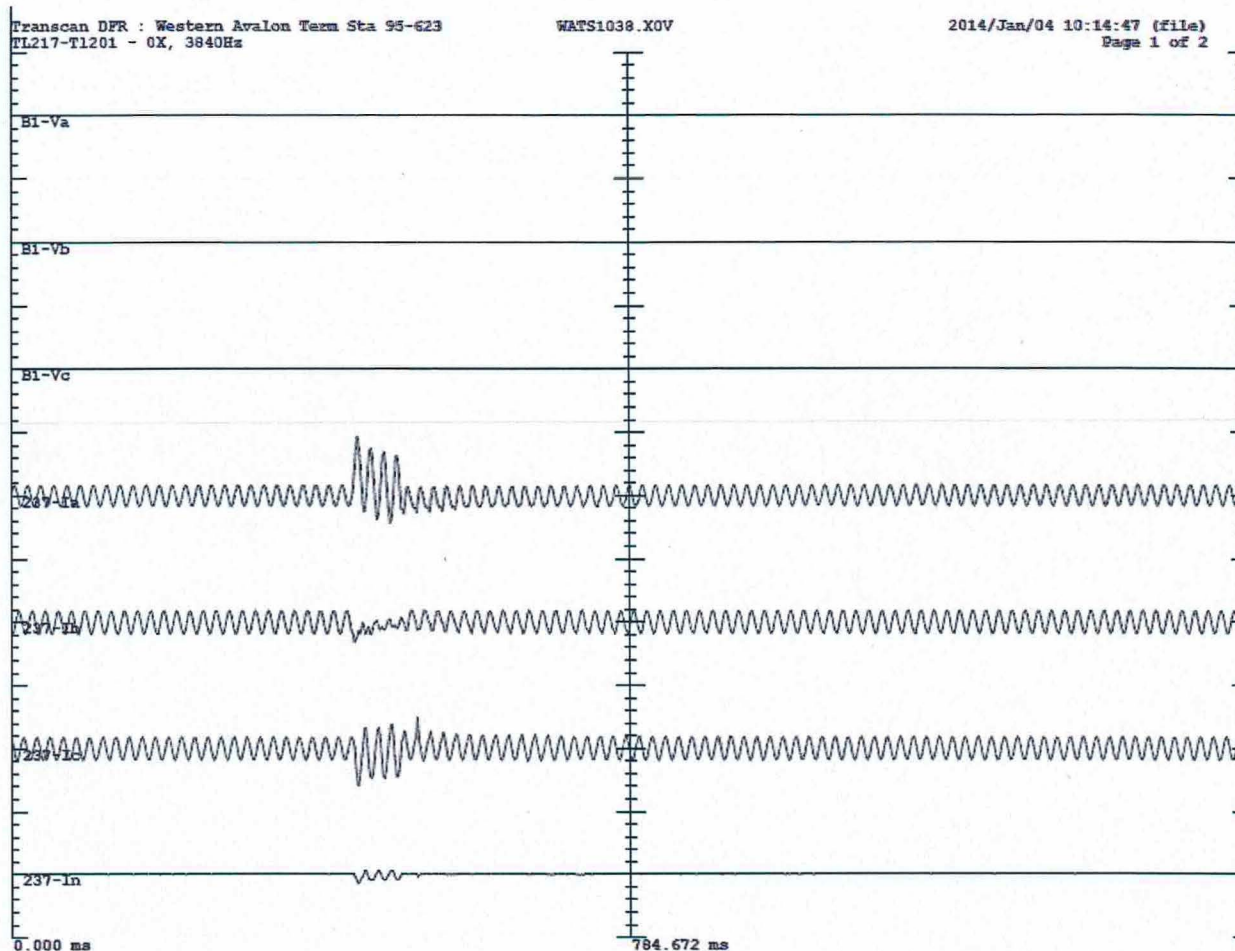
Figure 4: Holyrood generator transformer T1 is energized 10:14:43 Jan. 4, 2014

- b. Breaker B1L17 at Holyrood opened on only 2 phases when unit #1 tripped following the T1 incident. The problem was found and the breaker has subsequently been repaired under the supervision of ABB. This breaker is scheduled to be replaced as part of the program to upgrade breakers to meet fault level/interrupting capacity requirements. Type: Brown Boveri air blast DLF Built 1973

This trace from Western Avalon shows a disturbance that lasts for about 4 cycles when the generating unit #1 transformer at Holyrood is energized because one phase of the breaker B1L37 at Holyrood is still closed.
