## NEWFOUNDLAND AND LABRADOR HYDRO

*Protection Systems Impacts on 4 January 2014 Supply Disruptions*

– External Protection Review

22 March, 2014

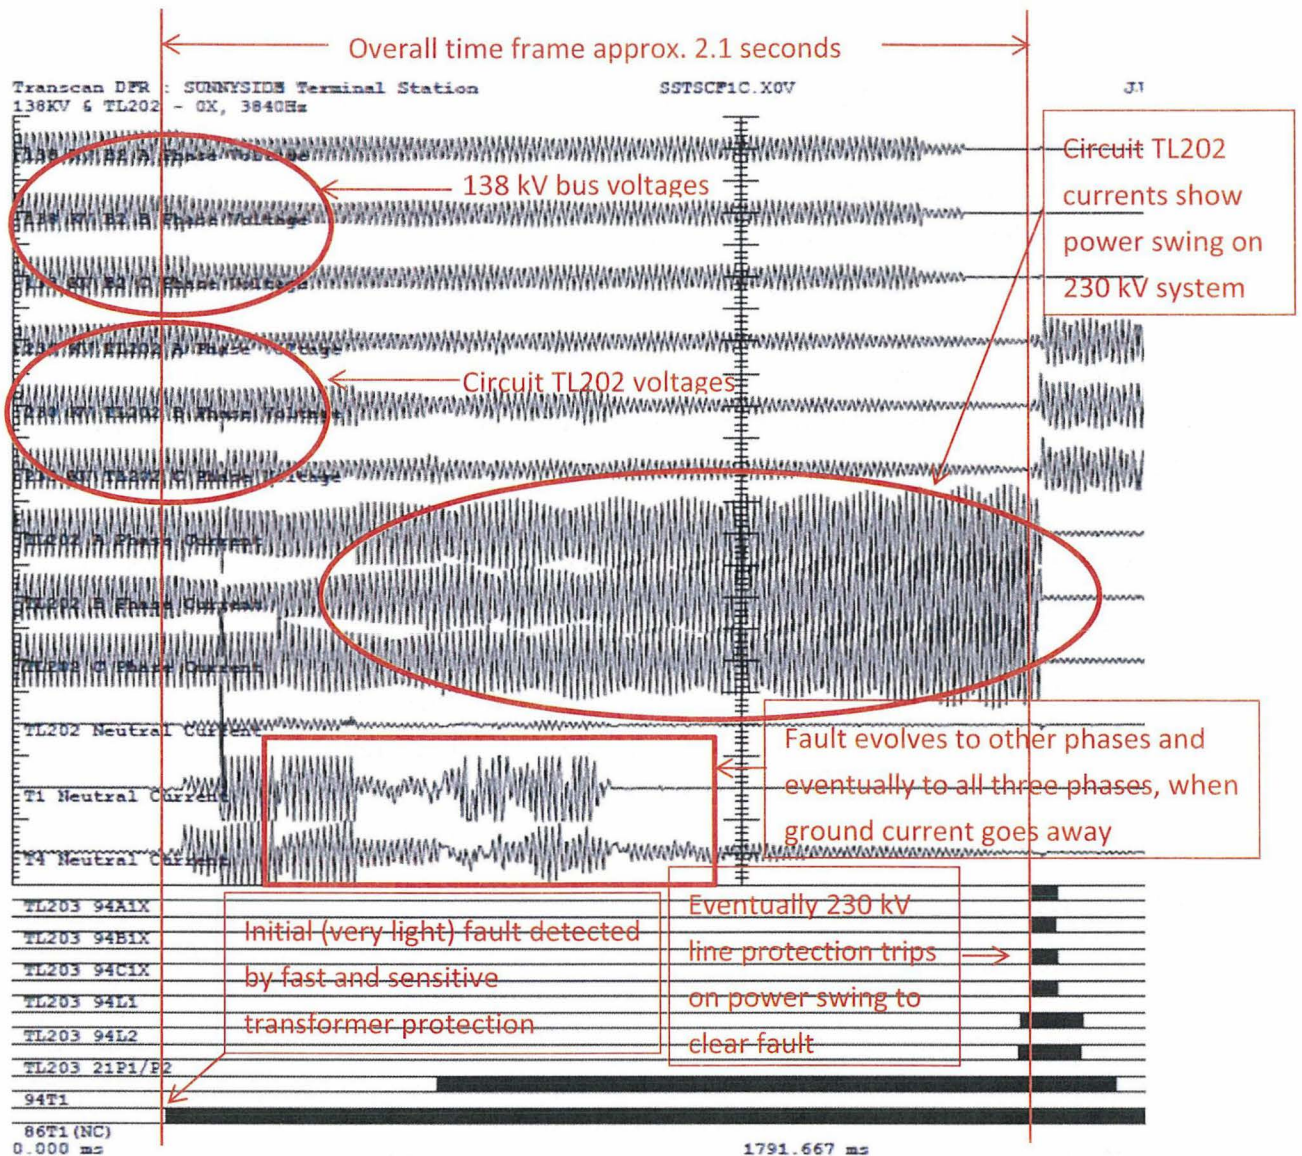
**Figure A1-1 Initial (9:05) Sunnyside fault – Digital Fault Recorder Record of Currents, Voltages and Events at Sunnyside Terminal Station**

A short circuit occurred at 09:05:34.600 inside transformer T1 at Sunnyside. The T1 transformer shares a tripping zone with similar transformer T4; so both transformers needed to be tripped off line by the same circuit breakers. The T1 protection correctly and promptly identified the fault and issued lockout trip signal by 86T1 as shown in Figure 1. Four of the five circuit breakers that needed to open did so promptly. However, 230 kV breaker B1L03 failed to open; so the fault was supplied for an additional extended time. See Figure A1-2 for location of the failed breaker.

The fifth breaker, B1L03 failed to open. Since clearing was delayed, the T1 fault arc evolved to other phases and eventually created a sustained three phase short circuit that caused the transformer tank to expel oil that caught fire. The extended duration of the short circuit resulted in a power swing that caused TL203 and TL237 to trip in an expected fashion. Tripping of TL203 and TL237 isolated the Avalon Peninsula from the major source of power supply and resulted in a system collapse and blackout.

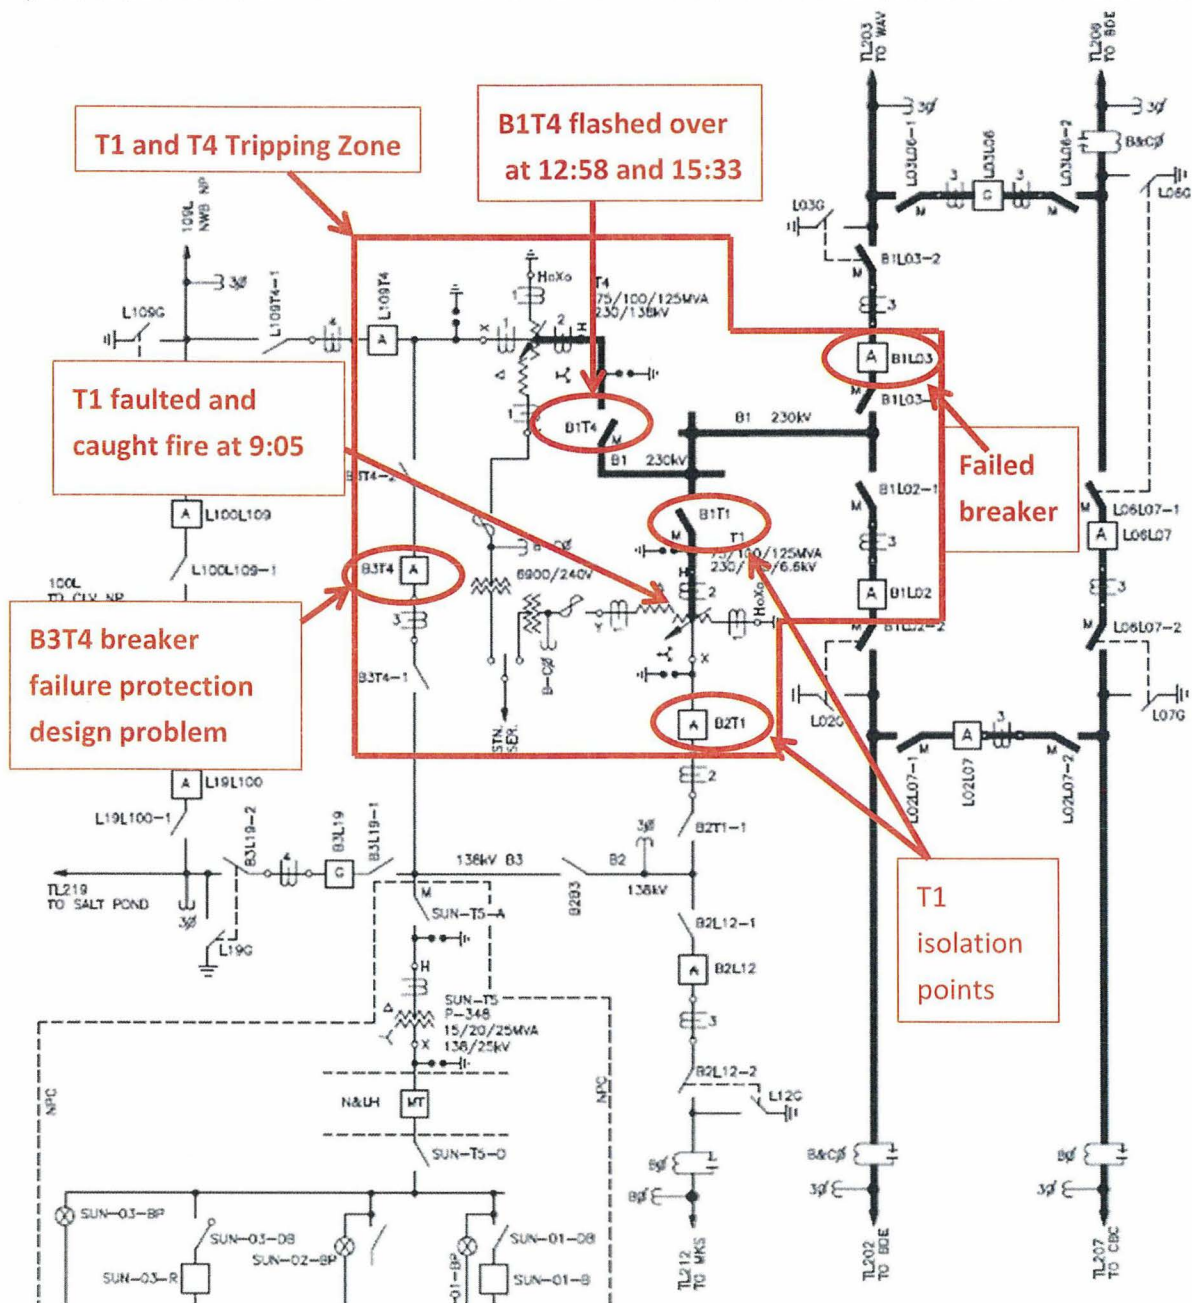
**Figure A1-2 Single Line Diagram of Sunnyside Substation**

T1 and T4 lockout relays are designed to trip all 5 breakers in the tripping zone shown in Figure A1-2, and maintain that tripping signal to the 230 kV breakers until after the faulted transformer has been isolated by its HV disconnect switch. Tripping of 138 kV breakers on the unfaulted transformer is also blocked if the faulted transformer has been isolated by its HV disconnect switch. However, the lockout relays initiate breaker failure protection **only** for 138 kV breakers in the tripping zone, not 230 kV breakers. The reason for not initiating breaker failure protections for the 230 kV breakers is not known, but is a key causal factor in the spread of the impact of the T1 fault beyond Sunnyside Terminal Station. The reason for initiating breaker failure protection through a different logic than initiating tripping is not clear. Newfoundland and Labrador Hydro do not have written guidelines as to the application or

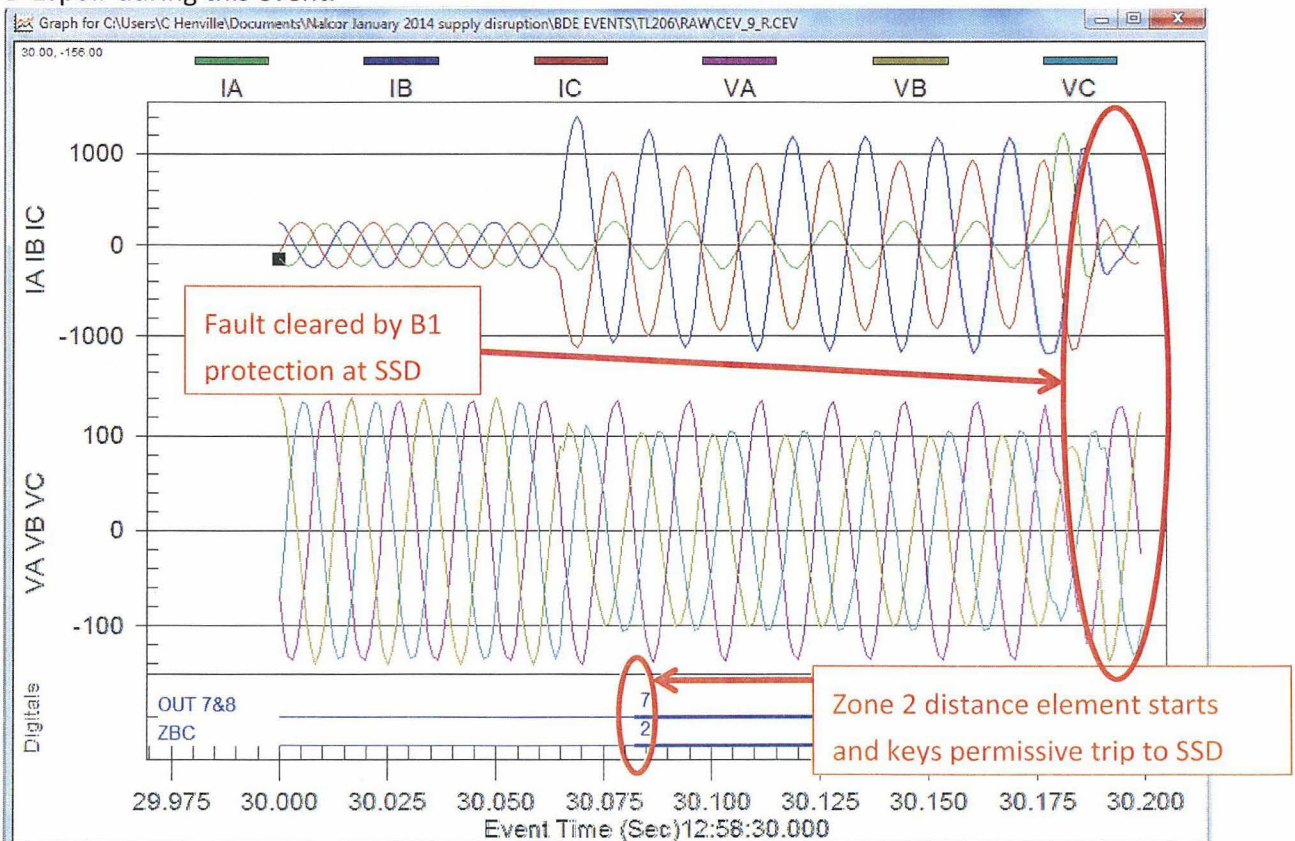
**Figure A1-3 Voltages and currents at the BDE terminal of TL206 during the 12:58 event. This is the second fault at Sunnyside on 4<sup>th</sup> January**

At 12:58 after T1 had been electrically isolated, an attempt was made to re-energize the 138 kV side of the station. The 230 kV side was re-energized without incident at 12:56:55.000. Station service was successfully restored at that time. Immediately after 138 kV breaker B3T4 was closed at 12:58:23.928, T4 isolation switch B1T4 started to open, and within a few seconds, Sunnyside 230 kV Bus 1 was tripped by the bus differential protection. It was noticed that the CT secondary wiring on the T1 HV bushing would have been damaged by the fire; so it was disconnected by emergency field modifications. However, analysis during the later investigations showed that it was the opening of disconnect switch B1T4 (see Figure A1-2) under load that caused a fault. Since it is not designed to open under load, an arc was drawn that (approximately five seconds after the switch started to open), flashed over between B and C phases. Figure A1-3 shows the voltages and currents measured at the TL206 terminal at Bay D'Espoir during this event.

The increase in currents and depression in voltages on phases B and C can be seen. Also, the

start of the phase BC zone 2 distance element can also be seen. These confirm the presence of a phase B to phase C short circuit at SSD B1 at this time.

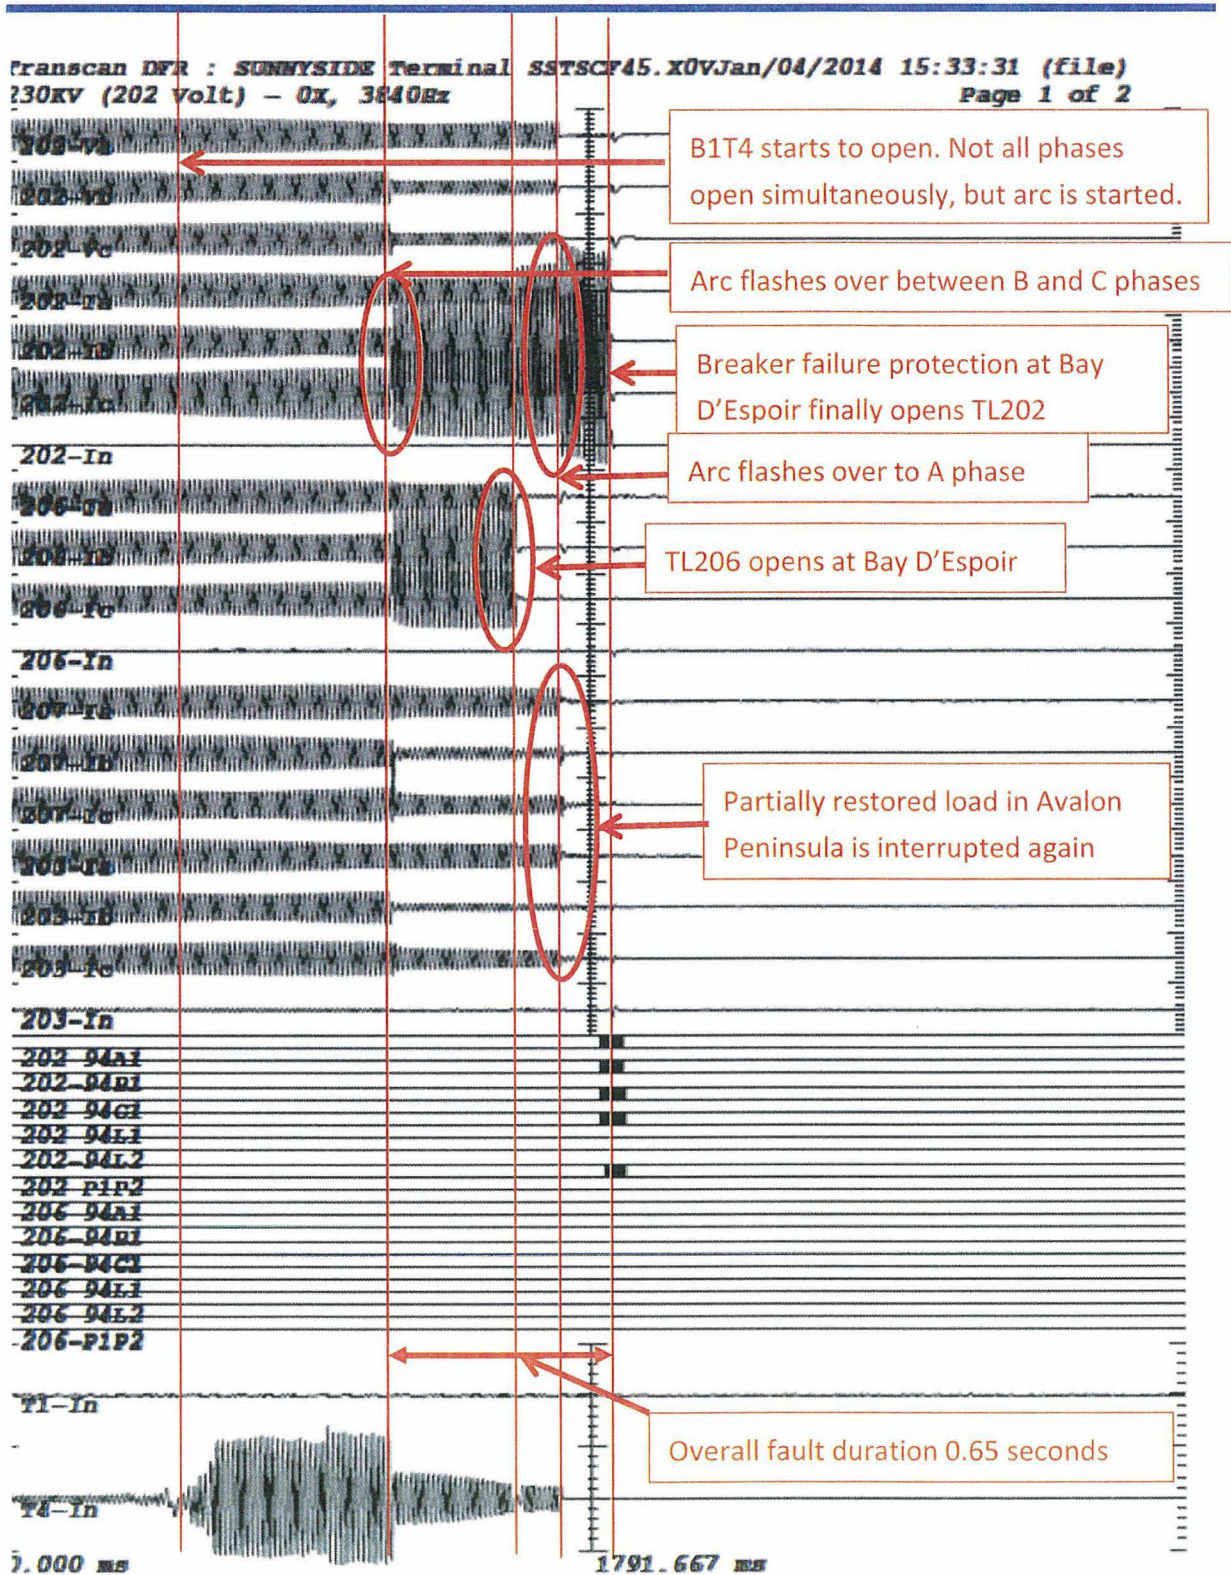
FigureA1-4 Third (15:33) Sunnyside fault – Digital Fault Recorder Record of Currents, Voltages and Events at Sunnyside Terminal Station

At 15:33 on 4<sup>th</sup> January, a second attempt was made to re-energize the 138 kV bus at Sunnyside by closing breaker B3T4 to load T4. In this case the B1 bus protection did not operate, but similar to the 12:58 event, the T4 230 kV isolation disconnect switch B1T4 opened automatically under load. In this case the initial phase to phase fault evolved into a three phase fault. See Figure A1-4 for oscillographic capture of currents and voltages during this incident. The Sunnyside B1 bus protection which should have operated to clear this fault did not do so, and the fault was sustained for approximately 0.6 seconds. See Figure A1-5 for recorded currents and voltages at the Bay D’Espoir terminal of TL206 at the start of this fault.

Remote protection at the TL202 and TL206 terminals at Bay D’Espoir attempted to clear the fault by zone 2 delayed tripping after 0.3 seconds, but breakers at the TL202 terminal were slow to open and an additional delay was incurred until the breaker failure protection for both breakers timed out. The breaker failure protection eventually opened the two slow breakers plus additional breakers at Bay D’Espoir to shed additional generation and trip TL204. Tripping of TL202 and TL206 removed all remaining 230 kV supply to the Avalon Peninsula including St. John’s load that had already been restored after the 9:05 incident and Come By Chance refinery.

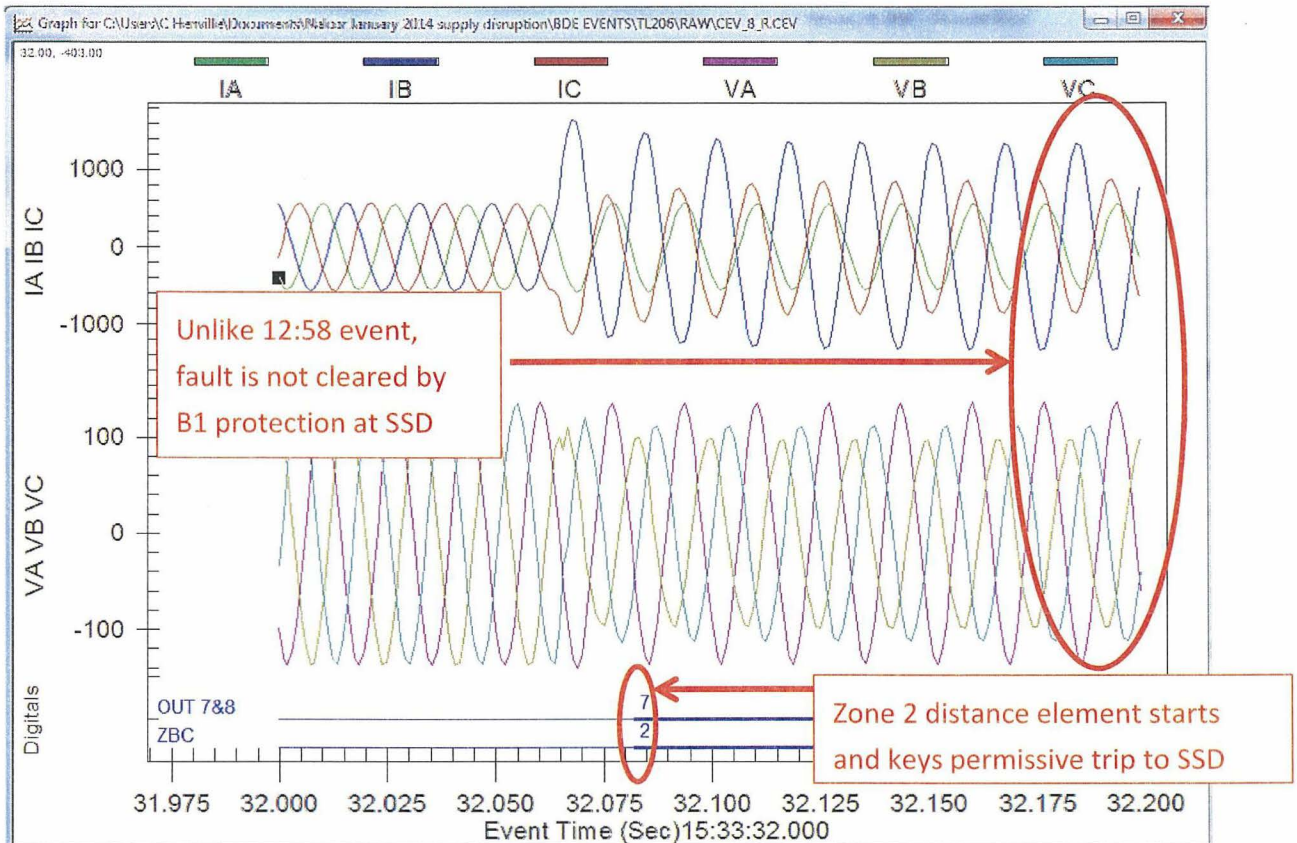
**Figure A1-5 Third (15:33) Sunnyside fault – Digital Fault Recorder Record of Currents, and voltages at Bay D'Espoir Terminal of TL206**

TL206 tripped approximately 0.3 seconds after fault initiation (as expected for the zone 2 time delay). TL202 tripped approximately 0.35 seconds after TL206 due to the additional delay resulting from slow tripping, of both of its breakers, and waiting for breaker failure protection.

Adjust the time delay on the Bay D’Espoir TL202 and TL206 zone 2 elements from 0.3 seconds to 0.6 seconds. Note that previous implementation of this recommendation would not have affected the 4<sup>th</sup> January disturbances, but could be important to reduce the probability of future major disturbances. This adjustment has been implemented.
