NEWFOUNDLAND AND LABRADOR HYDRO

Emergency Response and Restoration

March 2014

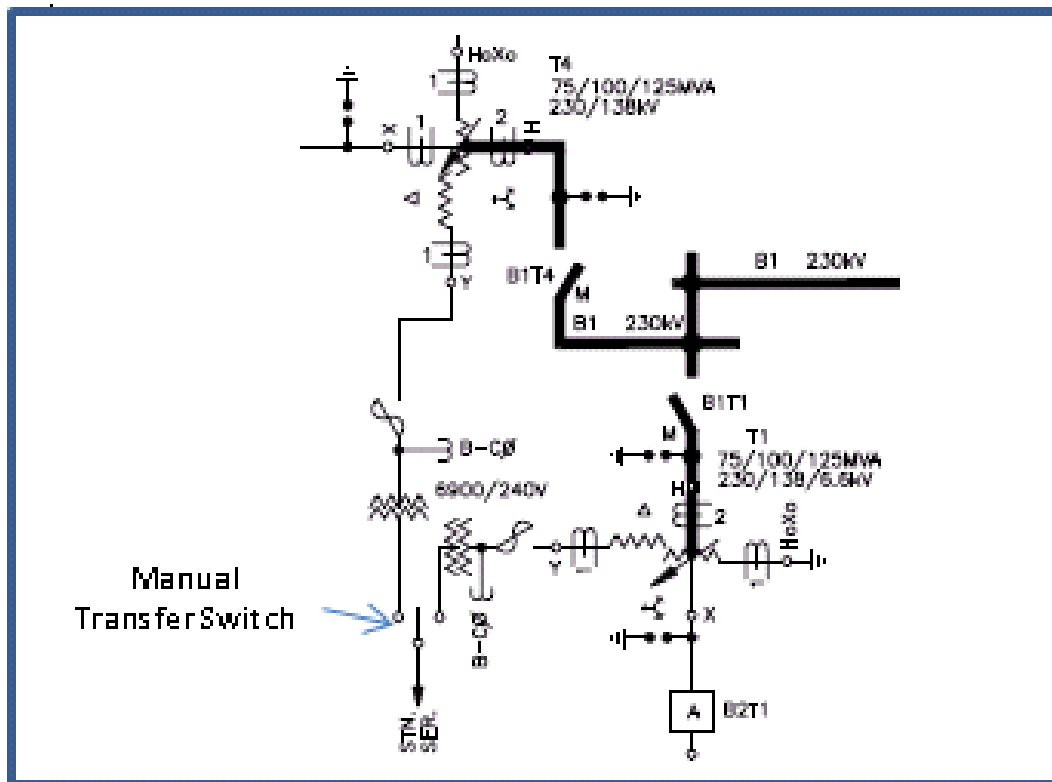
Figure 1: Sunnyside Station Service Supply Arrangement

19 With the failure of SSD T1, the station service supply to the station controls was interrupted.
20 The restoration of station service was very important to maintain air supply to air blast circuit
21 breakers. Air blast circuit breakers use compressed air to actuate head mechanisms and
22 extinguish arc in order to interrupt electrical circuits when required. Therefore, the crew
23 established a priority to connect station service through an alternate feed.

24
25 It was decided to switch the station service to SSD T4 manually (no automatic transfer switch
26 system) to gain station service supply when SSD T4 was energized. To maintain redundancy, it
27 was decided that a second alternate supply would also be acquired through the means of a
28 portable generator in the event that station service could not be achieved through SSD T4. A
29 portable generator was rented and arranged to be shipped to SSD TS as soon as possible.

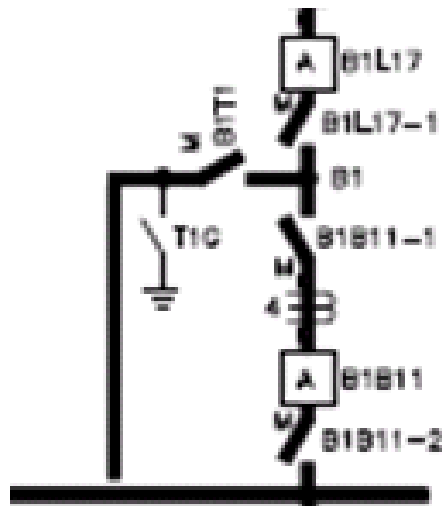
Figure 2 - Holyrood Unit 1 230 kV Connection Arrangement

While closing the Unit 1 disconnect switch B1T1, at 21:27, there was a protection operation resulting in multiple breaker operations in the Holyrood TS thus causing all units at Holyrood to trip offline. This resulted in a loss of service to many customers on the Avalon Peninsula. The process for restoration of essential plant services commenced with the normal start up of the two emergency diesel generators, supplemented by Newfoundland Power's mobile gas turbine.

A very bright flash of light from the Holyrood TS was reported by staff at the Holyrood plant at the time of the disconnect switch operation. It was immediately identified that the cause of the outage was located in the Holyrood TS and required terminal station maintenance staff to respond. TRO crews were dispatched to both the Holyrood and the Western Avalon terminal stations. In addition, TRO technical support and operations staff mobilized to the Bishop's Falls office to help manage and provide technical assistance for the restoration of the station. System operations engineers were also notified and requested to start analyzing data to determine the source of the problem.
