BOARD OF COMMISSIONERS OF PUBLIC UTILITIES

**IN THE MATTER OF AN
INVESTIGATION AND HEARING
INTO
SUPPLY ISSUES AND POWER OUTAGES ON THE
ISLAND INTERCONNECTED SYSTEM**

INTERIM REPORT

MAY 15, 2014

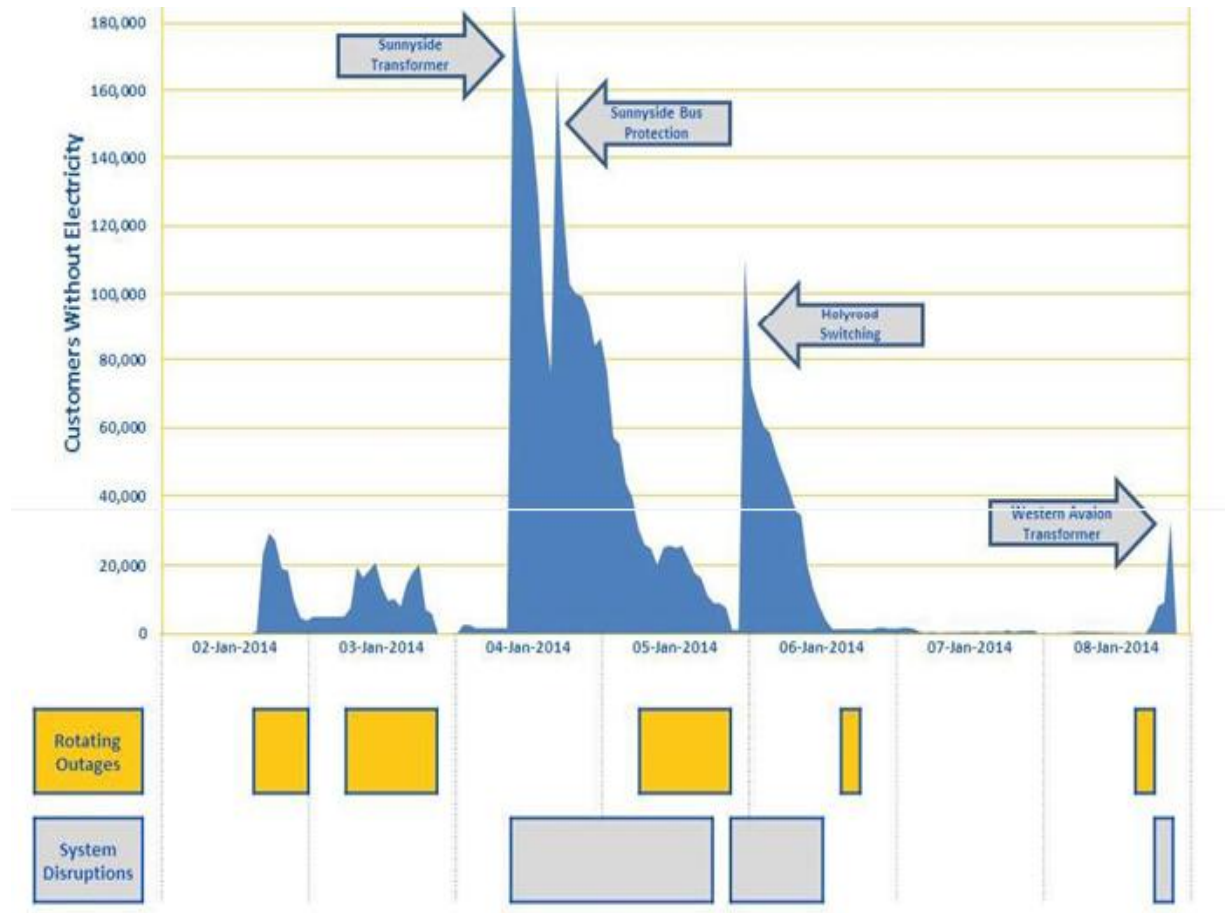
1 The timing and impact of these outages on Newfoundland Power's customers is set out in the
 2 following figure:⁷

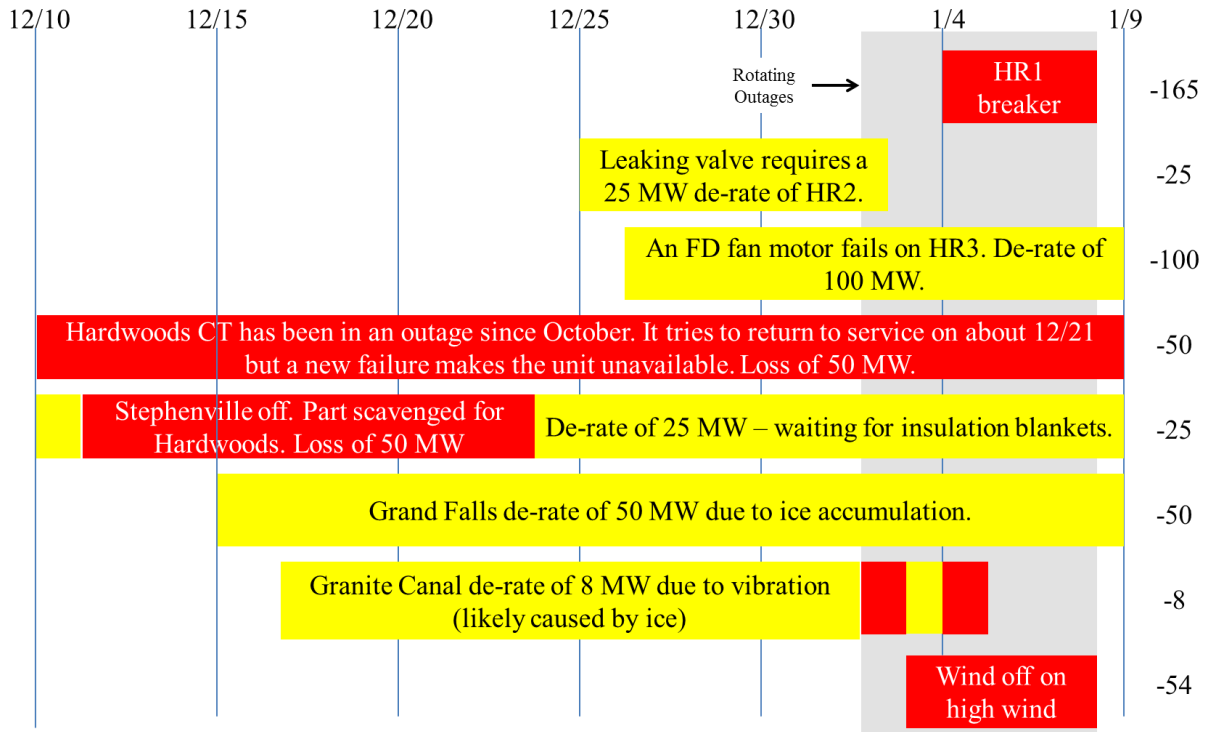
5 The December 2013 generation availability is shown below:¹⁸

Note 1: 60 MW interruptible contributed by Corner Brook P&P starting 12/31
 Note 2: Grand Falls was operating 25 MW above expectations before the 50 MW reduction
