**NALCOR Holyrood GS**

**Outage Reports 2012**

# Turbine Generator Summary Report - 2012 Newfoundland & Labrador Hydro - Holyrood TGS

Reference # Nalcor-Holyrood –STG- ESO-000326/399-01

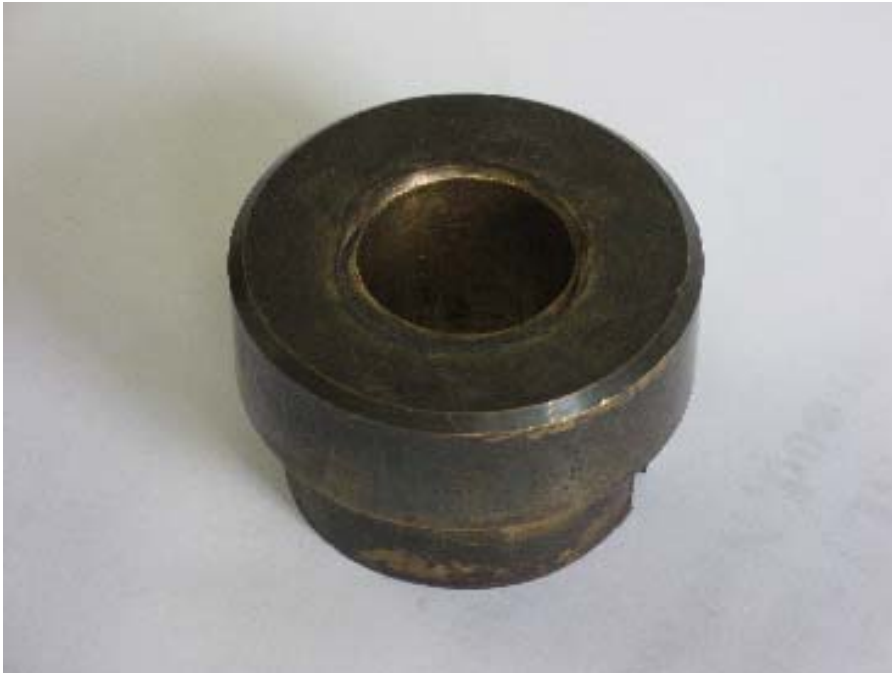
The speed relay was removed. The cylinder was scratched inside and also had a 0.001” taper. It was honed to remove the taper and the scratching. The piston was scored and the shaft bushing was excessively worn. These parts were replaced with new parts that were ordered oversized and machined locally to match the new cylinder diameter.

Figure 10.1 Shaft Bushing Worn

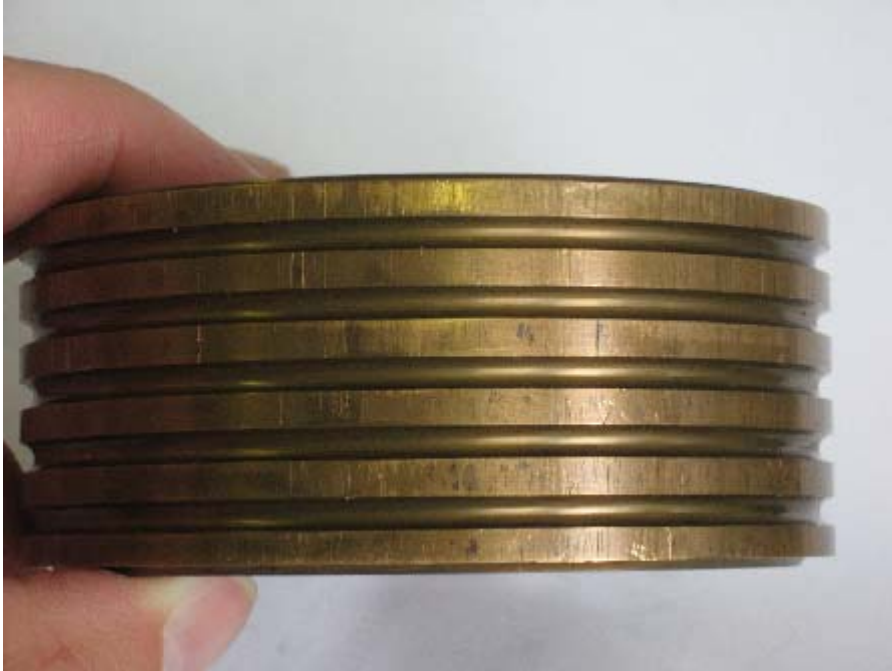
Figure 10.2 Scoring and wear of piston

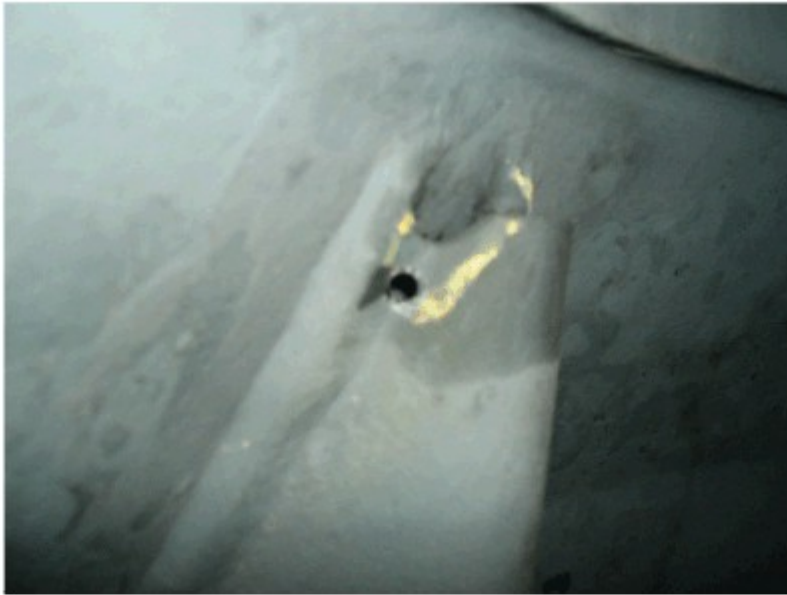
**Crack Indications MSV Anti Swirl Vane**

**Left side at the top of the vane**

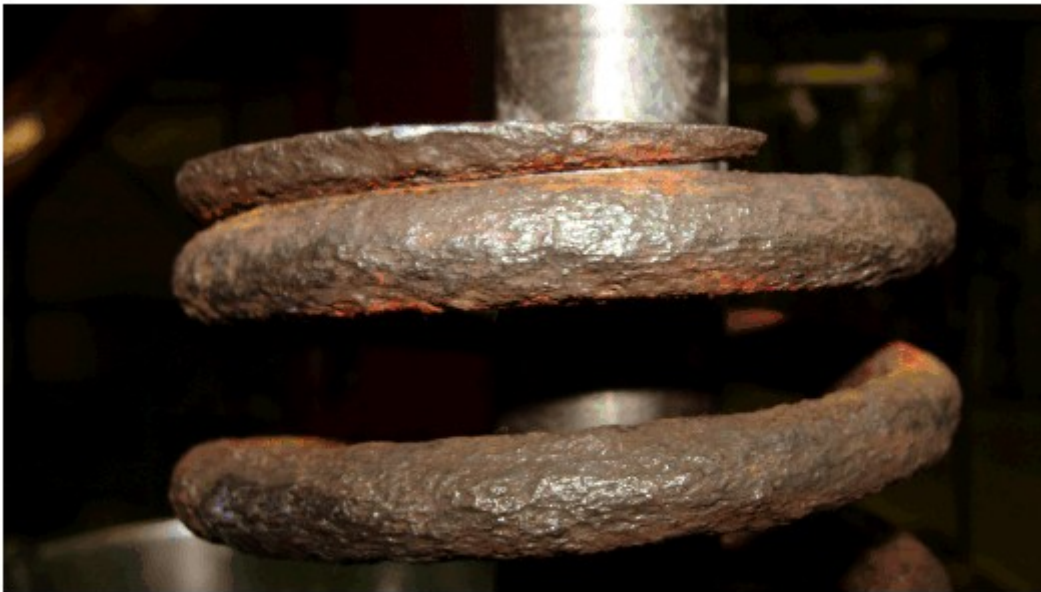
Typical rust conditions of springs in the NRV air operated actuators

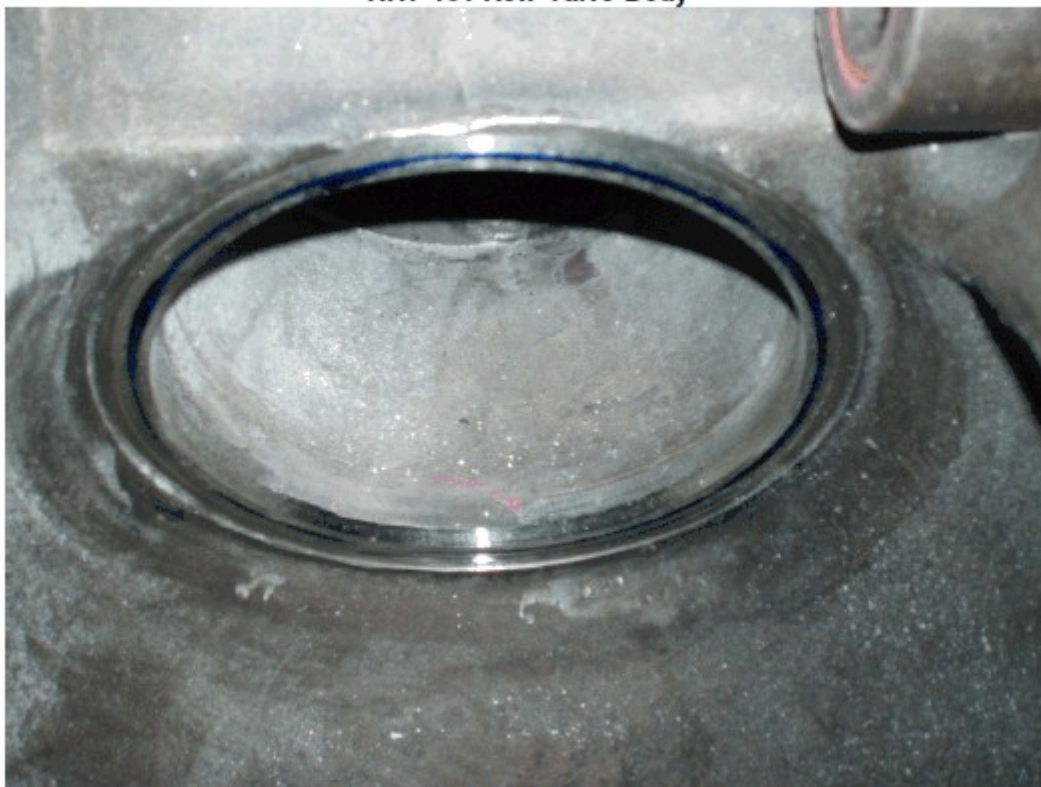
**NRV 101 New Valve Body**

1. NRV 101 valve body was found to be cracked and was replaced with a new valve body that had been originally ordered for Unit 2. Two Pipefitter welders were hired to complete this job under permit applied for and issued by the Provincial Jurisdiction. The boiler inspector, Mr. Travis Rideout, completed the inspection and accepted the work.

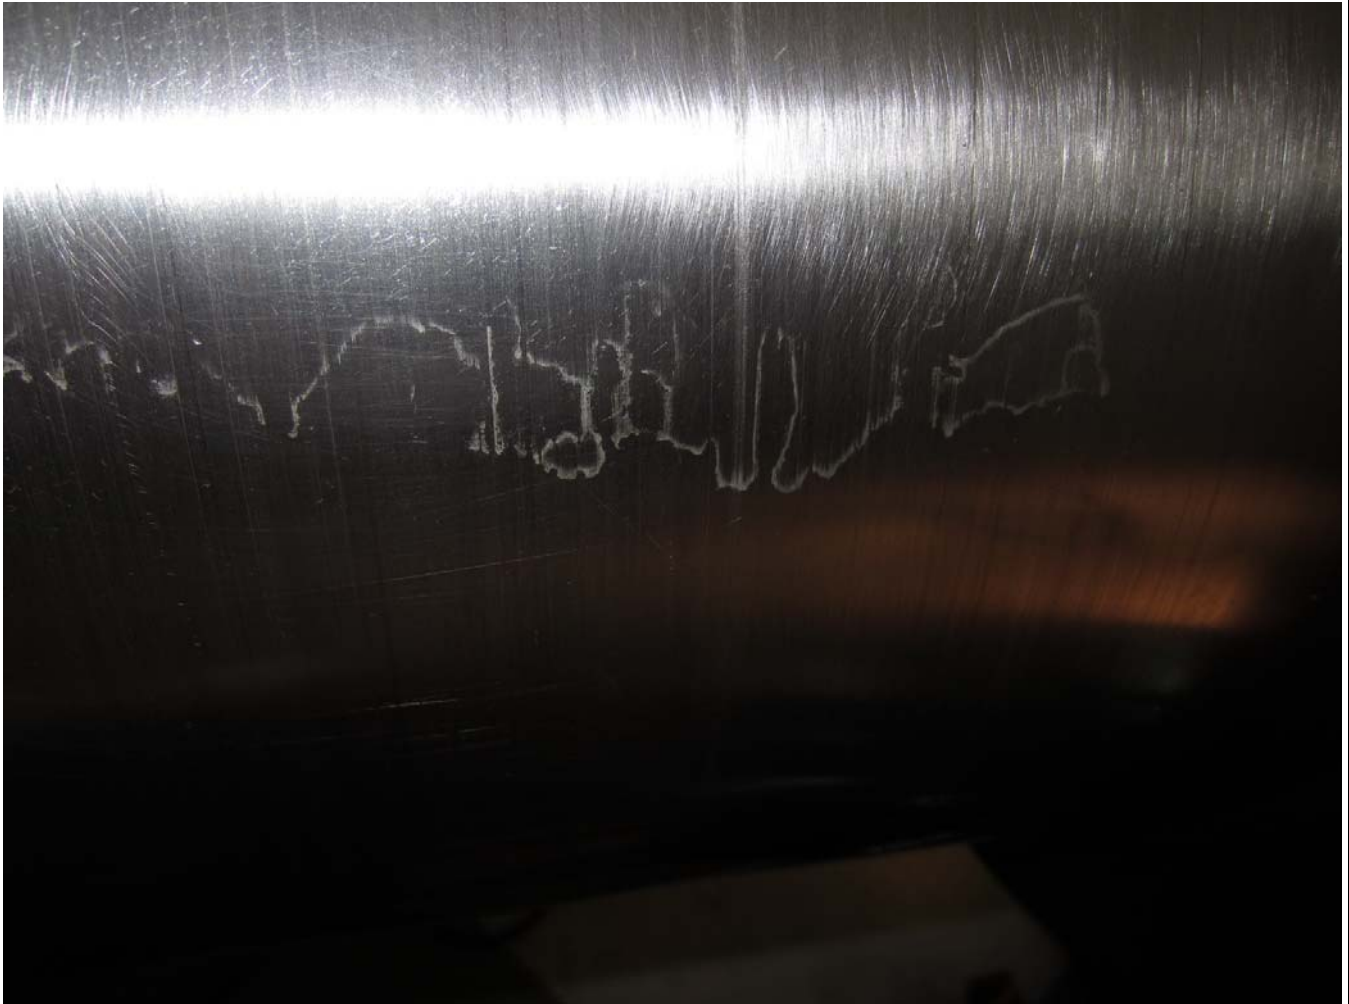
### Electrolysis on journal

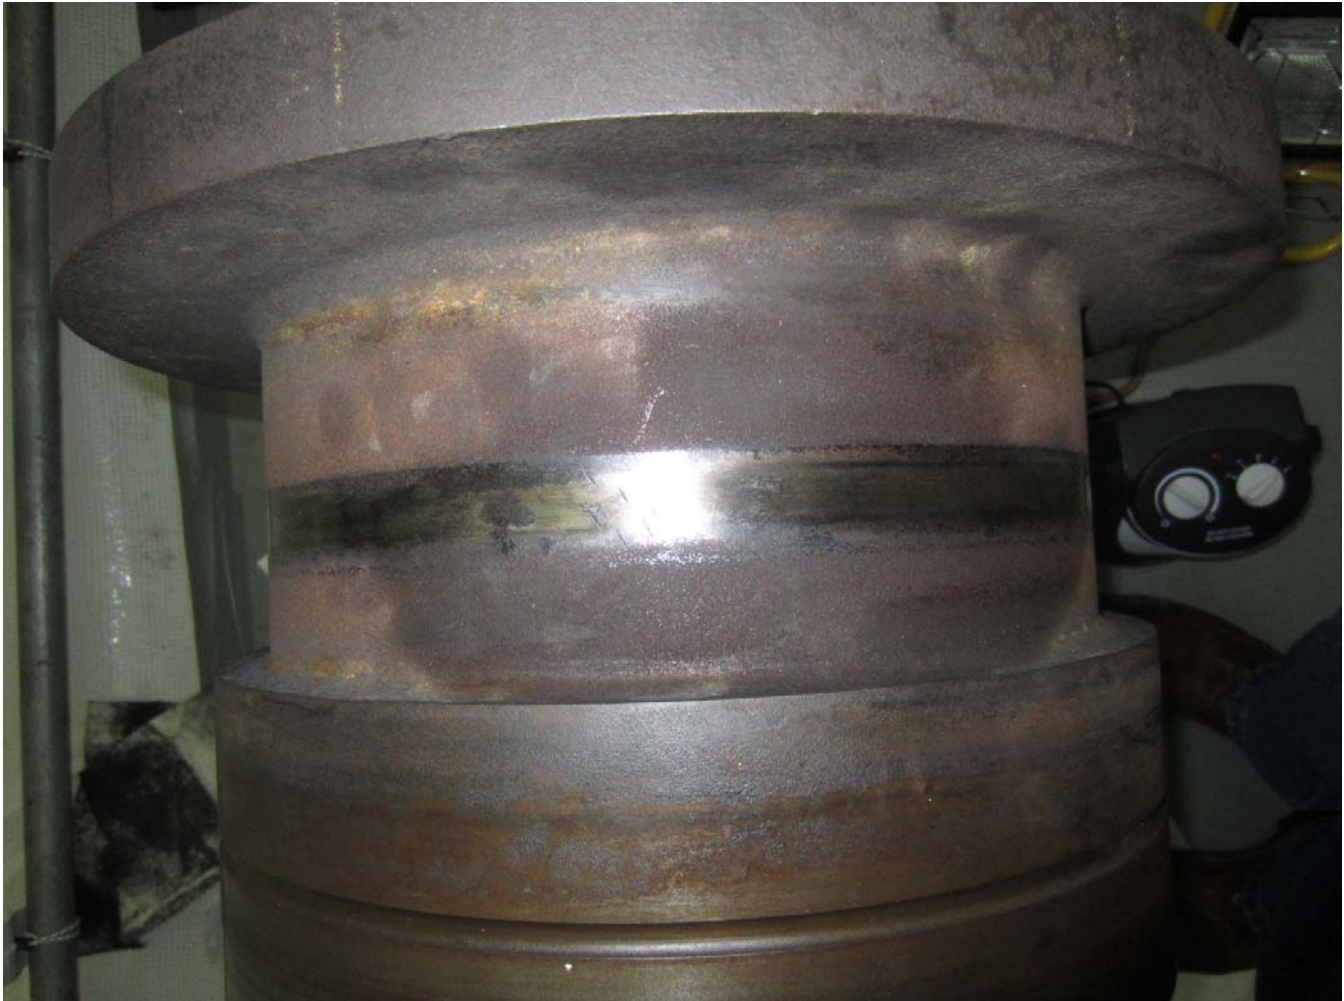
**Oxidation on generator rotor**

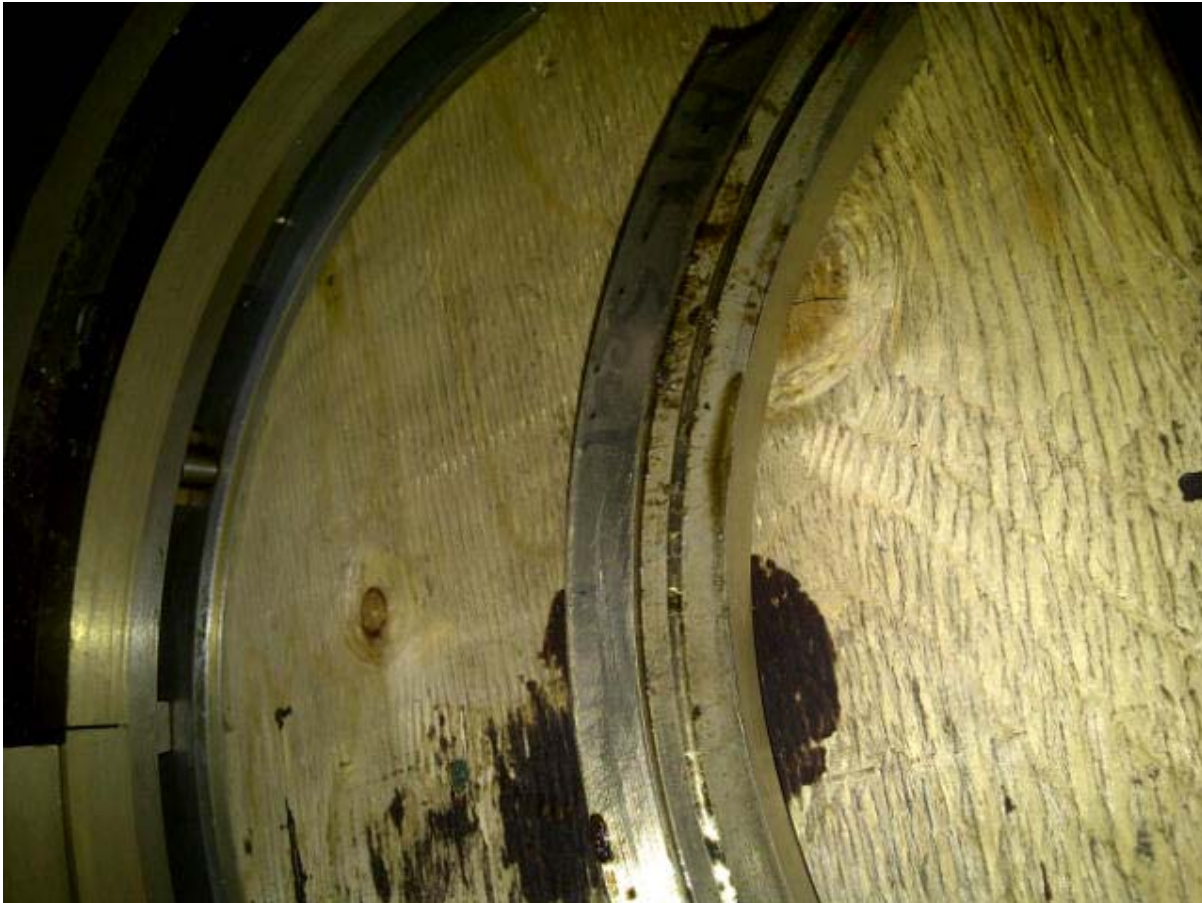
Dirt and sludge in hydrogen seal casings and on rings

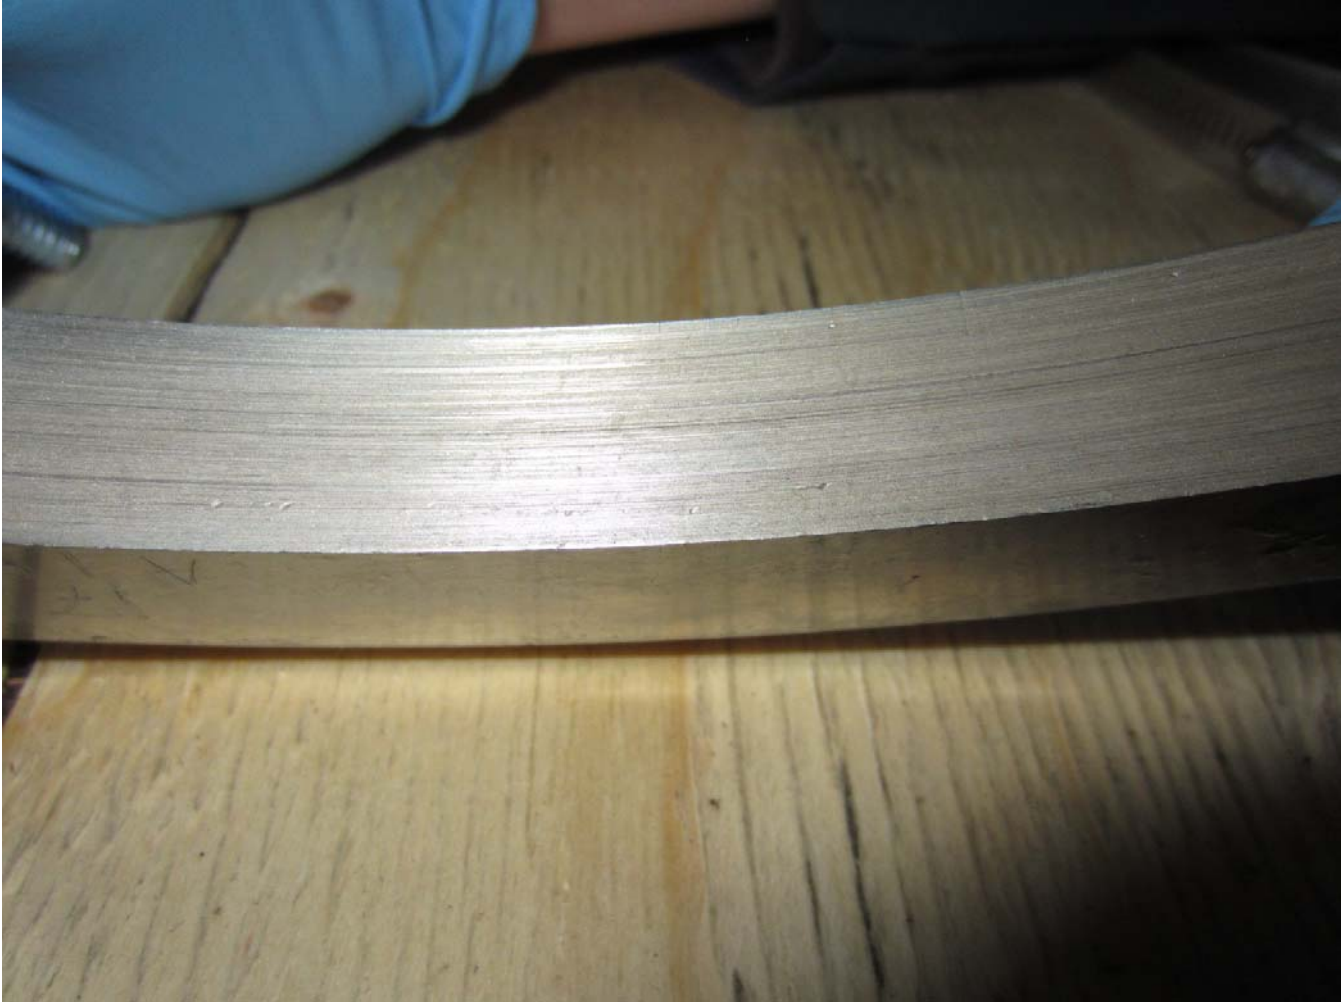
### Scoring on hydrogen seal ring

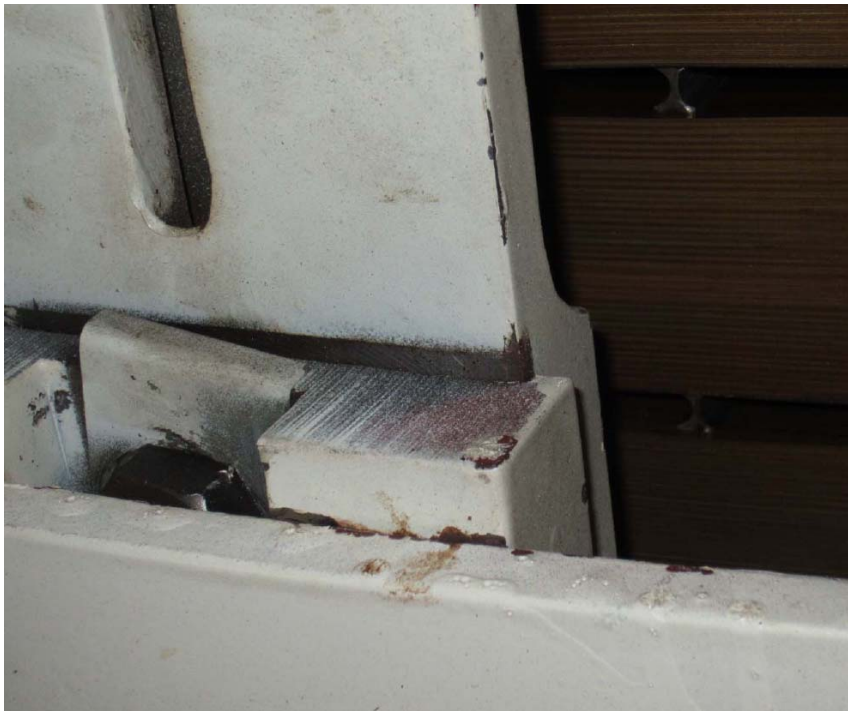
The front belly band of the stator was found with some greasing and signs of movement. Signs of movement as shown:

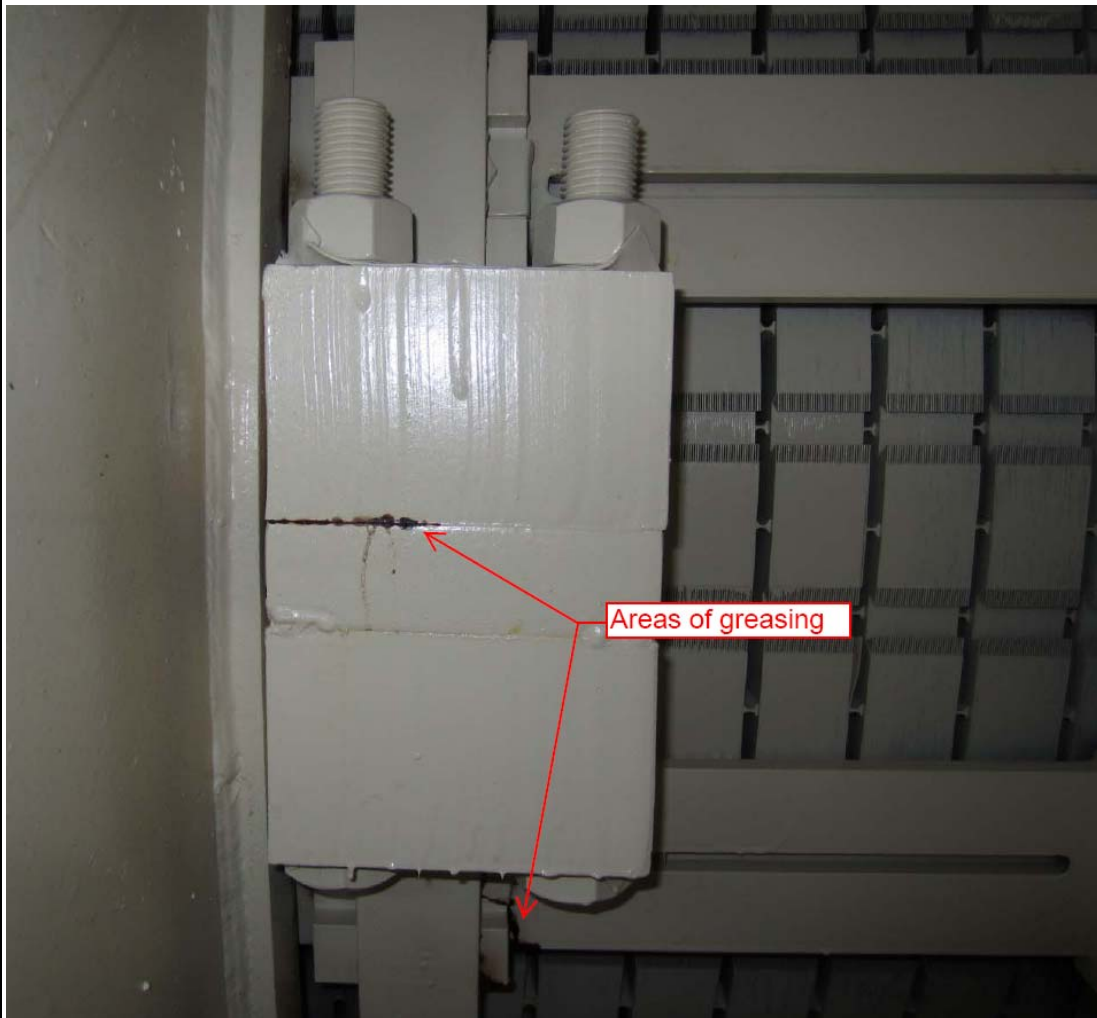
Greasing on the belly band as shown:

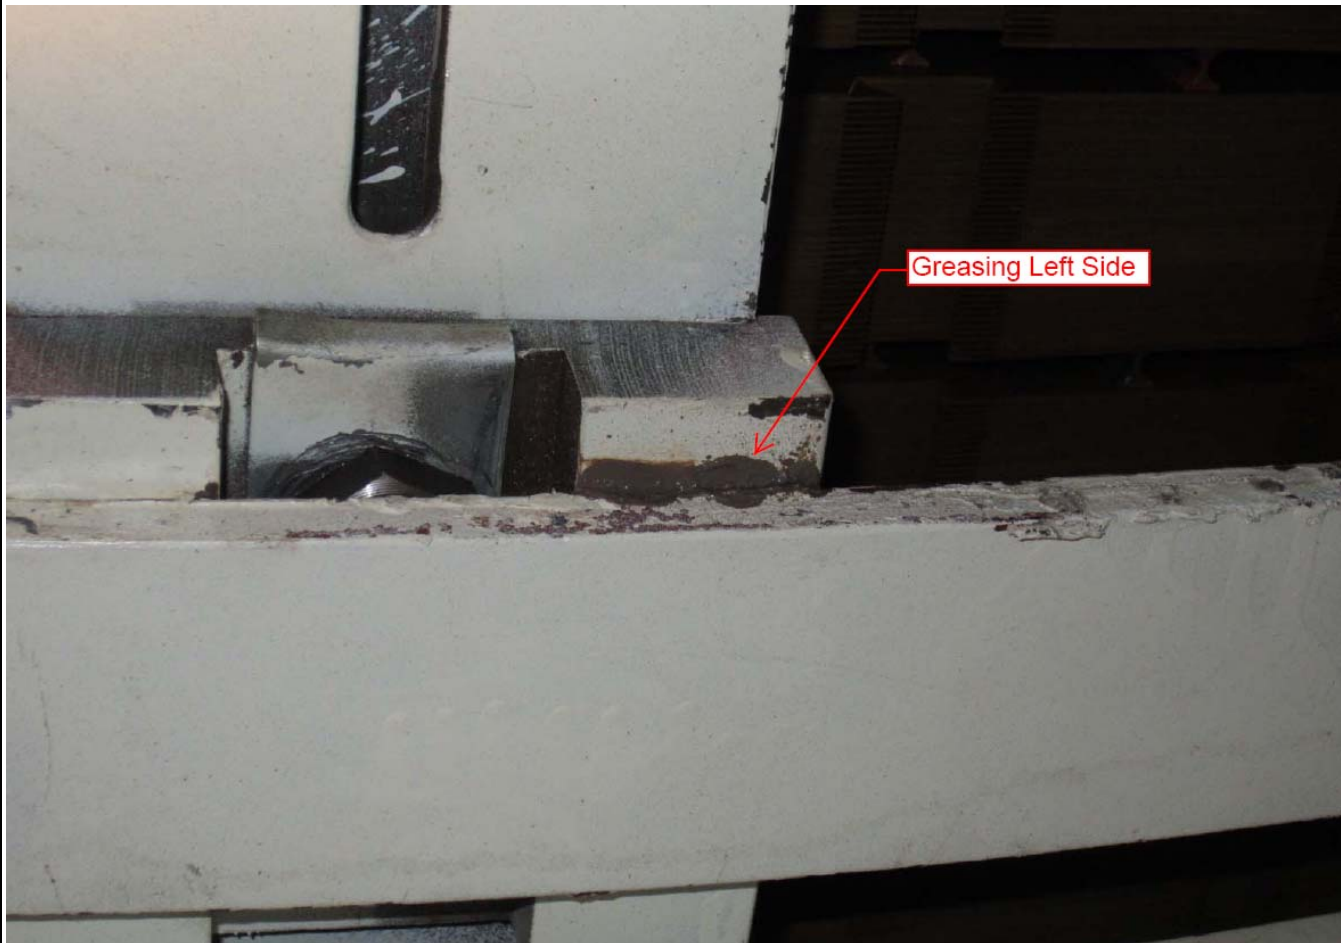
Further greasing on the left side:

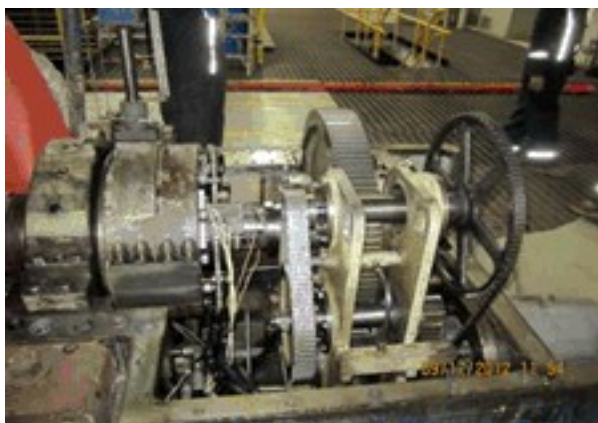
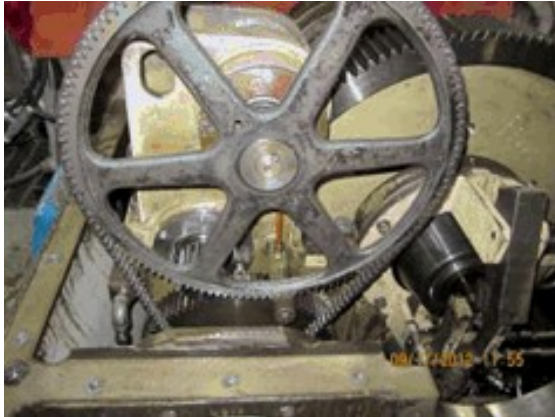
The Turning gear pinion was found loose and could have come adrift.(Photo to Right)

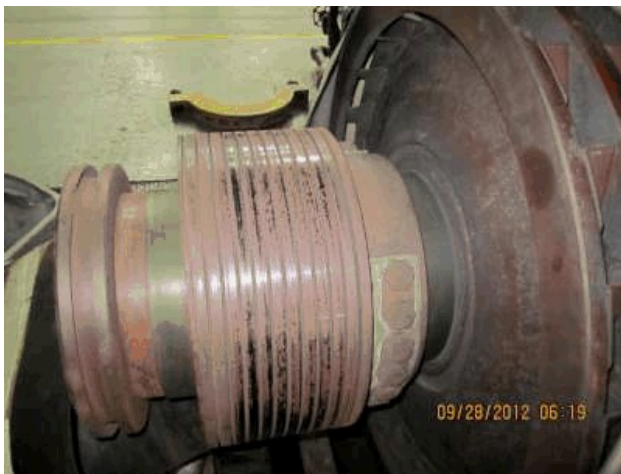
The slip rings were found with a heavy oxidized surface.

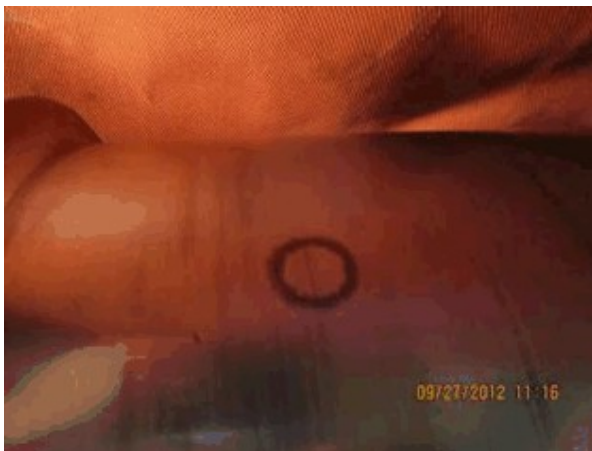
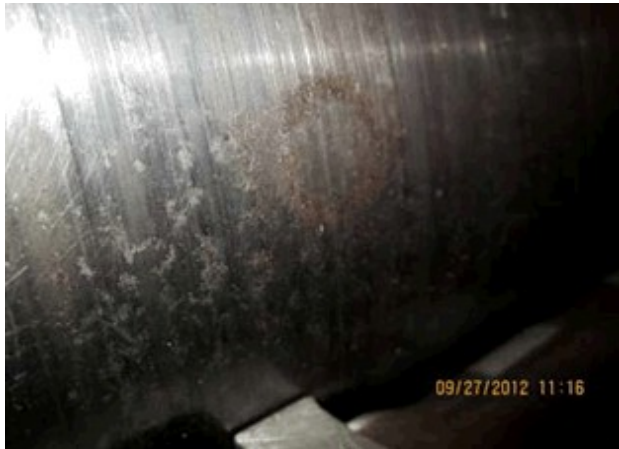
During the bearing and keep removal there were several circular marks on the journal and heavy frosting in the bearing from arcing. The circular arcing may have come from welding in the past.

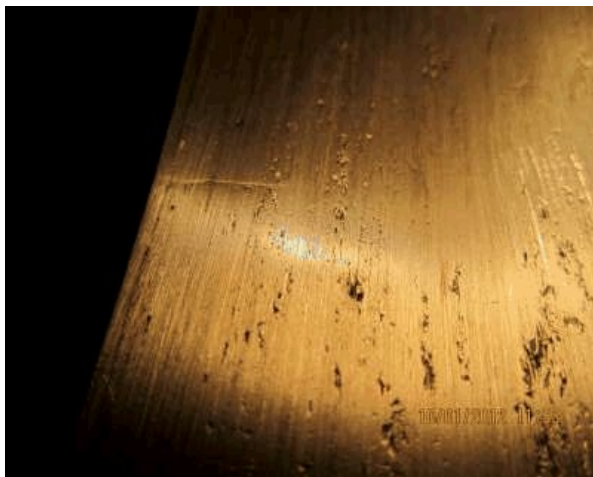
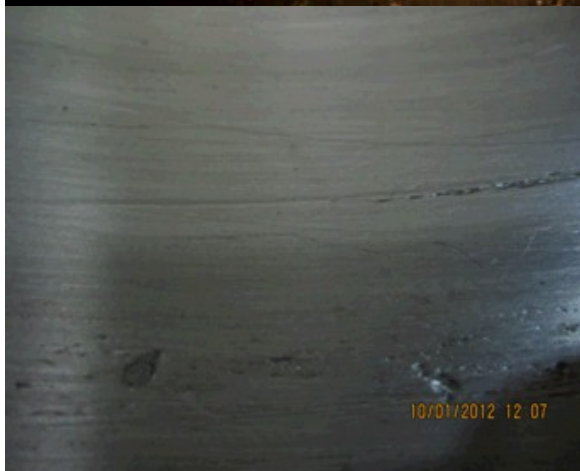
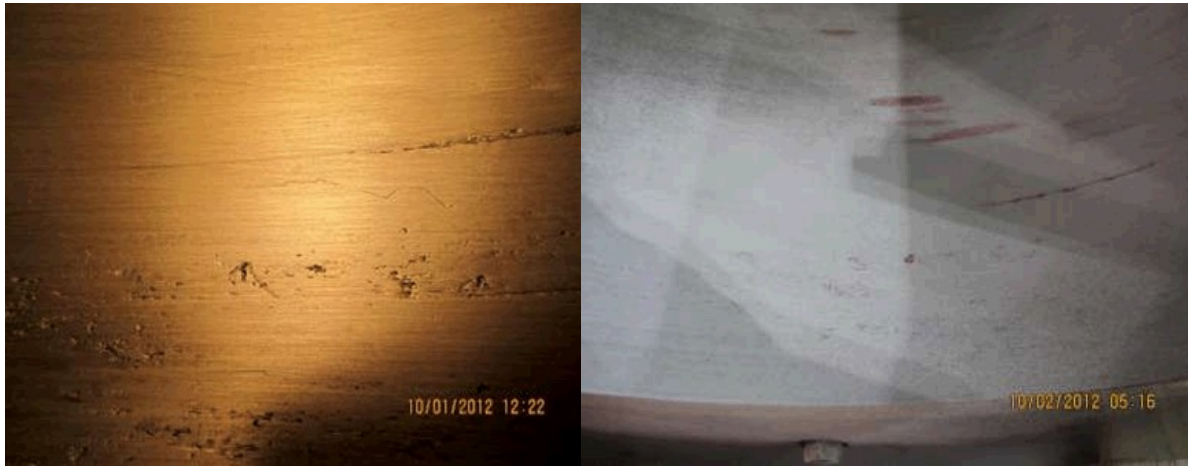
The lower bearing NDE had two crack indications, one straight and one half circle. NDT cleared both indications in 3rd photo below.

There was heavy shaft and bearing scoring due to oil contamination. The Journal was strapped and the bearing was cleaned up.

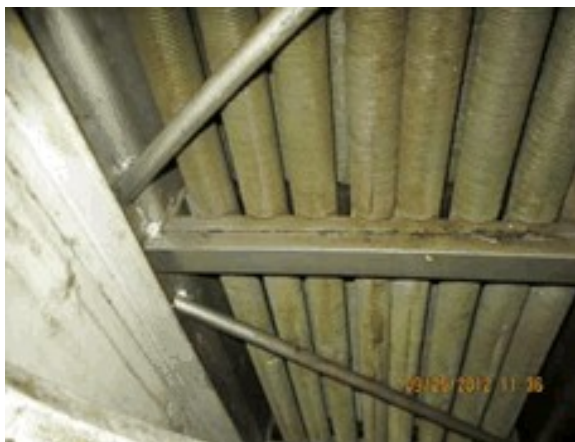
The H2 coolers were visible from the end cover being removed. They had a heavy yellow varnish build-up.
