1 **Q. Describe Newfoundland Power's asset management practices for its generating**
2 **facilities, including both maintenance and capital refurbishment programs and**
3 **practices, and how the generator maintenance programs are managed including the**
4 **use of maintenance management software. In the response provide copies of any**
5 **documents that describe the policies and practices followed.**

6
7 **A. 1. Generation Asset Management Practices**
8

2. Generation Capital Refurbishment Programs

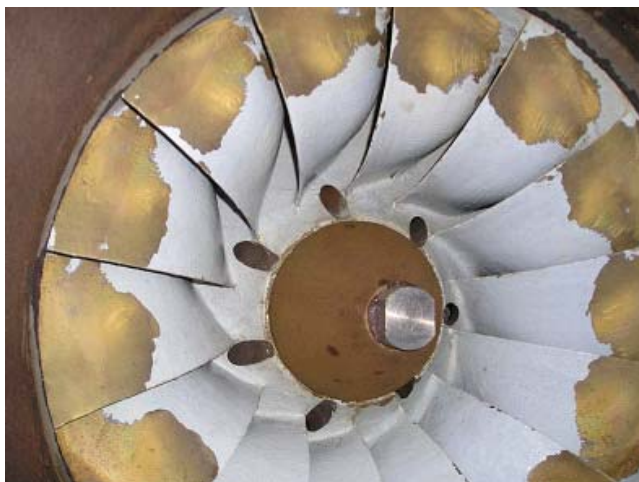
Figures 2 and 3 are photographs of the turbine runner on Generator No. 2 taken during a 2007 inspection. This runner was refurbished in 2001, with extensive repairs to the runner blades. Holes in the buckets were welded with aluminum bronze rods. The entire runner was coated with a Belzona Super Glide ceramic coating. Two new 660 bronze rotating seals were installed and machined to give proper clearance. The stationary seal was repaired and reinstalled in the turbine. Subsequent inspections have revealed additional cavitation and 50% of the Belzona coating has since eroded.

Figure 2-Low pressure side showing loss of belzona coating

As part of the overall plant refurbishment the Company currently plans to bring forward a capital budget project proposal for the replacement of the turbine runners at Lockston Plant in the 2012 Capital Budget Application. This capital budget project proposal will require detailed engineering design work be completed. Completing the detailed engineering design work in advance will allow Newfoundland Power to prepare engineering specifications and tender documents in 2011 to ensure the project can be completed during the 2012 construction season.⁵

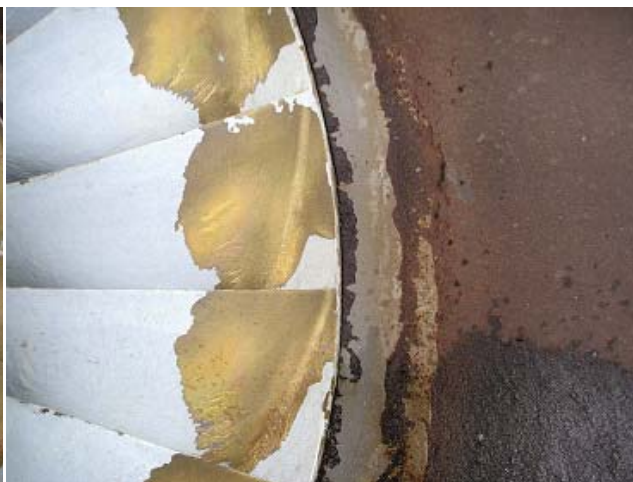
Figure 3-Cavitation

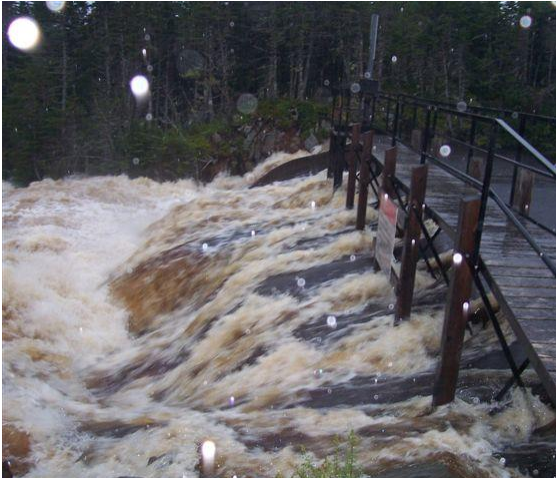
were replaced in November 2010. The internal timbers and structural members, however, were not replaced during the 2008 and 2010 remediation work. As illustrated in Figures 2 and 3, these have now deteriorated to the point that replacement of the dam and outlet is required to maintain the integrity of the structure.

Figure 1 - Long Pond Dam (Hurricane Igor)

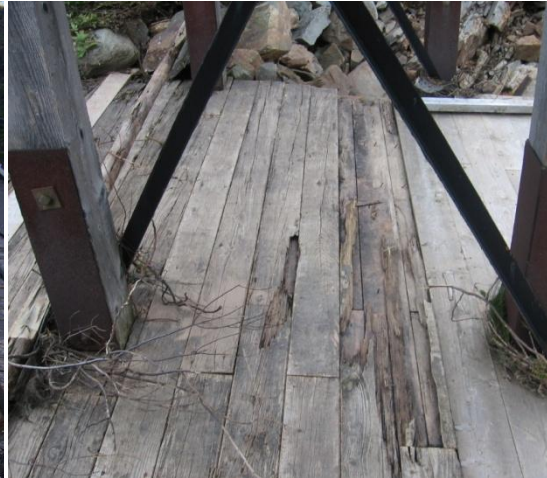
Figure 2 - Long Pond Dam (Deteriorated Decking)

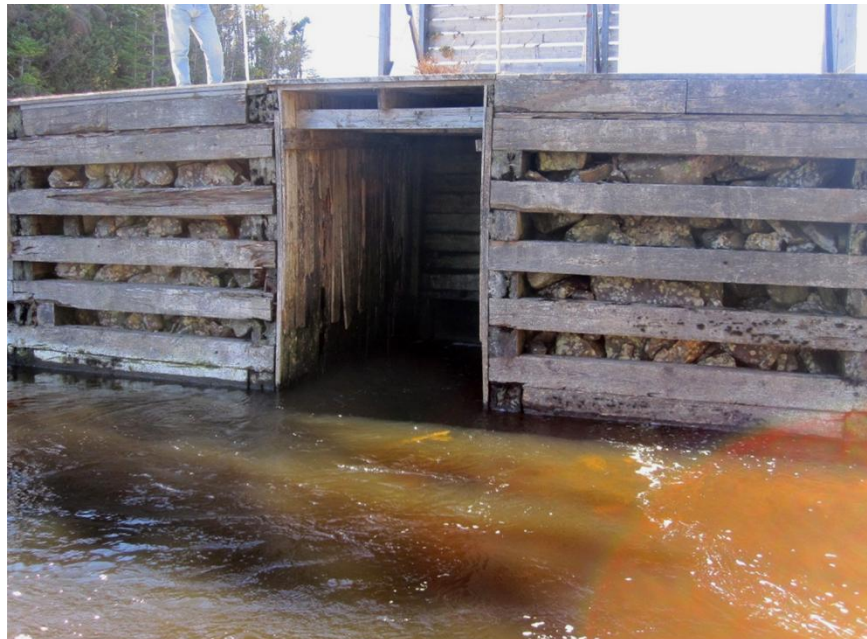
Figure 3 - Long Pond Dam (Deteriorated Outlet and Cribbing)

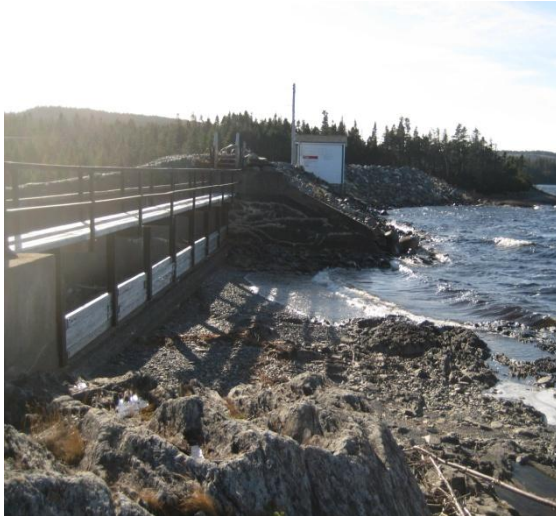
This project involves replacement of the existing stoplog spillway, shown in Figures 4 and 5, with a new concrete structure. Stability analysis indicates that the spillway does not meet requirements for overturning and the structure lacks available freeboard with the stoplogs in place. Accessing the structure to remove stoplogs during flood conditions is difficult, and presents a safety hazard for power plant operators. Replacing the stoplog spillway will address dam safety deficiencies and remove a significant safety hazard.

Figure 4 - Tors Cove Spillway (Upstream)

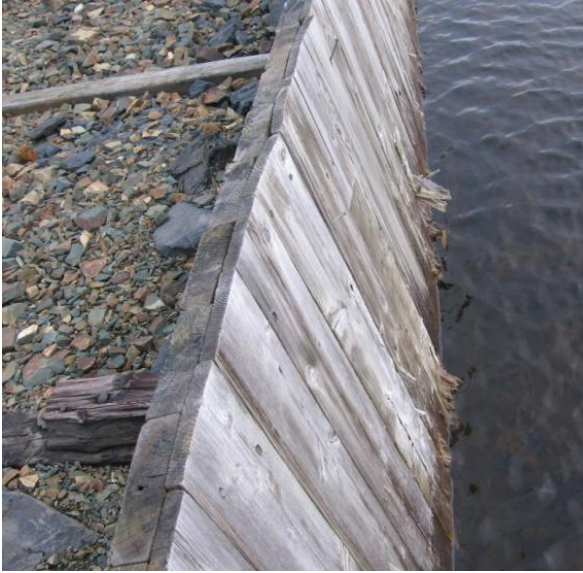
Figure 6 - Misaligned Timber Facing with Ice Damage

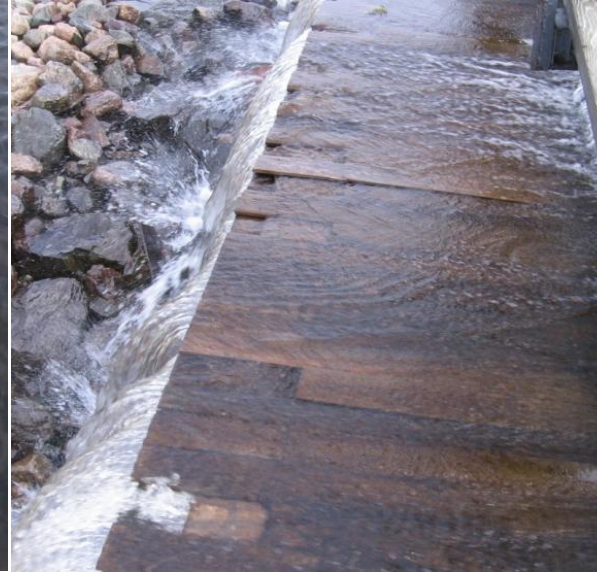
Figure 7 - Delaminating Spillway Decking

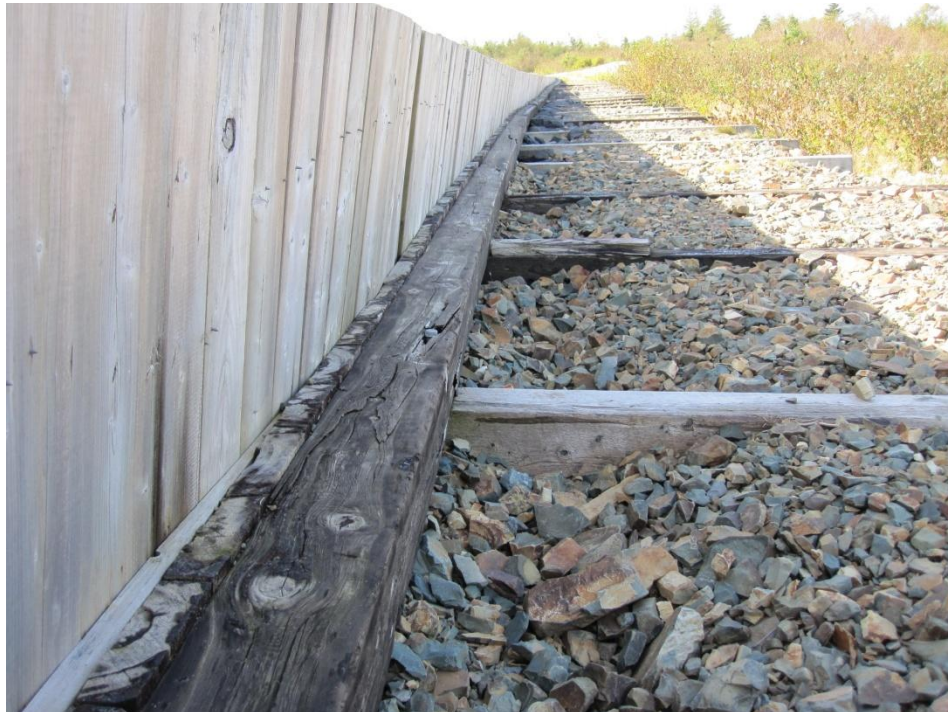
Figure 8 - Deteriorated Timbers with Erosion of Rockfill from Overtopping

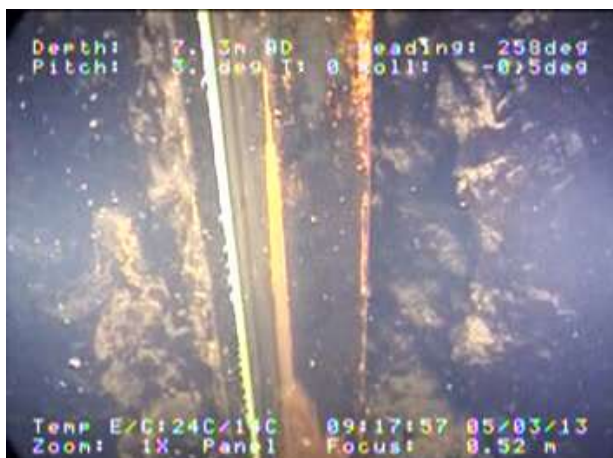
Figure 15 – Gate Guide (Note: Deteriorated Concrete behind gate guide)

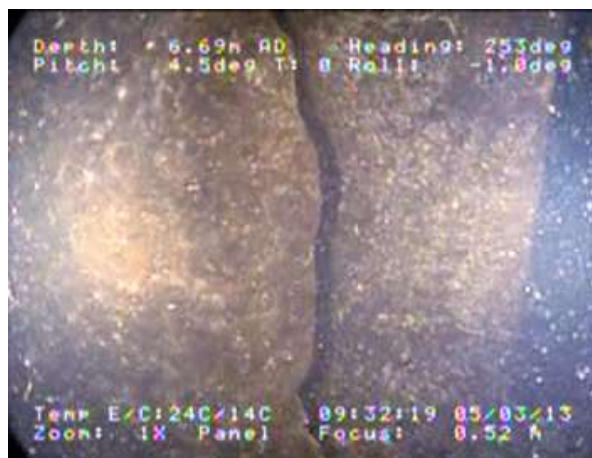
Figure 16 – Crack in intake conduit roof

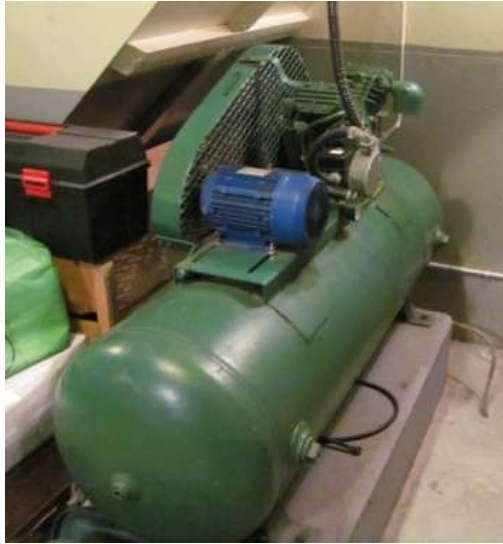
Compressed air is used to operate the generator braking system. The compressor motor was replaced in 2004 but the compressor and pressure tank are 1959 vintage. The unit does not have an air-water separator, pressure regulator or pressure switch for low air alarm. The age of the 80-gallon J.B Baird pressure vessel dictates that the compressor should be replaced.

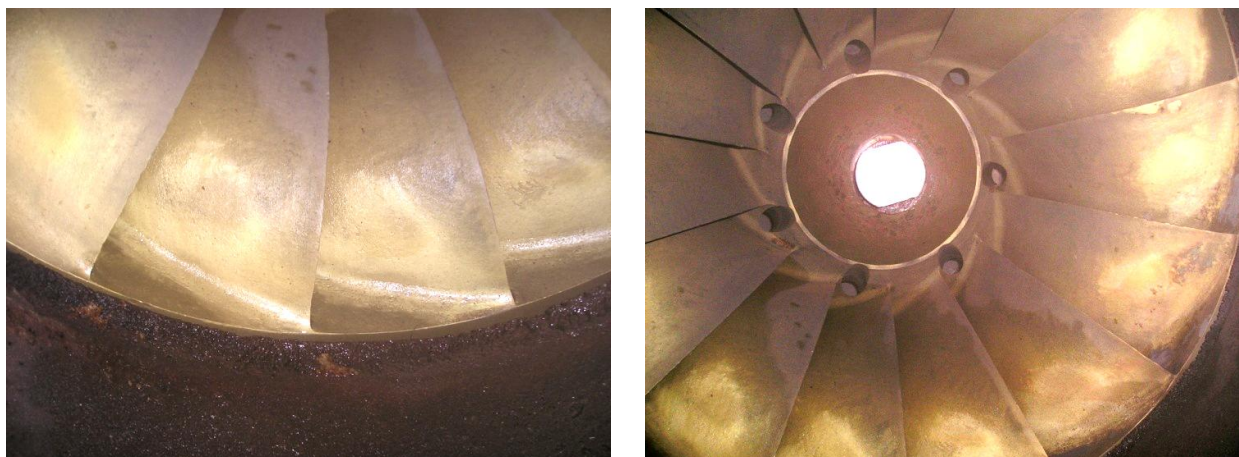
Figure 7 – 2007 Inspection of Low Pressure Side of G1 Runner showing Belzona Erosion and Cavitation

Index testing, performed by ACRES in 2003, determined the peak efficiency of unit G1 was 84.4%. This is considered low as compared to that expected of a modern runner design. To improve efficiency and minimize the operating cost associated with maintaining the existing mild steel runner, it will be replaced with a higher efficiency stainless steel unit. A replacement runner is expected to result in a peak unit efficiency of 87% with a resulting increase in energy production of 0.3 GWH annually. The stationary seals and downstream spool pieces that form part of the seal around the runner are eroding and will need to be replaced to ensure proper operation of the new runner.

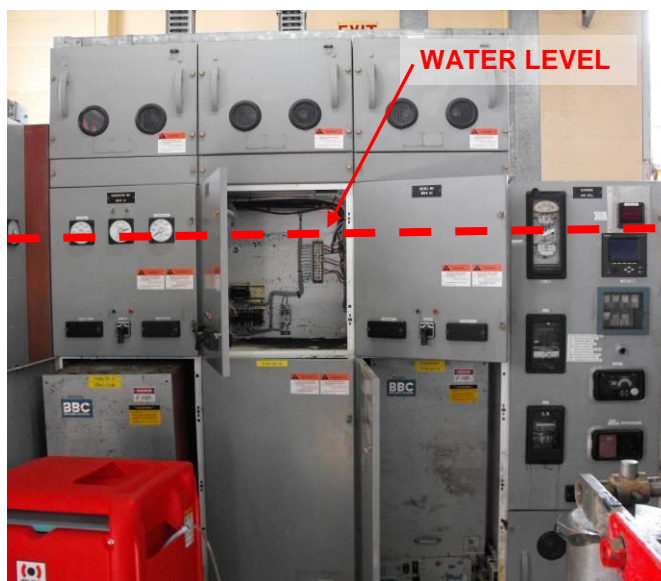
The generator breakers were completely submerged and will require refurbishment at a facility with the specialized test equipment, parts and skills to complete this work. All switchgear compartments and control wiring will be cleaned and dried on site. The CTs were submerged but are sealed units that will be reused after cleaning, drying and testing. The generator PTs are located in the top compartments of the switchgear and were not submerged. They will be reused. The bus PT is located in the bottom of the metering cubicle that was completely submerged. It will be tested and reused if possible. If not, it will be replaced by the generator PT that is currently on the diesel unit, generator G3, which is being retired.

Figure 2 - Damaged Switchgear

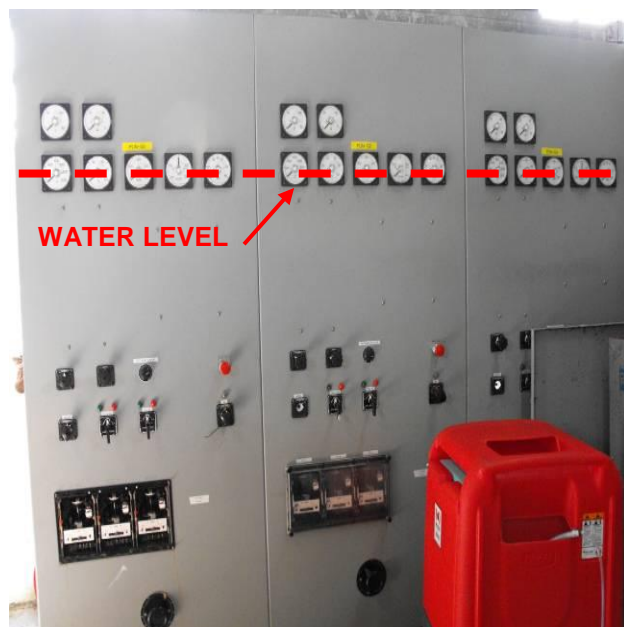
Figure 3 - Damaged Protection and Control

The protective relays, voltage regulators, controls switches and bottom row of meters were all submerged causing the mechanisms and electrical contacts in this equipment to corrode. As a result, they are no longer serviceable. Figure 3 shows the high water mark relative to the equipment mounted in the panels.

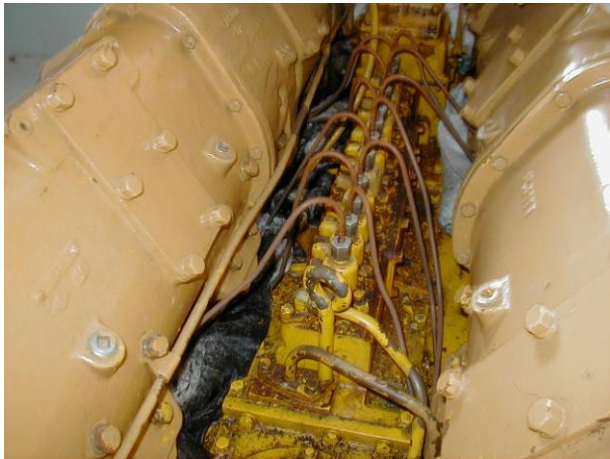
Fuel Leaks in the Engine Vee

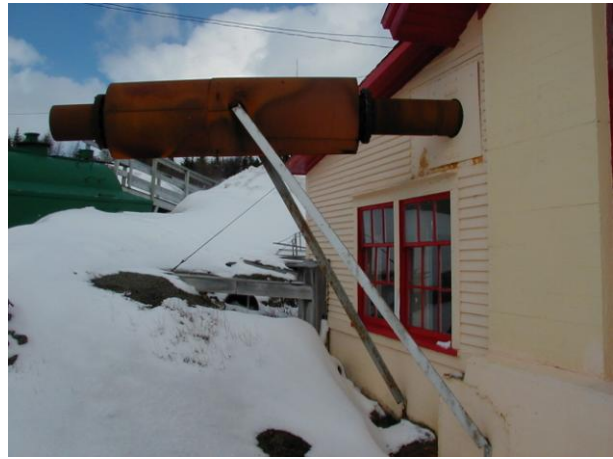
Corroded Exhaust Muffler

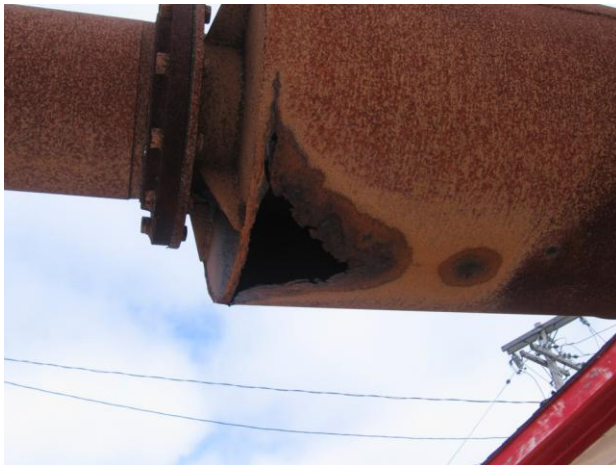
Hole In Muffler

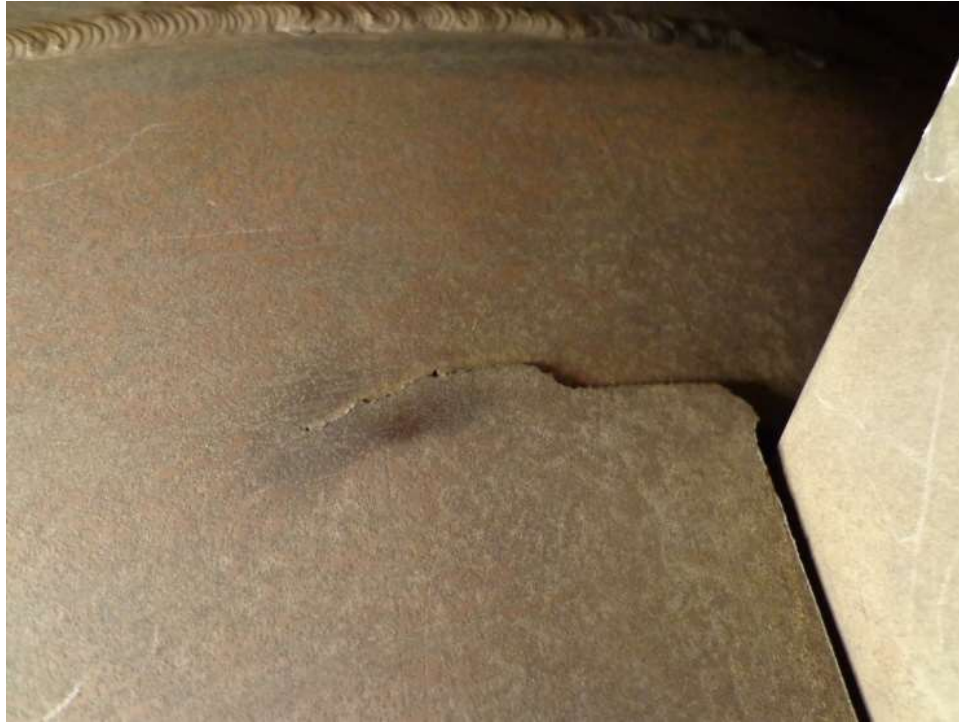
Figure 3 – Crack in Power Turbine Inlet Duct

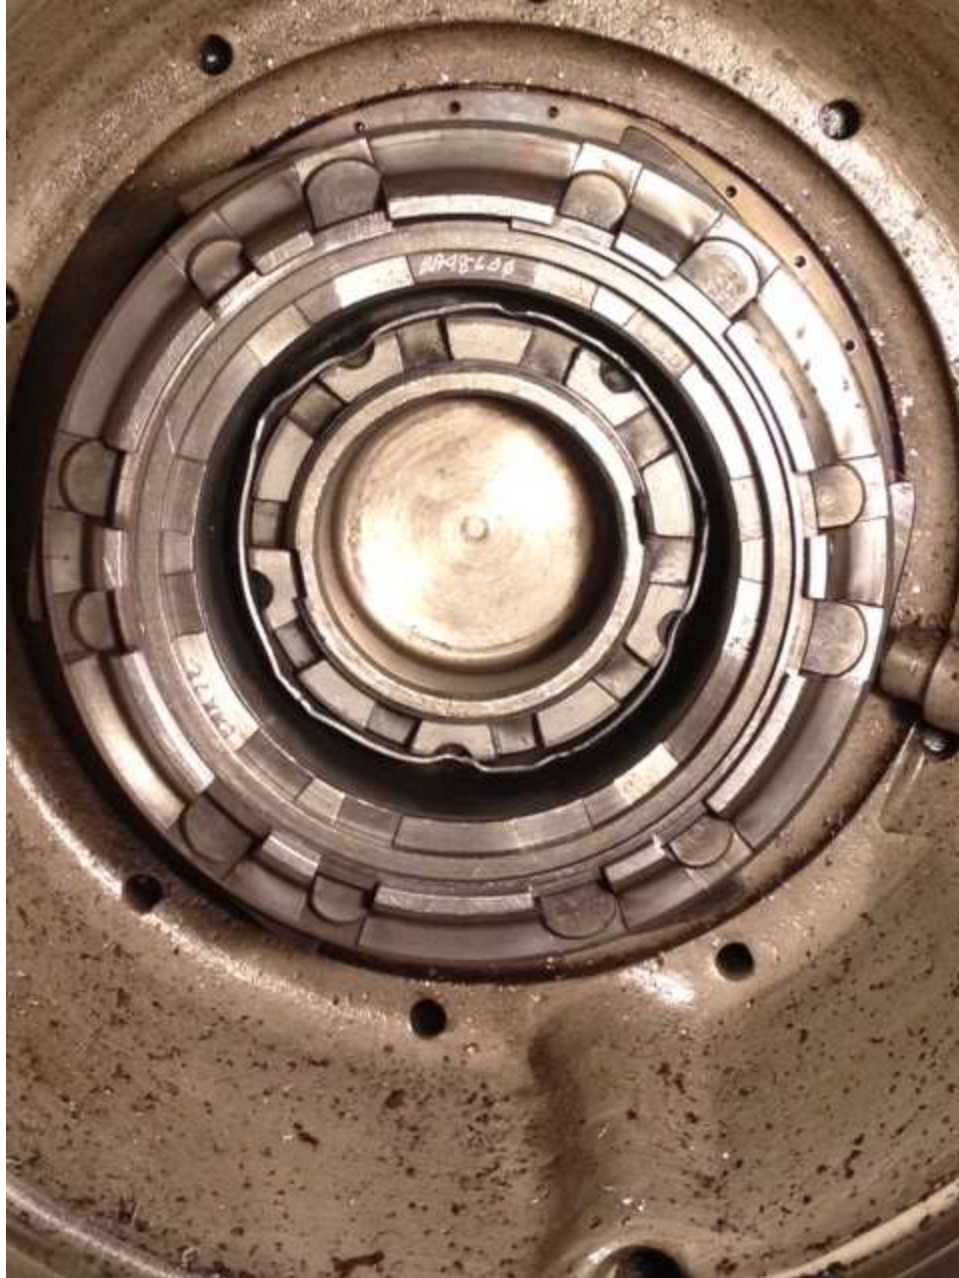
Figure 4 – Damaged Front Bearing

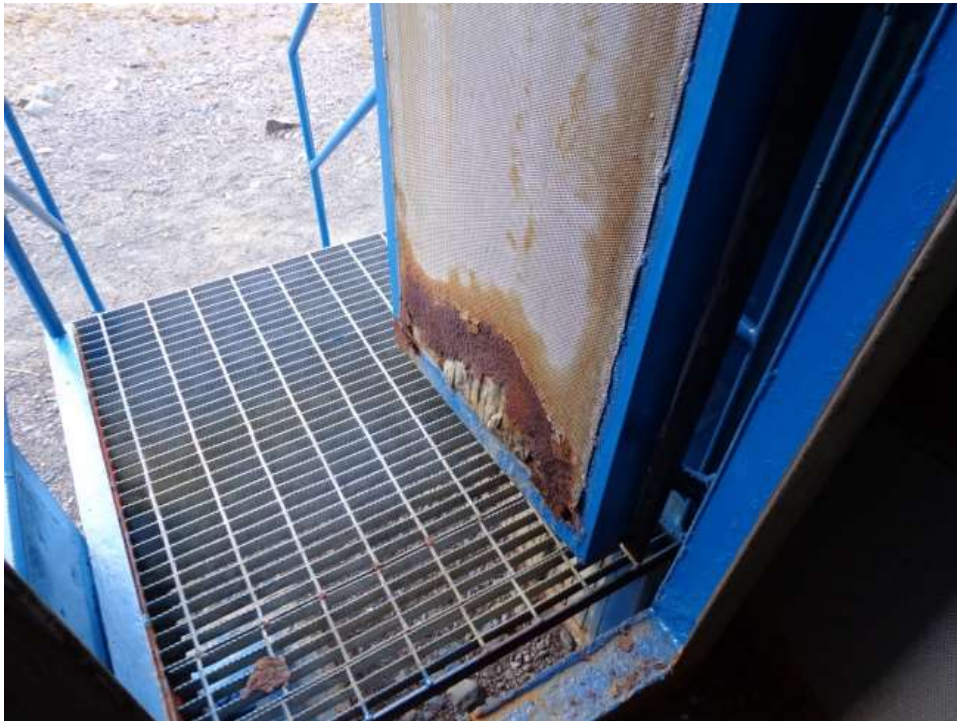
Figure 2 – Corrosion Damage Intake Plenum Door

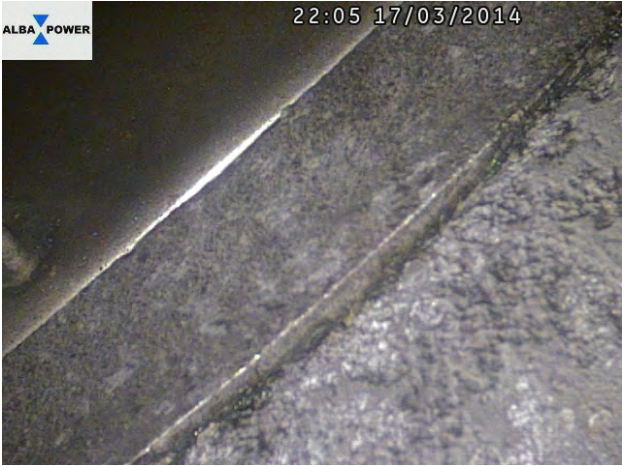
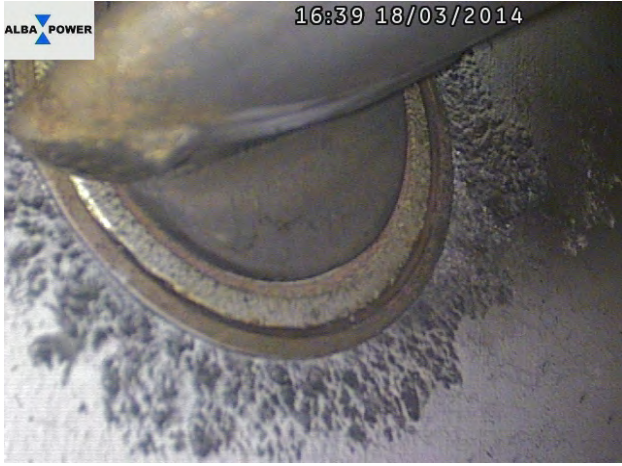
Air intake housing (Corrosion)	VIGV bush location (Corrosion)

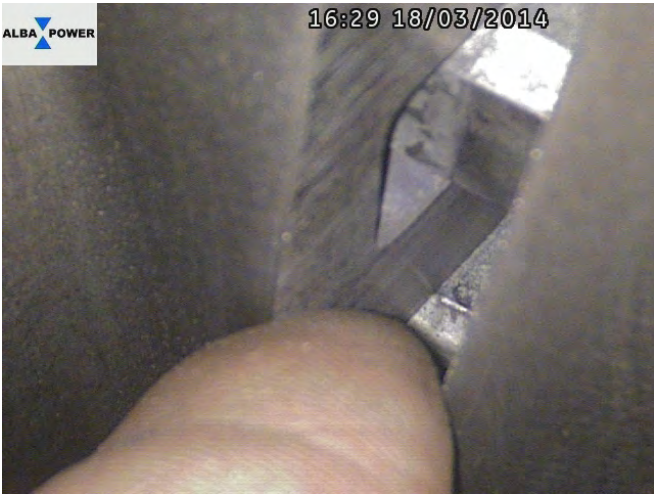
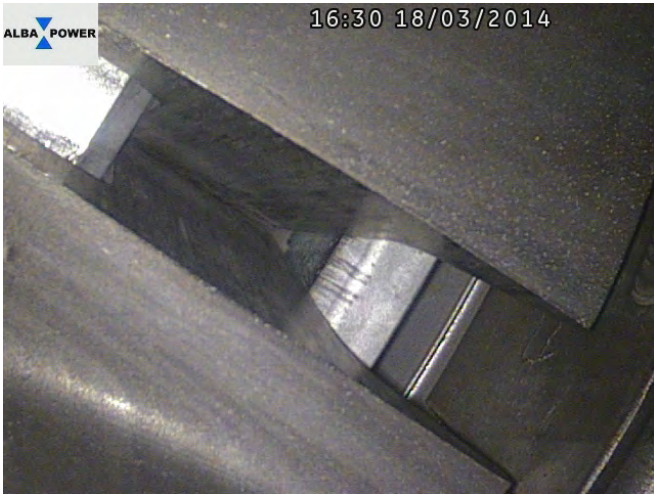
Stage 00 blades (worn)	Stage 00 blades (worn)

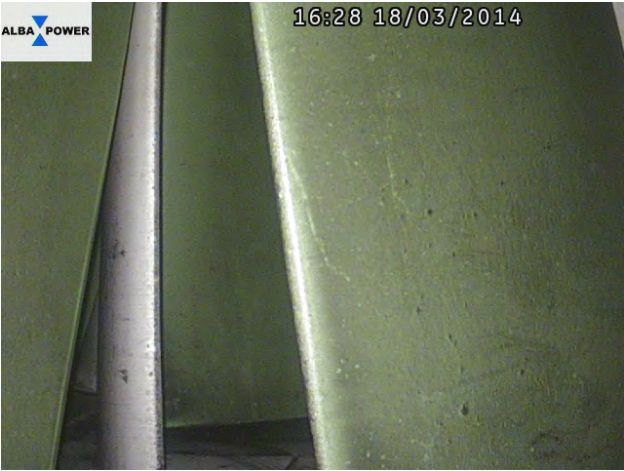
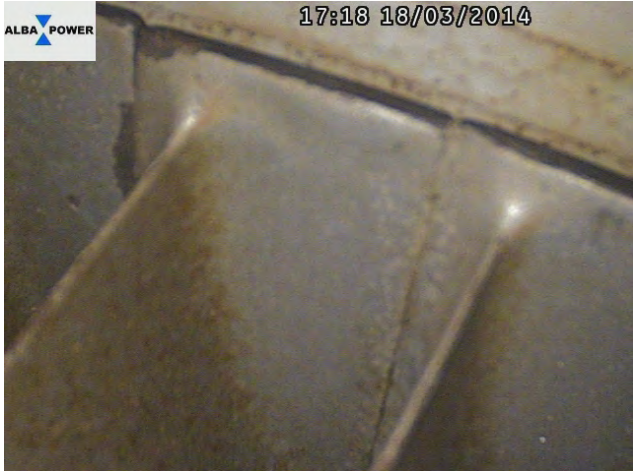
Coating degradation	Corrosion on stage 15 stators

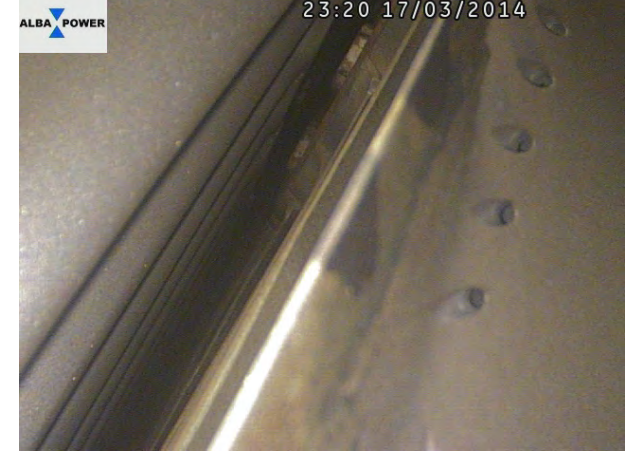
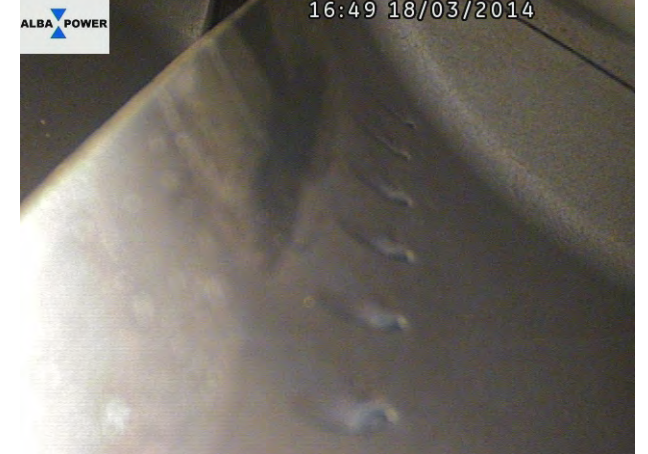
<p>LP NGV (old repair)</p>	<p>LP NGV (old repair)</p>

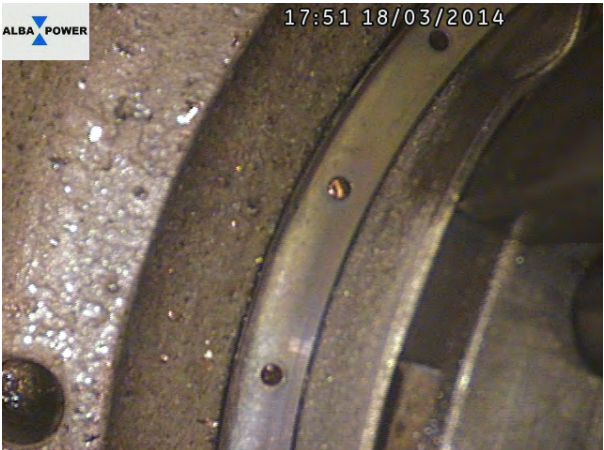
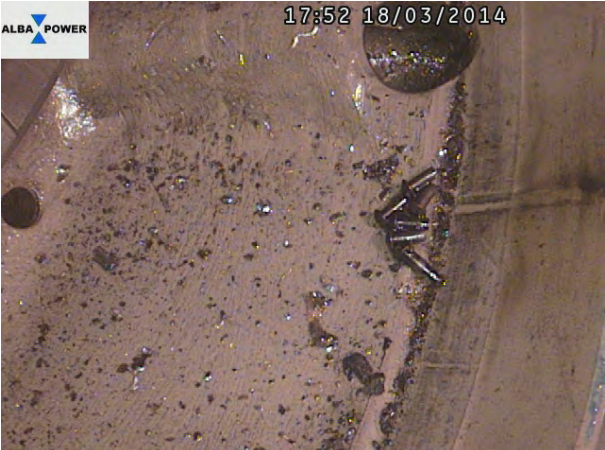
<p>17:52 18/03/2014</p>
<p>Rivets missing from front bearing</p>	<p>Rivets lying next to the oil scavenge drain</p>

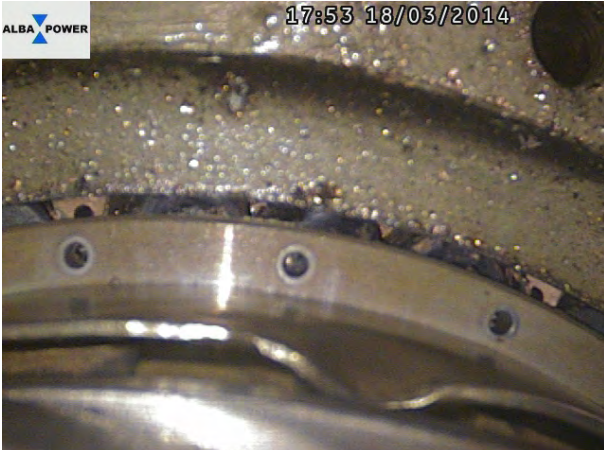
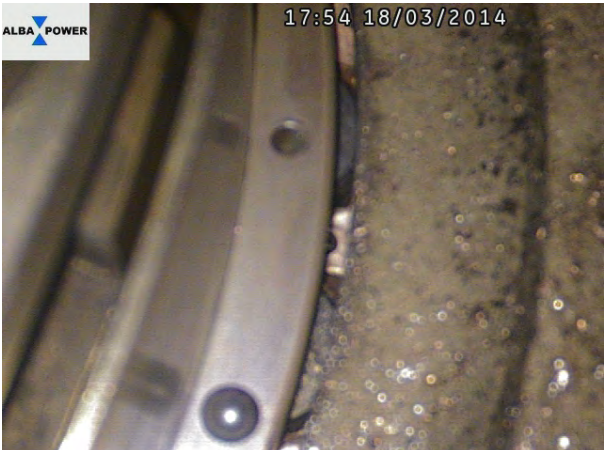
<p>17:54 18/03/2014</p>
<p>Front bearing failure</p>	<p>Front bearing failure</p>

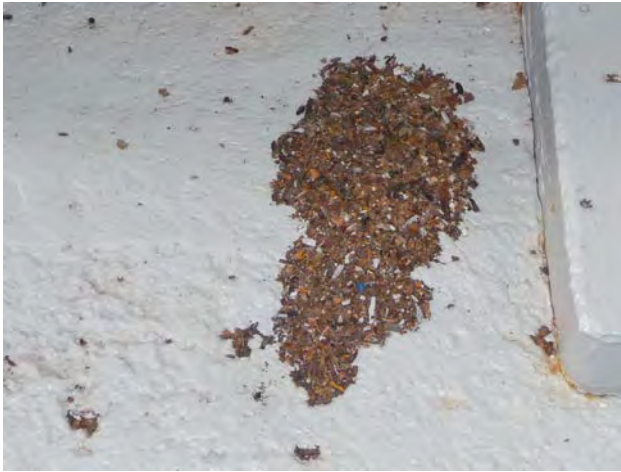
Air intake plenum (rust debris)

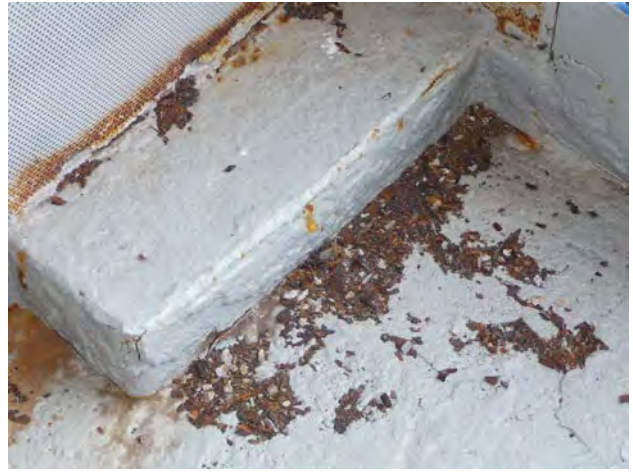
Air intake plenum (rust debris)

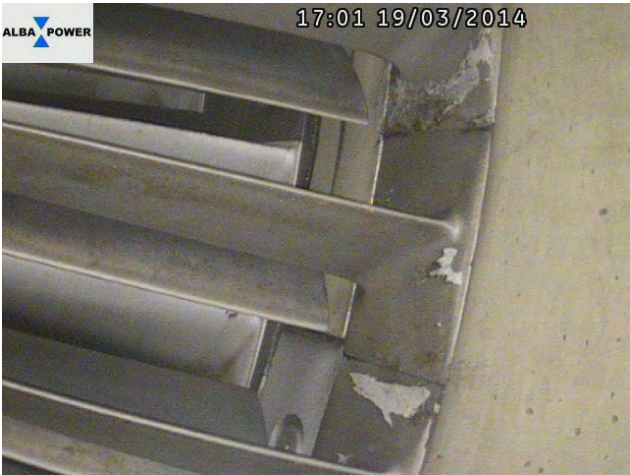
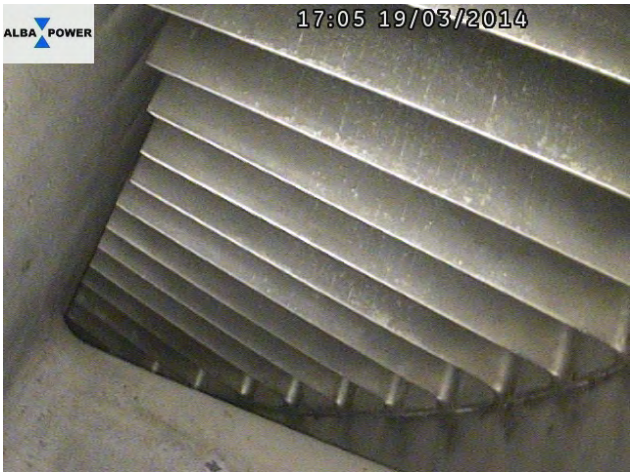
Coating degradation on LP stators	Coating loss on the leading edge LP stators

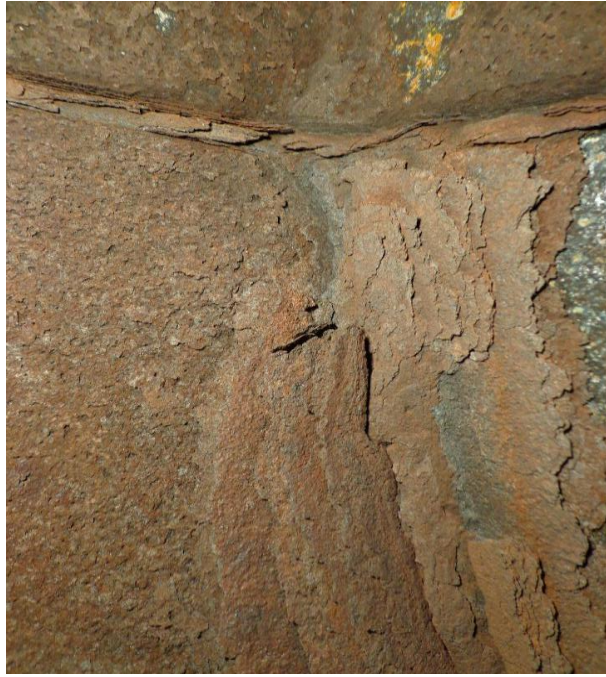
Fig 1 Corrosion in exhaust system.

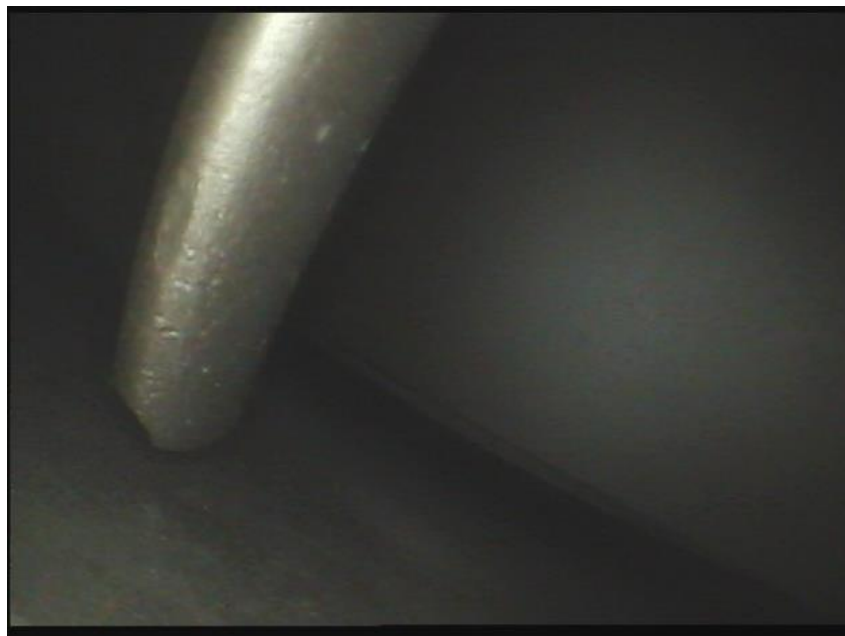
Fig 2 Blade impact damage and pitting

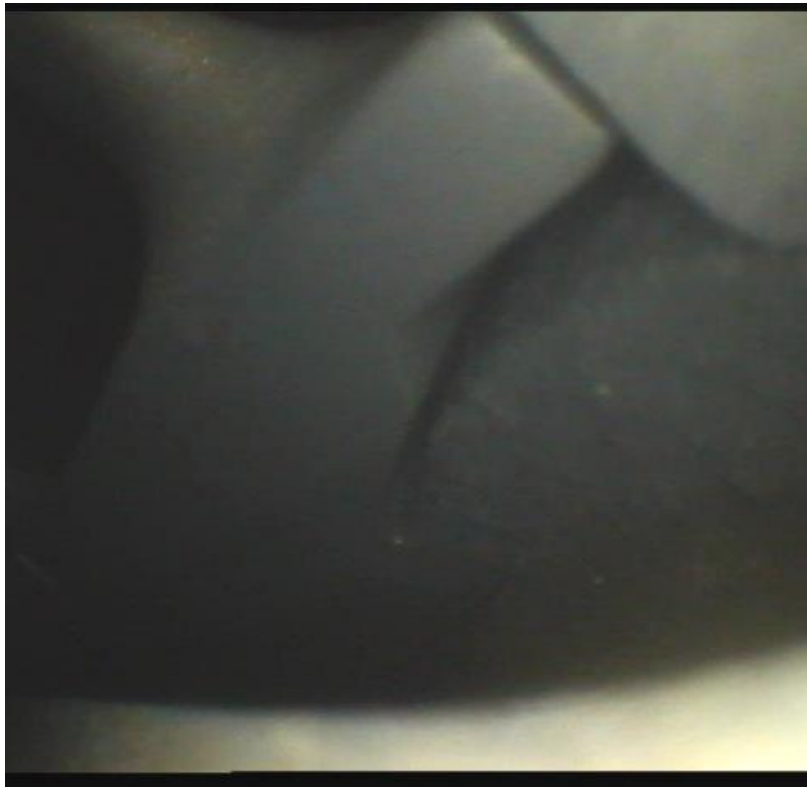
Fig 3 Blade and disc pitting at roots.

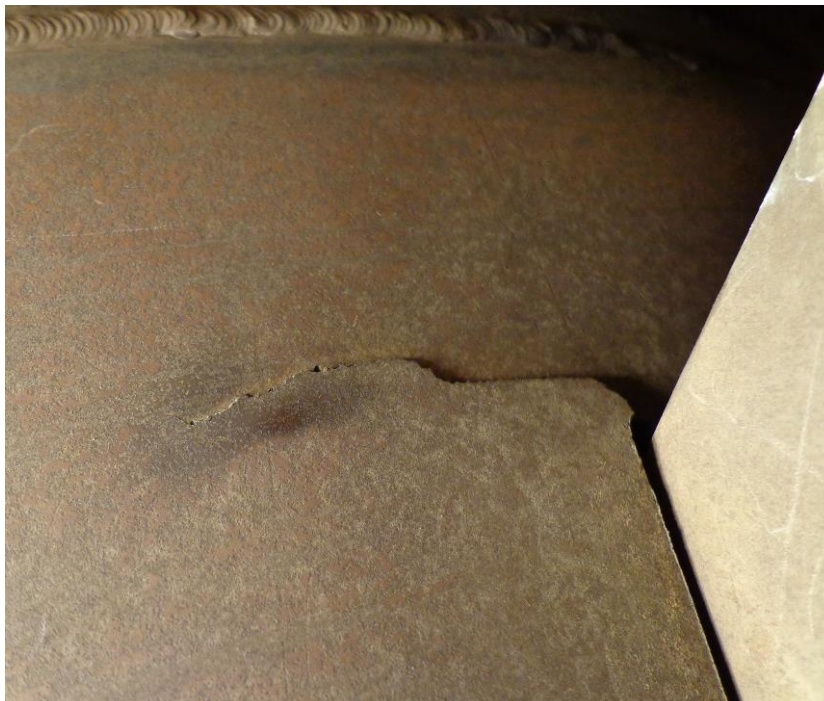
Fig 4 Crack in inner duct

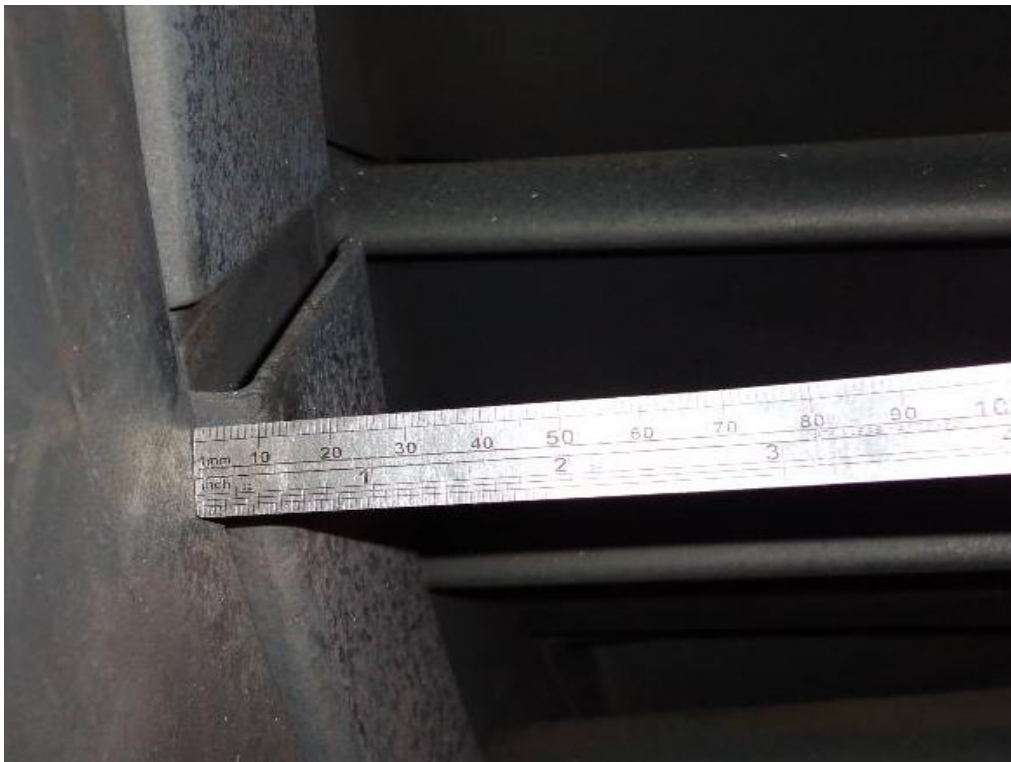
Fig 3 Protrusion of stator shroud

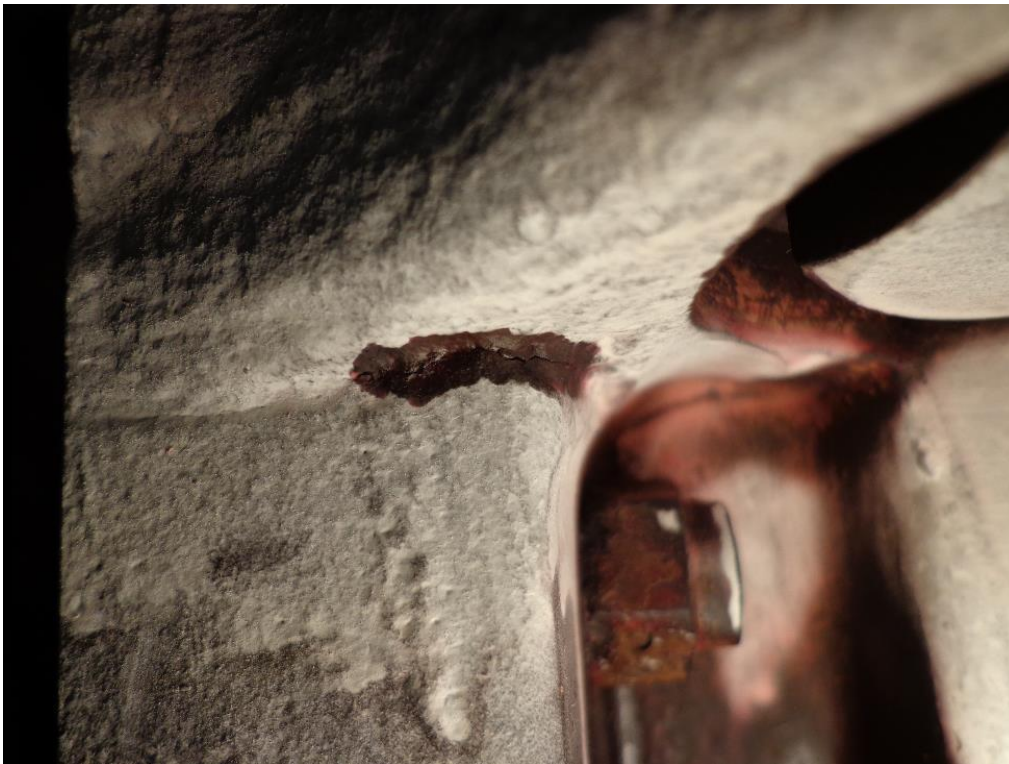
Fig 4 Crack in pressure casing
