**Review of the Newfoundland and Labrador Hydro
March 4, 2015 Voltage Collapse**

**Newfoundland and Labrador
Board of Commissioners of Public Utilities**

The Liberty Consulting Group

October 22, 2015

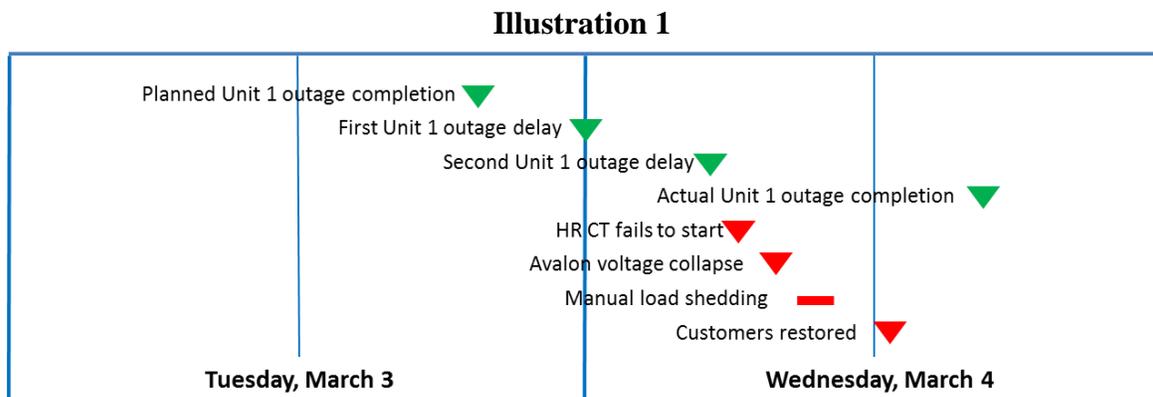
Illustration 1 summarizes the timeline of the March 4, 2015, events.

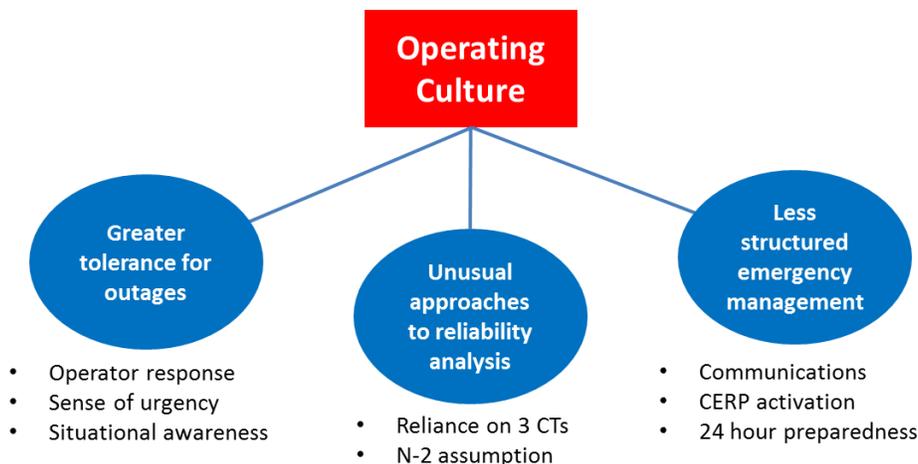
Illustration 2

A number of factors contributed to or exacerbated the events of March 4, 2015. The following illustration summarizes their relationship to Hydro's operating culture, which Liberty views as the root cause of the March 4th events.
