**Re: *Reliability and Resource Adequacy Study Review – Design Review for L'Anse au Diable and Dowden's Point Grounding Stations***

## **L'Anse au Diable Breakwater Rehabilitation Design Brief**

### **L'Anse au Diable Phase 2 Grounding Station Breakwater Design Re-Evaluation Rehabilitation**

Project No.: 2021-227

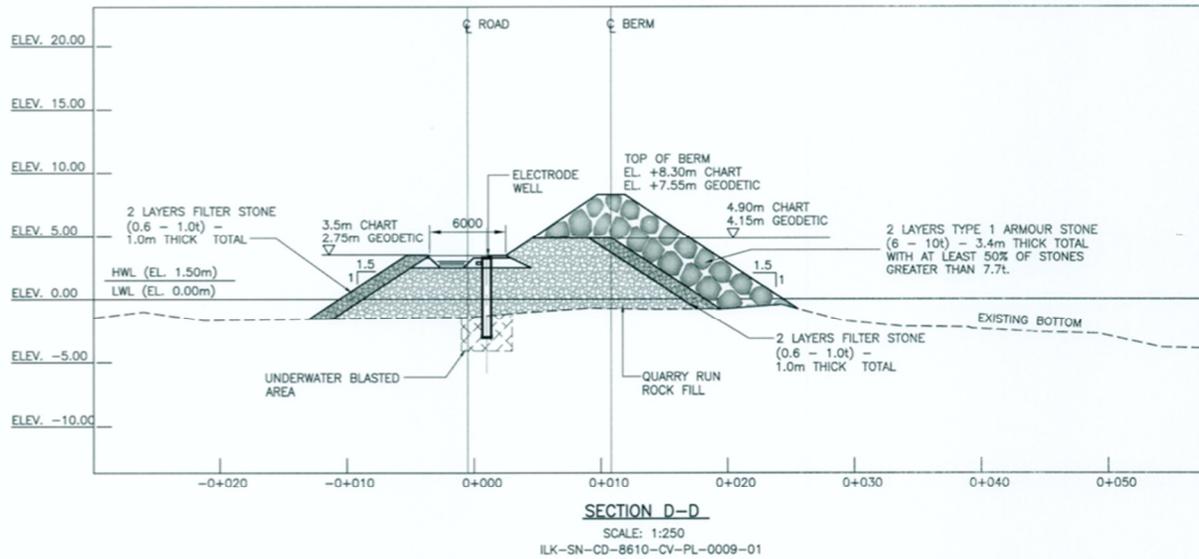
Figure Design Cross Section D-D [5]

Design documents include a site overview as well as cross sections at various points along the breakwater. Elevations on the design drawings include height for core, filter, and armor stones; as-built elevations are to be as close as possible to these elevations as these elevations are the determined heights for the breakwater to resist wave action.

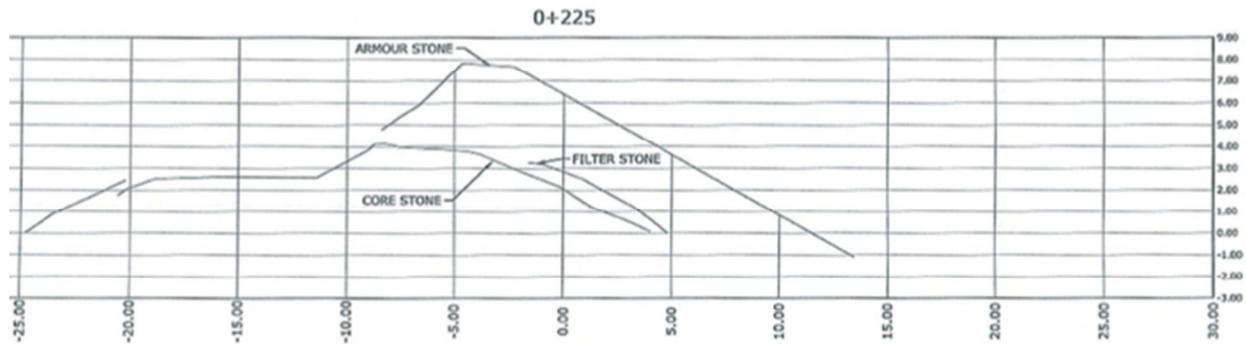
Figure As-Built Elevations [6]

When reviewing as-built elevations it appears that numerous points along the breakwater have lower than design elevations. The low elevations are not limited to a certain layer but are present in the core, filter, and armor stones.

Station - Cross Section	Armor		Filter		Core Seaward		Core Landward	
	Design	Actual	Design	Actual	Design	Actual	Design	Actual
0+050 - A-A	7.55	7.75	4.15	4.50	4.15	4.25	-	-
0+075	7.55	7.75	4.15	4.50	4.15	4.00	-	-
0+125 - B-B	7.55	7.75	4.15	4.70	4.15	4.00	2.75	2.50
0+175 - C-C	7.55	7.75	4.15	3.95	4.15	4.10	2.75	2.75
0+225 - D-D	7.55	7.80	4.15	3.20	4.15	4.10	2.75	2.60
0+275 - E-E	7.55	7.20	4.15	4.5	4.15	4.15	2.75	2.60

We have proceeded to complete a design remediation as per reference [8] producing drawings to remediate the breakwater under extreme conditions. All design values match the existing except we used the worst-case design scenario of an offshore wave of 7 m reduced by a factor of 0.88 for an inshore design wave of 6.1 m increased from the original design value.

The remediation design has increased the crest height of the breakwater to a proposed height of 9.0m to 10m as shown in the accompanying drawings titled L'anse au Diable Phase 2 Grounding Station Break Water Design Re-Evaluation Rehabilitation.
