Re: Application for Approval of Various Supplemental Capital Projects at the Holyrood Thermal Generation Station

Application for Approval of Various Supplemental Capital Projects at the Holyrood Thermal Generating Station

Schedule 1
Refurbishment of Day Tank
Holyrood Thermal Generating Station

**OUT OF-SERVICE INSPECTION
OF
Bunker C # 6 fuel Oil Tank**

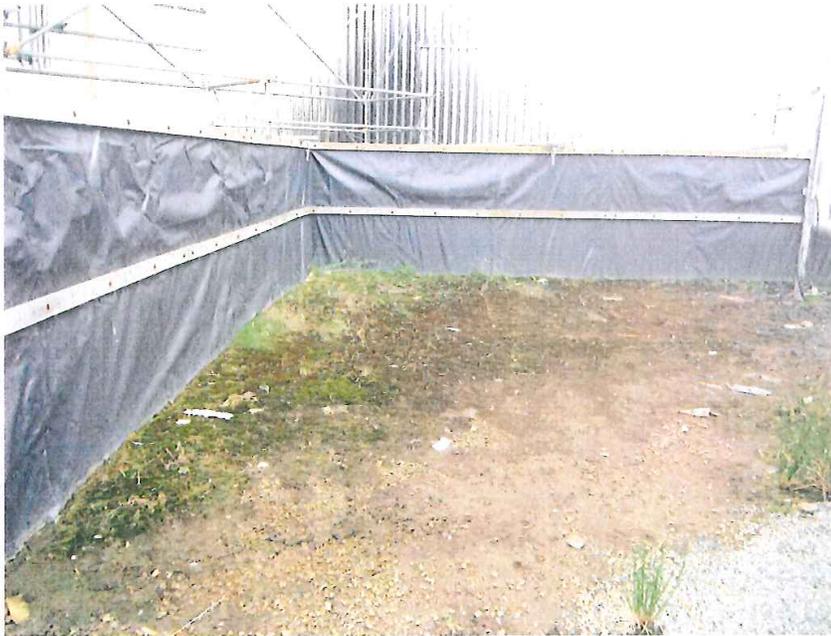
6.1 Dyke

Vegetation inside dyke next to plant

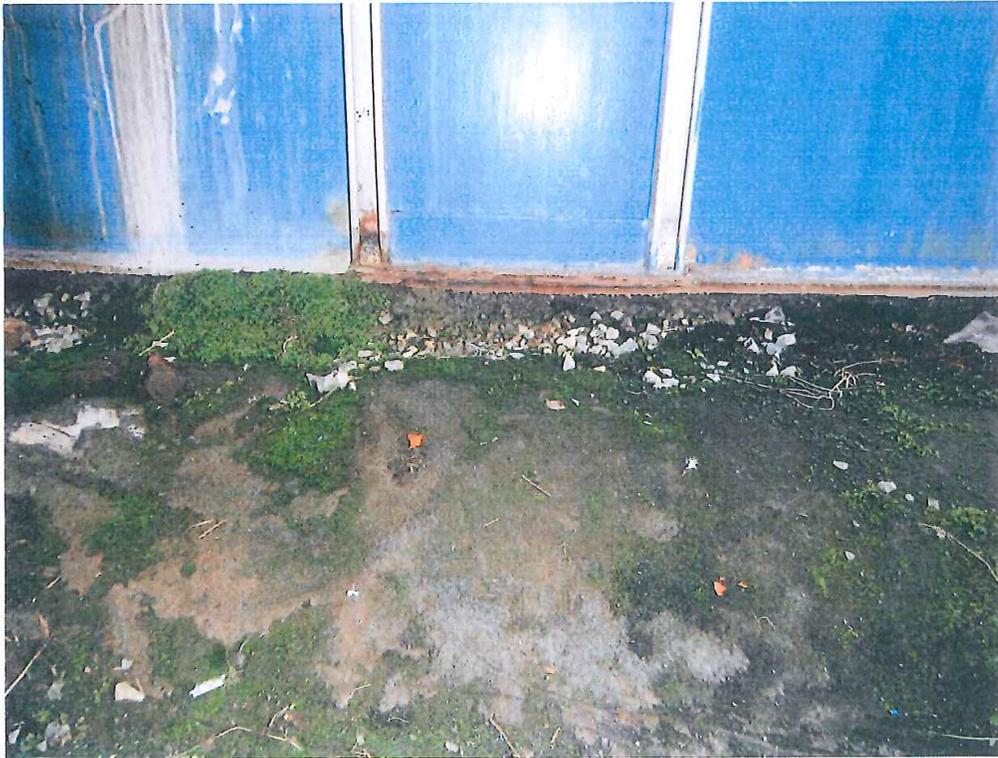
6.2 Tank Base

Vegetation and exposed liner around tank pedestal and base of tank.

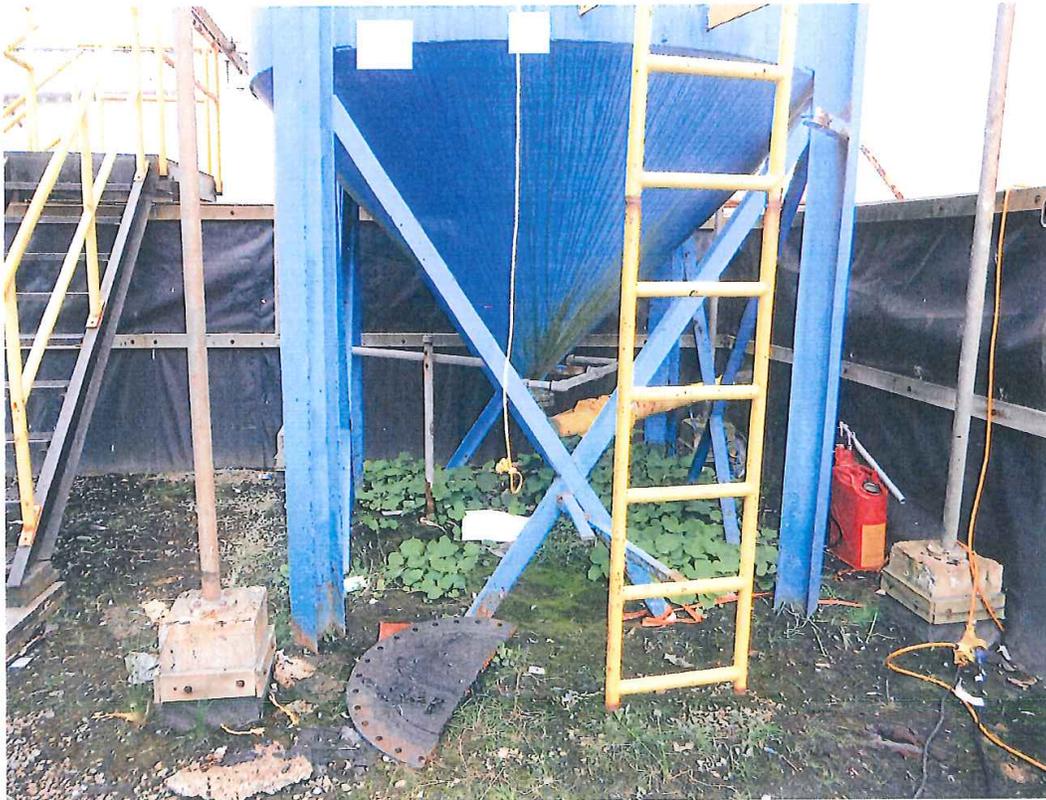
6.3 Blending tank inside dyke

Structural legs buried and covered with moss and vegetation no evidence of
Liner under the legs of the additive tank

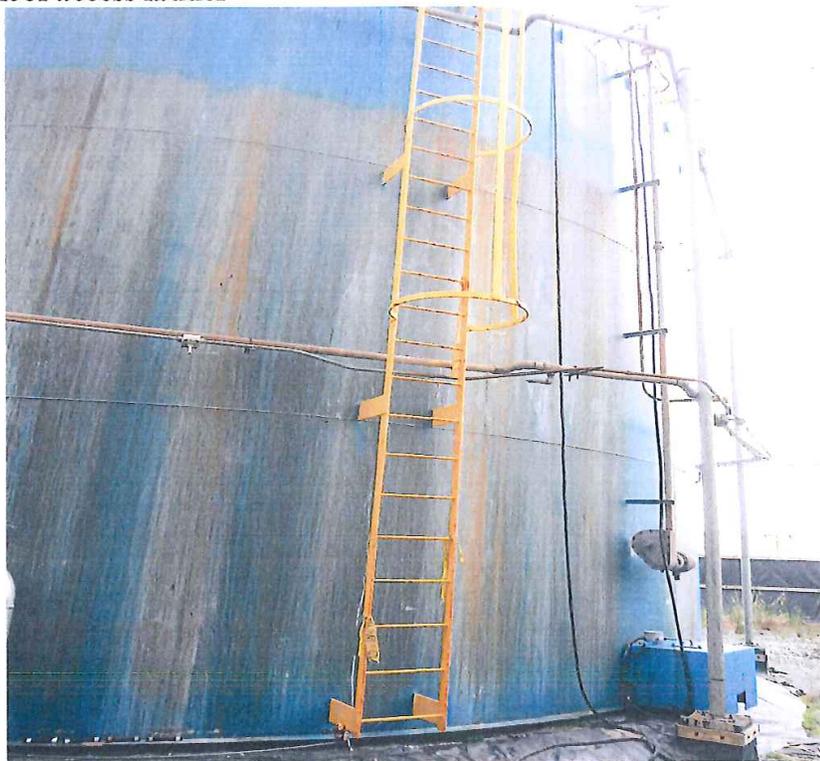
6.4 Roof access ladder

Ladder in Good condition exposed liner evident

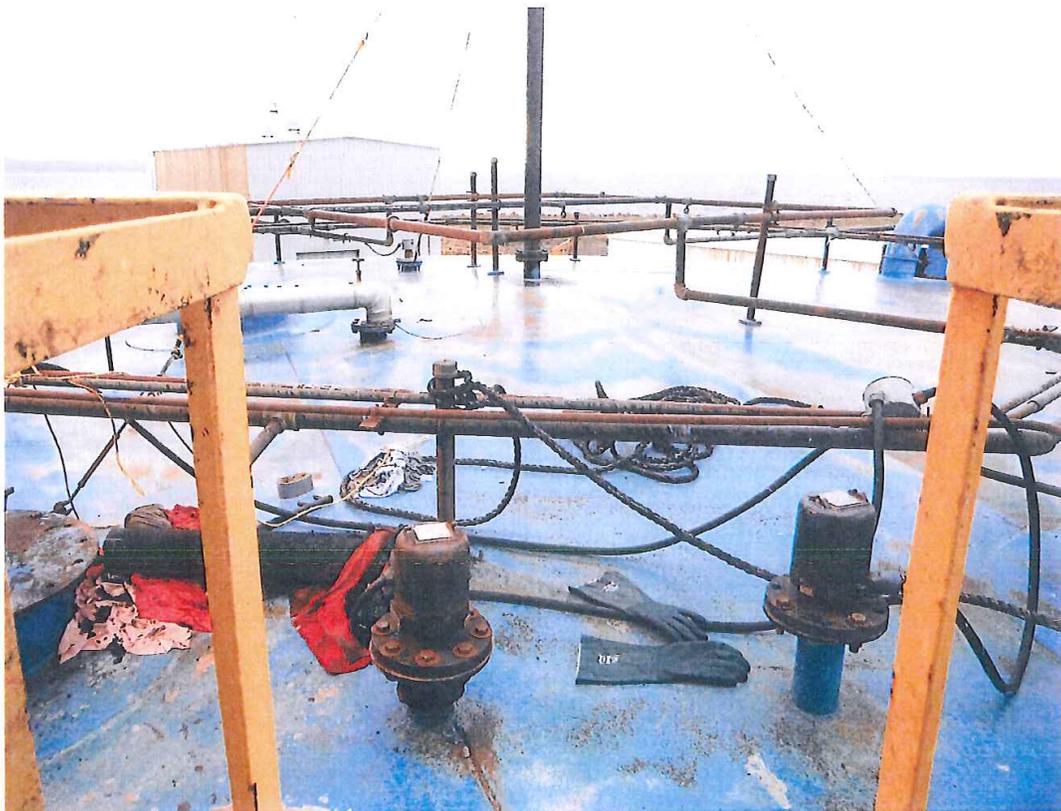
6.5 Roof

Roof typical view paint failure however roof plating in good condition

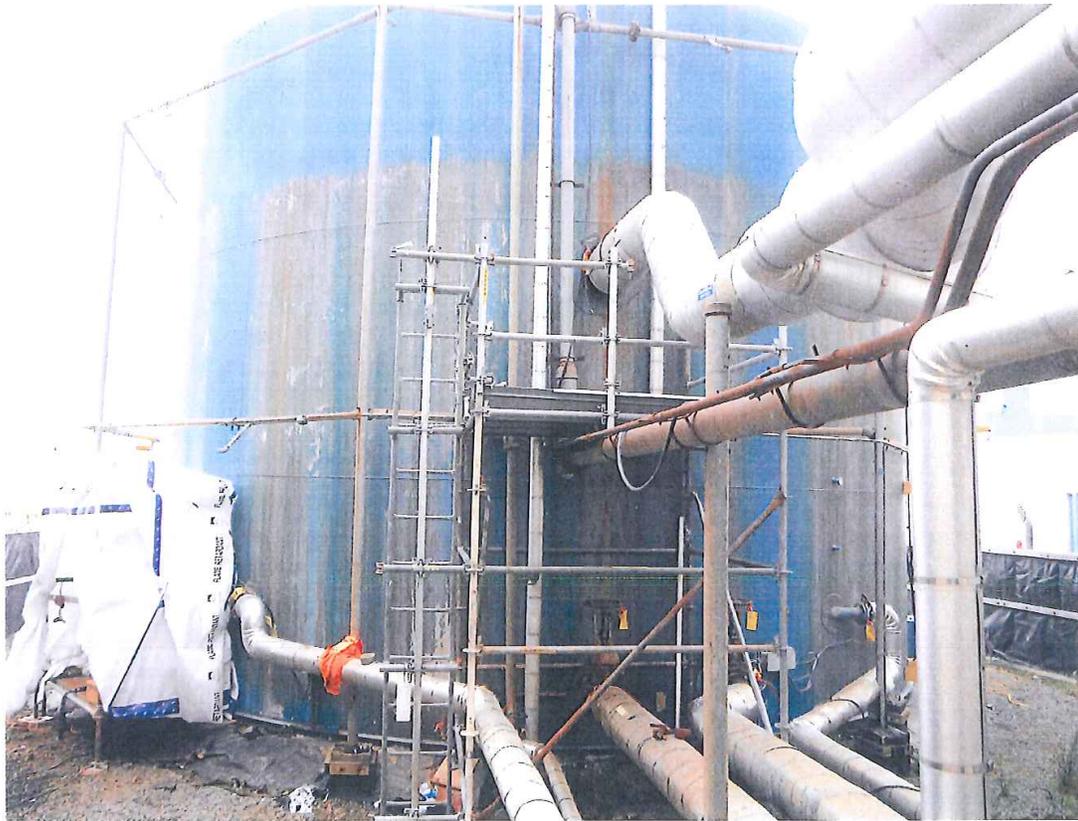
6.6 Piping

Tank piping and broken insulation from walking on the lines recommend repairing Shell paint failure

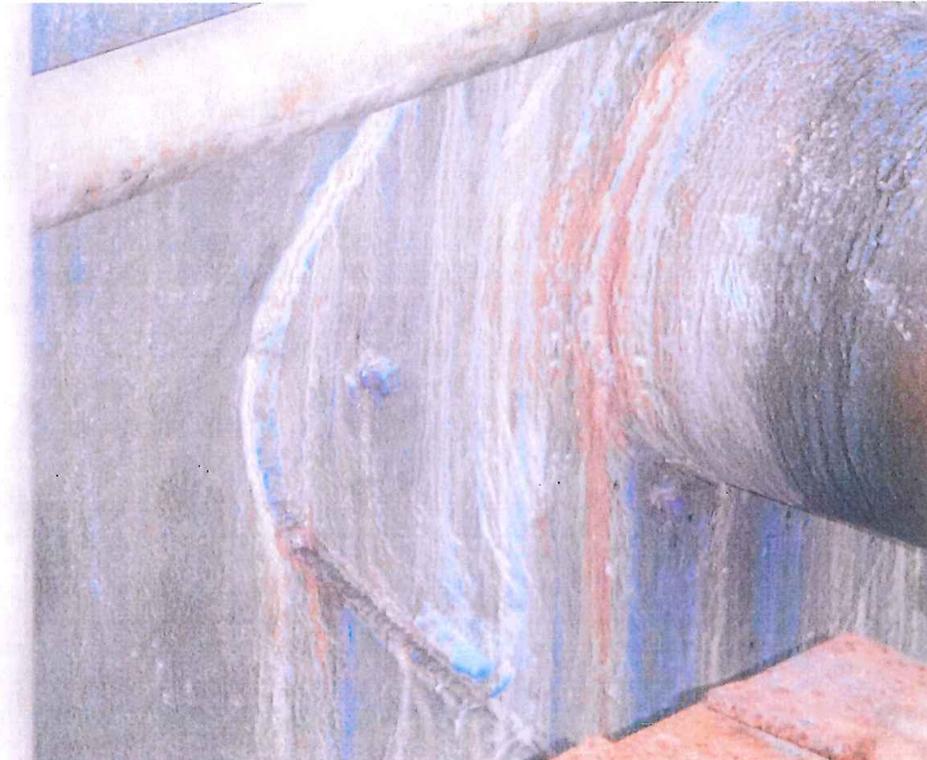
6.7 Repad Plug

Nozzle Repad plugged and this should be removed and replaced with silicone

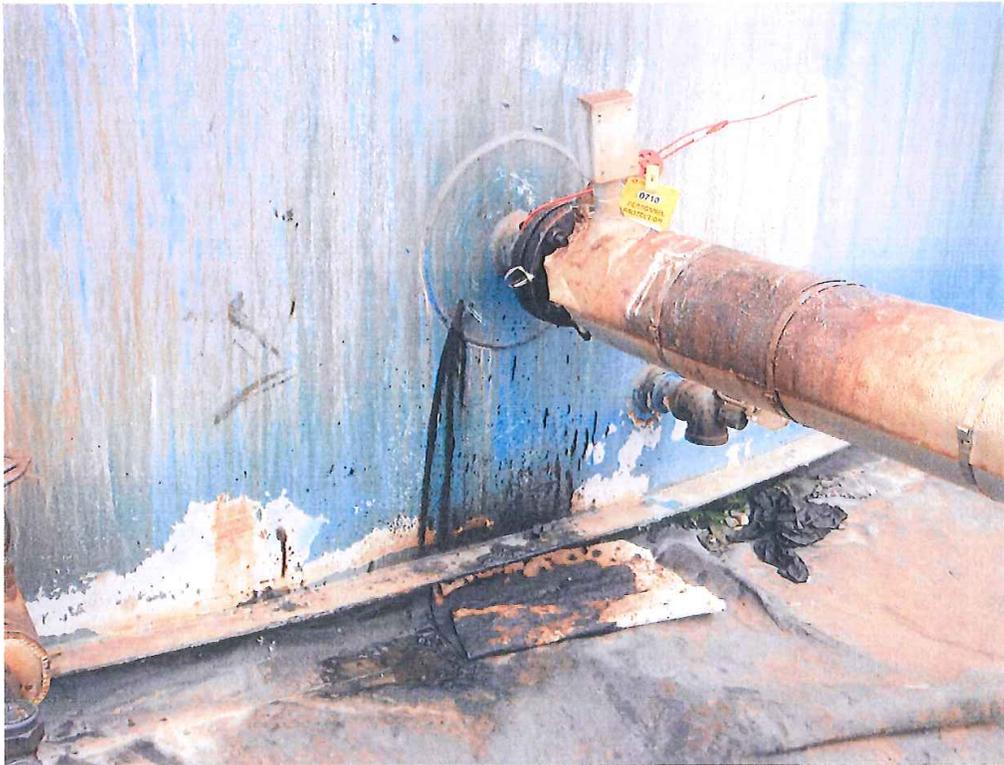
6.8

Tank chine area undermined and exposed dyke liner repad plugged recommend removal and replace with silicone

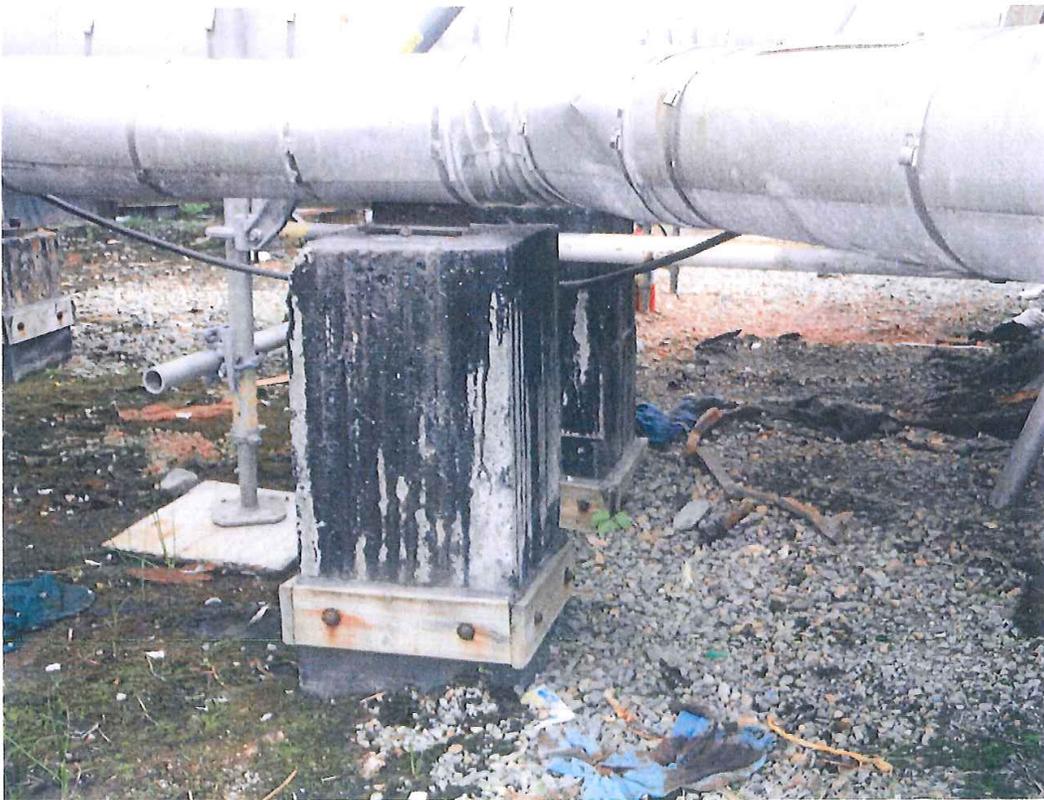
7.0 Piping Supports

Typical Insulated pipe and support with dyke liner seal

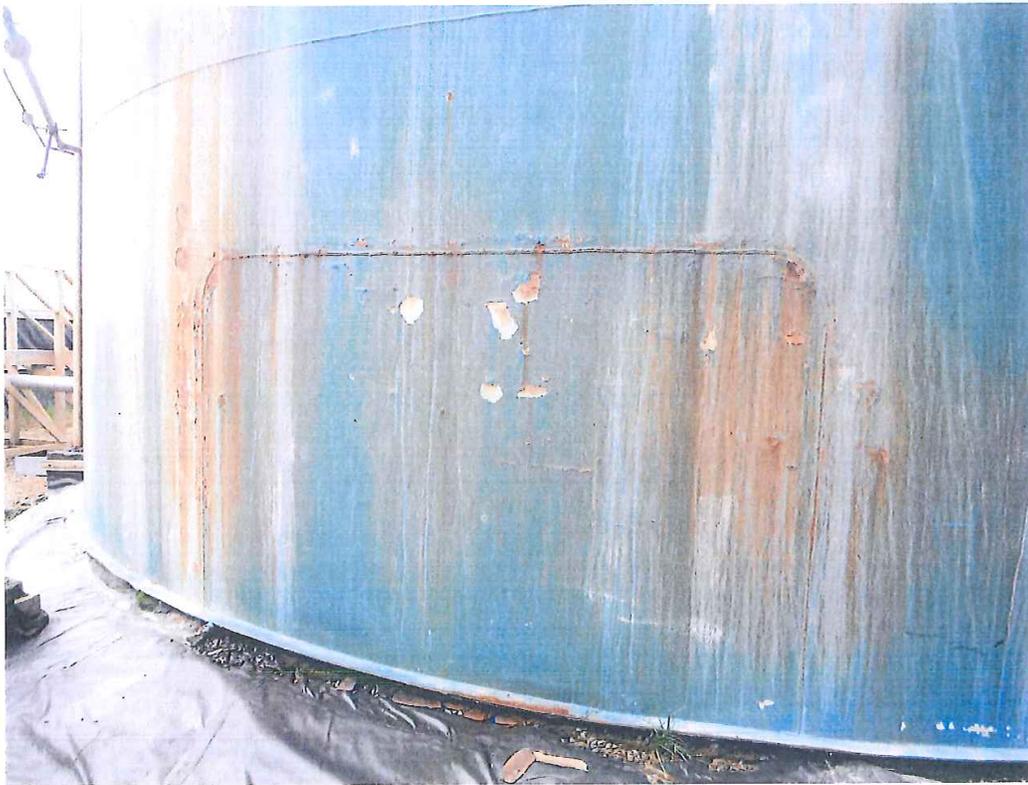
7.1 Leak area

Leak area , chine undermining, and exposed liner

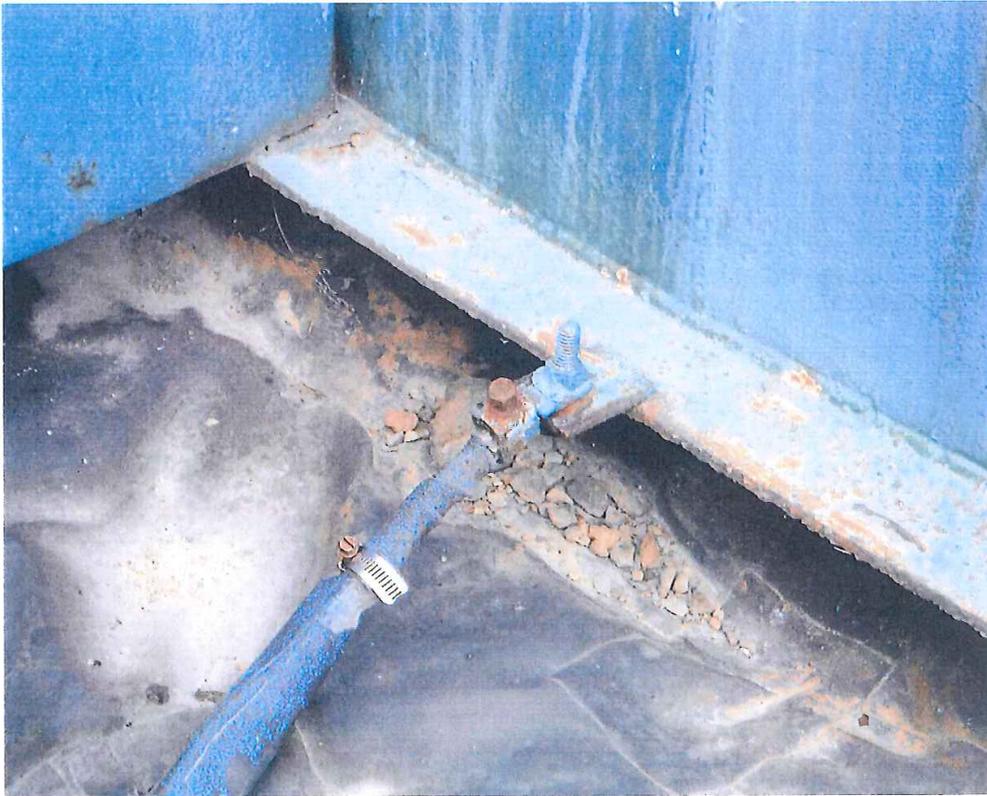
7.2 Ground wire

Grounding cable attached and in good condition

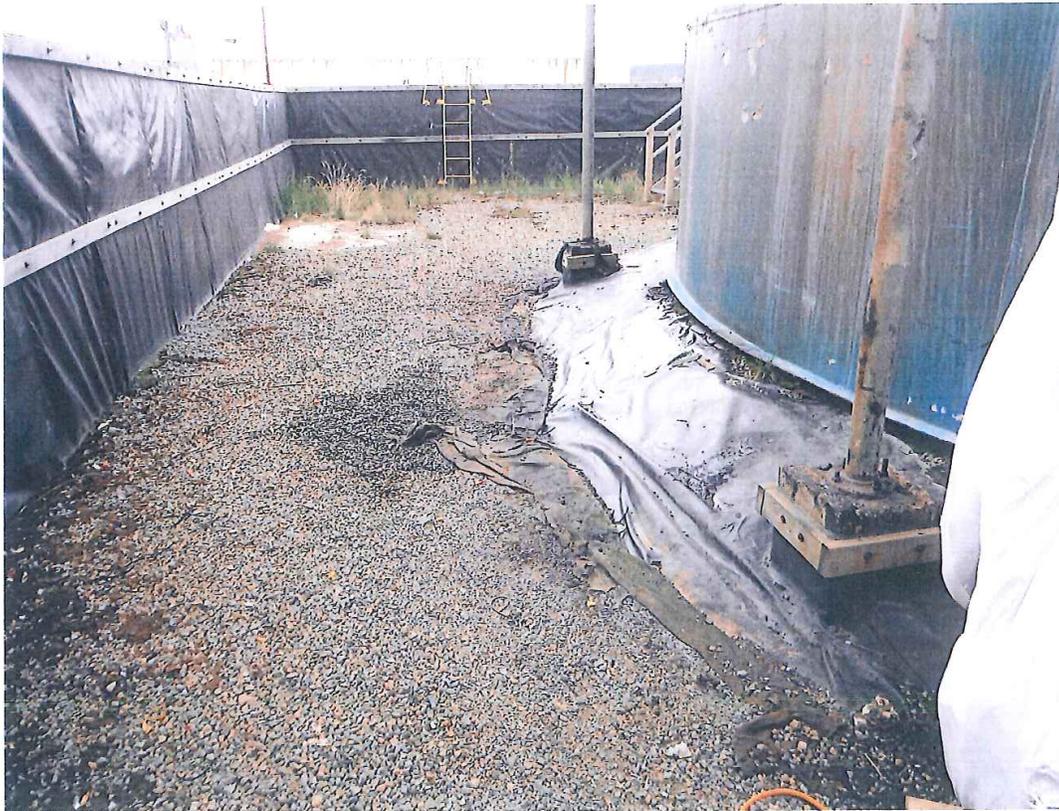
7.3 Dyke

Dyke liner failure with exposed filter fabric, vegetation in dyke

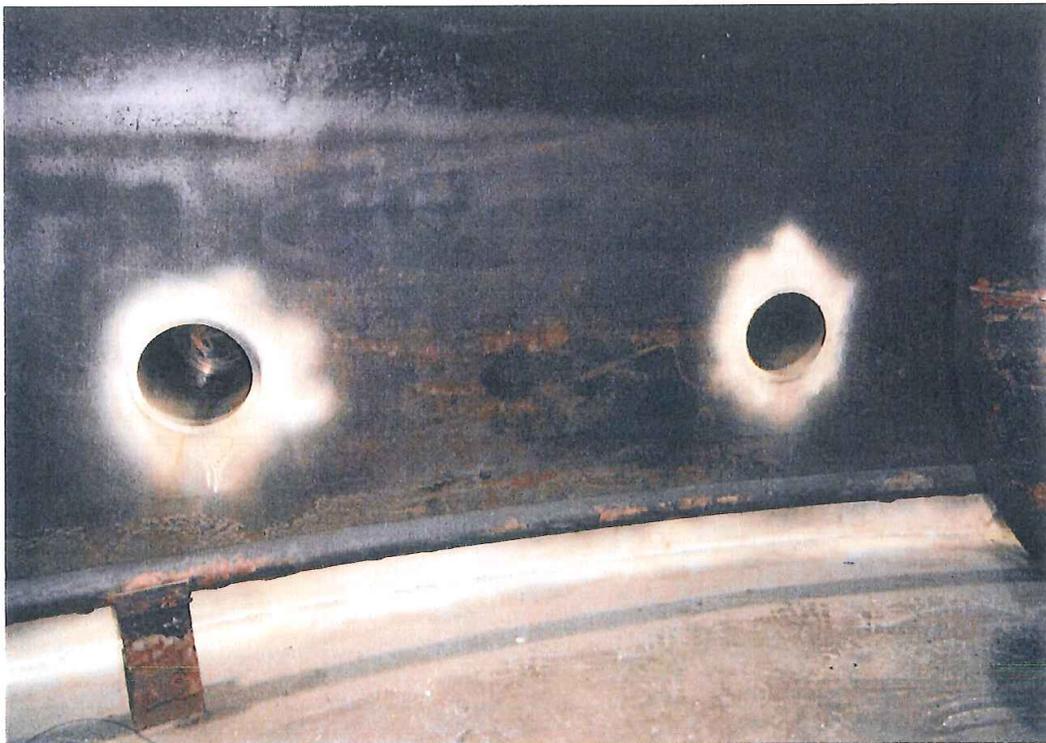
7.9 Nozzles

Bottom corner weld MPI 100% of cir. All nozzle penetrations MPI 100%

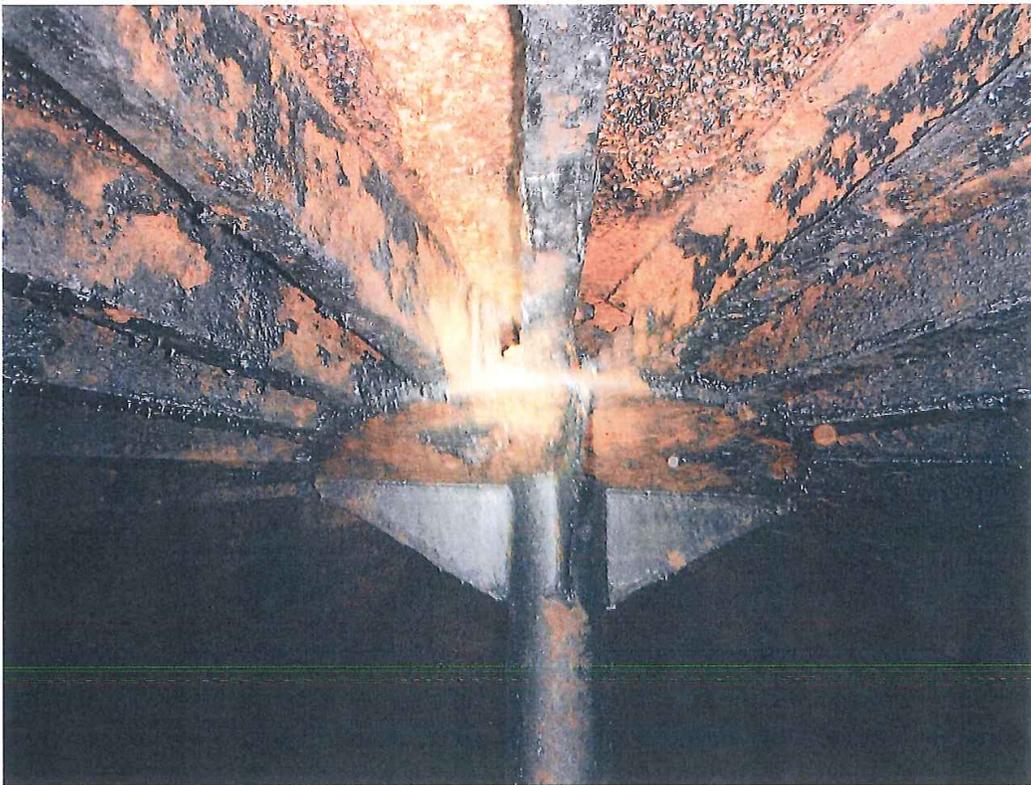
8.0 Roof rafters

Typical scaling and corrosion on Roof Rafters no issues noted

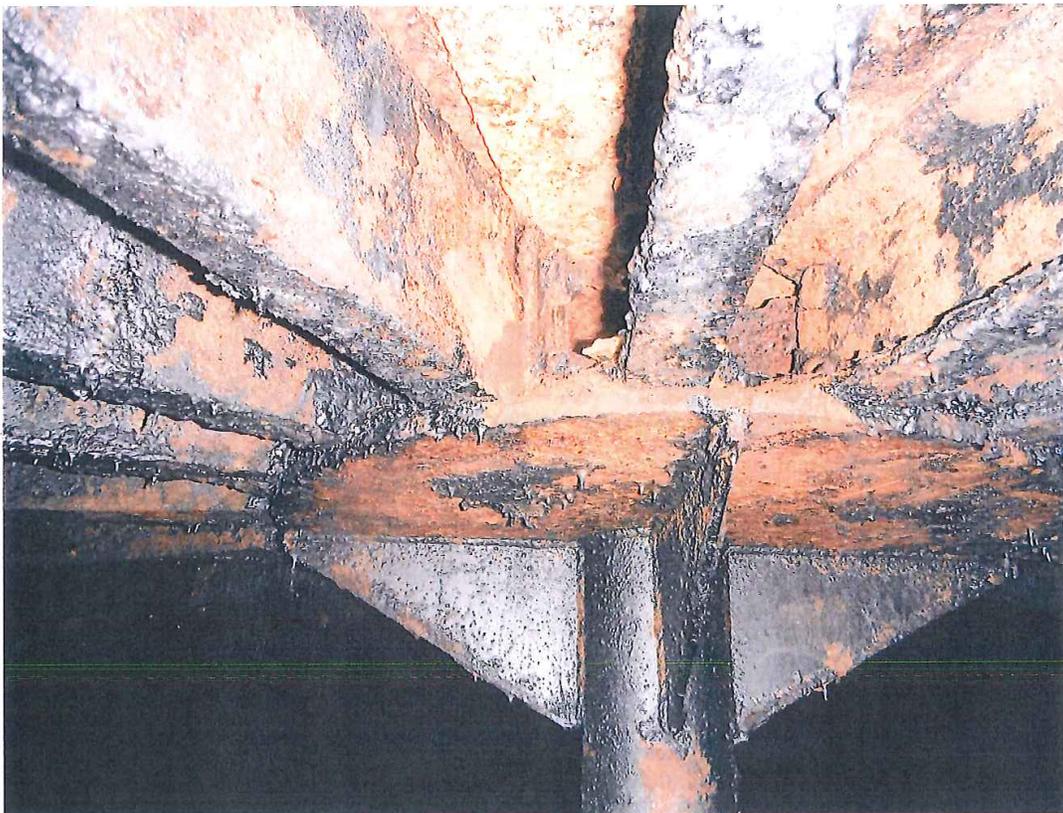
8.1 Center column

Dollar plate unable to clean due to access

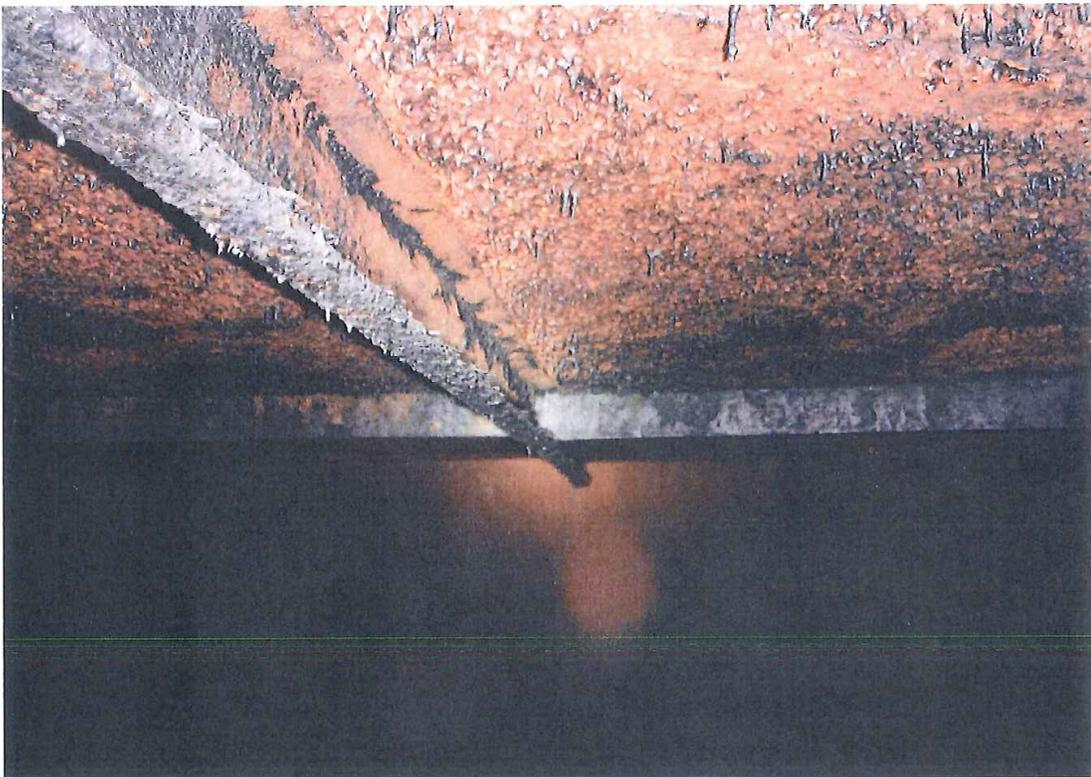
8.3 Rafters

Minor twist in rafter monitor at next Internal Inspection

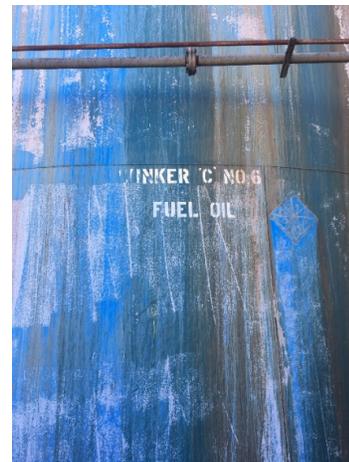
Figure 16: Tank product identification and staining on shell from corrosion on roof.

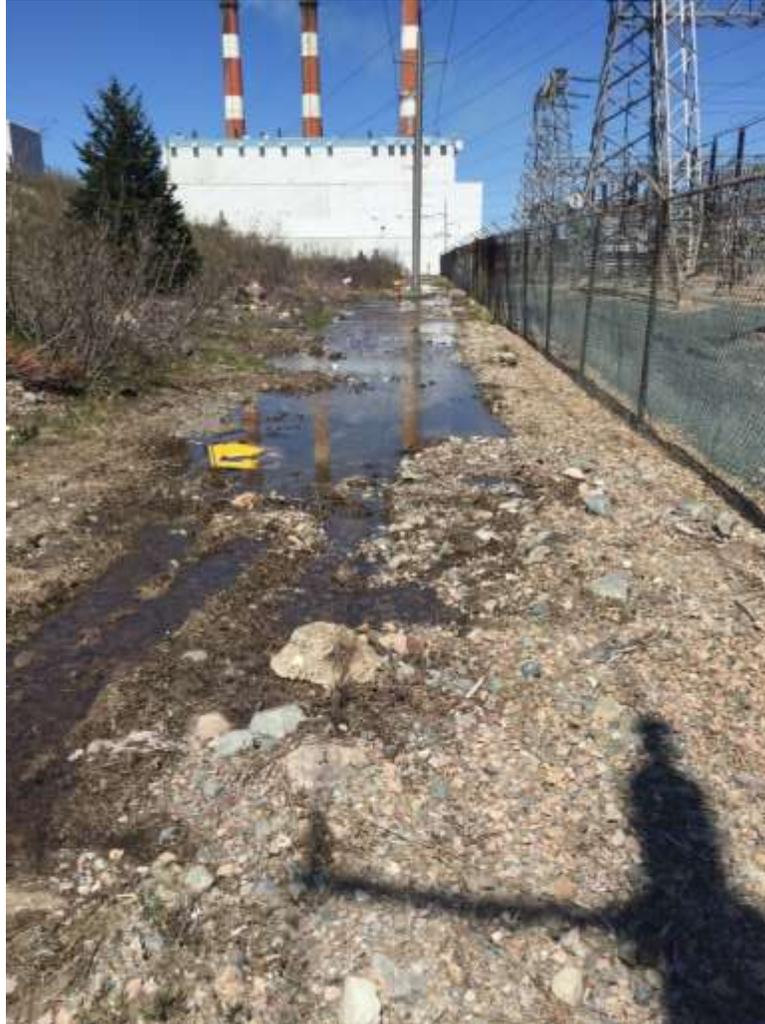
10 The tank farm firewater loop provides fire protection to the tank farm. Currently, the tank farm
11 firewater loop is in a deteriorated condition. Failures to the underground firewater distribution system
12 at the Holyrood TGS have been occurring regularly since 2018. Two hydrants and four isolation valves on
13 the tank farm firewater loop failed in 2019 and 2020 and required replacement. Figure 2 shows
14 firewater system leakage that resulted from a break in the tank farm firewater loop in 2019. The leakage
15 caused flooding to the surrounding area near the terminal station and the replacement of a valve and
16 section of pipe was required. The HTGS Study highlighted the deteriorated condition of the underground
17 firewater distribution system at the Holyrood TGS, including the tank farm firewater loop.

Figure 2: Flooding Near the Terminal Station due to a Break on the Tank Farm Firewater Loop

19. The proposed project involves the replacement of the original underground firewater distribution system surrounding the tank farm to reduce the risk of firewater system impairment, therefore mitigating the associated reliability and safety risk associated with a fire in the tank farm area. Deferral of this project could result in frequent and extensive failures that require extended periods to repair, leaving the tank farm without firewater protection. Hydro believes this is an unacceptable risk to the reliable service of the Holyrood TGS in light of its operational extension to March 31, 2024. Further details with respect to the proposed project are contained in Schedule 3 to this application.
