July 15, 2025

**Re: 2026 Capital Budget Application**

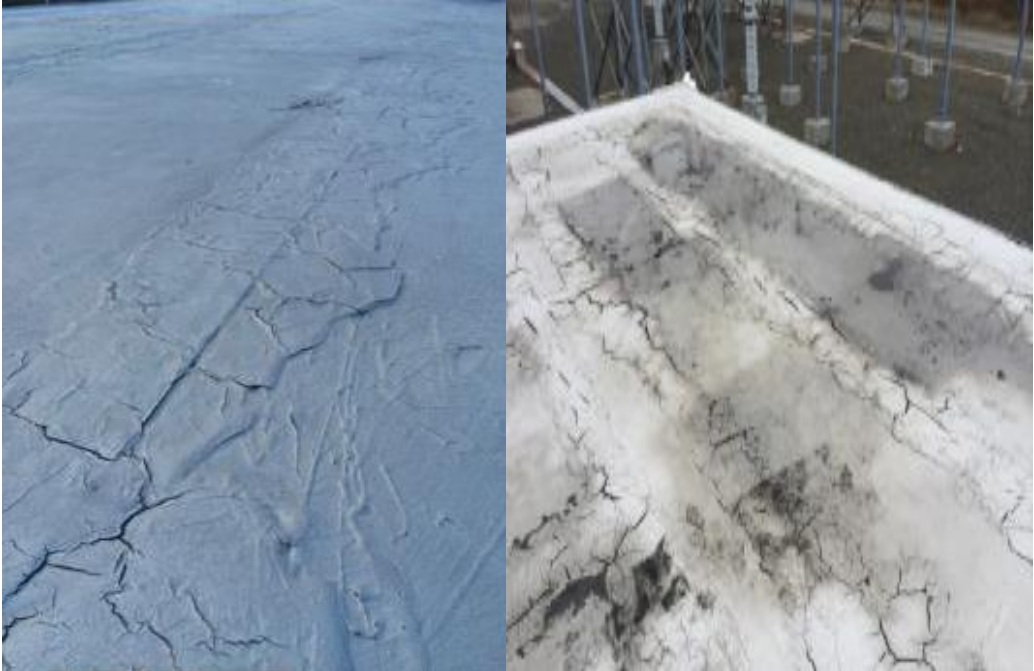
**Figure 16: Terminal Station Control Buildings Showing Cracking and Deterioration of the Roof Membrane System**

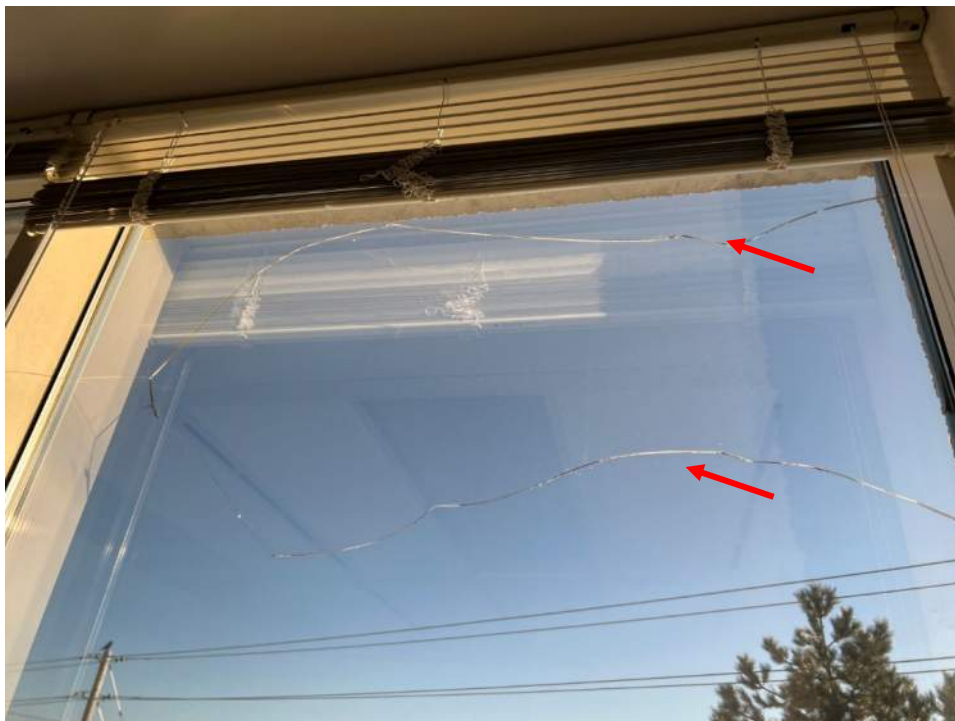
Photo No. 6: Typical view of cracked and showing an annealed breakage pattern windows (red arrows)

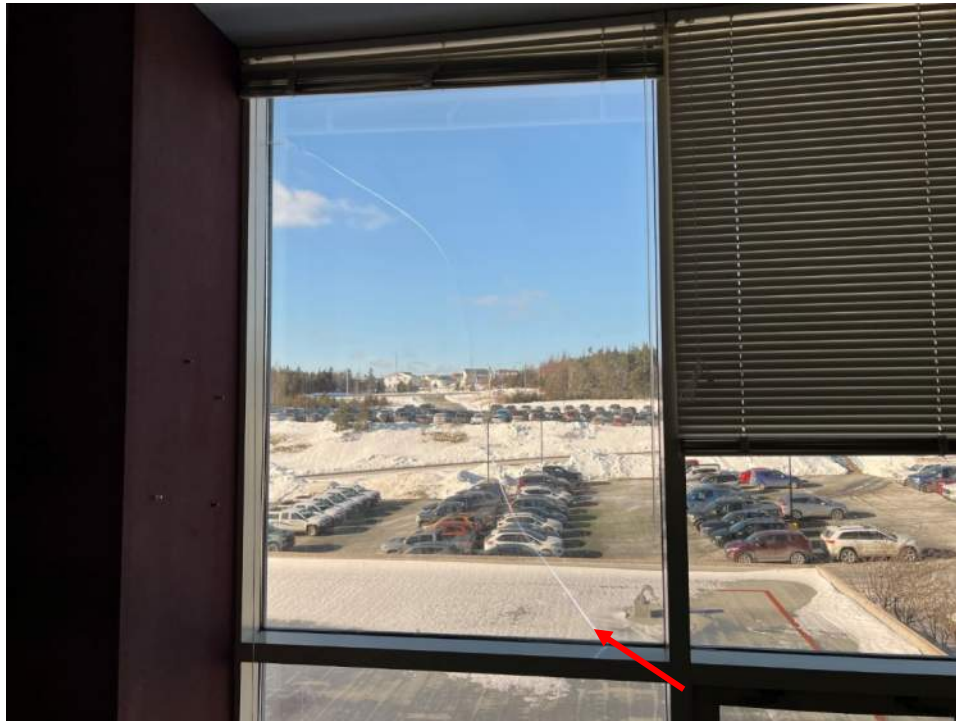
Photo No. 7: Typical view of cracked and showing an annealed breakage pattern windows (red arrow)

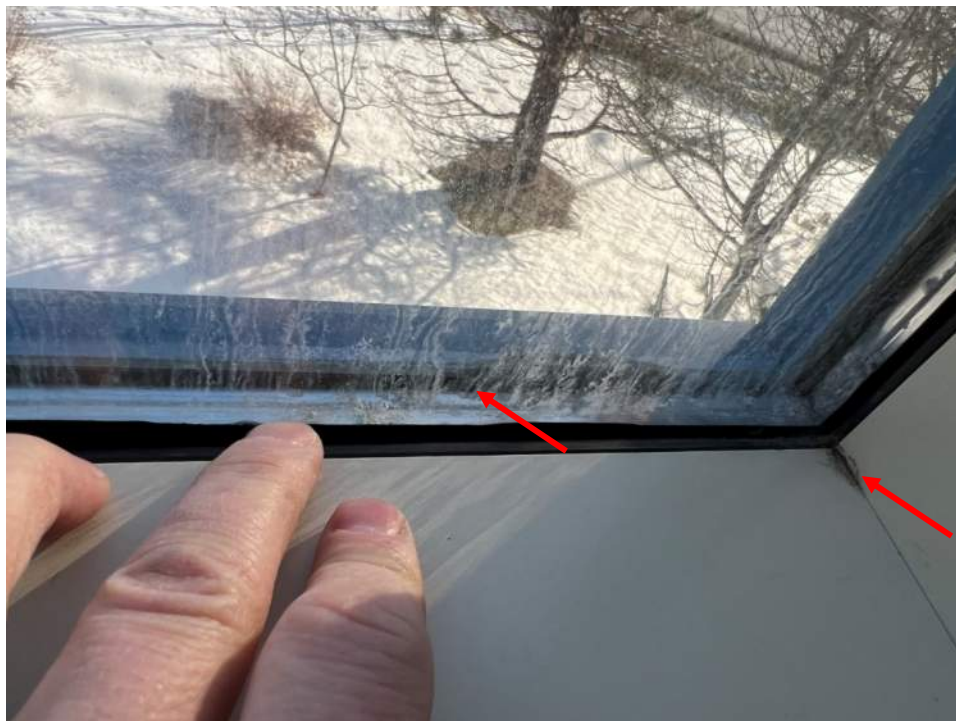
Photo No. 8: Typical view of curtain wall is in fair-to-poor condition overall (red arrows)

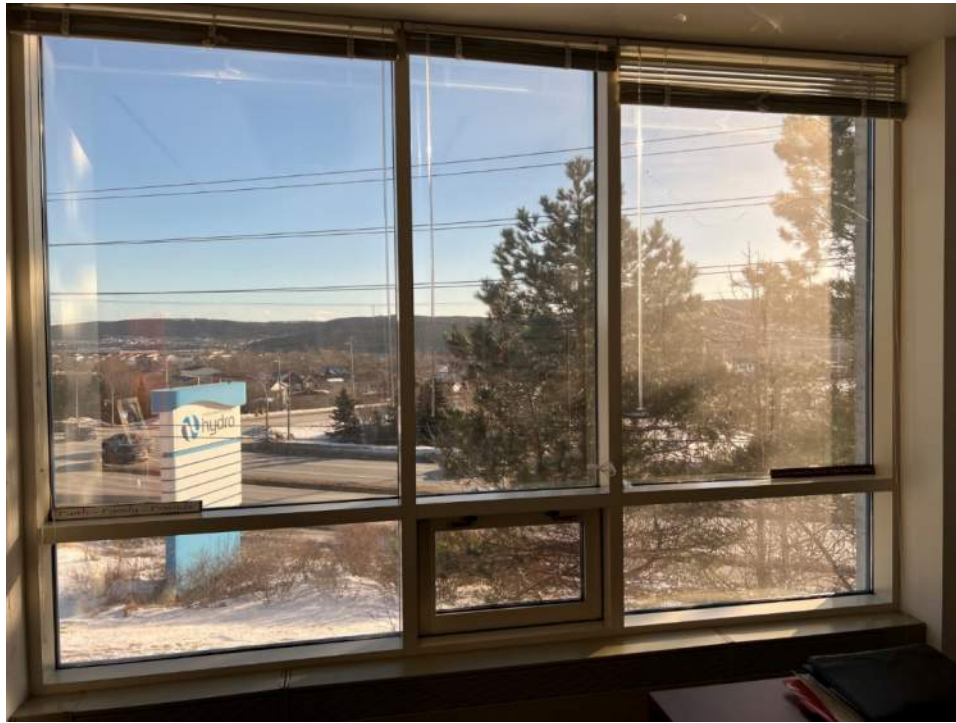
**Photo No. 9:** Overview of curtain wall is in fair-to-poor condition overall

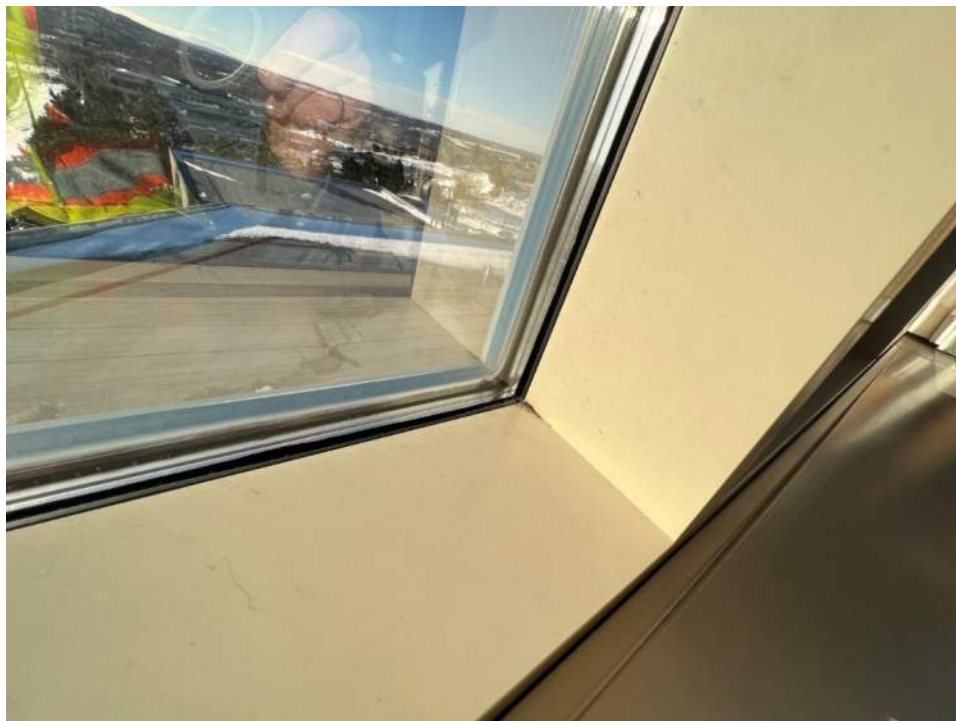
**Photo No. 10:** Typical view of curtain wall is in fair-to-poor condition overall

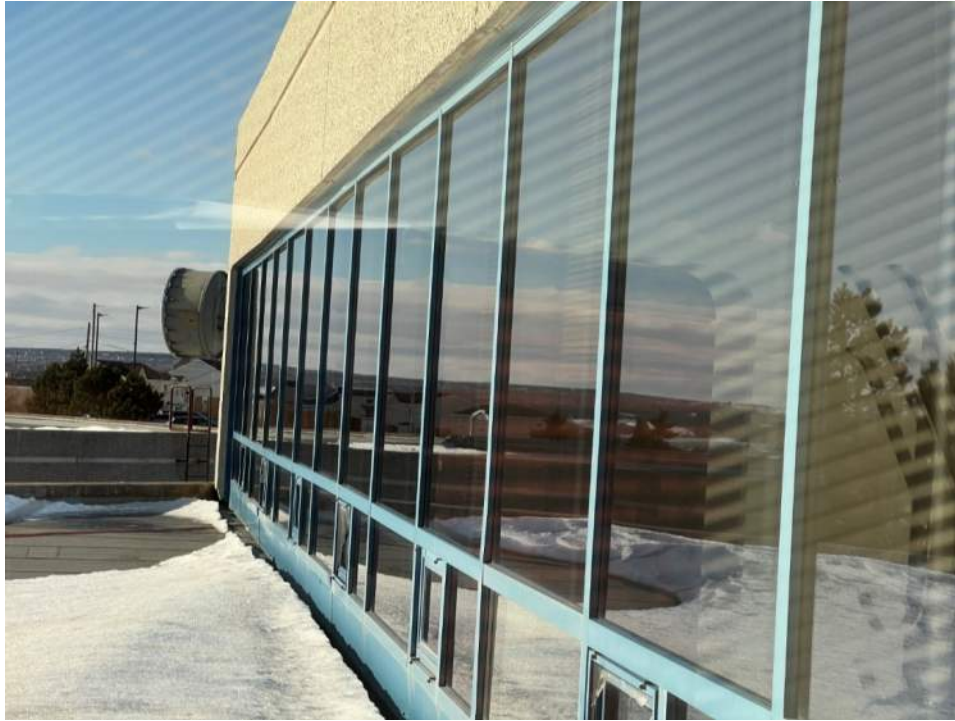
**Photo No. 11:** Typical view of curtain wall is in fair-to-poor condition overall with fading of the exterior caps

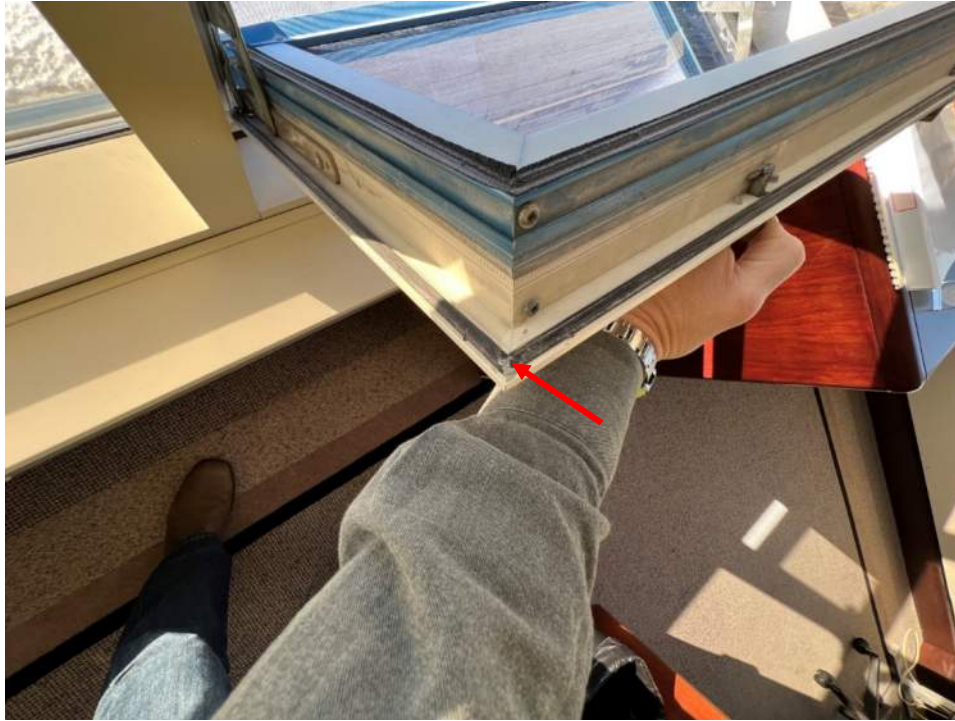
**Photo No. 13:** Typical view of weather stripping appears in poor condition (red arrow)

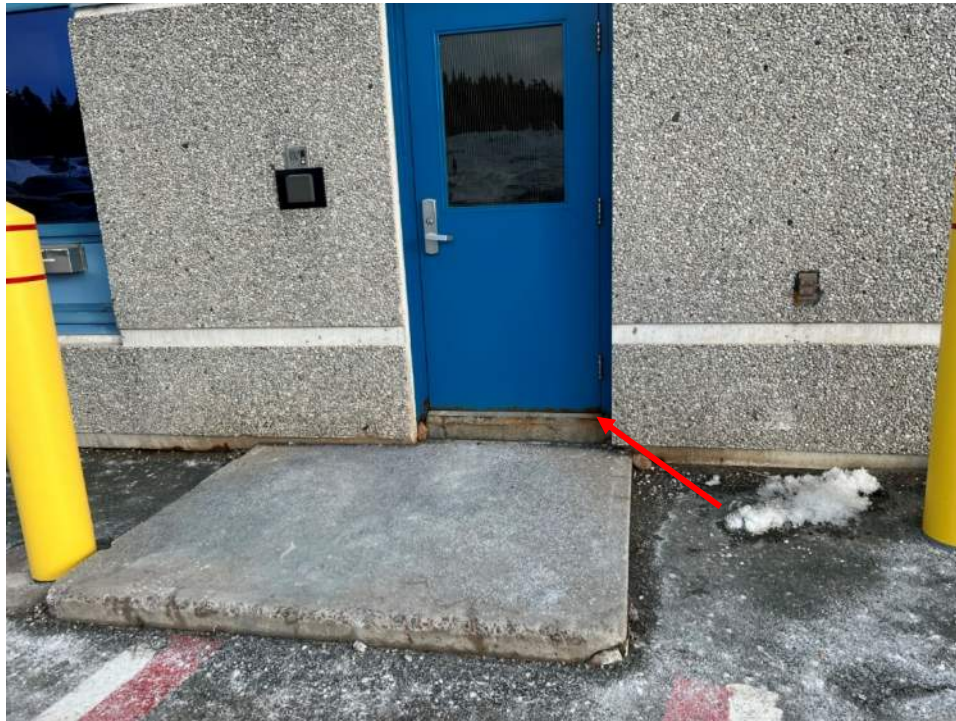
**Photo No. 23:** Typical view of anodizing is noted faded, and there is rust formation at the bottom of the doors (red arrow)

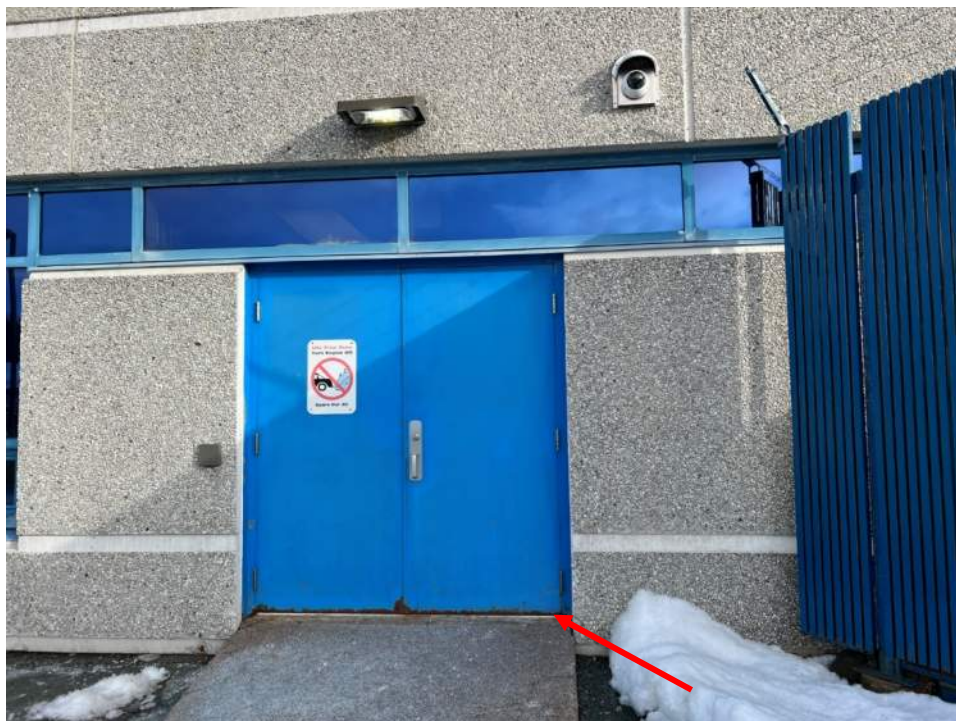
**Photo No. 24:** Typical view of rust formation at the bottom of the doors (red arrow)

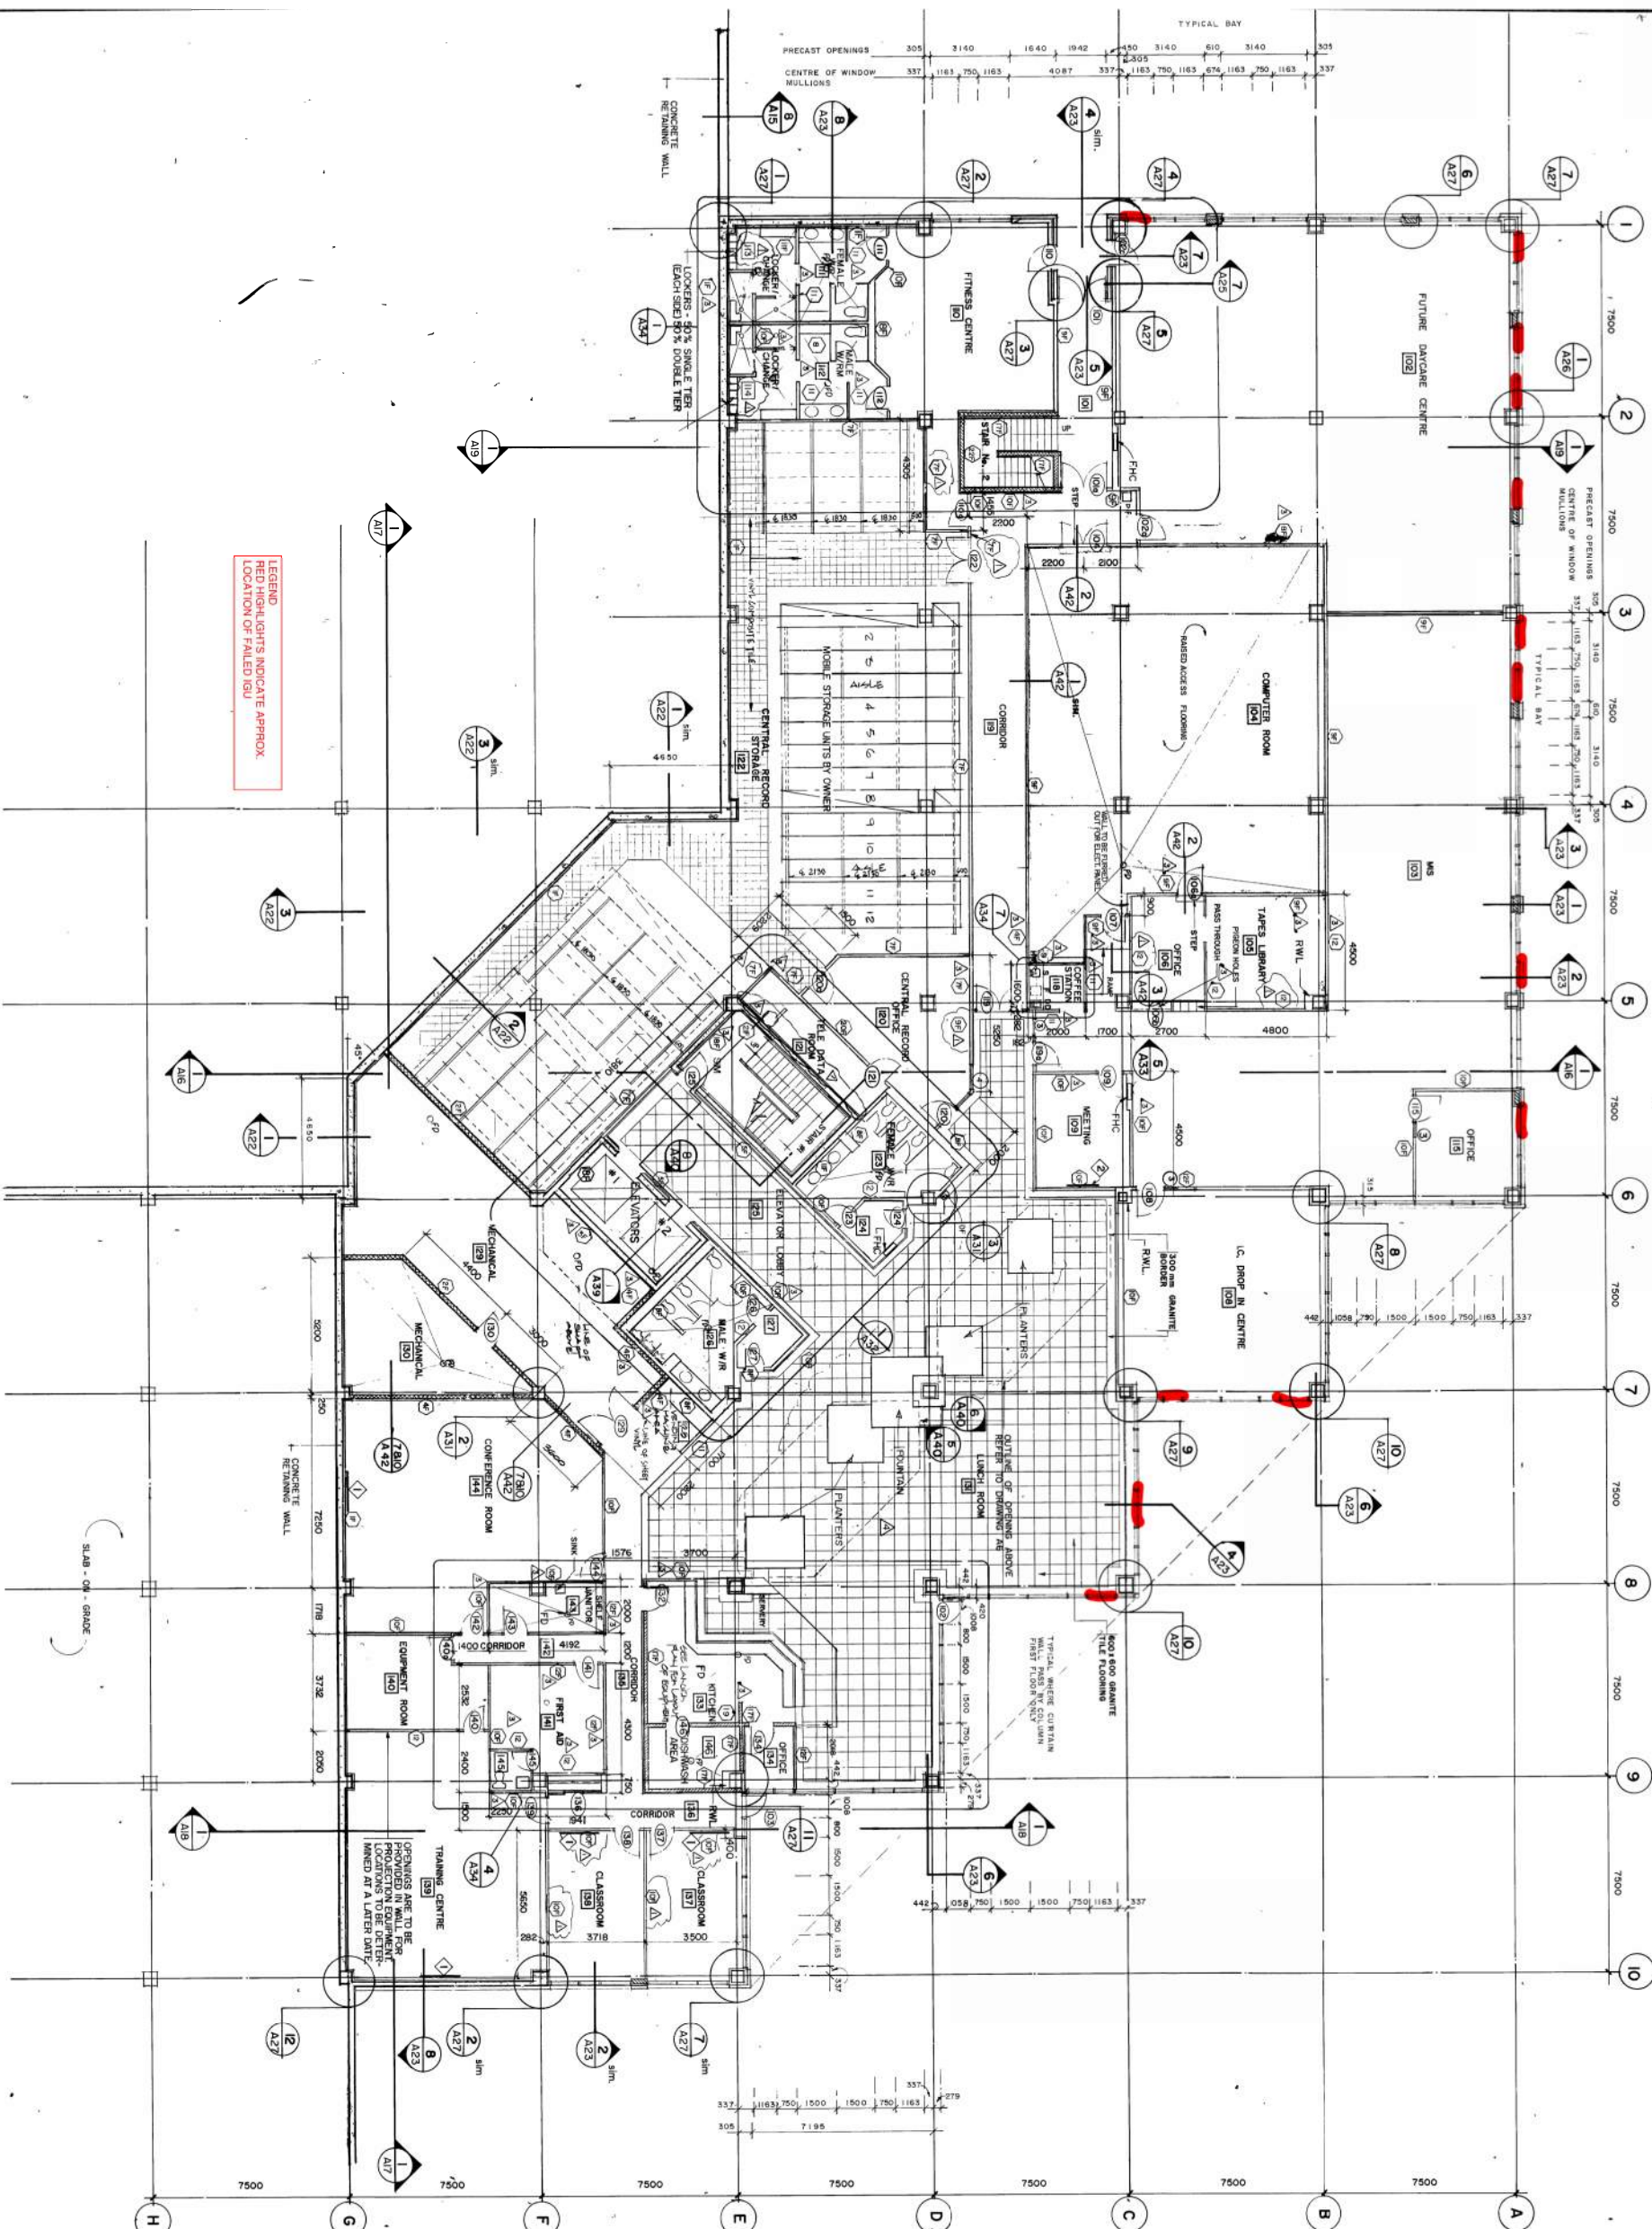
### Approximate IGU Failure Locations

LEGEND  
RED HIGHLIGHTS INDICATE APPROX.  
LOCATION OF FAILED ISU

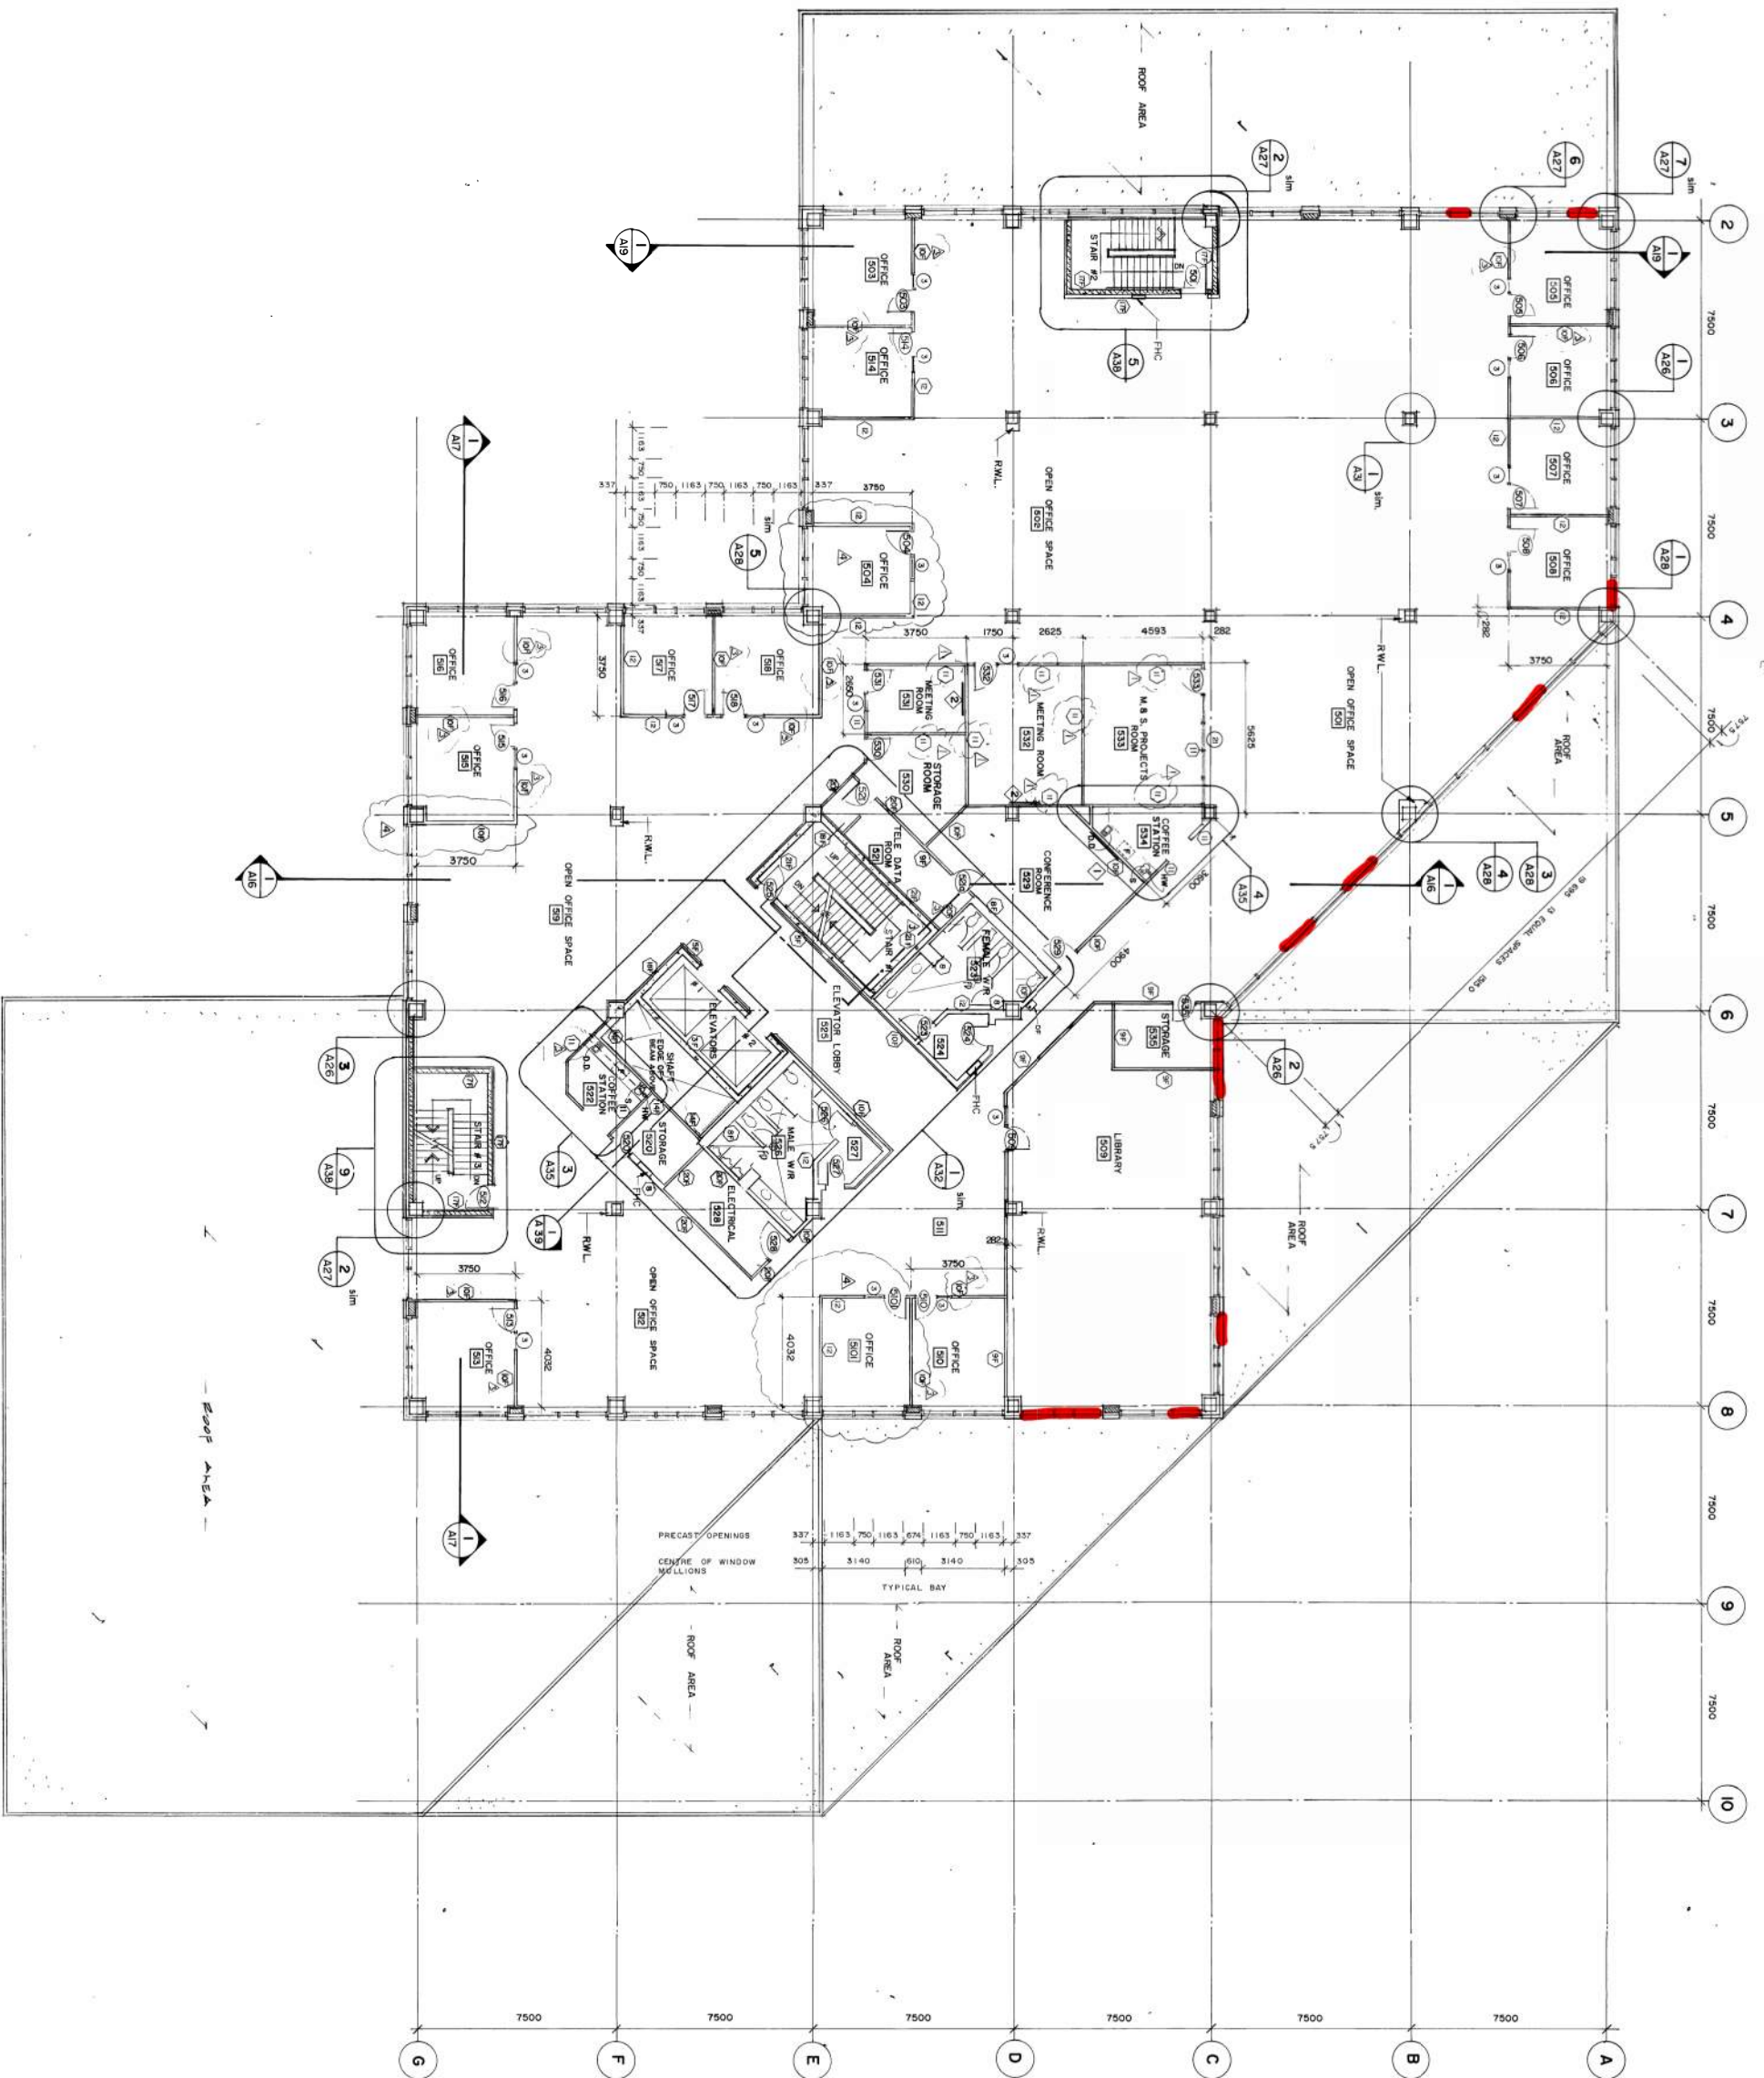
Roof Area

LEGEND  
RED HIGHLIGHTS INDICATE APPROX.  
LOCATION OF FAILED IGU

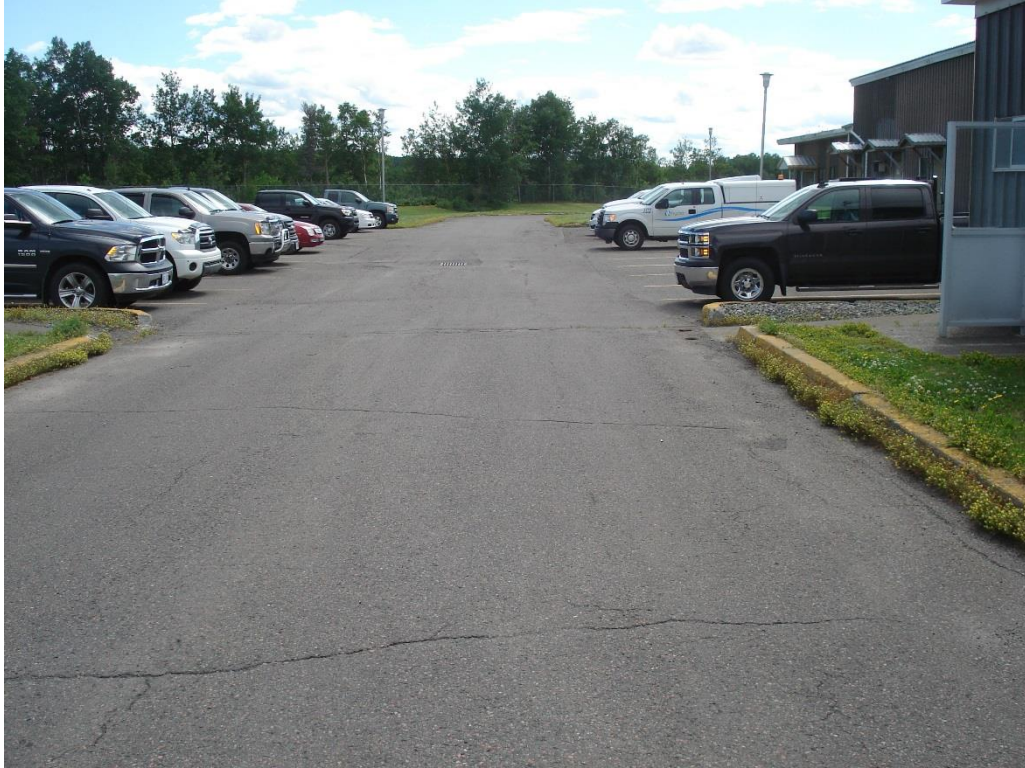
Photo 1 - Asphalt Cracking

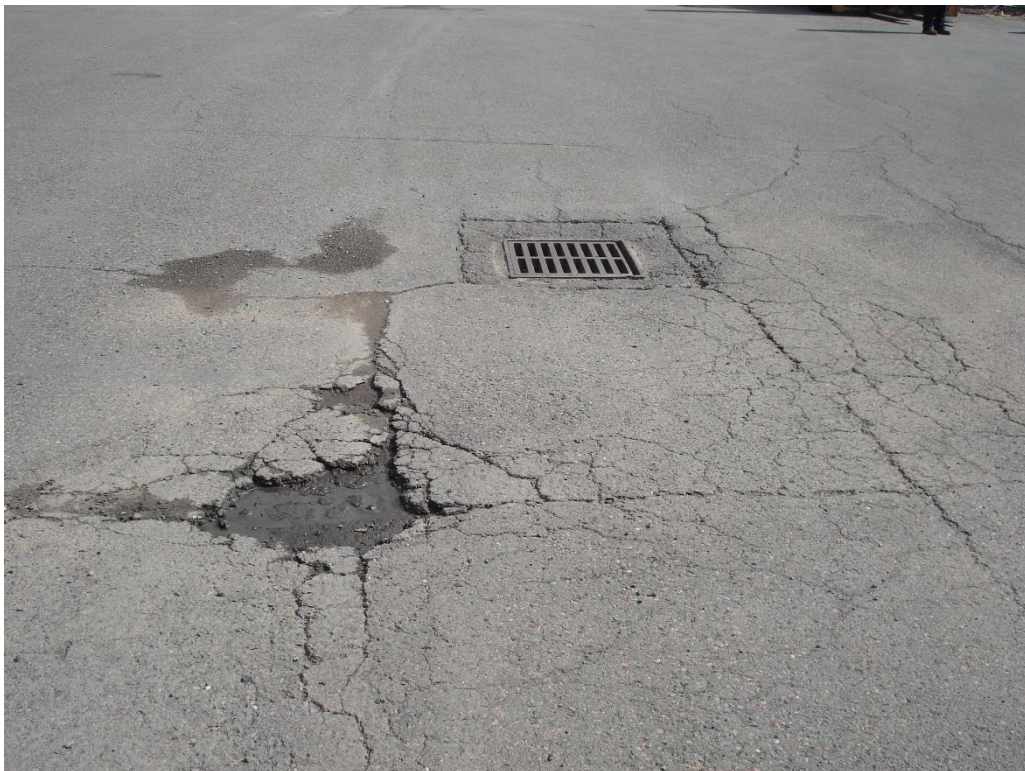
Photo 2 - Asphalt Degrading

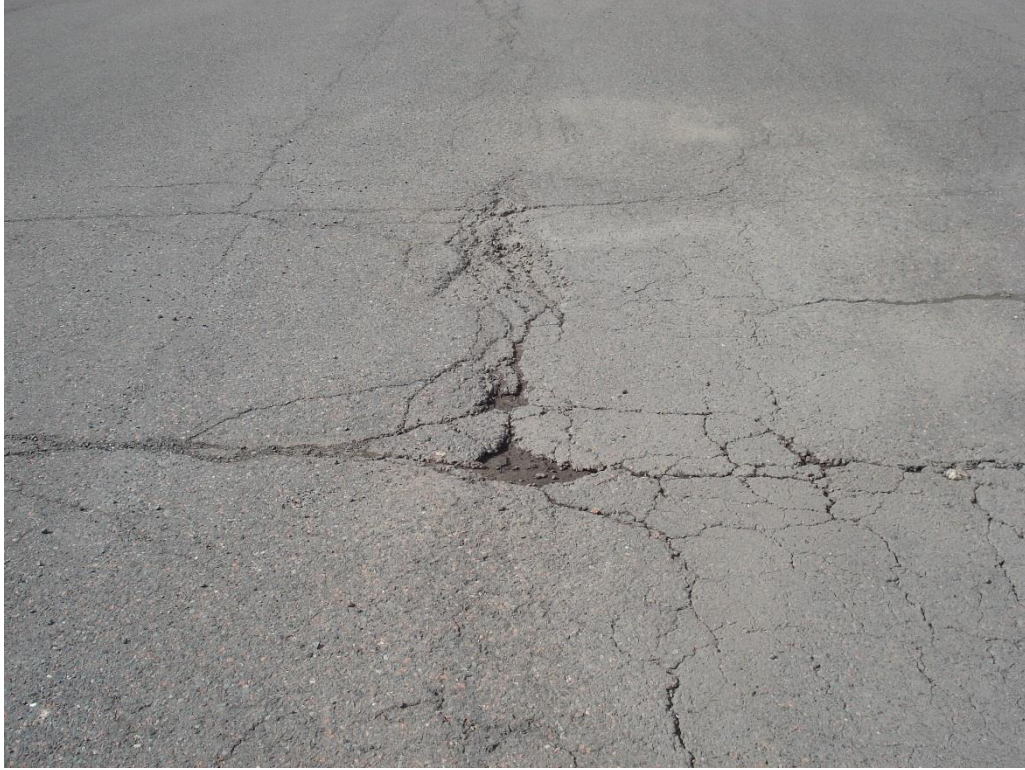
Photo 3 - Asphalt Degrading

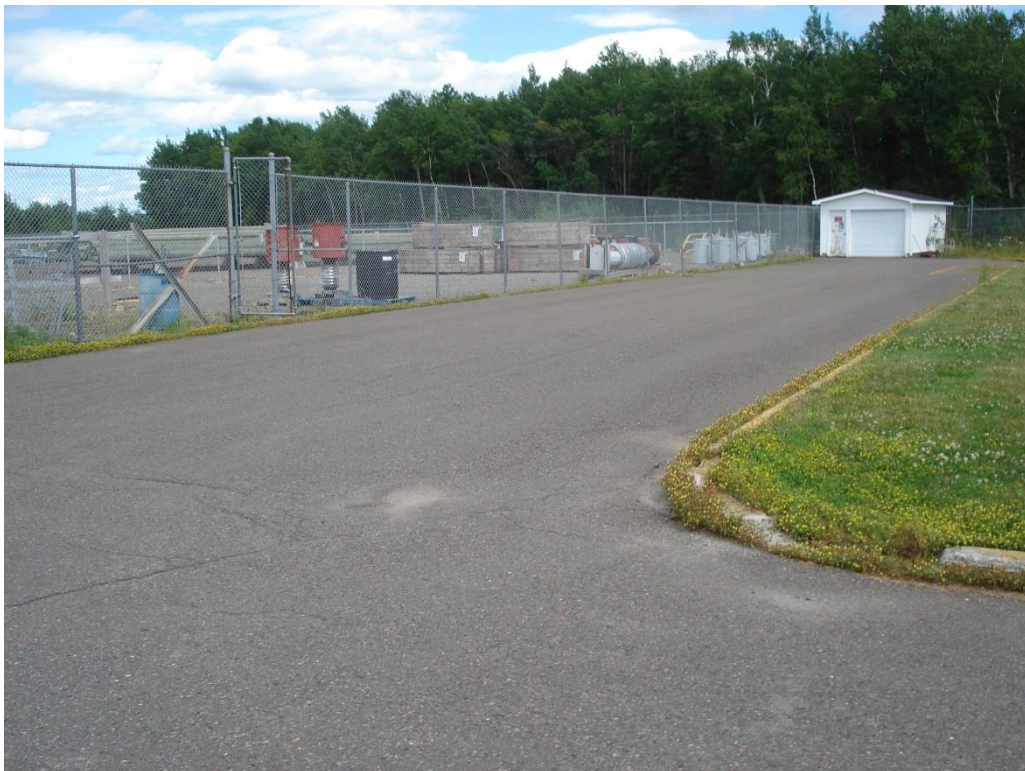
Photo 4 - Curb Damage

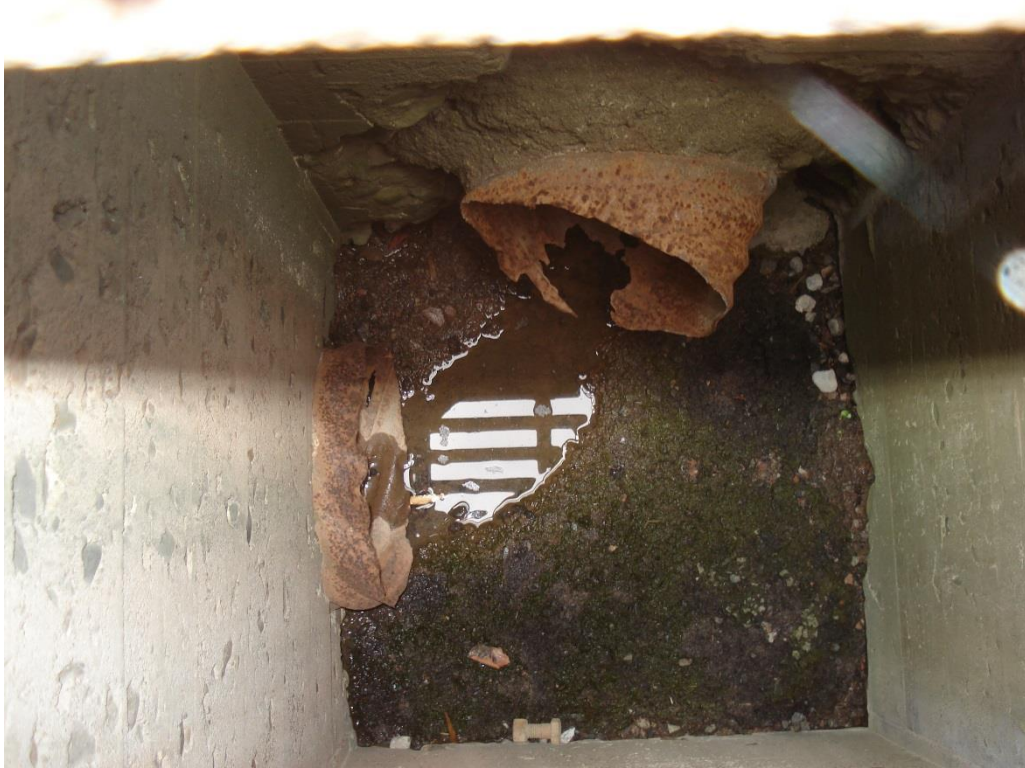
Photo 13 - CMP Corroded

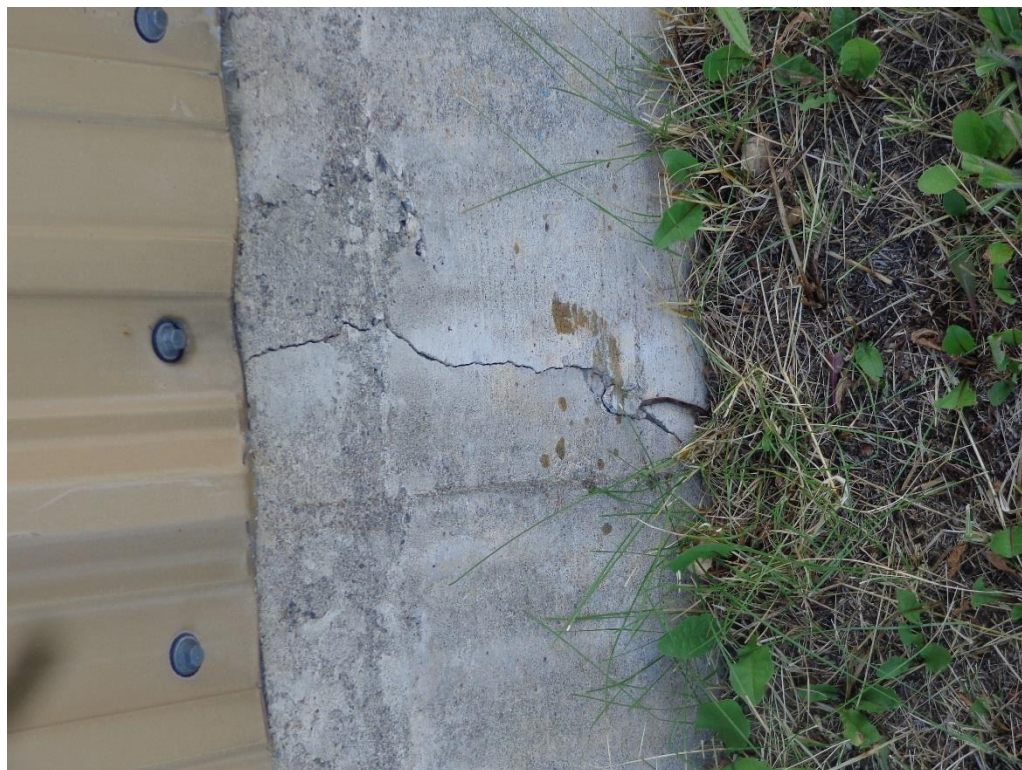
Photo 1 - Vertical Crack in Foundation Wall

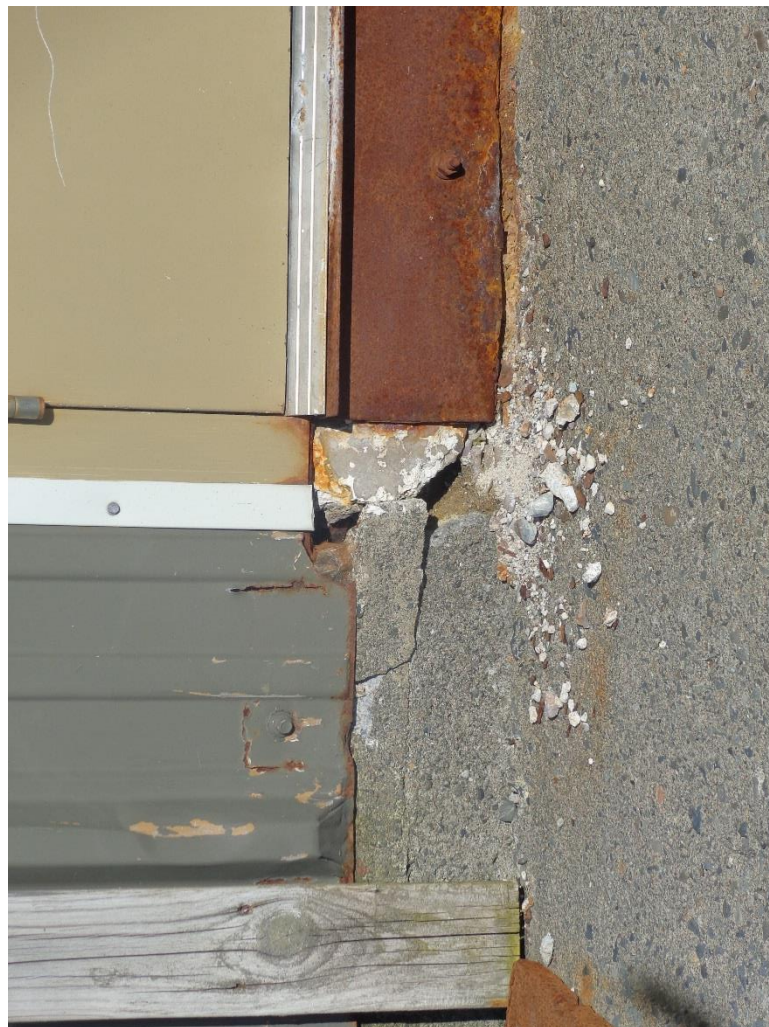
Photo 2 - Damage to Concrete Foundation Wall

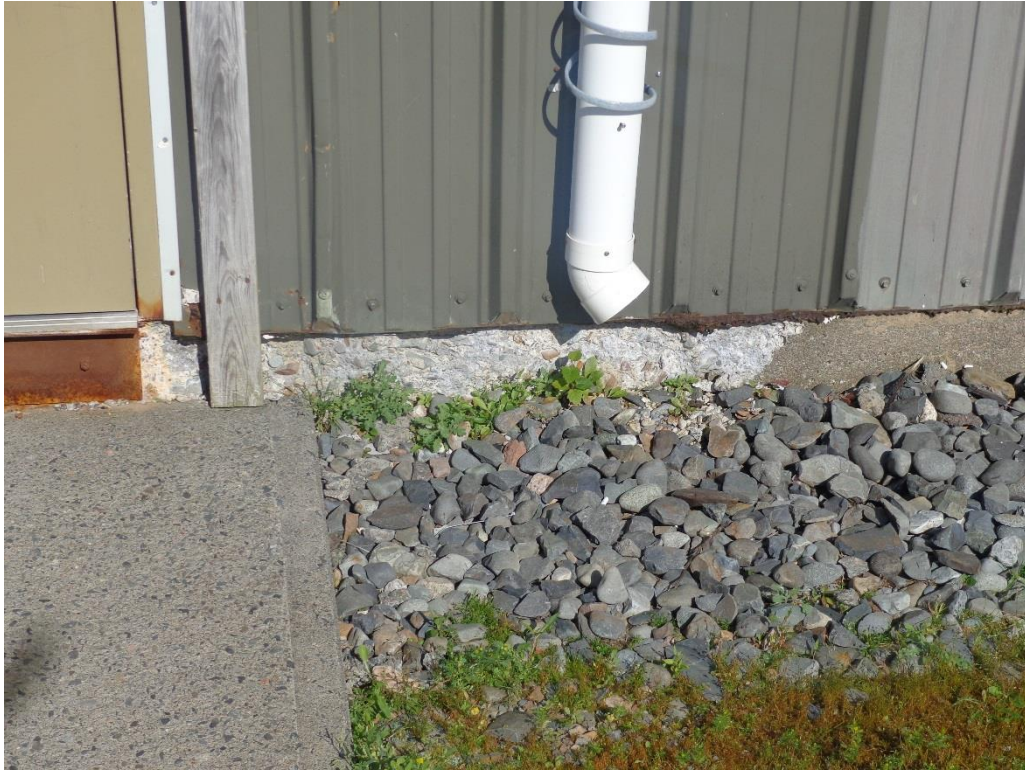
*Photo 3 - Scaled Concrete on Foundation Wall*

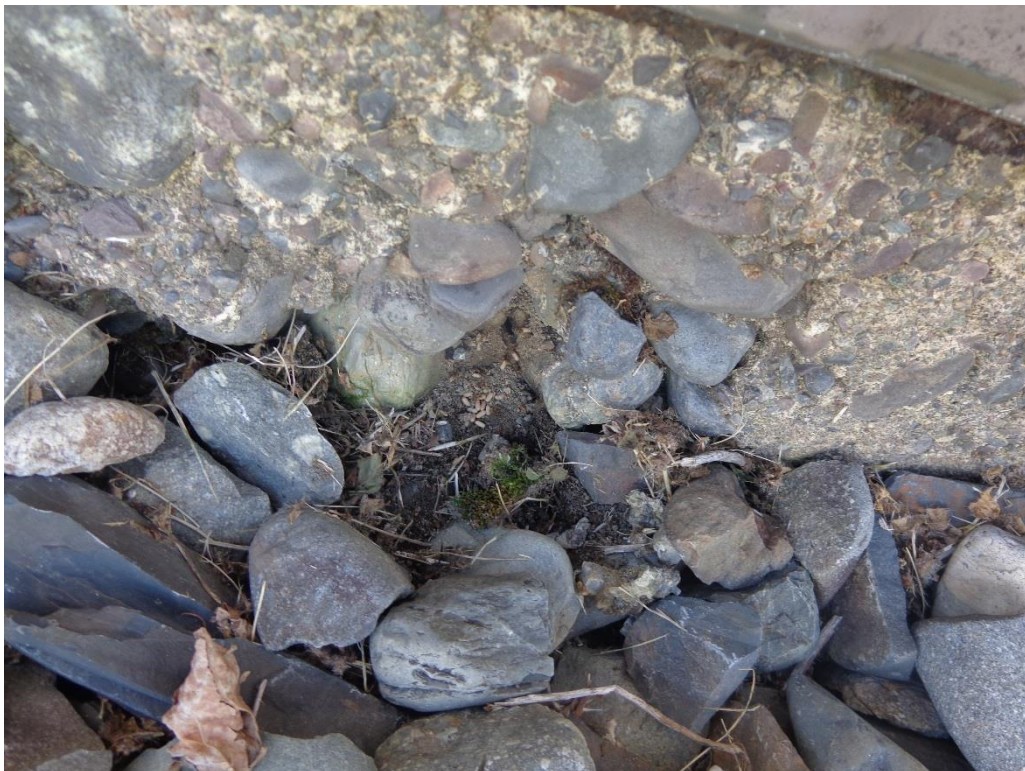
*Photo 4 - Ants Entering Building Through Foundation Wall*

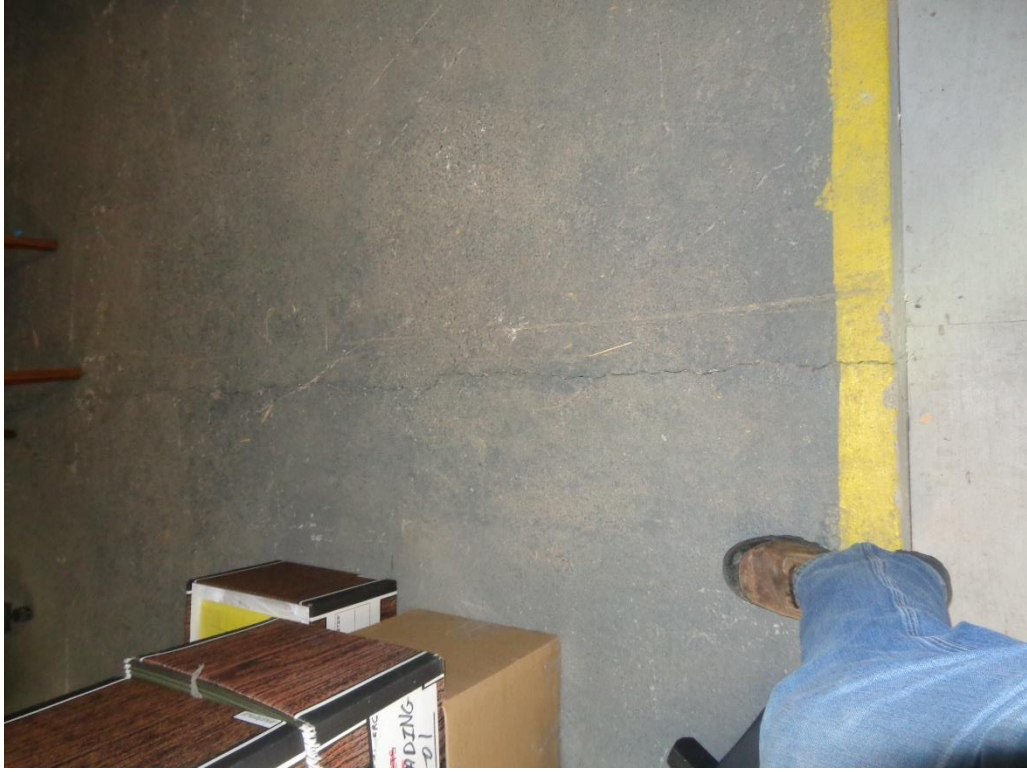
Photo 16 - Small Shrinkage Crack in Slab
