July 15, 2025

**Re: 2026 Capital Budget Application**

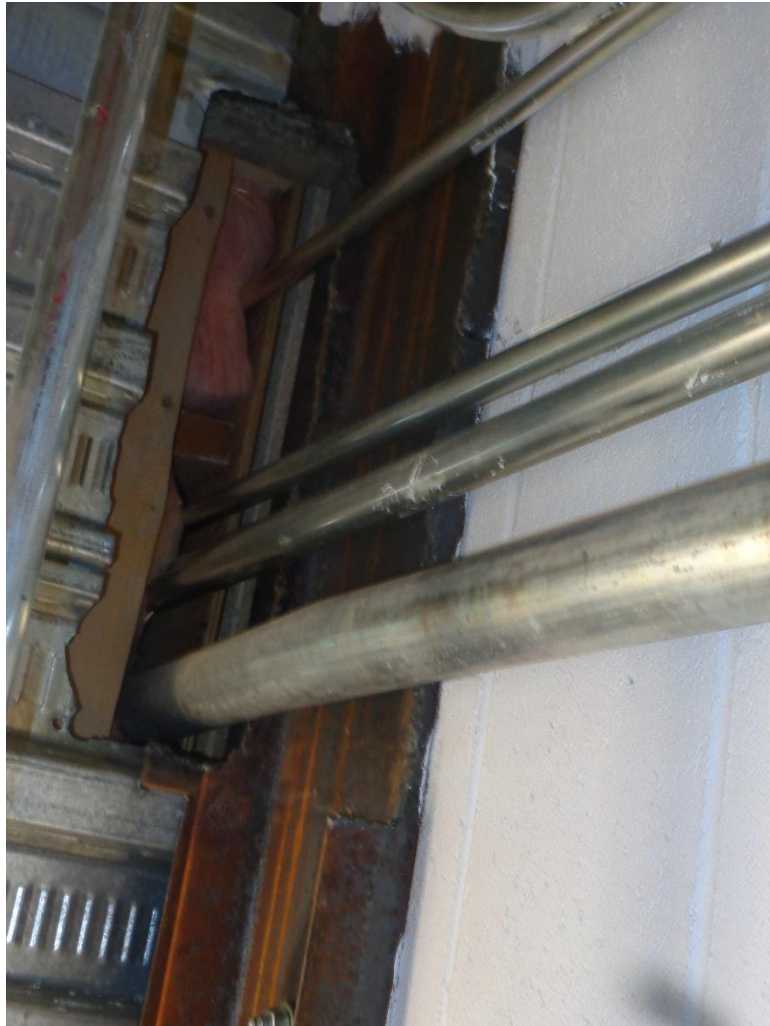
Photo 15 - Channel's Flanges Removed

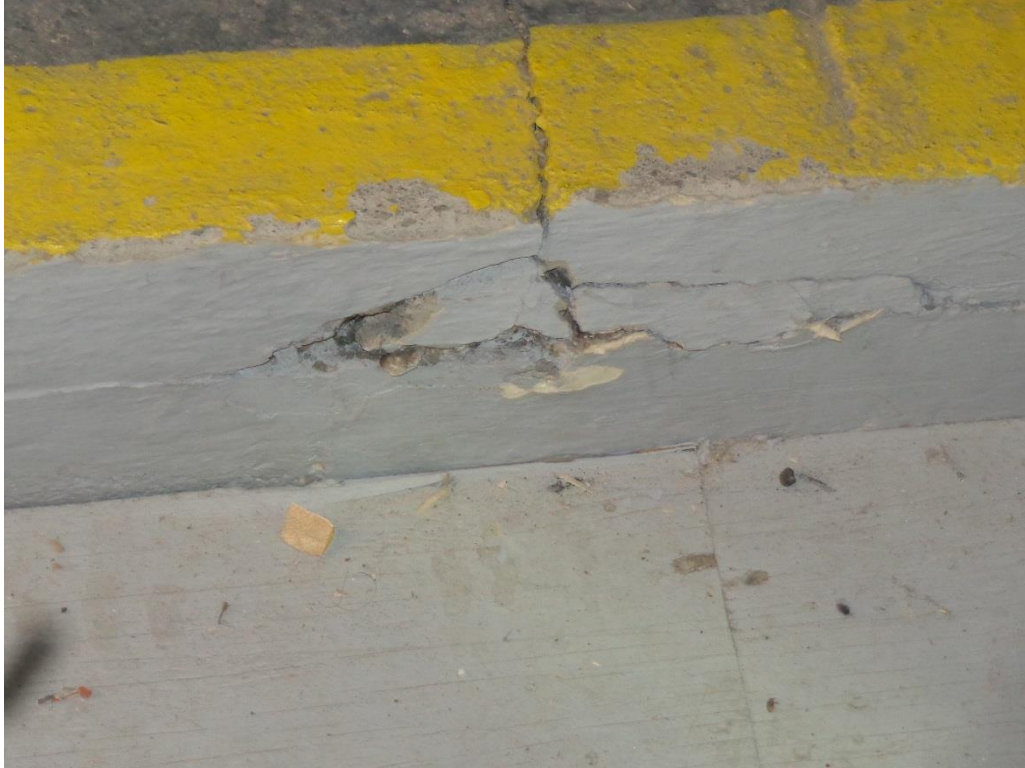
Photo 17 - Horizontal Crack in Slab

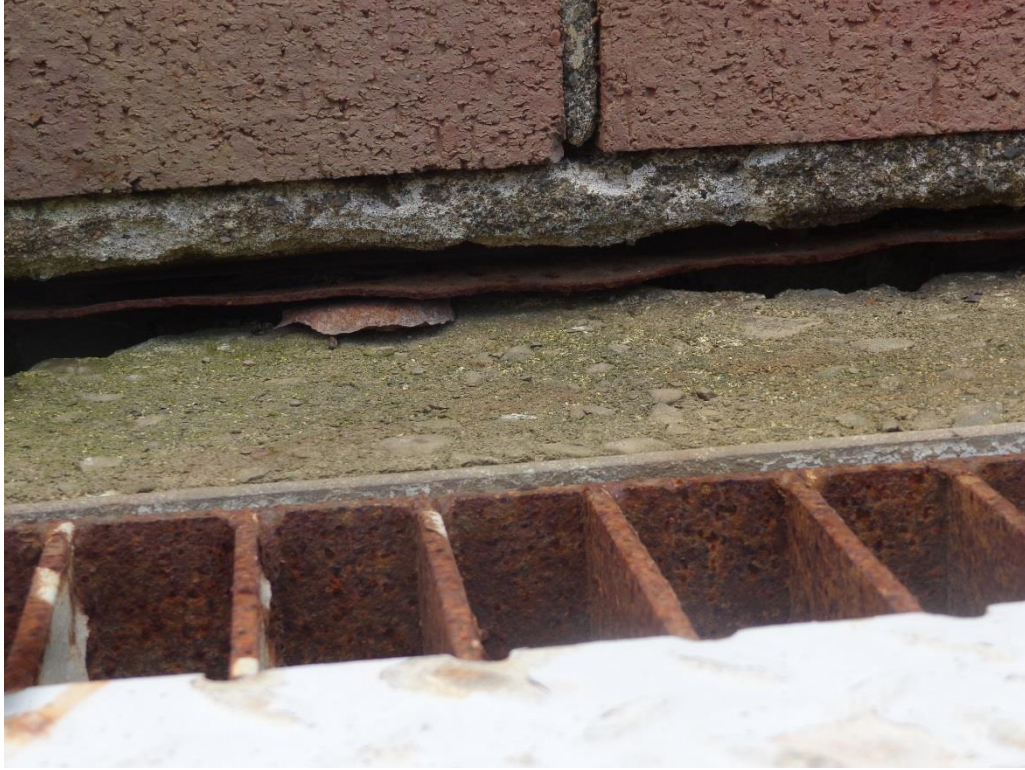
Photo 19 - Shelf Angle in Poor Condition

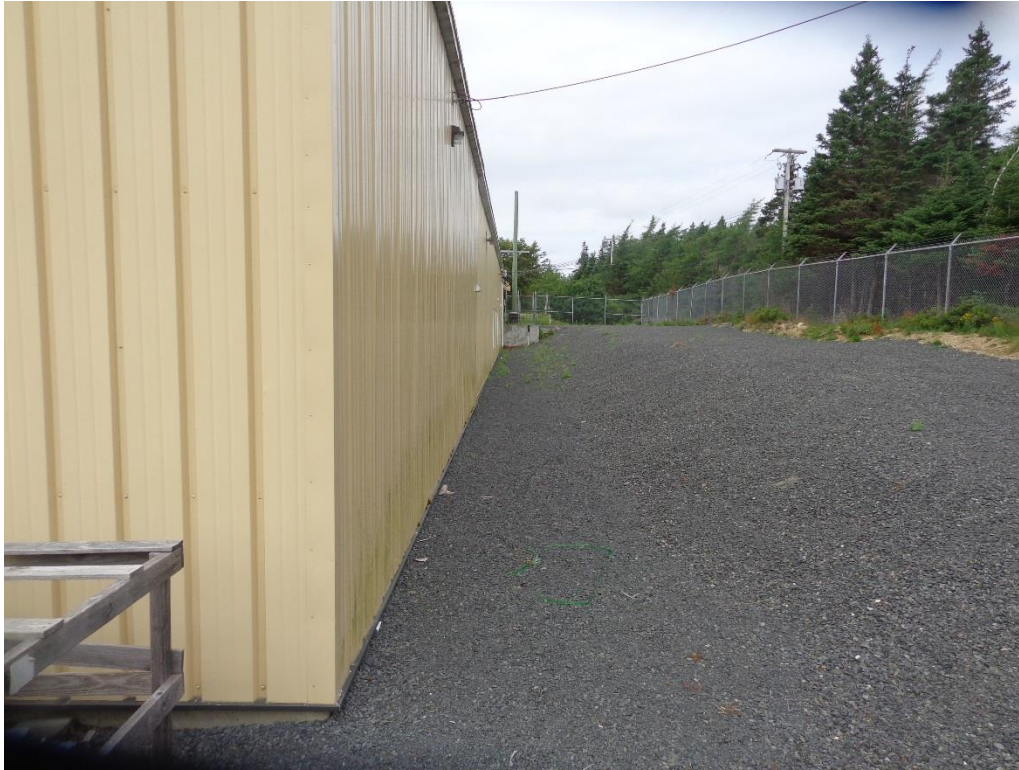
*Photo 1 - Site Grading Towards Foundation Wall*

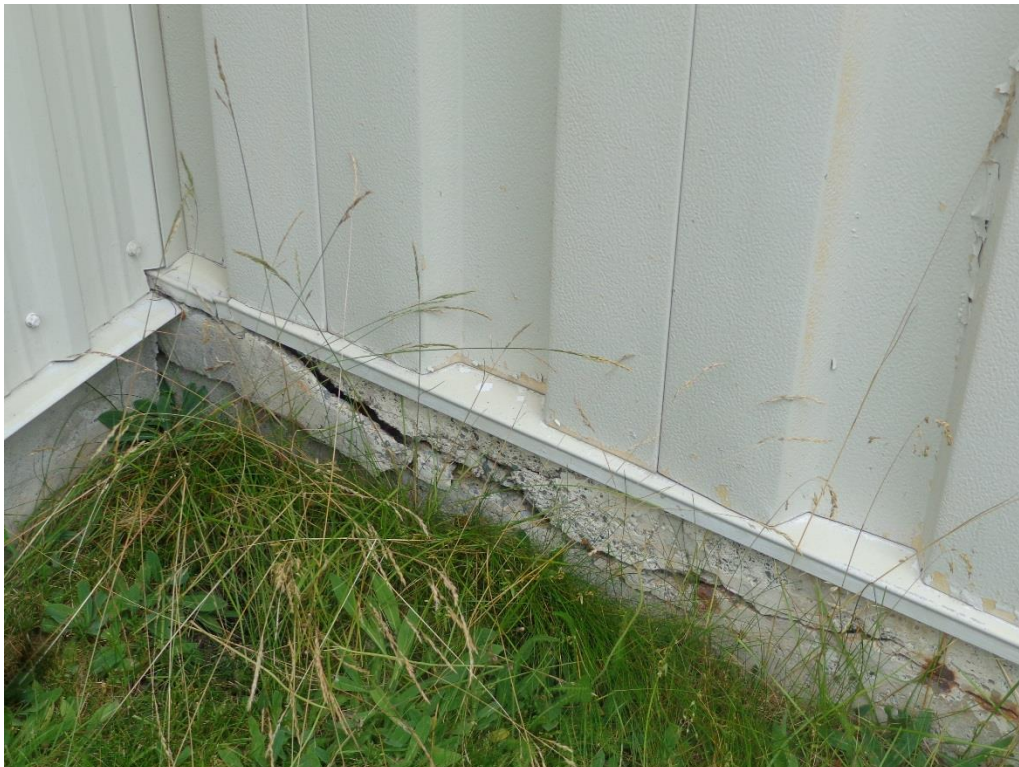
*Photo 2 - Large Horizontal Cracks in Foundation*

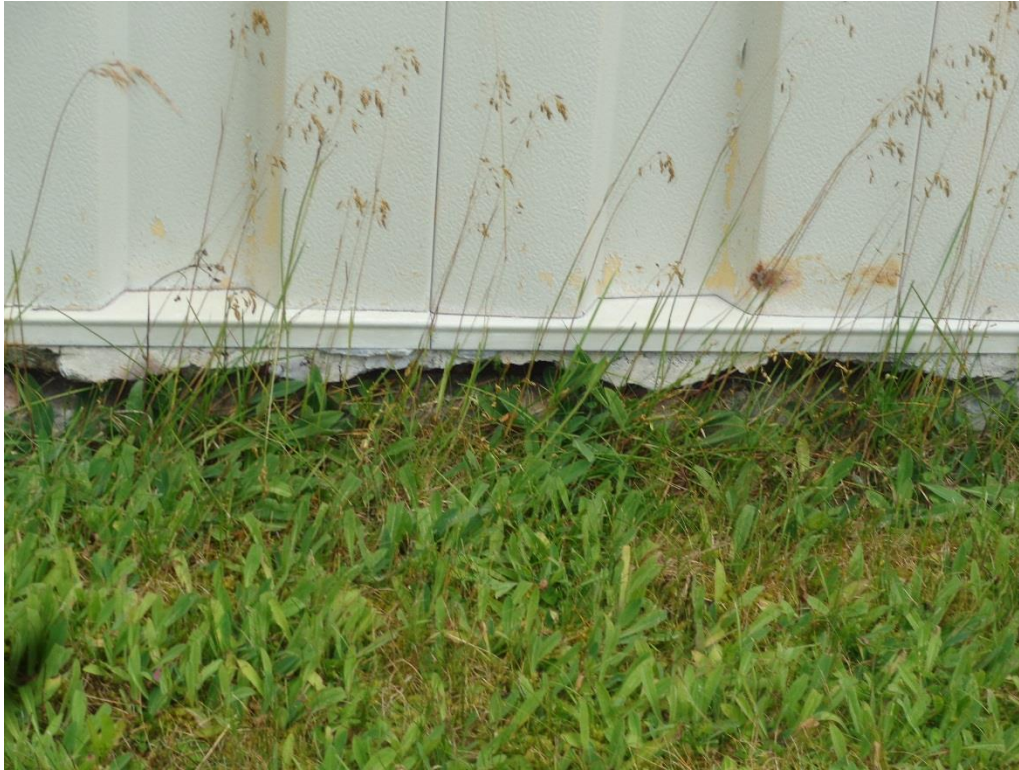
*Photo 3 - Large Spall in Foundation*

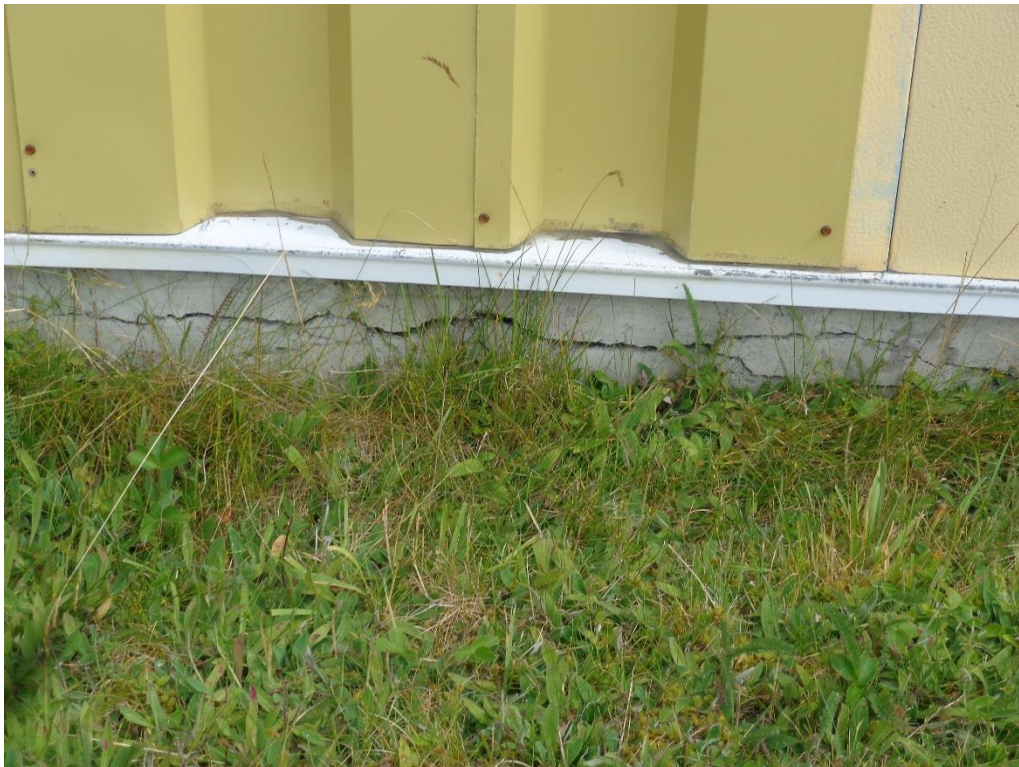
*Photo 4 - Large Horizontal Crack in Foundation Wall*

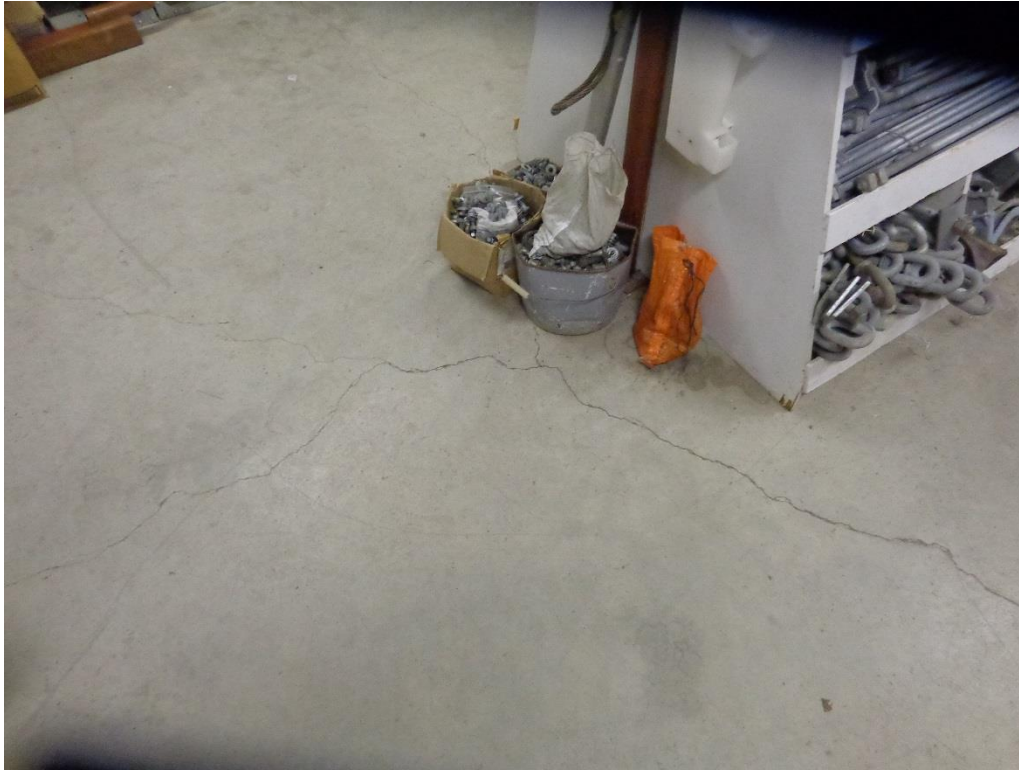
Photo 5 - Shrinkage Cracks in Interior Slab (2)

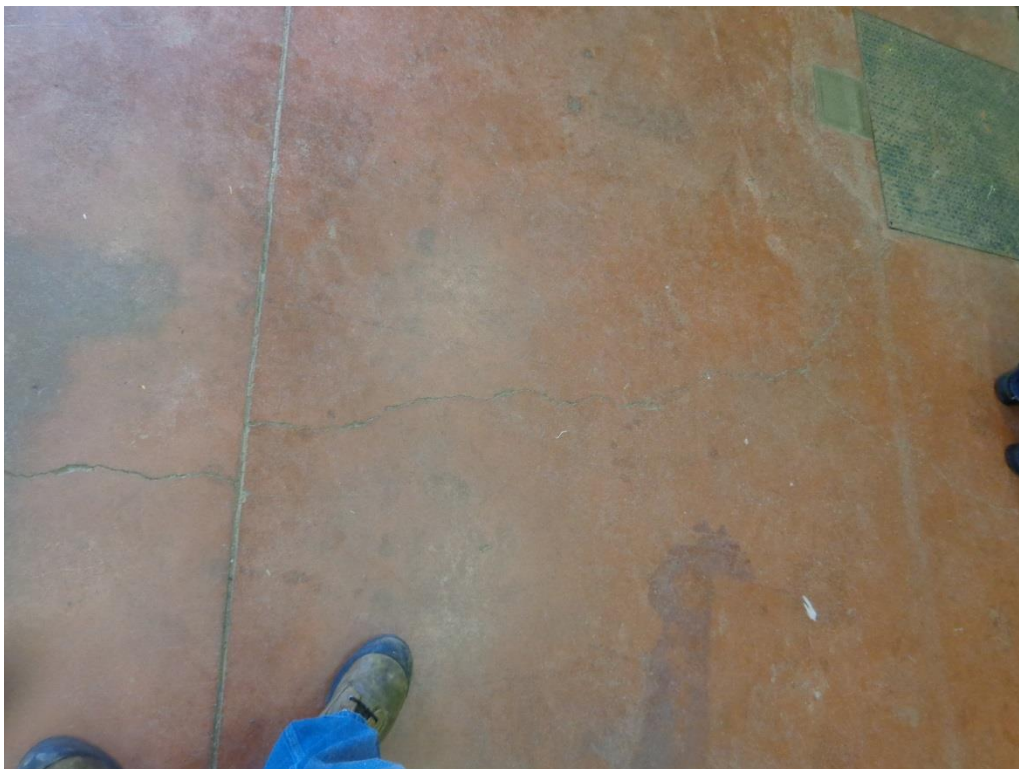
Photo 6 - Shrinkage Cracks in Interior Slab

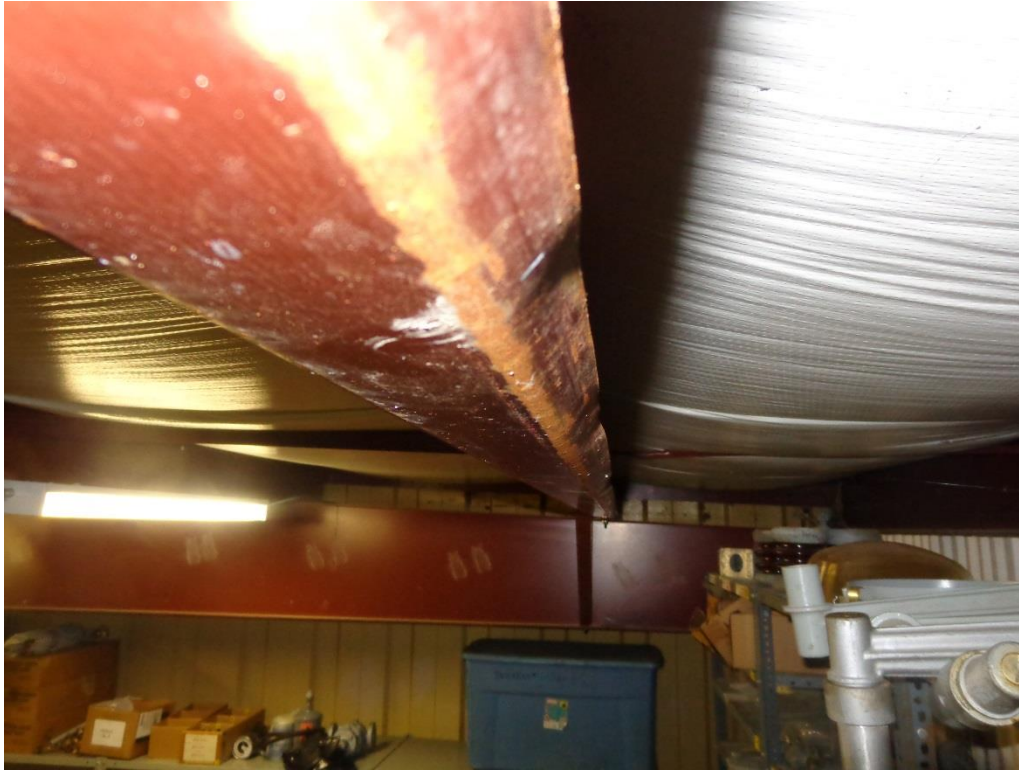
Photo 7 - Deformation of Purlin

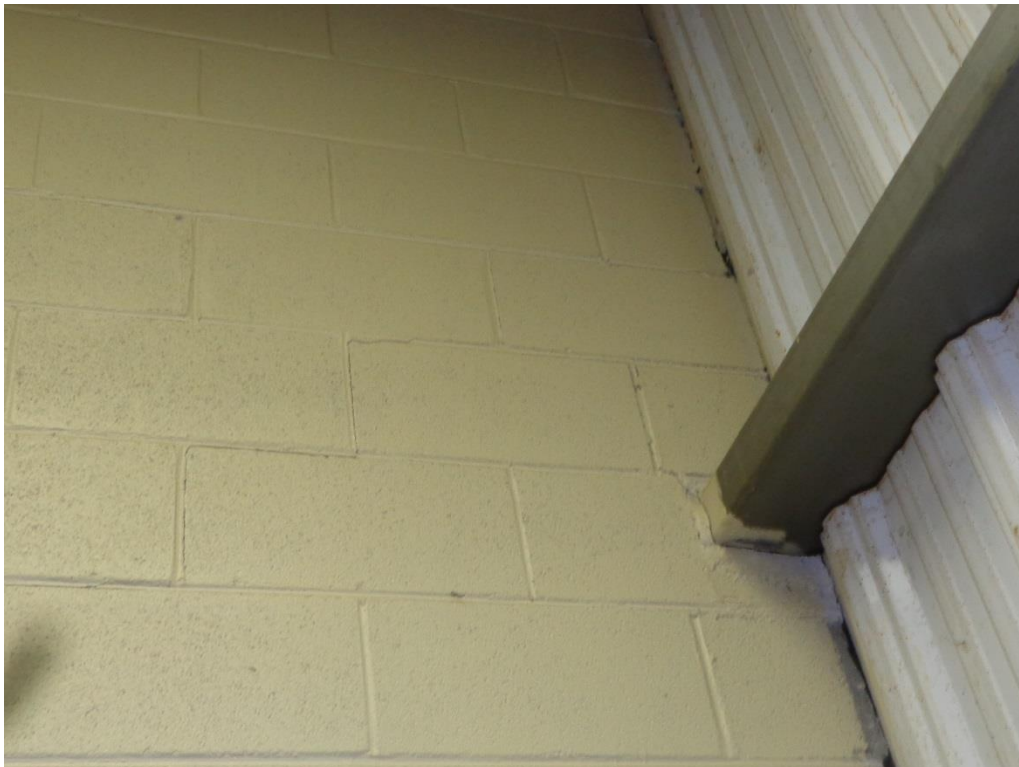
Photo 12 - Settlement Cracks in Block Wall

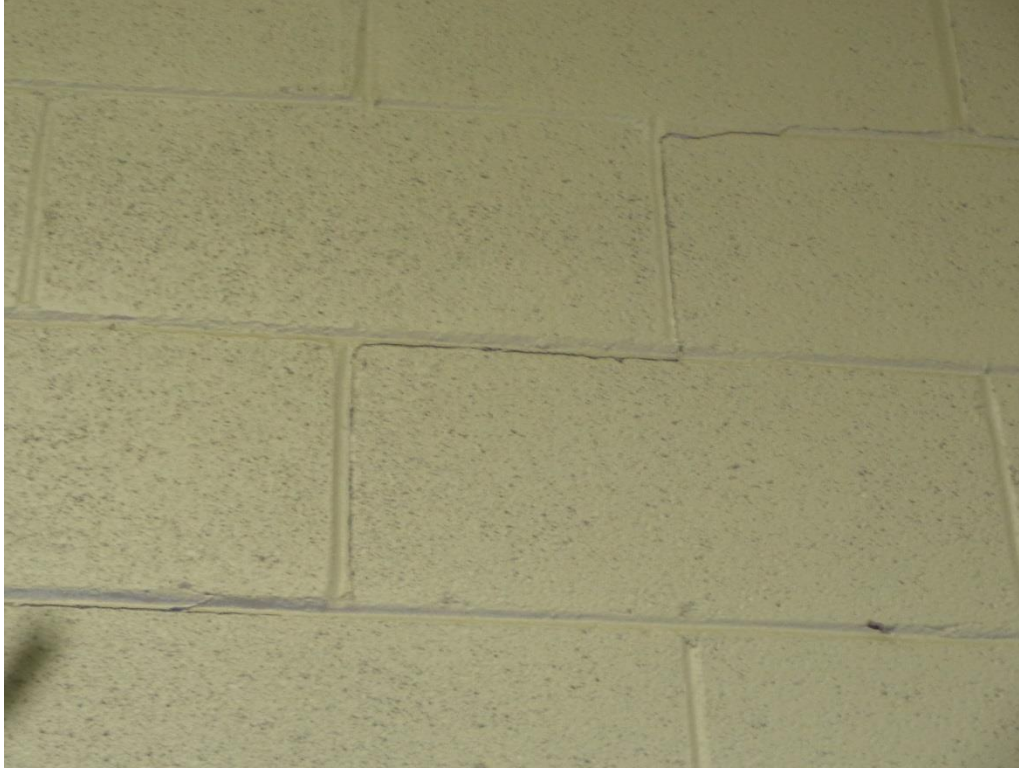
*Photo 13 - Settlement Cracks in Block Wall (2)*

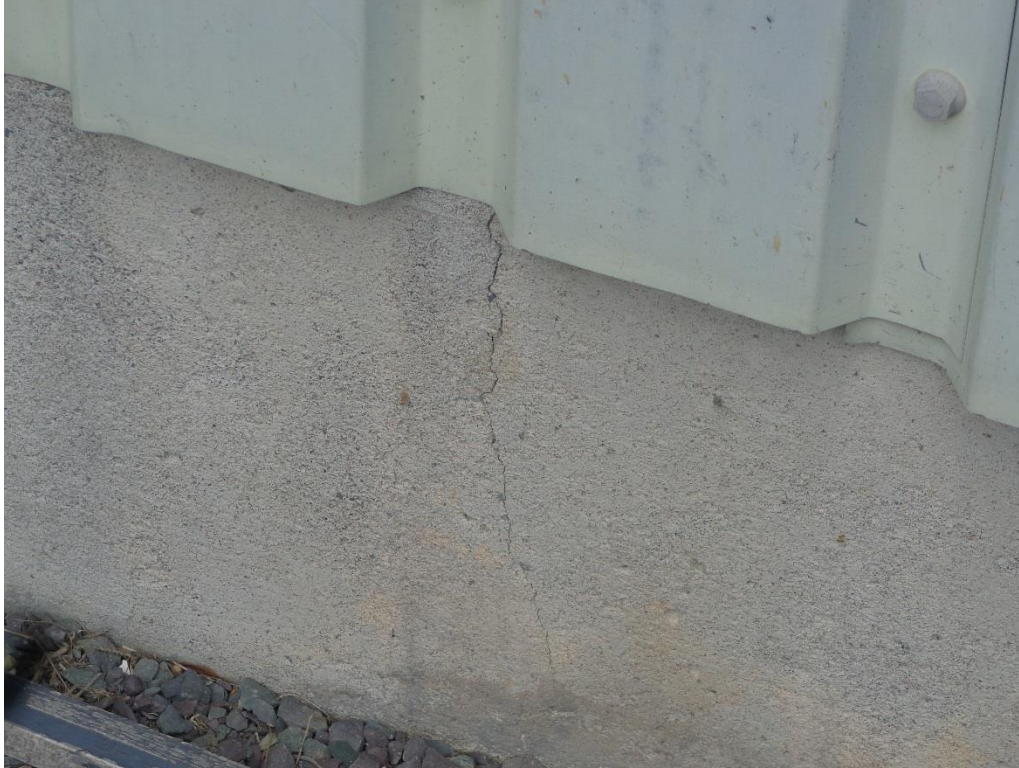
Photo 1 - Small Vertical Crack in Foundation Wall

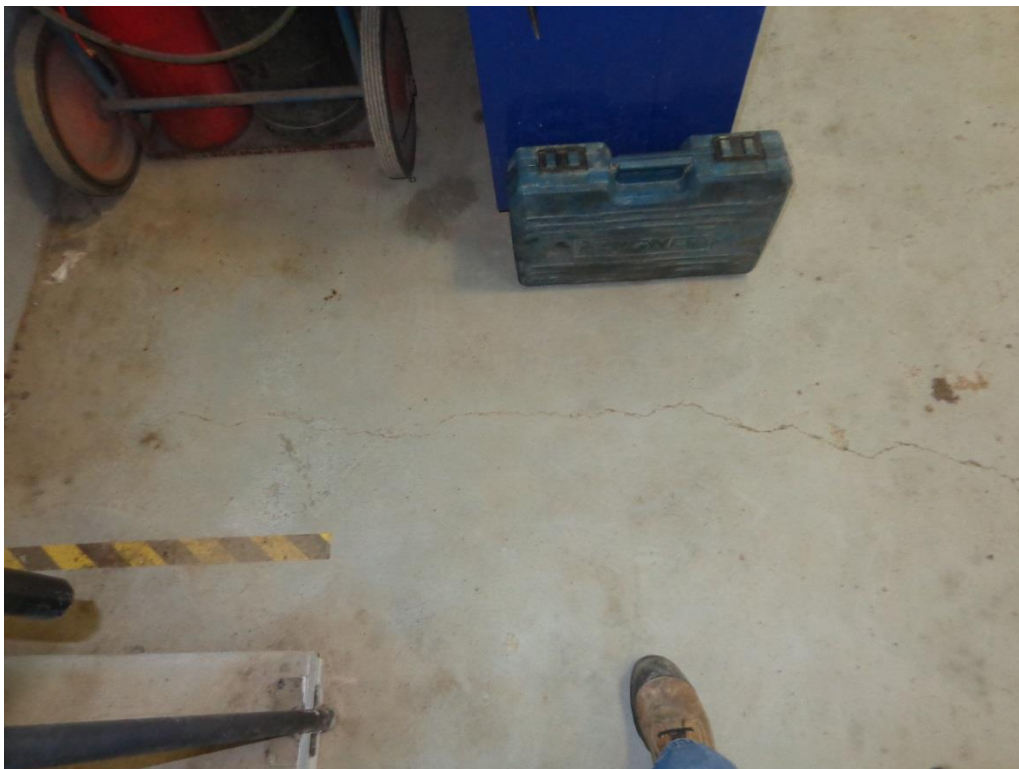
Photo 4 - Shrinkage Crack in Garage Interior Slab

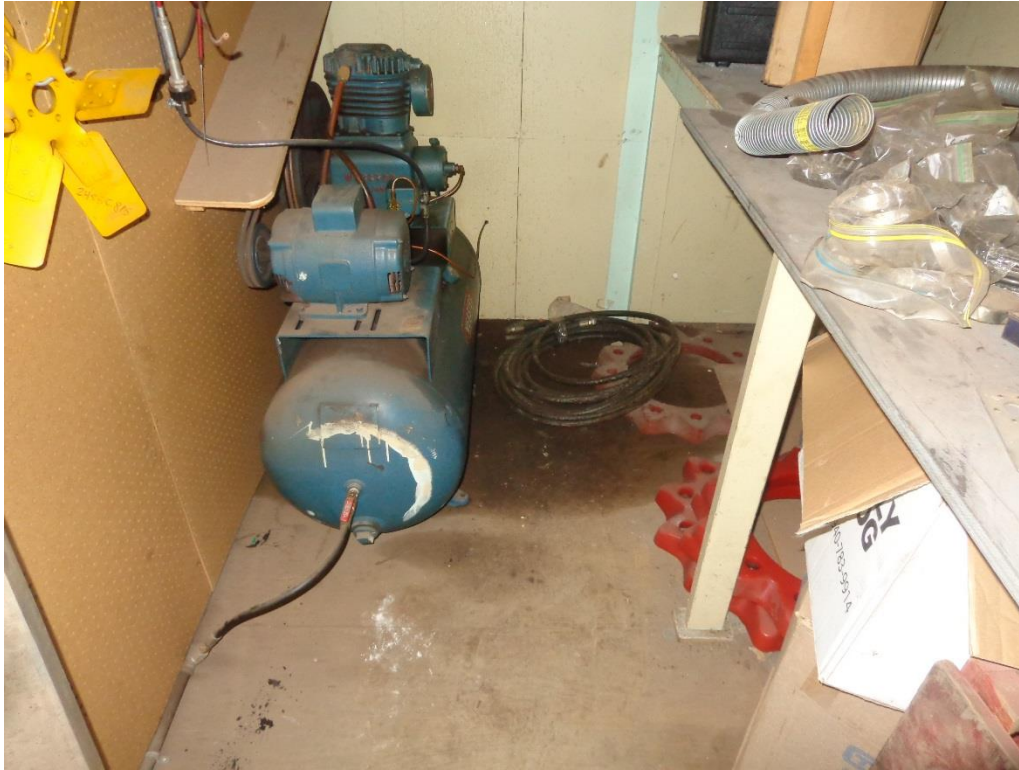
Photo 5 - Moisture or Staining by Equipment

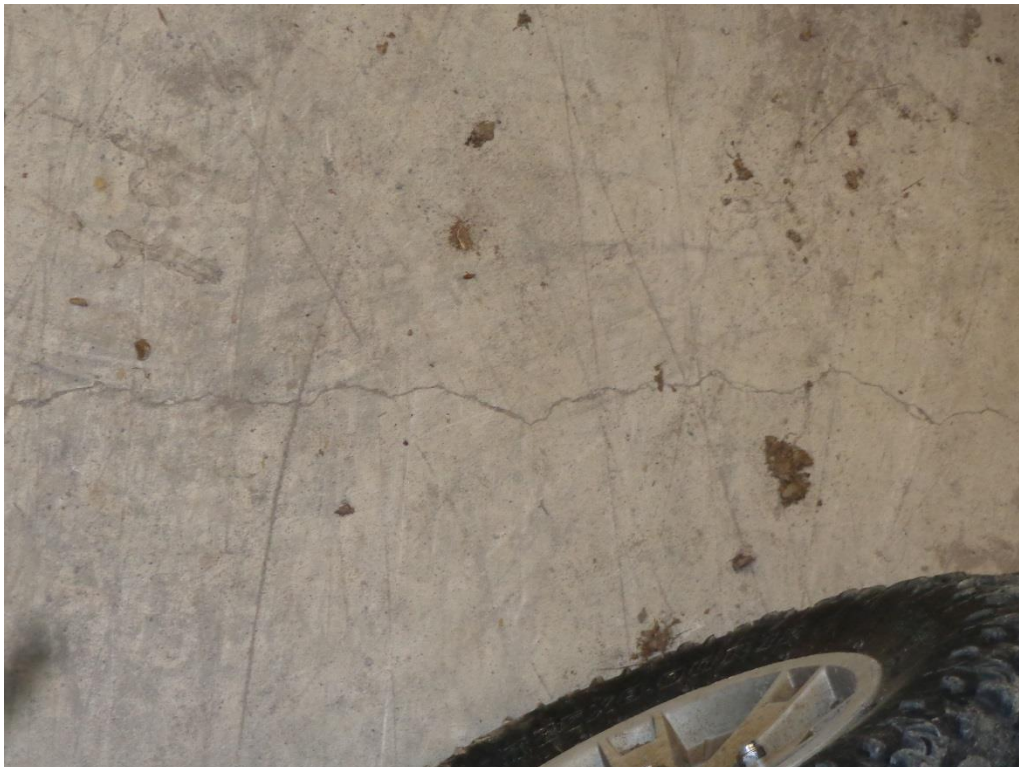
Photo 2 - Floor Shrinkage Cracks

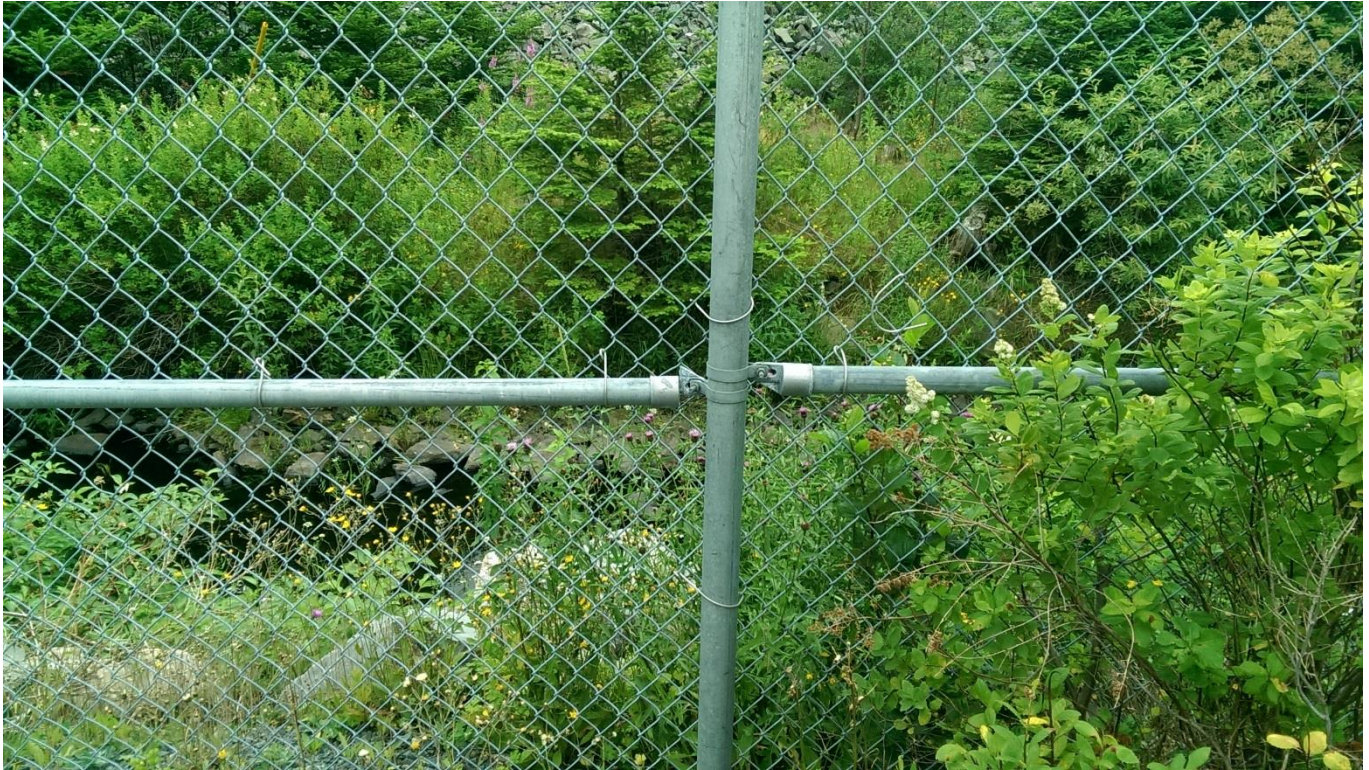
Photo 15 - Brace Fitting Broken

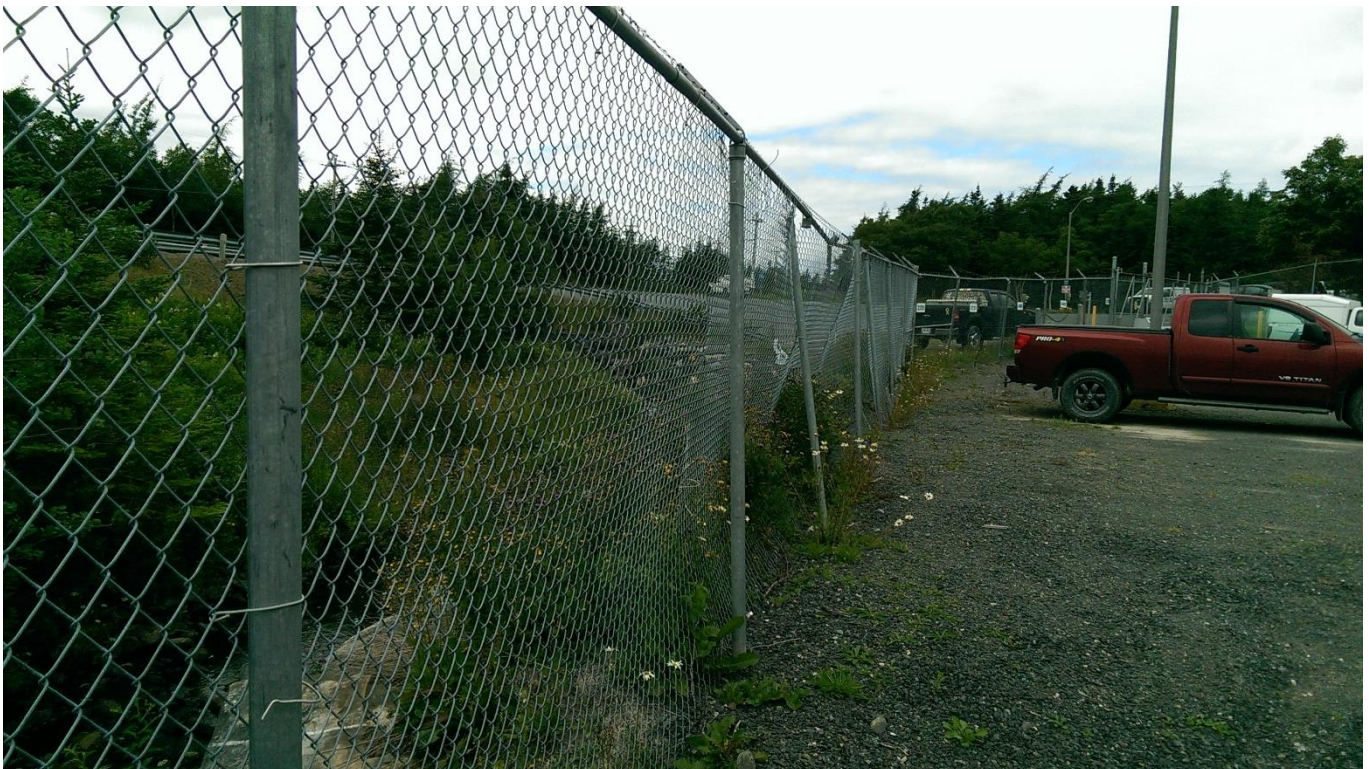
Photo 16 - Fence Leaning and Off From Bottom

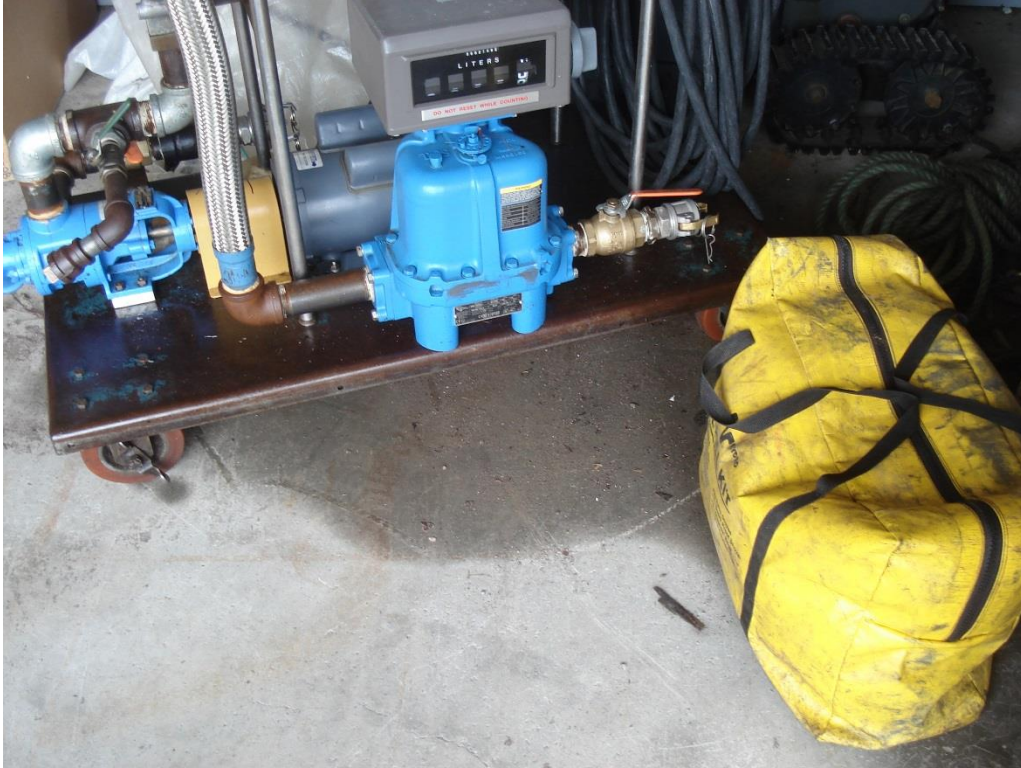
Photo 1 – Stained Floor

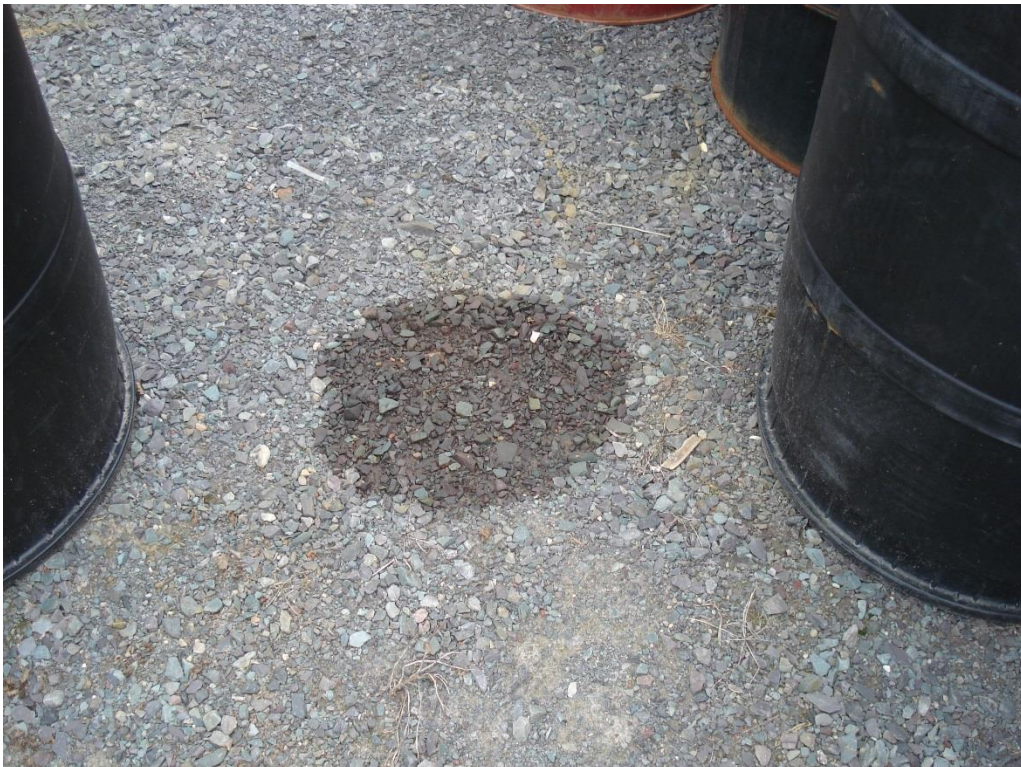
Photo 2 – Stained Ground

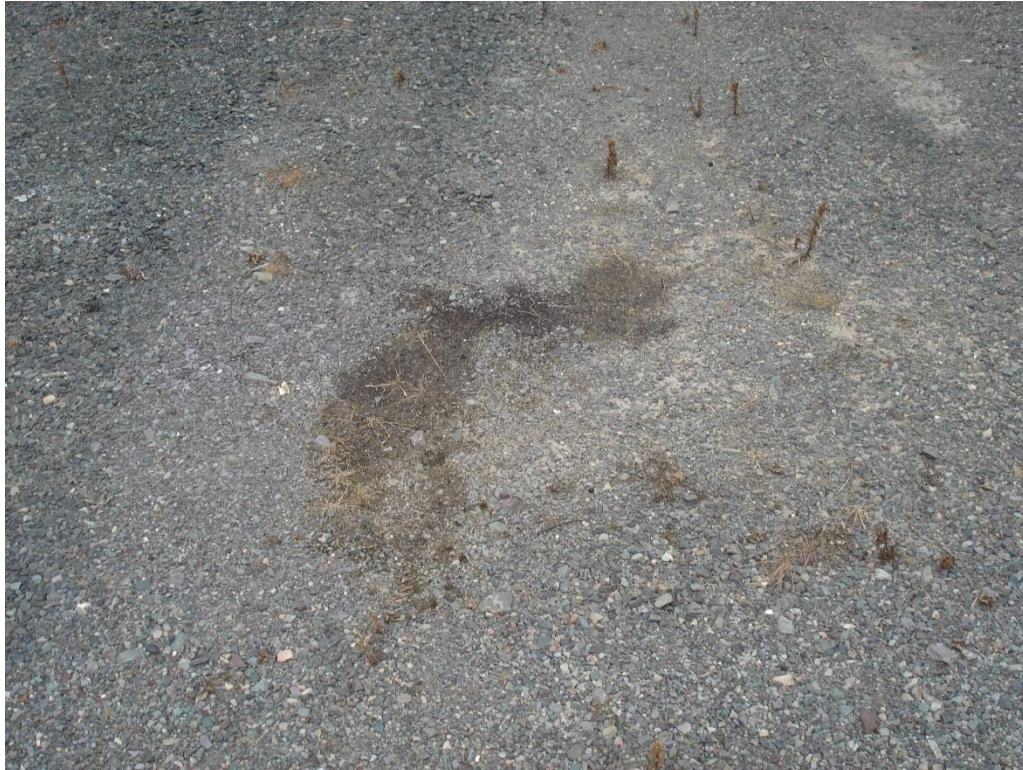
Photo 3 – Stained Ground

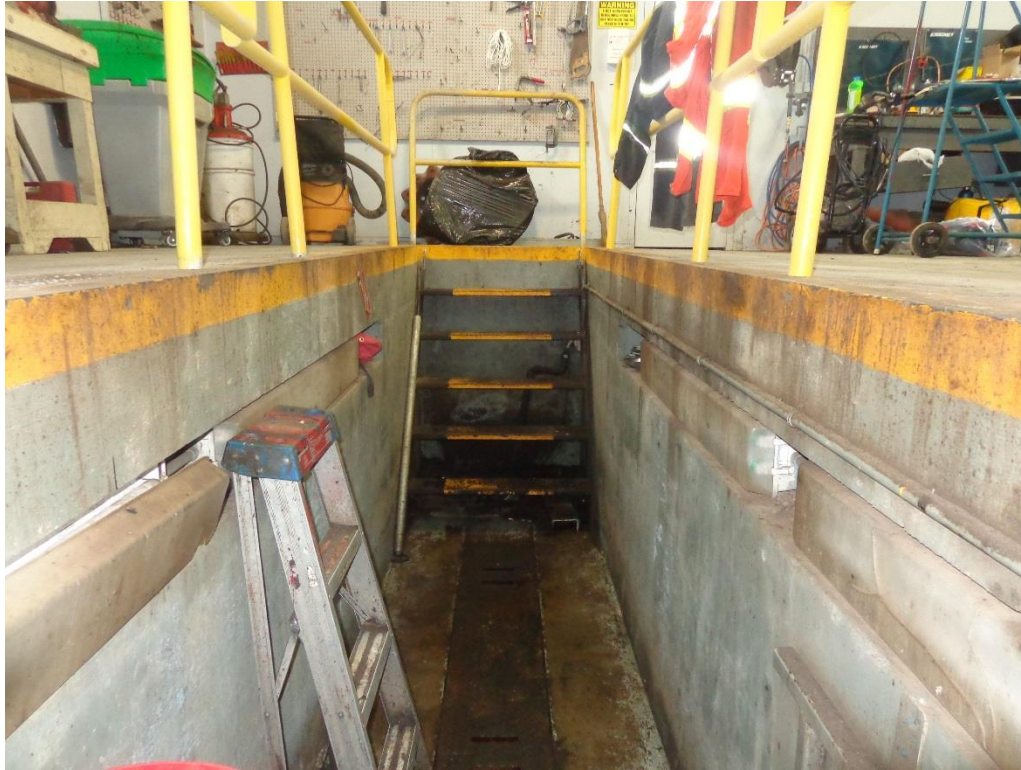
Photo 23 - Service Pit Staining

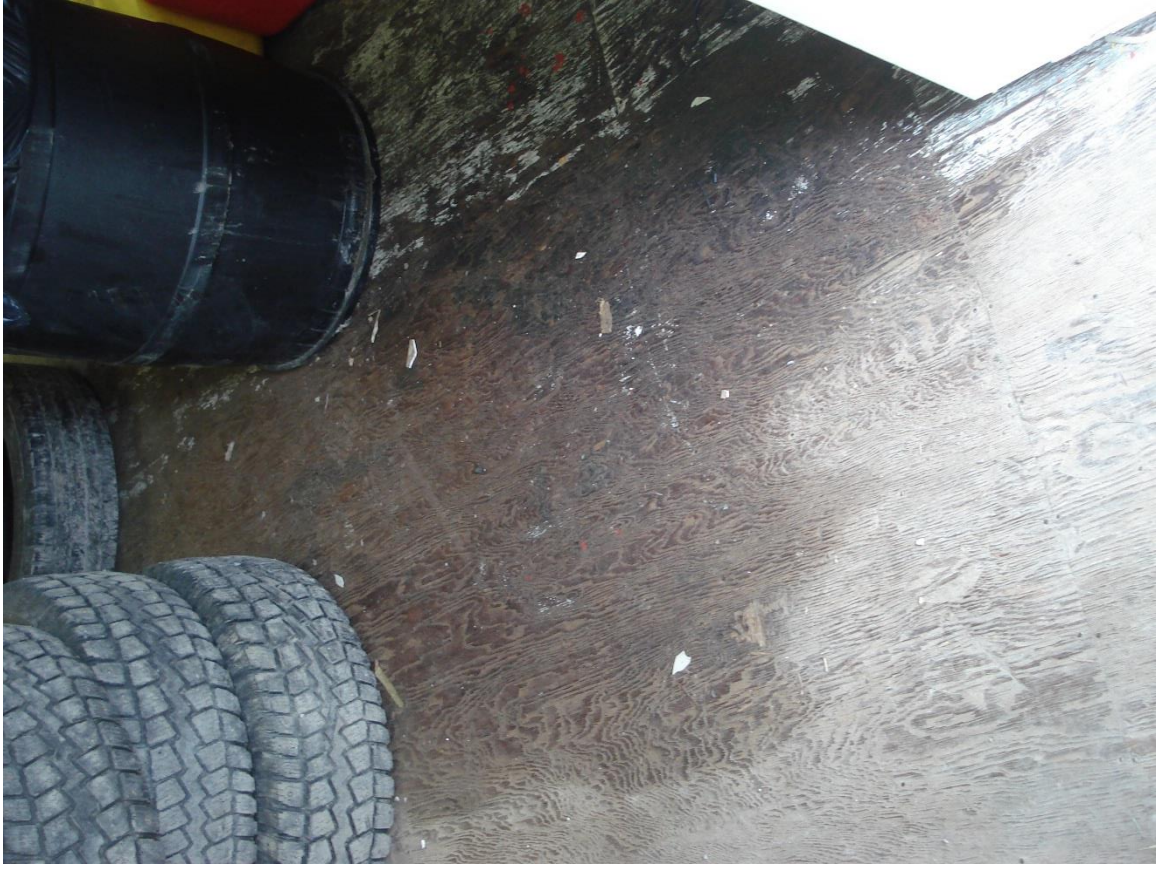
Photo 30 - Staining on Floor
