- 1 **Q. Provide electronic copies of all storm restoration reports submitted to the Public**  
 2 **Utilities Board related to major storm outage events (especially Hurricane Igor in**  
 3 **2010) since 2004.**  
 4  
 5 A. Copies of all storm restoration reports submitted to the Public Utilities Board related to  
 6 major storm outage events since 2004 are included as Attachments A through D of this  
 7 response. Storm restoration reports for Tropical Storm Leslie and Winter Storm  
 8 November 2013 have been previously filed as Attachments C and E in the response to  
 9 Request for Information PUB-NP-166.  
 10

**Transmission and Distribution Line Rebuilds  
March 2010 Ice Storm**

**April 30, 2010**

**Hurricane Igor, September 2010**

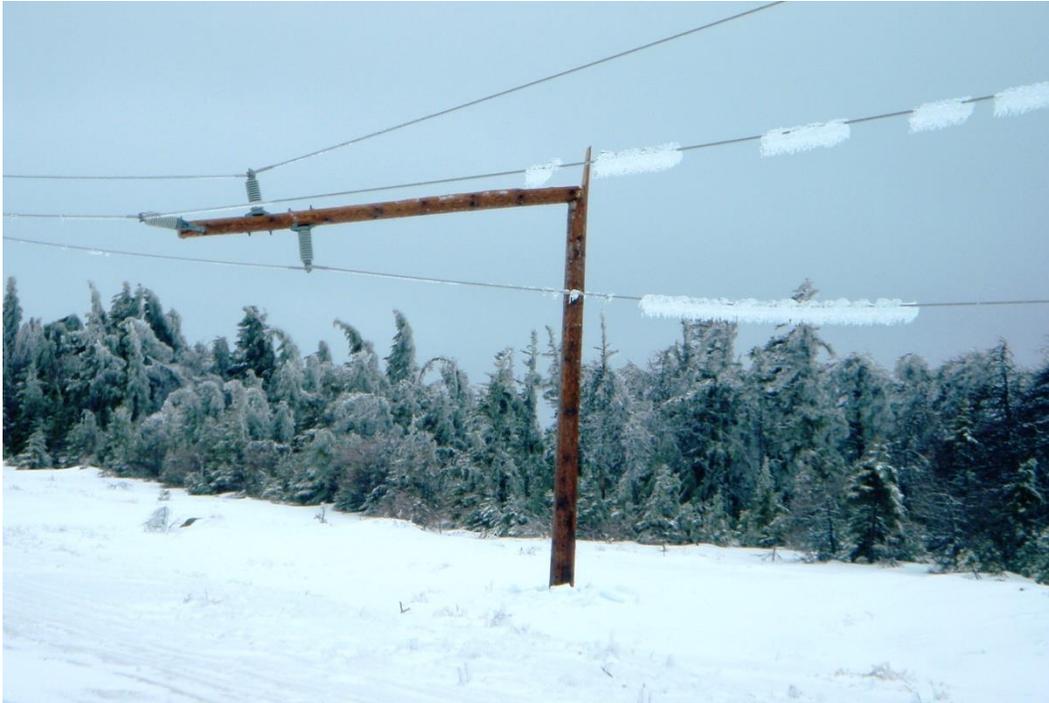
Cracked Pole

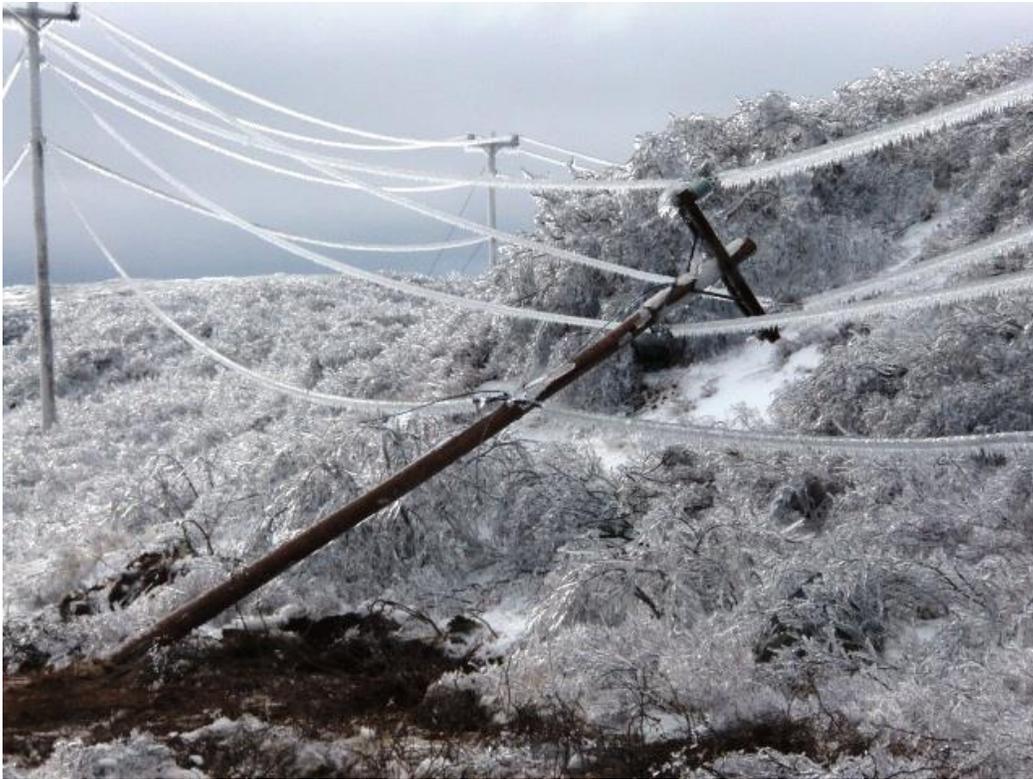
Distribution Structure Leaning Heavily

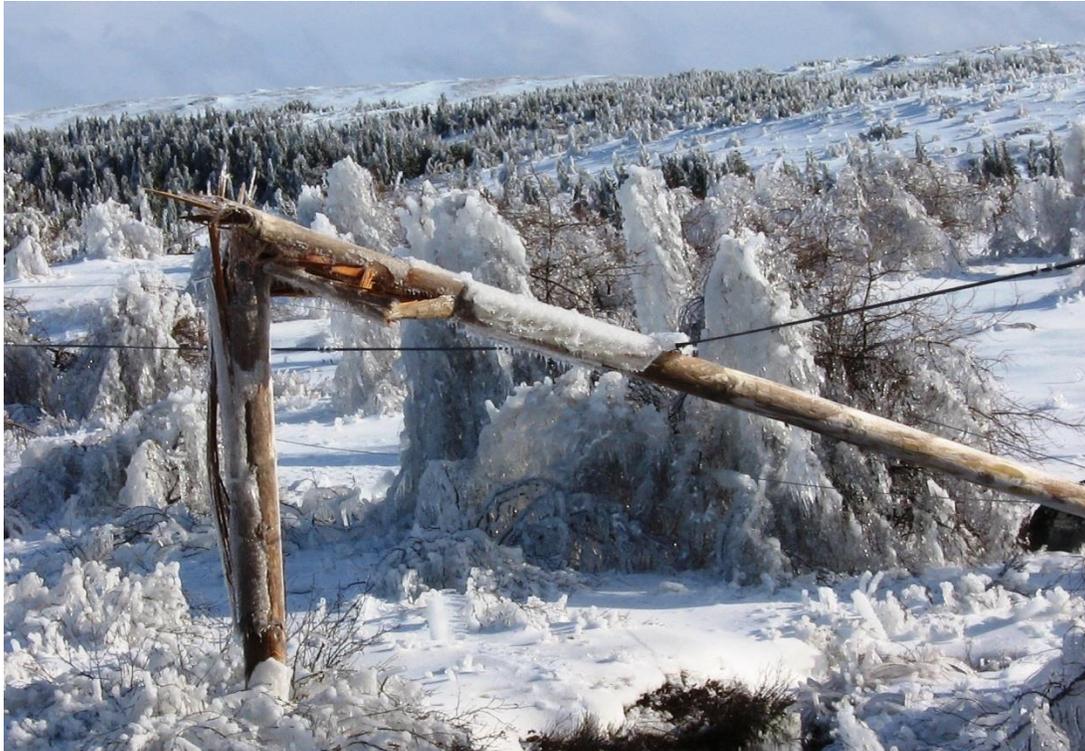
Distribution Structure Covered in Ice

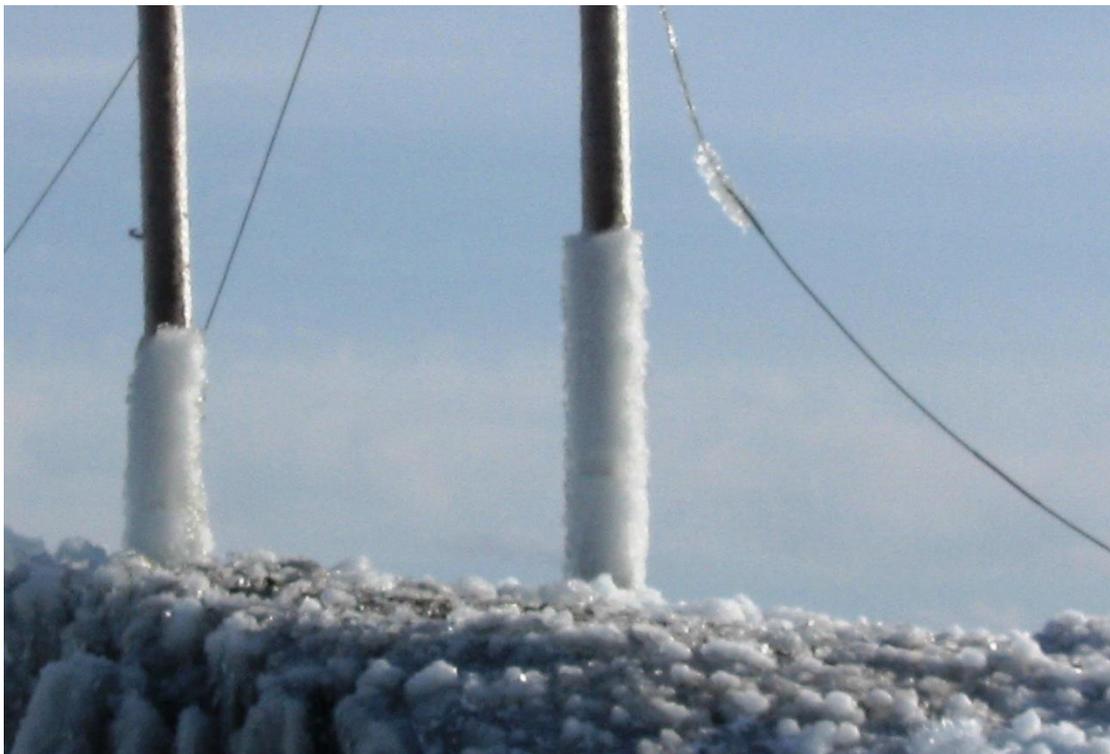
Ice Thickness is Apparent at Base of Poles

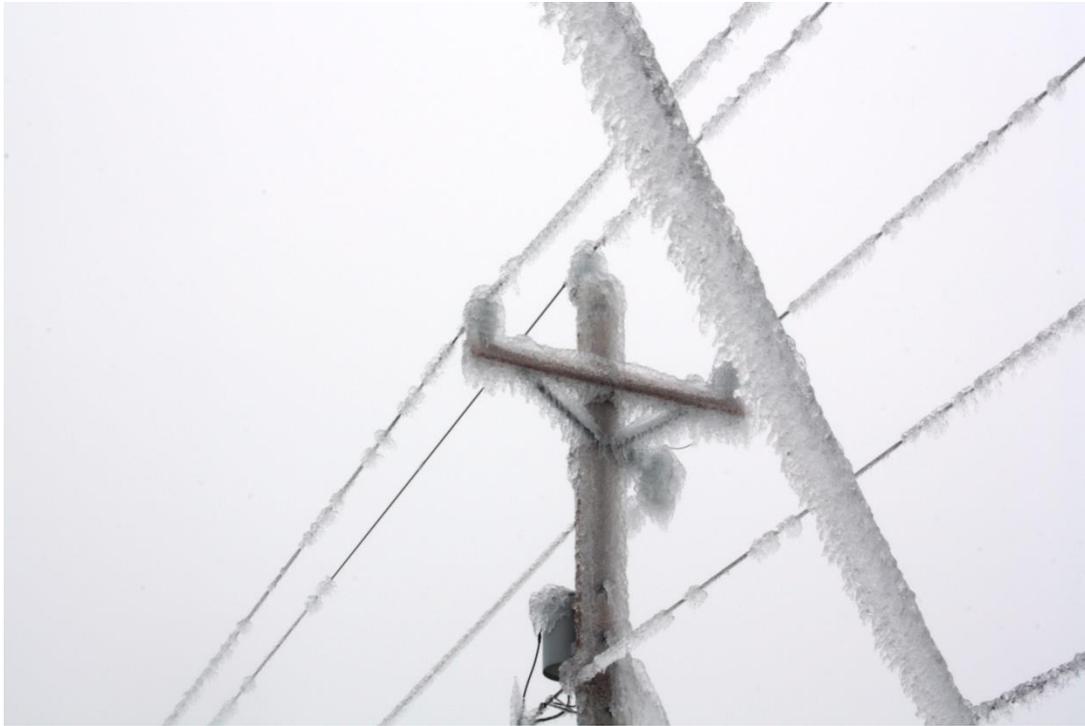
Distribution Structure Covered in Ice

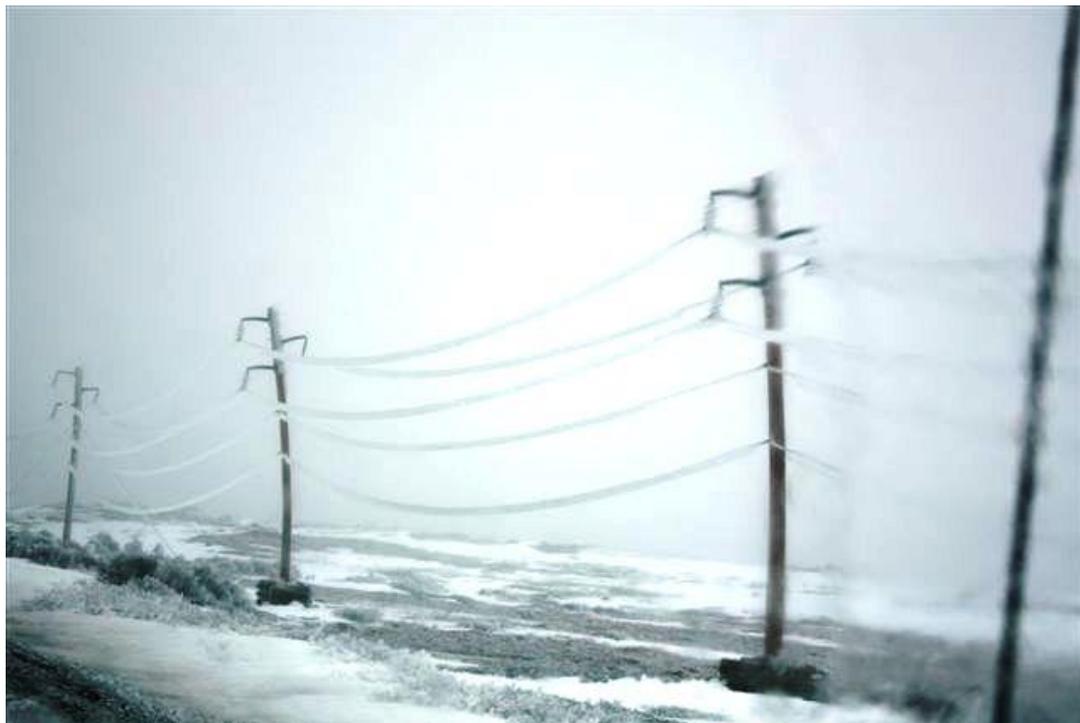
Poles bending Under Ice Load

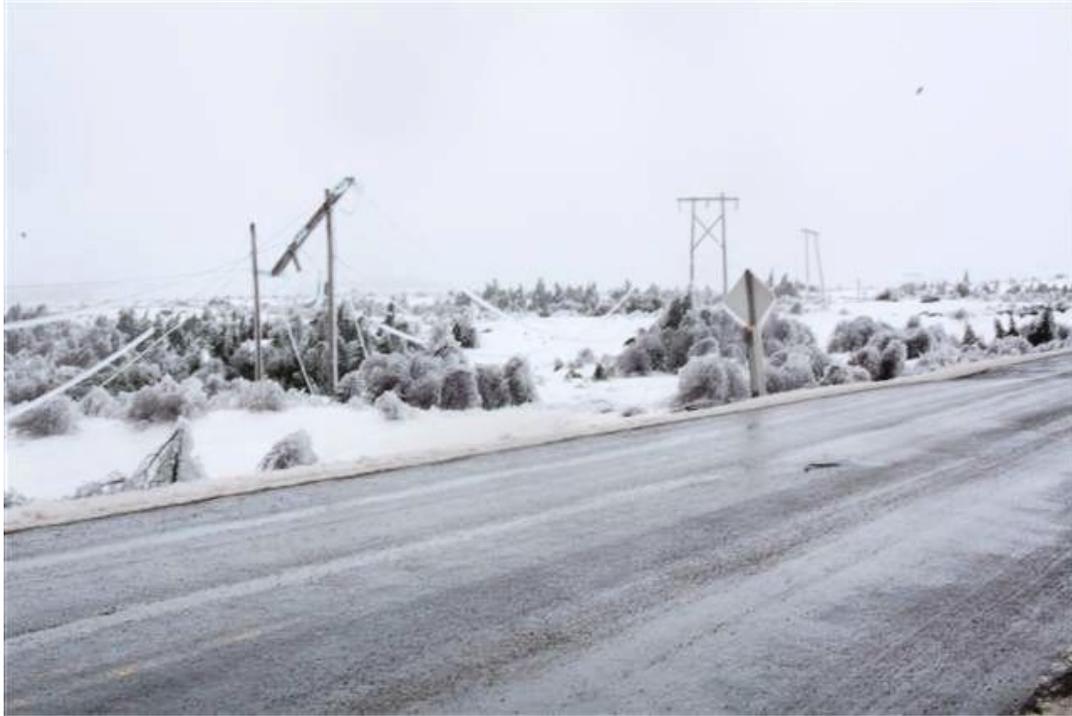
Four transmission lines on the Bay de Verde Peninsula (55L, 41L, 65L and 80L) were damaged during the storm. Some of the heaviest ice loading was experienced on transmission line 41L. Foot-long samples of ice taken from this line weighed 7.5 lbs. This is equivalent to 2.4 radial inches of ice. Newfoundland Power has not experienced ice loading of this magnitude since the devastating ice storm of 1984.

A total of 106 transmission line poles was damaged and required replacement on the Avalon Peninsula. Fifty-five of those poles were on 41L.

Structure Damage 41L

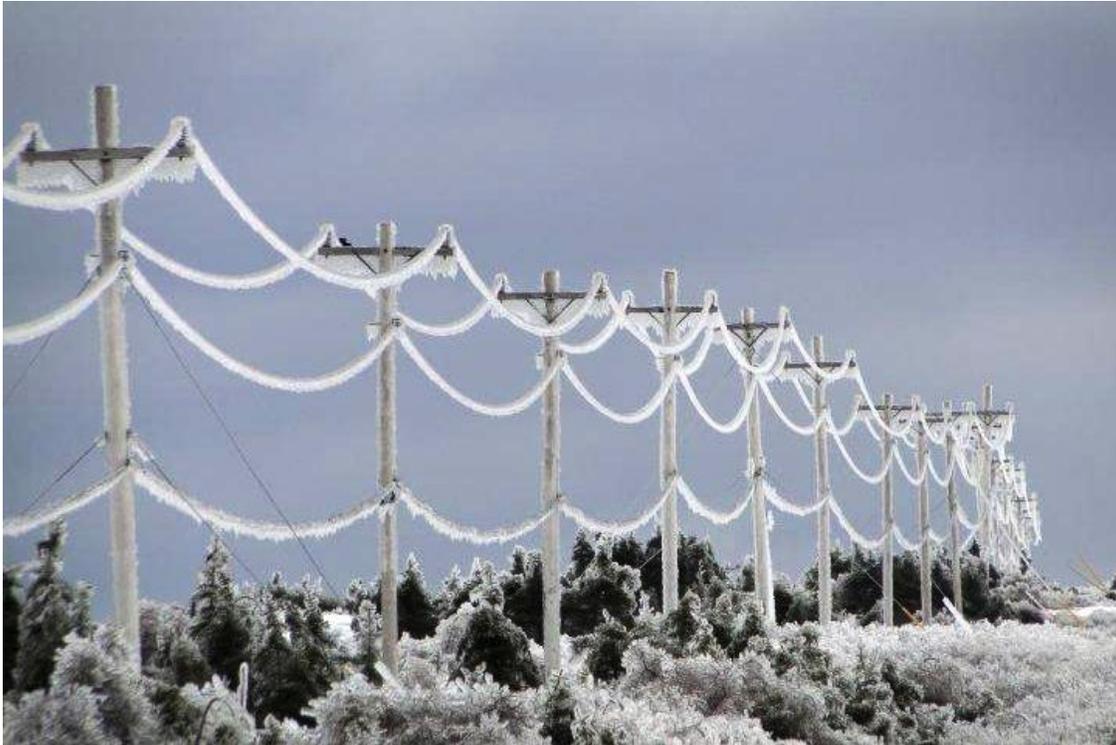
Ice on Conductors Near New Chelsea

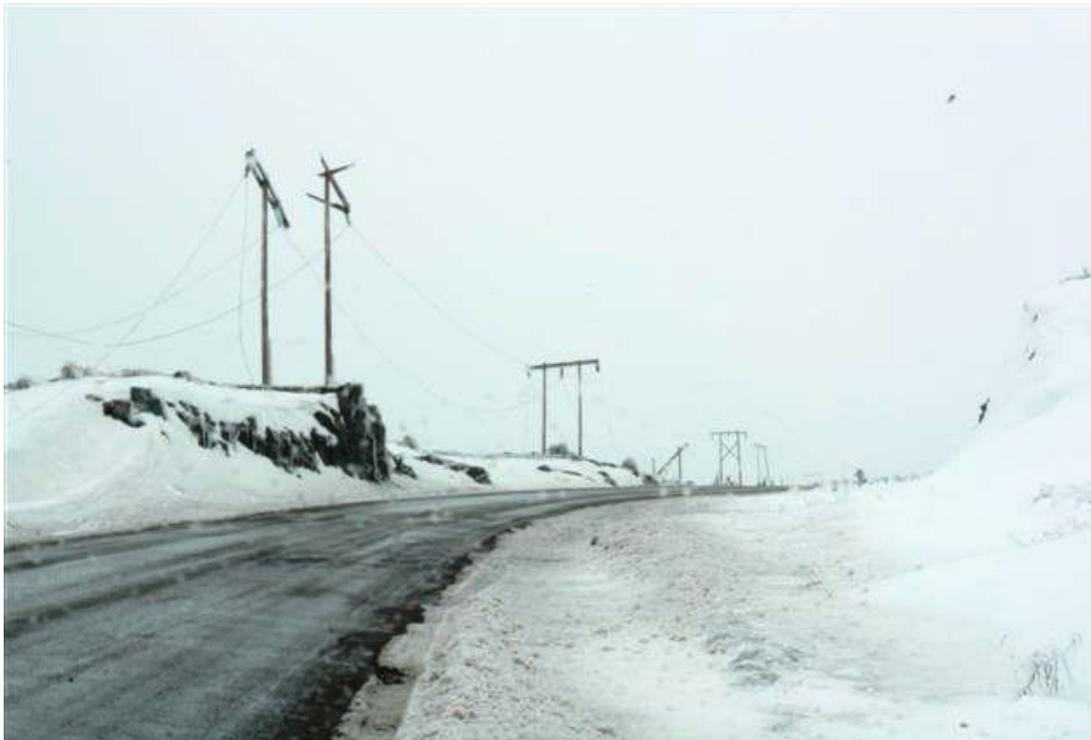
Broken Crossarms on 41L Across the Hearts Content Barrens

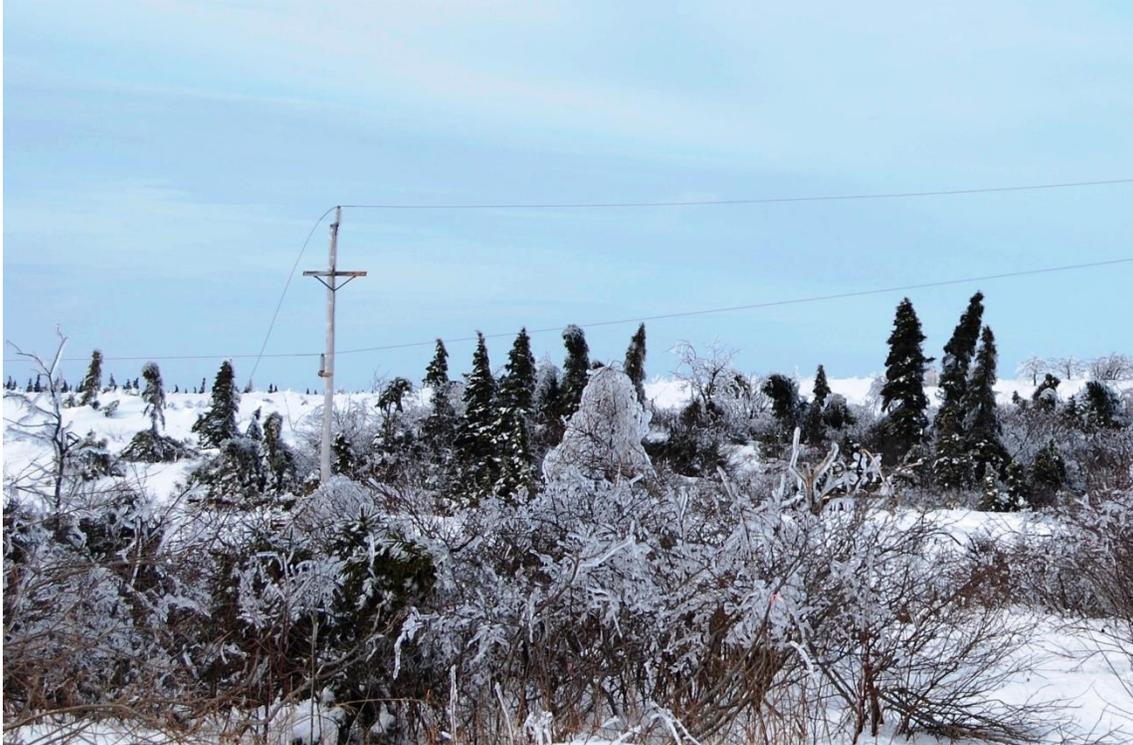
Transmission line 116L was the only transmission line damaged in the Bonavista North area. Nineteen structures were damaged, but only 1 pole required replacement. All repair work on 116L is complete.

Broken Conductor on 116L

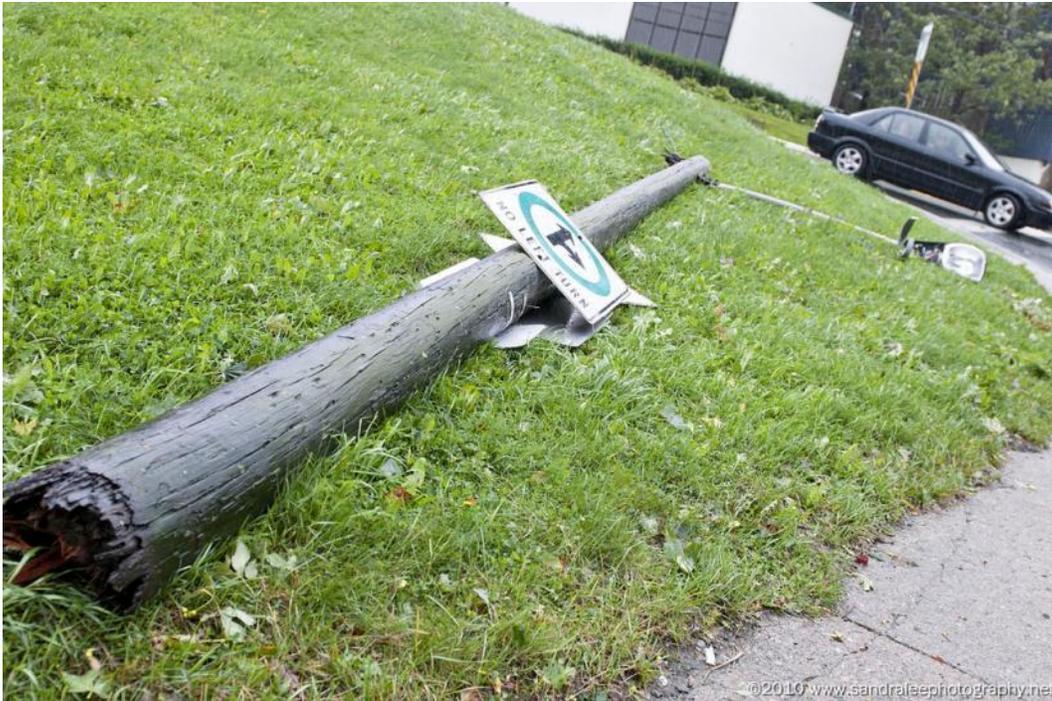
Streetlight Pole Cracked at Base

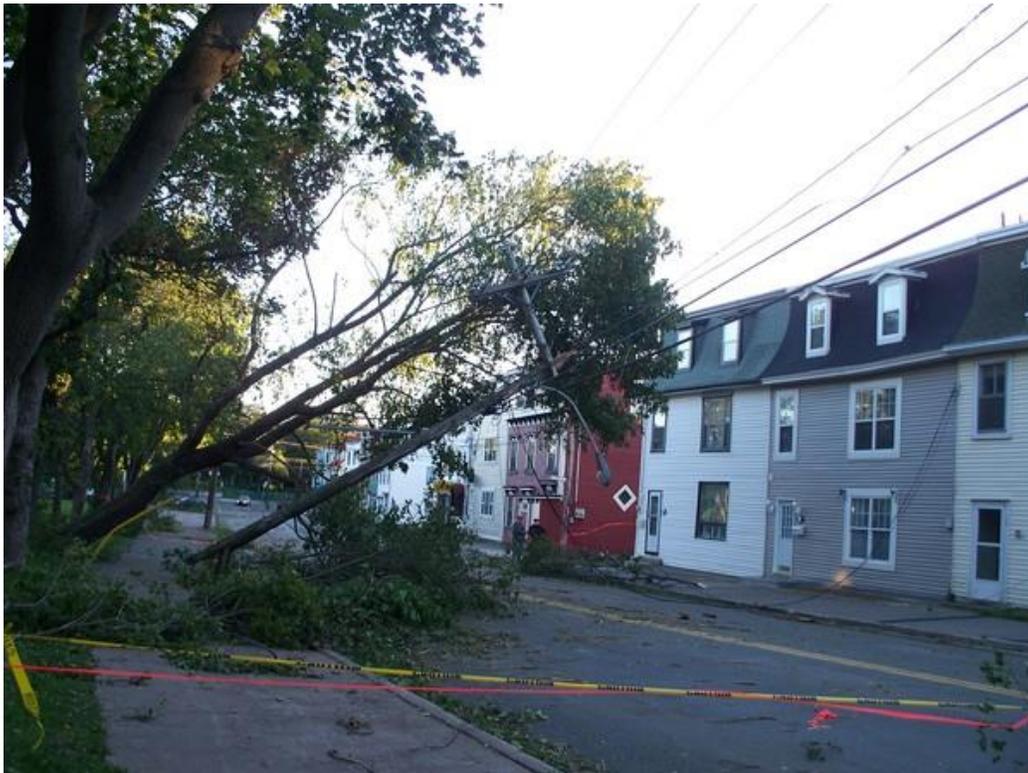
Tree in Line on Military Road, St. John's

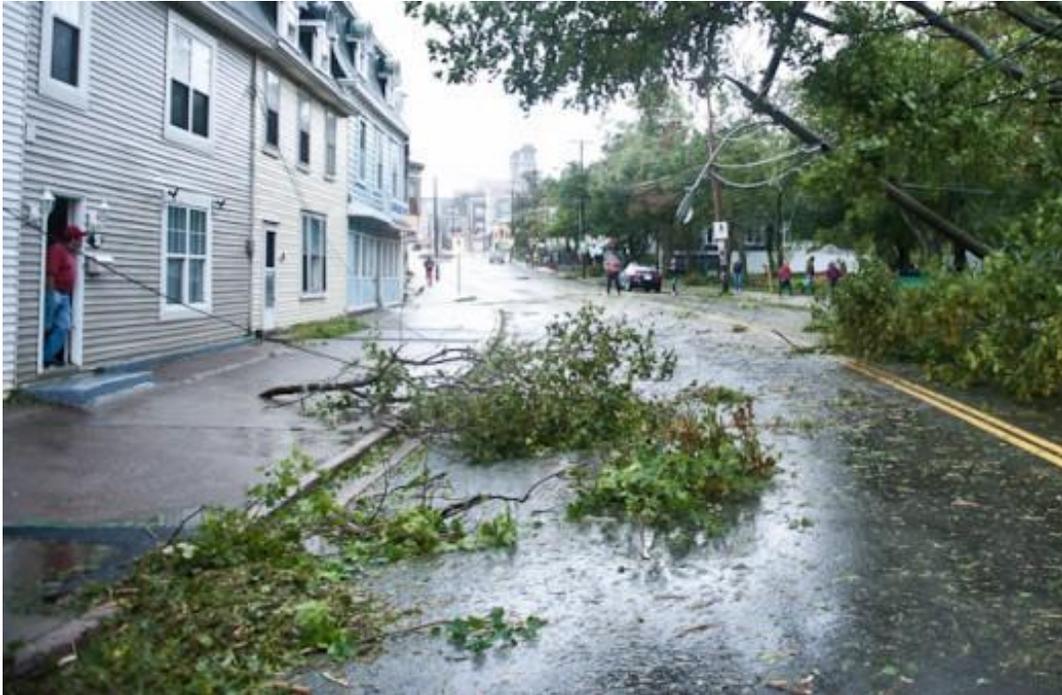
Trees Take Down Line, St. John's

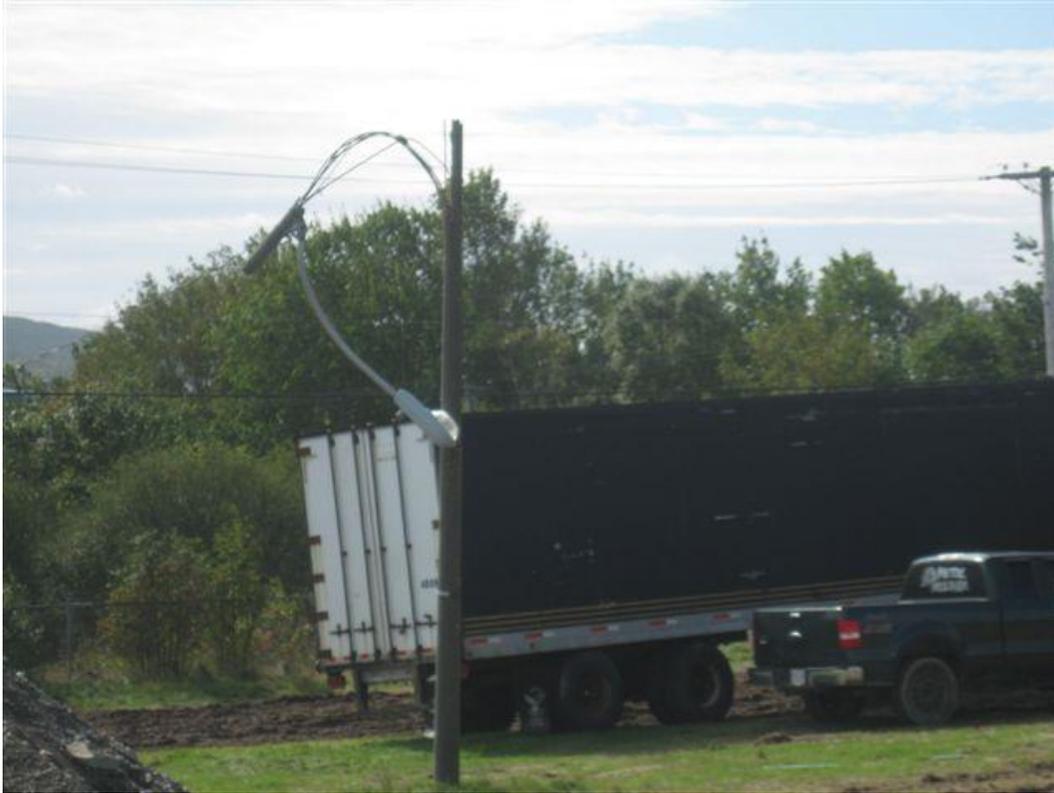
Streetlight Hanging from Broken Pole

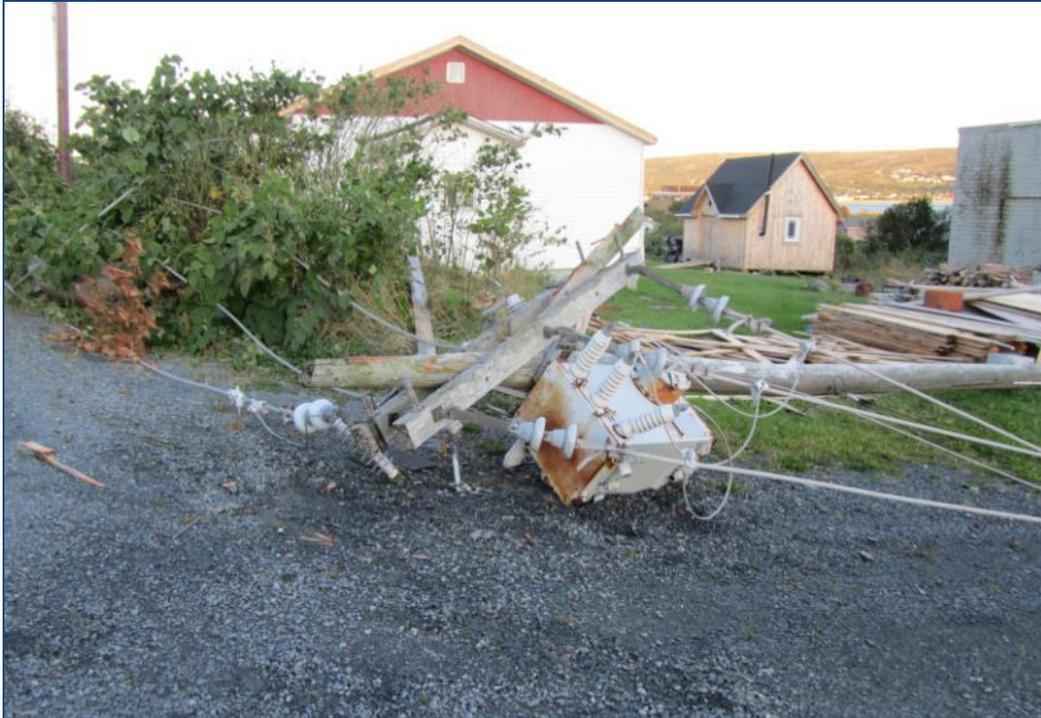
Metering Tank with Broken Pole, Fish Meal Plant, Carbonear

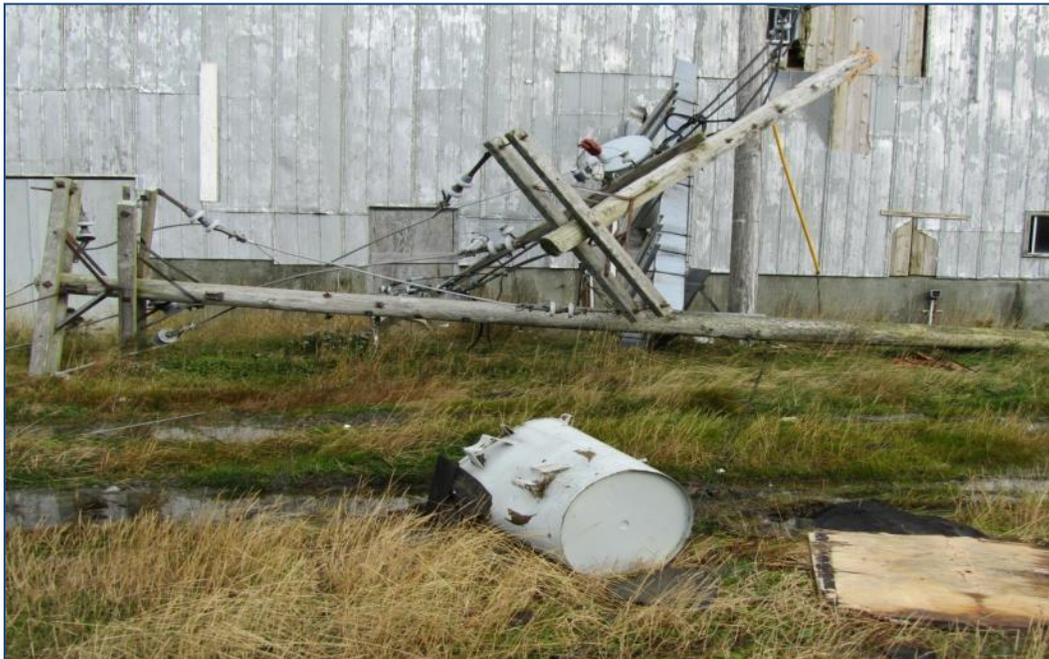
Broken Distribution Structures and Transformer on Ground, Fish Meal Plant, Carbonear

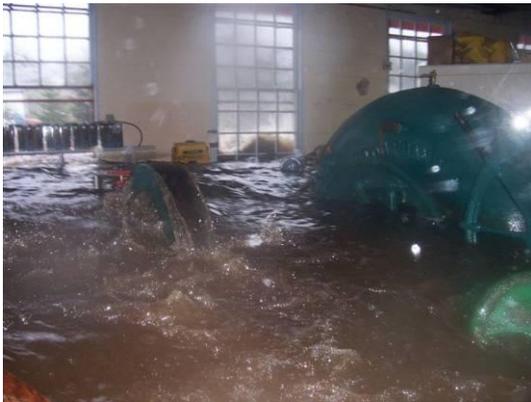
**Figure 1 - 2m of water in the powerhouse**  
(Note: Turbine still spinning)

The generators, governors, switchgear, control panels, metering panel, battery bank, battery charger, DC distribution panel and AC distribution panel were partially or completely submerged by the approximate 2 metres of water that flowed through the powerhouse.

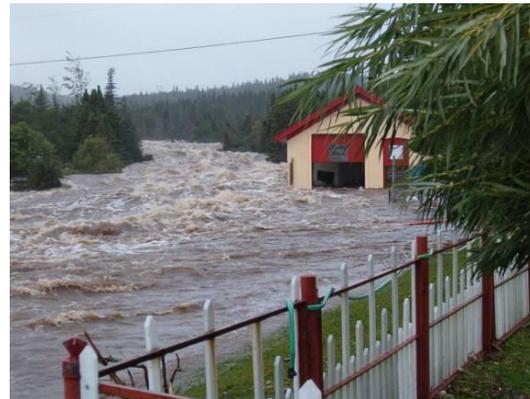
**Figure 2 - Flood Flows at Port Union Plant**

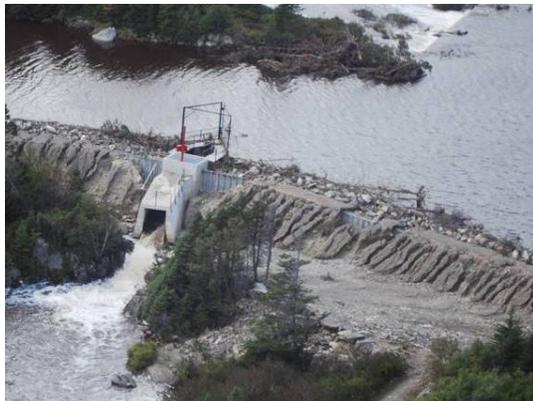
Figure 3 - Whirl Pond Dam

Storage structures on Whirl Pond and Long Pond also overtopped causing extensive damage. High flows eroded the abutments at the control gate on Long Pond. At Whirl Pond, the spillway capacity was exceeded by the flood flows that were 2.5 times the 1-in-1000 year flows. As a result Whirl Pond Dam overtopped eroding the crest and downstream side of the dam to the steel core as shown in Figure 3. The three freeboard dams on Whirl Pond were also damaged, with two being significantly eroded with overtopping flows and one receiving minor damage from wave action.

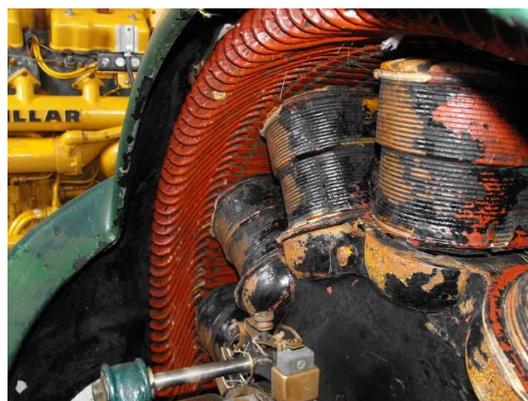
The two generators, G1 and G2, were disassembled, inspected and tested by a third party to determine the extent of the damage.<sup>2</sup> The stators have wood and grass embedded between the laminations. This damage is more extensive on G2 than G1. The G2 stator winding has short circuited to the steel casing. The G2 rotor poles and slip rings were damaged by impact with debris floating in the water. The G2 exciter windings are in poor shape with heat damage and visible burn marks suggesting the unit was energized as water levels rose. The commutator on the exciter has extensive copper damage.

Figure 1 - Damage to G1 Stator and Rotor

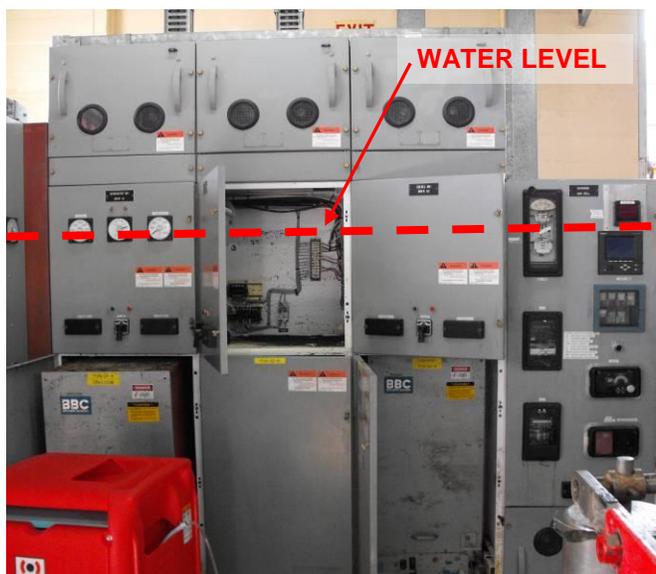
Figure 2 - Damaged Switchgear

The generator breakers were completely submerged and will require refurbishment at a facility with the specialized test equipment, parts and skills to complete this work. All switchgear compartments and control wiring will be cleaned and dried on site. The CTs were submerged but are sealed units that will be reused after cleaning, drying and testing. The generator PTs are located in the top compartments of the switchgear and were not submerged. They will be reused. The bus PT is located in the bottom of the metering cubicle that was completely submerged. It will be tested and reused if possible. If not, it will be replaced by the generator PT that is currently on the diesel unit, generator G3, which is being retired.

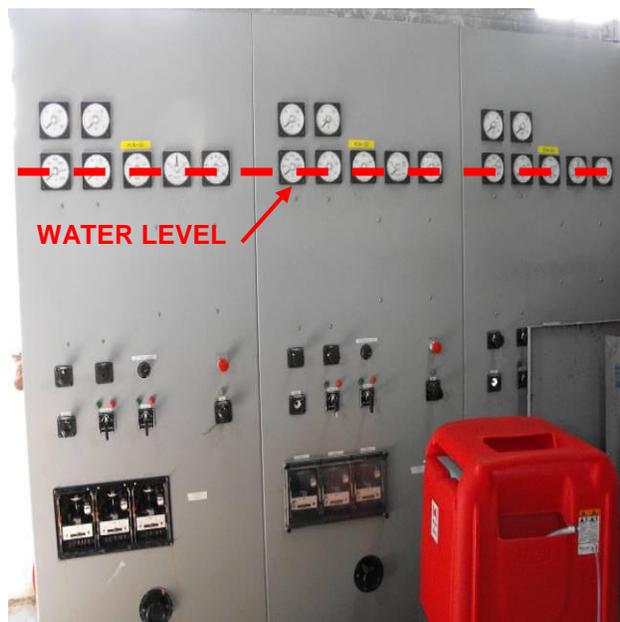
Figure 3 - Damaged Protection and Control

The protective relays, voltage regulators, controls switches and bottom row of meters were all submerged causing the mechanisms and electrical contacts in this equipment to corrode. As a result, they are no longer serviceable. Figure 3 shows the high water mark relative to the equipment mounted in the panels.

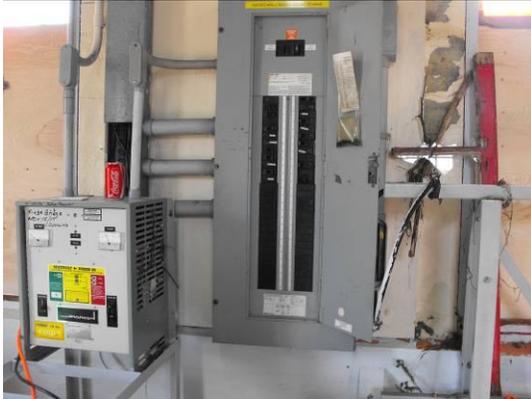
Figure 4 - DC Distribution Panel and Battery Charger

The DC panel and distribution system has been cleaned, dried and returned to service.

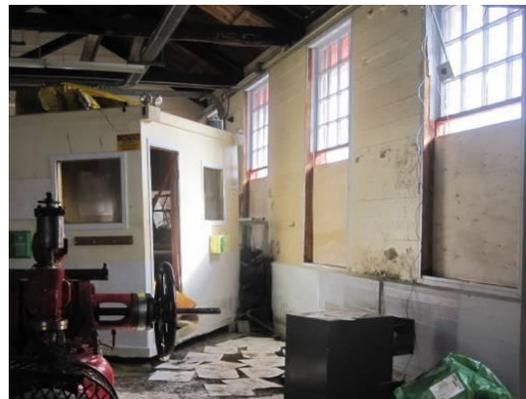
Figure 5 - Damaged Plant Windows

Immediately after the flood, the windows were temporarily boarded up to secure the plant and make it weather tight. The damaged windows are not repairable and therefore require complete replacement. The new sliding windows will be of vinyl construction.

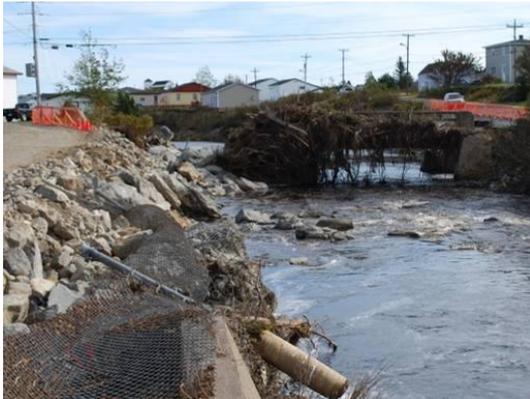
**Figure 6 - Erosion, Plant Access Road  
(Downstream of Plant)**

The high flood waters in the channel adjacent to the powerhouse caused severe erosion of the access road. The road has been temporarily restored to allow access to the plant during the winter season. Additional work is required to permanently stabilize the road and provide long term access to the plant.

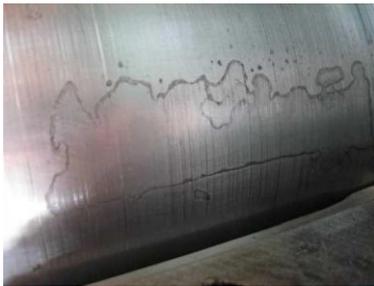
**Figure 7 - Turbine guide bearing  
showing filiform corrosion. Depth of  
defect is about 0.0005"**

As a result of the high water levels present, both units ran with no oil in the bearings for an extended period. Both units were disassembled, inspected and tested by a third party to determine the extent of the damage. Inspections revealed that water entered the bearings and caused corrosion and scoring. The bearings will be refurbished and bored to an adequate size. Bearing housings also show radial cracking of the threaded bolt holes, which will be repaired.

Both units will be reassembled using modern laser alignment techniques. This will ensure continued reliability of the refurbished components.

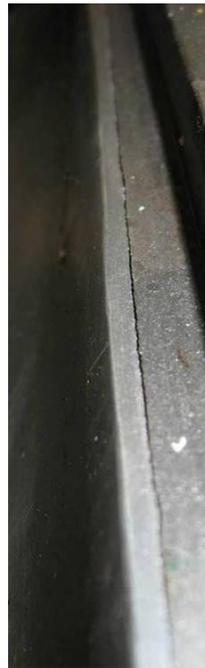
**Figure 9 –  
Delaminating of  
Babbitt**

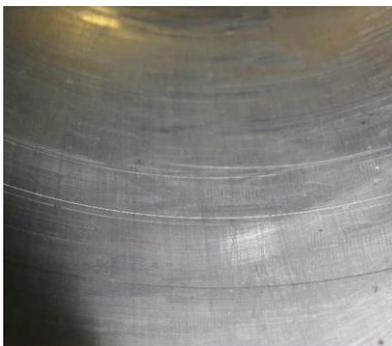
**Figure 8 – Scoring on  
Babbitt**

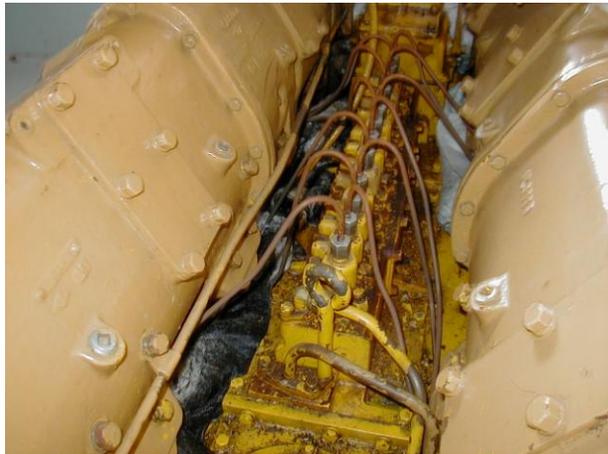
The February 2010 inspection identified oil leaks due to cracks in the cylinder head and oil pump housing, which required containment and absorbent materials in close proximity with the hot sections of the engine. Corrosion was prevalent, particularly on the exhaust system. Originally the engine cooling system used a mixture of water and glycol. Due to environmental concerns regarding the release of glycol into the local water system, the cooling system had previously been modified to use only water cooling. The modified cooling water system had experienced regular failures. The unit was last operated in 2007, at which time it had approximately 800 operating hours.

Fuel Leaks in the Engine Vee

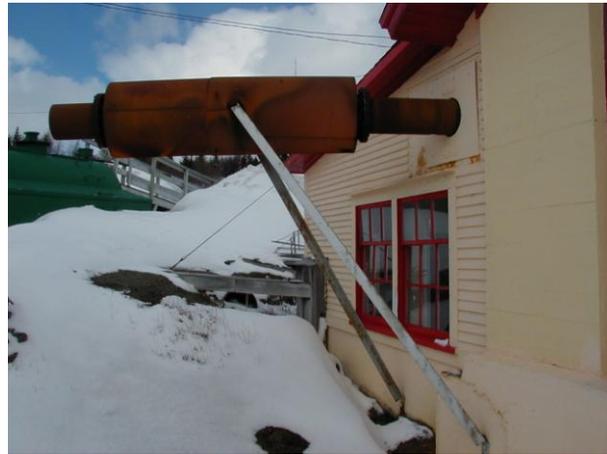
Corroded Exhaust Muffler

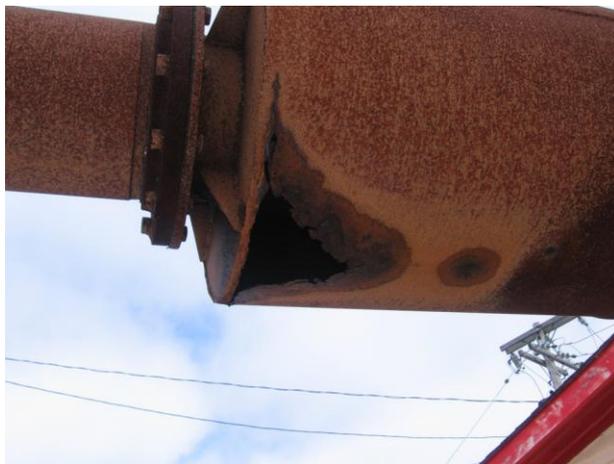
Hole In Muffler

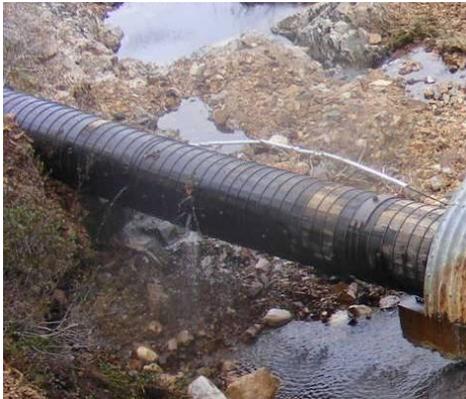
Figure 1 - Undermined Penstock

The flood washed out six of the original timber penstock supports and eroded the underlying fill. Immediately after the flood, the penstock was temporarily supported with timber cribbing, stabilizing the penstock and allowing the plant to operate safely.

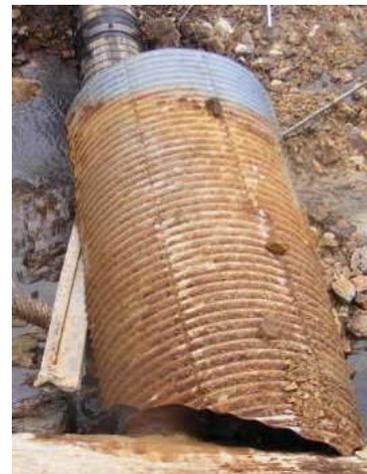
Figure 2 - Damaged multi-plate culvert  
(Rust indicates extent of the rockfill)

In 2011, new downstream rockfill and a new multi-plate culvert will be installed. The material used for the rockfill will be of sufficient size to withstand the wave overtopping that would result from a 1-in-500 year return period storm.

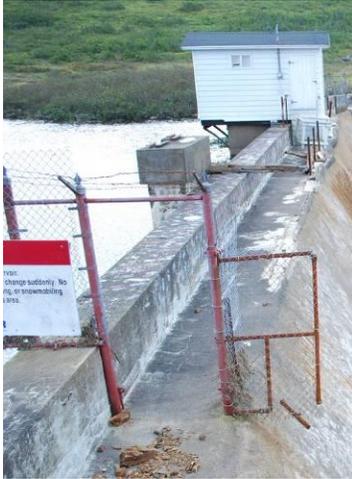
**Figure 3 - Damage to Fence**

The overtopping waters caused erosion at the abutments. Repairs to the abutments will be completed at the same time as the rockfill is being replaced.

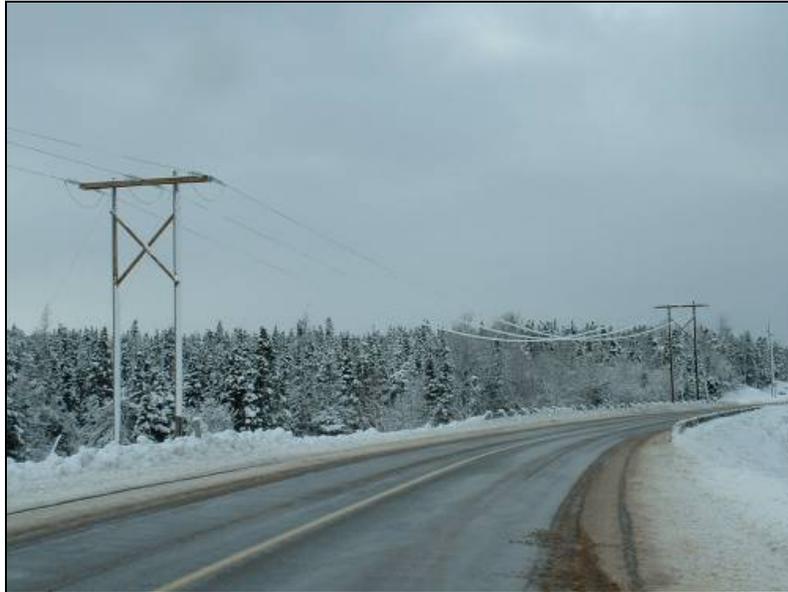
1. Section of transmission 110L that was rebuilt during 2006-2007. The ice build up did not damage this section of line.

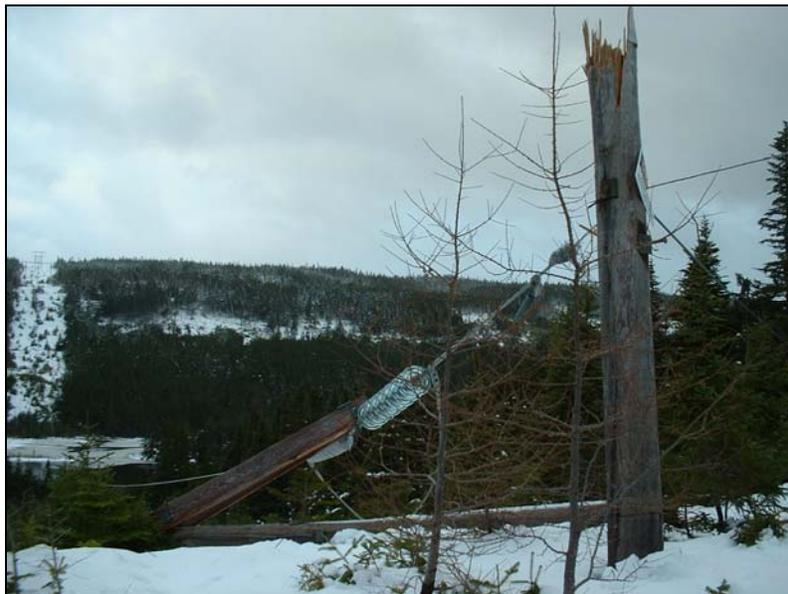
2. Double pole structure (vintage 1976) snapped on transmission line 123L on Bonavista Peninsula.

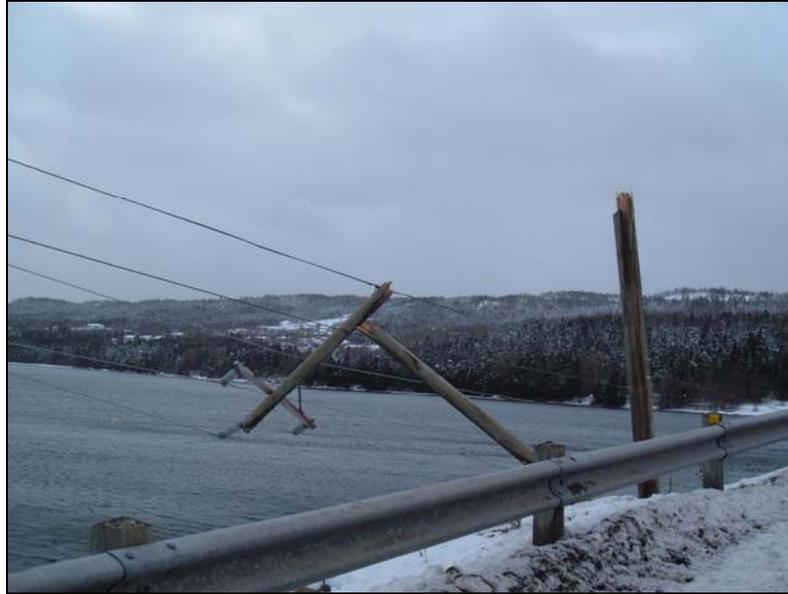
3. Distribution feeder pole snapped on Random Island Causeway.
