**Re: Quarterly Report on Asset Performance in Support of Resource Adequacy for the Twelve Months Ended March 31, 2025**

# Quarterly Report on Asset Performance in Support of Resource Adequacy

Attachment 1: L3501/2 Failure Investigation OPGW Tower Peaks – Central Newfoundland

Attachment 2: L3501/2 Failure Investigation Ice Storm Southern Labrador

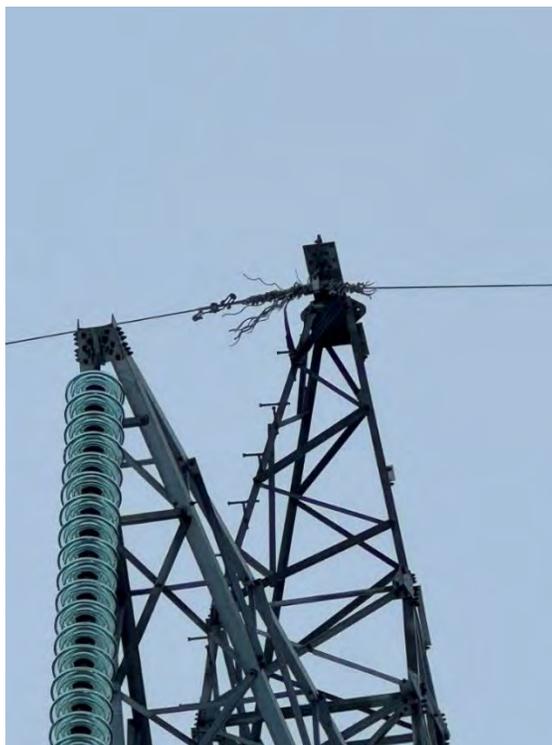
**Figure 6: OPGW Pulled through Clamp with damaged armor rods**

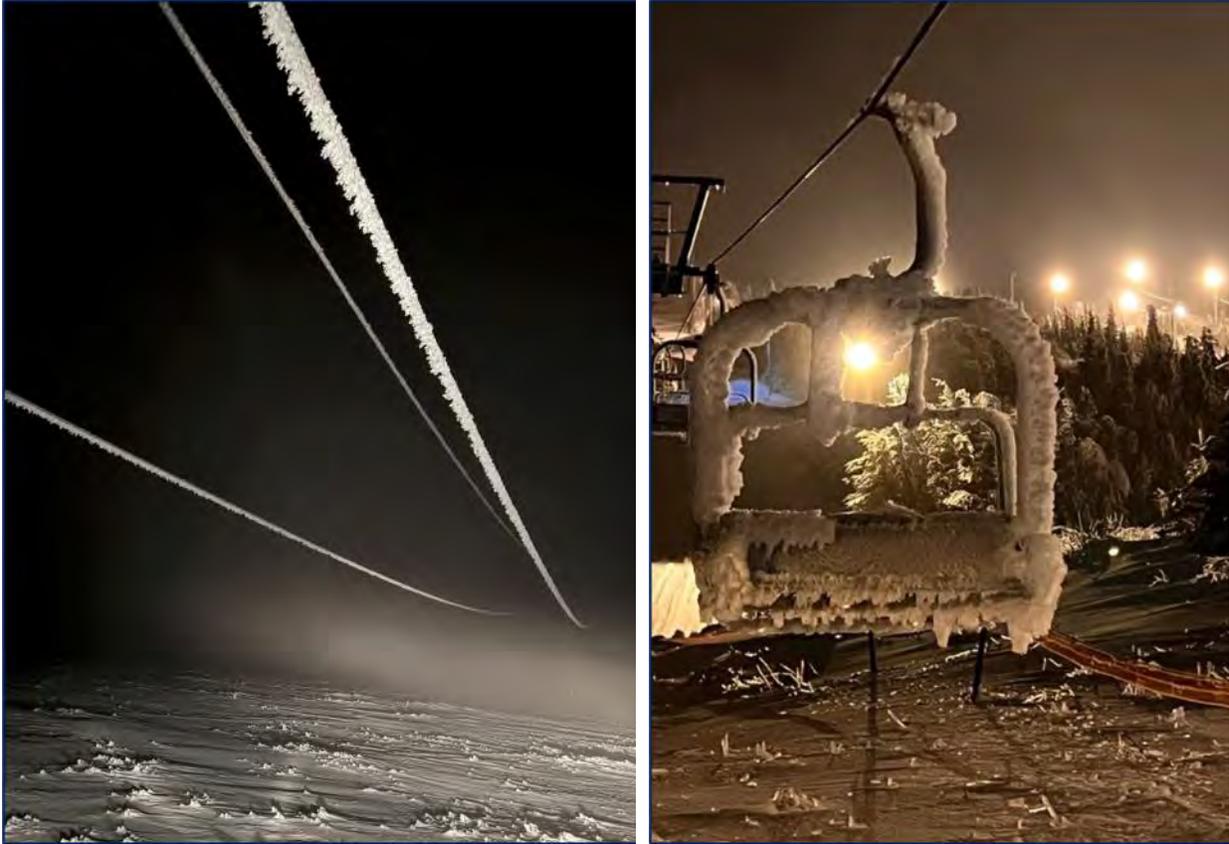
- 1 damaged. Figure 10 shows buildup of ice on the line on February 9<sup>th</sup> and on the chair lifts of the nearby
- 2 ski resort in White Hills.

**Figure 10: Ice Buildup on Lines and White Hills Chair lift (9-Feb-24)**

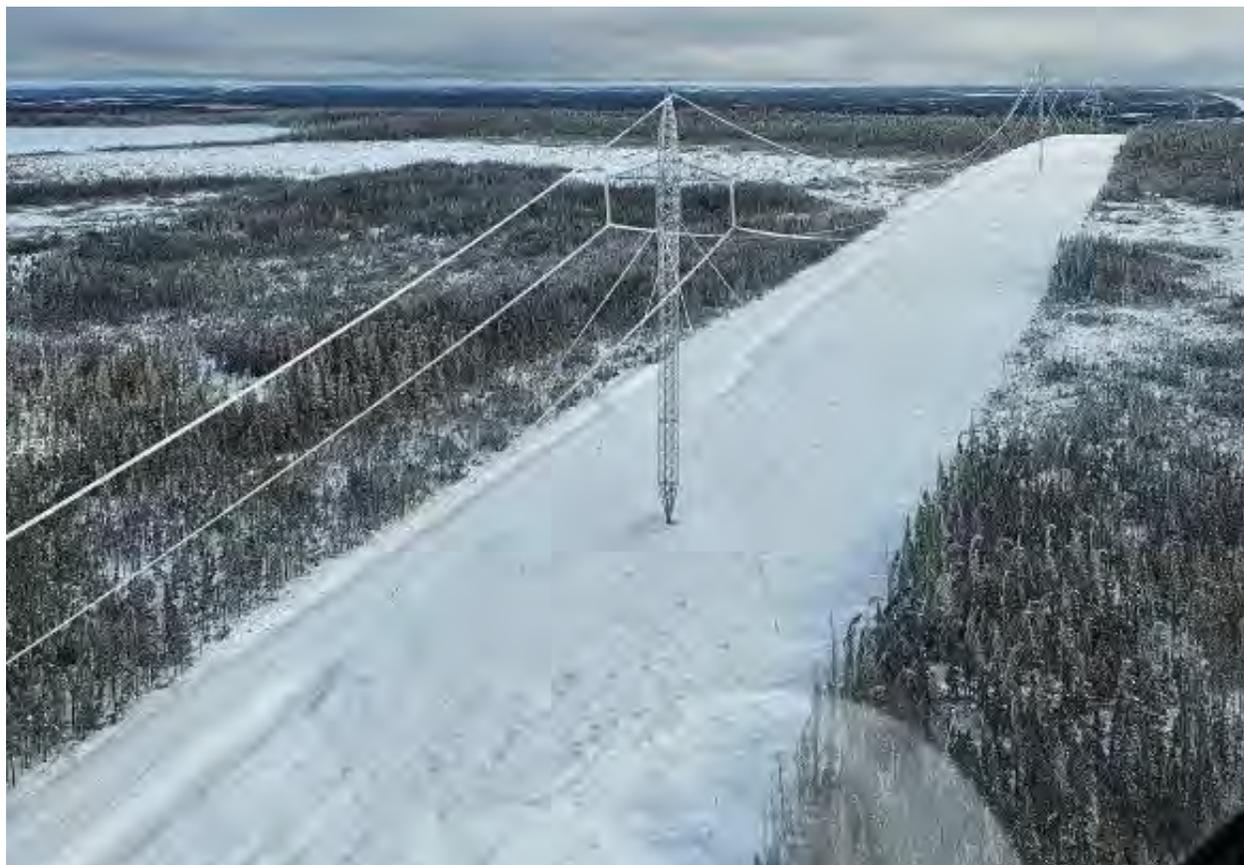
**Figure 12: Ice at Str. 2561**

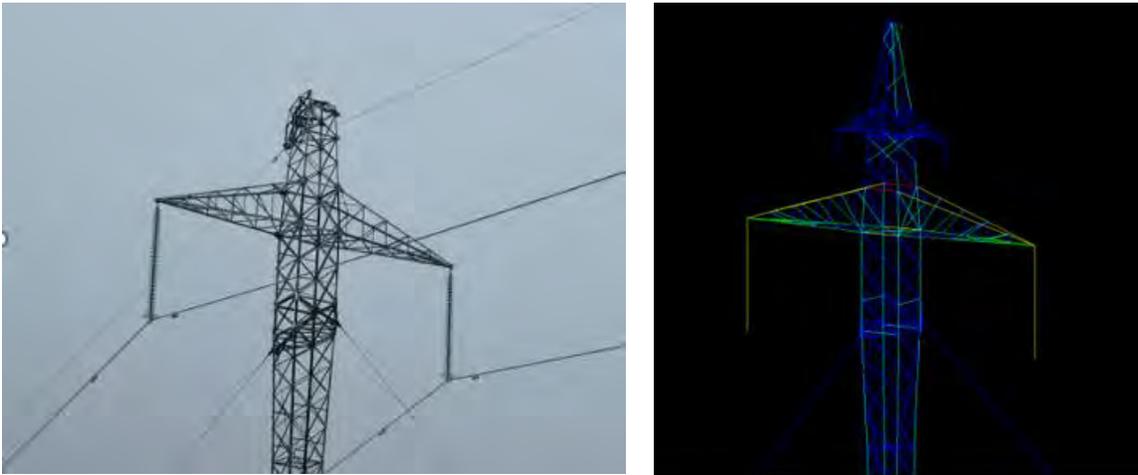
Figure 15: Failure in the Field Compared to Modeling of Tower Failure Under Ice Loading

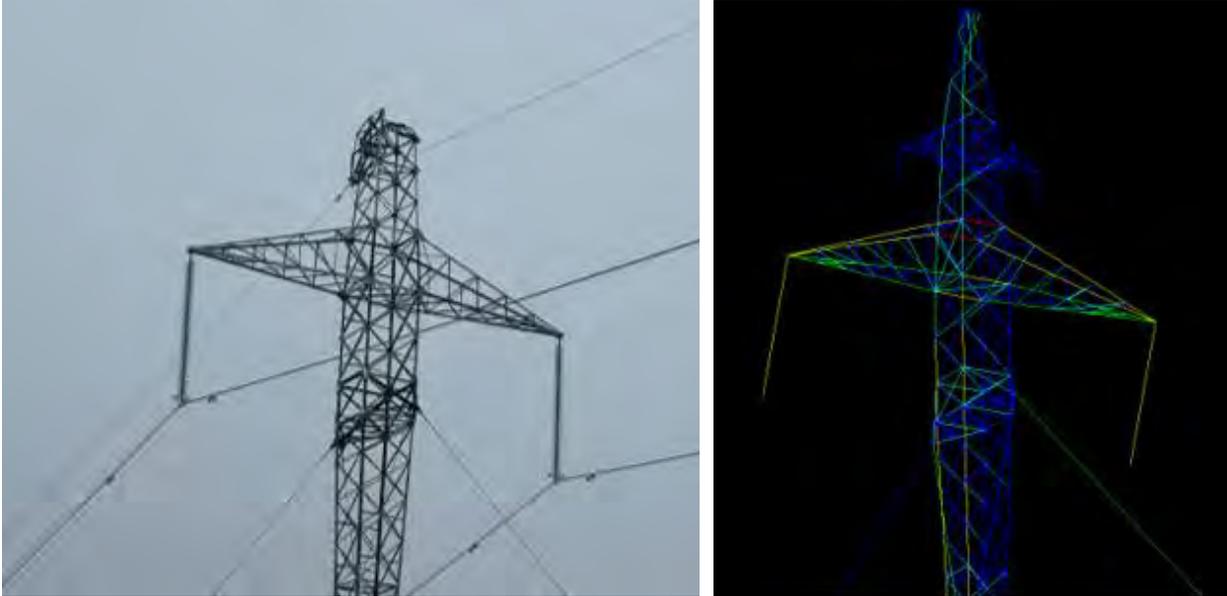
**Figure 16: Failure in the Field Compared to Modeling of Tower Failure Under Wind and Ice Combined Loading**

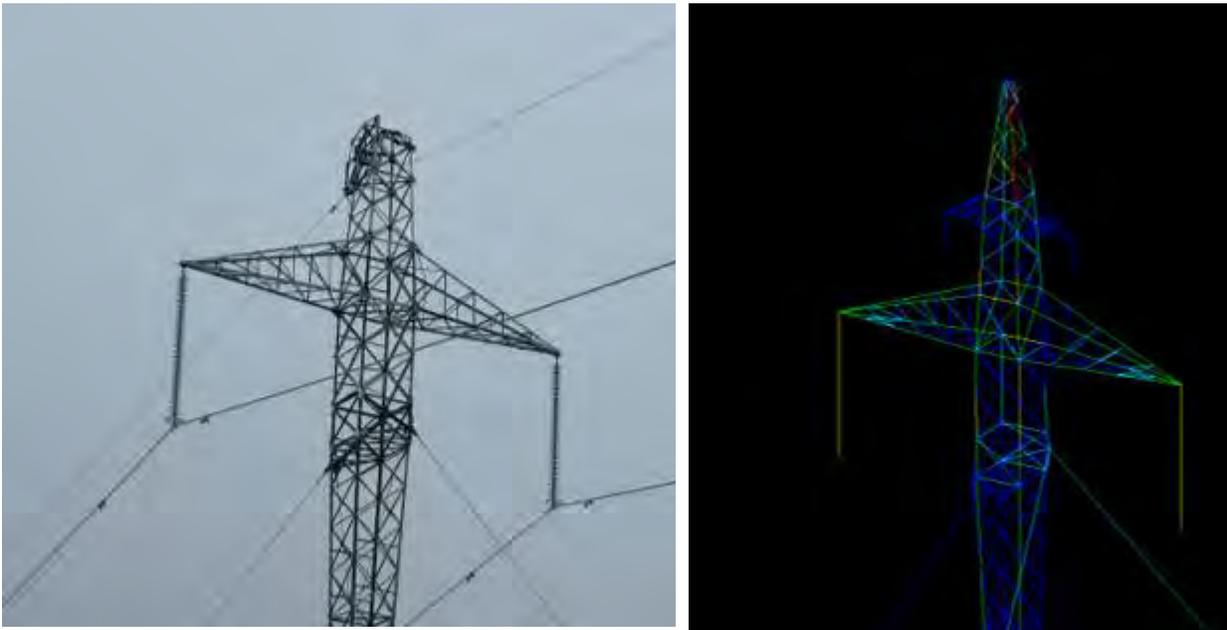
**Figure 17: Failure in the Field Compared to Modeling of Tower Failure Under Unbalanced Ice Loading**

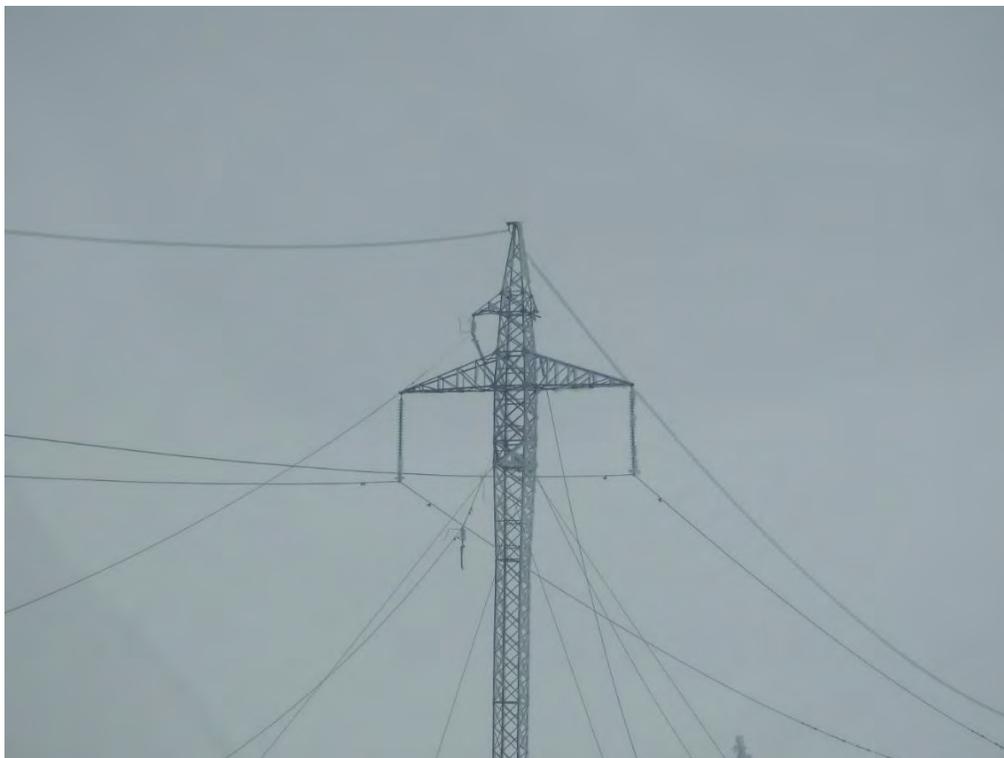
**Figure 4: Str. 1228 Electrode Cross Arm Failure**

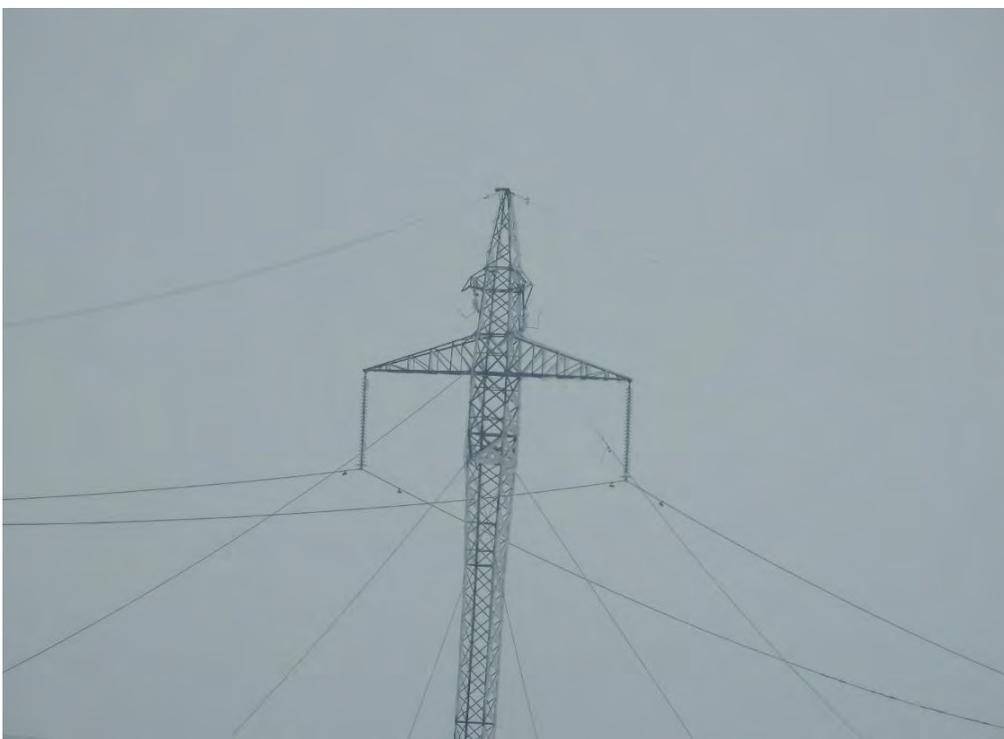
**Figure 5: Str. 1224 Electrode Cross Arm Failures**

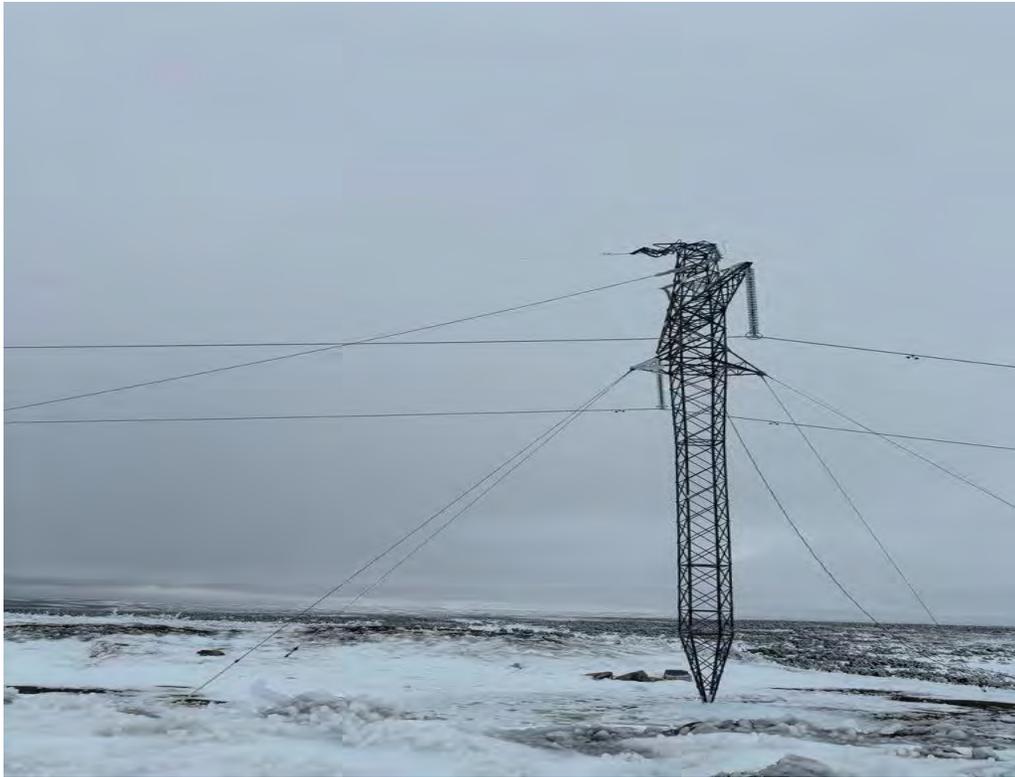
**Figure 6: OPGW Peak Failure**

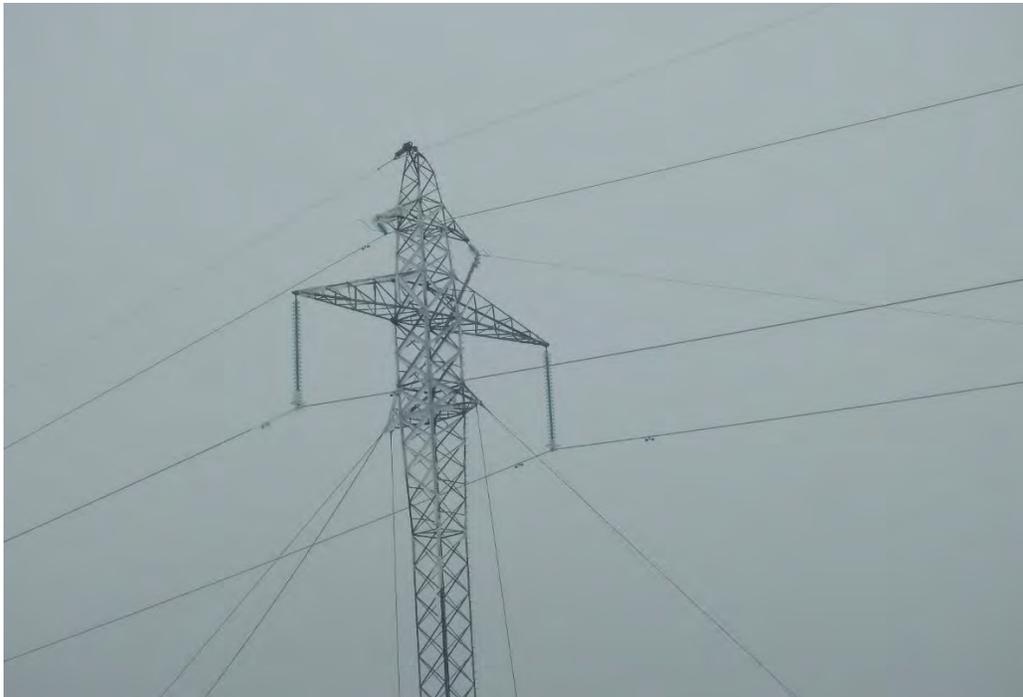
**Figure 7: Str. 1221 Minor OPGW Peak Damage, Bird Caging of Electrode Conductor, Electrode Conductor on Ground**

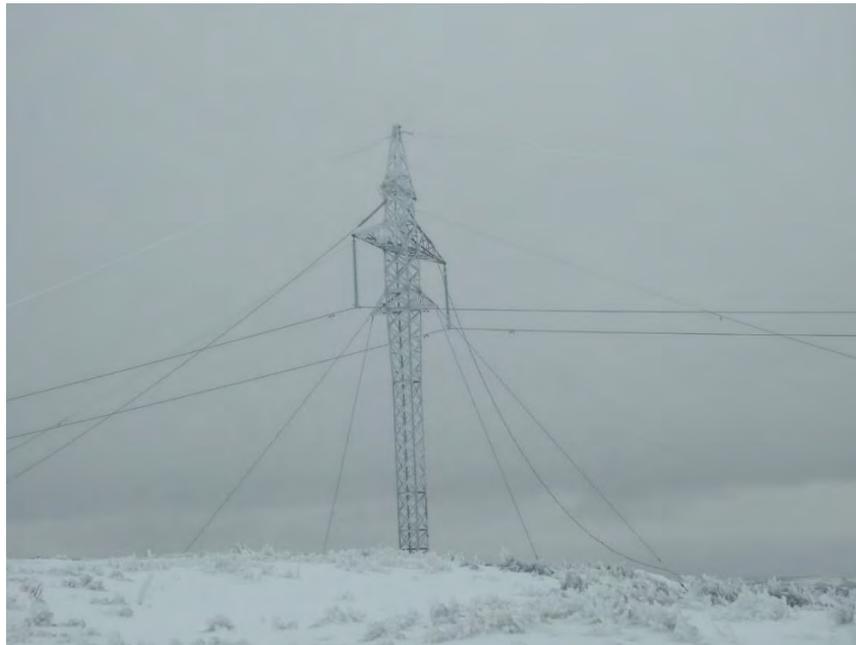
**Figure 10: Ice on OGPW at Time of Failure**

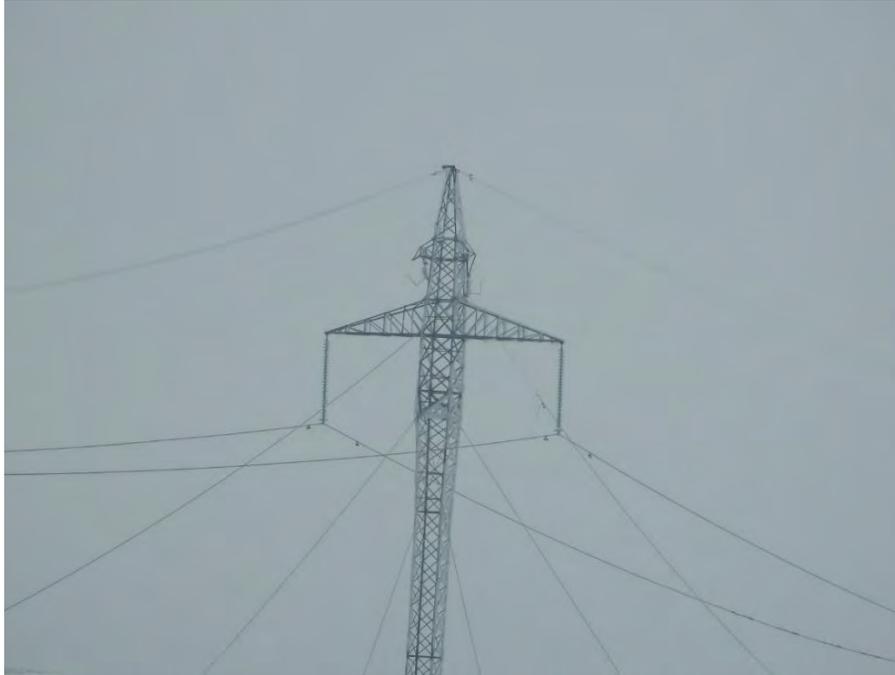
Figure 15: Str. 1224 with Damaged Electrode Crossarm

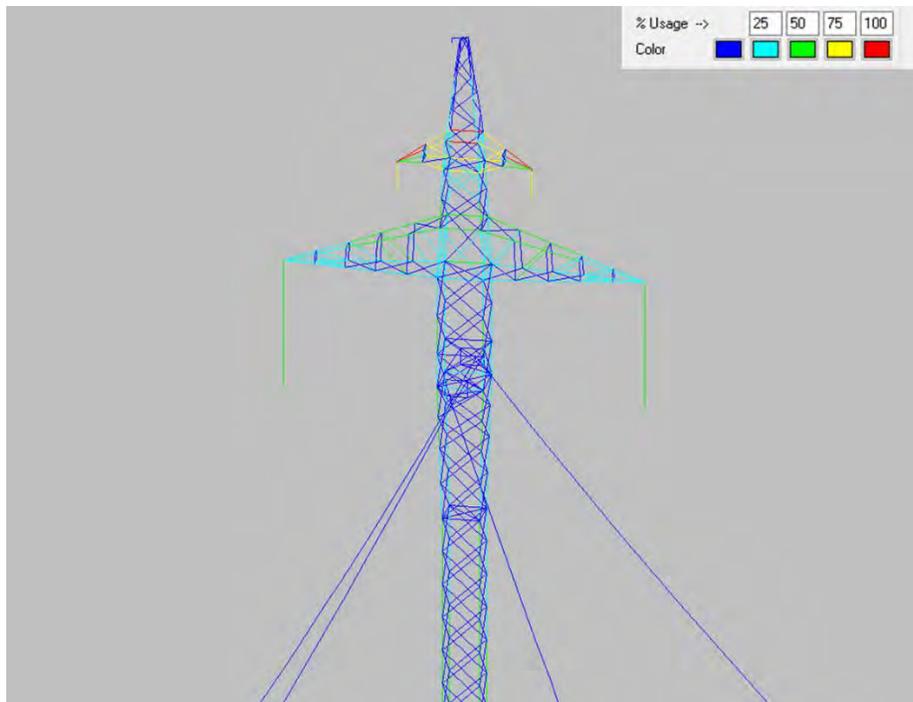
Figure 16: Model of Str. 1224 showing Members in the Electrode Crossarm Exceeding Capacity

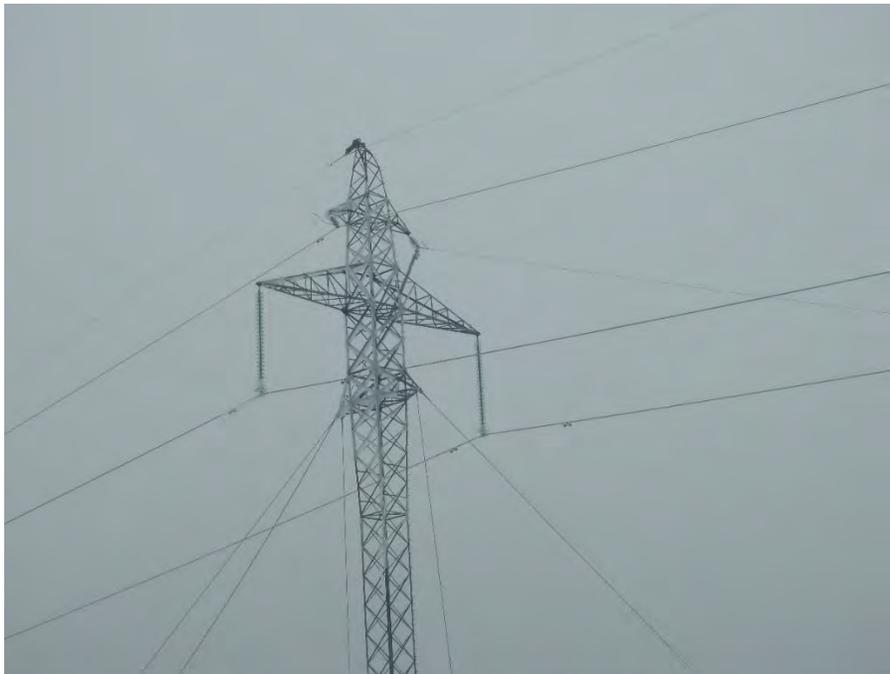
**Figure 17: Str. 1221 with OPGW Peak and Electrode Crossarm Damage**

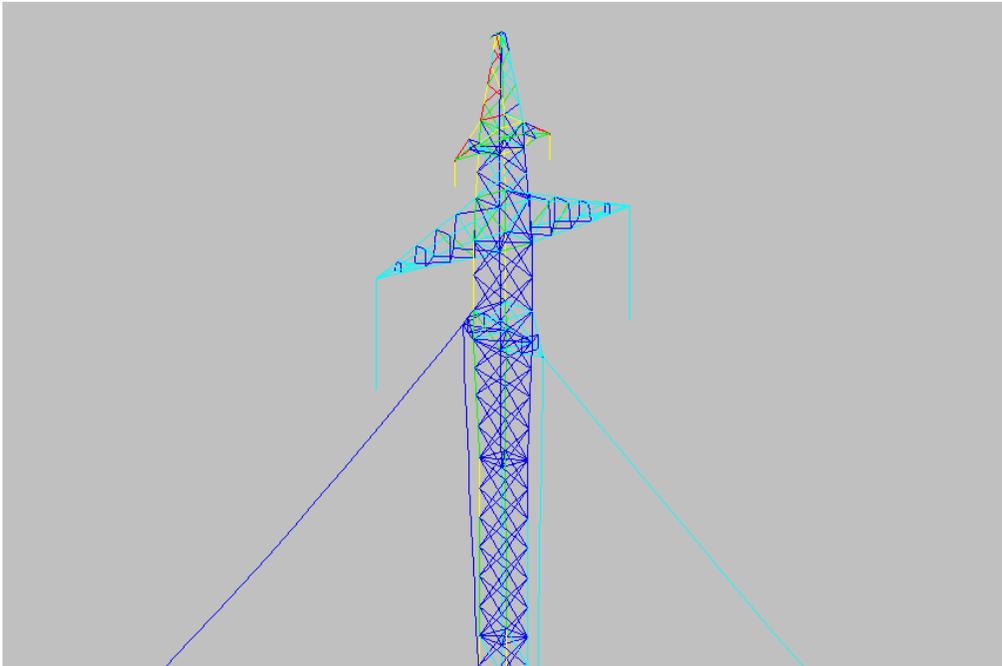
**Figure 18: Model of Str. 1221 on Unbalanced Ice Load Case showing Members in the OPGW Peak and Electrode Crossarm Exceeding Capacity**

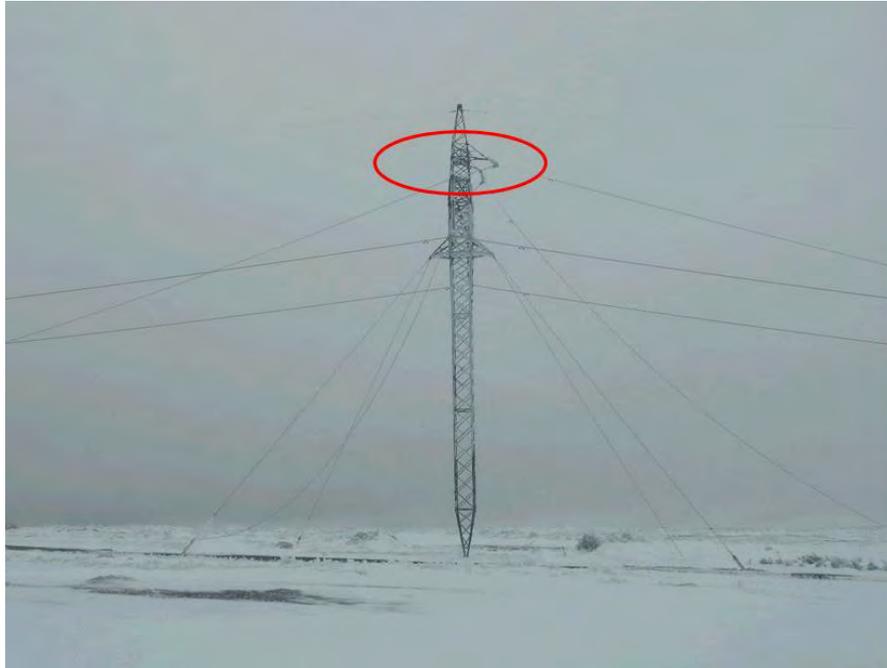
Figure 1-2: General view of suspension Tower #1225 subsequent to the line failures on March 30, 2024 [1]. The image shows the locations of conductor EL-1 and EL-2 (ellipse), which were attached to the crossarms of the tower via suspension insulators.

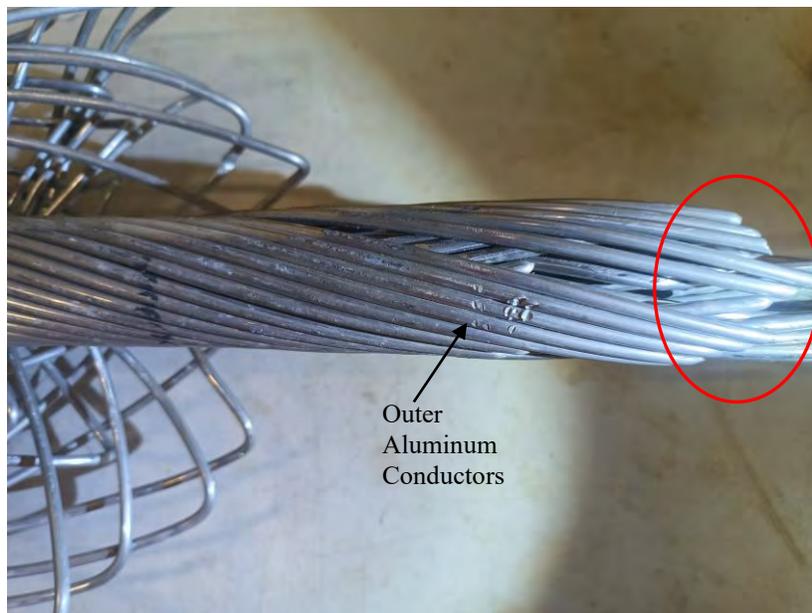
Figure 2-3: Photograph of the upper vertical external circumferential surface of conductor EL-1 as installed in the field. The image shows the fracture ends of the wire strands observed on the upper circumferential surface of the conductor (ellipse).

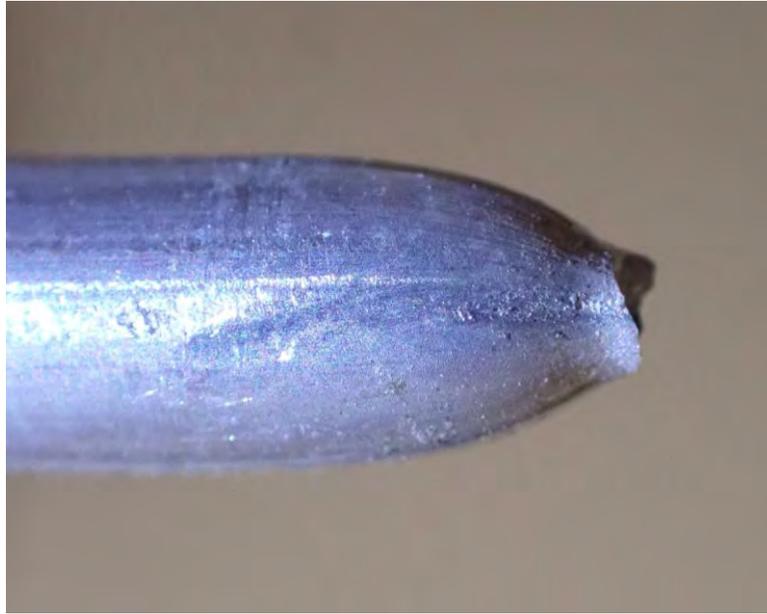
*Figure 2-5: Close-up view of a representative example of the fracture failure morphologies observed for conductor EL-1 (subsequent to conductor disassembly). The first morphology was characterized by a tapered (necked) interval immediately adjacent to the strand fracture surface.*

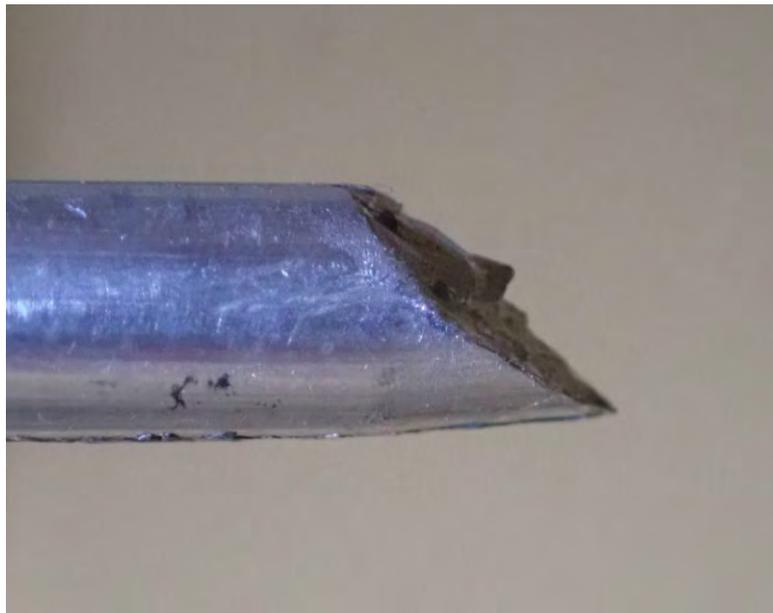
*Figure 2-6: Close-up view of a representative example of the fracture failure morphologies observed for conductor EL-1 (subsequent to conductor disassembly). The second morphology was characterized by an oblique fracture plane extending across the diameter of the strand.*

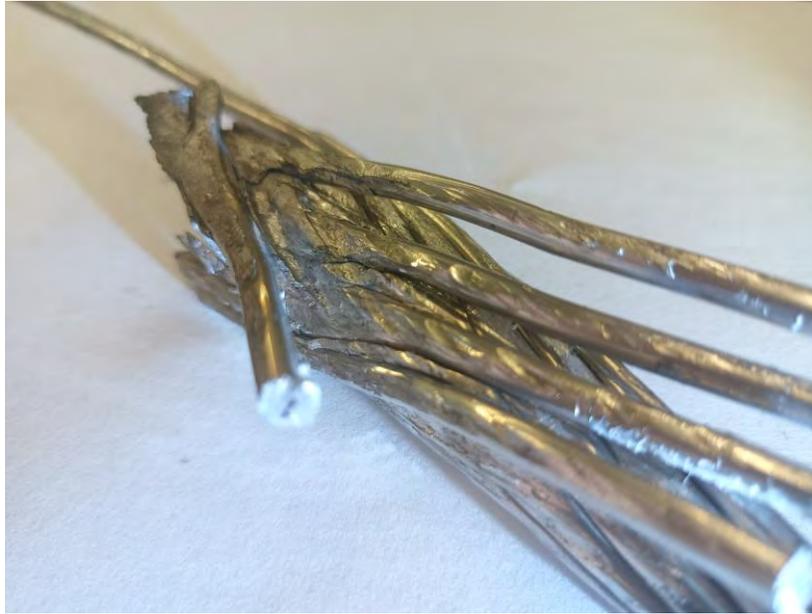
*Figure 2-7: Close-up view of a representative example of the aluminum strand fusing observed (subsequent to conductor disassembly).*

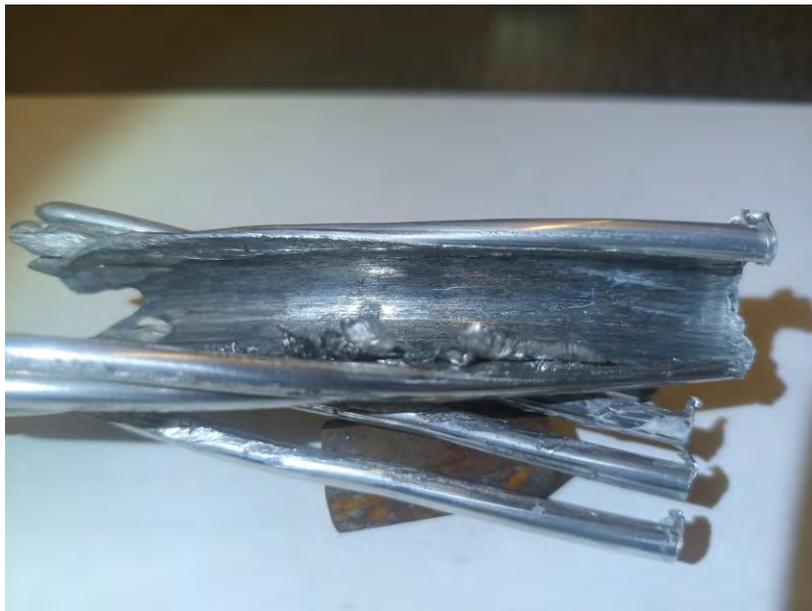
*Figure 2-8: Close-up view of a second representative example of the aluminum strand fusing observed (subsequent to conductor disassembly).*

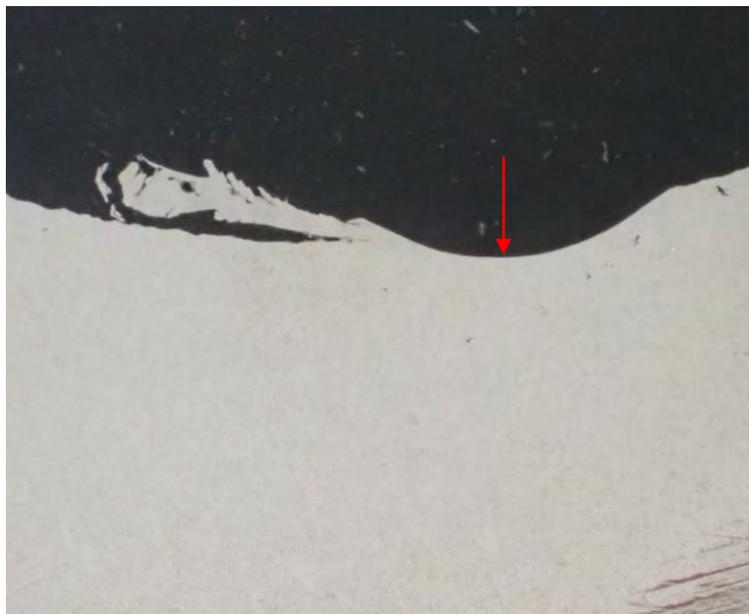
*Figure 2-10: Close-up sectional view through the localized brinelling (arrow) shown in Figure 2-9. The image shows the approximate semi-circular morphology of the damage observed at the site (ellipse).*

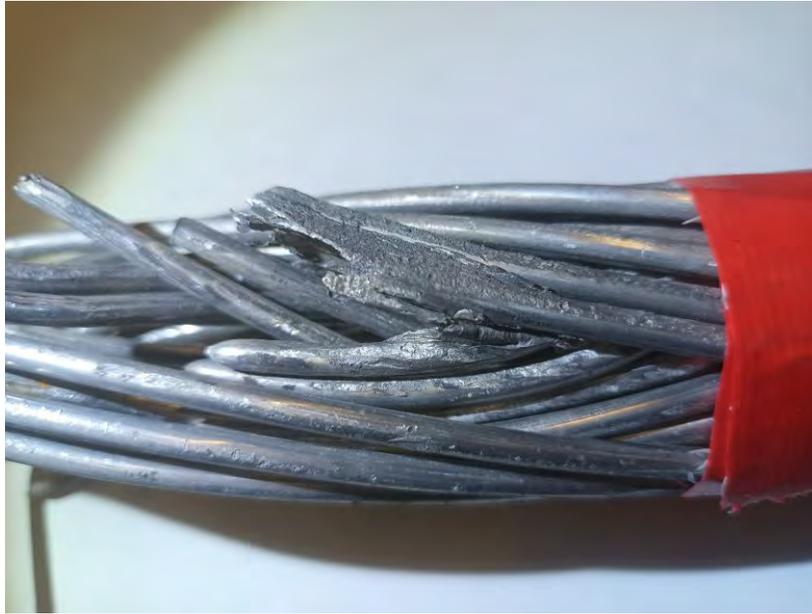
*Figure 2-16: Photograph of the lower vertical external circumferential surface of conductor EL-2 as installed in the field. The image shows the significant aluminum strand to strand fusing observed on the lower circumferential surface.*

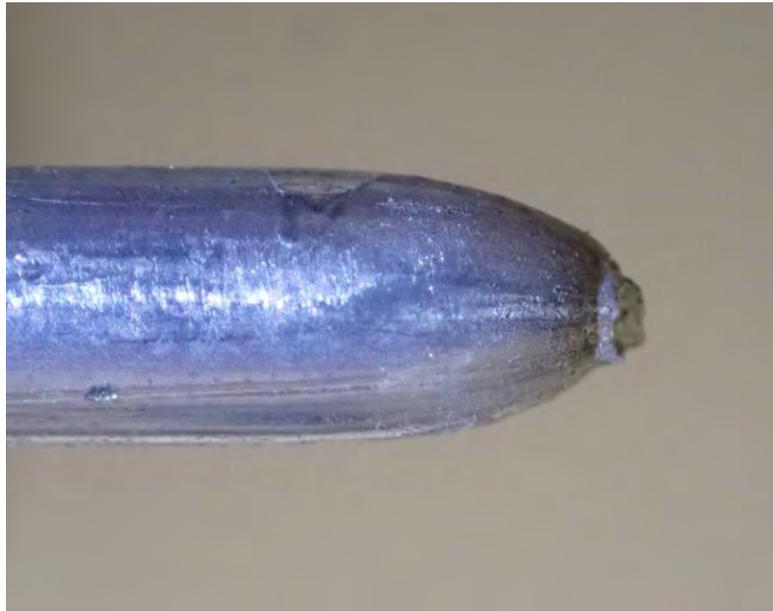
*Figure 2-17: Close-up view of a representative example of the fracture failure morphologies observed for conductor EL-2 (subsequent to conductor disassembly). The first morphology was characterized by a tapered (necked) interval immediately adjacent to the strand fracture surface.*

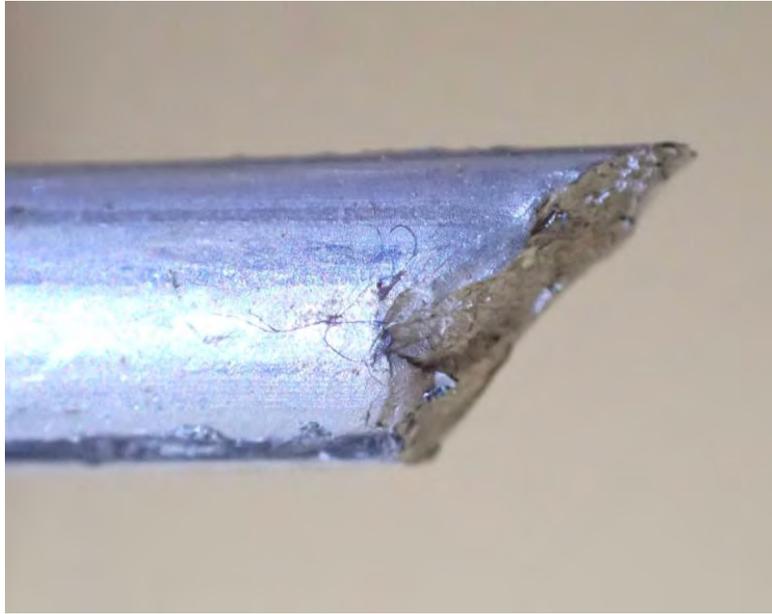
*Figure 2-18: Close-up view of a representative example of the fracture failure morphologies observed for conductor EL-2 (subsequent to conductor disassembly). The second morphology was characterized by an oblique fracture plane extending across the diameter of the strand.*

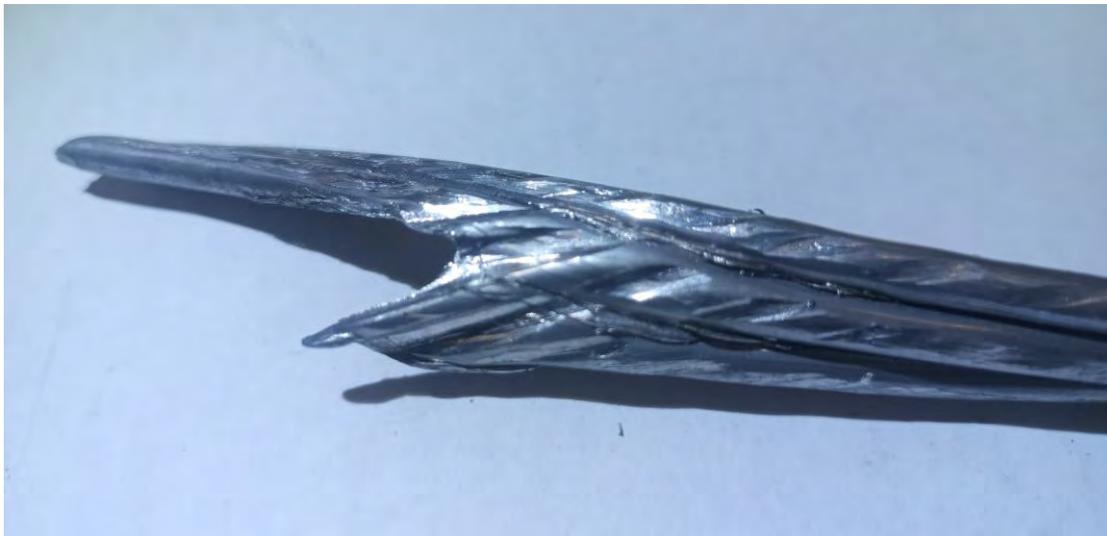
*Figure 2-19: Close-up view of a representative example of the aluminum strand fusing observed (subsequent to conductor disassembly).*

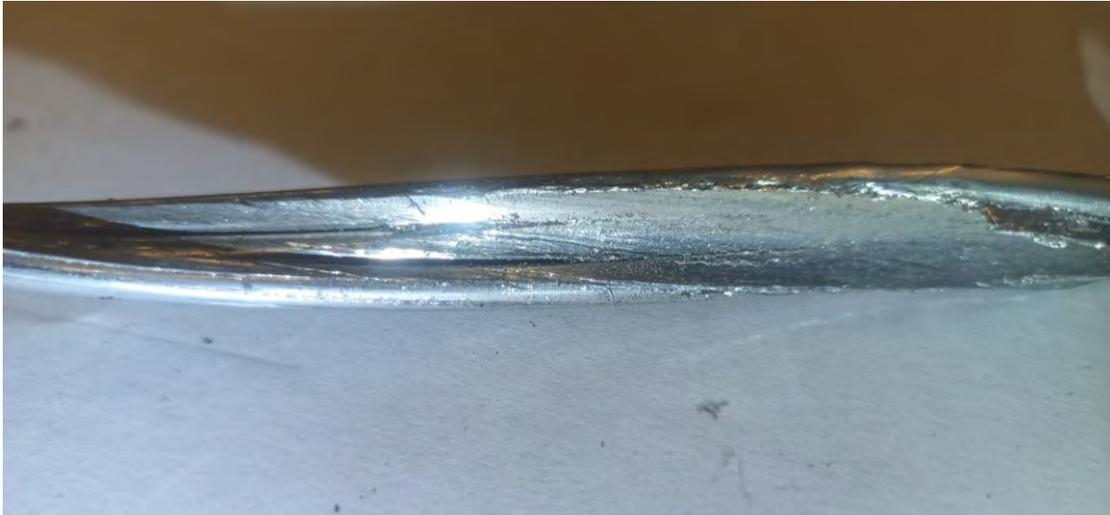
Figure 2-20: Close-up view of a second representative example of the aluminum strand fusing observed (subsequent to conductor disassembly).

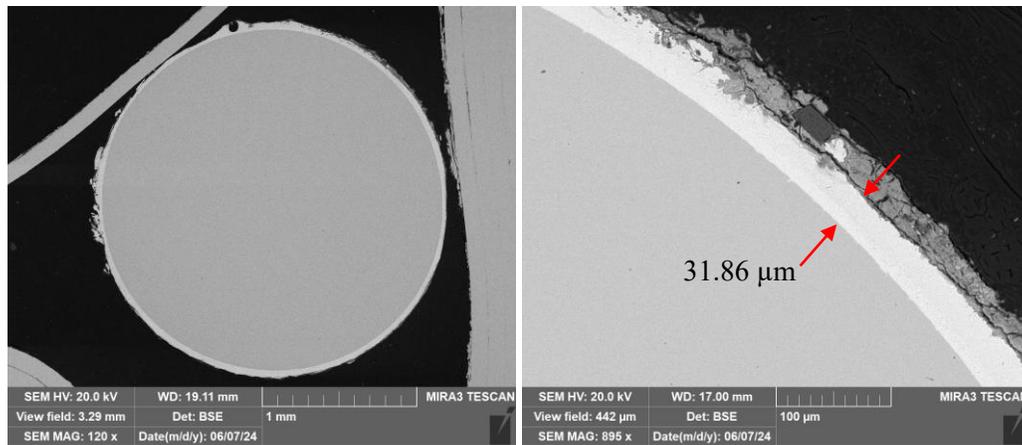
Figure 3-2: SEM backscatter image of a representative example of a zinc coated steel reinforcing strand for the failed conductor EL-1. The image shows the significant variation in the thickness of the zinc coating observed around the circumference of the steel reinforcing strand.

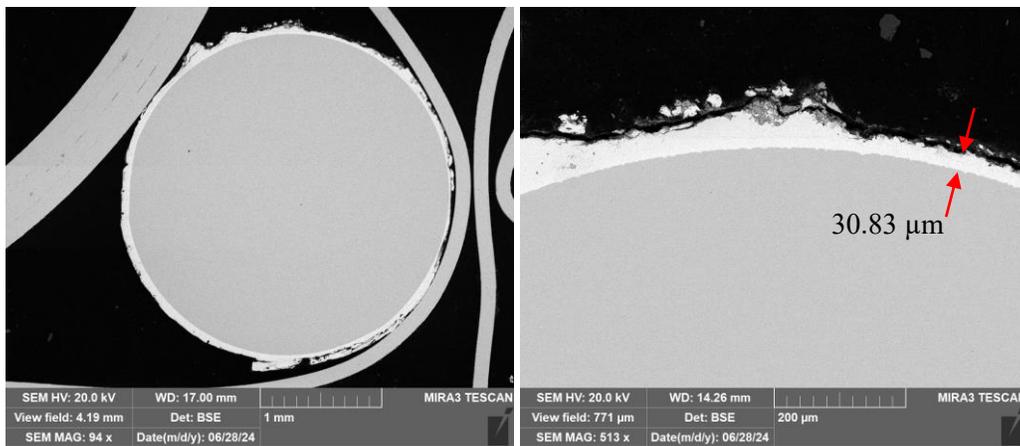
Figure 3-3: SEM backscatter image of a representative example of a zinc coated steel reinforcing strand for the failed conductor EL-2. The image shows the significant variation in the thickness of the zinc coating observed around the circumference of the steel reinforcing strand.

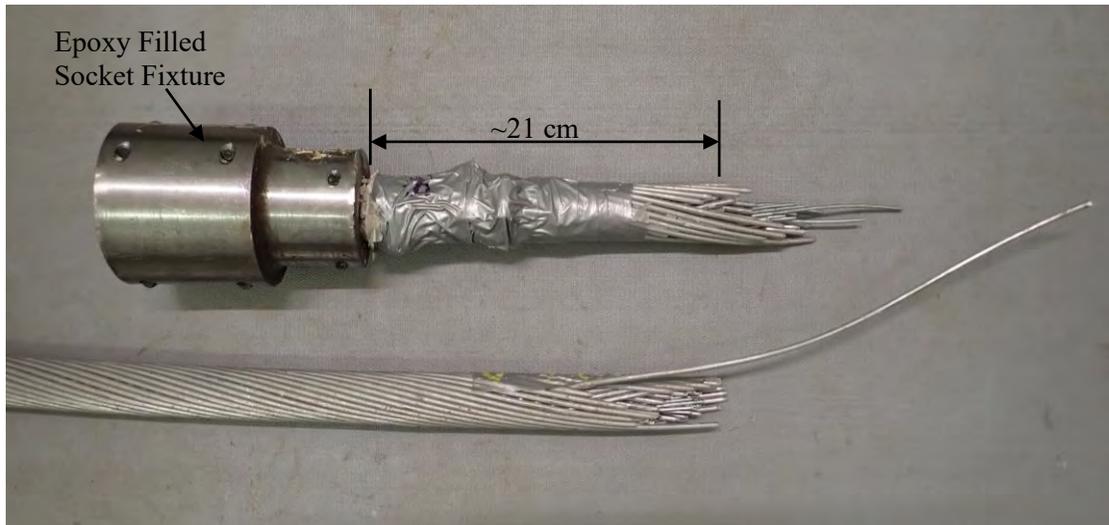
Figure 3-7: Photograph showing the service exposed conductor subsequent to failure. The axial position of the conductor failure was approximately 21 cm from the beginning of one of the epoxy filled terminations.

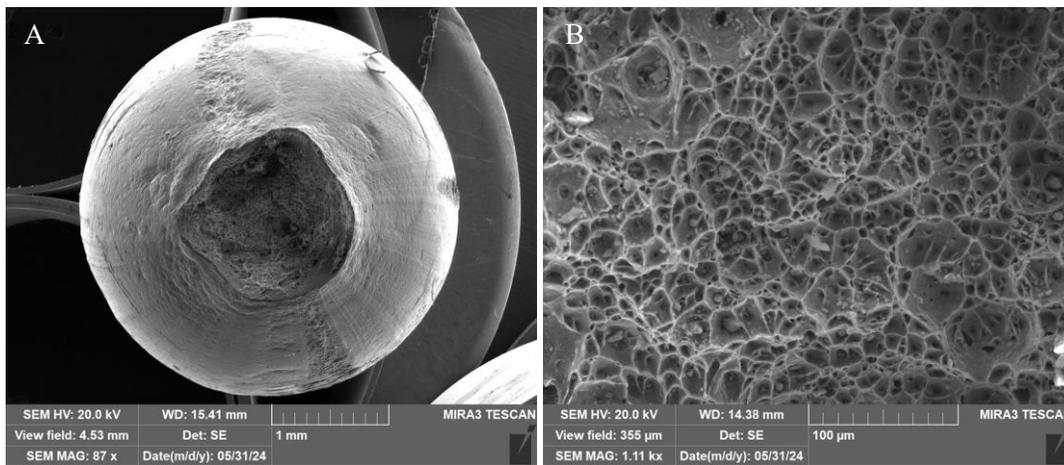
Figure 3-10: SEM fractographic images of a representative example of the fracture surface associated with the failure of the outer aluminum wire strands. The image shows the cup and cone failure (A) and the void coalescence (B) typically associated with a ductile, limit load fracture mechanism.

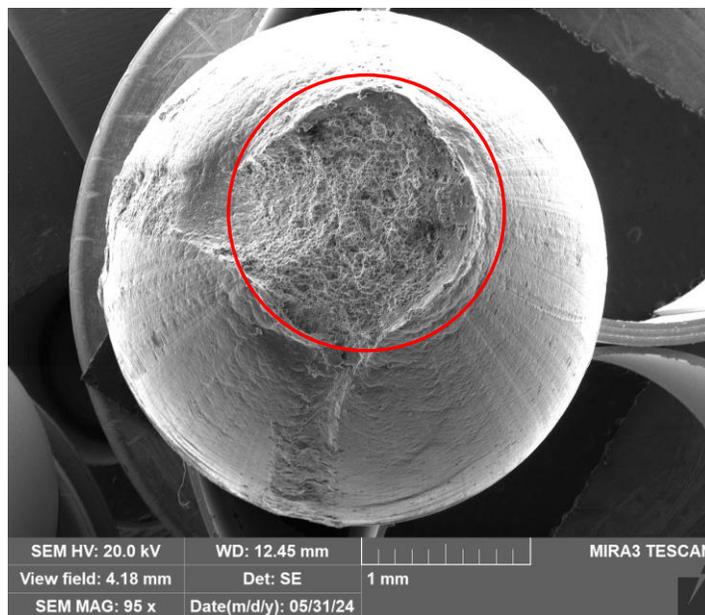
Figure 4-1: Low magnification SEM secondary image of a representative example of the fracture surface (ellipse) associated with the tapered-end (necked) geometry observed terminating the failed aluminum wire strands during the preliminary examination of conductor EL-1 (Figure 2-5). The image shows the general cup and cone morphology of the failed end of the wire strand.

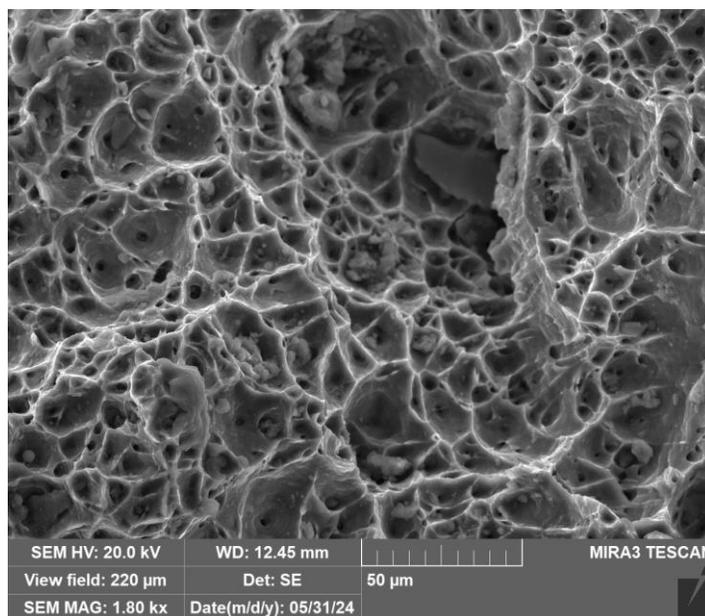
Figure 4-2: High magnification fractographic image within the proximity of the strand centroid shown in Figure 4-1. The image indicates that the strand fracture mechanism was dominated by void coalescence (i.e. ductile fracture) at the site.

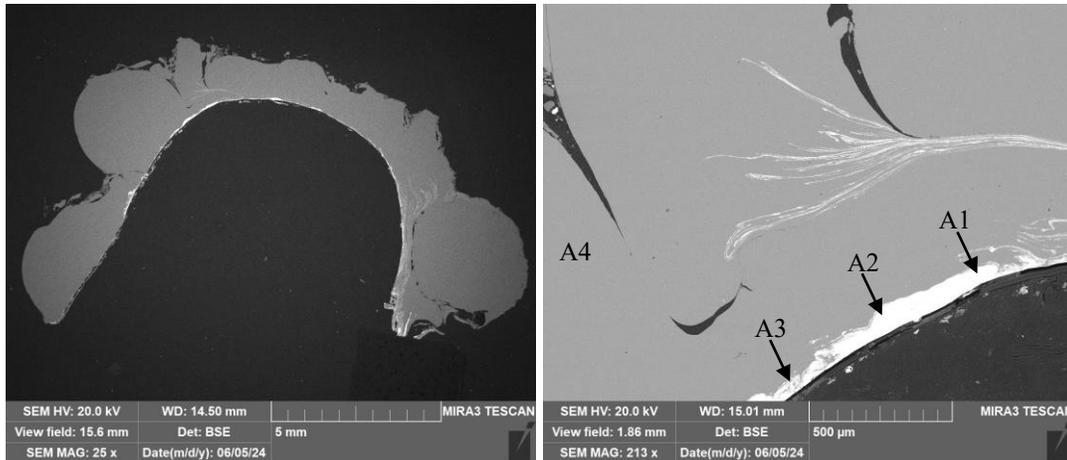
Figure 4-5: Sectional view SEM backscatter image of a representative example of the strand to strand fusing observed in conductor EL-1. The image also shows the location of the SEM EDS analyses conducted to determine the composition of the high density (light) phase observed (results are summarized in Table 4-1).

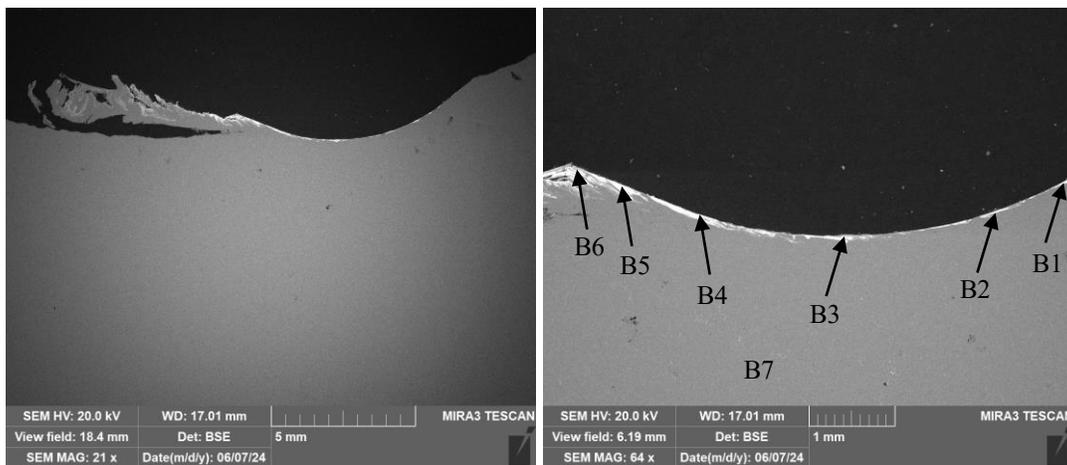
Figure 4-6: Sectional view SEM backscatter image of a representative example of the clamp material immediately adjacent to the site of localized brinelling observed. The image also shows the location of the SEM EDS analyses conducted to determine the composition of the high density (light) phase observed (results are summarized in Table 4-2).

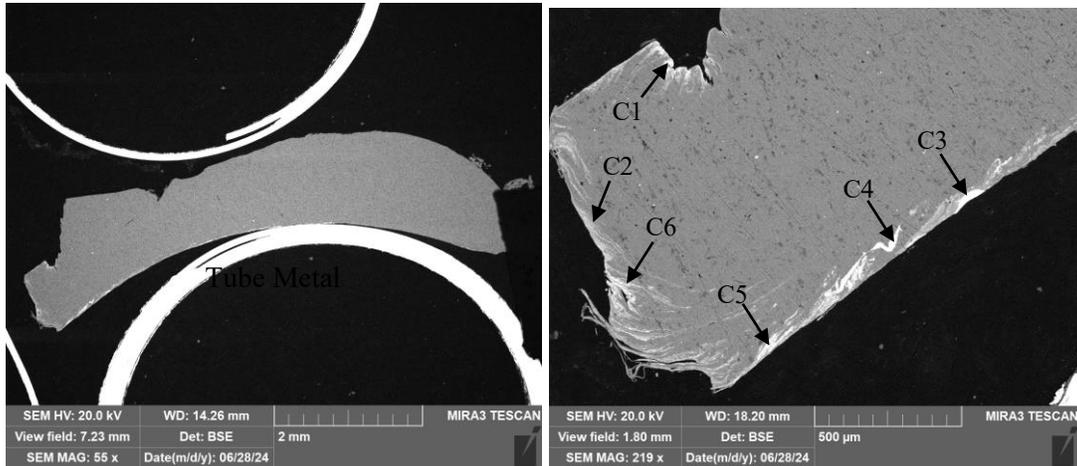
Figure 4-11: Sectional view SEM backscatter image of a representative example of the strand to strand fusing observed in conductor EL-2. The image also shows the location of the SEM EDS analyses conducted to determine the composition of the high density (light) phase observed (results are summarized in Table 4-3).
