**Re: Quarterly Report on Asset Performance in Support of Resource Adequacy for the Twelve Months Ended March 31, 2025**

# Quarterly Report on Asset Performance in Support of Resource Adequacy

Attachment 1: L3501/2 Failure Investigation OPGW Tower Peaks – Central Newfoundland

Attachment 2: L3501/2 Failure Investigation Ice Storm Southern Labrador

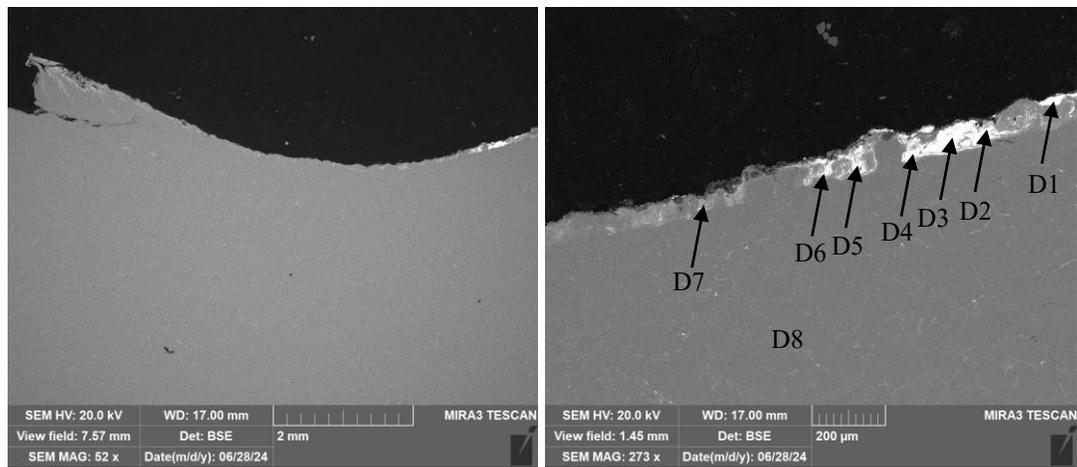
Figure 4-12: Sectional view SEM backscatter images of a representative example of the clamp material immediately adjacent to the site of localized brinelling observed. The image also shows the location of the SEM EDS analyses conducted to determine the composition of the high density (light) phase observed (results are summarized in Table 4-4).
