Re: An Application by Newfoundland and Labrador Hydro (Hydro) for the approval of the of the Refurbishment of Bay d'Espoir Penstock 2 and Bay d'Espoir Unit 3 Turbine Major Overhaul.

# **PENSTOCK NO. 2 INSPECTION AND EVALUATION**

## BAY D'ESPOIR HYDROELECTRIC DEVELOPMENT

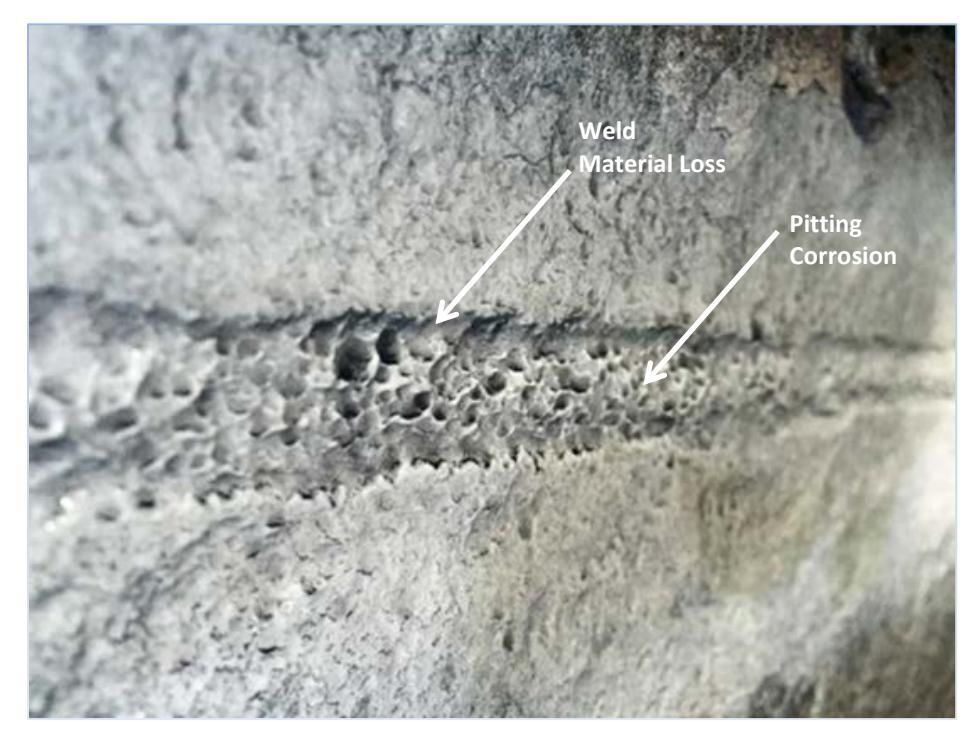
8 Weld investigations completed of the interior of Penstock 1 in September 2016 revealed 9 corrosion and microscopic cracking concentrated in the weld with less pitting shown in the 10 adjacent base plate material. This weld corrosion and resulting loss of the weld material 11 thickness, as shown in Photo 2, indicate that the remaining weld thickness no longer meets 12 minimum design requirements for Penstock 1. Detailed discussion can be found in the Bay 13 d'Espoir Penstock 1 Refurbishment report submitted to the Board on January 9, 2017 14 (Appendix A). As a follow-up to the work on Penstock 1, a root cause analysis was 15 performed by a third party consultant. The root cause analysis report is expected to be 16 submitted to Hydro by mid-March and will be forwarded to the Board at that time.

Photo 2: Deep Pitting Corrosion and Material Loss Shown in Weld

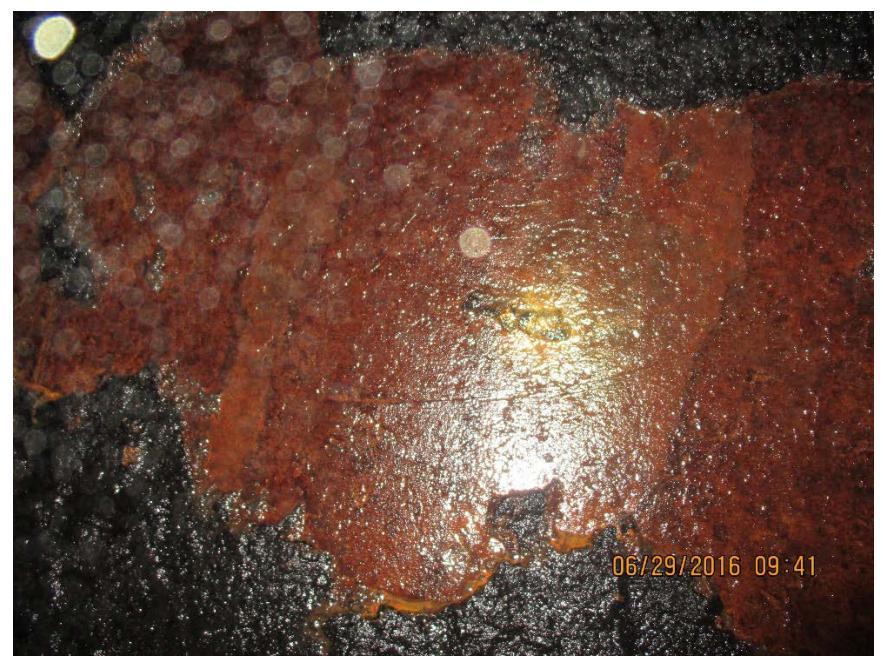
is shown in photo 3. As a result of the algae, it was difficult to visually inspect most of the
welds and the weld inspection was limited to the areas where the algae and coating had
fallen off the metal surface. These areas showed corrosion; however, cracking was not
visible. A recommendation of the report was to complete a detailed weld inspection,
including microscopic crack testing of Penstock 2 in 2017. This level of inspection would
include removal of sections of algae and coating in each penstock can<sup>1</sup> and testing for
cracks using both magnetic particle equipment<sup>2</sup> and angled beam equipment.<sup>3</sup>

Photo 3: Surface Corrosion Where Algae and Coating Have Fallen Off Surface

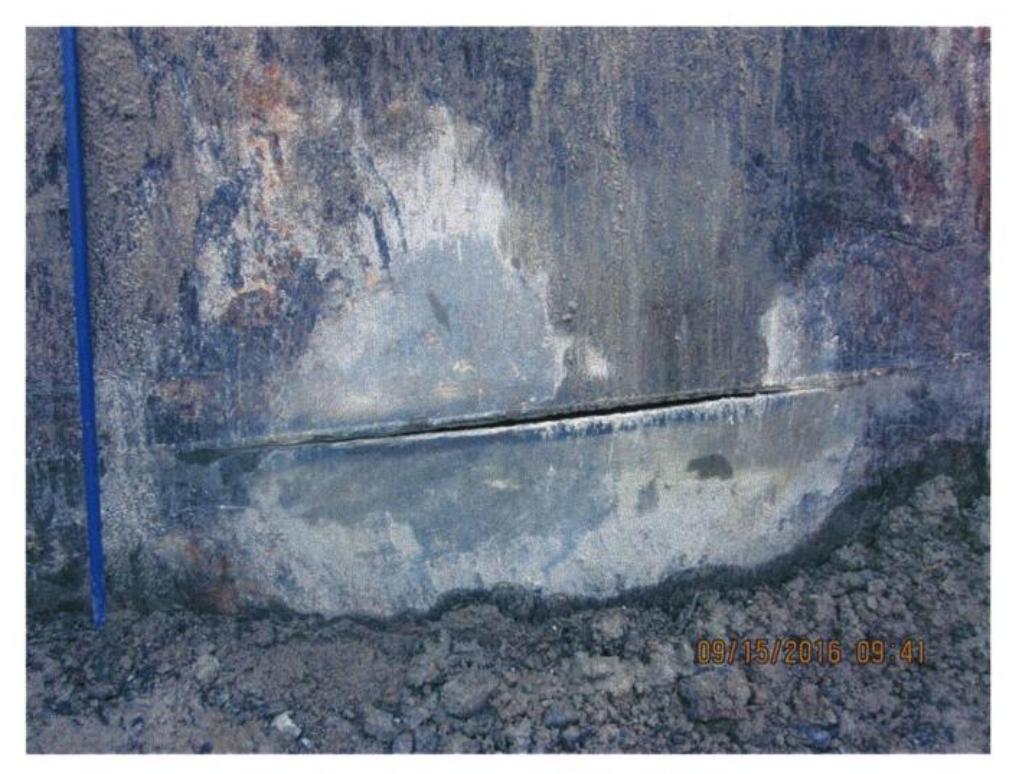
On September 14, 2016, a leak was discovered in Penstock 1 at the Bay d'Espoir plant. Site
investigation revealed a 1.1m open crack along a horizontal weld in the penstock (see Photo 1)
approximately 230m downstream of the penstock intake gate. This open crack followed
another open crack that had developed in May 2016, which was repaired at that time. Both
open cracks were in close proximity. With the second open crack development, it was then
suspected that the May crack was not an anomaly and that a more detailed investigation was
required.

Photo 1: Open crack in Penstock 1

The penstock was removed from service to repair the open crack, complete a detailed inspection of the penstock to determine if any further issues existed affecting penstock reliability, and to determine the root cause of the failure. Hatch, having local metallurgy expertise, was engaged to assist Newfoundland and Labrador Hydro (Hydro) in completing the detailed inspection, developing the resulting refurbishment plan, and determining the root cause of failure.

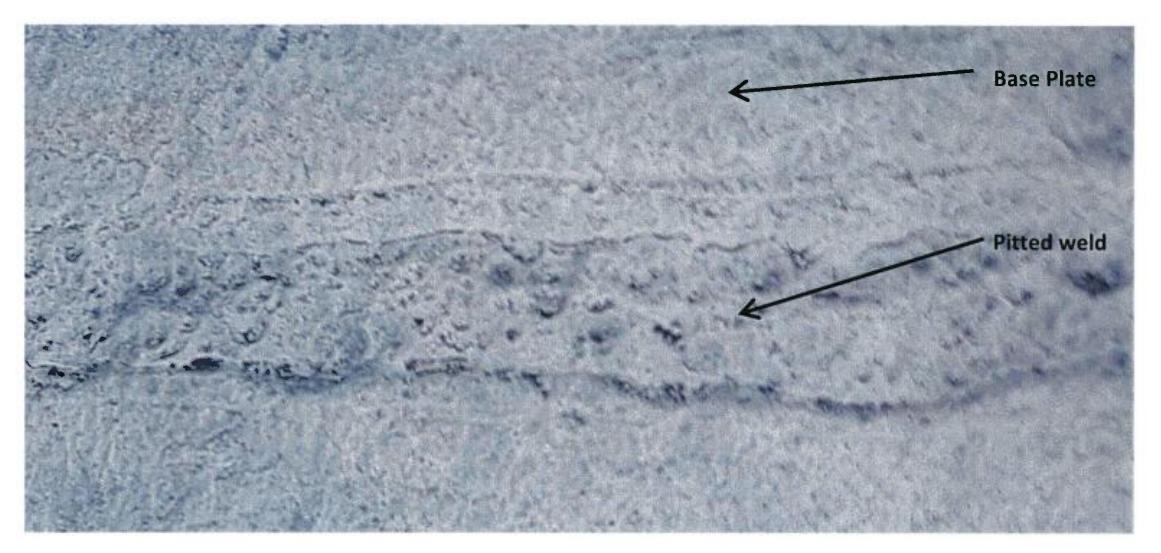
- 8 An investigation of the open crack area, initially including the area 10m upstream and
- 9 downstream of the crack area, was completed by Hatch with Bay d'Espoir operations support.
- 10 The welds in this area of the penstock displayed corrosion primarily concentrated in the weld
- 11 with less pitting shown in the adjacent base metal. Photos 4 and 5 show the extent of the
- 12 corrosion observed in the horizontal welds in the inspected area as compared to the base plate.

Photo 4: pitting in weld on interior of penstock

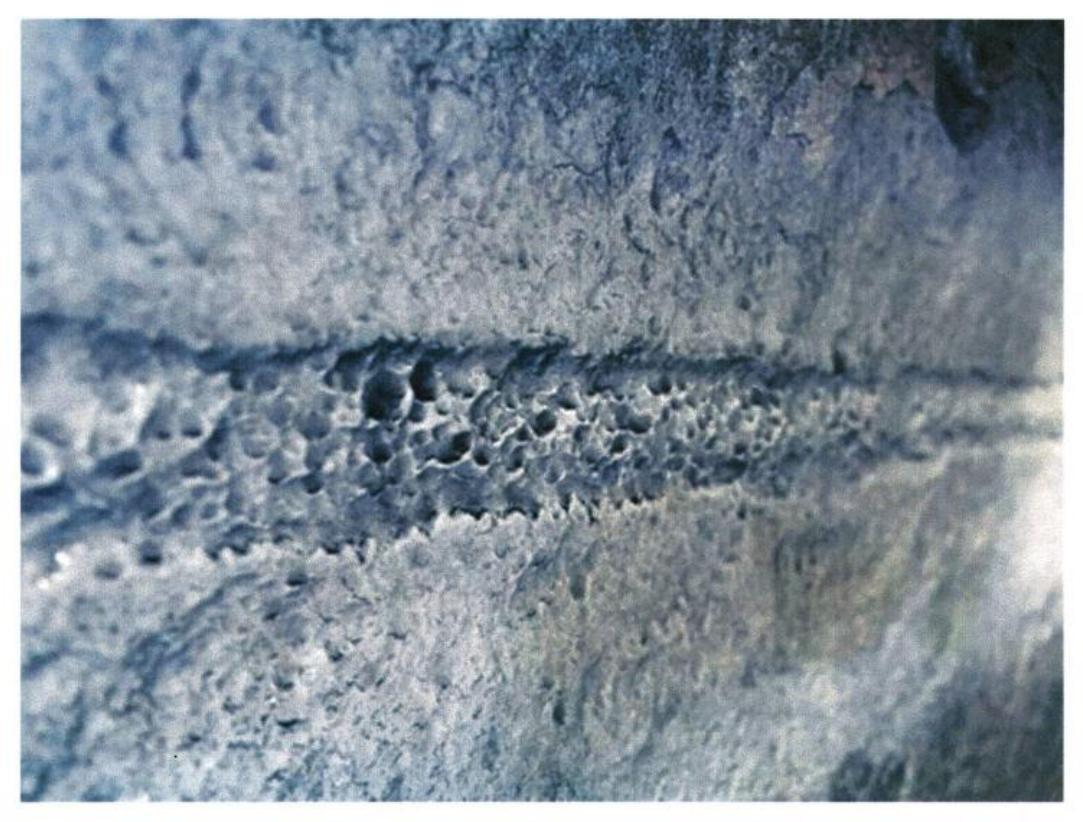
Photo 5: Deep pitting shown in weld

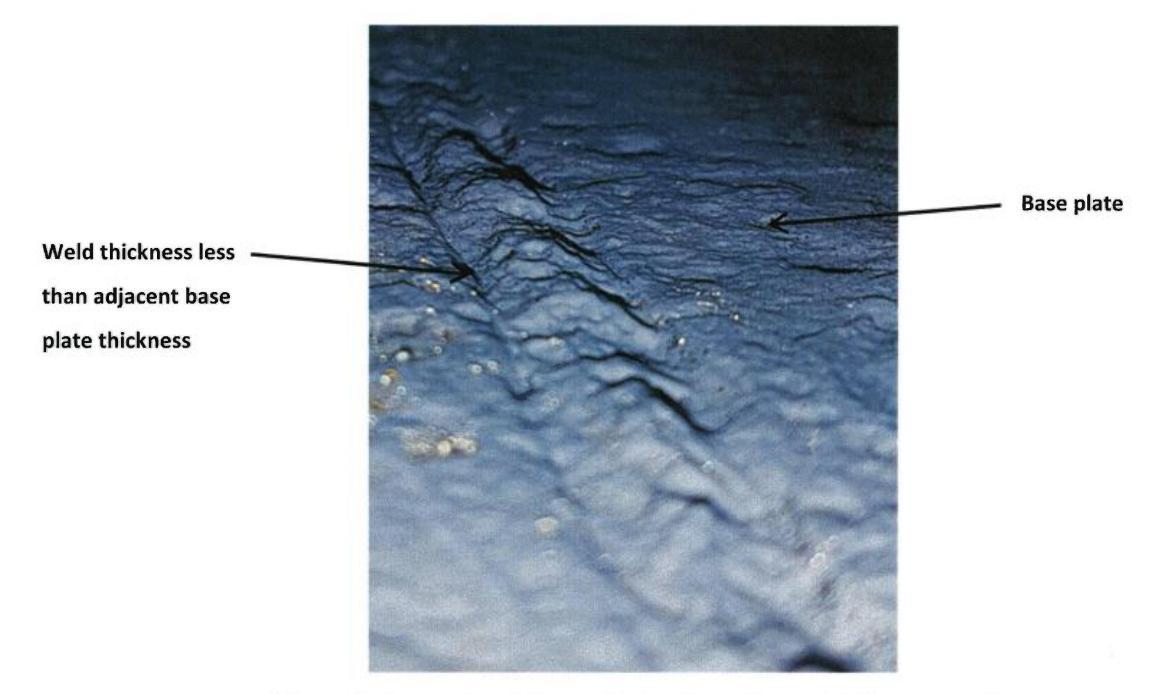
- 1 loss in the weld adjacent to the base plate as shown in photos 6 and 7. As shown in these
- 2 pictures, the surface of the weld material adjacent to the base plate appears to be below the
- 3 surface of the base plate as is evidenced by the noted erosion channels each side of the weld.

Photo 6: Loss of weld material at interface with base metal

- These erosion channels represent loss of the weld material. Proper weld design dictates that
   the weld material needs be the same thickness or thicker than the adjacent base plate material.

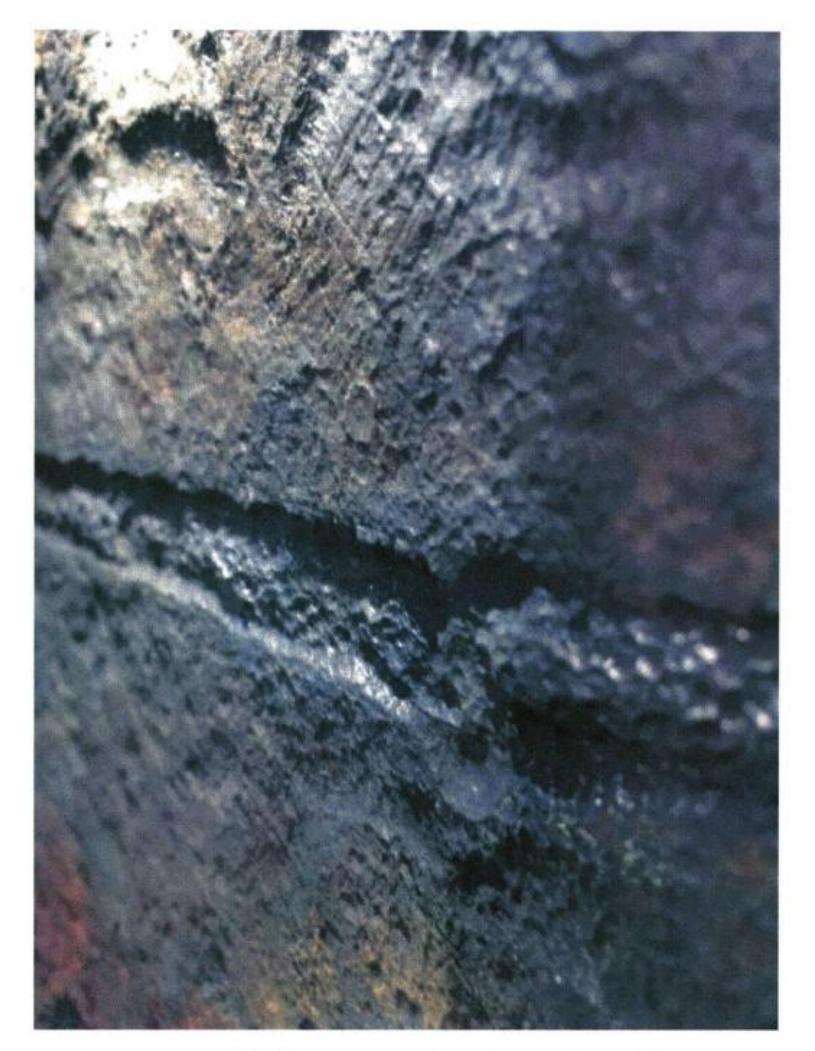
Photo 7: Weld thickness less than base plate thickness

- 3 In the case of some of the welds in Penstock 1, it was noted that these erosion channels
- 4 reduced the weld material thickness to less than that of the adjacent base plate thickness, thus

- 5 the remaining weld thickness no longer met minimum design requirements of the penstock.
- 6
- 7 Cracking was also evident in the welds. Many of the weld cracks were, on average, found to be

2 is highly probable under normal loads. Given both the loss of material thickness due to 3 corrosion as well as the weld cracking, refurbishment of these deficient welds was concluded by 4 Hydro's consultant to be required before operation of Penstock 1 could safely be resumed. 5 6 The refurbishment work rendered Bay d'Espoir Units 1 and 2 unavailable for generation until 7 the work to rehabilitate the welds could be completed. Due to the criticality of Bay d'Espoir to 8 the Island Interconnected System, urgent and immediate work to refurbish these welds was 9 determined to be necessary to ensure reliable service to customers. 10 11 4.3 **Investigation Results** 12 Hatch concluded that the majority of the horizontal welds between the intake and 460m 13 downstream of the intake had enough material loss, as well as visible crack depth, to be 14 ineffective at resisting the stresses caused by normal operation. For the most part, the 15 circumferential welds displayed minimal corrosion; however, some of these welds were 16 deteriorated to the extent where refurbishment was also required. Generally, the circumferential welds that were deteriorated were those located close to the intake.<sup>2</sup> The 17 remaining welds 450m from the intake down to the scroll case were found to be in good 18 condition with no need for refurbishment. 19 20 21 A root cause analysis to determine why the weld deterioration occurred is currently underway 22 with a report expected in February 2017. 23 24 It was also determined that the almost 50 year old interior coating system had failed 25 throughout the penstock. The coating system will also be considered as part of the root cause 26 report. 27 28 <sup>2</sup> The penstock is constructed of many cans, one connected to the next, end to end, using a circumferential weld

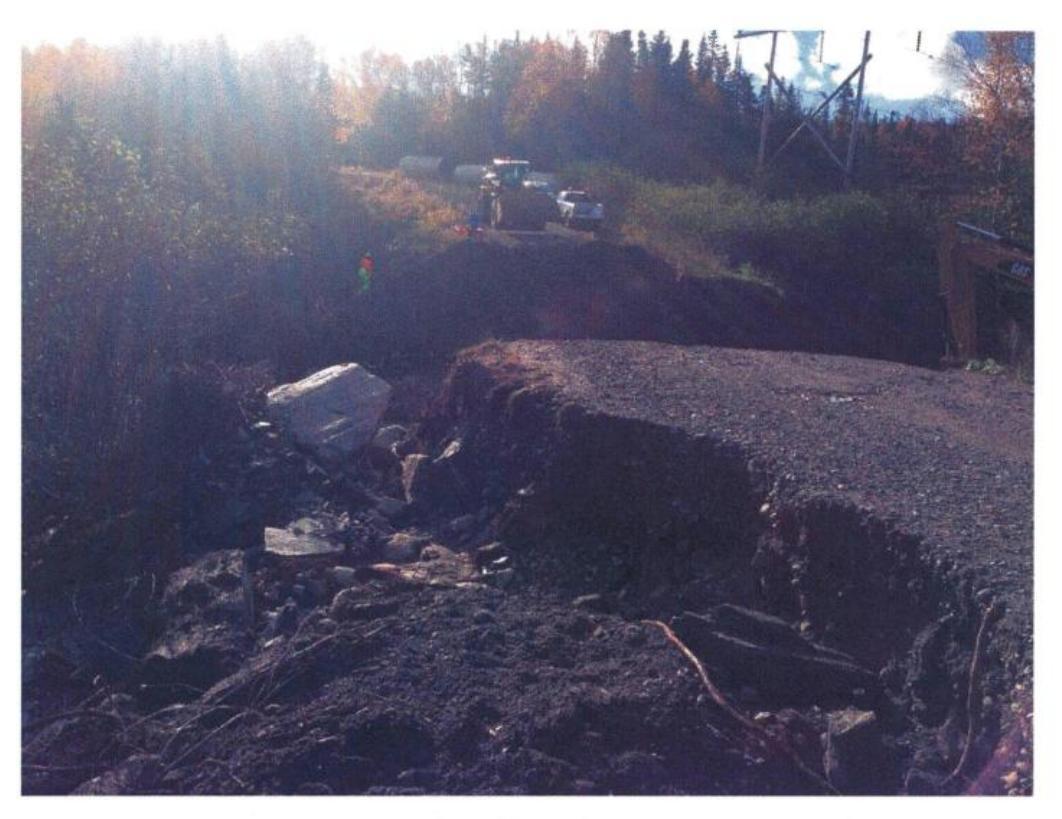
Photo A-3: Access road washouts due to Hurricane Matthew

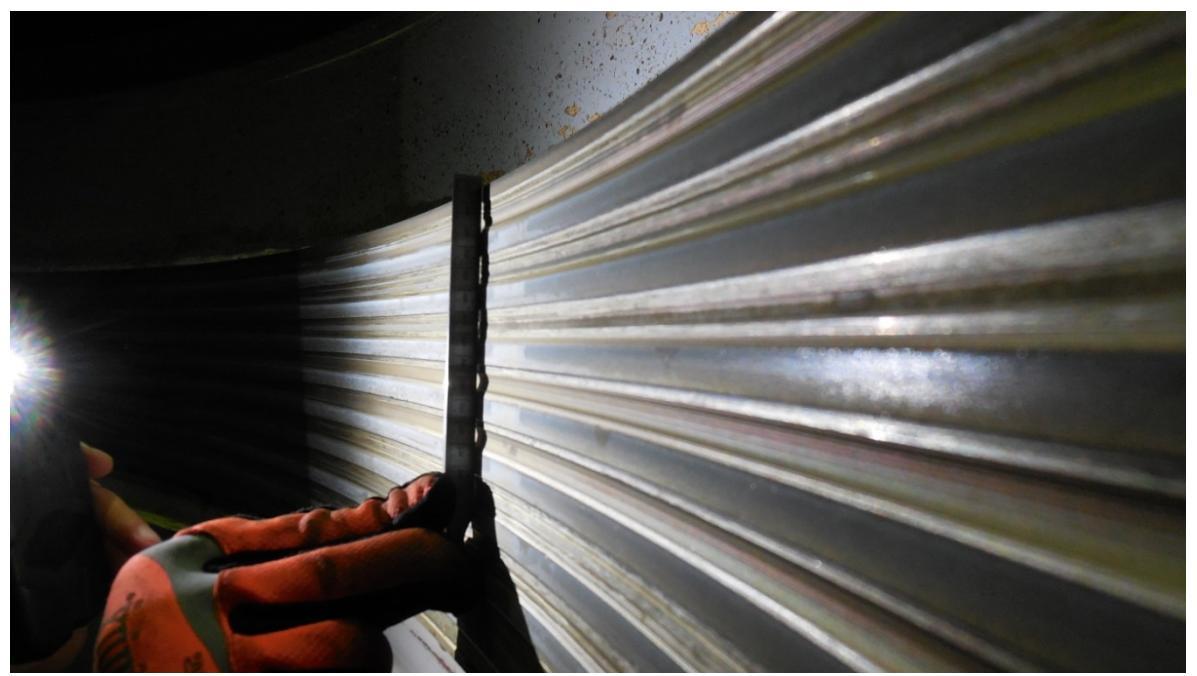
Photo 5: Damaged Section of Discharge Ring

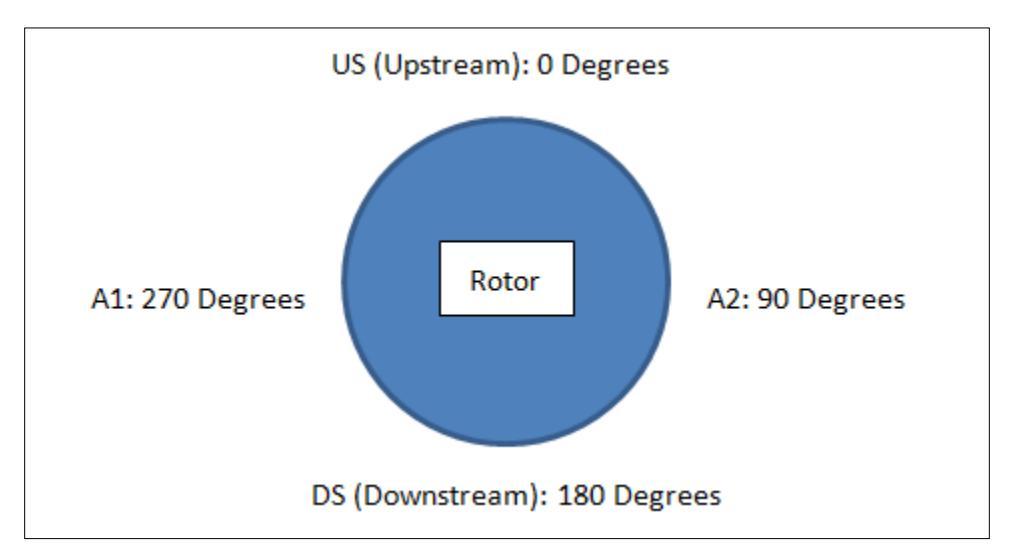
Figure 2: Position of the clearance readings as they relate to the data in Table 2

- 1 As indicated in Table 2, the readings on Axis 1 and 2 (A1 and A2) are getting smaller,
- 2 indicating the seal clearances are closing in this direction. Conversely, the Upstream and
- 3 Downstream (US and DS) readings are getting larger. This effect is known as Ovalling and
- 4 Unit 3 has surpassed the minimum design clearance and therefore intervention is required.
- 5
