Re: An Application by Newfoundland and Labrador Hydro (Hydro) pursuant to Subsection 41(3) of the Act for the approval of the Replacement of the lower reheater boiler tubes on Units 1 and 2, and additional reliability improvements at the Holyrood Thermal Generating Station

Units 1 and 2 Boilers Lower Reheater Tube Replacement And Reliability Improvements

4 1.2 Winter 2016 Boiler Reheat Tube Failure

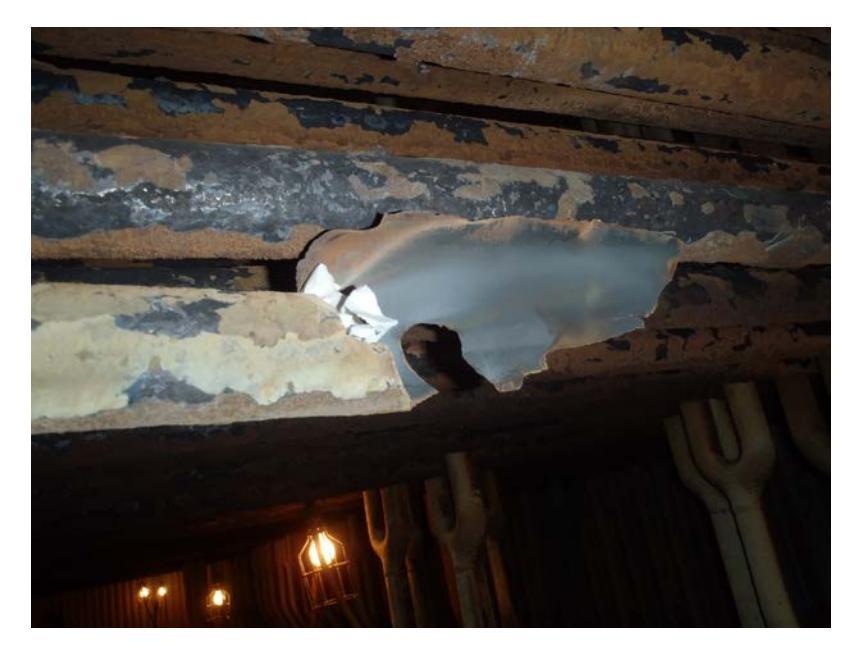
5 On January 6, 2016, while operating at 165 MW, Unit 2 experienced a tube failure in the 6 lower reheater section of the boiler. Upon discovery of the tube failure, Unit 2 was taken 7 offline in a controlled shutdown and cooled to allow for internal inspection. As the boiler 8 operates at very high temperatures, it takes approximately 36 hours to cool the unit 9 sufficiently to allow for safe entry into the boiler to conduct the inspection. Upon 10 completing the inspection overnight on January 7, four tube failures in the lower reheat 11 section of the boiler and three tube leaks in the upper reheat section of the boiler were 12 identified. To prepare for the anticipated tube replacement, all required resources and 13 materials were mobilized on January 7 during the unit cooldown period. As such, once the 14 inspection was completed and the scope of the replacements was defined, work on Unit 2 15 was able to begin immediately. Crews worked 24 hours a day, seven days a week to 16 complete the tube replacements and the work was completed on January 14, 2016.

3 The Unit was again taken offline in a controlled fashion and cooled to allow for access and 4 inspection. Upon completing the inspection overnight on January 20, one tube failure in the lower reheat section of the boiler was identified. Considering the possibility of further 5 6 failures and a favorable long term weather forecast, it was decided to replace as many of 7 the lowest wall thickness tubes as the favorable weather window would permit. Taking 8 advantage of the already mobilized and experienced work crew, the favorable weather 9 window, and available materials, over the period since the unit first went out of service 10 January 6, 2016, 27 lower and three upper reheat tubes were replaced prior to the unit going back in service February 3, 2016.¹ 11

Figure 3: Failed Reheater Tube in Unit 2

9 The tubes to be replaced are highlighted in green in Figure 2. The project includes 10 procurement, installation, testing and commissioning of new boiler tubes. Additional work 11 will be required such as replacing the front wall reheater header vestibule refractory seal, 12 membrane and seal plates, as these items must be removed to facilitate the reheater tube 13 replacements. Reheater tubes that were replaced during the Unit 1 and 2 forced outages in 14 January and February 2016 will not require replacement under this project.

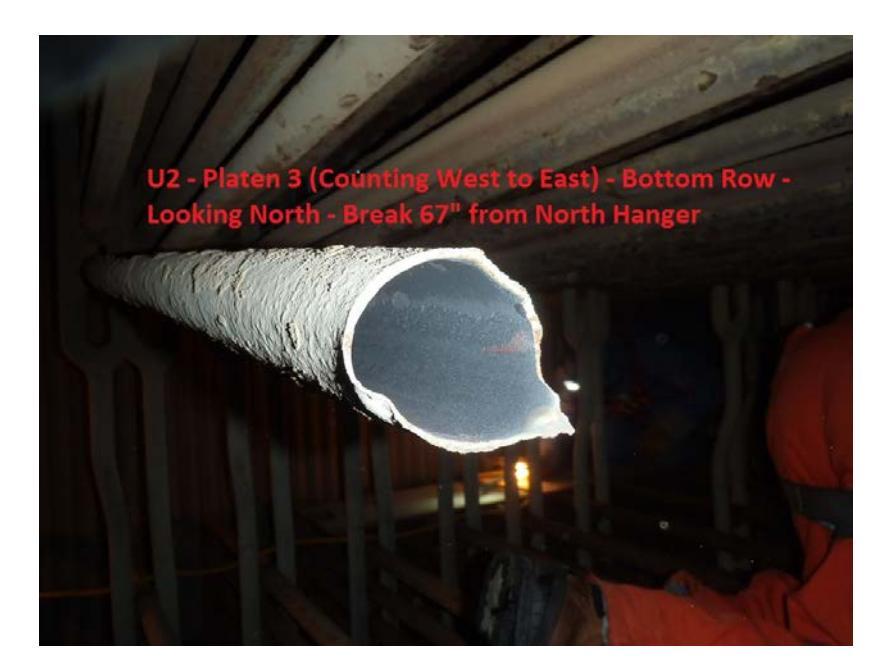
Figure 4: Failed Reheater Tube in Unit 2

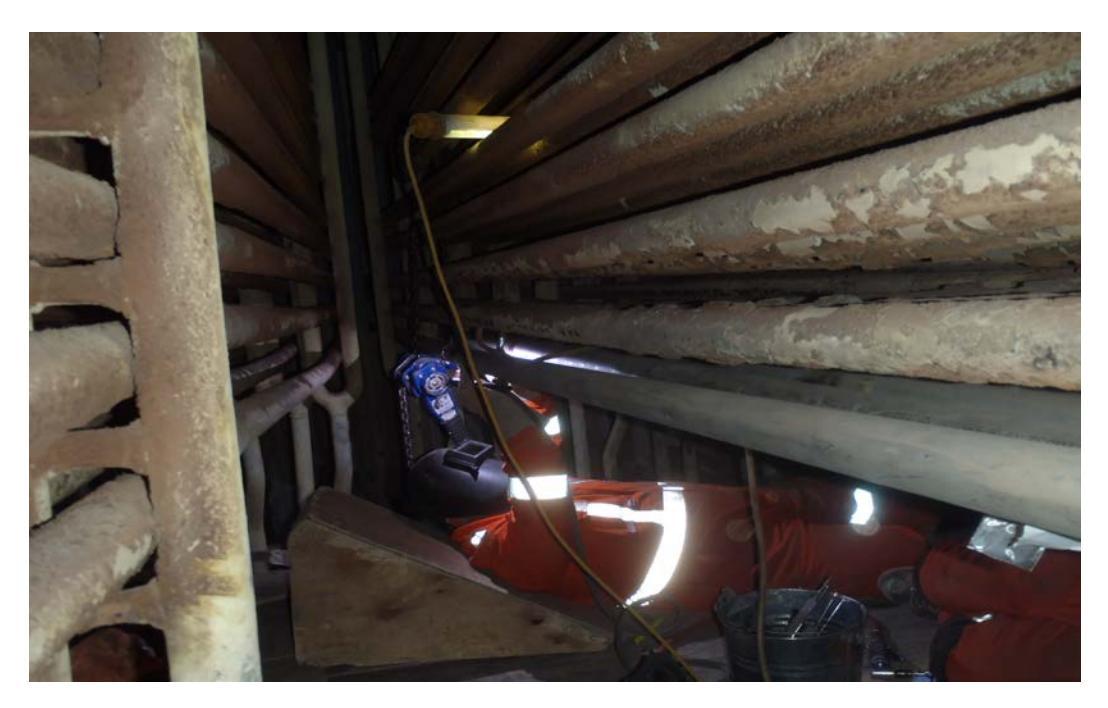
Figure 5: Welding Repair in Lower Reheater

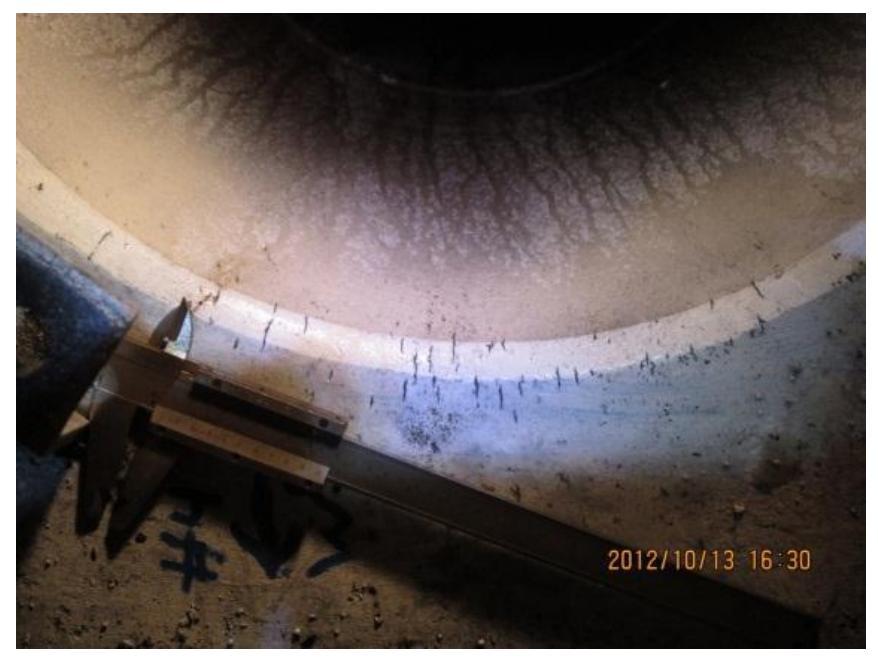
The cracking was oriented in the east west direction (axial to the drum) the maximum depth on Unit 2 was reported as 4.3mm (0.170''). The maximum depth on Unit 1 was 5.3mm (0.21'').

Figure 1 Steam Drum Cracking at the Downcomer Nozzles – Typical Damage

The damage was removed by grinding. On Unit 2 the original profile was restored by B&W with a weld repair. For Unit 1, the damage was dispositioned by B&W as acceptable. The flaws were blended out.

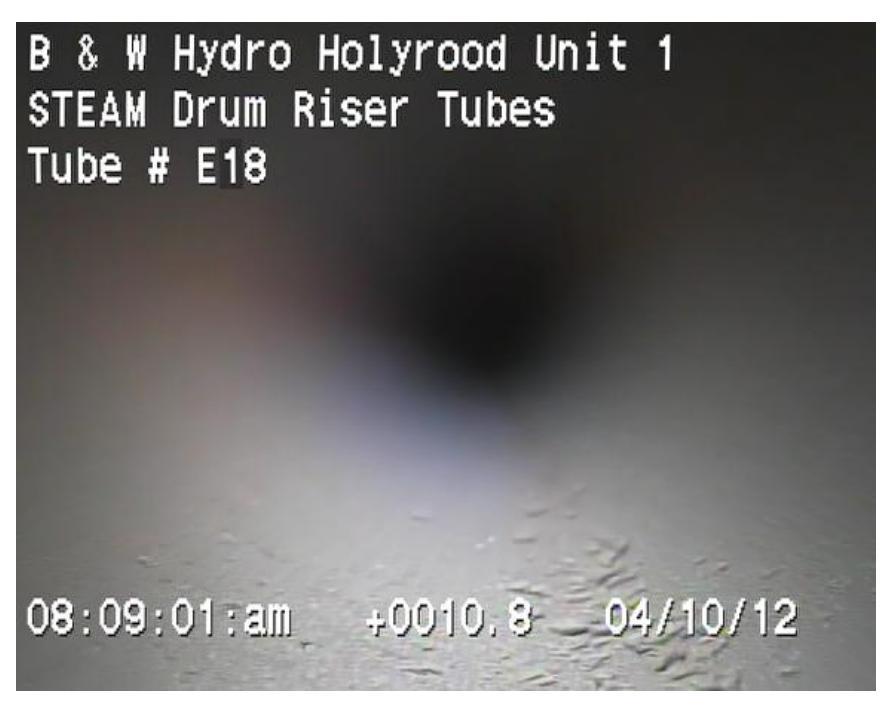
The same risers were inspected visually with a video probe from inside the steam drum to the upper waterwall header. Scoring was noted on the axial wall, and pitting. Most of the pitting was random but in at least one case, multiple pits aligned in the axial direction were noted. A sample is provided in Figure 2. The damage is not considered an immediate integrity concern but further investigation of the severity and numbers of risers affected is required.

Figure 2 Aligned Pits in the Bottom of a Riser Tube (bottom of picture) Note: date of inspection is incorrect

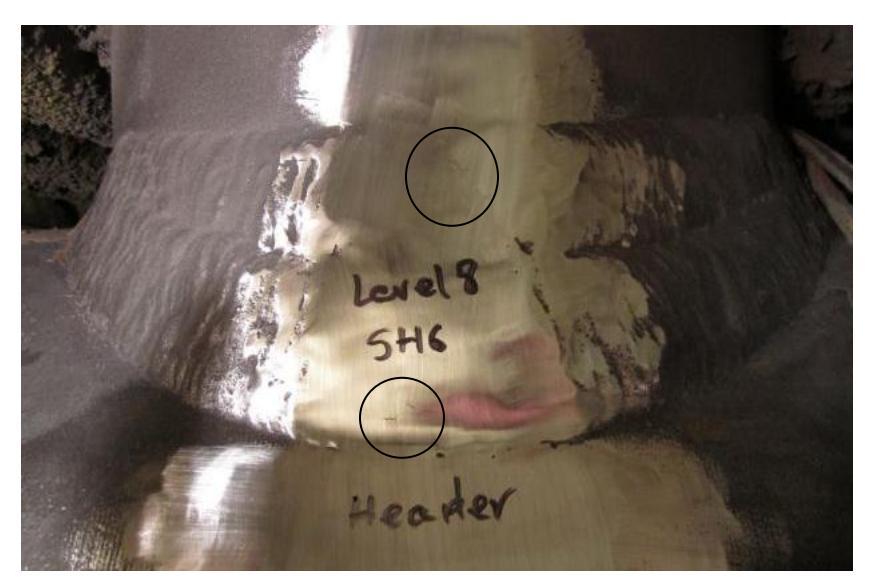
Replication after grinding identified remaining micro cracks. This condition was found at the east nozzle, 6 o'clock position. It is anticipated the micro-cracks would be consumed in the weld repair. There were similar indications identified in the 6 o'clock grind out area on the west nozzle. As none of the indications was apparent by MT, the component was determined fit for service.

Figure 3 Unit 2 SH6 Outlet Nozzle Configuration and East Nozzle Crack Locations

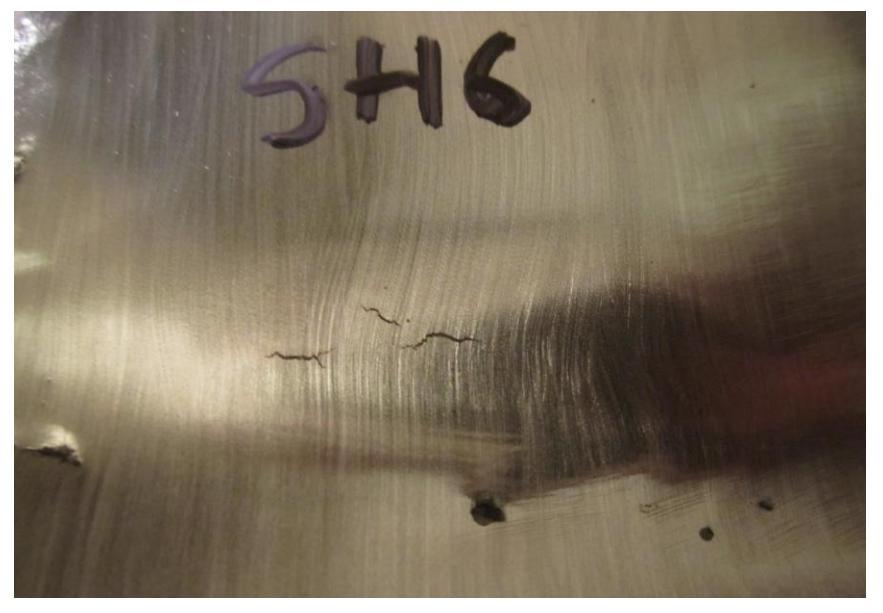
Figure 4 Unit 2 SH6 Outlet Nozzle Cracking, Lower 12 o'clock Position on East Nozzle

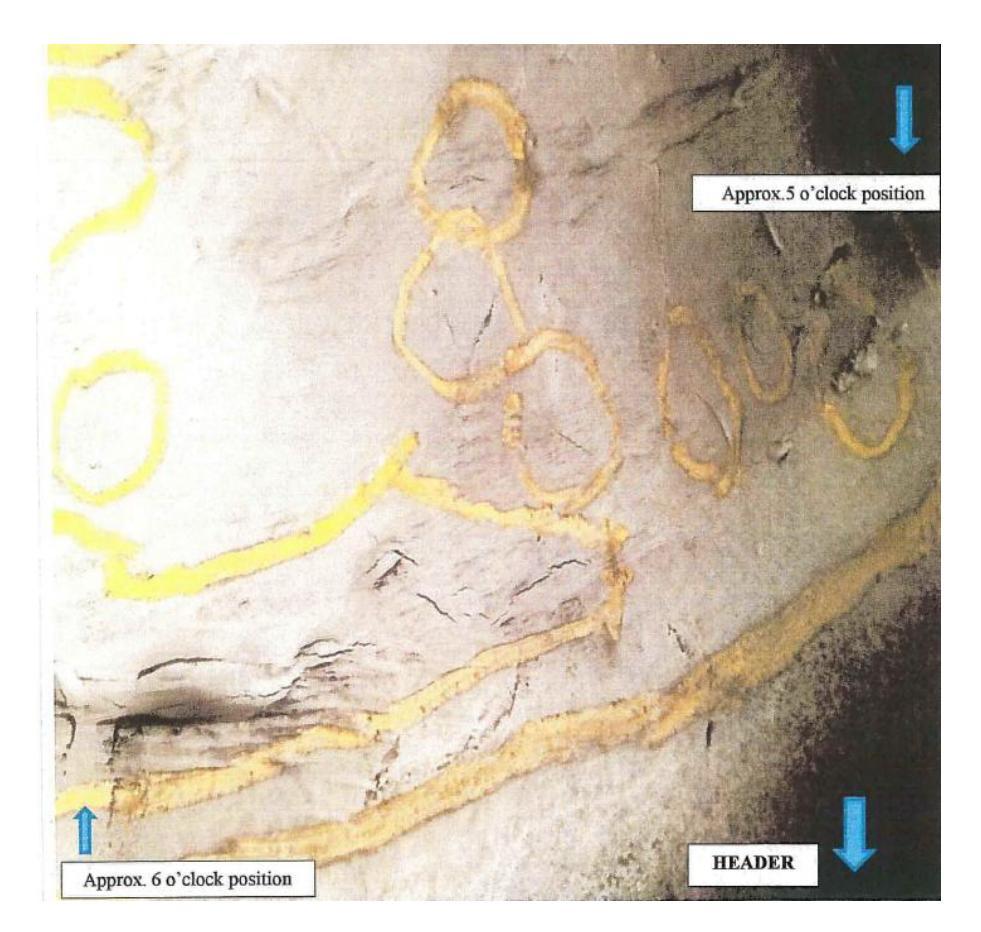
The Unit 1 SH6 nozzle inspections consisted of MPI on both welds and follow-up on any findings. Multiple cracks were identified in the weld on the east nozzle, Figure 5. Replication of the cracks concluded that the damage was creep extending into the heat affect zone of the header. The damage was removed by grinding and weld repaired. The depth was approximately 9 mm (0.35"). There was no damage detected at the east nozzle.

Figure 5 Unit 1 SH6 East Outlet Nozzle weld cracking

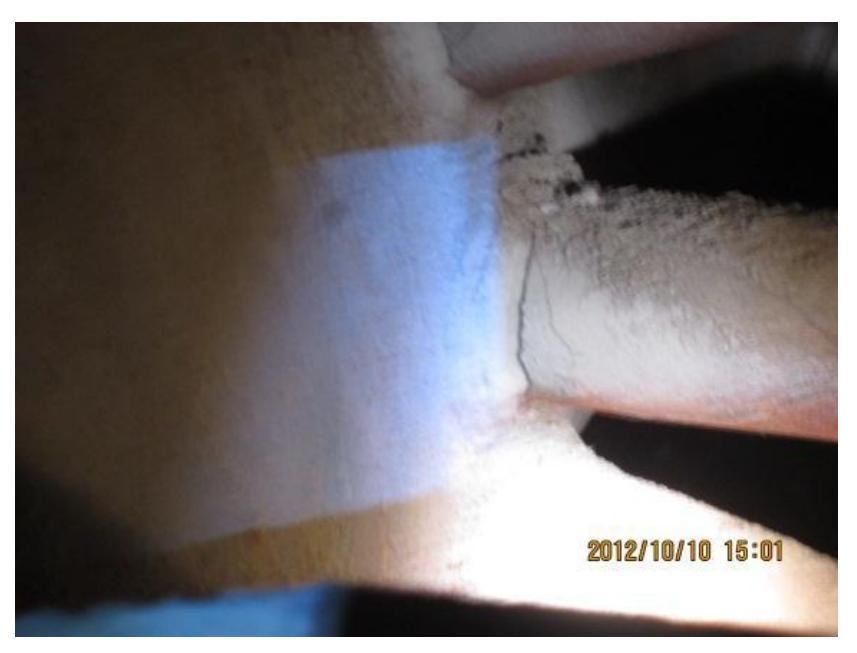
Figure 6 SH6 Stub Tube Weld Toe Cracking – Typical

The damage was removed by grinding and weld repairs were made by B&W. Similar damage was identified on Unit 1 and was weld repaired.

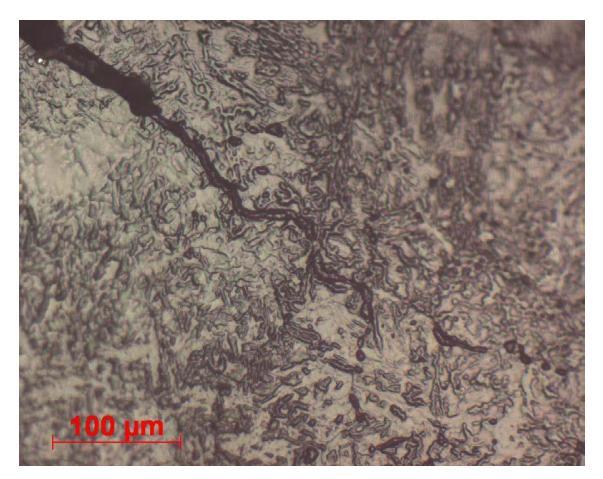
Figure 7a Crack tip microstructure Unit 2 SH6 East Nozzle, 12 o'clock

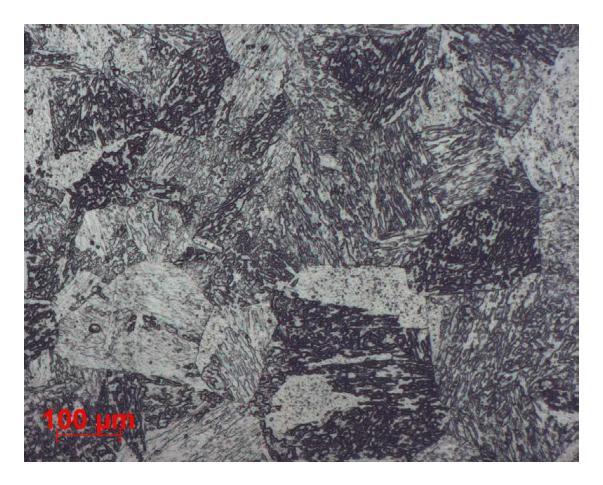
Figure 7b Microstructure after crack removal, with no evidence of creep

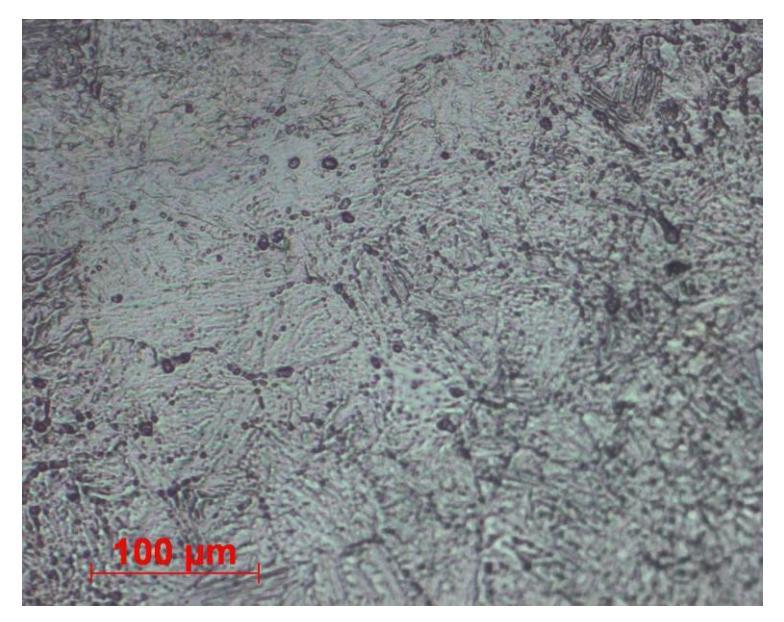
Damage in the Unit 2 main steam lines at the turbine flange was classified as Type III, isolated voids. A sample is provided in Figure 7c. The indications in the SH6 nozzle welds could be classified the same way. From industry guidelines, repair is not required for Type III, isolated void creep damage. The disposition of creep damage and follow-up is discussed further in Section 5.

Figure 7c Possible isolated creep voids in the Unit 2 West main steam pipe turbine flange weld course grained HAZ (Type III).

Creep can be managed through inspection and repair. It is recommended Unit 2 nozzles be re-inspected by MPI in 2013, or at the next outage. Future inspections will be based on EPRI guidelines [R-16].

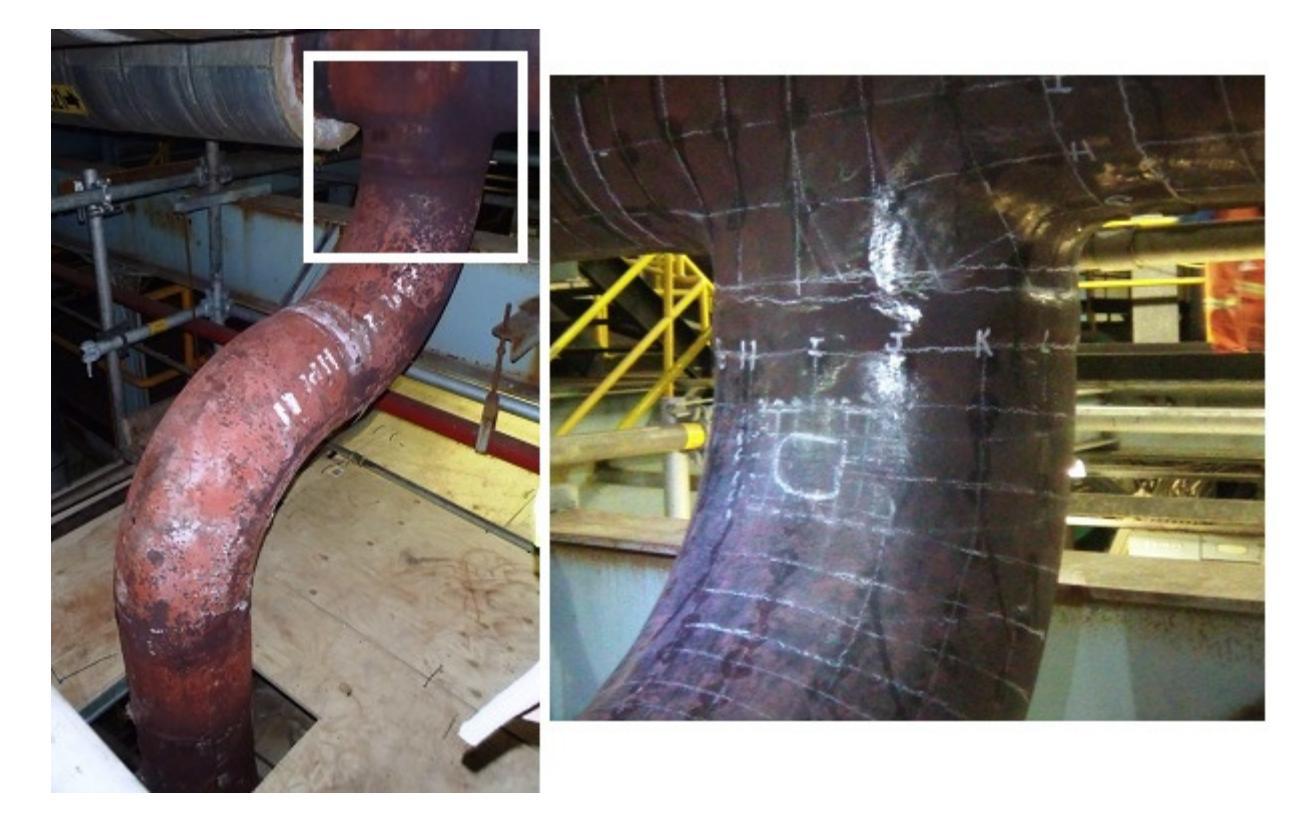
Figure 1: Unit 3 No. 6 Feedwater Heater Low Wall Thickness Location

Additional locations are recommended for re-inspection in 1 or 2 years, such as the attemperator feedwater station and the west boiler feed pump. The superheat attemperator feedwater station, on the 8th floor, west side of the boiler, was modified in 2010 according to the available drawing. Calculations for the new 90° bend installed at the inlet before the block valve indicate that re-inspection in 2 years is necessary. This assumes that the variation in wall thickness observed is due to FAC and not a variation in the manufactured thickness of the bend itself. A repeat inspection is recommended to confirm thinning. Re-inspection is required within 1 year in the west boiler feed pump discharge pipe, and downstream of the isolating valve. All other locations inspected for FAC indicated margin enough for the target life with re-inspections recommended in 4 years time or greater. Further details can be found in the FAC report [R-7].

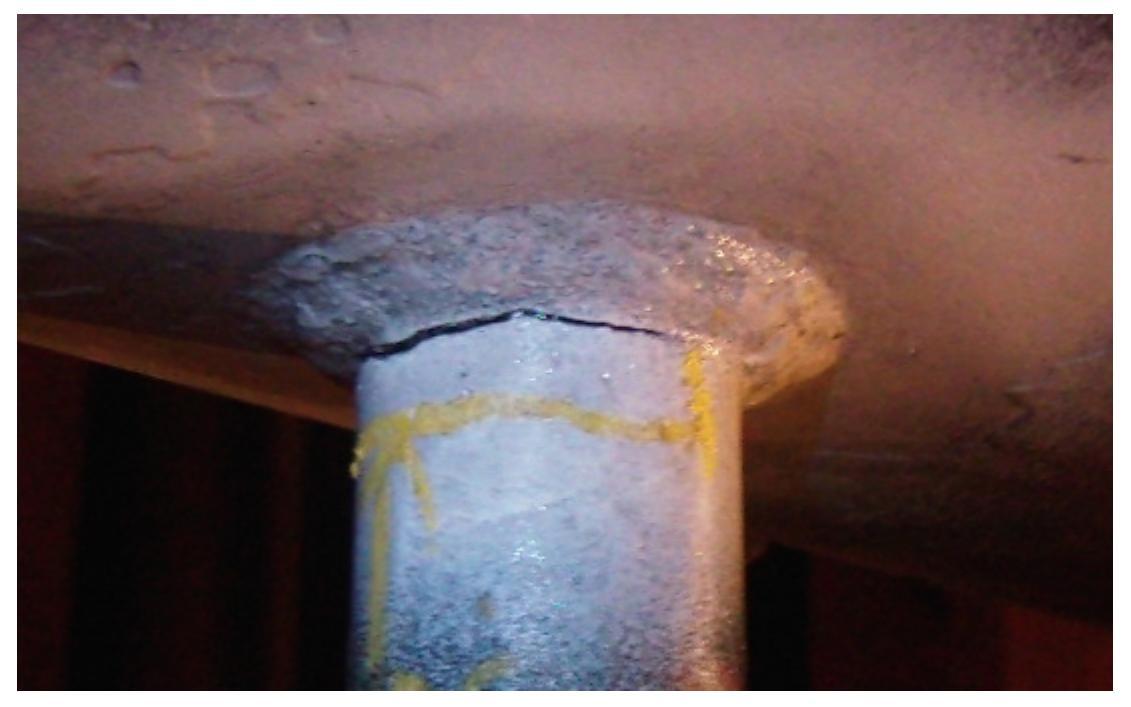
Figure 2: Unit 3 Hot Reheat (Reheater Outlet) Header Drain Crack

A repair was performed on the drain weld. MT examination was performed on the weld prep area to confirm the crack has been sufficiently removed, following welding (prior to heat treatment), and after post-weld heat treatment (PWHT). No indications were identified and header was deemed fit for service.

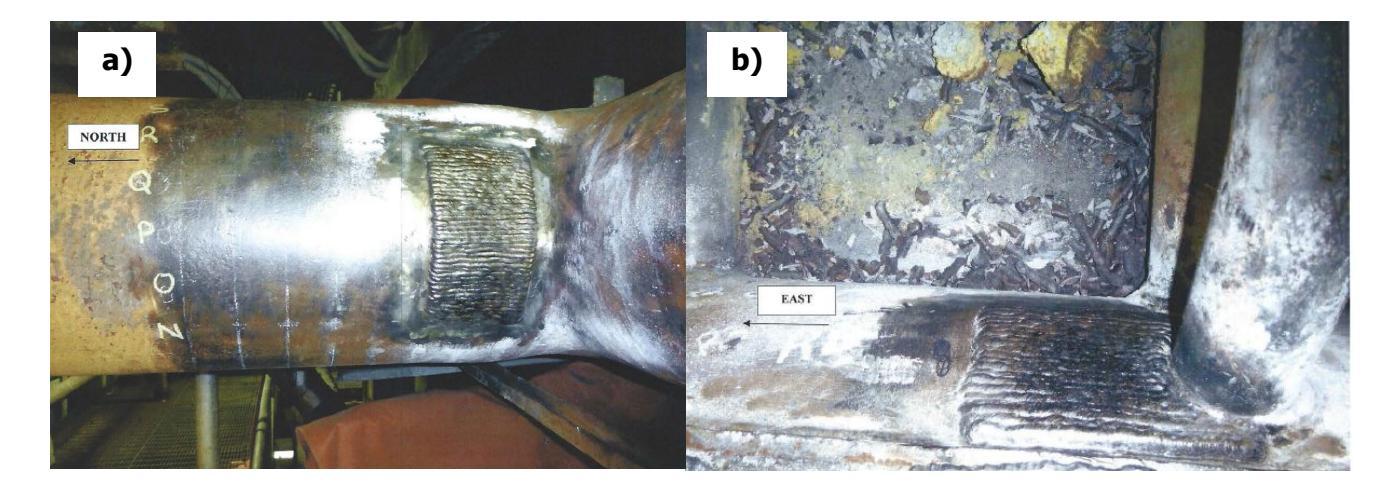
Figure 4: Unit 2 Economiser Inlet Header Pad Weld, a) Tee Inlet, b) Tee between platens.

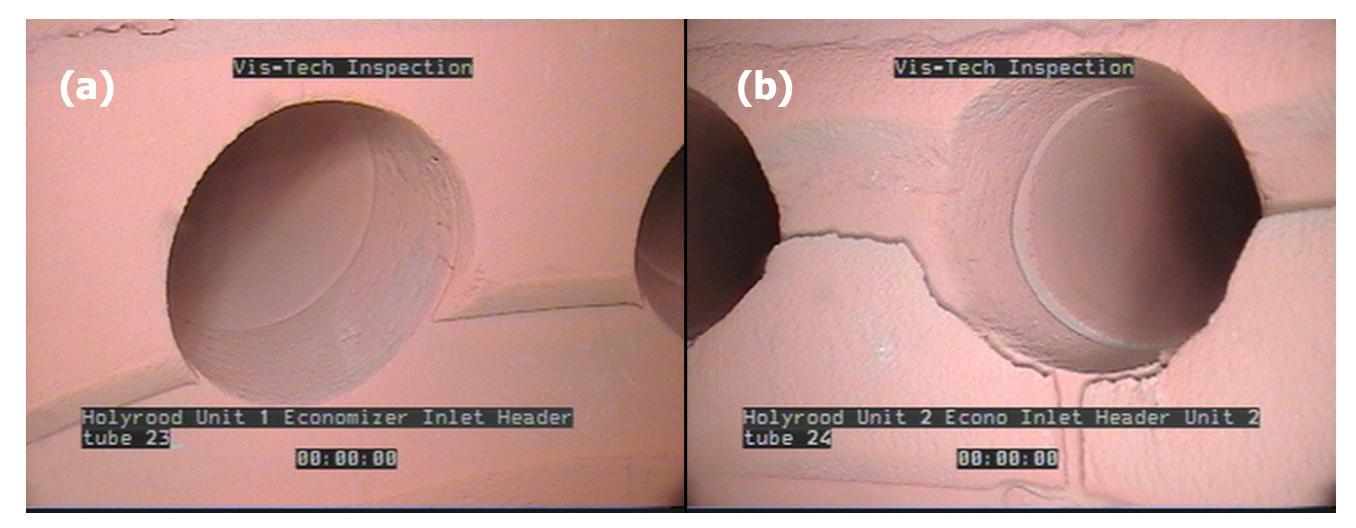
The economizer inlet header of Unit 1 was also selected for inspection. Once again cracking was observed at the boreholes with some cracks extending into the ligament between holes, into the boreholes and in to the economizer tubing. The wall thickness measurements again found indications of FAC but not to the extent as was seen in Unit 2 (see Figure 5). Images from the internal inspection indicate that FAC damage is not as severe as Unit 2. There was no need for repairs in the Unit 1 economizer inlet header. Per the Alstom recommendation, re-inspection should be carried out in 3 years.

Figure 5: Economiser Inlet Header (a) Unit 1 and (b) Unit 2 Comparison

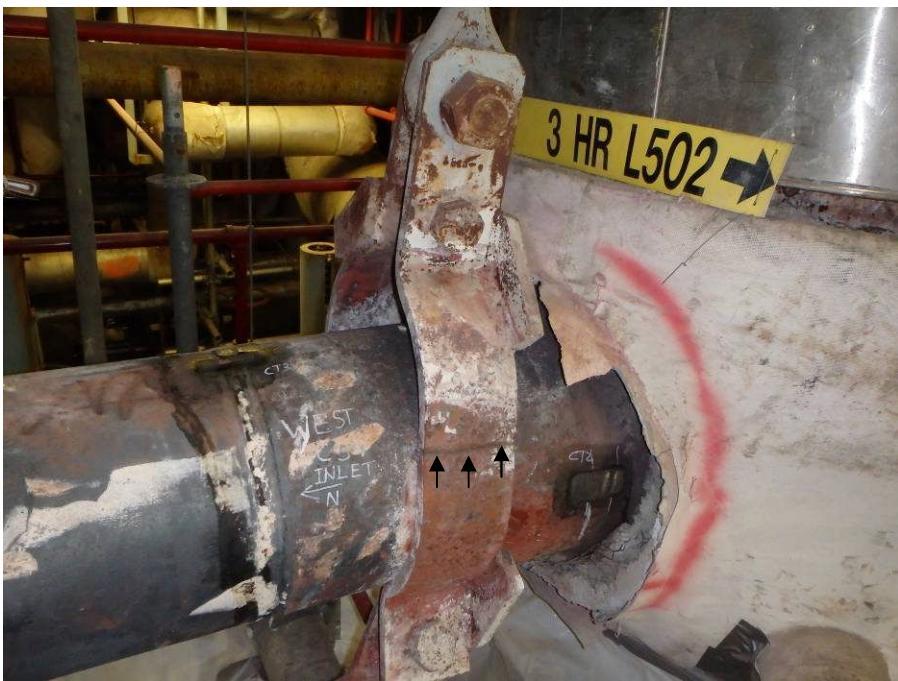
The function of the hangers was to provide vertical support for the 16 inch reheat line pipes and the combined stop valves [1]. The east hanger supported the inlet side of the combined stop valve 3-HR-V512 on line 3-HR-L500, whereas the west hanger supported the inlet side of the combined stop valve 3-HR-V513 on line 3-HR-L501 [1]. During normal operation, the pipes associated with the hangers contained superheated steam at a temperature of approximately 1000 °F [1]. Each hanger consisted of two sides configured in a pipe clamp arrangement. The sides of the hanger were mechanically fastened to each other at the top and bottom clamp tabs resulting in a friction fit between the pipe and the semicircular clamp surfaces. A clevis rod arrangement was utilized to attach the upper tab of the hanger) was insulated with a layer of refractory material to minimize heat loss during operation [1]. The specification for the hanger material was reported as ASTM A387, Grade 12 [1]. Newfoundland Hydro requested that Wayland Engineering provide an opinion on the mechanism(s) responsible for the fracture failures detected on the hangers.

Figure 1 - Photograph showing the general pipe hanger arrangement. Arrows indicate one of the hanger fracture failures observed during a scheduled inspection.

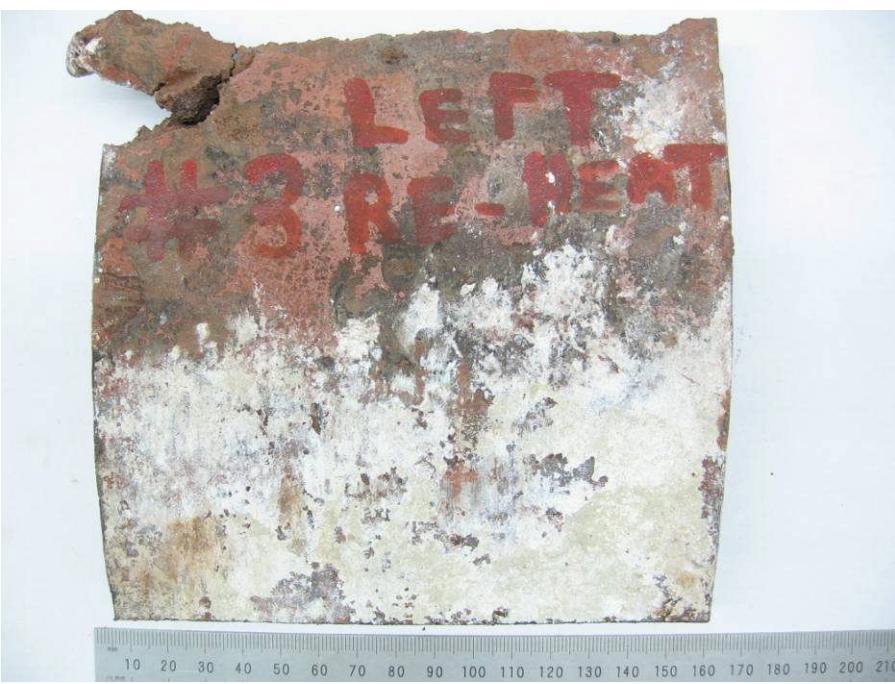
Figure 5 - Photograph showing a side view of the fracture failure of one of the east sections of pipe hanger.

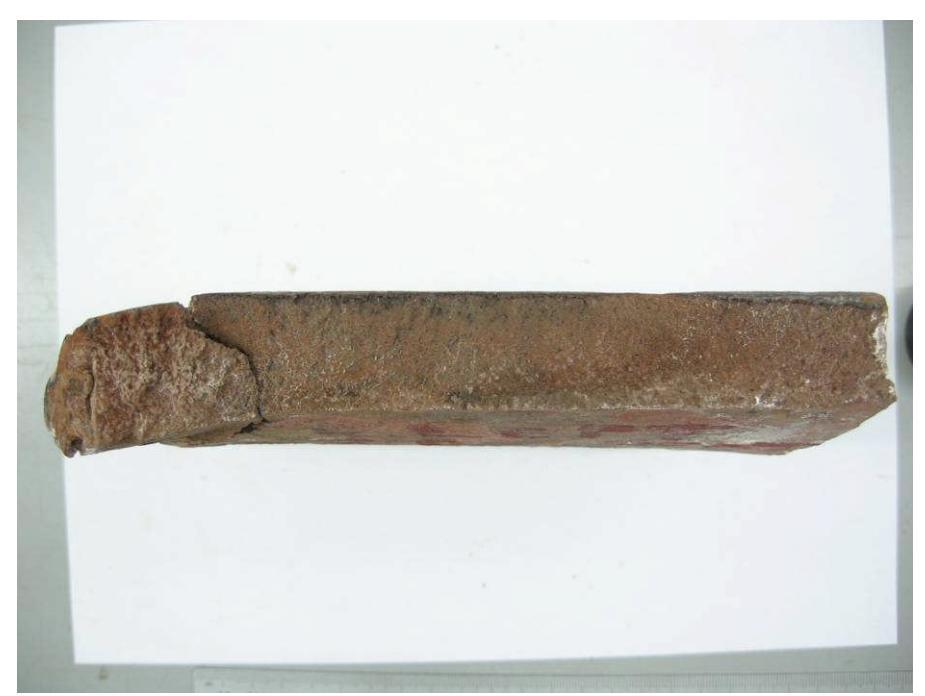
Figure 6 - Photograph showing the fracture surface associated with the east section of pipe hanger shown in Figure 5.

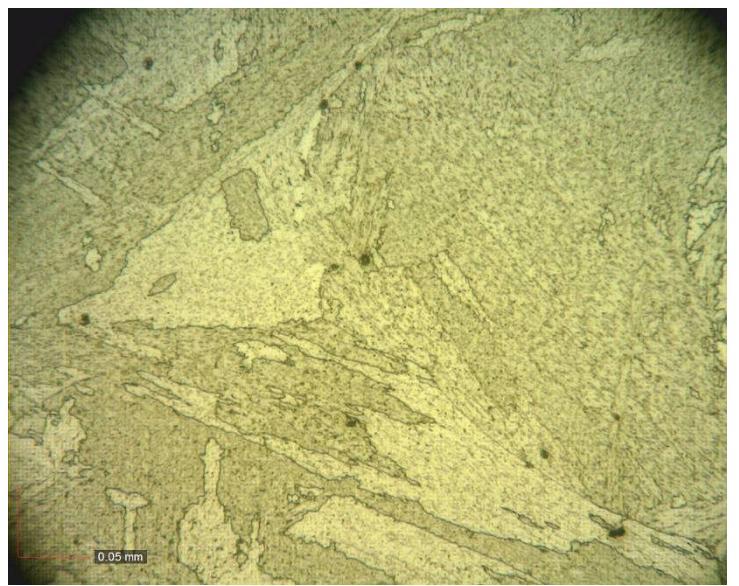
Figure 7 – Micrograph showing the spheroidized microstructure and the migration of the spheroidized carbides to the grain boundaries for the east hanger.

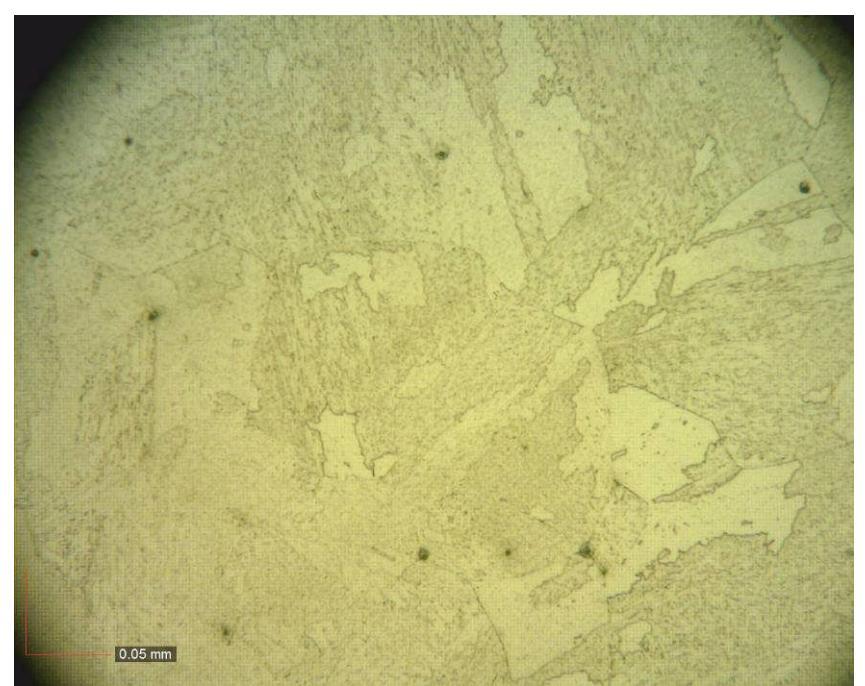
Figure 8 – Micrograph showing the spheroidized microstructure and the migration of the spheroidized carbides to the grain boundaries for the east hanger.

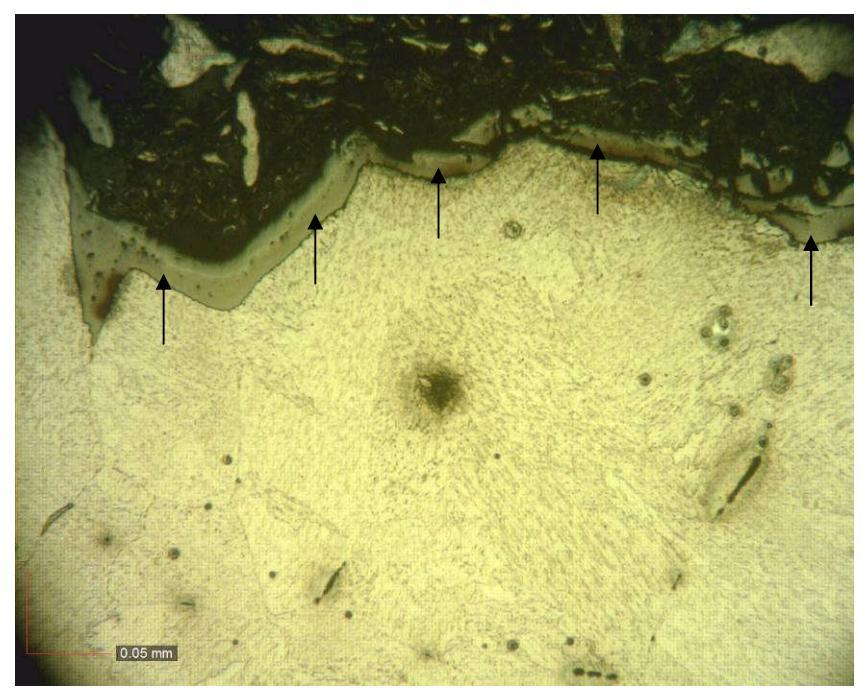
Figure 9 – Sectional view micrograph of the material adjacent to the fracture surface associated with the pipe hanger indications. The micrograph also shows the deposits typically observed on the fracture surfaces (arrows).

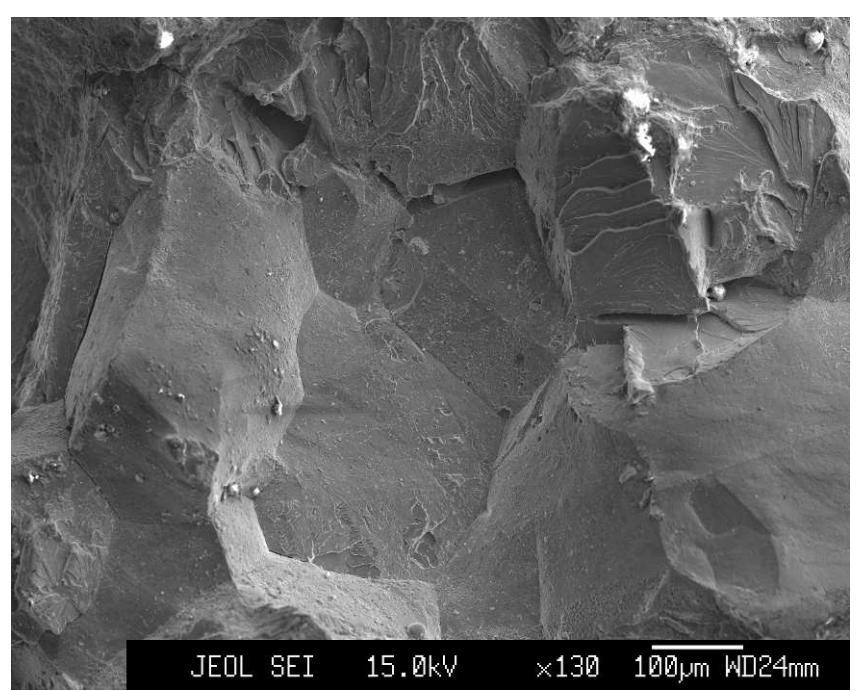
Figure 12 – SEM fractograph image showing the predominantly intergranular fracture topology observed (evidence of transgranular cleavage was also observed on the fracture surface). Of note is the relatively large grain size in comparison to the spheroidized ferrite/pearlite microstructure shown in Figure 7 and Figure 8.

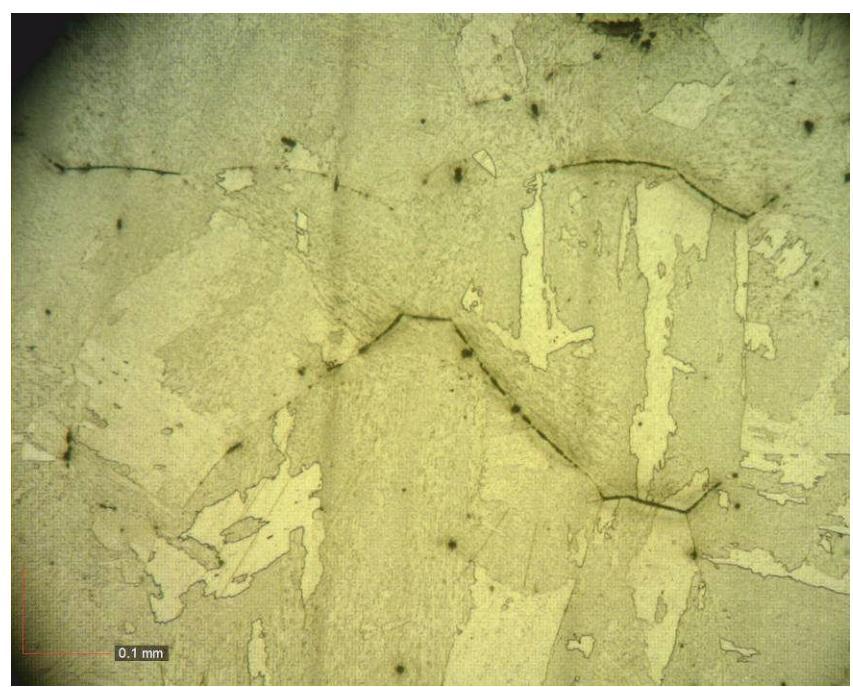
Figure 13 – Sectional view micrograph showing the presence of microfissures observed in the material away from the primary crack propagation path. The micrograph suggests that the crack propagation observed proceeded along prior austenitic grain boundaries.

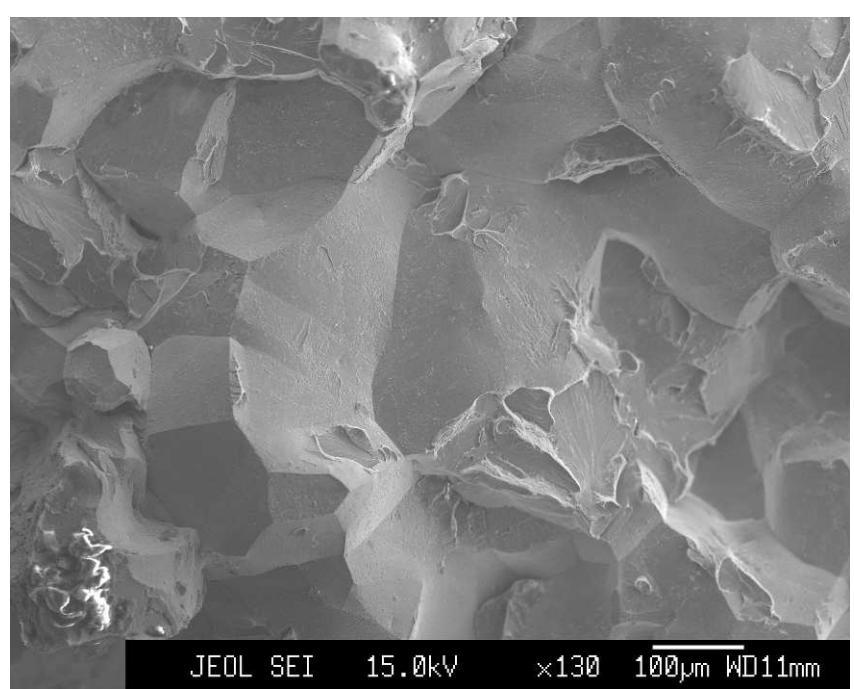
Figure 14 – SEM fractograph of the crack propagation plane for the as received pipe hanger material loaded at a dynamic rate. The morphology indicates that the propagation mechanism is dominated by a combination of intergranular fracture and transgranular cleavage.

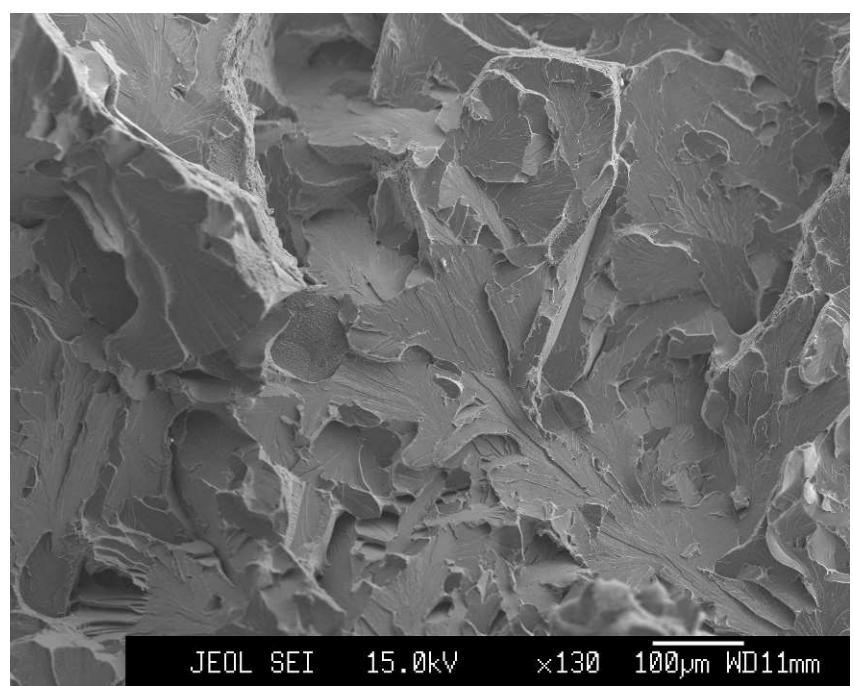
Figure 15 – SEM fractograph of the crack propagation plane for material heat treated at 1200 $^{\circ}$ F and loaded at a dynamic rate. In comparison to the as received material test (Figure 14), the morphology of the heat treated fracture plane indicates that the propagation mechanism is dominated by a combination of transgranular cleavage and void coalescence.
