1	Q.	Provide a description of Hydro's preventive maintenance plan as it relates to the
2		inspection of boiler tubes including but not limited to:
3		i. the schedule for the testing of the various boiler tubes (broken down by
4		specific areas) at the Holyrood Thermal Generating Plant;
5		ii. the last recorded preventive maintenance testing of the boiler tubes for Unit
6		1 and Unit 2; and
7		iii. the results of the last recorded preventive maintenance testing or of any
8		other testing that occurred.
9		
10		
11	A.	Boiler Tube Description
12		Holyrood boiler tubing can be classified as tubes containing feedwater
13		(economizer), tubes containing steam (superheat and reheat) and waterwall tubes.
14		Feedwater tubing is located in the boiler just before the exhaust gas leaves the
15		boiler and preheats the water to be turned into steam. The superheat and the
16		reheat tubing are located in the upper parts of the boiler and is where the steam

PUB-NLH-001, Attachment 2

#### METALLURGICAL DWD REPORT

Representative:	David Gosse	Plant:	NL Hydro
		Location:	Holyrood, Newfoundland and Labrador,
			Canada
		Unit:	1
		Report No.:	2013-0187-1
		Report Date:	July 3, 2013
		Sample Date:	M

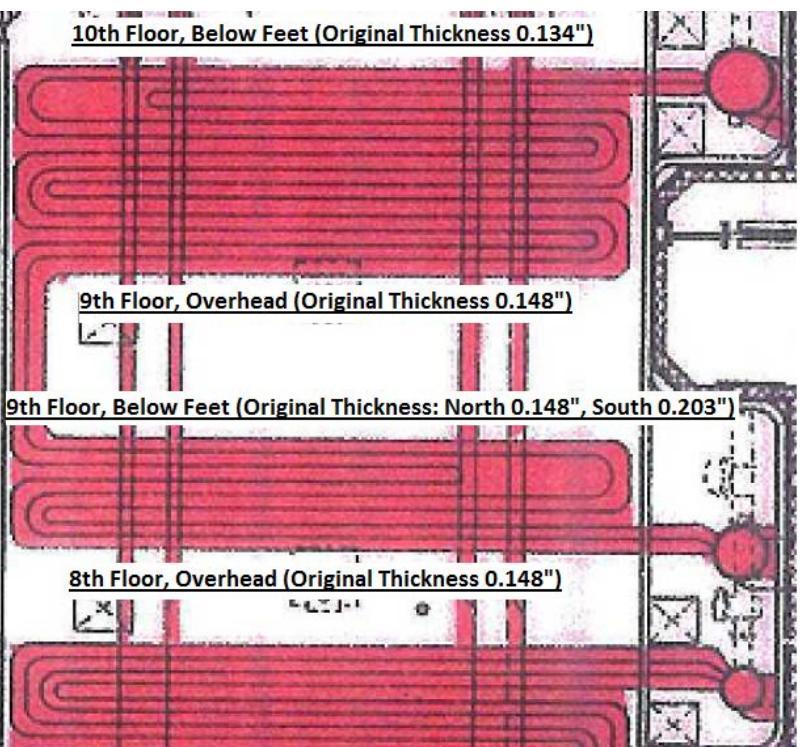
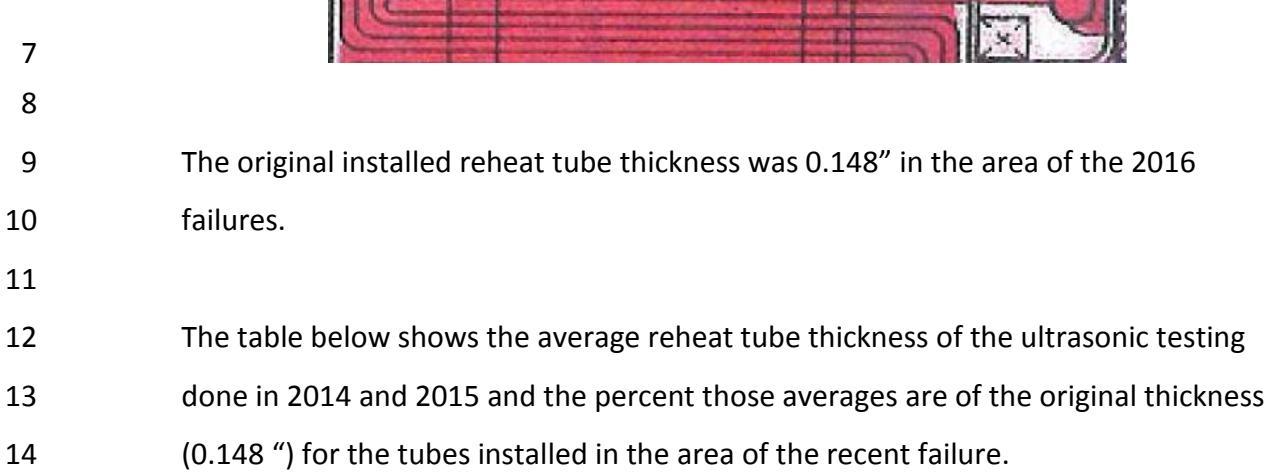
4 The area in which the 2016 tubing failure occurred is the lower reheat section of 5 the boiler, "8th Floor, Overhead" and it is location is shown in the diagram below.

1	A	verage Thickn	ess
2	8th Floor, O	verhead, "Lov	ver Reheater"
3		Inches	% Original
4	Unit 1, 2015	0.116	78.4%
5	Unit 1, 2014	0.126	85.1%
6	Unit 2, 2015	0.118	79.7%
7	Unit 2, 2014	0.134	90.5%

8 The 2014 results show that the reheat tubing in the area of the failures had an 9 average thickness of 85% or more as compared to the original thickness. This 10 thickness was after 45 and 46 years of operation for Units 1 and 2 respectively. The 11 2015 thicknesses show increased tube thinning in Unit 1 and 2.

13 In 2016, the reheaters in Unit 1 and Unit 2 incurred their first tube failure in their 14 operational history. In response, Hydro evaluated tube inspection and maintenance 15 data, as well as the electrical system load forecast, and then executed a tube 16 replacement work plan. During that work, failed tubes were replaced, as well as additional replacements of other tubing found through inspections to have 17 thicknesses similar to the failed tubes. As an additional response, due to the 18 average thickness being below 85%, the point at which Babcock & Wilcox PSB-26 19 20 recommends replacement, and for which Hydro now has experienced failures, 21 Hydro is planning replacement of the lower reheat tubing in 2016 and as such will 22 submit, to the Board, a supplemental application for lower heat tube replacement 23 in Unit 1 and 2. As part of the work this year, additional tubing thickness 24 assessment will be undertaken to allow Hydro to determine if a further derating of 25 Unit 1 and 2 is required.

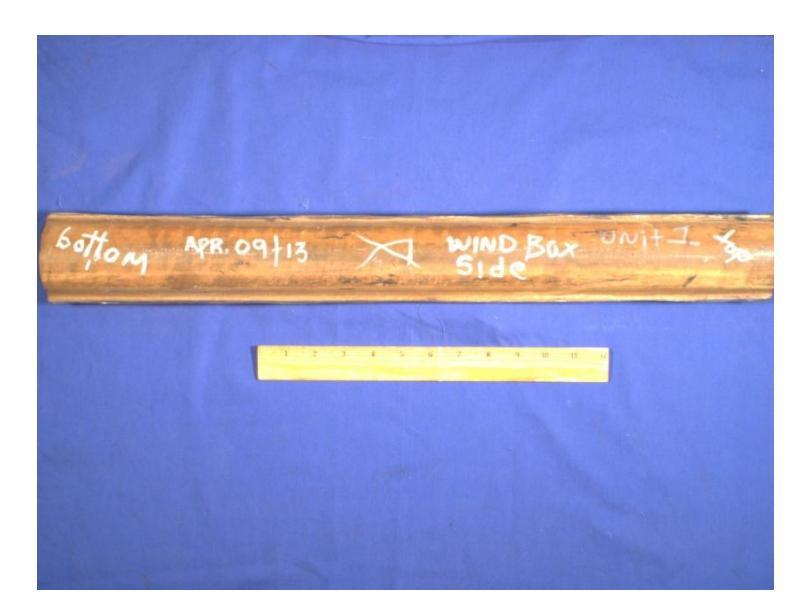
Figure 1. Photograph of the tube section, as received.

Figure 1 shows the tube sample, as received. Visual inspection revealed no evidence of imminent failure from overheating or fireside corrosion. There was no significant or excessive build-up of deposits noted on the external surface. The internal surface of the tube was covered with light-gray and brown deposits (Figures 2 and 3).

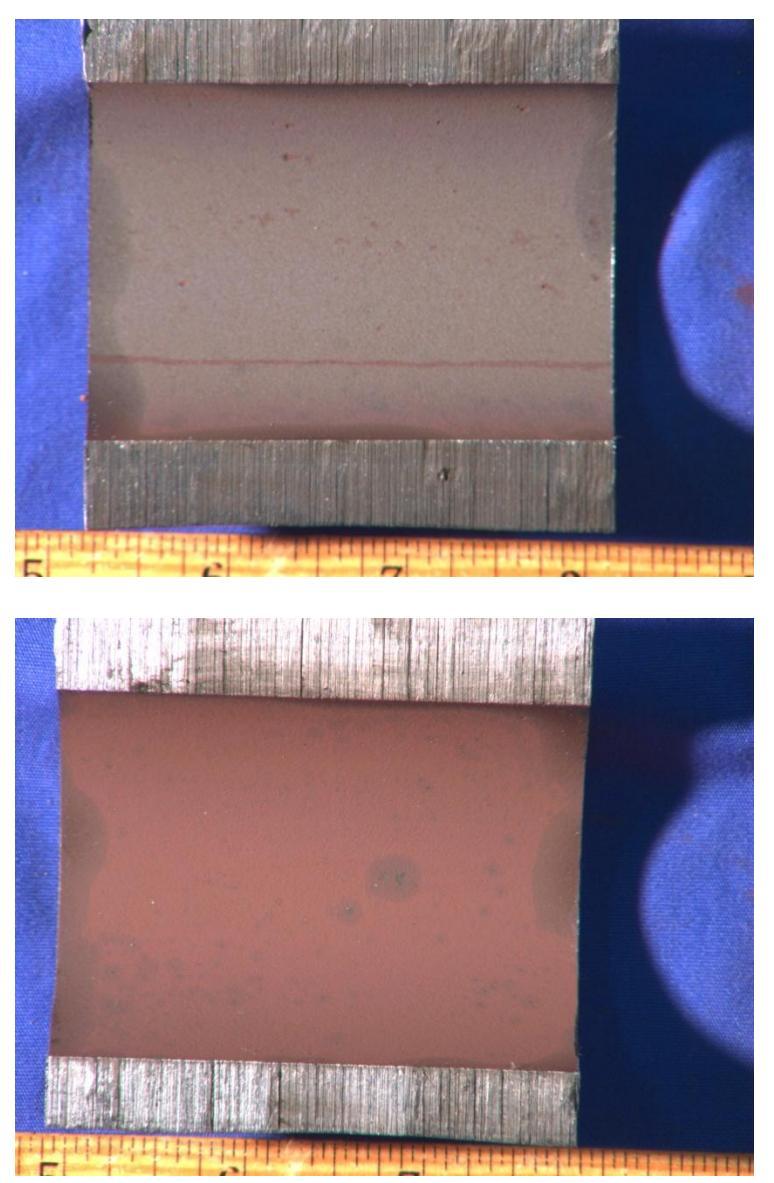
Figure 2. Photograph of internal surface of DWD test section, Side I.

Figure 3. Photograph of internal surface of DWD test section, Side II.

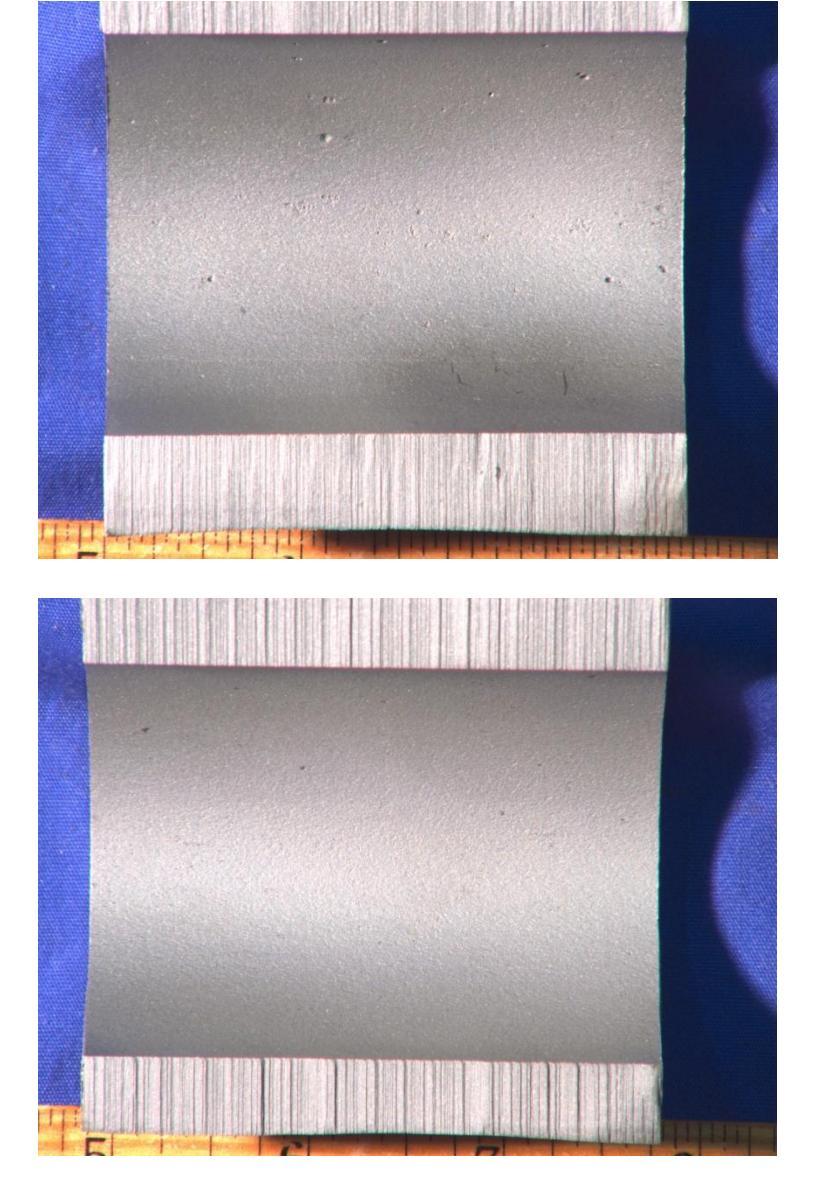
After cleaning, the condition of the internal surface was evaluated (Figures 4 and 5). Corrosion pits were observed on both sides. The wall thickness and pit data are also listed in Table 1.

Figure 4. Photograph of internal surface of DWD test section, Side I, after mechanical cleaning.

Figure 5. Photograph of internal surface of DWD test section, Side II, after mechanical cleaning.

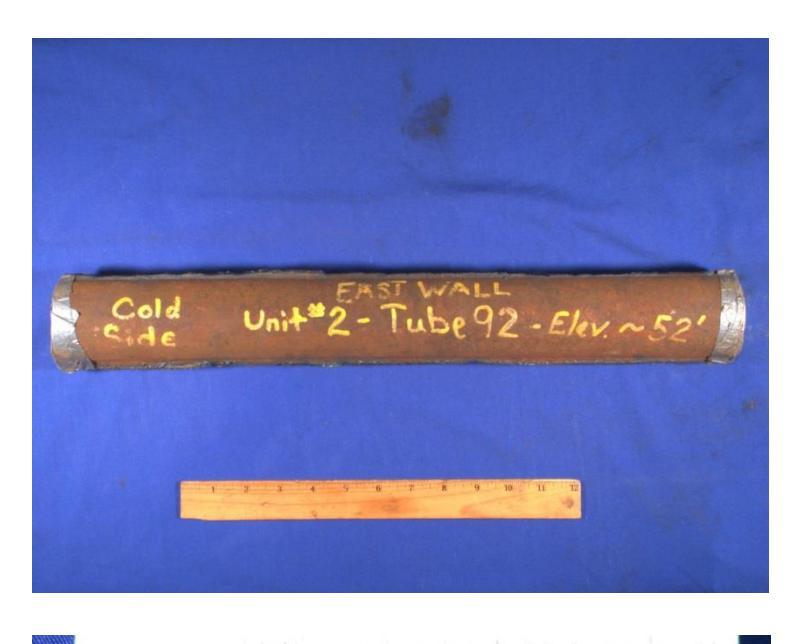
Figure 1. Photograph of the tube section, as received.

Figure 1 shows the tube sample, as received. Visual inspection revealed no evidence of imminent failure from overheating or fireside corrosion. There was no significant or excessive build-up of deposits noted on the external surface. The internal surface of the tube was covered with light-gray and brown deposits (Figures 2 and 3).

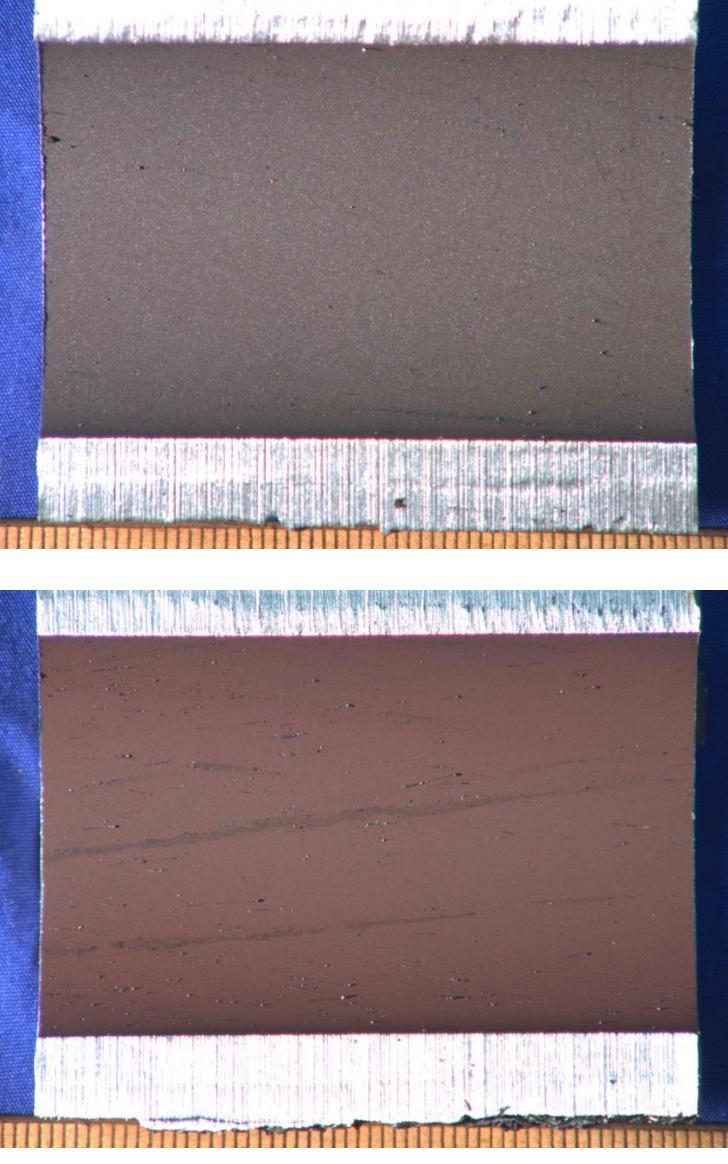
Figure 2. Photograph of internal surface of DWD test section, Side I.

Figure 3. Photograph of internal surface of DWD test section, Side II.

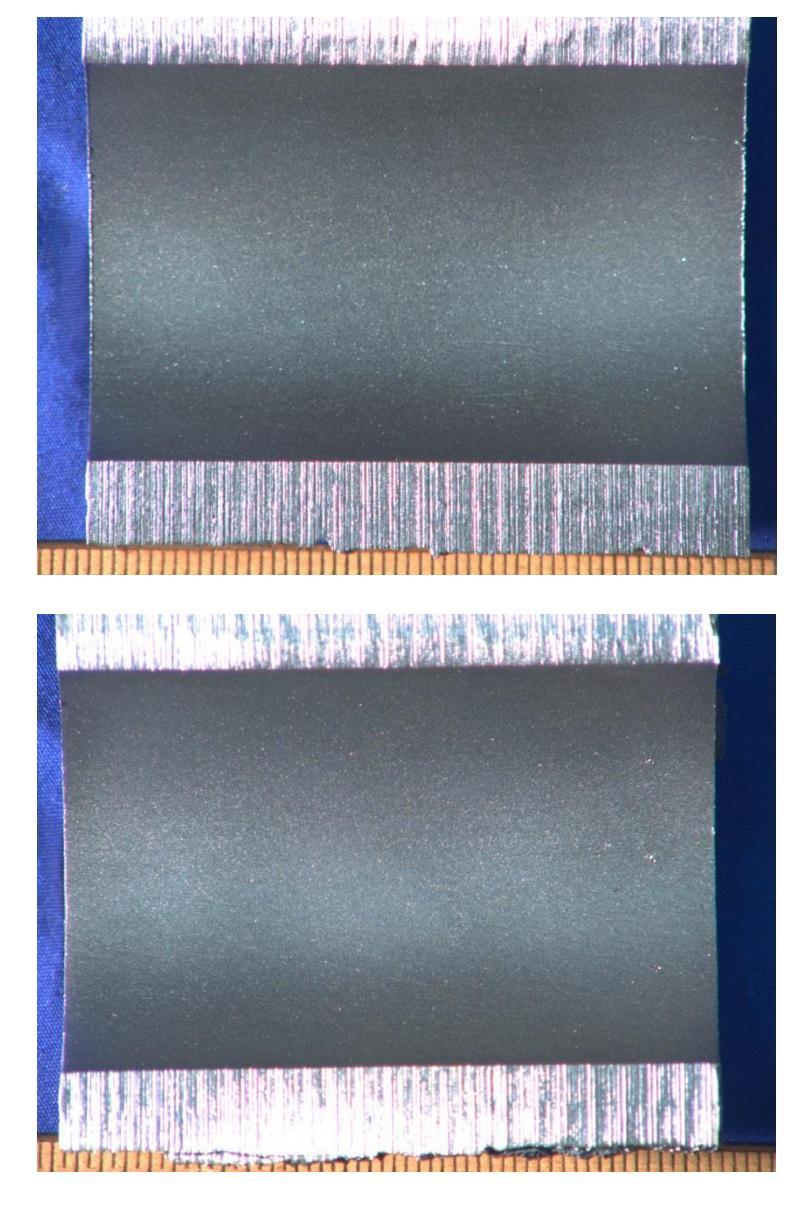
After cleaning, the condition of the internal surface was evaluated (Figures 4 and 5). Shallow corrosion pits were observed on both sides. The wall thickness and pit data are also listed in Table 1.

Figure 4. Photograph of internal surface of DWD test section, Side I, after mechanical cleaning.

Figure 5. Photograph of internal surface of DWD test section, Side II, after mechanical cleaning.
