1. Hydraulic Generation Refurbishment and Modernization (2019-2020)

Hydraulic Generation Refurbishment and Modernization

July 2018

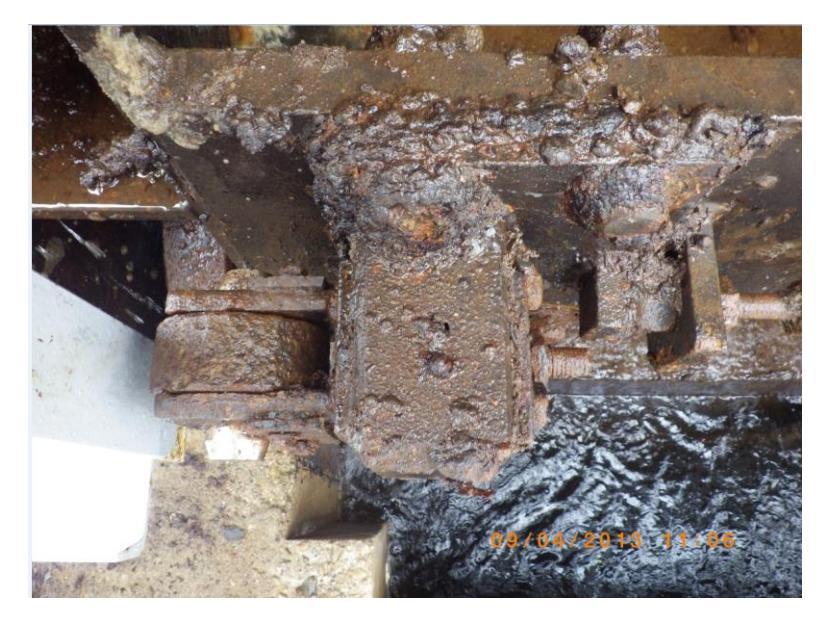
2 A detailed assessment of Bay d'Espoir Intake 1 was completed in 2016 and it was determined 3 that there were varying levels of deterioration, particularly in the submerged/embedded 4 components. Deterioration consists of concrete erosion and corrosion on embedded parts/ gate components. Critical components that have shown deterioration include main rollers, roll 5 6 paths, side-rollers and seals. It was also noted that the deterioration of these components is 7 creating extra stress on the hoist system. As these intakes are the same vintage, with similar 8 operating conditions and in the same environment, Hydro expects that the state of Intakes 2 9 and 3 are similar to the state of Intake 1 identified in 2016. Also, in 2013 Intake gate 2 failed to 10 close due to issues related to those identified for the Intake 1. Figure 5 and Figure 6 are images of the side and main rollers on Intakes 2 and 1. 11

Figure 5: Bay d'Espoir Intake 2 Side Rollers - 2013

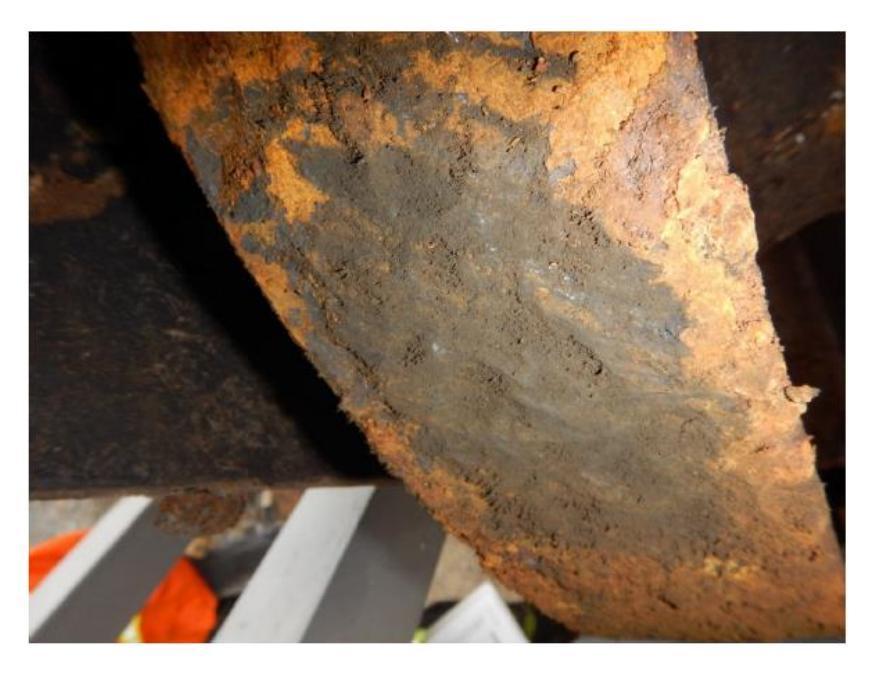
Figure 6: Pitting Corrosion on Main Rollers – Intake 1 2016

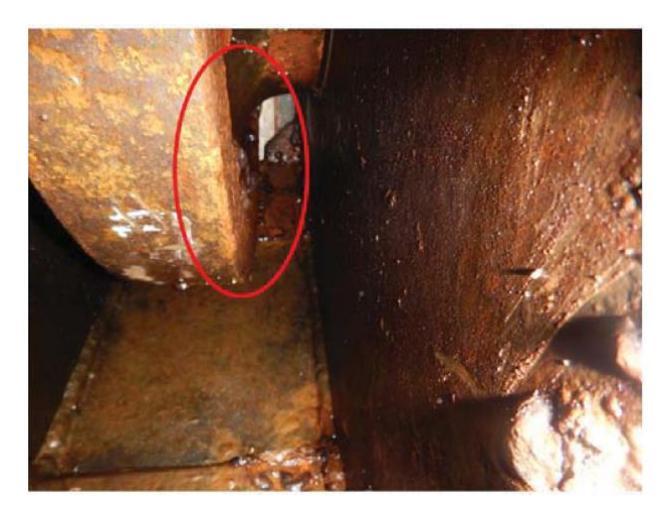
8 In 2017, a detailed condition assessment of the Ebbegunbaeg control structure was completed. 9 The assessment revealed operational issues with the gates, which include damage to the main 10 rollers, embedded parts and lifting systems. The assessment also identified concrete 11 deterioration on the piers, decking, and around the embedded parts. Figure 8, Figure 9, and 12 Figure 10 show some of the deteriorated conditions.

Figure 8: Roller Corrosion - Ebbegunbaeg

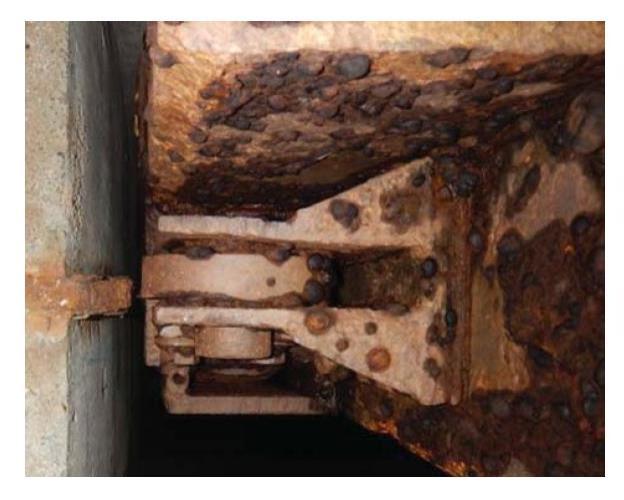
Figure 9: Seized Side Roller - Ebbegunbaeg

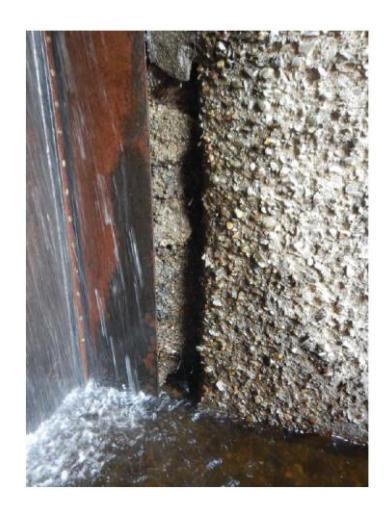
Figure 10: Concrete Deterioration - Ebbegunbaeg

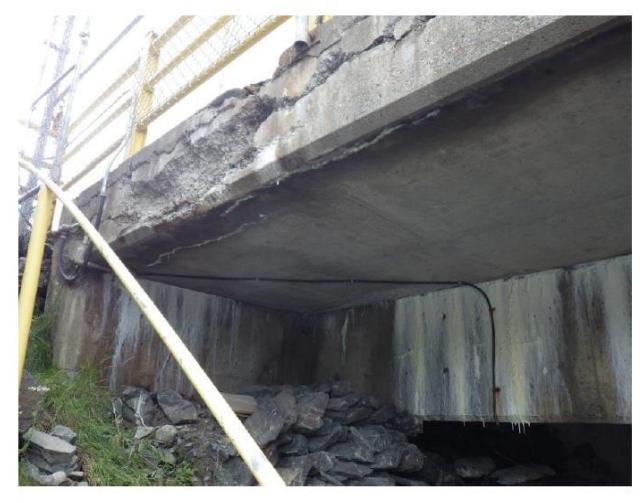
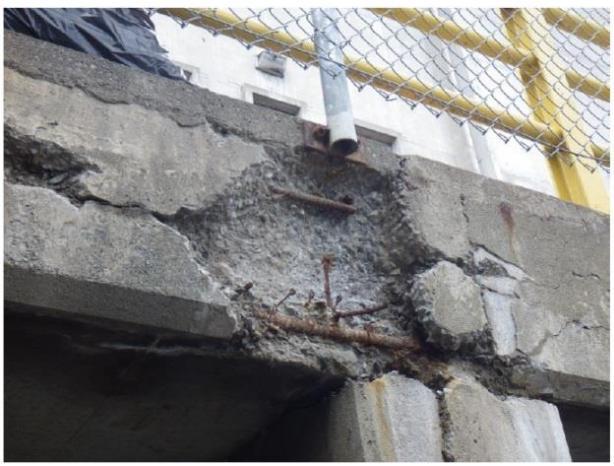
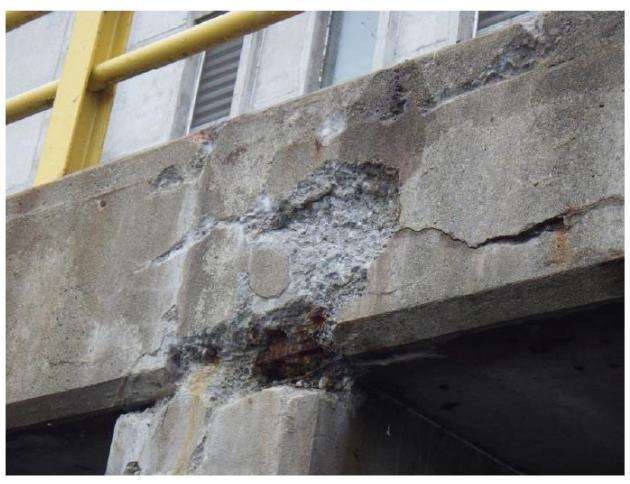
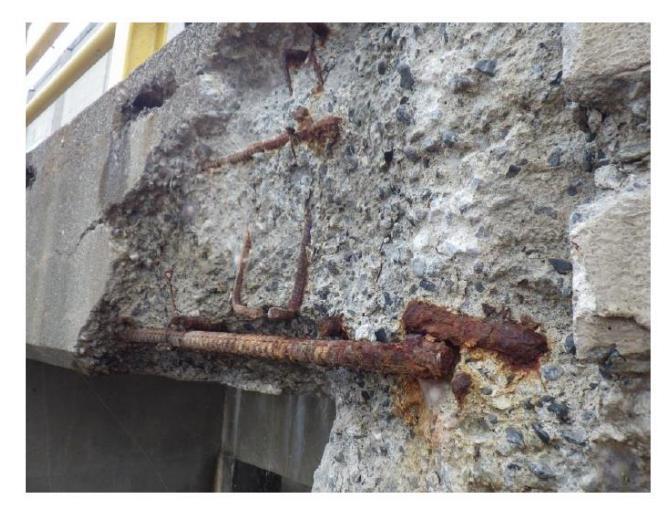
10 Figure 12 to Figure 15 highlight some of the concrete deterioration.

Figure 12: Deterioration on the Draft Tube Deck

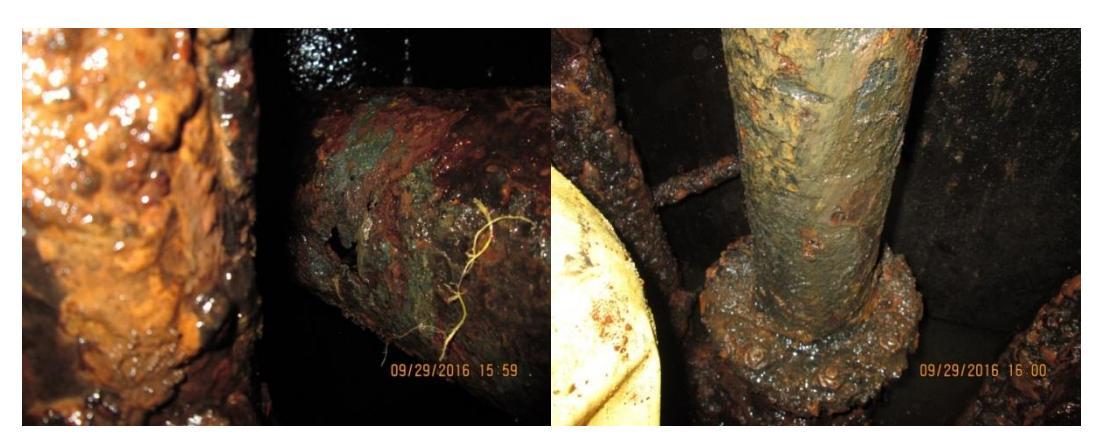
5 At Paradise River, pumps, motors, piping and guide rails are submerged and located at the 6 bottom of the sump, see Figure 18. At Hinds Lake, the drainage pump is a vertical turbine 7 pump; the bottom column and pump are submerged in water, see Figure 19.

Figure 18: Corroded Component in the Paradise Sump

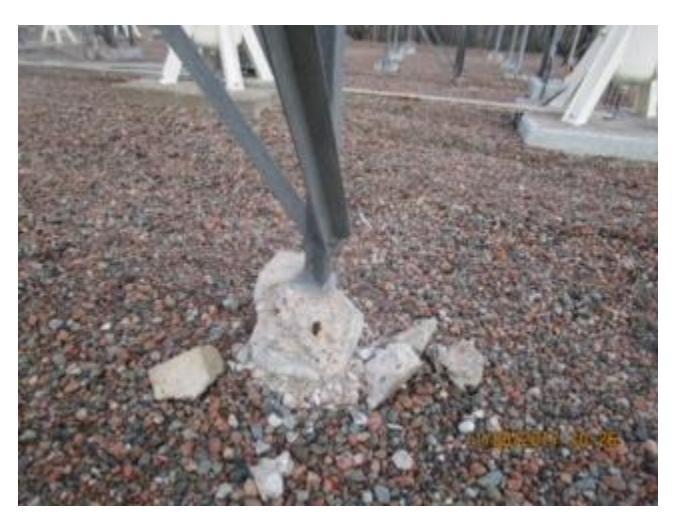
Figure 1: Compromised Foundation at Buchan's Terminal Station

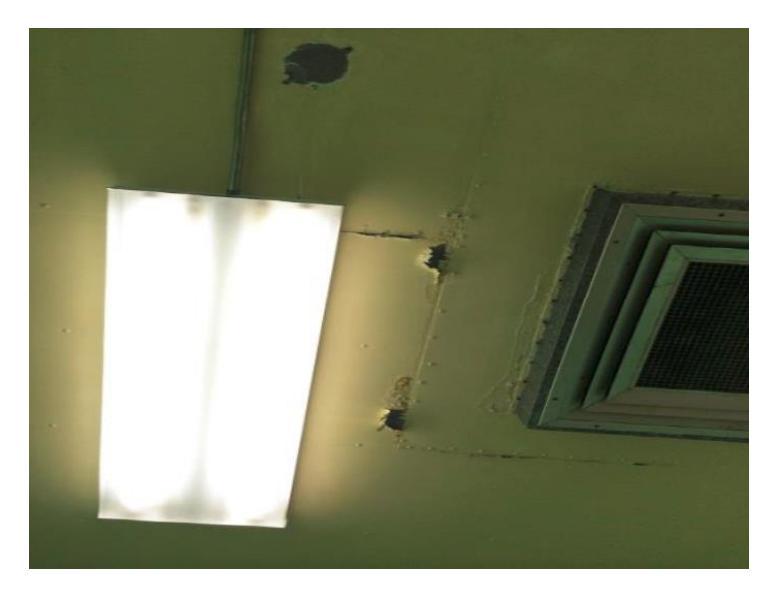
- Replace Roof System (Figure 2): Roof has reached end of expected service life, and is
 displaying significant surface cracking. Evidence of leaking present.
- Exterior Doors (Figure 3): Exterior doors are heavily rusted and deteriorated.
- Other Upgrades: Hydro will address other issues such as failed HVAC equipment, battery
 room ventilation, obsolete low voltage distribution equipment, and corroded water
 service entry.

Figure 2: Leaking Roof at Holyrood

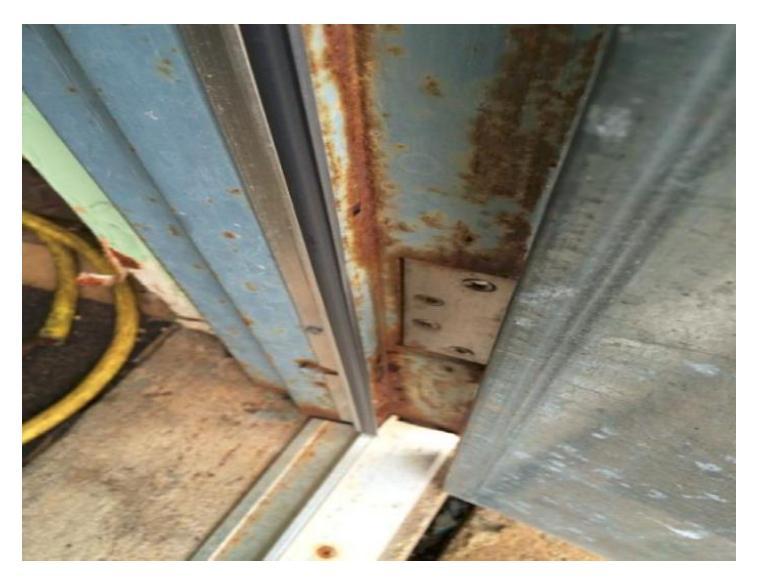
Figure 3: Rusted Doors at Holyrood

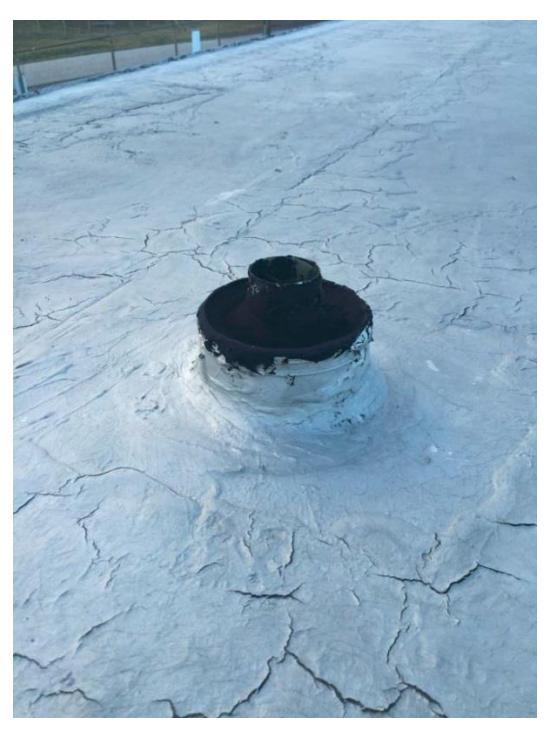
Figure 4: Roof Surface Cracking at Come By Chance

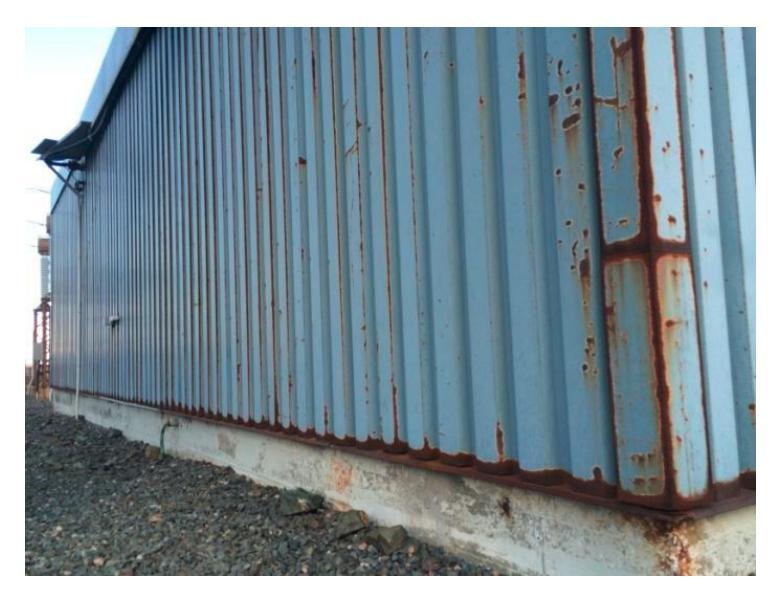
Figure 5: Rusting Exterior Cladding at Come By Chance

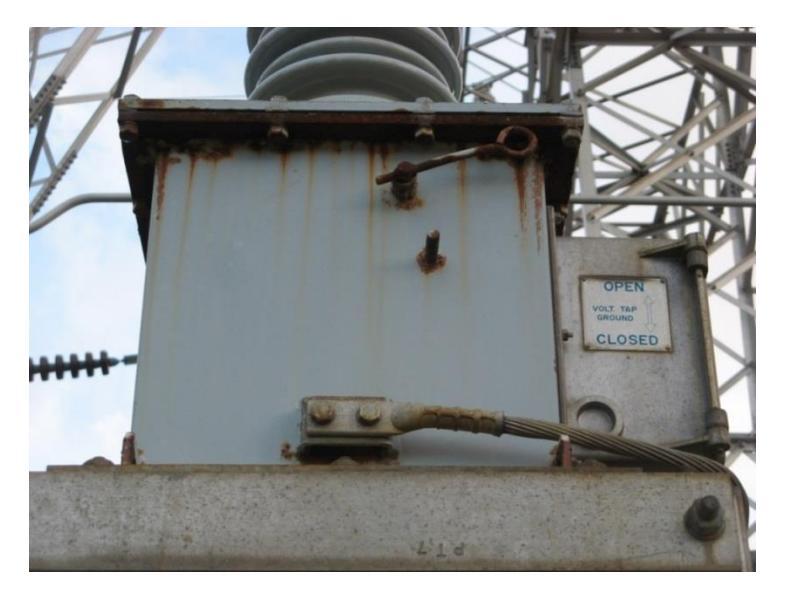
Physical deterioration involves conditions such as oil leaks, rusting, or small chips and cracks inthe insulation. Figure 2 shows an example of rusting on a PT tank.

Figure 2: Rusting on Potential Transformer

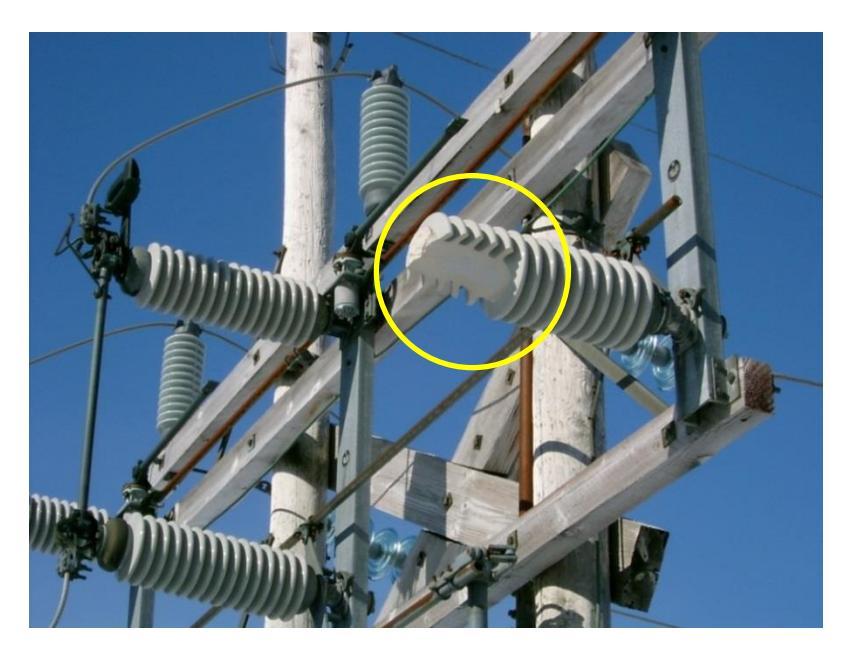
12 Figure 4 shows an example of a badly damaged disconnect switch.

Figure 4: Broken Insulator on 69 kV Disconnect Switch

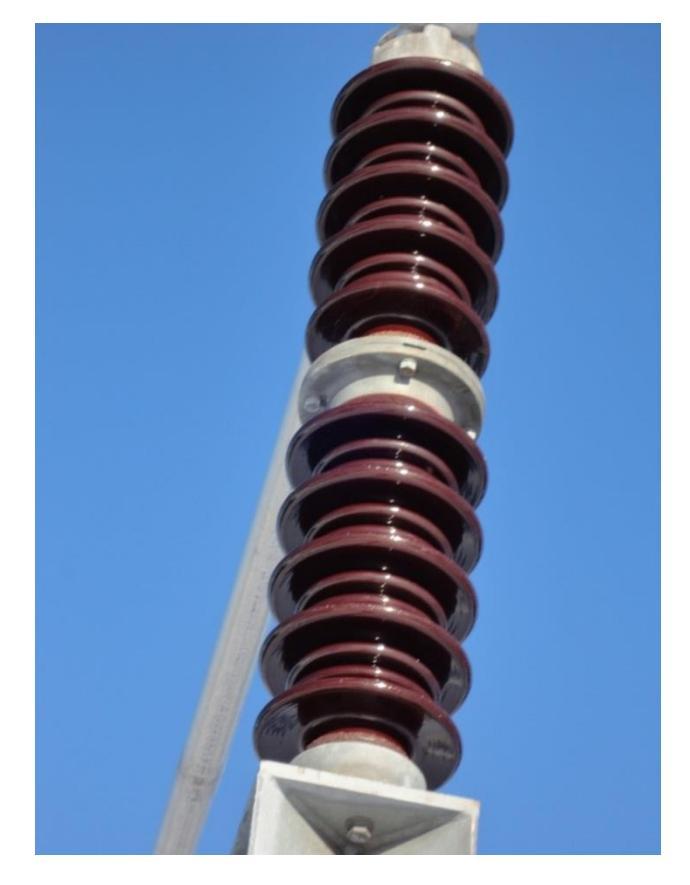
Figure 6: A Multi-cone type insulator prone to failure due to cement growth

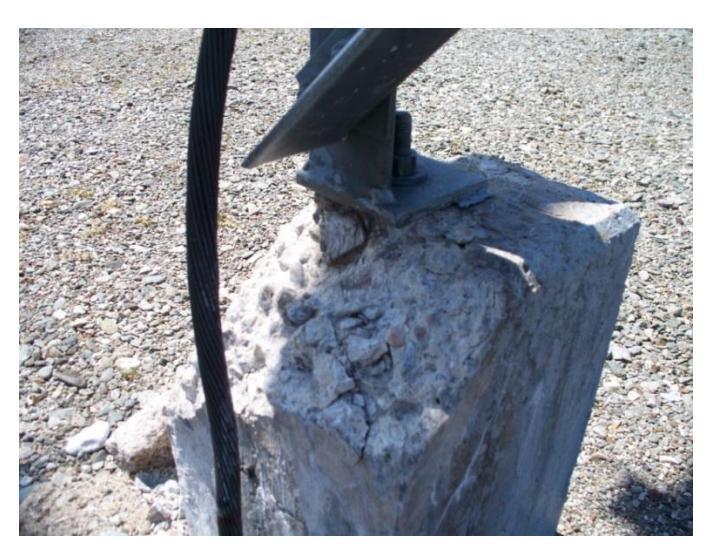
Figure 13: Structure B1T1 Bottom Terminal Stations

12 integrity. Degraded structure foundations are shown in Figure 13 and Figure 14.

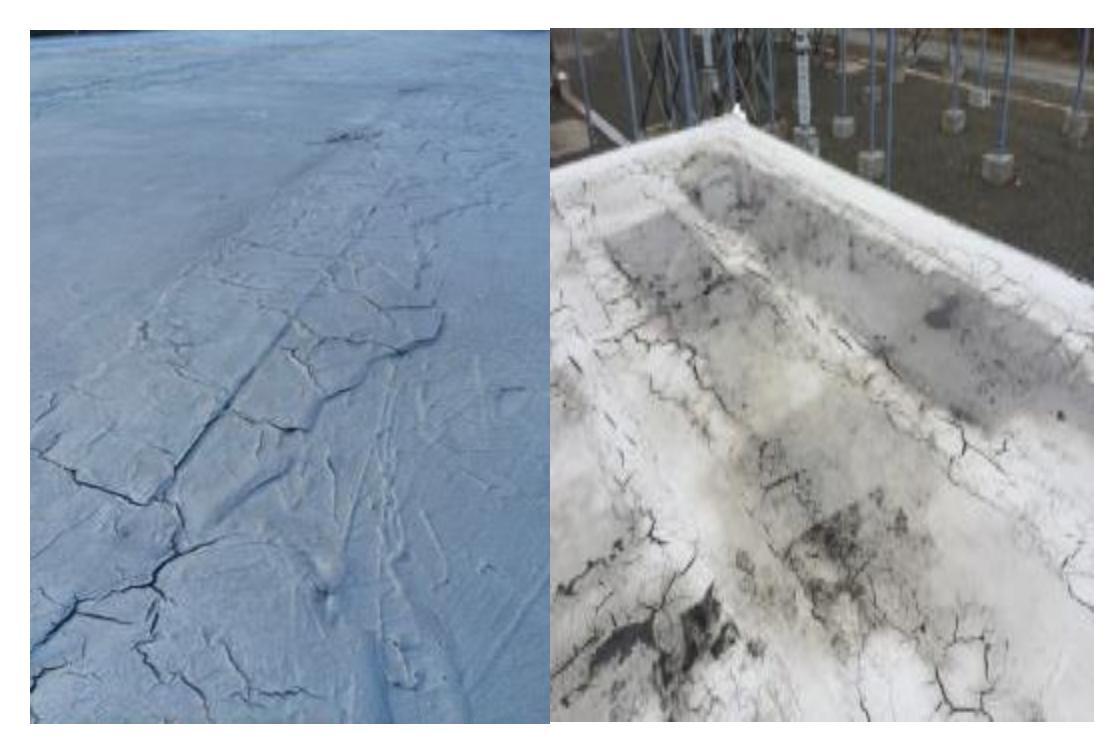
Figure 15: Terminal Station Control Buildings (Come By Chance and Sunnyside) showing cracking and deterioration of the roof membrane systems.

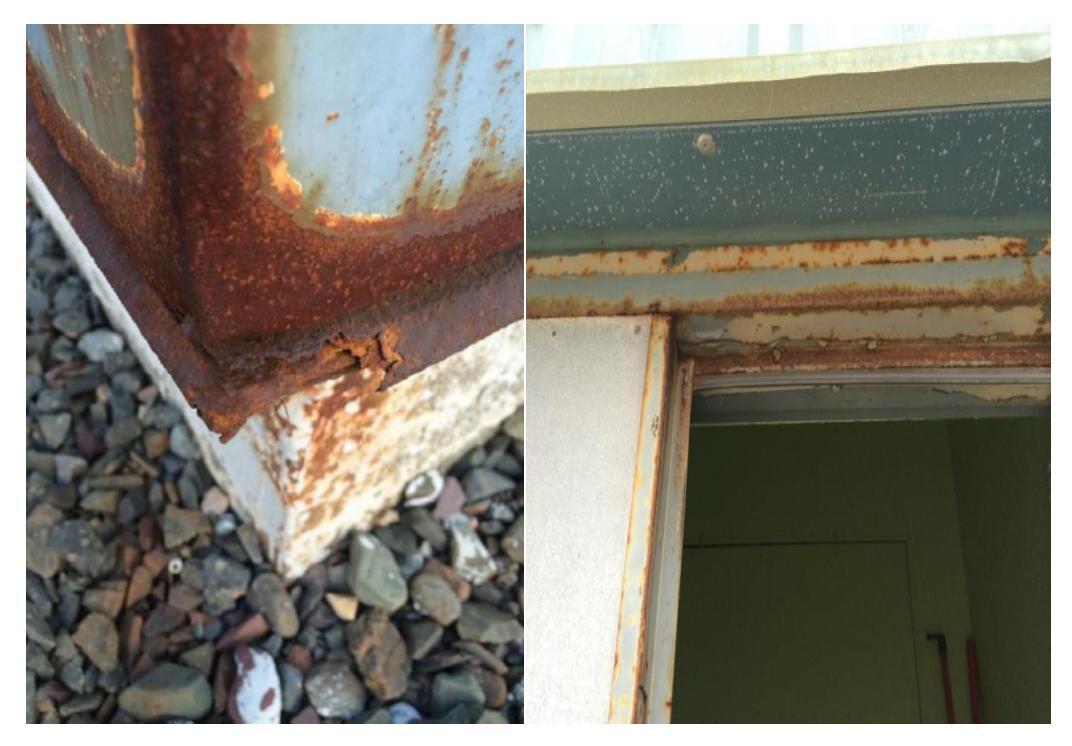
Figure 16: Building exterior cladding and doorways displaying severe rusting and deterioration

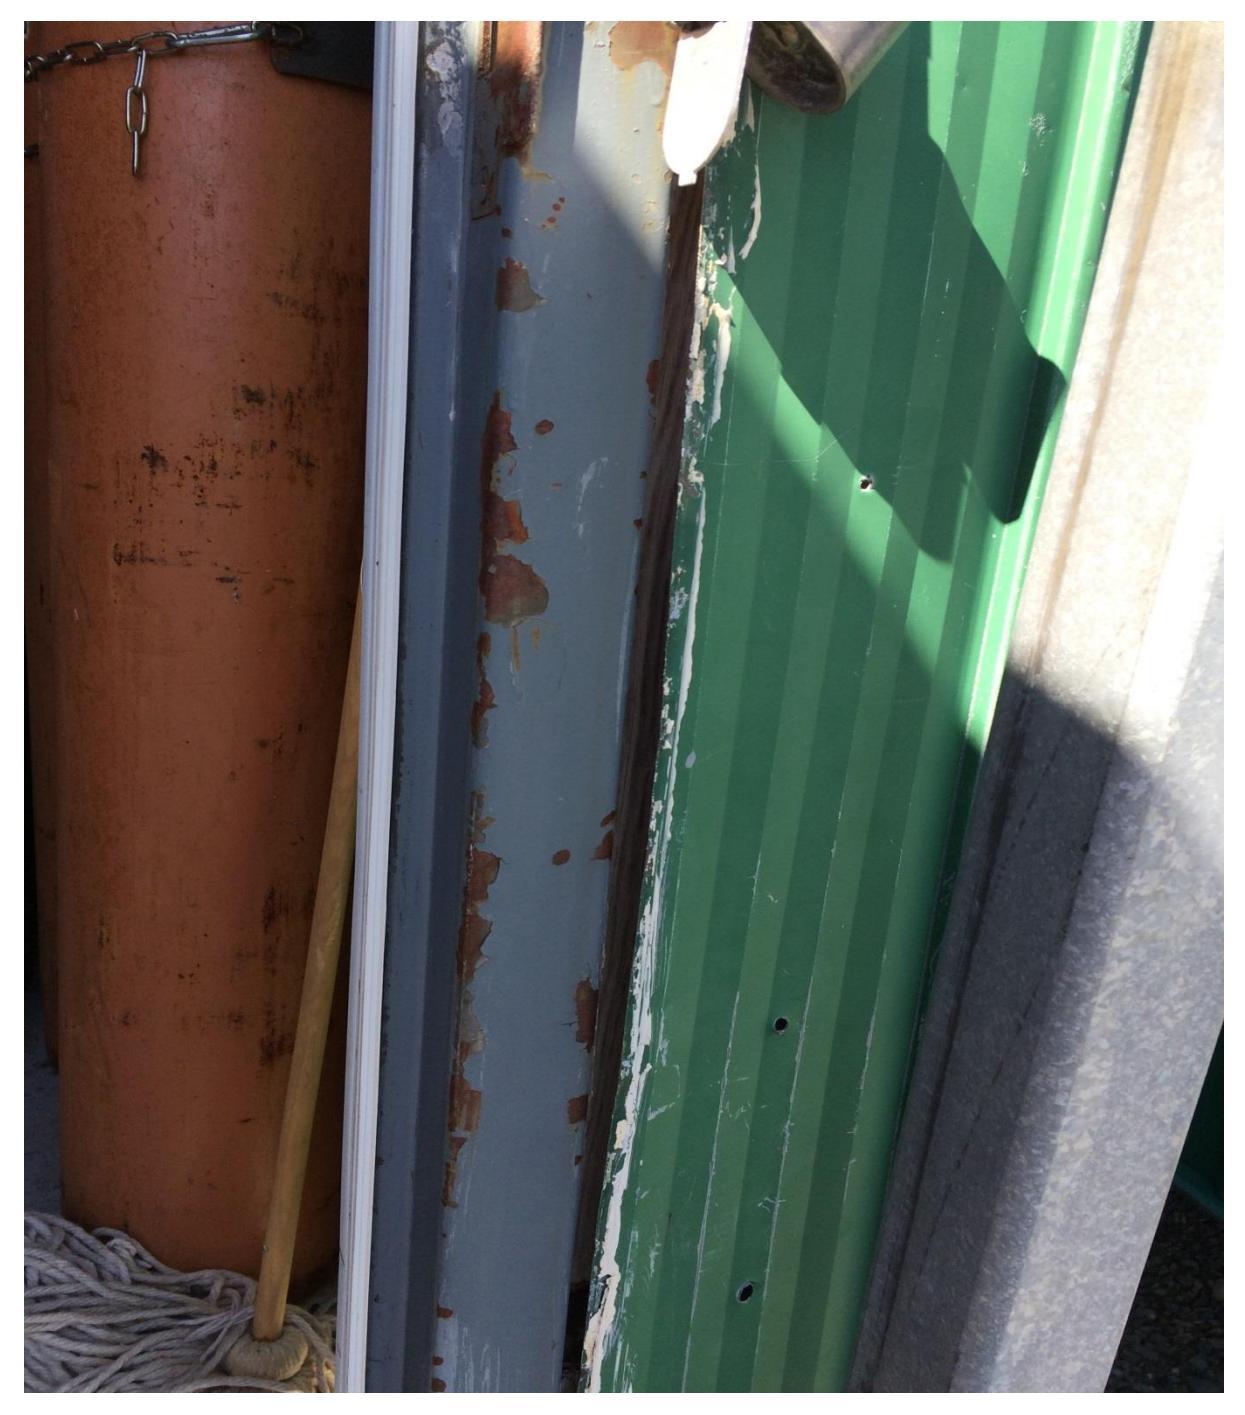
Figure 4: Gull Pond Hill – exterior metal siding – weathered, damaged, and separating from building

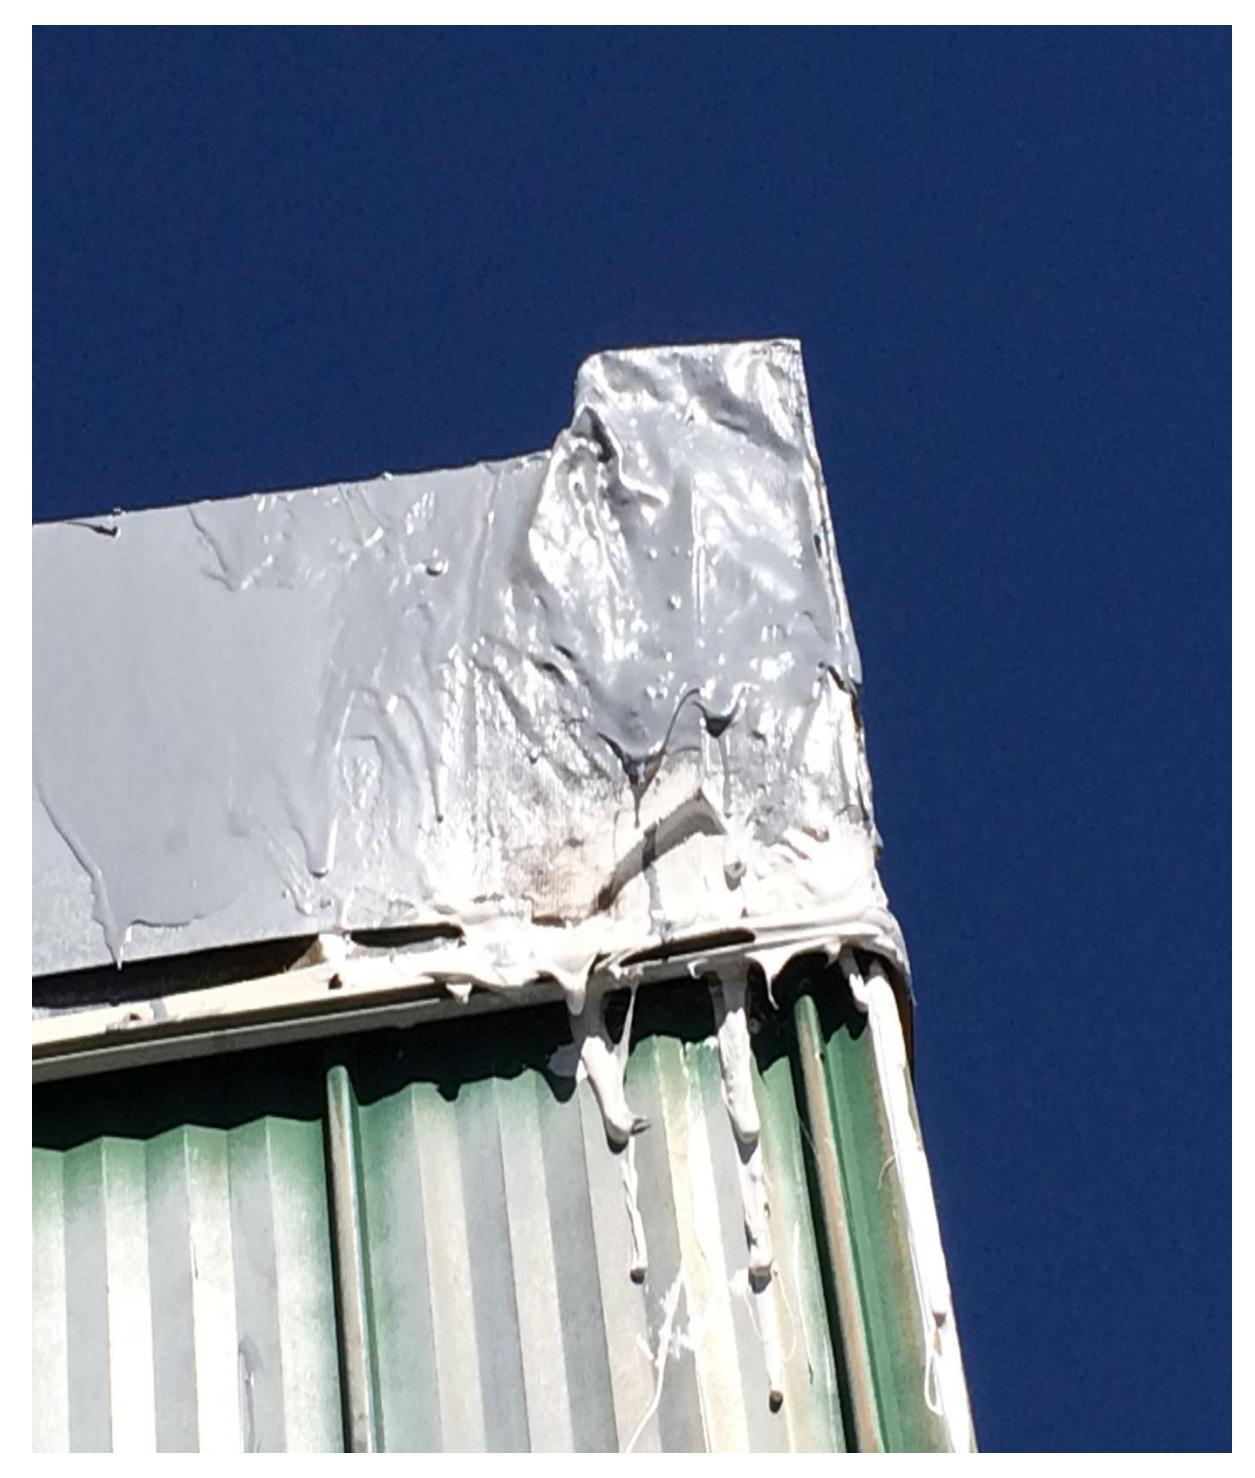
Figure 5: Gull Pond Hill – Temporary patching of metal roof to help prevent water entry

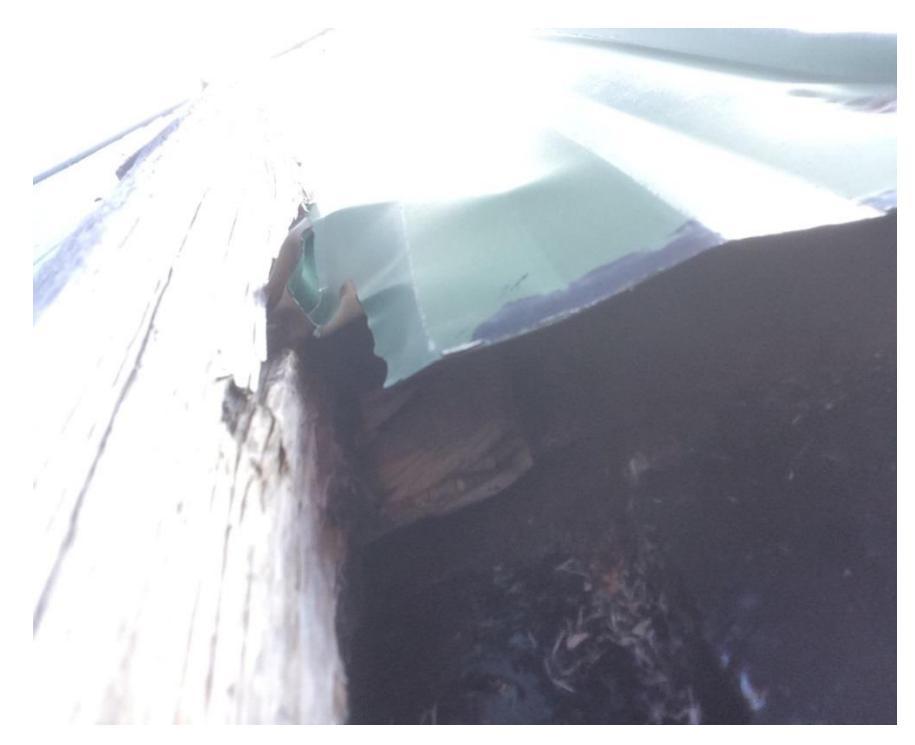
Figure 6: Gull Pond Hill – Damaged siding and exposed sheeting

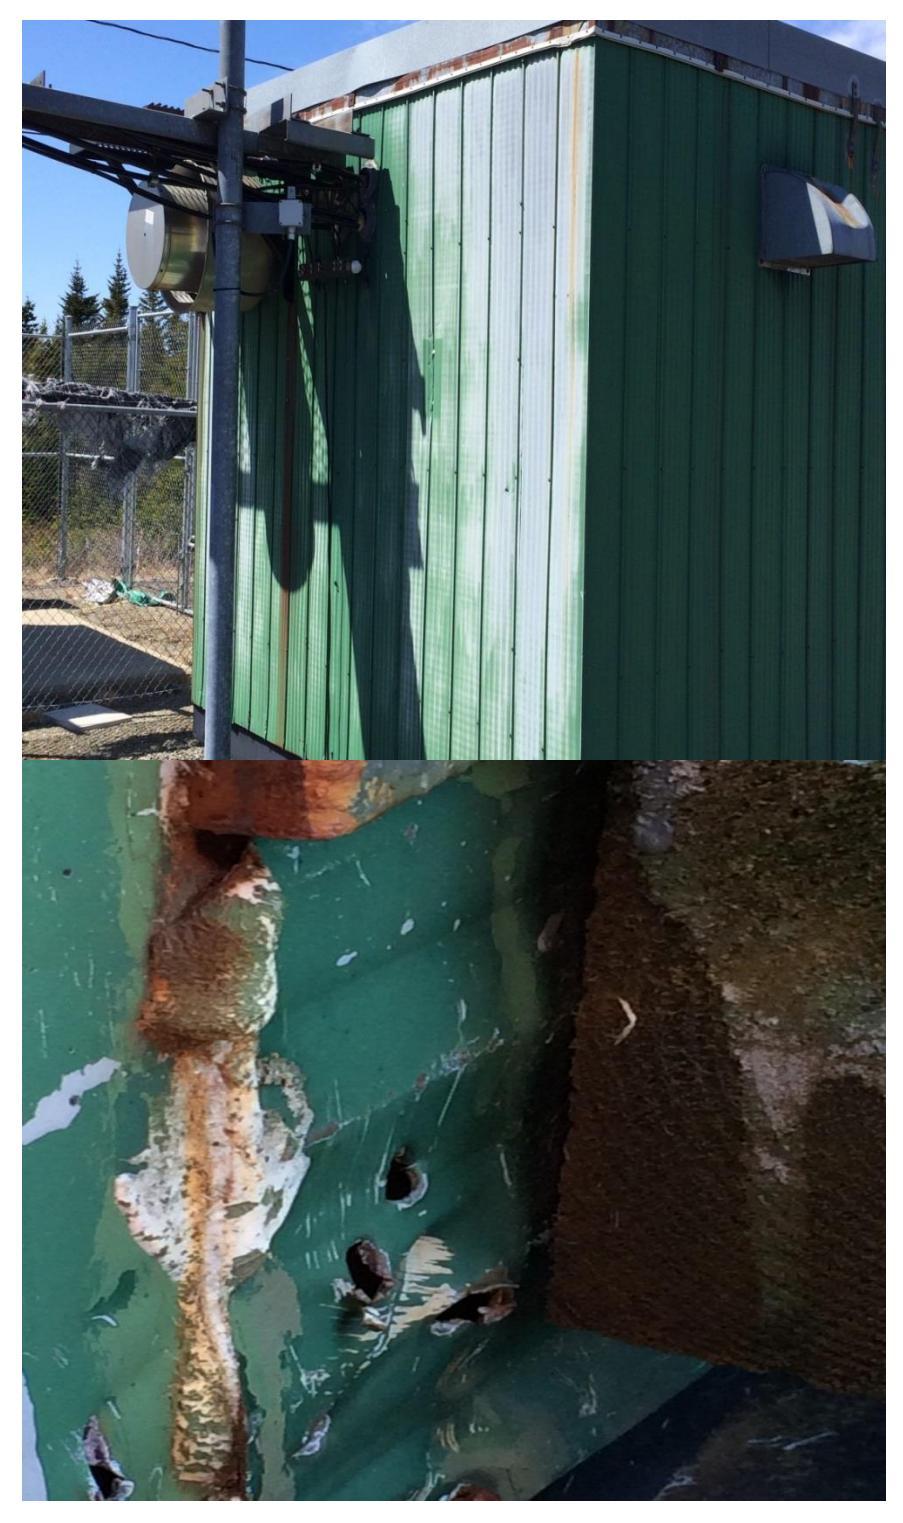
Figure 8A and 8B: Bay d'Espoir Hill – Deteriorated siding and rusted metal roof

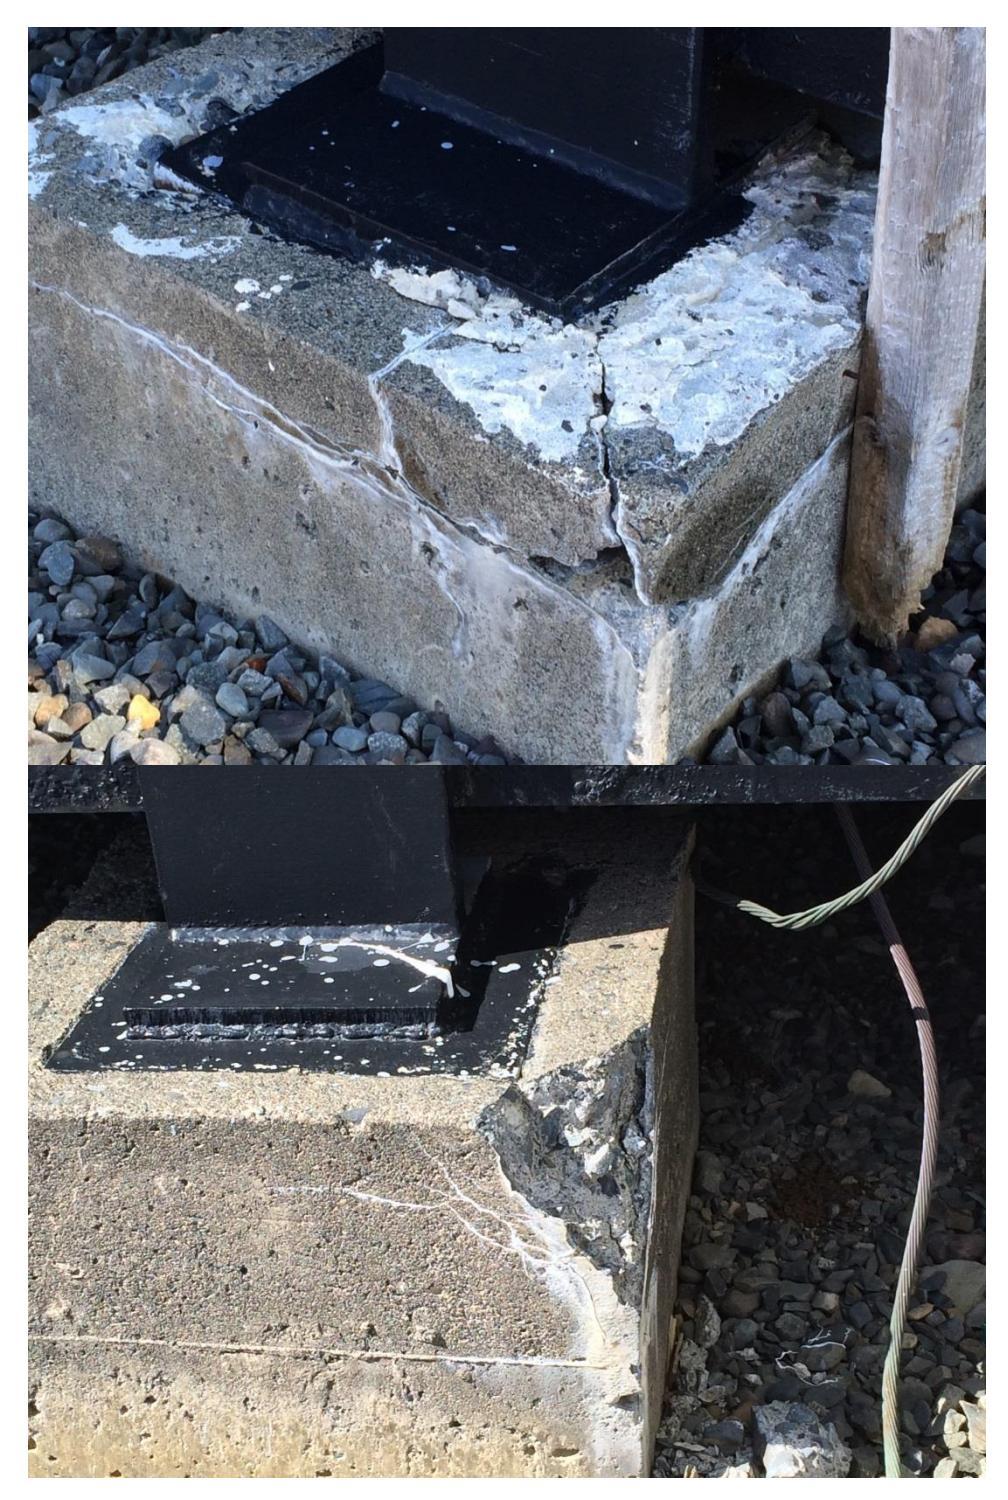
Figure 9A and 9B: Gull Pond Hill: Cracked and deteriorated building foundations

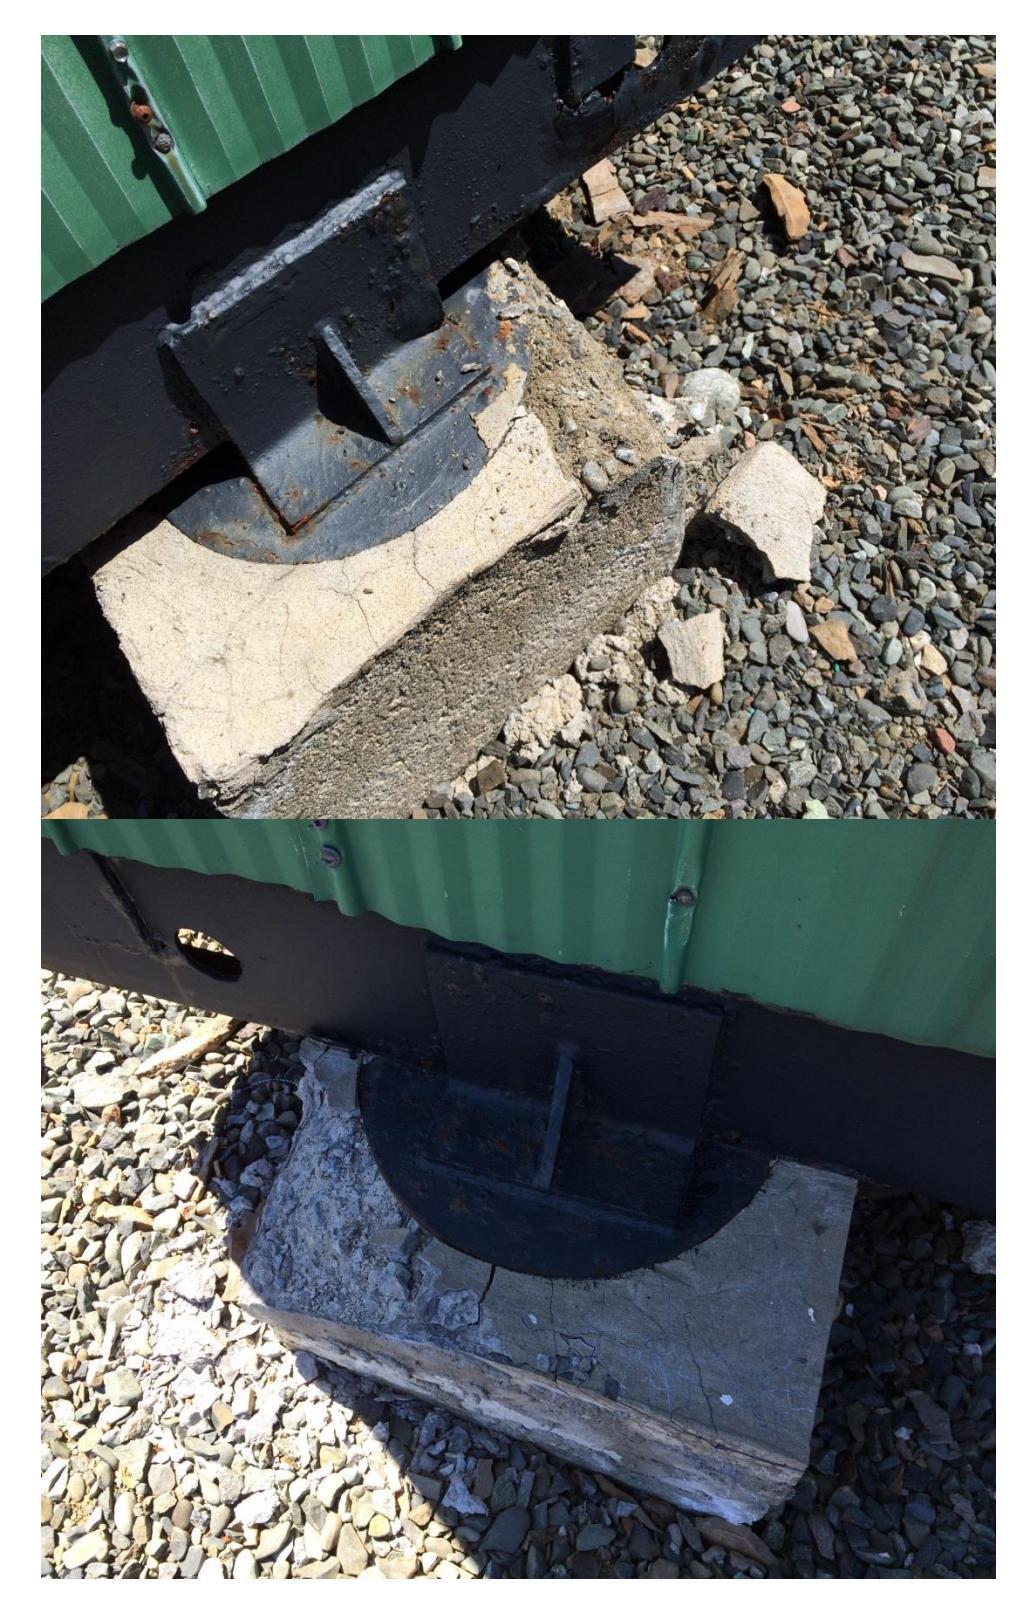
Figure 10A and 10B: Bay d'Espoir Hill – cracked and deteriorated building foundations

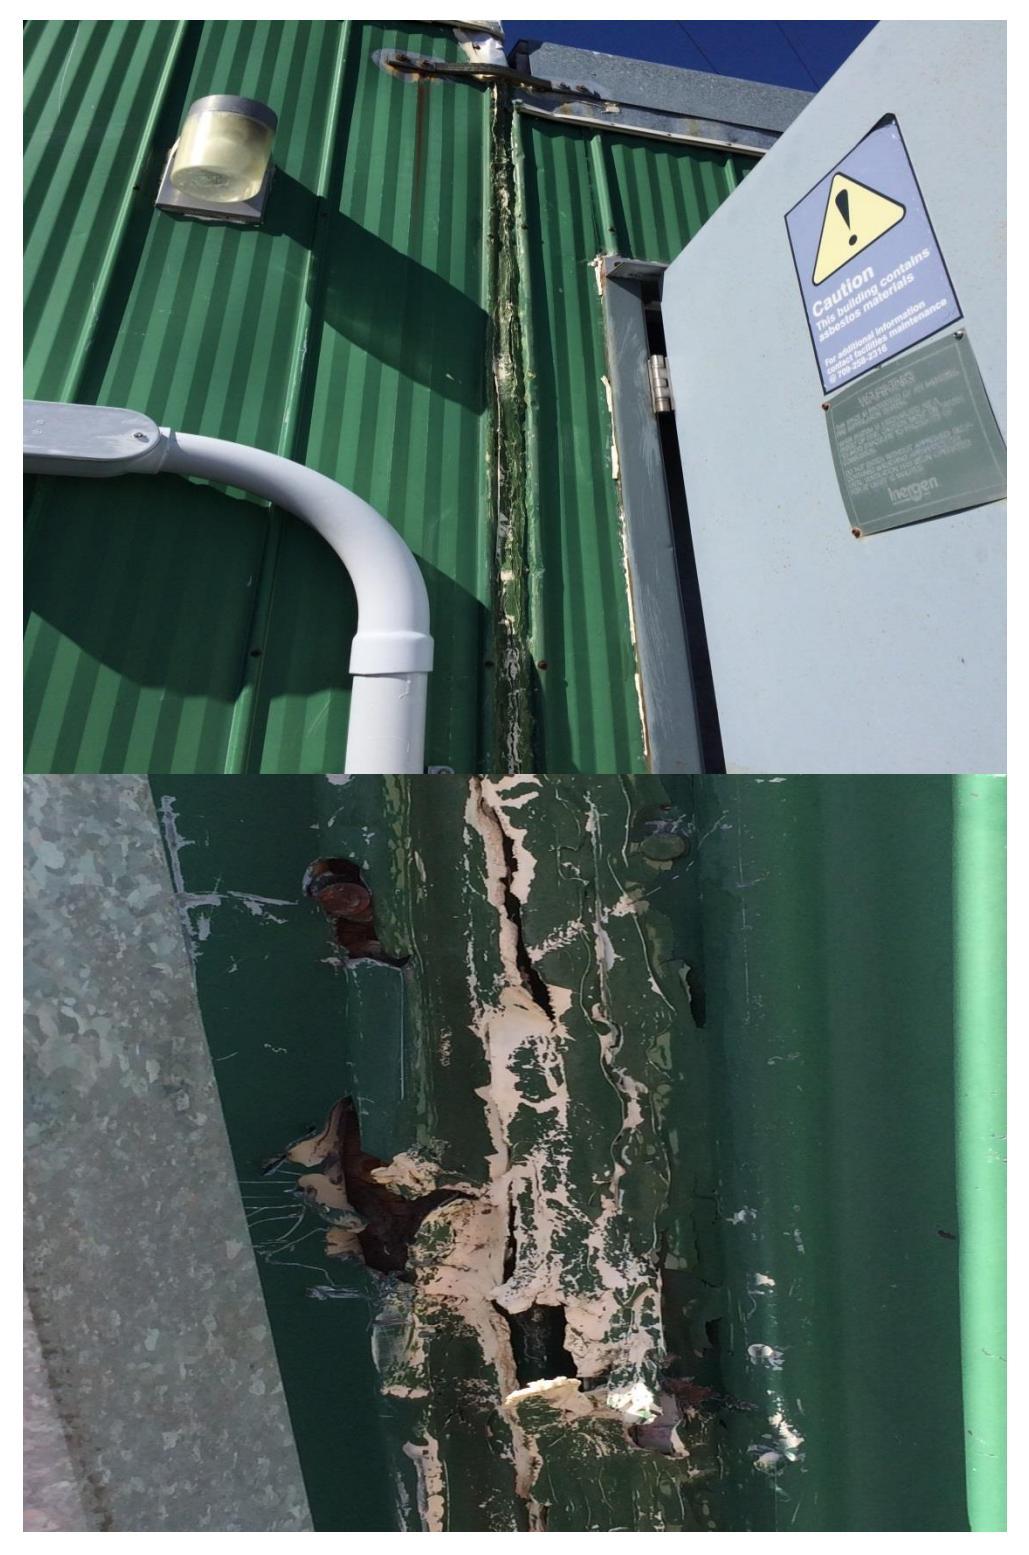
Figure 11A and 11B: Gull Pond Hill – porch separating from main shelter

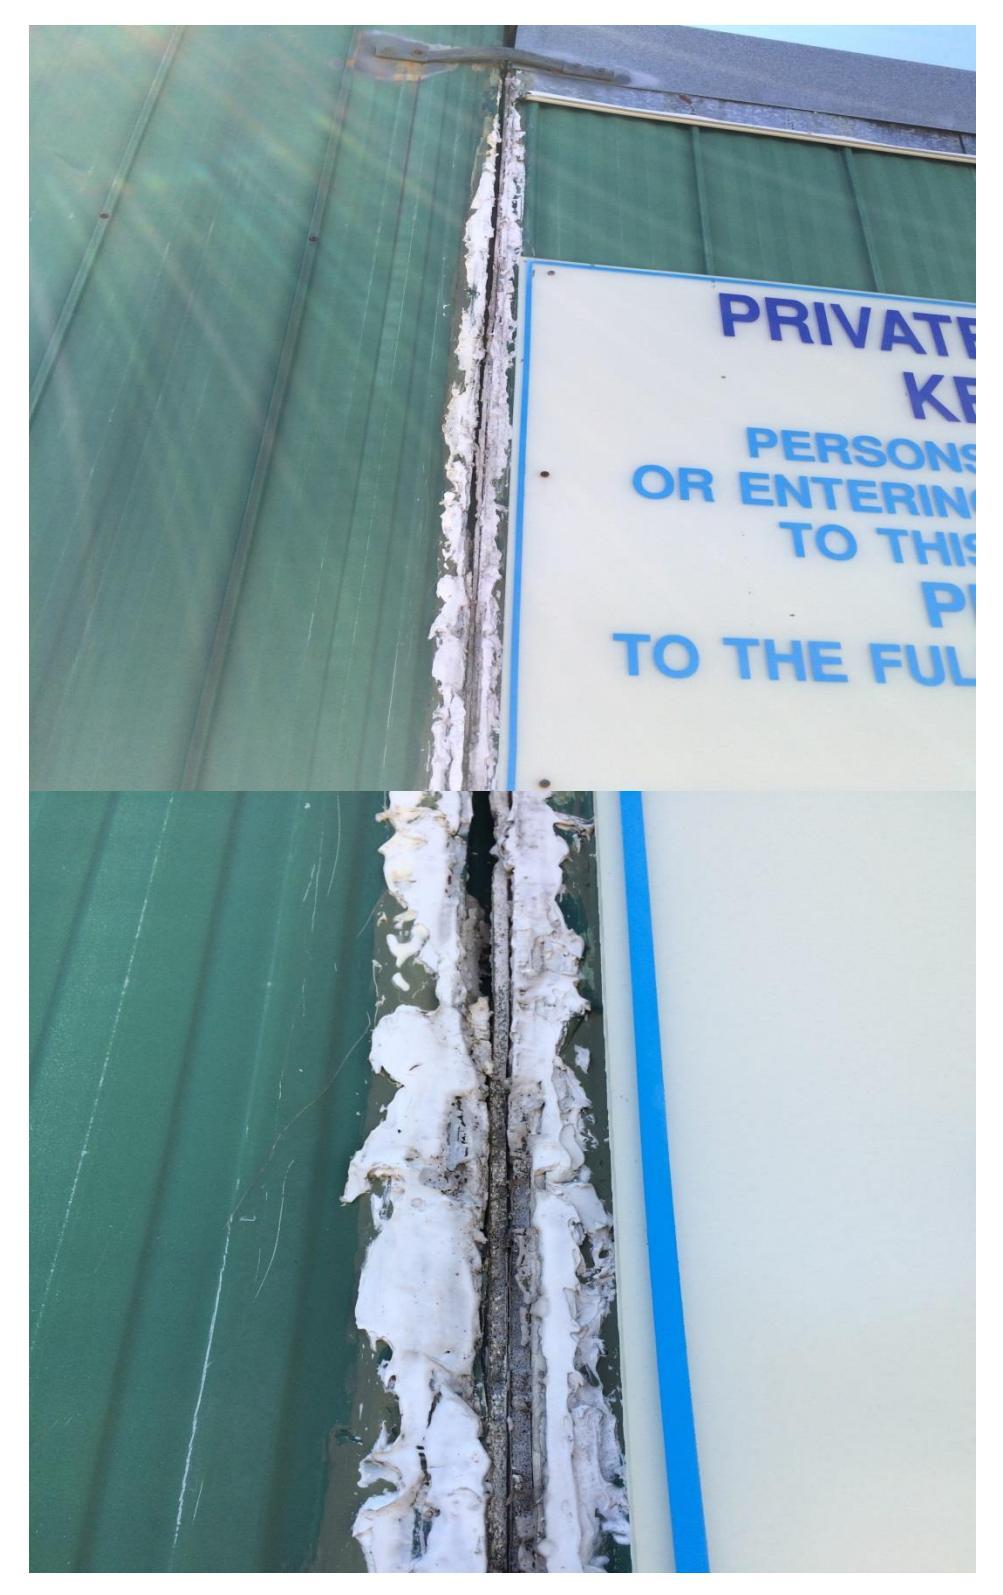
Figure 12A and 12B: Bay d'Espoir Hill – porch separating from main building
