1. Hydraulic Generation Refurbishment and Modernization (2019-2020)

Hydraulic Generation Refurbishment and Modernization

July 2018

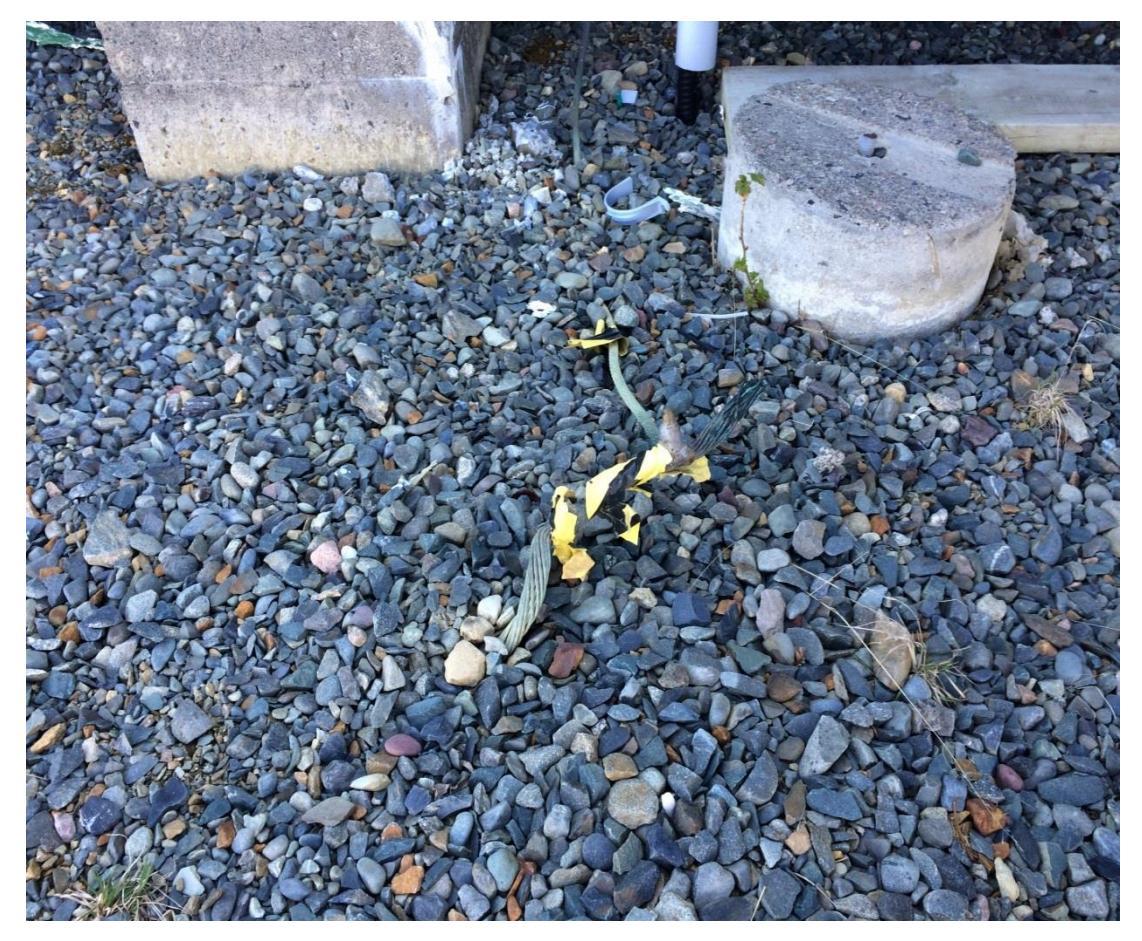
Figure 13: Gull Pond Hill – ground rod and wire above surface

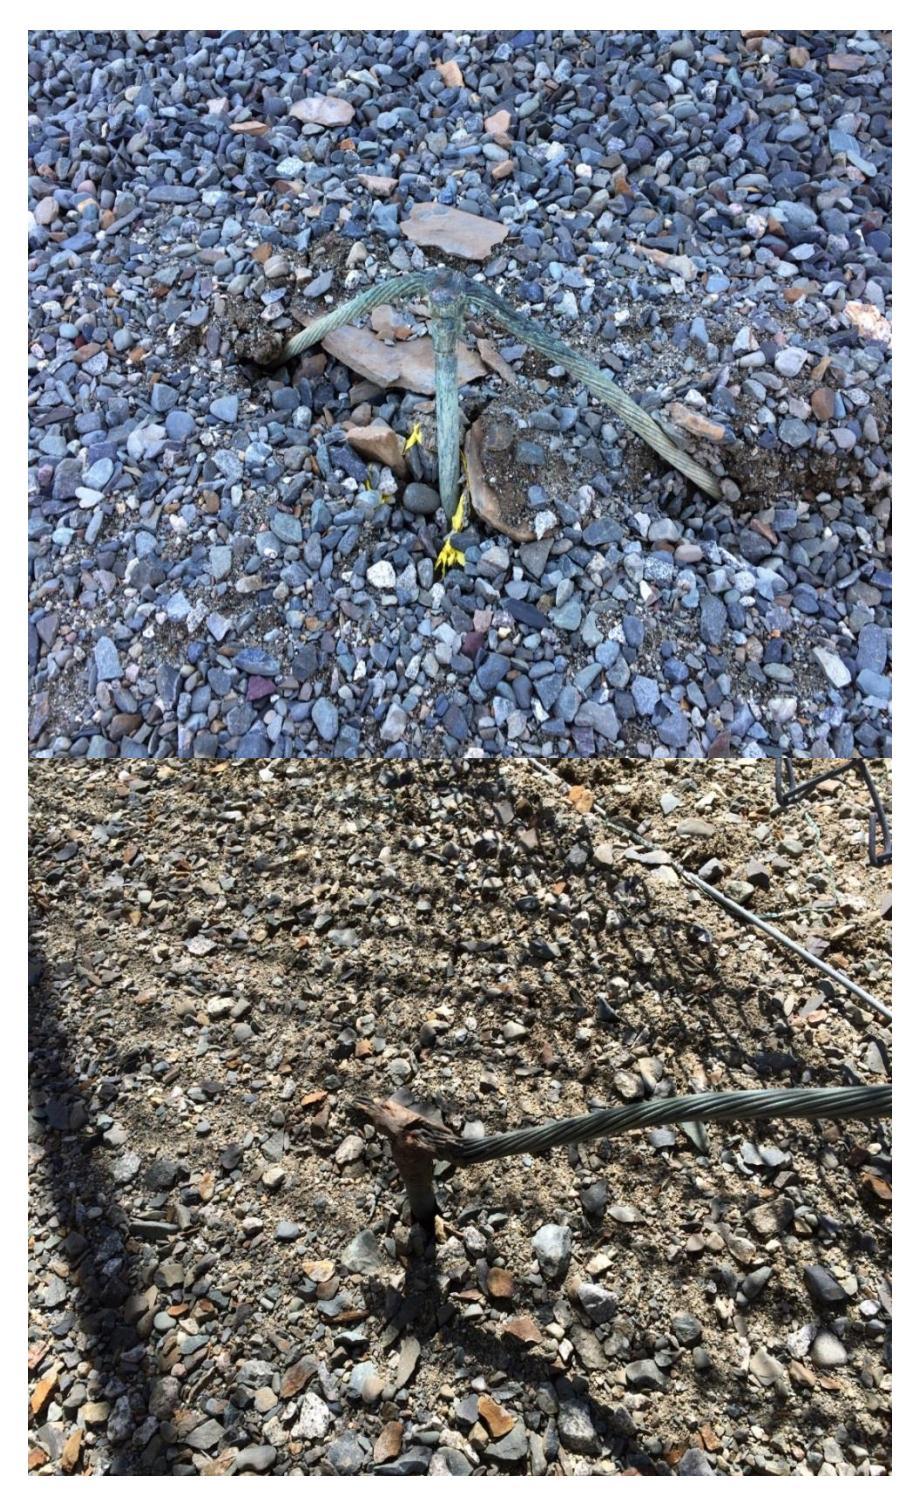
Figure 14A and 14B: Bay d'Espoir Hill – ground rods and wire migrating above the surface

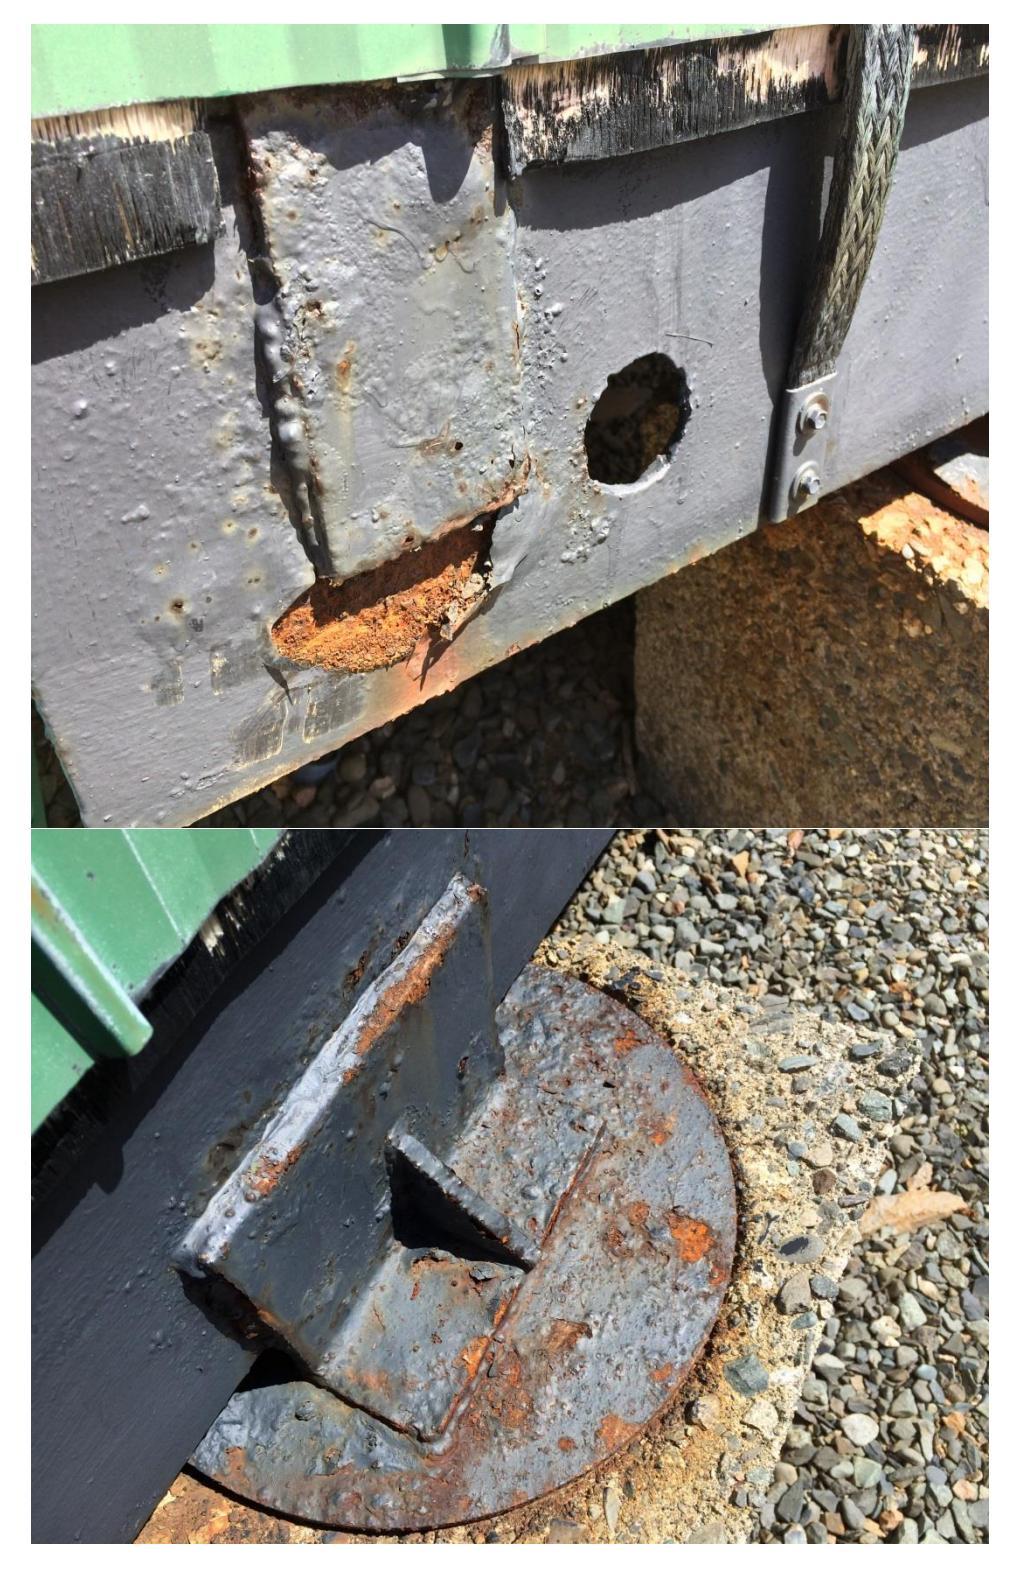
Figure 15A and 15B: Bay d'Espoir Hill – building metal floor frame rusting
