# Bay d'Espoir Penstock 1 Life Extension Project Update

Period Ended July 31, 2025

September 15, 2025

A report to the Board of Commissioners of Public Utilities

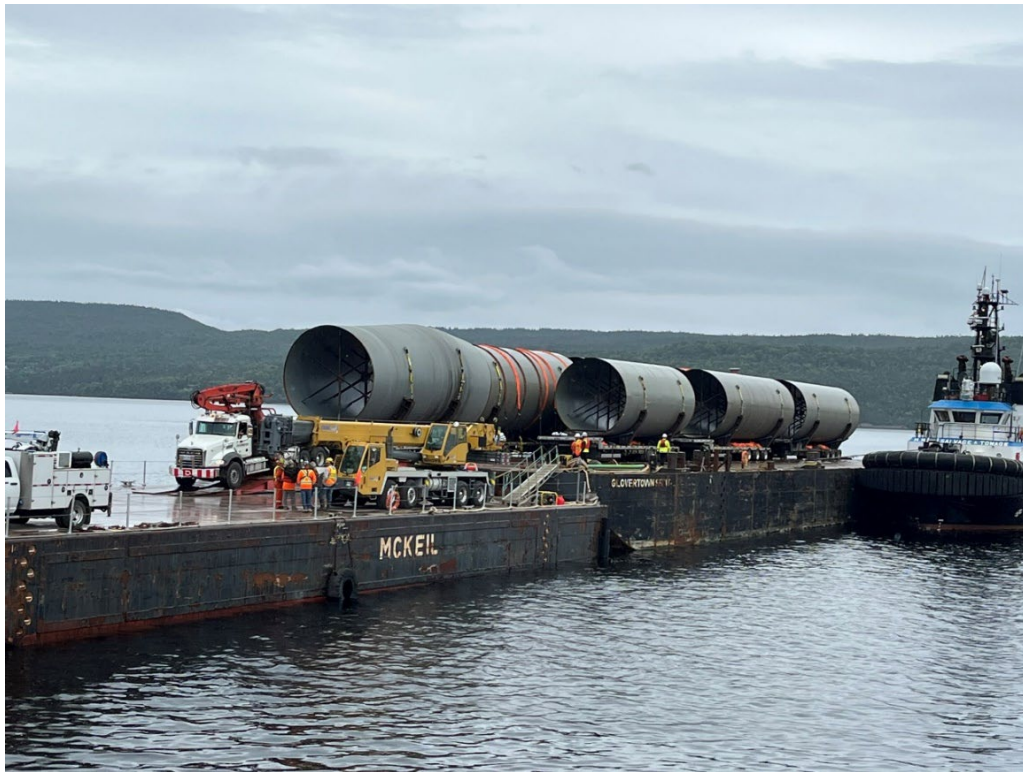
**Figure 1: Barge 3 Offloading**

The contractor has completed the fabrication and delivery of the penstock sections (commonly referred to as “cans”) as shown in Figure 1 and Figure 2. Fabrication and coatings have been completed on all 27 cans. Barge load 3 arrived in St. Joseph’s Cove on July 21, 2025, and all ten cans were delivered to the site July 22–23, 2025.

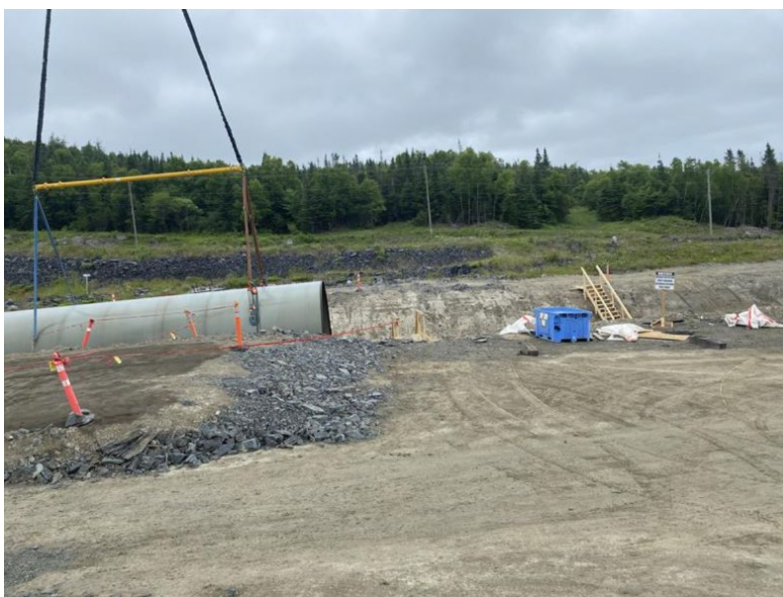
**Figure 3: Placement of Can 13**

Cans 13 through 18 were lifted, fitted, and tack-welded into place, with welding and non-destructive examination also completed up to Can 18. Exterior coating product was applied to the circumferential weld joints in the replacement section from Cans 7 to 15. Removal of interior bracing commenced from Cans 2 to 14.

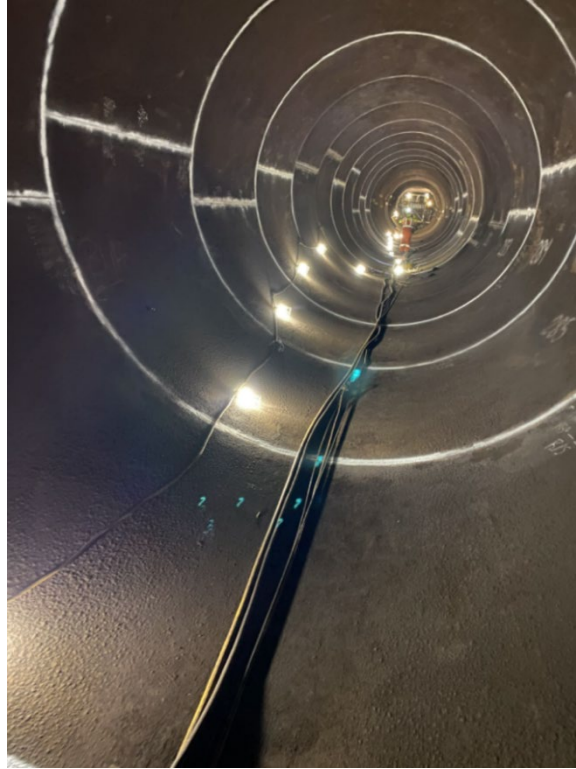
**Figure 6: Typical View of NDT in the Refurbishment Section**

Buffing, cleaning, and Non-Destructive Testing (“NDT”) of the existing welds on the lower refurbishment section is ongoing from temporary access point three, station 05+39 to station 11+00. Pressure washing of the interior of the cans continued between temporary access points two and the powerhouse, station 11+58. Completion of weld inspections and submittal of the associated Quality Surveillance Reports (“QSR”) is ongoing; 97 QSRs were submitted, which included the inspection of 210 cans. Weld repairs also continued on areas identified through the inspection process from Cut 2 to the temporary access point three.

Since the end of the reporting period, weld inspection in the refurbishment section has been substantially completed. The resulting quantity and scope of weld repairs appear to be less than originally anticipated. This milestone marks another significant step forward in ensuring readiness for return to service. The increased certainty in the weld repair scope allows the risk, identified in Table 2, associated with unknown or increased quantity and scope of weld repairs to be closed.

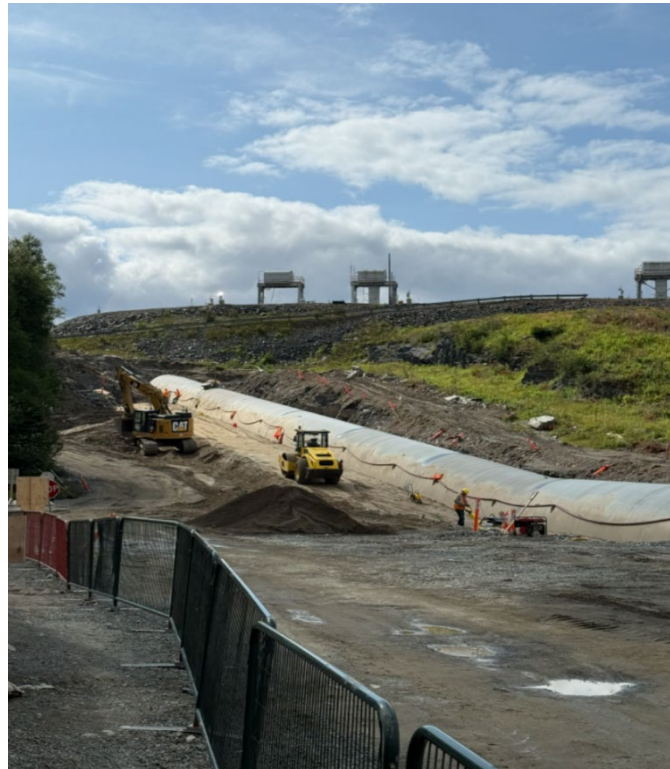
**Figure 7: Placing Common Backfill on South Side of Penstock**

On-site construction continued during the reporting period with excavation and backfilling, can placement, as well as refurbishment activities. Drain piping and bedding placement continued and were completed from Cans 18 to 23, and Cans 25 to 28. Due to a subsequent significant rain event, the drain piping and bedding in the area of Can 26 to 28 were washed out and required rework. The quarry at Upper Salmon was established for the common backfill material, and hauling and stockpiling of common material at the site has begun. Placement of common backfill material has also started from Can 2 to Can 10.
