# Bay d'Espoir Penstock 1 Life Extension Project Update

November 17, 2025

A report to the Board of Commissioners of Public Utilities

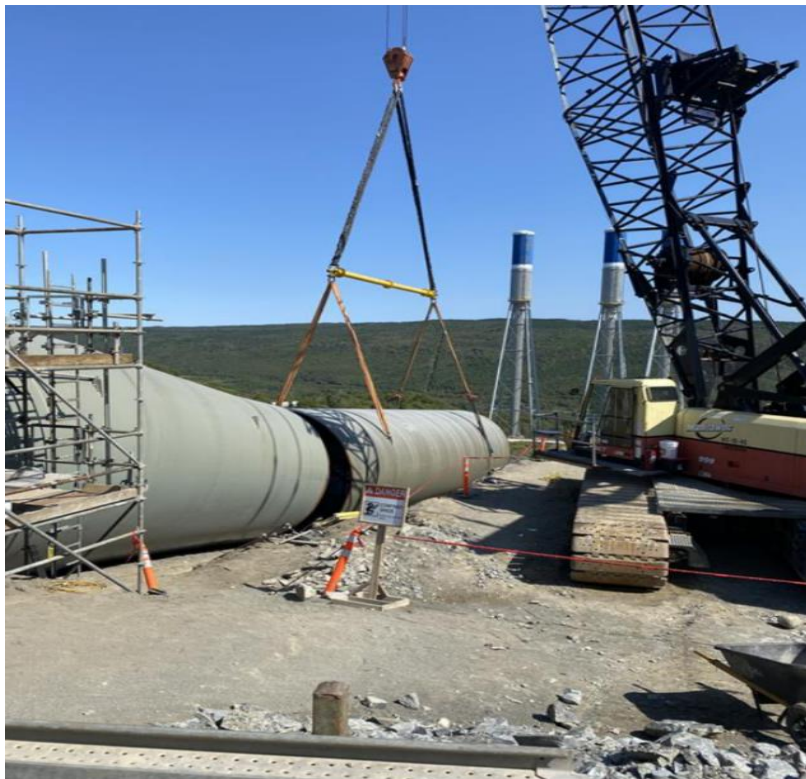
**Figure 1: Placement of Can 26**

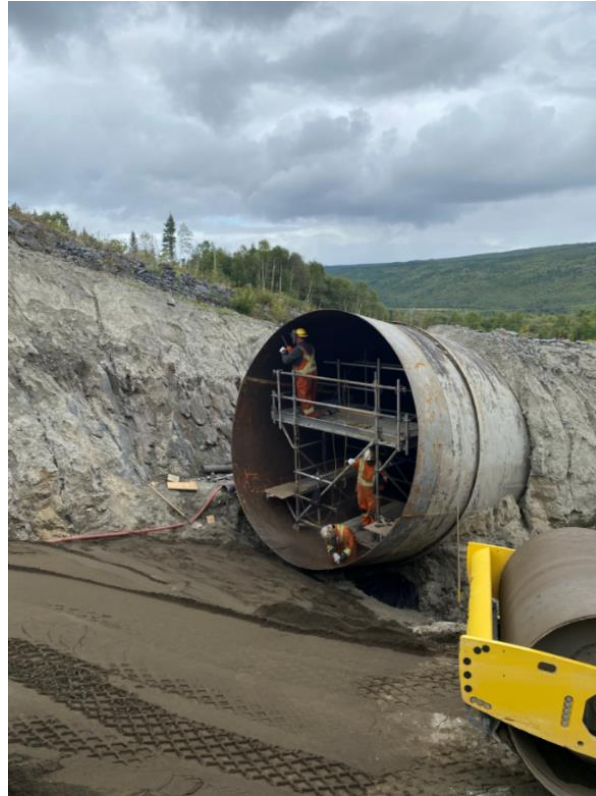
**Figure 2: Prepping Existing Penstock at Cut 2 for Can 28 Install**

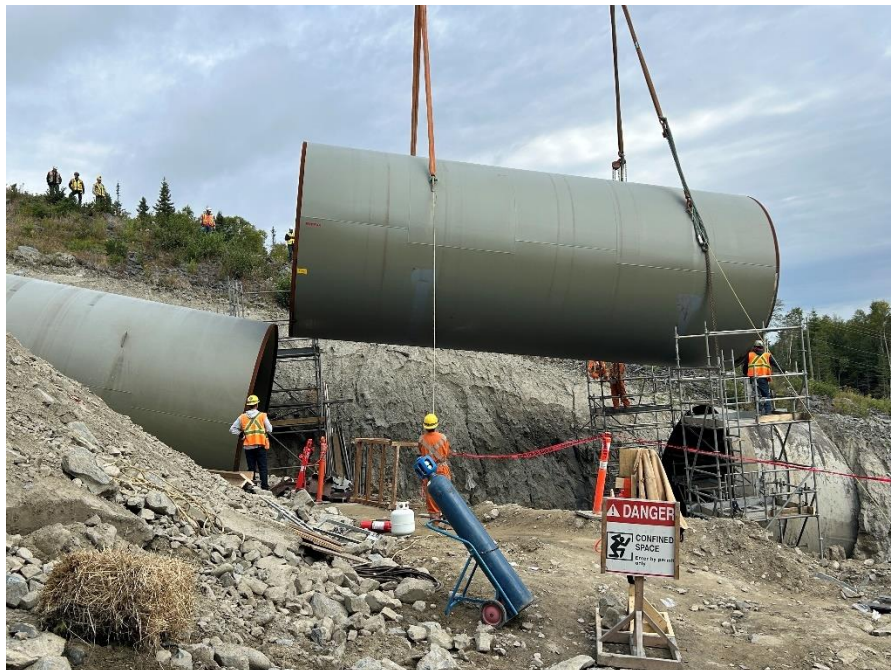
**Figure 3: Placing Final Can 28**

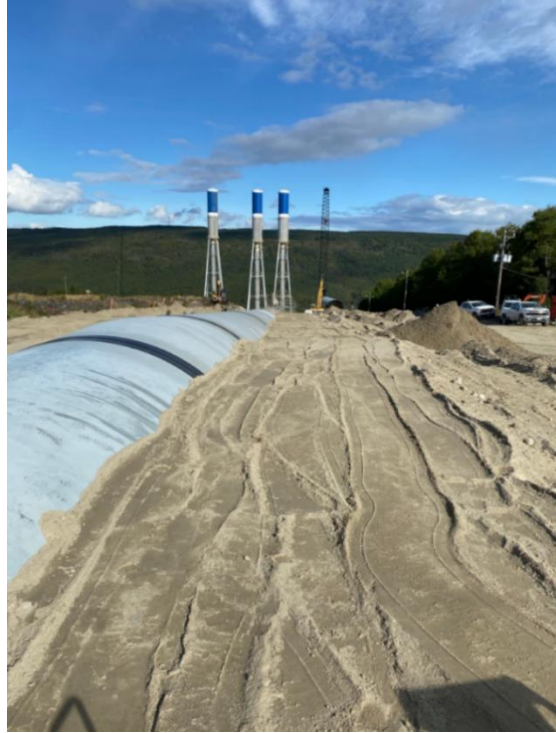
**Figure 4: Common Backfill Placement Near Can 14**

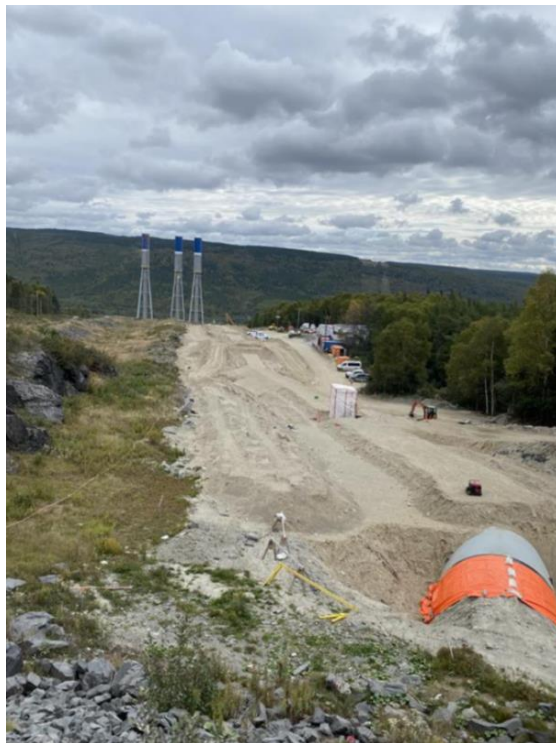
**Figure 5: Common Backfill Placement and Sloping**

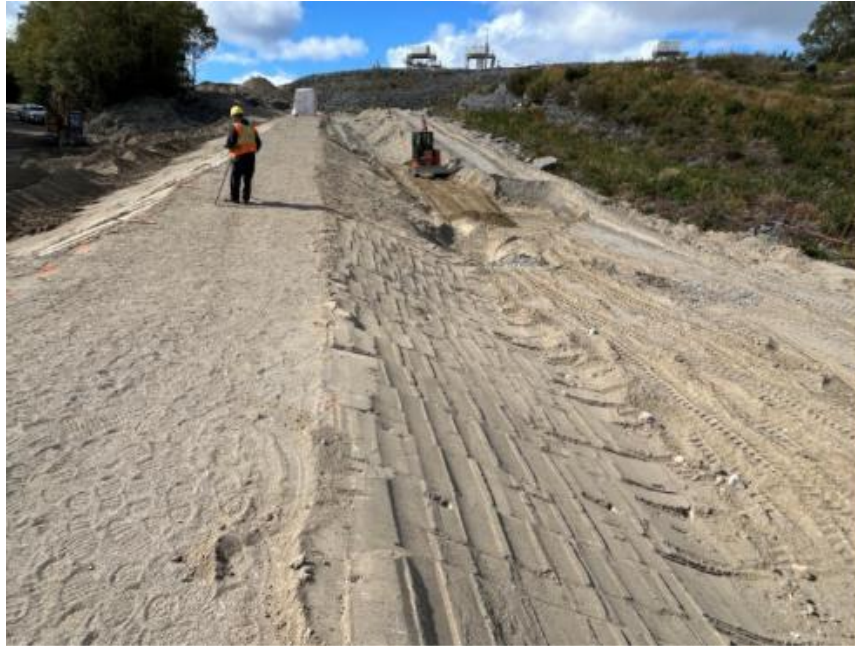
**Figure 6: Backfilling and Sloping to Final Grade**
