Re: An Application by Newfoundland and Labrador Hydro (Hydro) for the approval of the of the Refurbishment of Bay d'Espoir Penstock 2 and Bay d'Espoir Unit 3 Turbine Major Overhaul.

# **PENSTOCK NO. 2 INSPECTION AND EVALUATION**

## BAY D'ESPOIR HYDROELECTRIC DEVELOPMENT

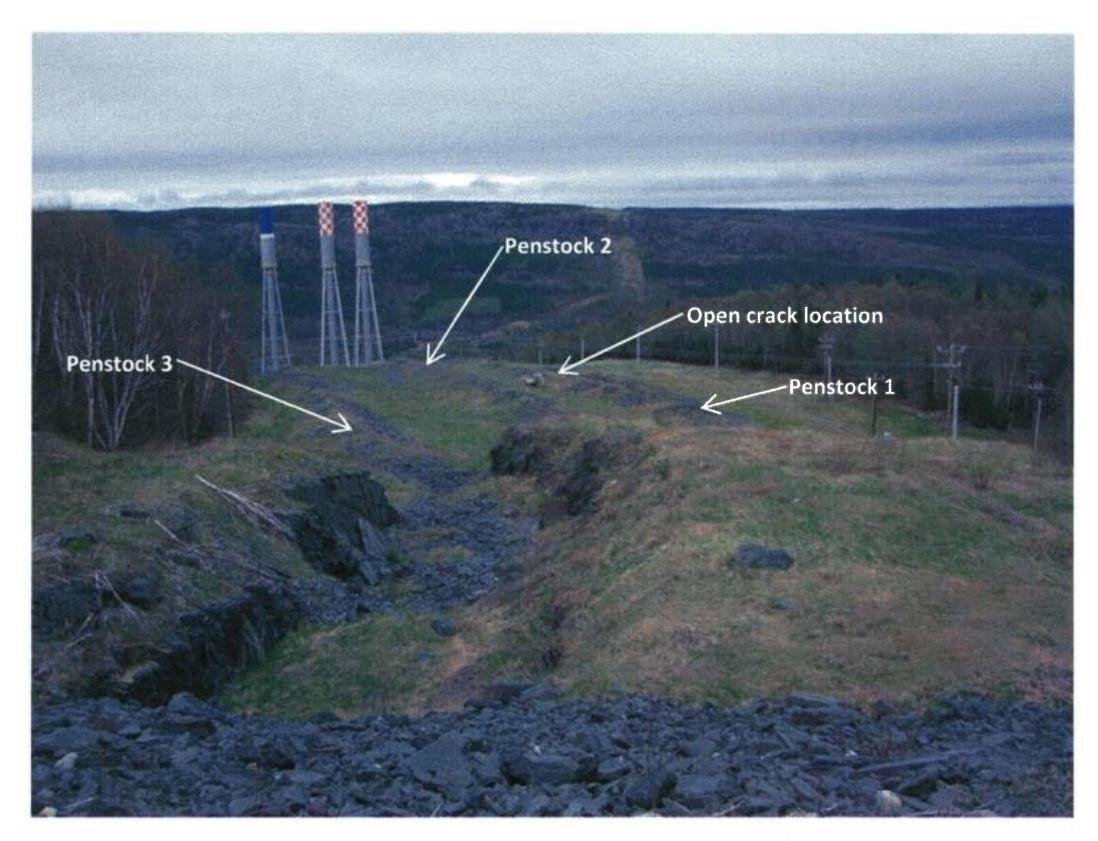
Photo 3: View of Penstocks 1, 2 and 3 as viewed from intake area

- 2 Once the September 2016 leak was discovered, Penstock 1 was taken out of service so as to
- 3 minimize further damage to the penstock and surrounding bedding support as well as
- 4 investigate the leak.
- 5
- 6 Preliminary investigation revealed an open crack in a horizontal weld of Penstock 1. The open
- 7 crack location is shown in Photo 3.

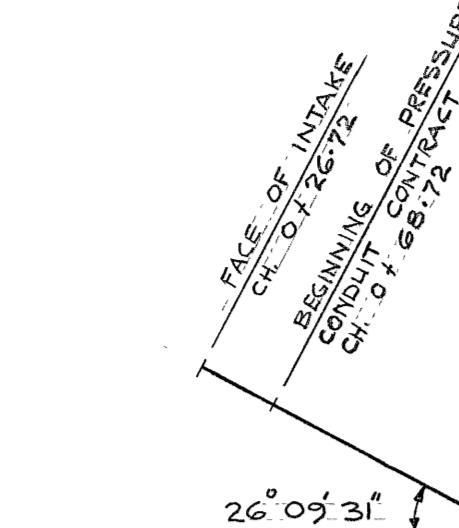
Please uncover a section of penstock near where arrows are shown. Goal is to uncover one section of plate for each original thickness. Recommend 1ftx1ft holes.

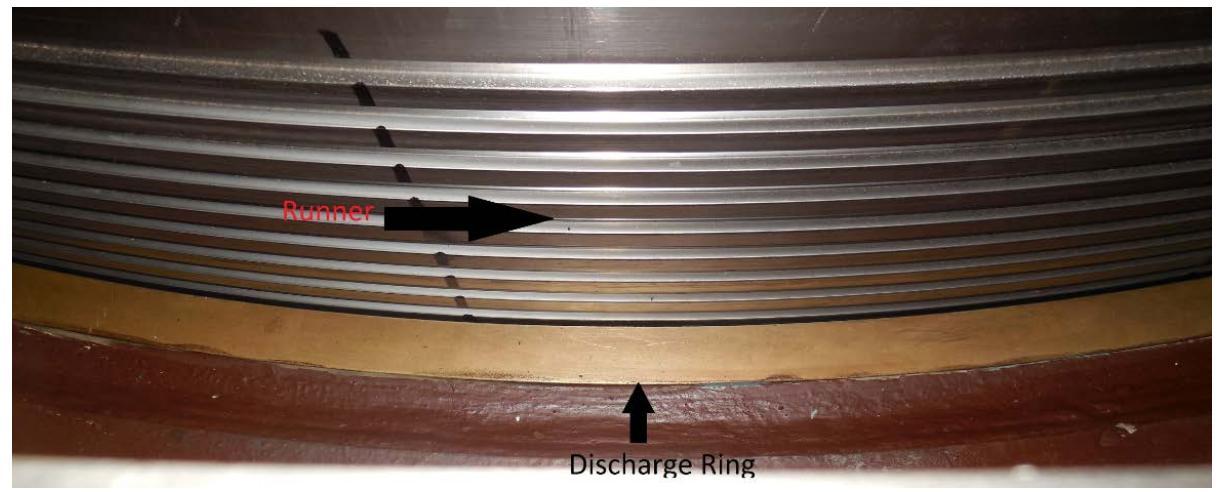
1 A critical item of condition based information in the assessment by Hydro is the seal 2 clearance measurements. The seal clearance is the distance between the stationary wearing 3 rings and the runner, Photo 4 (See Appendix A for a sectional drawing of a Bay d'Espoir 4 generating unit). Acceptable clearance distances are required for the reliable operation of 5 the turbine. It is normal for a turbine, which has operated for a long period of years, to 6 experience seal clearance loss. This loss can be caused by the rings suffering a wearing 7 phenomenon such as cavitation, corrosion, erosion, or distortion of the rings or the turbine 8 runner incurring axial movement due to bearing wear or misalignment. Unacceptable 9 clearances could result in inefficient operation and damage to the turbine.

Photo 4: Runner being lowered to sit next to the Discharge Ring.

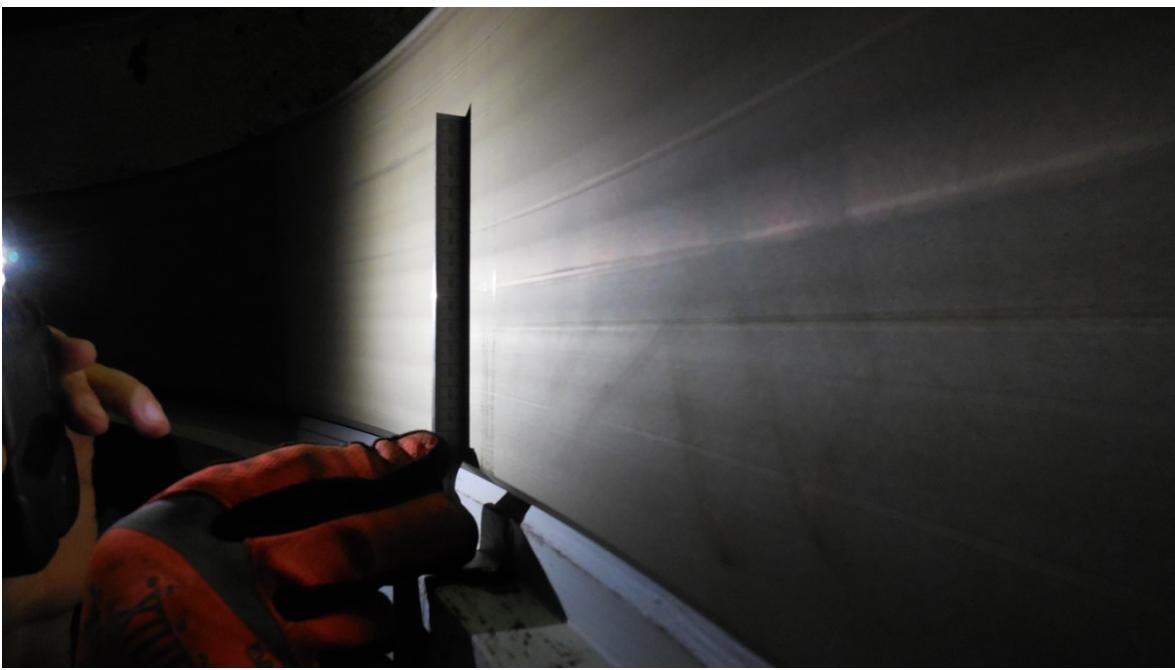
- 18 During the major overhaul of Unit 4, the runner seals and wicket gates were refurbished
- 19 and rehabilitation of concrete support for the turbine was performed. The level of
- 20 refurbishment required was more extensive than anticipated. Photos 5 and 6 show damage
- 21 and non-damaged sections of the discharge ring.

Photo 6: Non-Damaged Section of Discharge Ring
