Re: An Application by Newfoundland and Labrador Hydro (Hydro) pursuant to Subsection 41(3) of the Act for the approval of the replacement of a circuit breaker, insulators, synchronous condenser shaft seals and resistance rings, and level 2 condition assessments of the synchronous condensers, at the Wabush Terminal Station – Revisions

Appendix B: Voith 2015 SC1 and SC2 Annual Inspection Report and Recommendations

Voith 2015 SC1 and SC2 Annual Inspection Report and Recommendations

Nalcor Energy - Churchill Falls (Labrador) Wabush Terminal Station	
SC1 and SC2 Annual Inspection Report	PDM 2-01731078
	Revision -

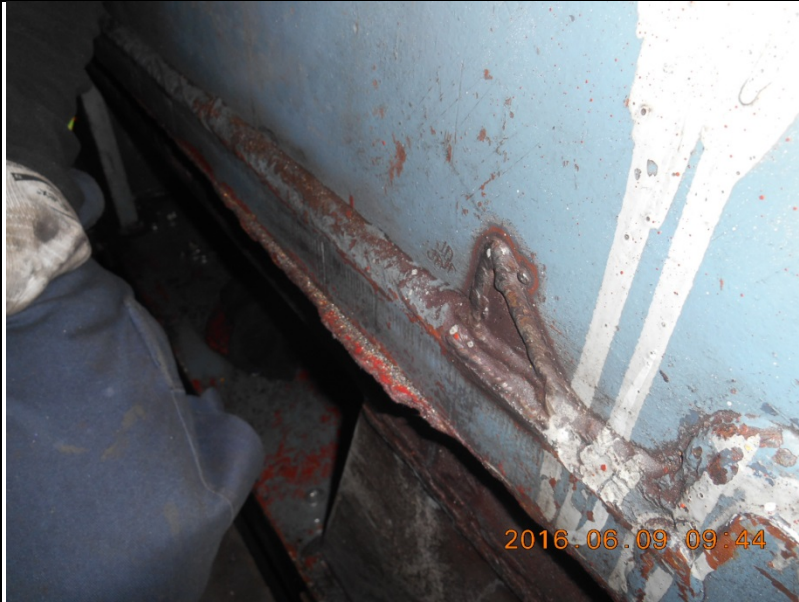
Externally, this unit is covered in a thin layer of oil, dirt, and small metal shavings in some areas. This is particularly prevalent on the bearing pedestals, which resulted in a 0 Ohm Megger reading on both pedestals until a thorough cleaning was performed around the pedestals and piping.

Fig. 3: Collector End Bearing Pedestal - Oil film and metal shavings accumulated on isolation pad

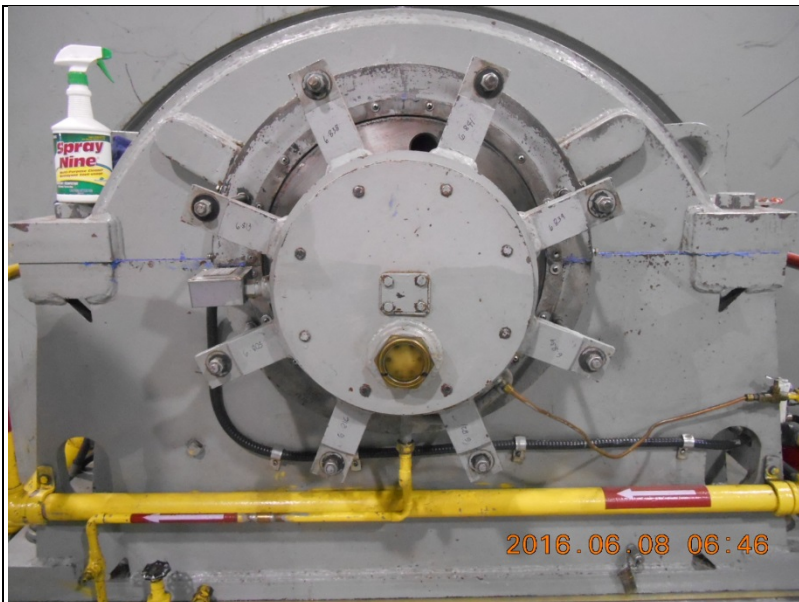
The As Found offsets between the pedestal face and the bearing housing are taken before removing the cover. These were recorded on the face of the bearing housing as can be seen in this photo.
CW from 11 o'clock (Pos 1)

- 1 – 6.838"
- 2 – 6.841"
- 3 – 6.839"
- 4 – 6.839"
- 5 – 6.821"
- 6 – 6.816"
- 7 – 6.825"
- 8 – 6.819"

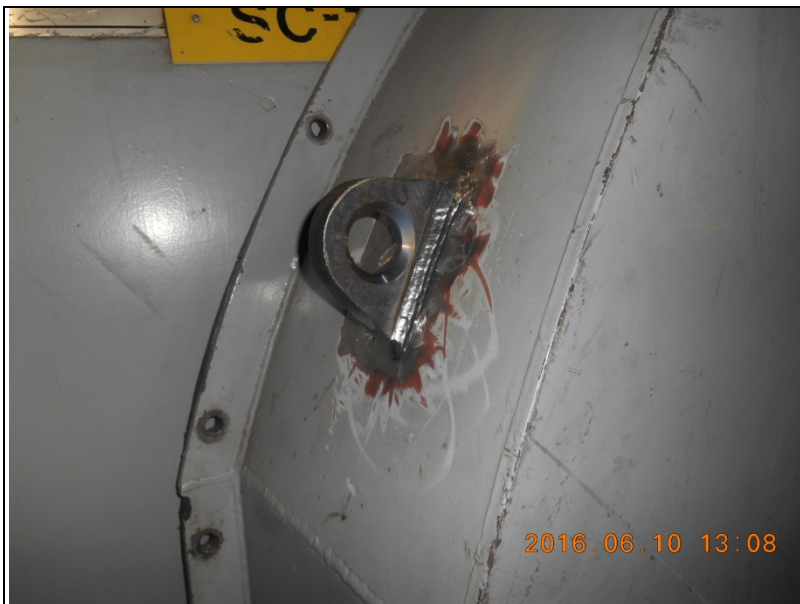
Fig. 27: New lifting lug installed

The lugs were manufactured to the original design of this unit OEM drawing #5-D-1845 item #2. They are welded in place with a 1/2" fillet around the circumference of the lug.

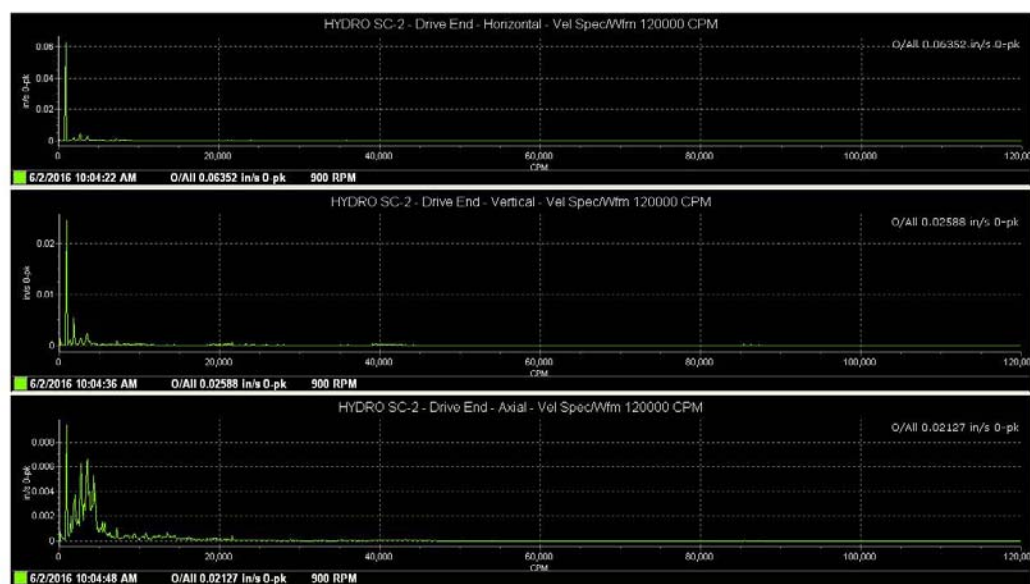
Fig. 33: Baseline Data NCRE

Baseline vibration data was collected prior to unit shutdown.

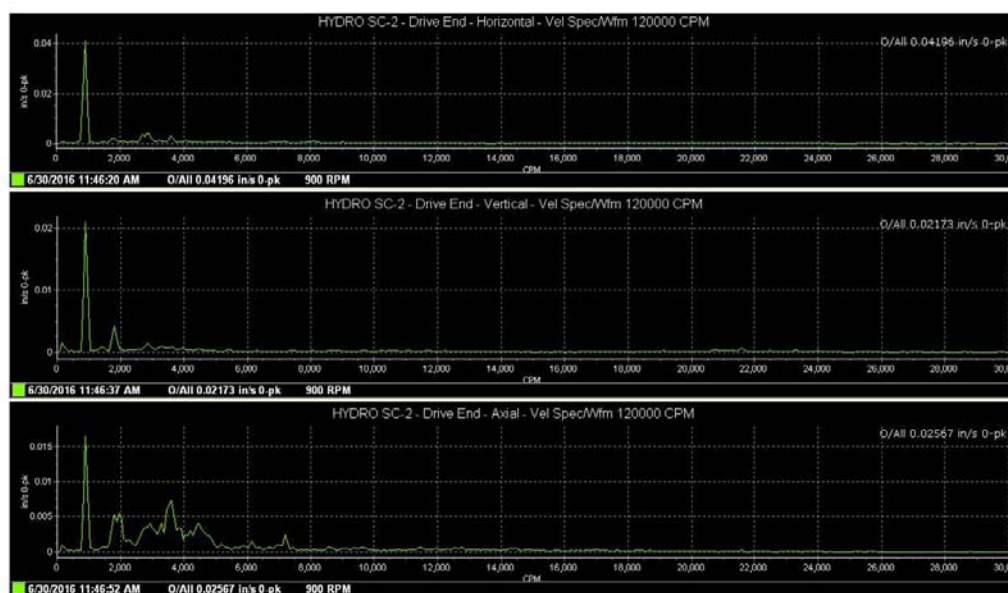
Fig. 35: Post Inspection Vibration Data CRE

Post inspection vibration data was collected after the unit was returned to service
