**Analysis of
Newfoundland Island Interconnected System
Power Supply Adequacy for the
Winter of 2018-19**

**The Board of Commissioners of Public Utilities
Newfoundland and Labrador**

The Liberty Consulting Group

August 30, 2018

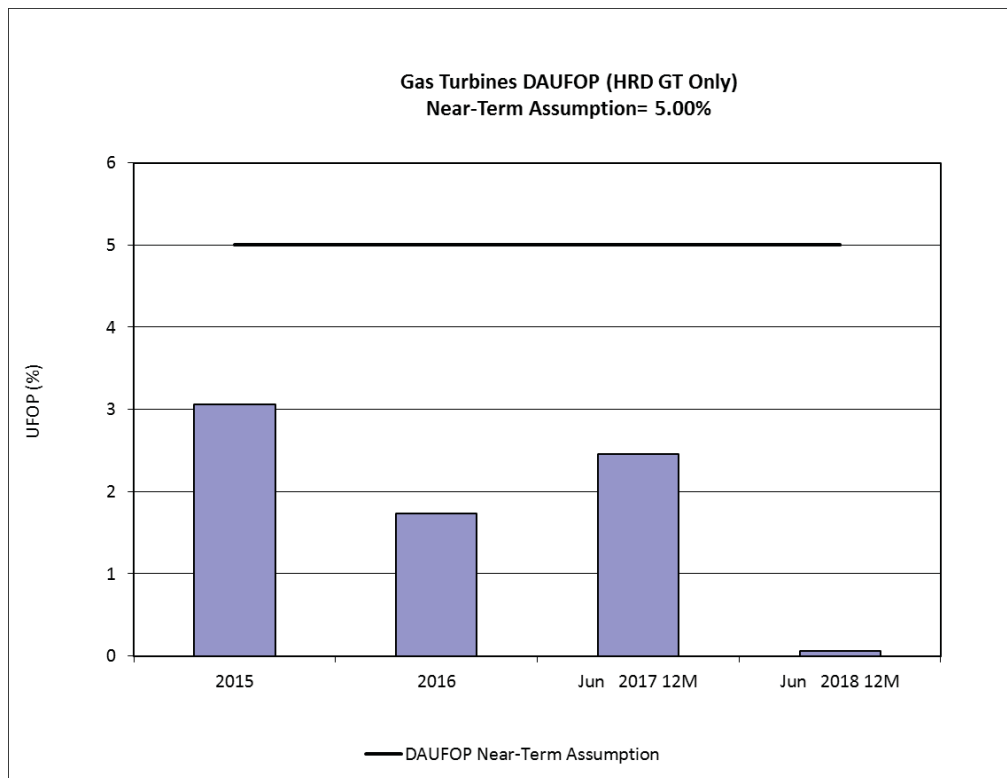
Figure 6: Gas Turbine DAUFOP – HRD Unit

1 The Stephenville gas turbine DAUFOP for the period was impacted by the unavailability of End A
2 as a result of an exhaust bellows failure at Hardwoods gas turbine End A on December 28, 2017.
3 End A was unavailable at this time due to issues with the power turbine rear bearing which
4 requires the bearing to be replaced. Hydro decided to remove the bellows from End A at
5 Stephenville and install it at Hardwoods End A to return that Unit to full capacity. It is currently
6 expected that the Stephenville gas turbine will be returned to full capacity in August 2018.
7
8 The Hardwoods gas turbine DAUFOP for the period is impacted by the unavailability of End A
9 due to an exhaust bellows failure on May 28, 2018. End A remains unavailable with a planned
10 return to service at the end of July 2018.
