1 **Q. Re: Tab 4.4 - Rebuild Distribution Lines Update – Stainless Steel Pole Mounted**
2 **Transformer Hanging Brackets**

10
11 Attachment B includes the metallurgical report titled Failure Analysis of a Transformer
12 Bracket dated January 6, 2004.

16
17 Attachment D includes the report titled Transformer Mounting Bracket Failures Analysis
18 Report dated April 24, 2008.

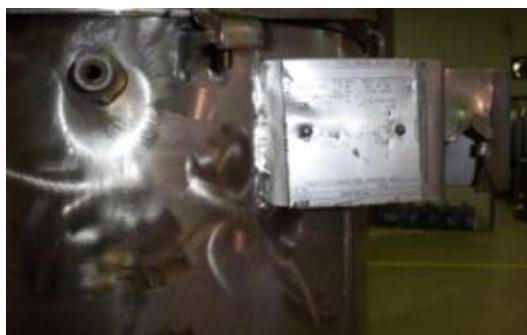
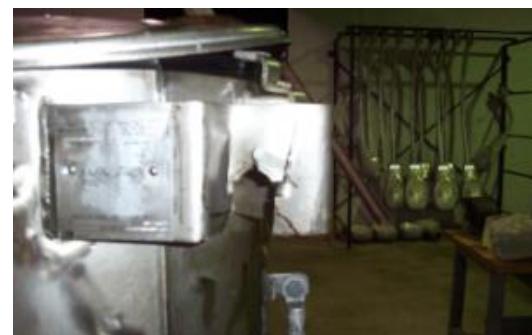
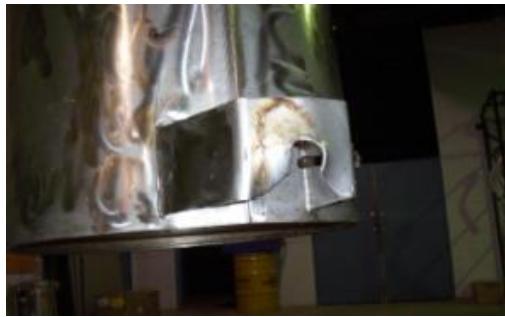
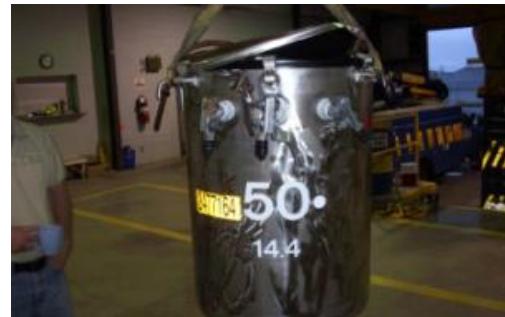
Attached are a few pictures of a 50 kVA ABB transformer manufactured in 2002 and installed in our Southern Harbour area. The transformer fell from the pole this past weekend. We have had discussions on several occasions in the past on our concern with the thickness of the hanger brackets. In 2003 and 2006 we provided pictures and transformers with broken hanger brackets. Both of these were also 50 kVA units and the transformers were removed from the pole without incident. The latest incident this weekend and the potential for major injury to the general public as well as negative public relations has caused us great concern. It has raised questions as to the integrity of the brackets on transformers presently installed in the field to the point that we may have to identify and remove these units from service for fear of bracket failure in the future.

>Here is the pictures of the transformer that fell out of the pole in Southern Hr.
>
>Manufactures date is May 2002.

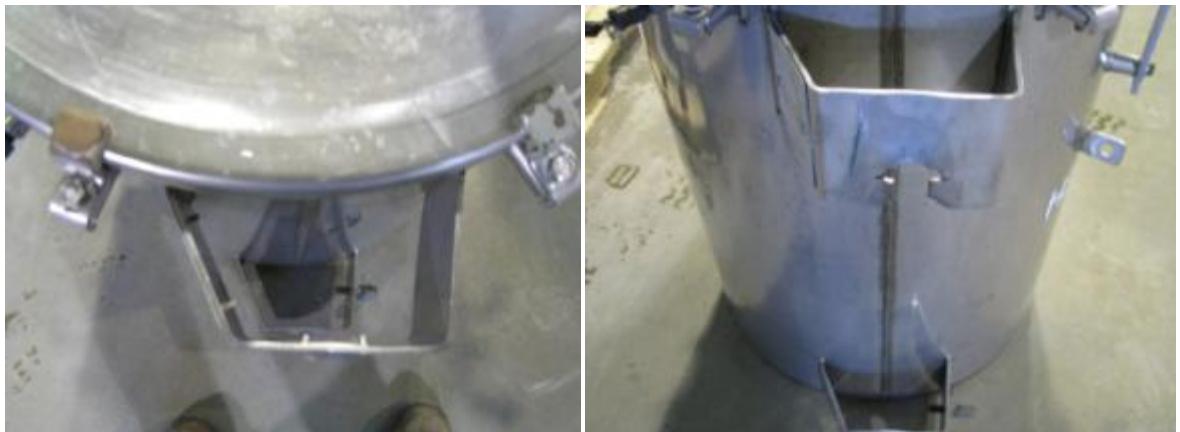
The transformer is being held in stores pending inspection by Distribution Standards.

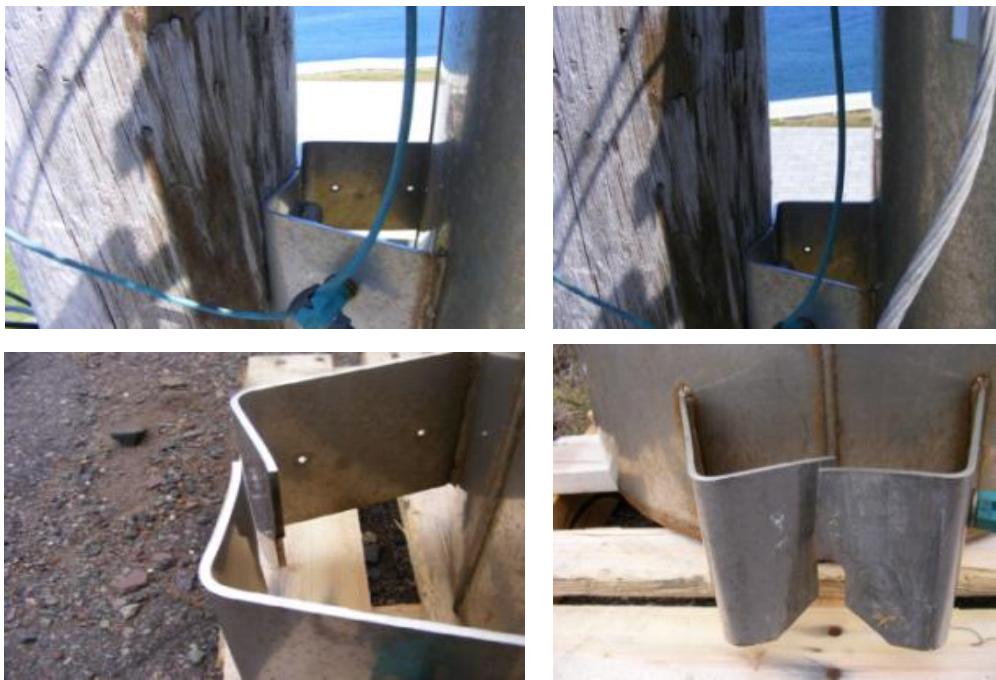
Attached are a few pictures of a unit found during our inspections with a broken lower bracket.

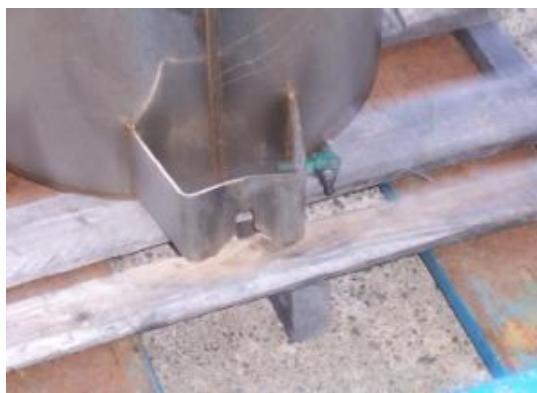
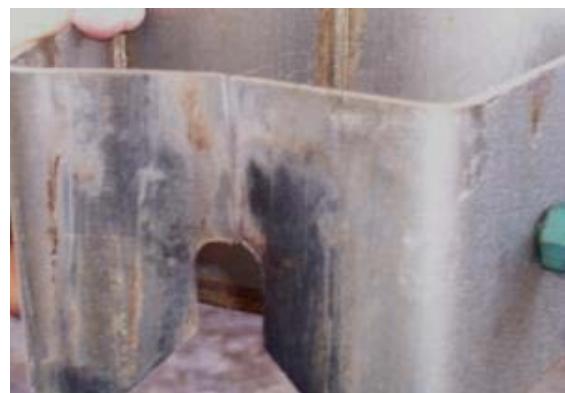
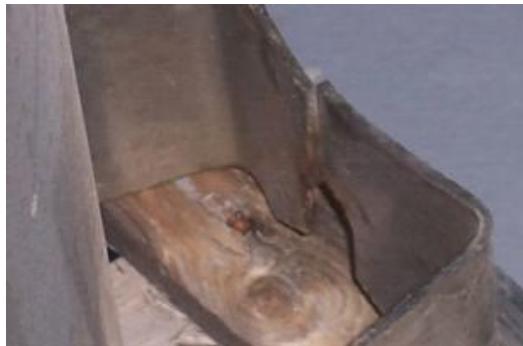
Also this transformer had the thick mounting bracket.

From: Keough, Robert
Sent: Thursday, January 15, 2009 3:14 PM
To: Moore, Geoff; Keating, Barry
Subject: Broken transformer.. 50 kva.

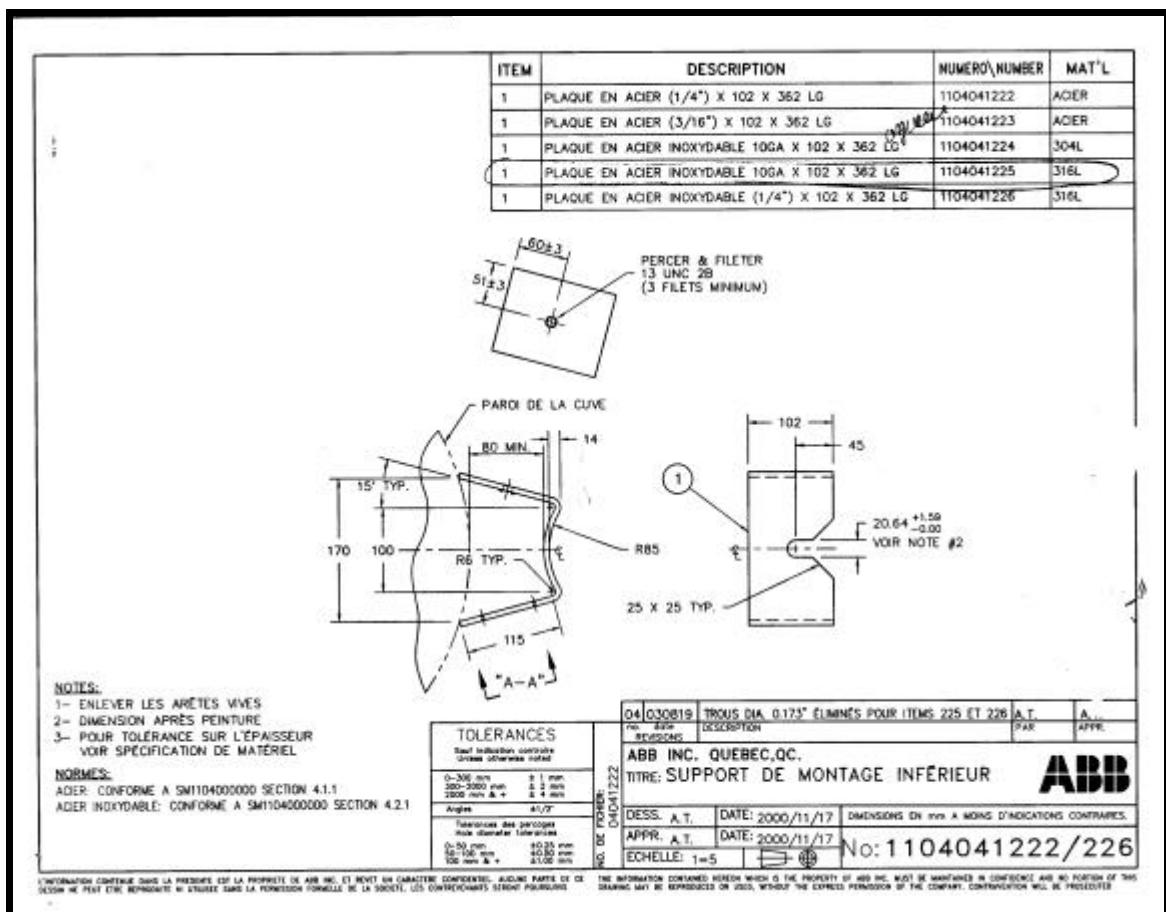
FIGURE 2
 Brackets Technical Drawing

The mounting bracket must be made according to drawing N°1104041222/226 specifications (Figure 2). It can be noticed from the item description that five different parts can be made by changing the material and the sheet thickness.

According to the mill test furnished by A.B.B., the sheet metal used to fabricate the studied sample is type 316L stainless steel gage 10. Hence, the sample part number would be 1104041225.

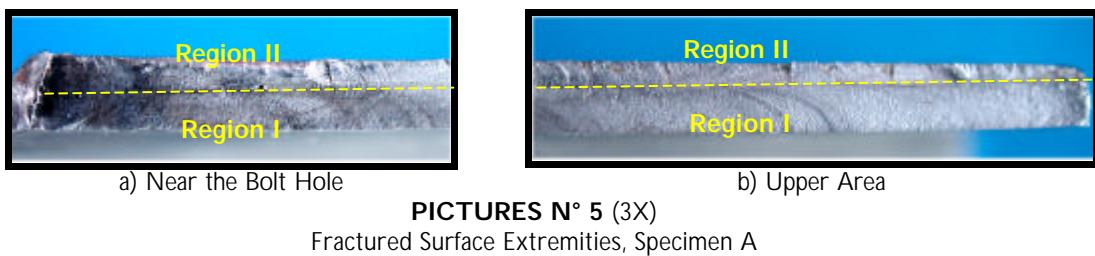
Preliminary observations of the ruptured surfaces gave much information. First of all, both surfaces show two distinct regions dividing the plate thickness. The region emerging to the plate surface transformer side, is called region I. The region emerging to the plate surface pole side, is called region II (See pictures n°1 and n° 3 for general views). It can be noticed that region II makes about half the plate thickness near the bolt hole (Bottom of pictures n° 4.) However, at the top of the pictures it makes about $\frac{1}{4}$ of the plate thickness. This can clearly be observed from pictures n° 5 taken at higher magnifications.

This particularity gives an indication that the stress applied on the part was not uniform through its width. It will be discussed in more details in section 3.2.1.

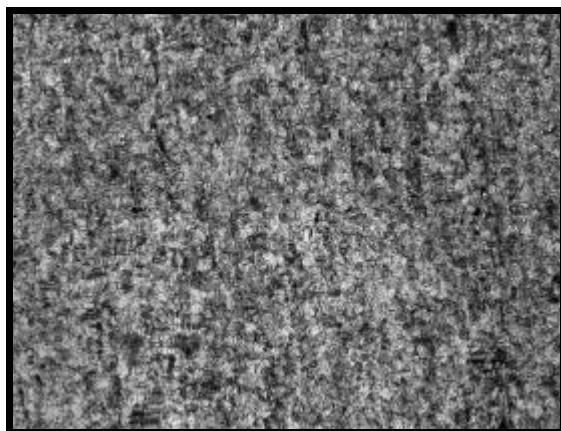
PICTURES N° 9
Specimen B Microstructure

The samples were polished and etched with marble. Their microstructure is typical of a type 316L stainless steel. It is composed of one phase only, austenite. When looking at a plan parallel to the plate surface, picture n° 9a, the grain are equiaxed and the structure is homogeneous. However, the microstructure of the transversal section bears sign of sheet forming. Its banded structure is typical of laminated products. One particularity could also be confirmed by metallographic examination. The material around the bolt hole was significantly deformed (Picture n° 10).

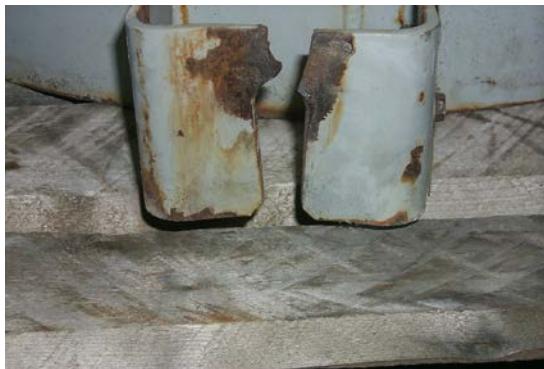
In 1999, a 50 Kva transformer made of mild steel manufactured by ABB London in 1992 fell from a pole. The hanger brackets were made of mild steel.

Verification of design conformity to CSA C2.2

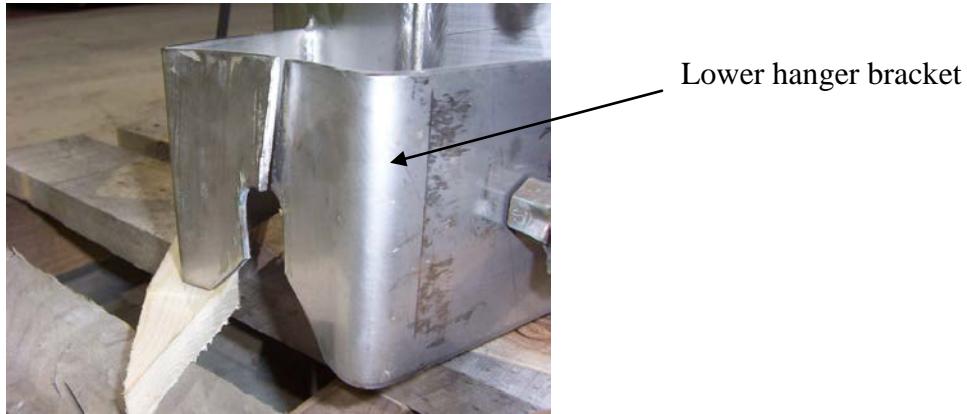
In July 2003, a 50 Kva transformer made of stainless steel 316L installed in February 2003 was removed with the lower hanger bracket broken. The hanger brackets were made of 10 GA (0.140") thickness SST 316L. During the same period a transformer from another supplier, installed in the same location fell from a pole.

Investigation

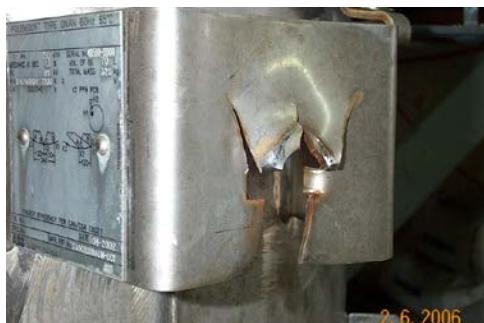
In June 2006, a 50 Kva transformer made of stainless steel 316L manufactured in June 2002 having a failure at the upper mounting bracket was discovered in service and removed before a total failure of the brackets. The hanger brackets were made of 10 GA (0.140") thickness SST 316L. The transformer was shipped back to ABB for repair. The transformer was replaced by a new one. No investigation report was performed on this specific case.

- Mr. Cliff Rose explained to ABB his concerns regarding the hanger bracket. He stated that the existing bracket design will not withstand the wind loading in Newfoundland environment and asked for alternatives to this ongoing problem.

ABB, based on NP comments started to supply a thicker hanger bracket on transformers up to 50 Kva, no amendment has been added in Newfoundland Power specification. ABB has been supplying thicker material at the beginning of new contract in January 2007, increasing the thickness of brackets from 10 GA (0.140") to 3/16" (0.1875").

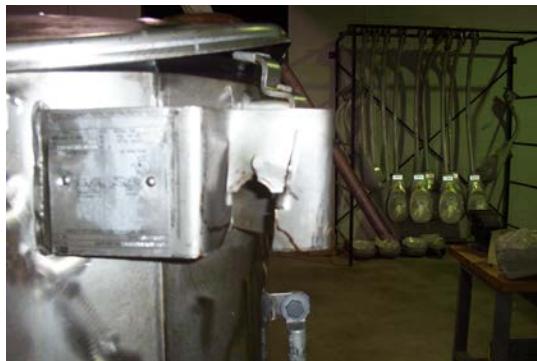
In October 2007, a 50 kva transformer made of stainless steel 316L manufactured in May 2002 fell from a pole. The hanger brackets were made of 10 GA (0.140") thickness SST 316L. The investigation is under way.

Investigation

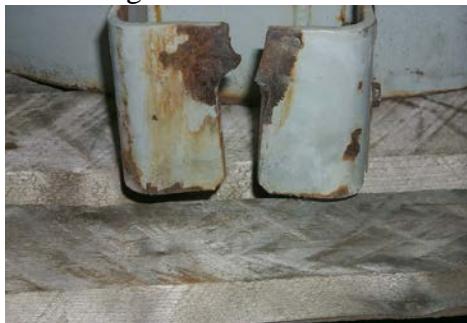
A 50 Kva transformer made of mild steel manufactured by ABB London in 1992 fell from a pole. The failure occurred at the upper mounting bracket. The mounting brackets were made of mild steel 7 GA (0.179").

Total weight of the transformer: 280 kg

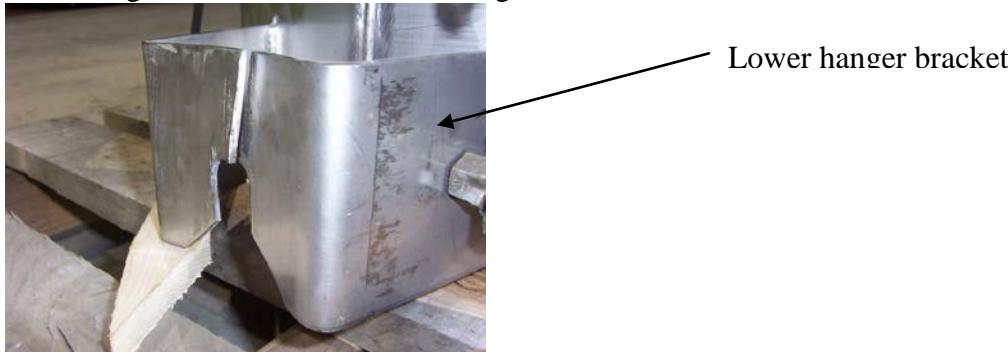
3.2 Reported in July 2003

A 50 Kva transformer made of stainless steel 316L installed in February 2003 was removed with the lower mounting bracket broken. The mounting brackets were made of 10 GA (0.140") thickness SST 316L. During the same period a transformer manufactured from another supplier, fell from the same pole.

Total weight of the transformer: 330 kg

Macroscopic observations made it possible to state that the part failed in two (2) steps under dynamic solicitation. Microscopic observations gave many indications that bolt tightening probably accelerated failure. Many cracks initiated around the bolt hole. Moreover, the bracket was scratched and deformed in that specific area. Finally, vibrations are probably responsible for fatigue propagation of the cracks.

A washer should be installed between the bolt and the bracket to give a more uniform tightening and to protect the bracket surface. Moreover, a maximum tightening torque should be proposed by design engineers to avoid, over stressing the part. Concerning the dynamic load applied on the bracket, it is probably caused by system vibrations and wind. The pole on which the transformer is installed could be inspected for abnormal movement.

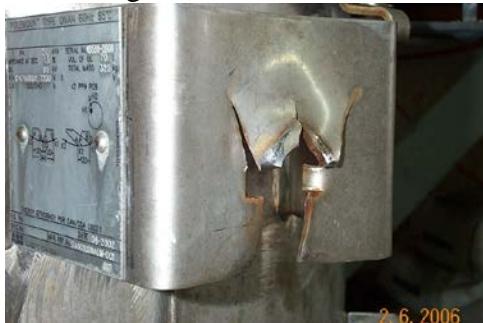
3.3 Reported in June 2006

A 50 Kva transformer made of stainless steel 316L manufactured in June 2002 having a failure at the upper mounting bracket was discovered in service and removed before a total failure of the brackets. The mounting brackets were made of 10 GA (0.140") thickness SST 316L.

Total weight of the transformer: 330 kg

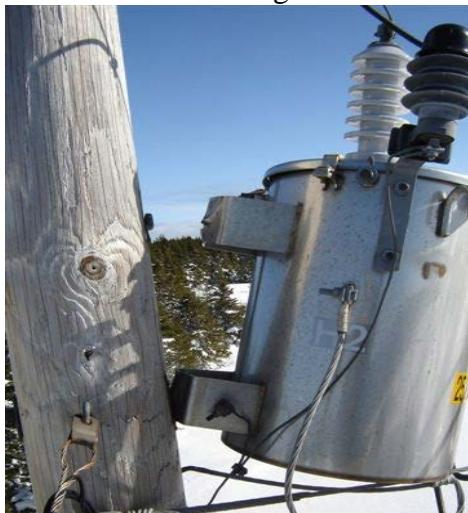
3.6 Reported in March 2008

A 25 Kva transformer made of stainless steel 316L that was manufactured in March 2003 was discovered with upper and lower mounting brackets distorted. The mounting brackets were made of 10 GA (0.140") thickness SST 316L. Total weight of the transformer: 200 kg
