1	Q.	Provide a description of Hydro's preventive maintenance plan as it relates to the
2		inspection of boiler tubes including but not limited to:
3		i. the schedule for the testing of the various boiler tubes (broken down by
4		specific areas) at the Holyrood Thermal Generating Plant;
5		ii. the last recorded preventive maintenance testing of the boiler tubes for Unit
6		1 and Unit 2; and
7		iii. the results of the last recorded preventive maintenance testing or of any
8		other testing that occurred.
9		
10		
11	A.	Boiler Tube Description
12		Holyrood boiler tubing can be classified as tubes containing feedwater
13		(economizer), tubes containing steam (superheat and reheat) and waterwall tubes.
14		Feedwater tubing is located in the boiler just before the exhaust gas leaves the
15		boiler and preheats the water to be turned into steam. The superheat and the
16		reheat tubing are located in the upper parts of the boiler and is where the steam

PUB-NLH-001, Attachment 2

#### METALLURGICAL DWD REPORT

Representative:	David Gosse	Plant:	NL Hydro
		Location:	Holyrood, Newfoundland and Labrador,
			Canada
		Unit:	1
		Report No.:	2013-0187-1
		Report Date:	July 3, 2013
		Sample Date:	M

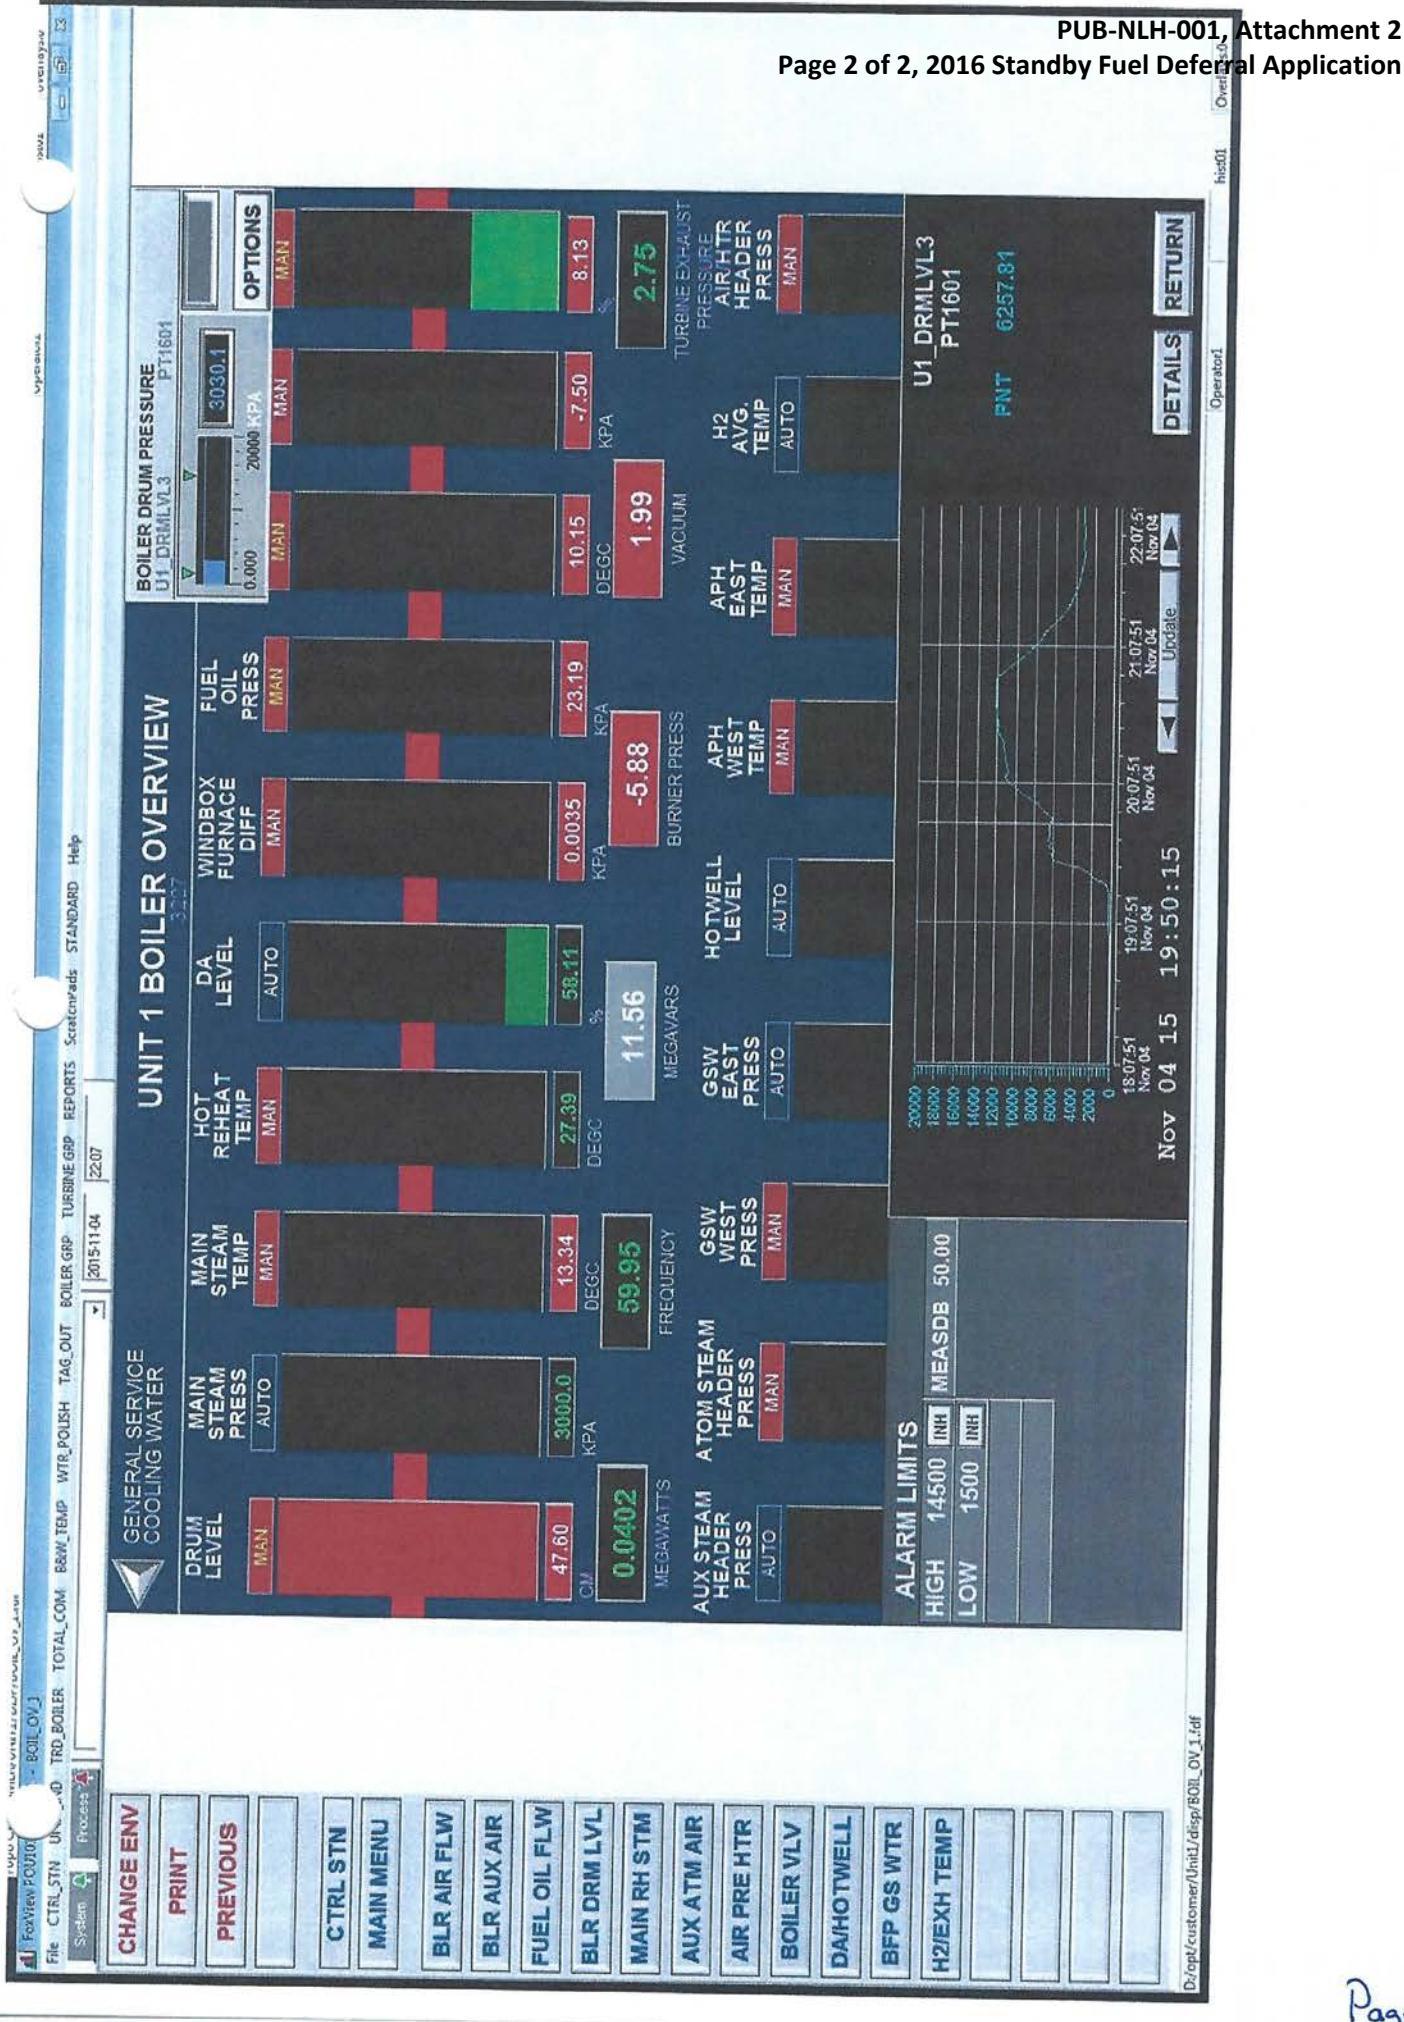
The Unit was hydrostatically brought up to approximately 12,000kPa and the internal pressure was held for roughly 30 min. While the Unit pressure was rising B&W Representatives Kris Jacobs and Shaun Lingley, performed internal visual inspections on all accessible elevations, as well as inspections where external work was performed during the 2015 Maintenance Outage, no leaks were detected. The unit was then depressurized and returned to NL Hydro operations.

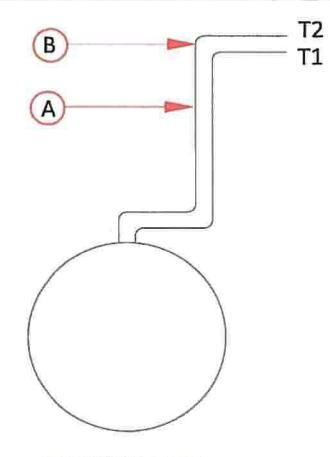
LOOKING EAST

newfoundland labrador	UNIT #1 - BOILER						
a nalcor energy company	PRIMARY SUPERHEATER						
NDE SHEET No 1-25.2 (pg. 2), Rev. 1	1	Inspector's Name:	SID RANSO	ave			
NON-DESTRUCTIVE EXAMINATION							
MAINTENANCE FILE NUMBER 102-05-1-17		Inspector's Signature:					
K		Date of Inspection:	AUG. 20	2015			
Area of Boiler and General Description of Non-			/				
Destructive Examination to be Performed	TUBE	(A) U.T. READING (in.)	(B) BENDS - U.T. READING (in.)	COMMENTS			
		0,180	0.160				
	.5	0.173	0.158				
	10	0.176	0.168				
	15	0.180	0.167				
	20	0.181	0.163				
	25	0.178	0:164				
	30	0-177	0.161				
Diana Caralanta Talan	35	0,181	0,159				
Horizontal Spaced Lower	40	0.178	0.157				
Assembely, east to west 8th Floor	45	0.173	0.153

1.) U.T. Inspection on the tubes	50	0.179	0,1.58				
Superheater inlet header (SH-2) -	55	0.182	0.163				
SEE DRAWING FOR DETAILS	60	A 181	0.166				
	65	0,176	B.1.59				
	70	0.179	0.162				
	75	0,177	0.1.57				
	80	0.182	0161				
	95	01100	0.167				
	Q A	0.180	0 160				
Economizer	93	0.179	0.158

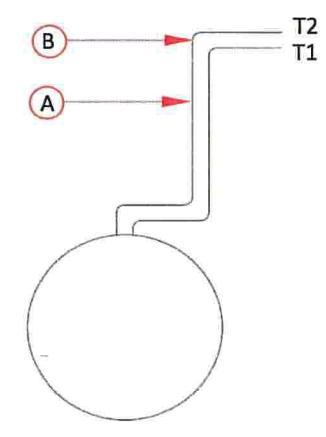
LOOKING EAST

1 hudro	UNIT #2 - BOILER						
a nakor energy company	PRIMARY SUPERHEATER						
NDE SHEET No 2-25.2 (pg. 2), Rev. 1		Inspector's Name:	S.RAPSO	ME			
NON-DESTRUCTIVE EXAMINATION				/			
USE ADDITIONAL SHEETS IF NECESSARY		Inspector's Signature:	1 - 10 th				
		Date of Inspection:	JULY 8,	2015			
Area of Boiler and General Description of Non-							
Destructive Examination to be Performed	TUBE	(A) U.T. READING (in.)	(B) BENDS - U.T. READING (in.)	COMMENTS			
	/	0.181	0.160				
	.5	0.185	0.162				
	10	0.184	0.164				
	15	0.187	0:160				
	20	0.190	0,159				
	25	0.192	0.168				
	30	0.188	0.155				
Drimons Superheater Tuber	35	0:191	0,158				
Horizontal Spaced Lower	40	0.192	0.163				
Assembely, east to west 8th Floor	45	0.187	0:160

1.) U.T. Inspection on the tubes 5ft, above the Primary	50	0.185	0.168				
Superheater inlet header (SH-2) -	55	0.189	0.163				
SEE DRAWING FOR DETAILS	100	0.191	0:167				
	65	0.182	0.160				
	70	0.191	0.168				
	75	0:192	0,165				
	80	0.194	0:161				
	85	0.183	0.165				
	90	0.191	0.162				
Economizer	93	0.193	0.159
