Board Order No. P.U. 3(2014)
Investigation and Hearing into Supply Issues and Power Outages on the
Island Interconnected System

NEWFOUNDLAND AND LABRADOR HYDRO

Events of January 2013

January 11, 2013 Power System Outage Report

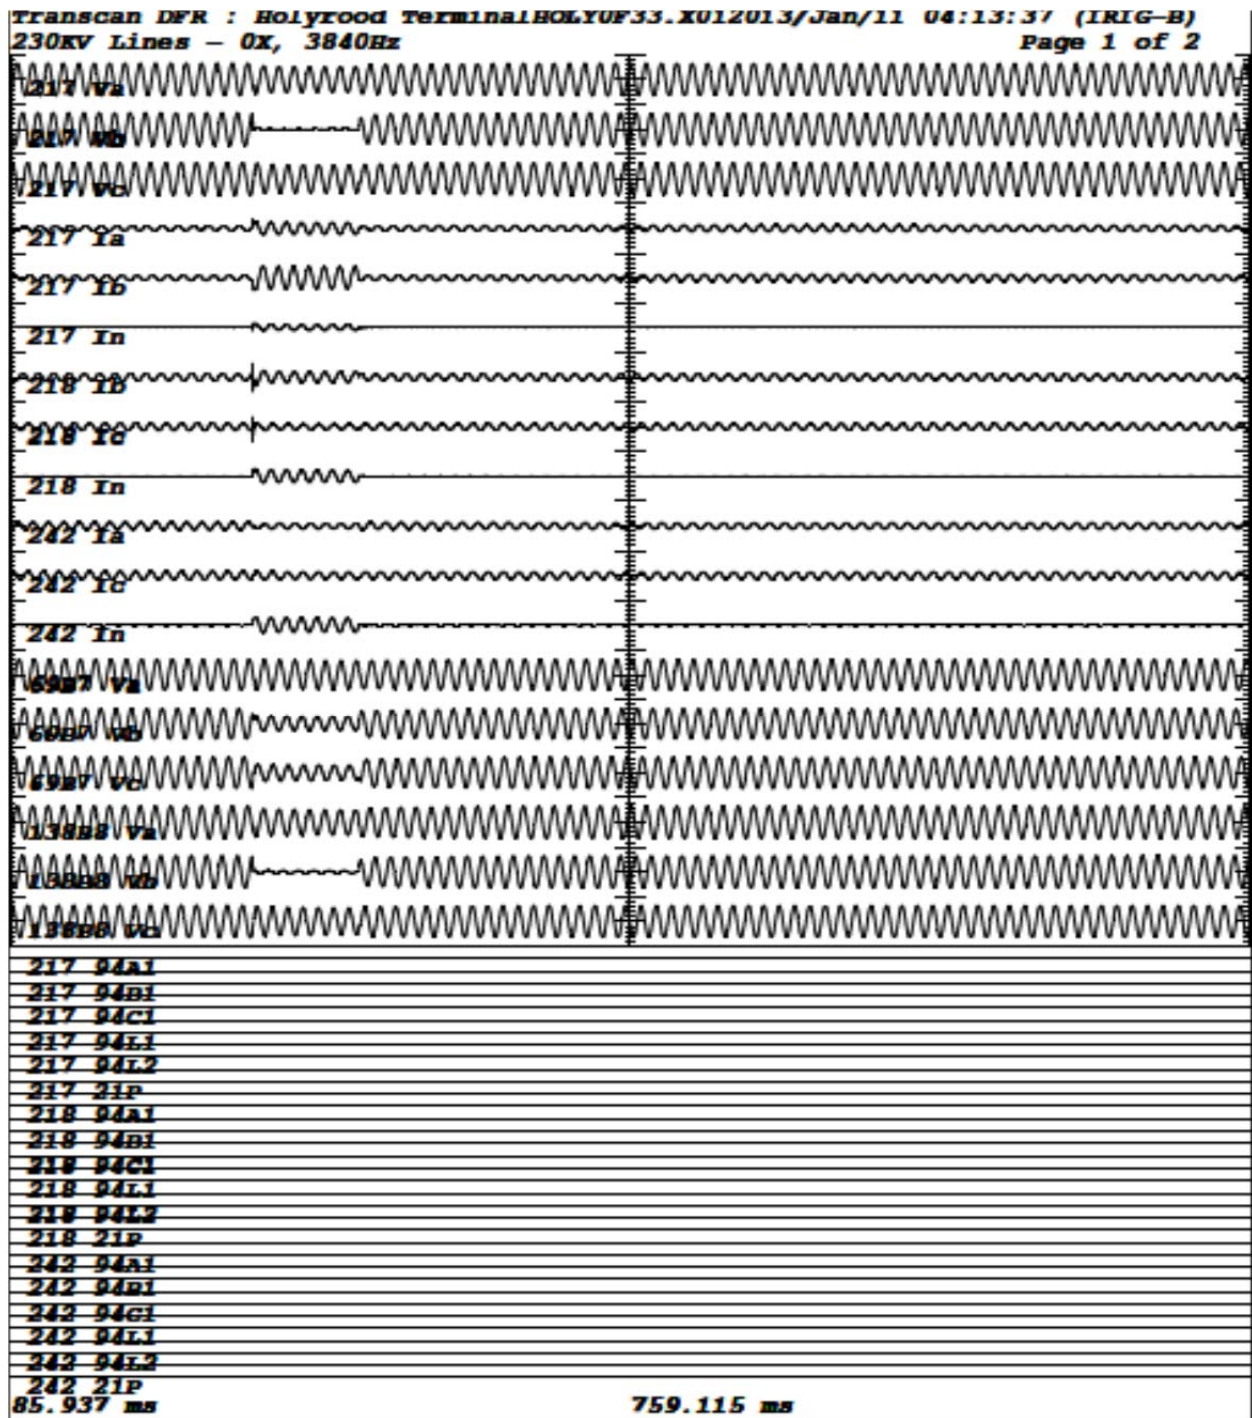
Figure 2-1: Holyrood DFR Trace at 0413 hours during Unit 3 Trip

The Holyrood DFR trace, Figure 2-1, for the event at 0413 hours follows. As indicated in the trace, there was a single phase 230 KV voltage depression (B-phase) to almost zero volts. Both 230 KV Unit 3 breakers B3B13 and B3L18 tripped and cleared the fault in seven cycles. There was no unit lockout operation recorded in the system SOE, however the Holyrood plant SOE indicated an operation of the Unit 3 lockout 86-2 which trips both unit breakers and shuts down the unit. Analysis of the fault data indicates that the fault was on the 230 KV line somewhere between the high side of the unit transformer and the unit breakers, most likely caused by the salt contamination of the station insulation which was prevalent, due to the high northerly winds in from the ocean.

- The plant SOE indicates operation of the Unit 3 generator lockout 86-2 but no lockouts were reported in the system SOE at this time. Therefore, a request to have the system SOE for this point and the other Unit 3 lockouts operation tested has been initiated.

- Internal plant trip reports for all unit trips should be completed by plant personnel and distributed to ensure that all systems worked as designed.

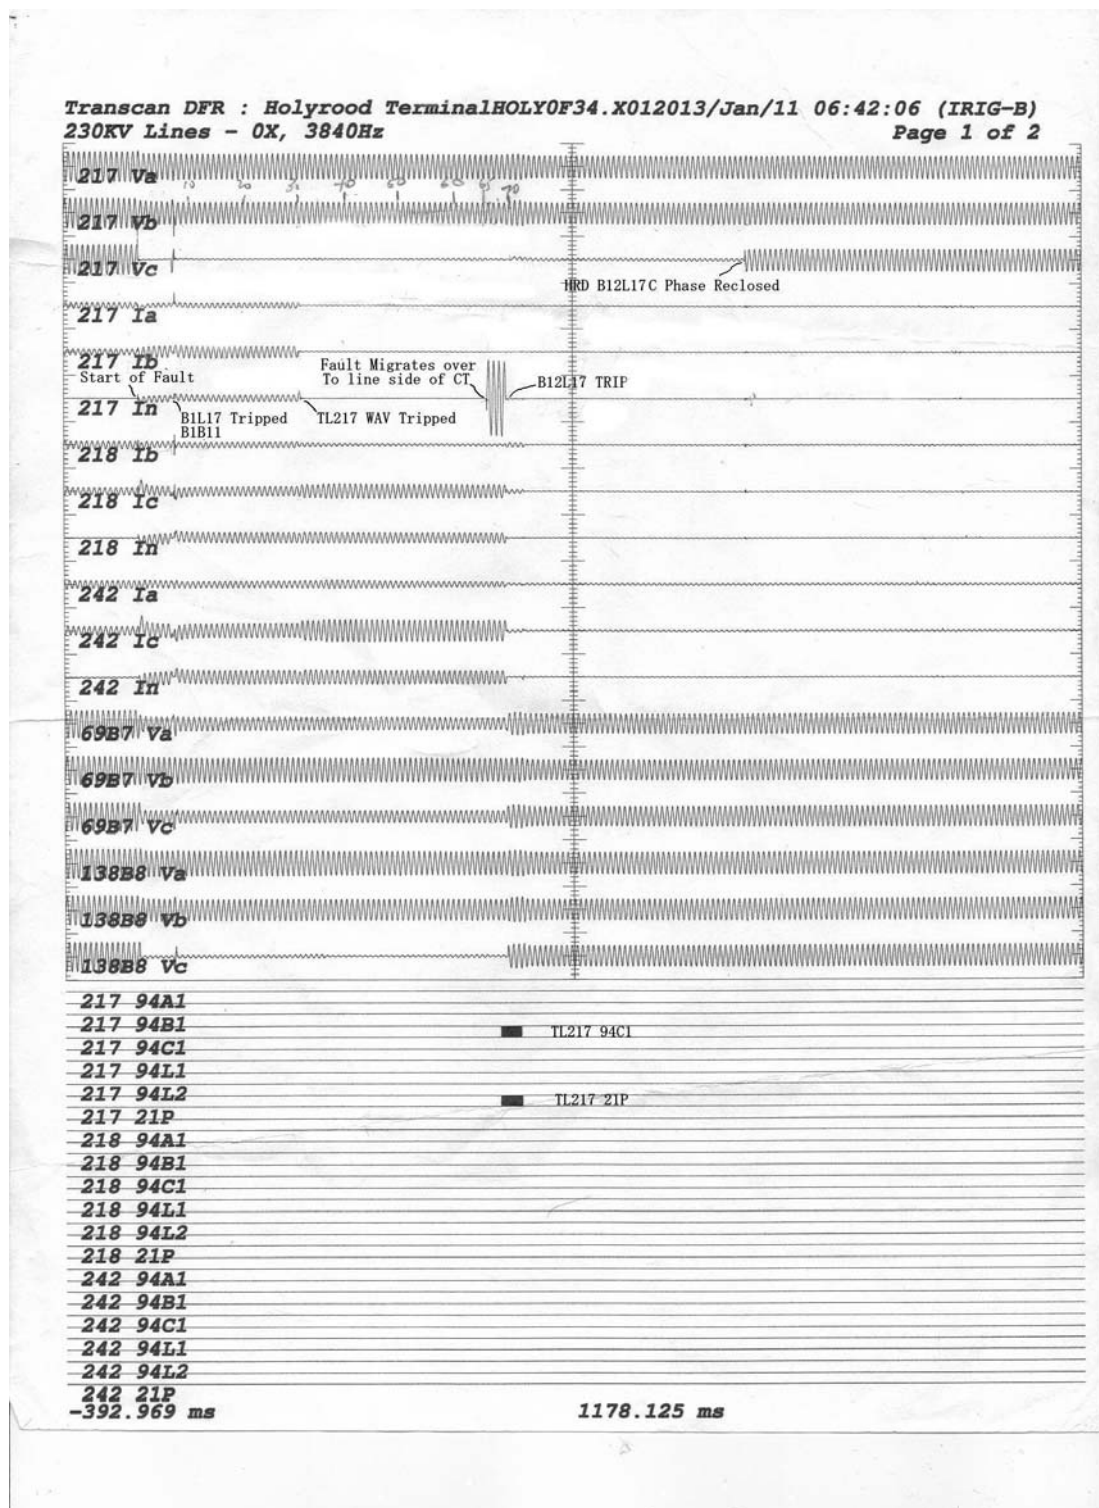
Figure 2-2: Holyrood DFR Trace at 0642 Hours during B1L17 Fault

Following the TL217 and Unit 2 trips, the 138 KV and 69 KV voltages rose significantly, indicating that the fault had now cleared. TL217 reclosed via B12L17 C phase at the Holyrood end at 112 cycles (44 cycles after tripping) and all voltages recovered at this point.

There was a fair amount of confusion in the analysis of this event as the open/close indication for Holyrood breaker B12L17 does not appear to be functioning properly. This may be an indication of issues with the auxiliary contacts on the breaker.

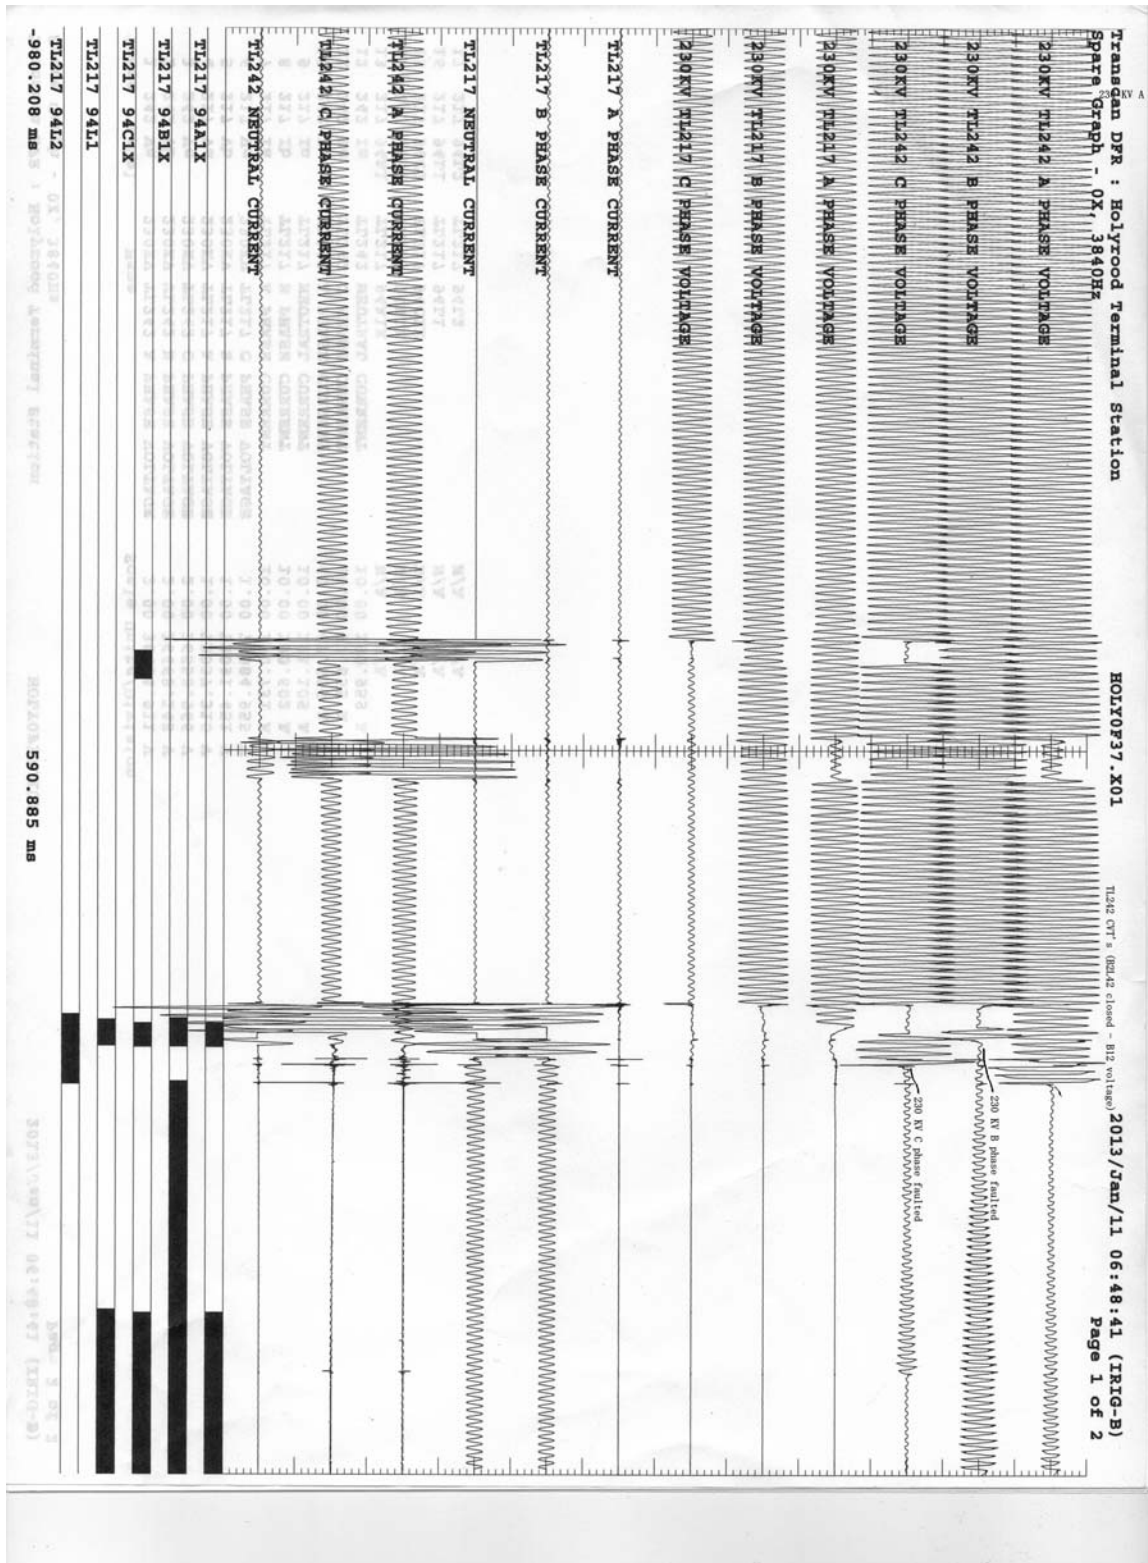
Figure 2-7: Holyrood DFR Trace at 0648 Hours Faults Showing TL242 CVT Voltages

230 KV in the vicinity of B12 causing a B-C ground fault. Figure 2-7 shows a current of approximately 230 A in the B12L17 CT supplied from the 66 KV into the B-C-ground fault. This figure also shows the TL242 CVT's voltages, connected to B12 via line breaker B12L42, collapsing when B and C phases faulted. This was followed by A phase flashing over approximately 2 cycles later. Figure 2-8 is a blow-up, showing voltages at the TL242 CVTs and the TL217 B phase current. All three phases were faulted.

At 88 cycles TL217 protection, P1 (Optimho), operated via the SOTF (switch on to fault) function which initiated B12L17 breaker failure protection. The latter timed out and tripped all connected breakers on the 230 KV bus B12 including breaker B12T10 which cleared the fault from the 66 KV system at 109 cycles. The 66 KV connection between Hardwoods and Holyrood remained in service until 23 seconds later when it tripped at the Seal Cove end via breaker SCV-38L-B due to overvoltage, this according to the NP SOE data.

- Once TL218 and TL242 tripped and the faults were supplied only from the 66 KV system (a weak infeed) and a 230 KV delta system, neither of the line protections operated. This was most likely due to the low fault current, approximately 230 A on the primary. The Schweitzer's LOP (loss of potential) function would have operated as the current was below 540 A (the current monitor 50M setting, below which the LOP operates with loss of the potential supply) and prevented any Schweitzer distance element trip. Similarly, the Optimho would have also identified a LOP but as the 230 KV voltage eventually increased (Figure 2-7), probably due to the changing nature as the arc blew outward, the voltage sensors most likely reset and saw the line as being reenergized and permitted the SOTF function to operate and initiate the breaker failure protection on B12L17.

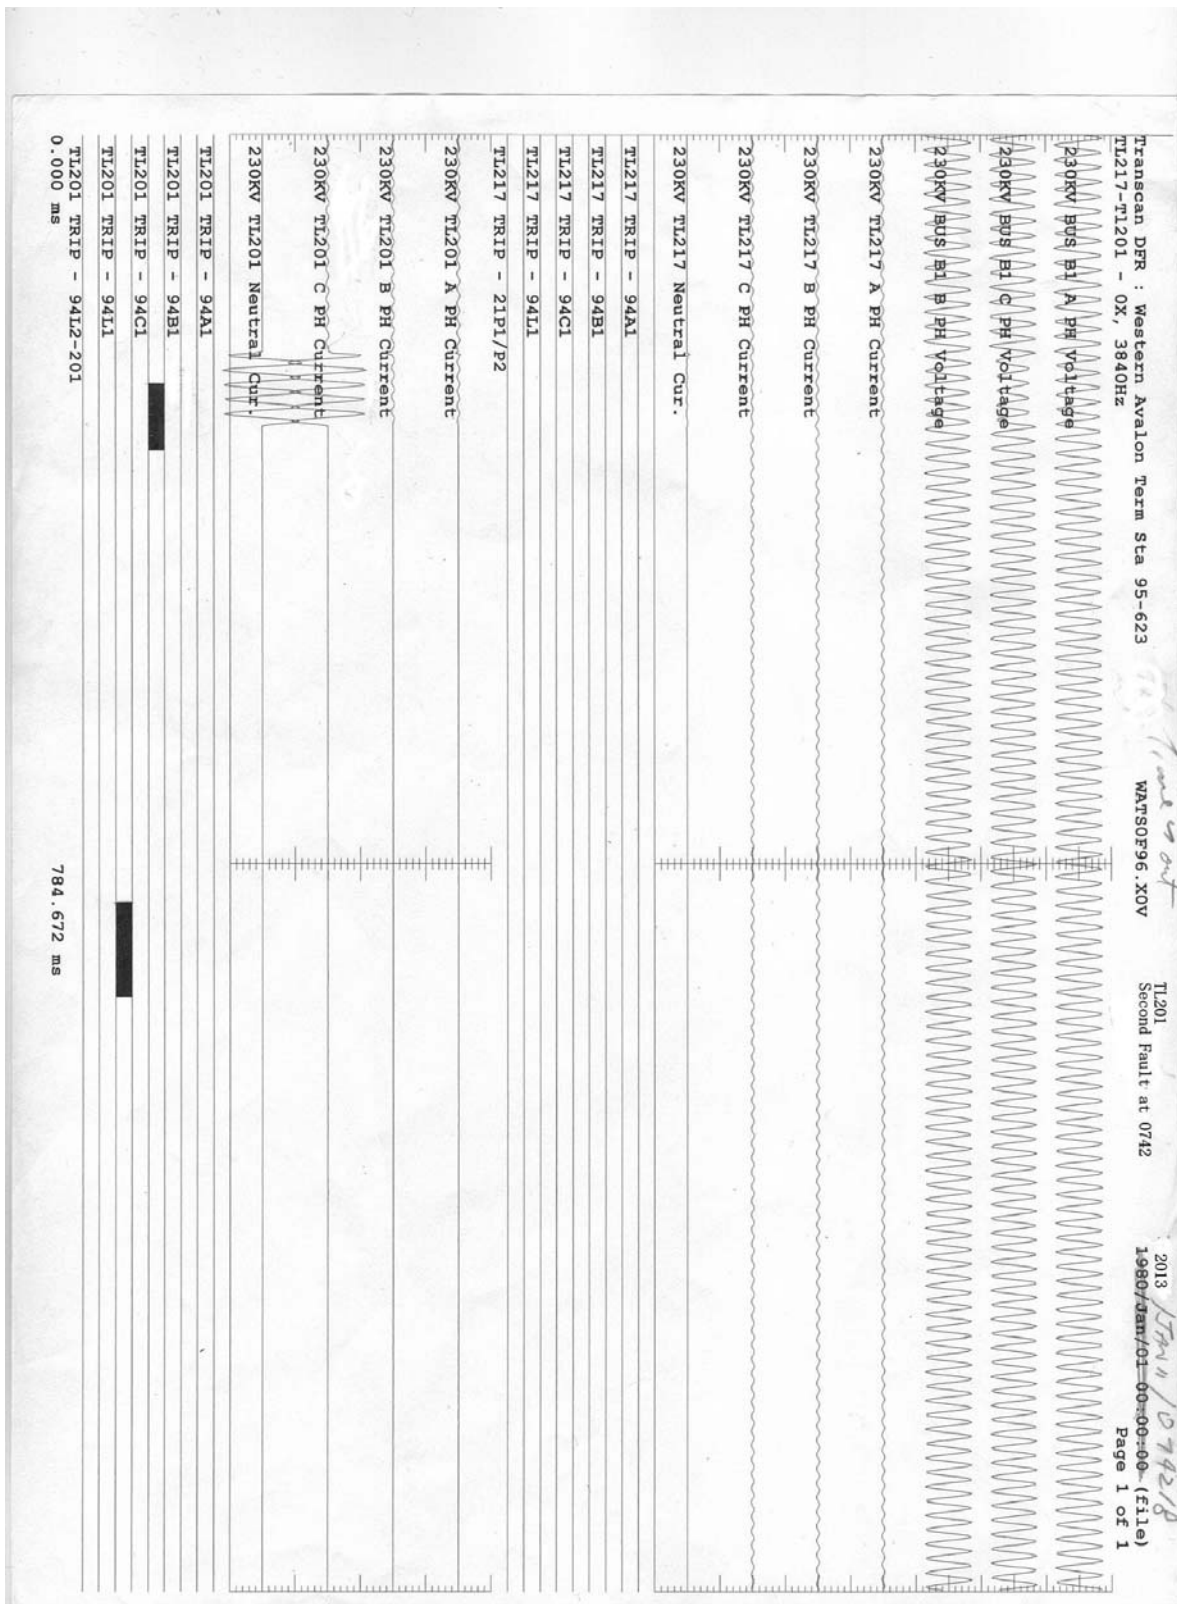
Figure 2-11: Western Avalon DFR at 0742 Hours Showing Second Fault to TL201

Prior to this event, all three units at Holyrood were offline, the 230 and 138 KV busses at Holyrood were de-energized with busses B12, B15 and B8 locked out and the Avalon Peninsula load, east of the Western Avalon (WAV) terminal station, was being supplied by TL201 with some local Newfoundland Power generation suspected to be still in service. As illustrated in the fault trace, Figure 2-10, a line to ground (C phase) fault developed on TL201 at 0742 hours. The line tripped C phase in four cycles at the Western Avalon end on P1 (Optimho protection only), followed by C phase at Hardwoods in seven cycles on both P1 & P2 protections and finally A and B phases at Hardwoods in 8 cycles on P1 protection only, eventually resulting in a 3 phase trip of the line. The trip of TL201 resulted in outages to the major load centers east of Western Avalon. At 41 cycles TL201 successfully reclosed at the Western Avalon end but faulted C phase

and tripped again approximately 2 seconds later, see Figure 2-11. The line fault was later revealed to be related to a jumper issue at Structure 210 located 49.9 km from WAV.

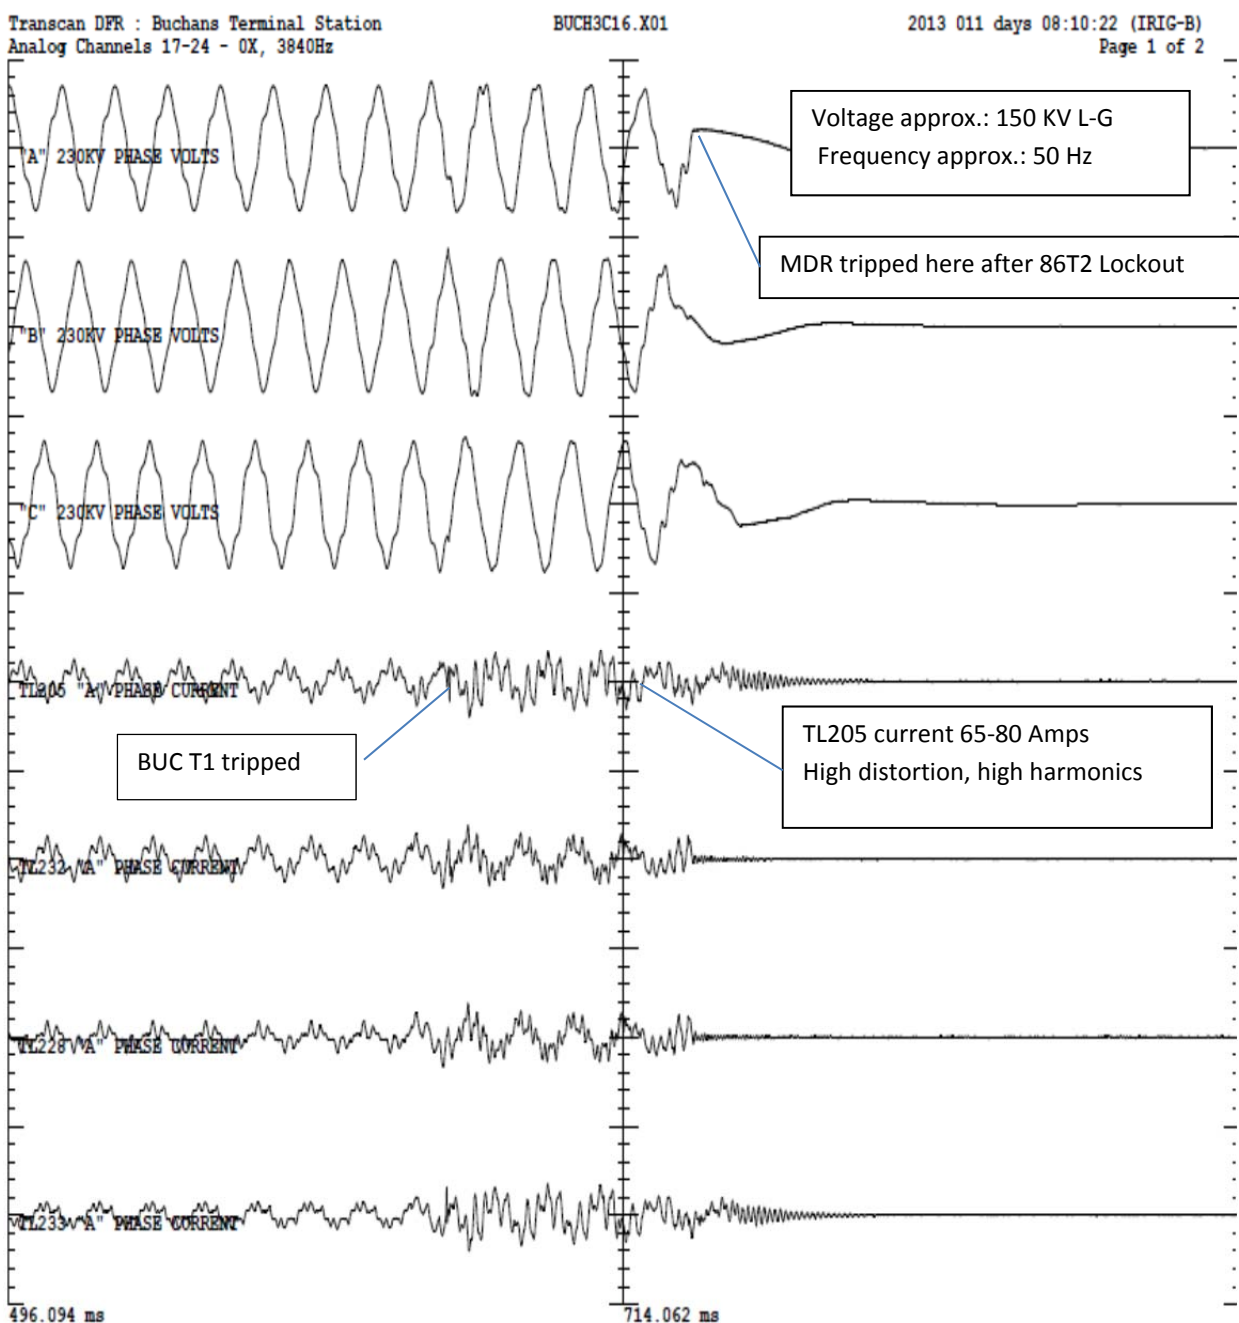
Figure 3-4: Buchans DFR Traces at 0810 hours Indicating Overexcitation Prior to BUC and MDR Lockouts

At 0810 hours, in an effort to off-load the system, the ECC Operator opened the two transformer breakers at Massey Drive (B2T2 and B3T3) interrupting the customer load there. This sudden load loss of load (approximately 40 MW) resulted in some voltage recovery and with the frequency still around 50 Hz, resulted in even more overexcitation of the transformers, resulting in the operation of Buchans T1 and Massey Drive T2 transformer differential protections. The overexcitation effects on the transformers just prior to trip is apparent by the wave distortion displayed in the Buchans DFR trace, Figure 3-4, for both the voltage and the current channels. The subsequent lockout operation of 86T1 at Buchans tripped breakers B1L05 and B1L28 (no lines were de-energized) followed by lockout operation of 86T2 at Massey Drive 3.5 cycles later. The latter operation tripped the 230 KV bus at Massey Drive, de-energizing all the 230 KV lines west of Stony Brook again. Transmission line TL248 also tripped at Deer Lake via the transfer trip from Massey Drive.

- At 0800 hours breaker B3L48 at MDR was closed, picking up Massey Drive loads and transmission lines TL205, TL211 and TL228 from the Hinds Lake plant. This caused Hinds Lake to become overloaded and to operate at a frequency of approximately 50 Hz. This lower frequency and overload caused a lower voltage on the 230 KV bus at Massey Drive, in the range of 200 to 210 KV, even with the line charging from the unloaded 230 KV lines. This underfrequency caused significant overexcitation of equipment, especially at the transformers. A frequency of 50 Hz results in an overexcitation of 20 per cent which is well outside the normal continuous design range of 10 per cent. However, the impact was offset by the lower voltage of about 10 percent. The overexcitation effect can be seen from the Massey Drive and Buchans DFR traces (see previous Figures 3-4 and 3-5) just before the Massey Drive 87T2 differential operation and 86T2 lockout which tripped the 230 KV lines and busses.

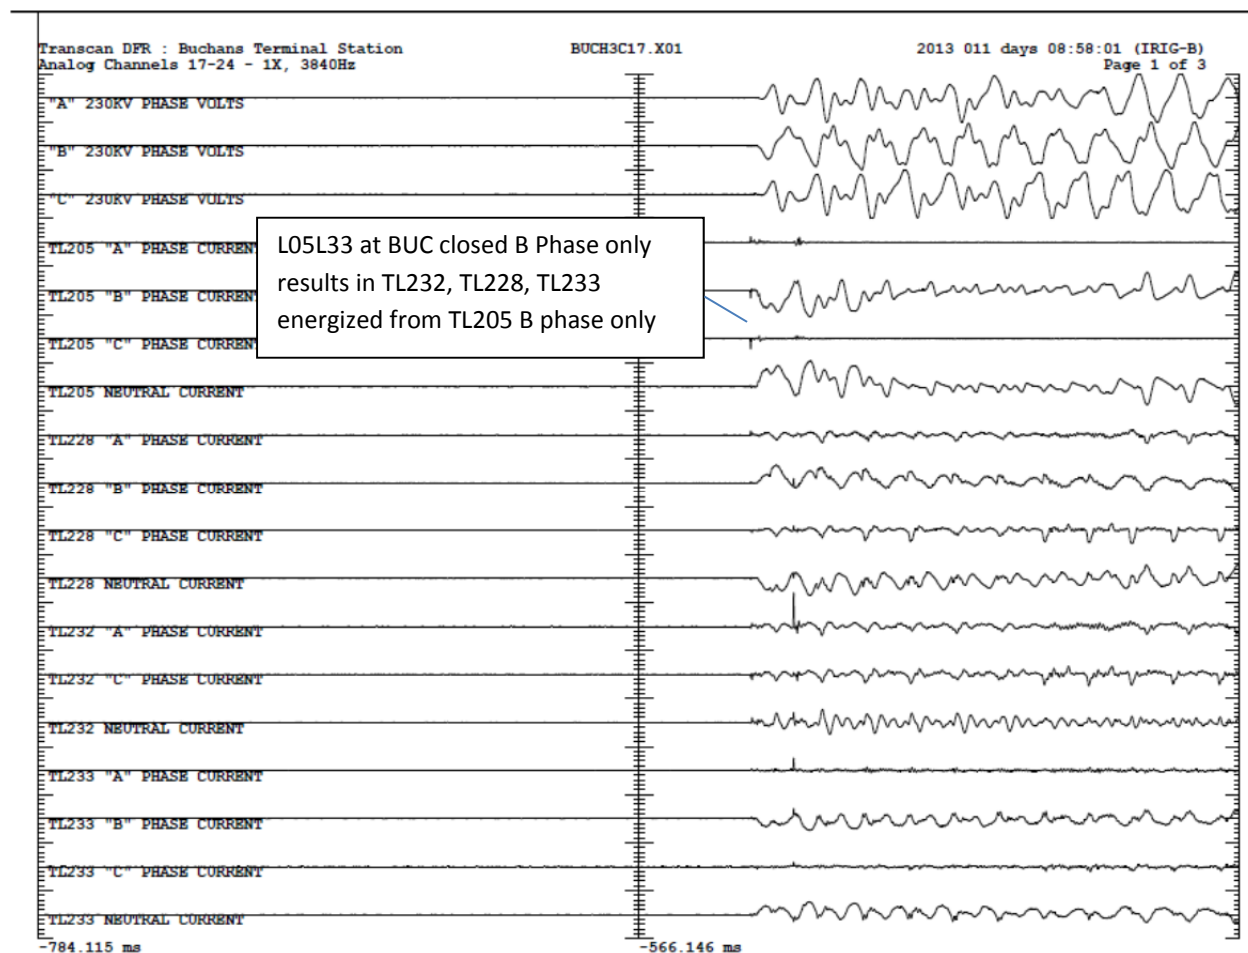
Figure 3-12: Buchans DFR Trace at 0858 Hours Showing the Start of Single Phasing

At 0858 hours breaker L05L31 at Stony Brook was closed by the ECC, energizing TL205 and also energizing, single phase through L05L33 (B phase), Buchans lines TL228, TL232, TL233 and the Bottom Brook terminal station (see Figure 3-12). Also energized at this time (single phase) were the 230 KV busses at Massey Drive via transmission line TL211. At this point loads were energized at Bottom Brook via the 138 KV bus and lines TL214 (supplying the Doyles and Port Aux Basques area) and TL250 (supplying the Burgeo area). No loads were single phased or energized at Buchans nor Massey Drive as they were isolated due to the lockout of Buchans T1 and the open 66 KV breakers at Massey Drive. Very high voltages were experienced on the 230 KV system due to the single phasing condition (see Figure 3-13). Voltages measured on the Bottom Brook DFR were 222 KV line to ground on B phase.

Seventeen cycles (0.28 seconds) later, L05L33 breaker failure lockout 86BF/L05L33 operated, followed by the tripping of Massey Drive breaker B1L28 one cycle later via TL228 - P1 (Optimho) SOTF protection. The Massey Drive 230 KV busses B1 and B5 remained energized, single phase from TL211. Buchans breaker L32L33 tripped one cycle later, de-energizing TL232.

The single phasing continued on for approximately 15 seconds, at which point Bottom Brook line TL250 tripped via its SEL 311 distance protection, de-energizing the Burgeo loads that were connected up to this time. After another 1.7 seconds, TL214 at Bottom Brook tripped via a transfer trip from Doyles which was initiated by the operation of the lockout 86T2 at Doyles. Doyles T2 (NP transformer 66/12.5 KV) protection operated, most likely due to the operation of the ground overcurrent protection picking up the trip relay 94T2 which trips the 86T2. The 86T2 lockout at Doyles also operated the high speed ground switch on TL214 and opened the NP 66 KV disconnect on T2. The opening of the disconnect T2-A on the high side of T2 initiates the opening of the ground switch.

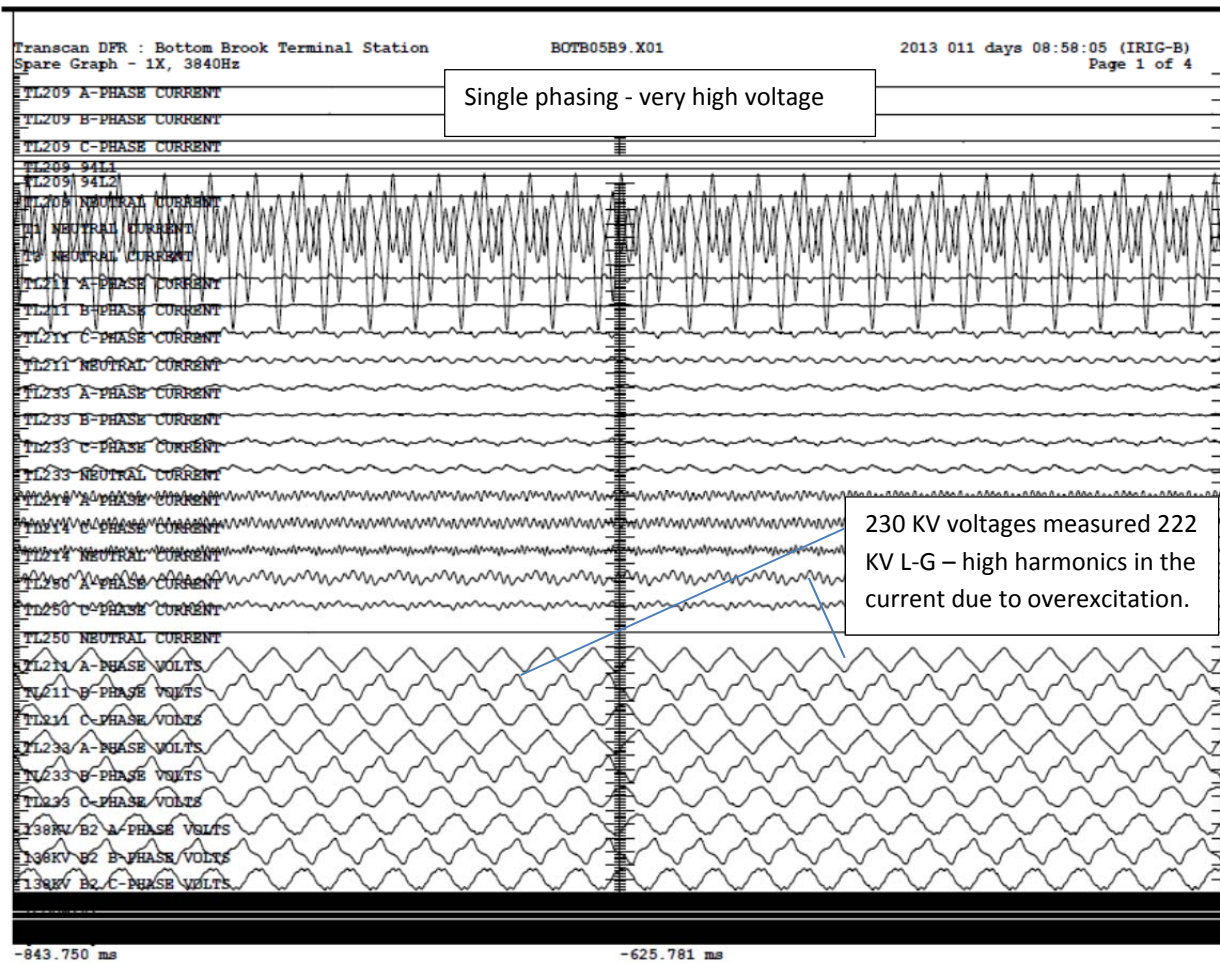
Figure 3-13: Bottom Brook DFR Trace at 0858 Hours Showing Very High Voltage During Single Phasing

- The single phasing of Buchans breaker L05L33 upon closure at 0858 hours caused issues such as over and under voltage, lockout operation, additional line tripping, Operator confusion and resulted in additional delays in restoring the system back to normal. When the breaker was opened by the ECC, B phase failed to open even though the breaker indicated open on the EMS status. The reason why the breaker failed to open on B phase and closed uncommanded is not known, however air system problems are suspected. The breaker was taken out of service following this event for an extended period and repaired. There was some damage found on the C phase head and it was replaced. There were auxiliary switches also found to be damaged and subsequently replaced. Tests were done on the breaker and the six year preventative maintenance procedures were completed. There were welded contacts found on relay 94L2 from the TL205 trip circuit, resulting in a permanent trip signal to trip coil no. 2 circuit. These were also repaired. In addition, an incorrectly mounted pressure was repositioned.

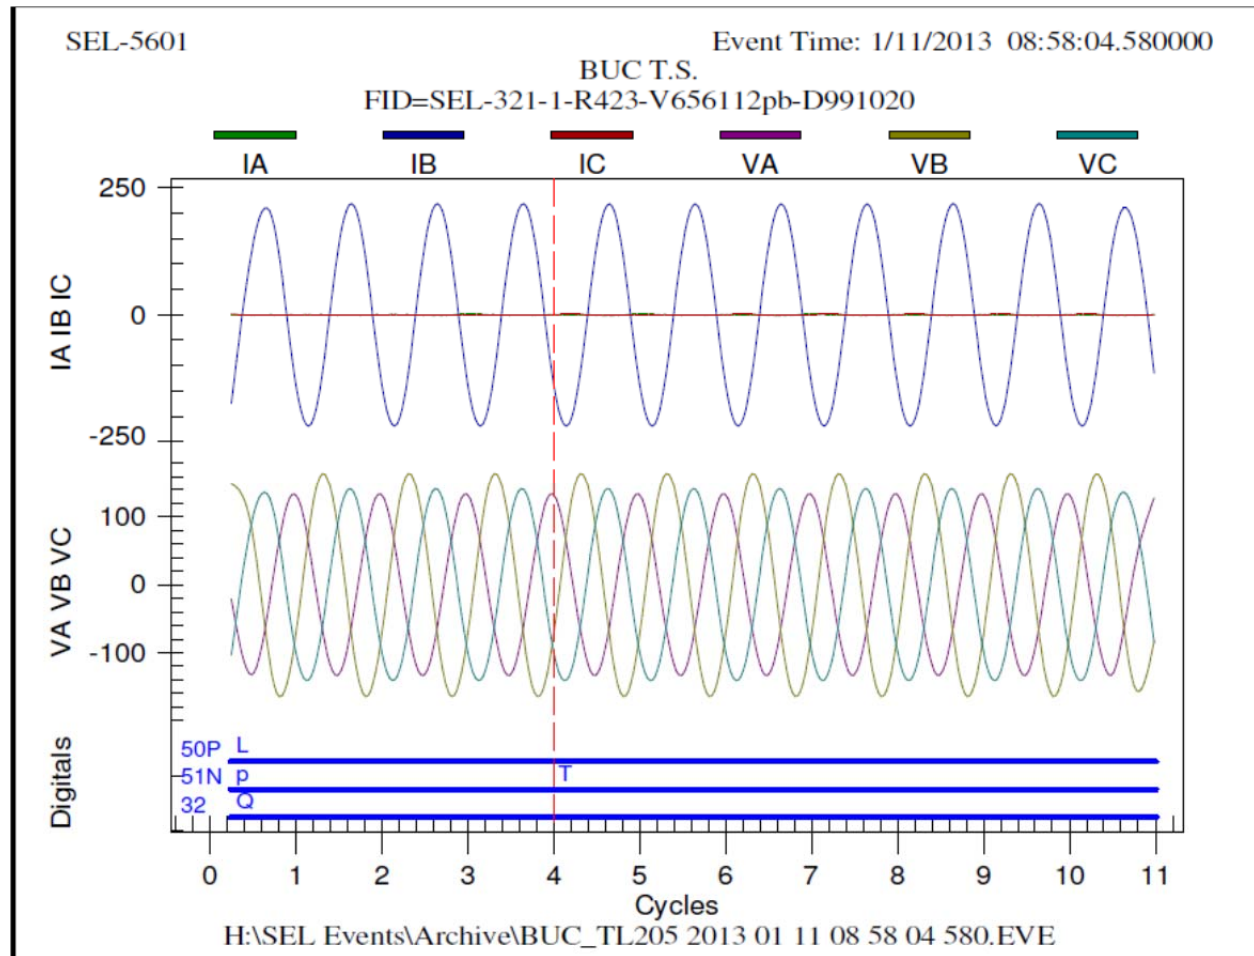
After approximately four seconds, Buchans line TL205's P2 (Schweitzer) ground overcurrent (51N) protection operated (Figure 3-14), sending trip signals to breaker B1L05 which was already open and L05L33. The B phase of breaker L05L33 still did not trip.

Figure 3-14: Buchans TL205 SEL Relay Report at 0858 Hours – 51N Operation

- The L05L33 breaker failure at Buchans was initiated after the 51N protection operated but failed to clear the condition. The current practice for a breaker failure operation is to trip local breakers but not remote end breakers. Remote end breakers are expected to clear via timed backup protection, in this case the 51N protection on TL205 and TL233 at the Stony Brook and Bottom Brook ends, respectively. This would most likely happen in the case of a fault with a failure to open condition but not for a phase failure to open condition as occurred in this case. For breaker failure operation as experienced here, transfer tripping of the remote breakers on TL205 and TL233 would prevent this condition from persisting by opening and locking out the remote end breakers.

- Further investigation and testing should be performed on Buchans breaker L05L33 to ensure that the failure to trip B phase, failure to trip on disagreement, and the

subsequent closure on loss of air is more completely understood, with repairs as required.

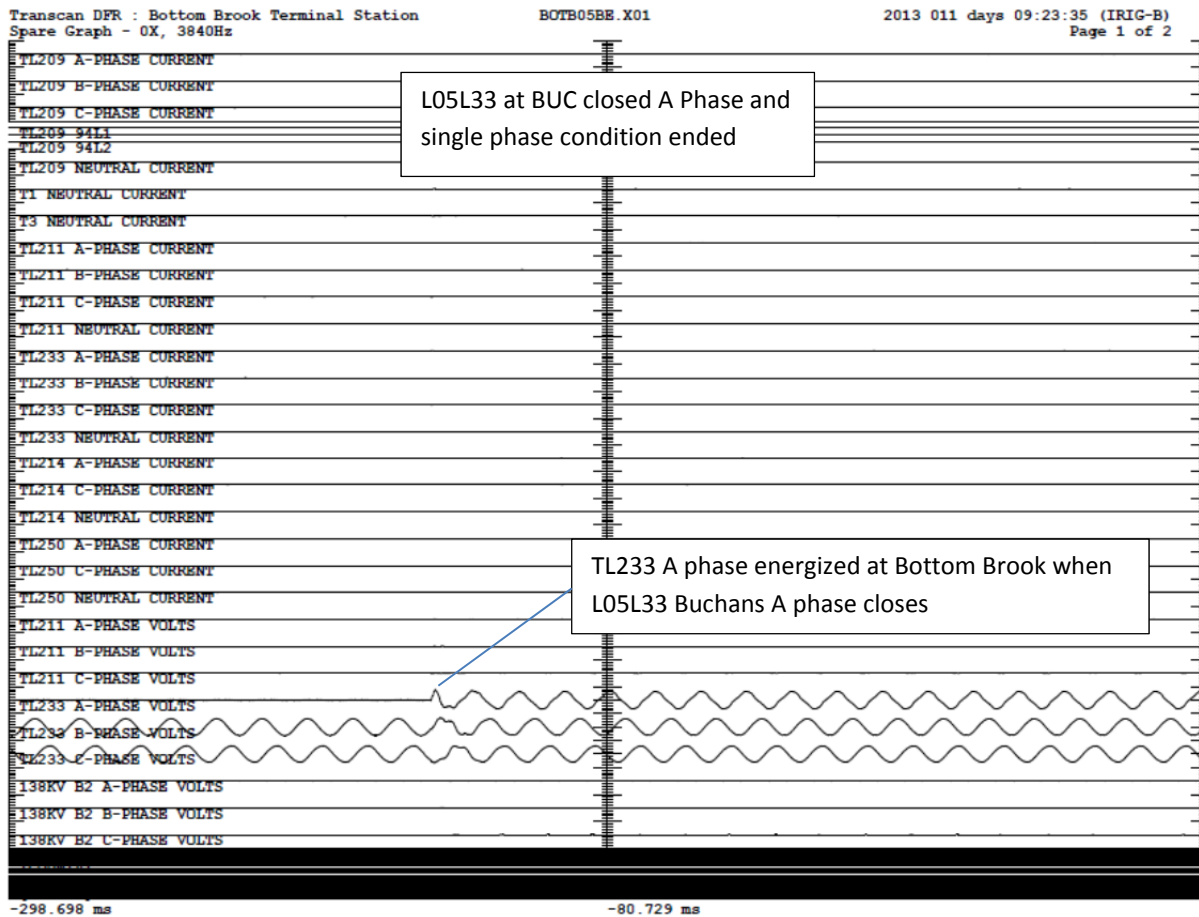
At 09:22:58 C phase of Buchans breaker L05L33 closed and 09:23:34 there was a closure of A phase (see Figure 3-15), most likely due to loss of air, ending the single phasing condition and energizing TL233 on all three phases. This closing now permitted the ECC to begin a more normal restoration of the West Coast system.

Figure 3-15: Bottom Brook DFR Trace at 0923 Hours Showing BUC L05L33 Closed Three Phase

- At 0923 hours, as noted previously, breaker L05L33 at Buchans closed three phase, energizing TL233 on all three phases and ending the abnormal single phasing condition.

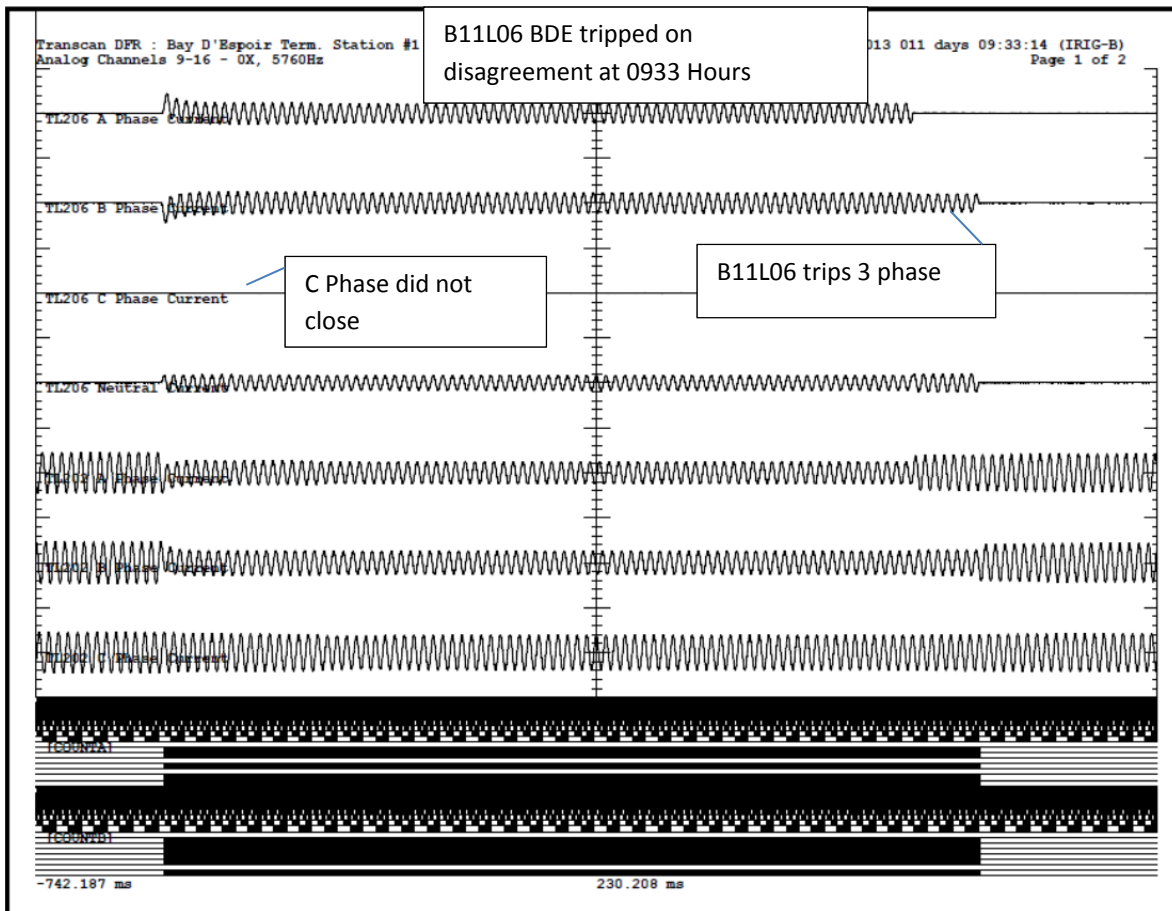
- At 0933 hours breaker B11L06 at Bay d’Espoir was closed by the ECC putting line TL206 in-service. It was already closed at the Sunnyside end. The breaker closed on A and C phases only and tripped 85 cycles later most likely on pneumatic disagreement, see Figure 3-16. Come by Chance capacitor banks C1 and C2 also tripped at this time, most likely due to the momentary voltage increase on the 230 KV bus at Come By Chance resulting from the impedance decrease and phase unbalance caused by the closing of the line in parallel with TL202. The 230 KV overvoltage level experienced at Come By Chance was most likely marginally, i.e. at the 110% trip setting, as the third bank in service at this time (C3) did not trip. Shortly after the trips the banks were put back in-service by the ECC.

Figure 3-16: Bay d'Espoir DFR Trace at 0933 Hours Showing TL206 Close and Trip

- At 0933 hours breaker B11L06 was closed at Bay d’Espoir to put TL206 in-service (it was already closed at the Sunnyside end). The breaker only closed two phases of the line to be in parallel with TL202, see DFR trace - previous Figure 3-16. It then tripped on disagreement. This was followed by the overvoltage tripping of two of three in-service capacitor banks at Come By Chance. An attempt was made to close the breaker again at 1422 hours but it again failed to latch closed. It was successfully closed at 1436 hours while in local control.

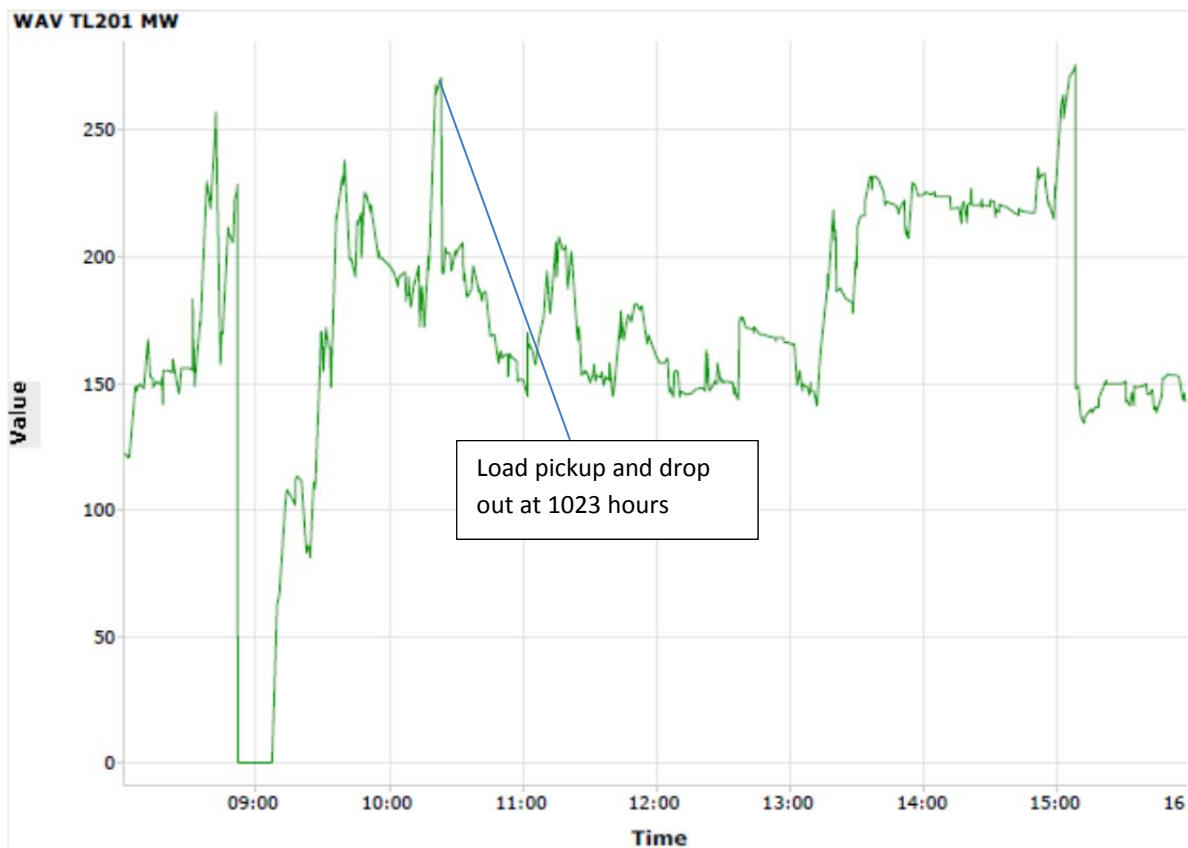
- At 1008 hours the Granite Canal unit was put on line. The unit was loaded up to 29 MW at 1013 hours.
- At 1023 hours there was a significant load increase followed by a drop of approximately 60 MW in the St. John's area, related to activity at the NP stations at Stamps Lane and Molloy's Lane, see Figure 3-17. This led to a system overvoltage and the tripping of capacitor banks C1, C2, C4 at Come By Chance.

Figure 3-17: TL201 MW Loading from 0800 to 1600 Hours

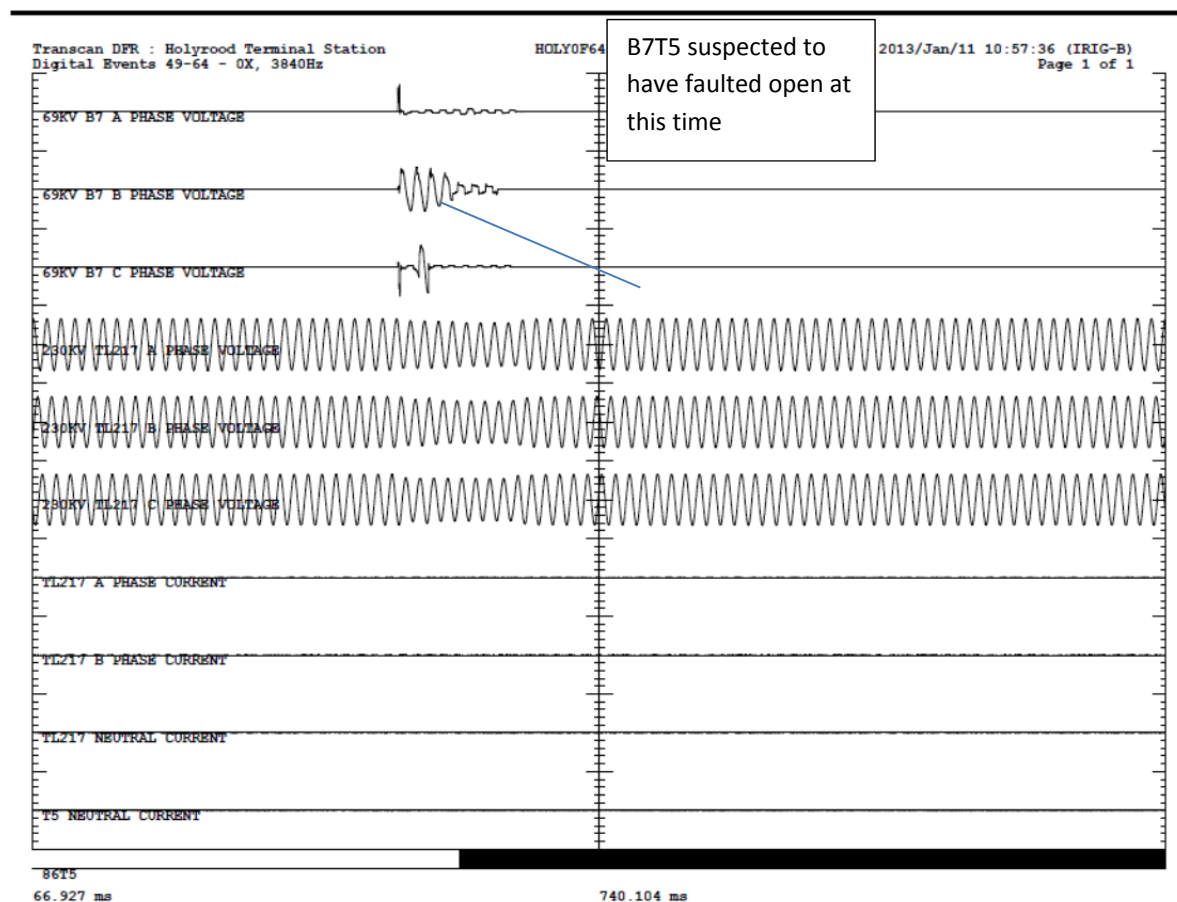
- At 1057 hours NP breaker 38L-B closed and tripped at Seal Cove. The Holyrood breaker, B7T5, faulted (it was open at the time) when energized from 38L, see Figure 3-18. The lockouts associated with T5 (86T5) and the 66 KV bus (86B6B7) both operated via instantaneous differential protection, transformer and bus respectively. The fault was cleared by breaker B7L38 at Holyrood and by NP 38L-B at Seal Cove.

Figure 3-18: Holyrood DFR Trace at 1057 Hours Showing Suspected Fault to Breaker B7T5

- At 1057 hours the Holyrood lockouts 86B6B7 and 86T5 operated when an attempt was made to energize the 66 KV bus B6B7 from NP's line 38L. As breaker B7T5 was open at the time and, given there was a fault as recorded in the DFR trace (see previous Figure 3-18), the fault location is, in all likelihood, on or in the breaker. This was also indicated by the protection operations (in both zones). A and B phases were involved, most likely related to the severe salt contamination. The fault was cleared by 38L protection at NP's Seal Cove station.

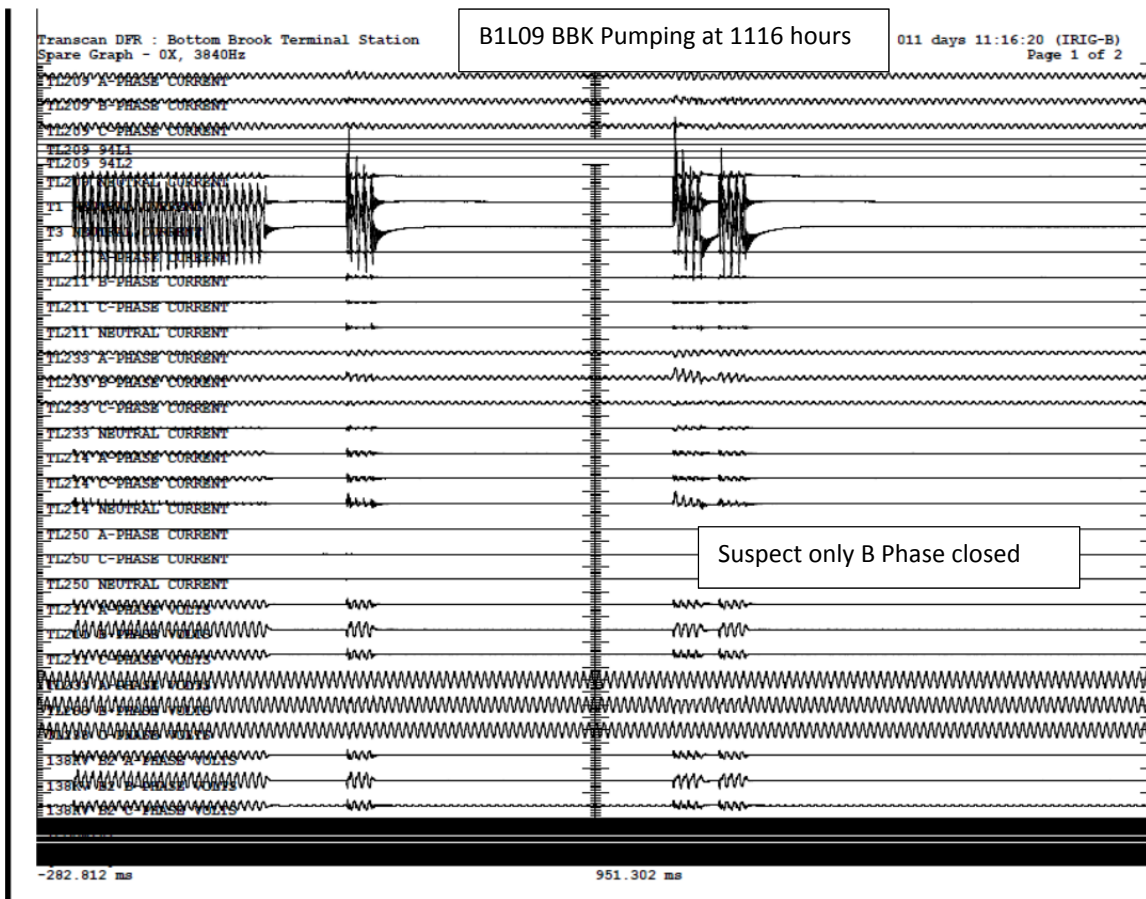
- At 1116 hours the Bottom Brook breaker B1L09 was closed by the ECC but opened and closed multiple times due to suspected breaker air problems. TL214 and the Doyles station were connected at the time. The breaker ended up open, see Figure 3-19.

Figure 3-19: Bottom Brook DFR Trace at 1116 Hours Showing BBK Breaker B1L09 Pumping

- At 1116 hours there was an issue with breaker B1L09 at Bottom Brook when it was closed to energize the station. It 'pumped' multiple times before ending up tripped. This can be seen in the Bottom Brook DFR trace, previous Figure 3-19. It is suspected that it only closed B phase. TL214 and the Doyles station were energized during the pumping operations.
