Board Order No. P.U. 3(2014)
Investigation and Hearing into Supply Issues and Power Outages on the
Island Interconnected System

NEWFOUNDLAND AND LABRADOR HYDRO

Events of January 2013

January 11, 2013 Power System Outage Report

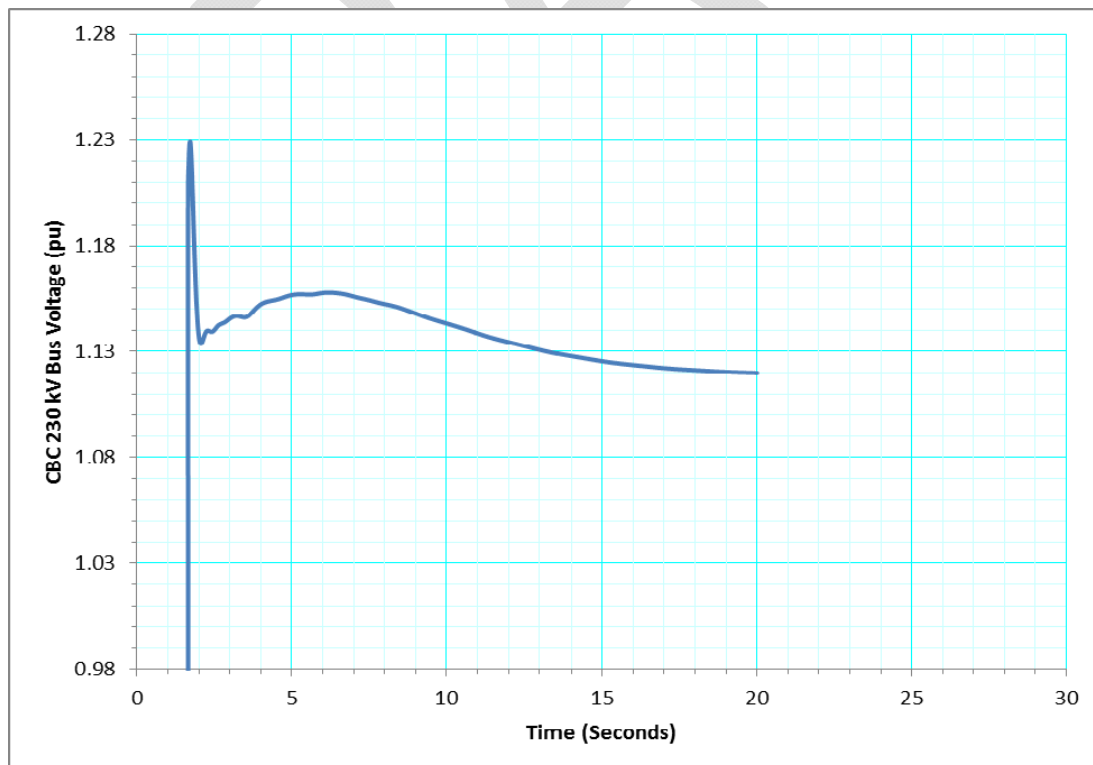
1. The SLG fault on TL201 resulted in the tripping of the line. This trip resulted in the isolation of load in St. John's area. This resulted in the interruption of 287 MW flow on TL201 at Western Avalon Terminal Station.
2. Voltages at Come-by-Chance Terminal Station become elevated due to the sudden loss of load. As illustrated in Figure 2. The overvoltages presented below would result in the tripping of the Come-By-Chance capacitor banks.

Figure 2 – CBC 230 kV Bus Voltage Following SLG Fault on TL201

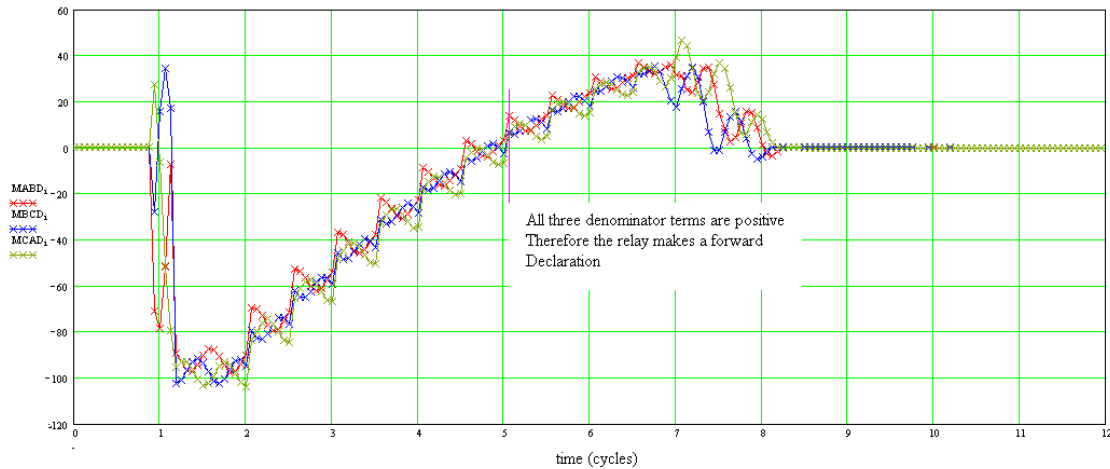
Fig.6 Plot of the denominator terms (directional term), from this plot it can be seen that at cycle 5.125 all three terms become greater than 0.5 and the relay declares the fault as forward.

If we examine Fig.6 and 7 we see that at time 5.125 cycles the denominator calculation for all three phase-to-phase distance elements becomes greater than 0.5 and at the same time the m-calculations for all three phase loops is less than the set values ($Z1P$, $Z2P$). Therefore at time 5.125 cycles all three distance elements assert their output, (this can be seen when examining the oscillographic record shown in Fig.1). At time of 7 cycles the 'm-calculation' impedance value is greater than the set value and all three distance elements de-assert, this can again be confirmed by the oscillographic record.

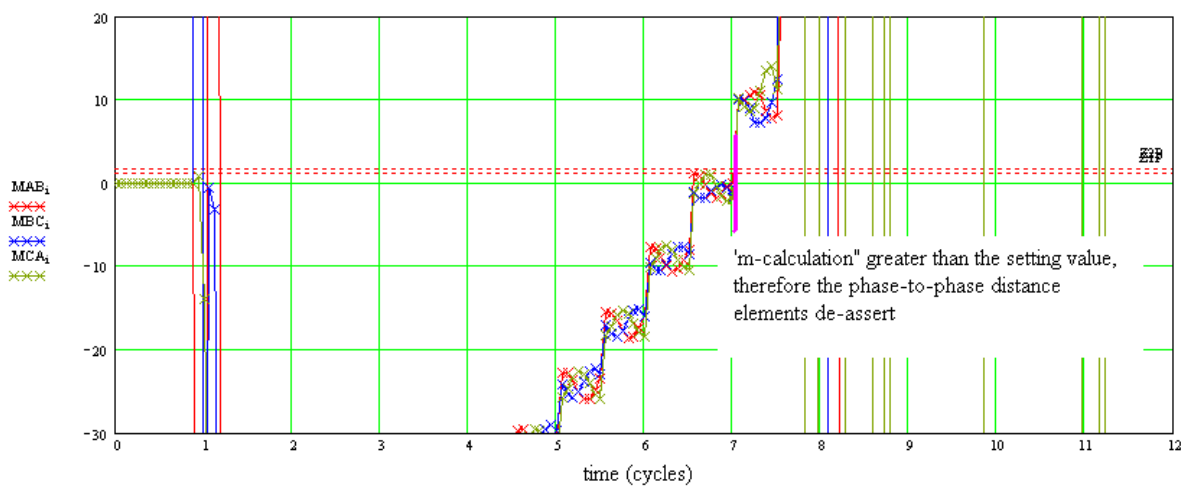
Fig.7. Plot of the “m-calculations” of the phase-to-phase distance elements.

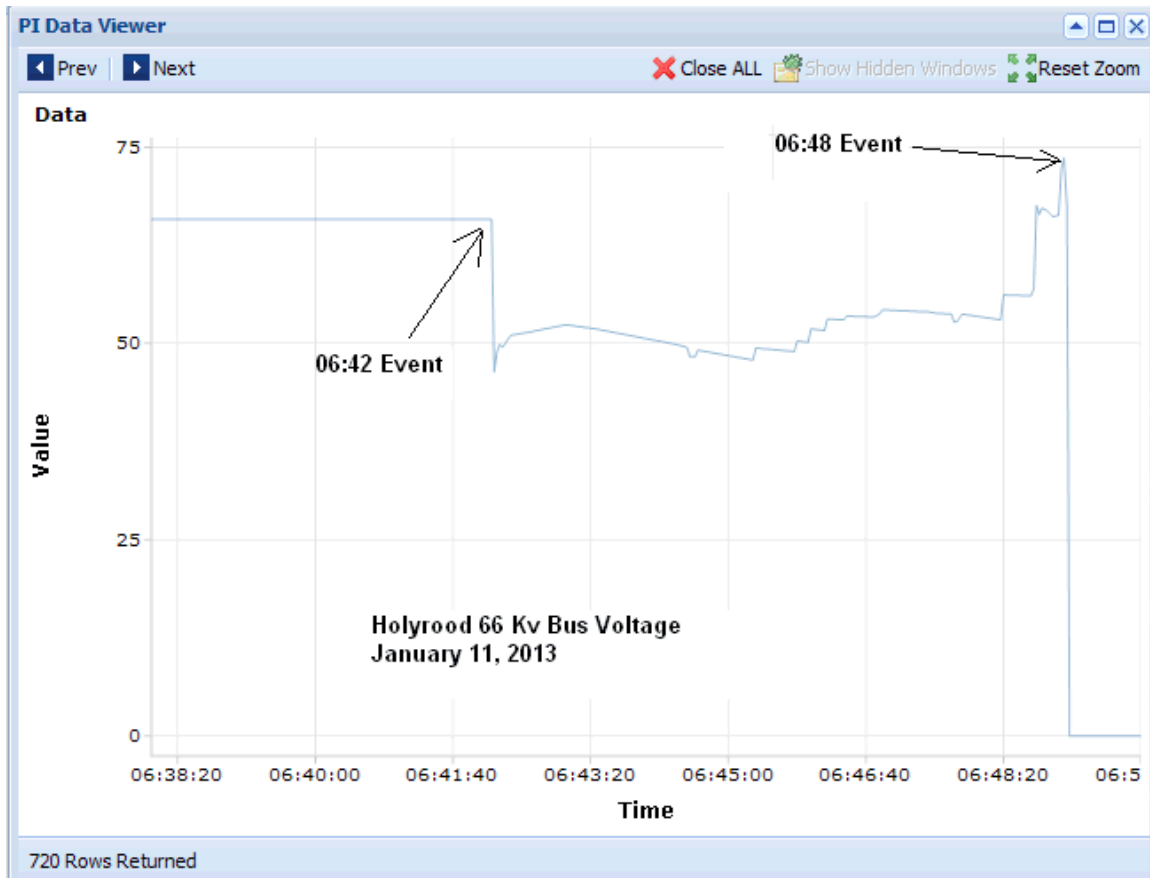
The removal of the generating units and other transmission system voltage support equipment resulted in a severe depression in system voltage to approximately 80% of normal voltage levels (See Figure 1).

Figure 1: Voltage depression experienced in the Holyrood Terminal Station during January 11, 2013 06:42 fault event

When Unit 1 was removed from operation in response to the terminal station electrical fault, the North AC Pump consequentially shut down. The South AC Pump tripped offline due to the voltage depression that was experienced during the terminal station electrical fault (See Figure 1). It did not restart with the loss of the North AC Pump, as is expected when the station service supply is available. The DC Pump started in response to the loss of the AC pumps and the resultant drop in lubricating oil pressure. However, it did not deliver sufficient lubricating oil to the generator bearings. The lack of sufficient lubricating oil continued for a period of approximately three minutes and fourteen seconds. With the plant completely shut down, many alarms and process upsets were being reviewed and assessed. Plant personnel manually started the 600 V emergency diesel generator D1, which removed the station service supply from the grid and established supply from the diesel generator. This resulted in the South AC Pump starting, recovering sufficient lubricating oil pressure. (See Figure 2 below for plant Distributed Control System {DCS} trends which illustrate this sequence of events.)

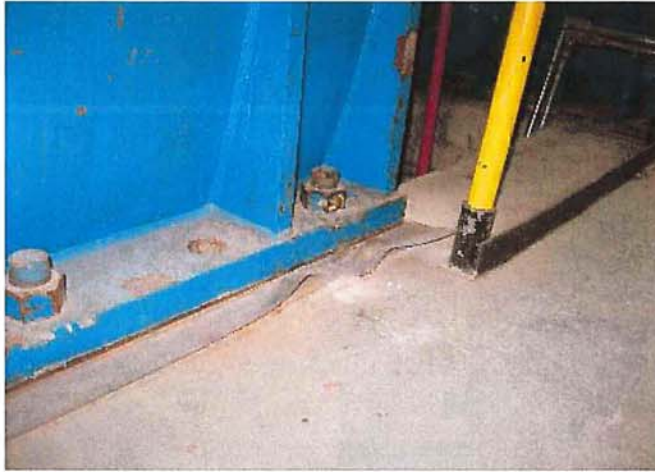
The shims on the generator base had moved and buckled indicating that they had come loose enough to move during the event. Keys and hold down bolts appeared to be intact. See photos below:

Figure 1 Generator Shim – LHS Turbine End
