1 **Q. Describe Newfoundland Power's asset management practices for its generating**
2 **facilities, including both maintenance and capital refurbishment programs and**
3 **practices, and how the generator maintenance programs are managed including the**
4 **use of maintenance management software. In the response provide copies of any**
5 **documents that describe the policies and practices followed.**

6
7 **A. 1. Generation Asset Management Practices**
8

2. Generation Capital Refurbishment Programs

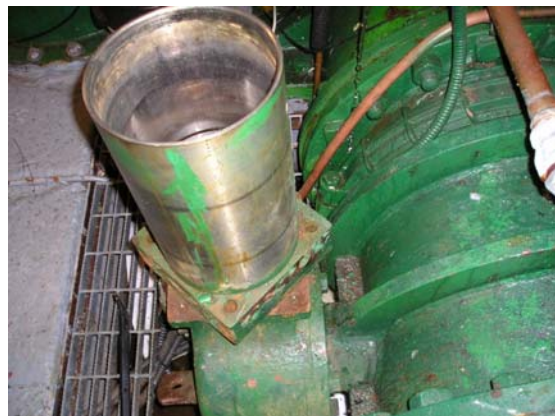
maintenance is required on the turbine. This situation limits the Company's ability to maintain and service other equipment in the plant. Typically the main valve assembly includes a bypass valve and drain valve.³ The existing main valve does not include either a drain valve or bypass valve. The lack of a bypass valve appears to be a contributing factor in the excessive leakage around the valve disc when in the closed position.

In its current condition the valve is prone to sticking in the open position. In 2009 the valve actuator failed in the open position. This presents a risk of equipment damage if the wicket gates fail to close on unit shut down.

Figure 1 - West Brook Main Valve

The closure of both the main valve and wicket gates is typically necessary to stop the flow of water from entering the turbine. If the wicket gates failed to stop the flow of water in this situation, a catastrophic failure of the turbine and generator would be very likely.

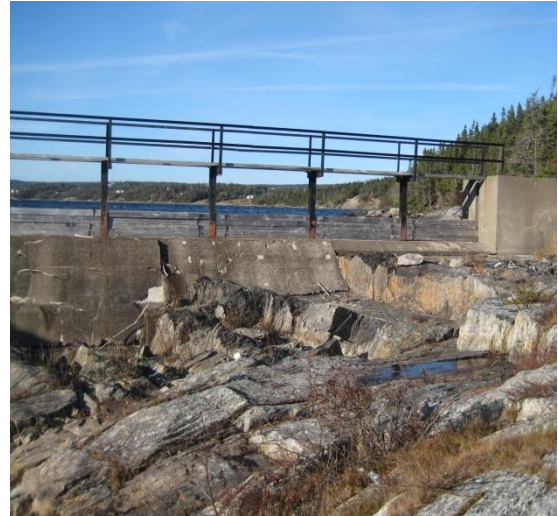
Figure 5 - Tors Cove Spillway (Downstream)

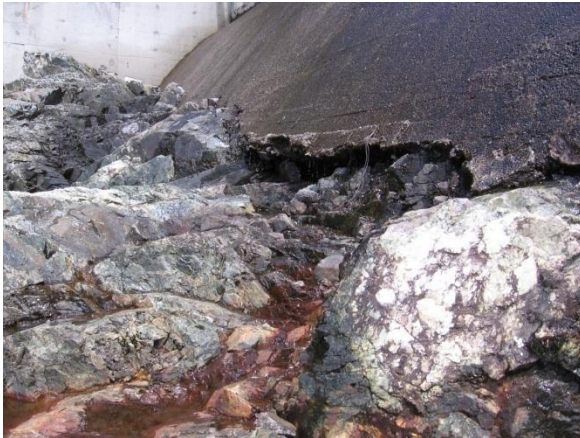
Figure 1 – Concrete Erosion at Spillway Toe

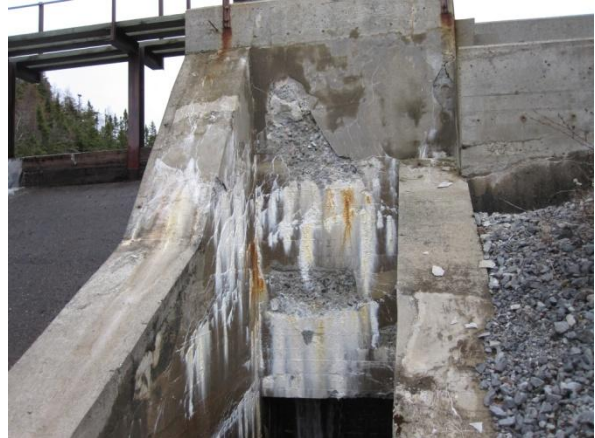
Figure 2 – Deteriorated Concrete on Sluice

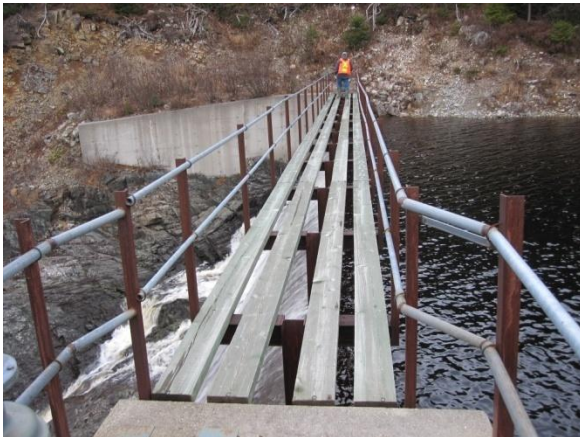
not meet current National Building Code of Canada requirements and the spillway abutment was constructed without railing. These deficiencies have been noted through inspections and will be corrected as part of this project.

Figure 3 – Missing and Substandard Railing

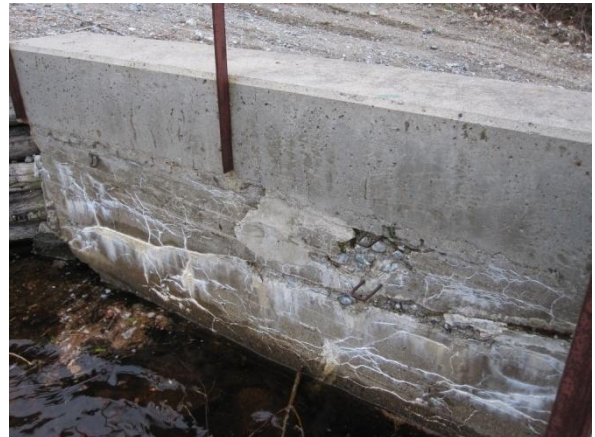
Figure 4 – Deteriorated Concrete on Upstream Face

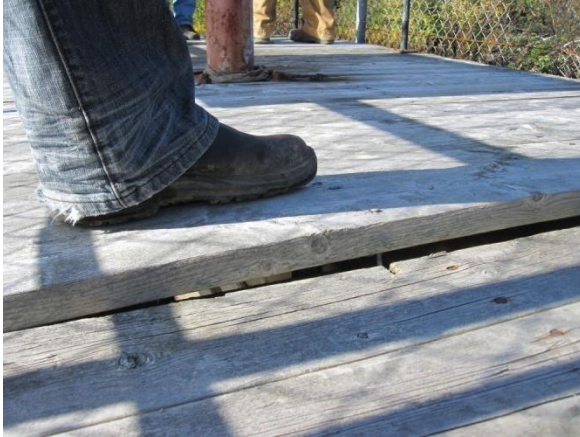
This project involves replacement of the existing timber crib spillway and outlet. Inspections have determined the foundation near the existing gate has settled and the gate is misaligned as a result. Timbers along the structure are deteriorated from exposure to ice and water. Due to the deterioration and settlement of the foundation the structure will be completely replaced.

Figure 5 – Results of Settling Foundation

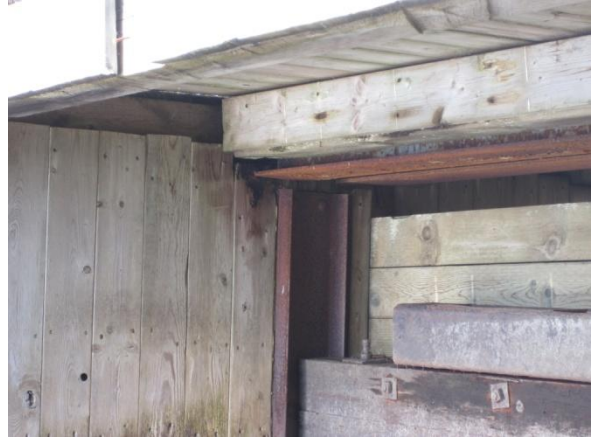
Figure 6 – Misalignment Due to Settling

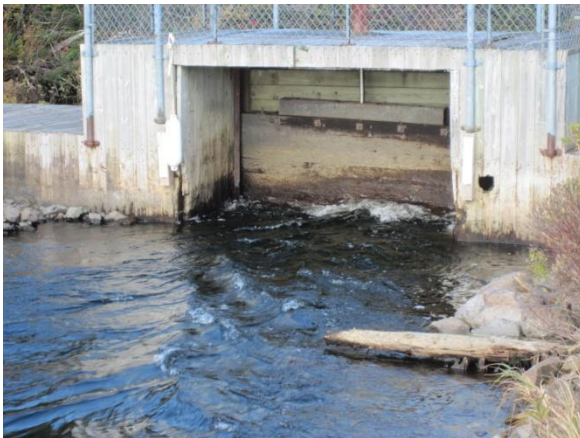
Figure 7 – Deteriorated Wood and Misaligned Gate

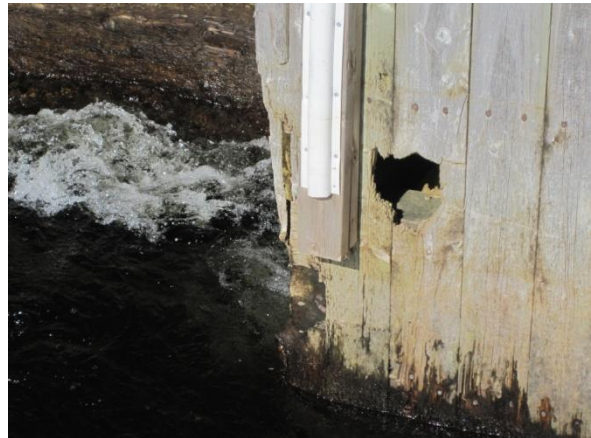
Figure 8 – Deteriorated Wood Structure

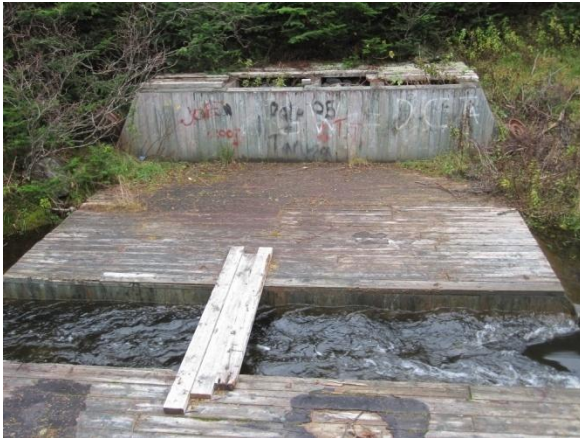
This project involves the replacement of the existing timber crib outlet and spillway. This structure previously housed an operational gate that has since been decommissioned as it was no longer required. This outlet remains important to the regulation of flow from Cochrane Pond. The structure in its current deteriorated condition is prone to vandalism including timber removal and camp fires. The outlet will be replaced with a modified steel or concrete design to reduce vandalism and public safety risks.

Figure 9 – Evidence of Fires and Crossing Using Structure Timbers

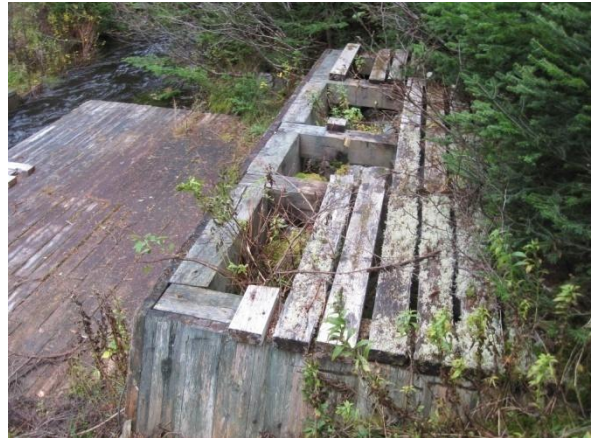
Figure 10 – Removed Timbers

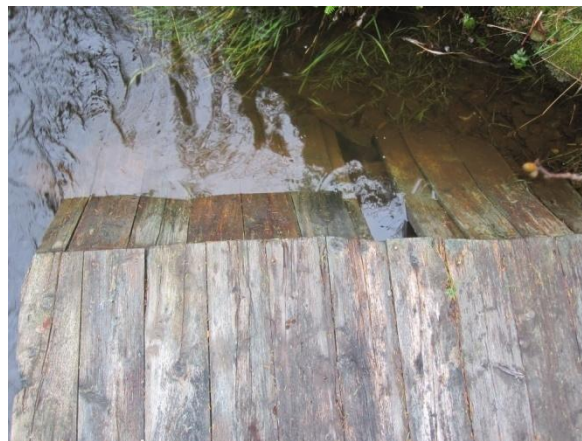
Figure 11 – Timber Deterioration

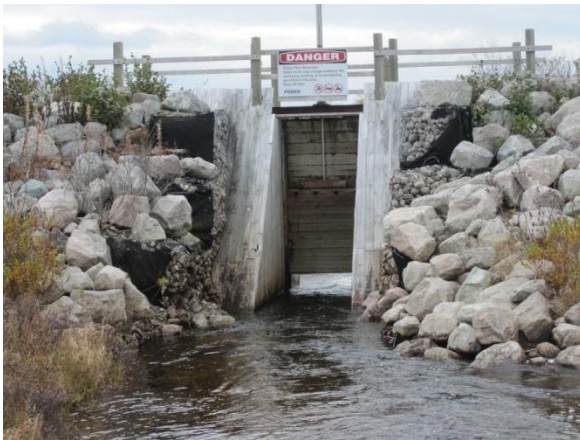
This project involves replacing the existing timber outlet structure and gabion wing walls. The lower sections of the gabion wing walls have corroded and are losing ballast. The risk of collapse of the gabion rock ballast has increased as the corrosion becomes more prevalent on the gabion baskets. The existing structure is used as a pedestrian bridge by the public. The wing walls currently do not have safety railings as they cannot be accommodated with the existing design. A more robust wingwall design that incorporates appropriate safety measures is required.

Figure 12 – Gate Structure

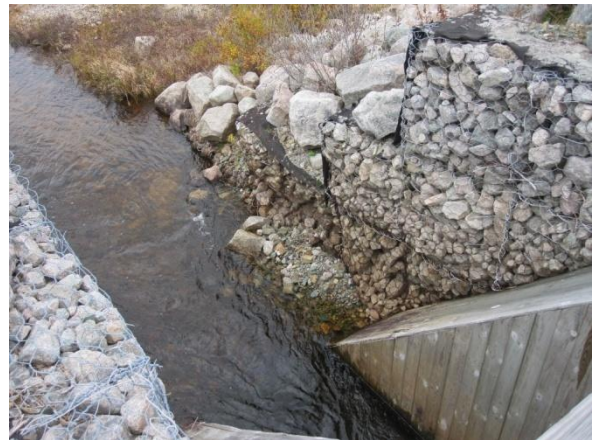
Figure 13 – Corroded Gabions - Upstream

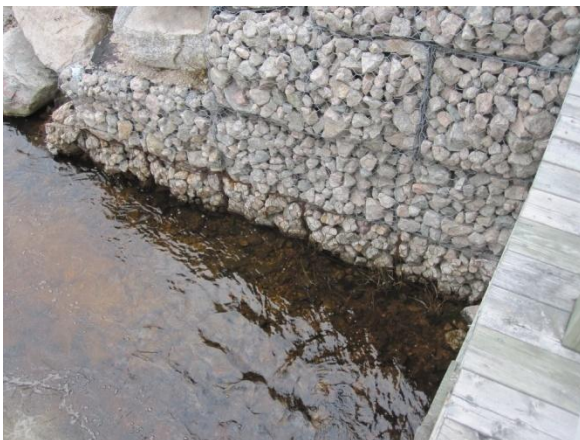
Figure 14 – Corroded Gabions - Downstream

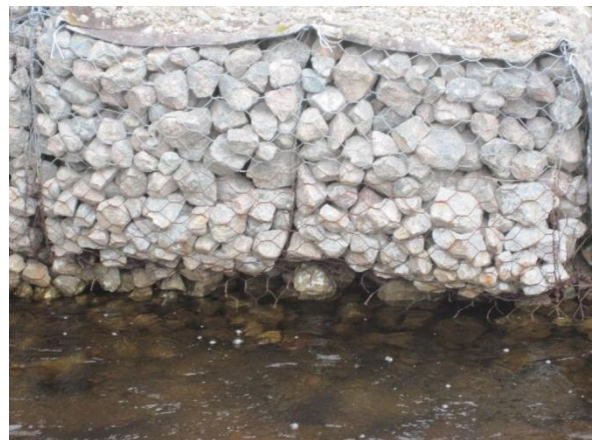
Figure 15 – Corroded Gabions - Downstream

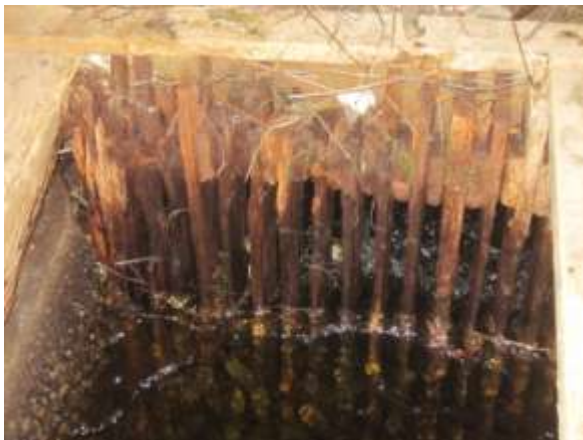
floor were replaced in 1991. Recent observations and inspections have indicated that both the trashrack and adjacent timber joists have deteriorated significantly. A new trashrack is required, as failure could cause extensive damage to the turbine. Replacement of the gatehouse deck joists is required to ensure employee safety.

Figure 1 – Deteriorated Trash Rack

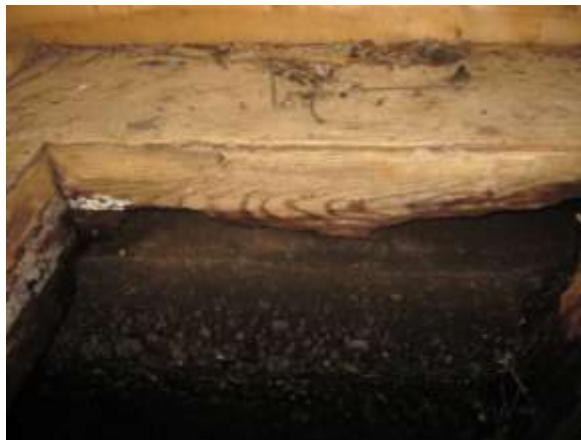
Figure 2 – Deteriorated Timber Deck

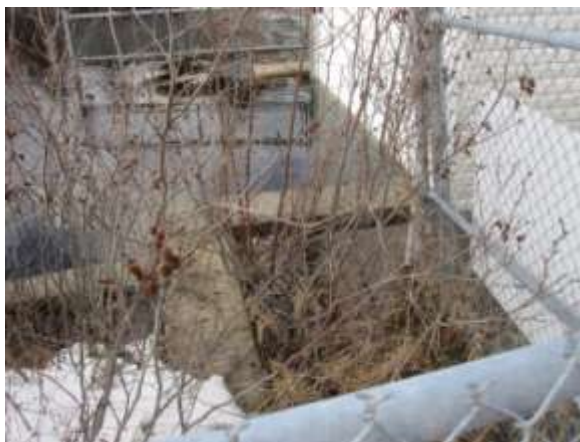
During period of high inflows, such as significant rainfall events or snow melts, the water rises to, or exceeds the height of the gatehouse timber frame. The water flows through the gatehouse and floods the adjacent parking area. As a result of the timber being frequently close to or in the water, it has deteriorated significantly. During extreme flood events, high water limits access to the gatehouse. Improvements to the structure and parking lot grade are required to divert the flood waters toward the spill channel to ensure the continued safety and integrity of the structure.

Figure 3 – High Water (Above Floor Elevation)

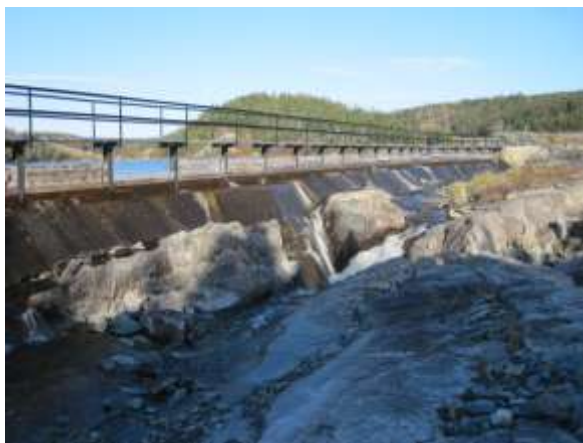
Accessing the structure to remove stoplogs is critical to dam safety. Access during extreme flood conditions is difficult, and operation of this type of spillway is a safety hazard for power plant operators. In addition to dam safety deficiencies, the spillway does not meet public safety requirements. Replacing the stoplog spillway with a concrete overflow spillway without an access walkway will address dam safety deficiencies and remove a significant public and employee safety hazard.

The deteriorated stoplogs leak considerably and this condition is expected to worsen over time. Based on field measurements, it is estimated that approximately 1.35 GWh of energy is lost annually as a direct result of the leakage. Addressing the leakage as part of the construction of a new concrete structure will save approximately \$227,000 in annual purchase power cost.³

Figure 4 – Cape Broyle Spillway

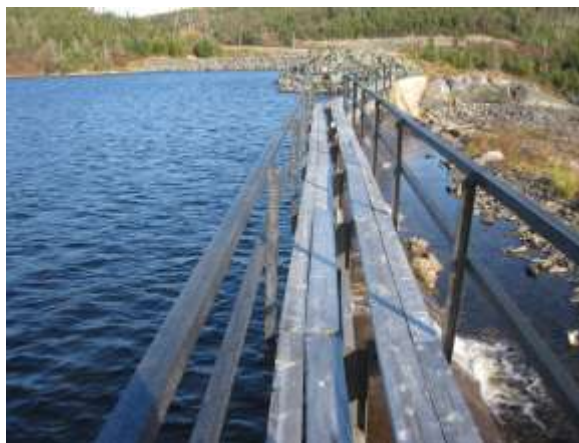
Figure 5 – Access Walkway

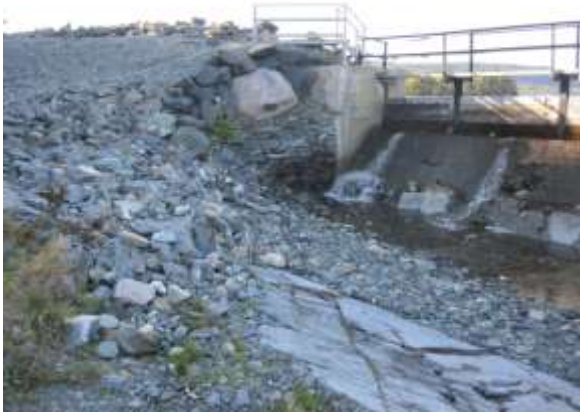
**Figure 6 – Deteriorated Concrete and Abutment
Prone to Washout**

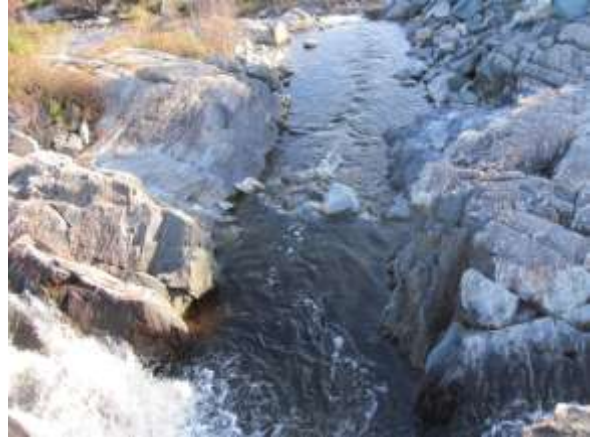
Figure 7 – Significant Leakage

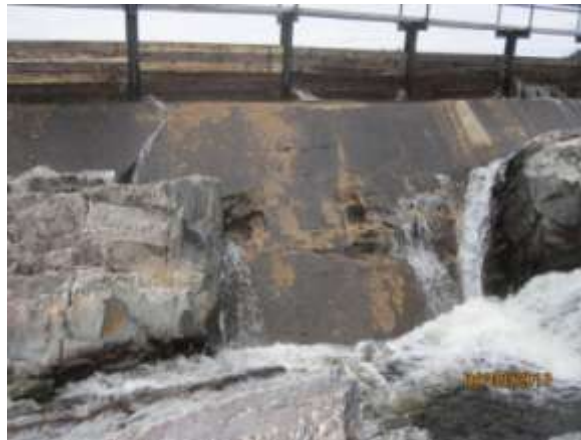
Figure 8 – Concrete Deterioration

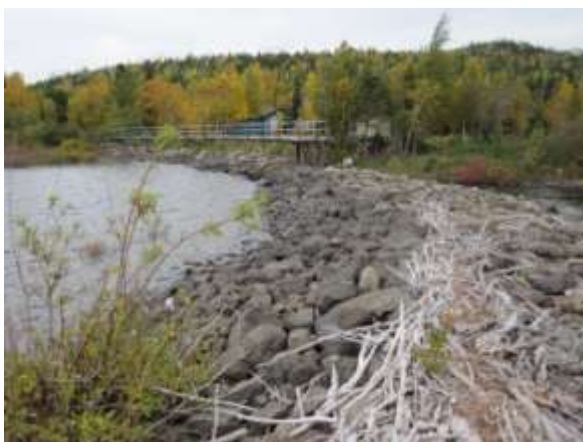
The West Lake dam and spillway are a part of the Sandy Brook plant watershed. West Lake Dam was reconstructed in 1984. This project involves replacing the existing concrete outlet structure, refurbishing the spillway and completing safety improvements. Refurbishment of the concrete outlet structure is required as it has significant vertical cracking and the wingwall concrete has eroded due to turbulence. The steel spillway cutoff has heaved vertically and as a result the spillway is no longer level. Refurbishment is required as the vertical rise has decreased spillway capacity and poses a tripping hazard to both employees and cabin owners in the area. The walkway also does not meet current public safety requirements. Improvements to walkway safety will be incorporated into the new outlet design.

Figure 9 – West Lake Dam and Spillway

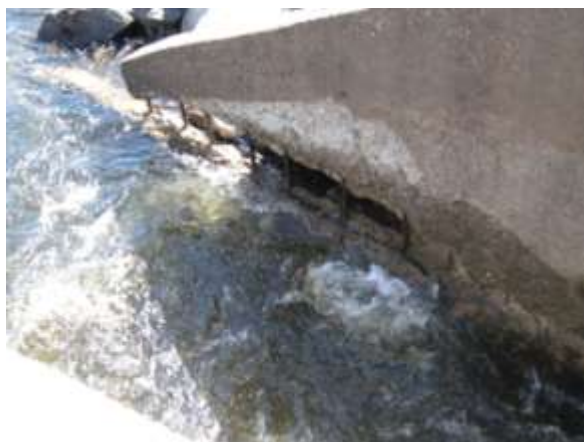
Figure 10 – Deteriorated Wingwall Concrete

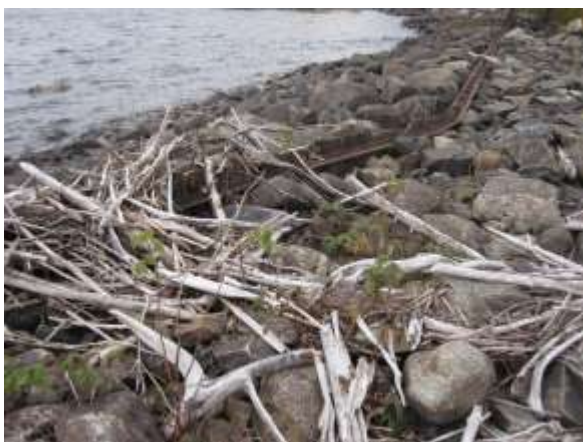
Figure 11 – Heaved Cutoff Wall

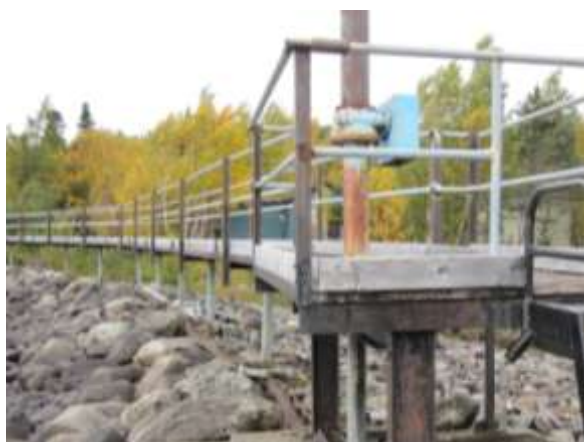
Figure 12 – Walkway and Gate Structure

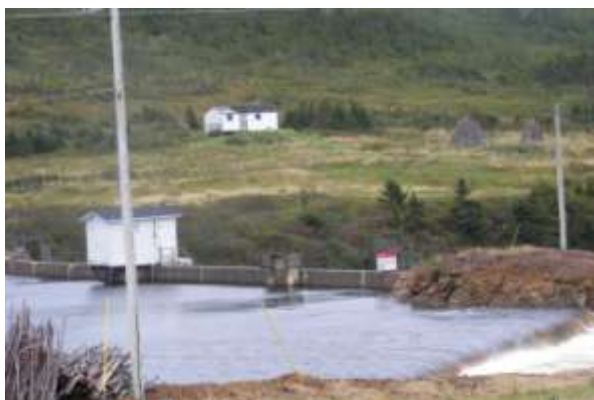
The Lawn intake structure was constructed in the mid 1930's as part of the original hydro development. The concrete intake conduit and support structure for the intake gate at Lawn Plant requires rehabilitation. This portion of the structure has deteriorated to the point where pieces of concrete are breaking free of the intake structure and traveling through the penstock to the generator turbine. In addition, excessive flows currently migrate through the concrete that is installed on the top and sides of the gate when the gate is in the closed position. The flows have increased such that the penstock can no longer be dewatered for maintenance purposes.

Figure 13 – Lawn Forebay Dam

This project involves rehabilitation of the existing concrete intake conduit and support structure for the intake gate at Lawn Plant.

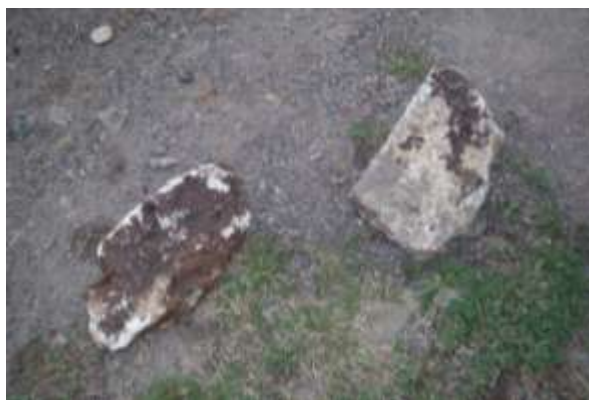
Figure 14 – Concrete Removed from Turbine

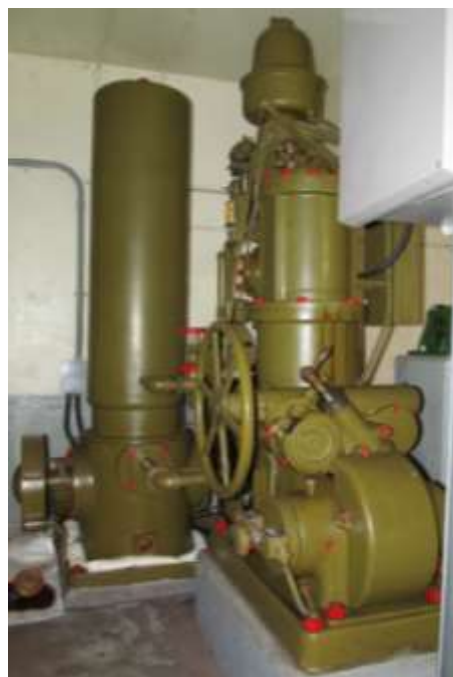
The Woodward Type LR gateshaft governor is the original unit. It has been reliable and, except for minor oil leakage, has no outstanding maintenance issues. The original equipment manufacturer discontinued manufacturing replacement parts for these units as of July 1, 2008. A number of third party companies provide maintenance support, including parts, but these companies and the utility industry is moving towards replacing the hydraulic control portion of these governors with digital systems that provide enhanced control and feedback capabilities.¹

The governor speed control and gate limit are motorized and can be operated remotely utilizing electromechanical relay logic to control the load on the unit. There are no gate position or gate limit setpoint transducers and therefore no feedback of these quantities for unit control or remote indication. More advanced control of the governor setpoints is required to implement a water management system in the unit control PLC to optimize the energy produced from the available water.

Figure 1 - Woodward Governor

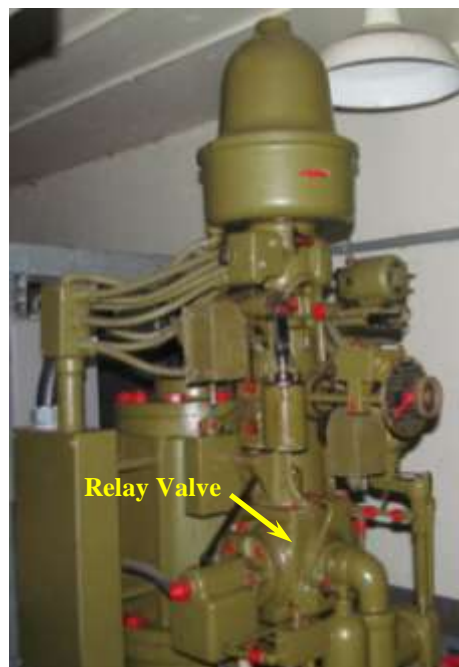
Figure 2 - Governor Control Head

The governor consists of two sections, the power piston that provides the force necessary to operate the wicket gates under load and the control head that adjusts the position of the power piston to maintain the system frequency through varying load conditions. The control head, which initiates the movement of the power piston, will be replaced down to the relay valve with a PLC based digital control system. The fly ball governor head, pilot valve assembly, mechanical restoring linkages and permanent magnet generator used for speed sensing will be removed. The new governor control system will facilitate the implementation of a water management system. The existing hydraulic power piston assembly will be retained, along with the relay valve, handwheel, and gate operating linkages. Reconditioning of all seals, bushings and other components that have deteriorated through the previous 54 years of service will be required to eliminate leakage and extend the life of the power piston and relay valve assemblies.

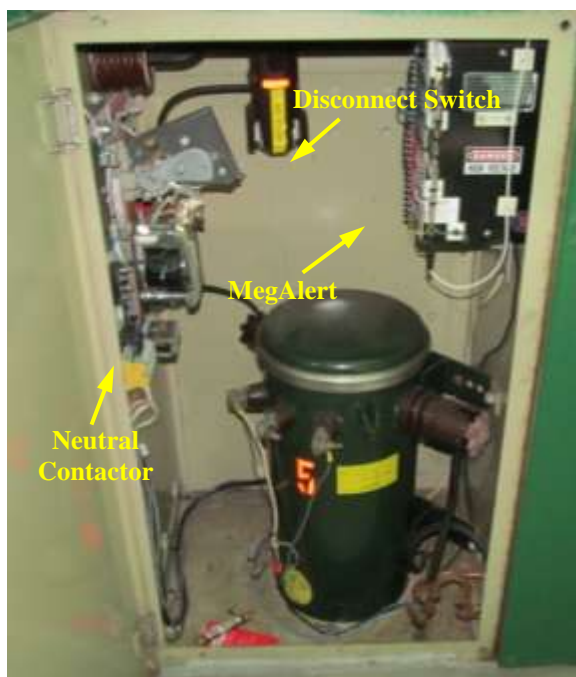
Figure 3 – Neutral Grounding Transformer

The generator neutral is high-impedance grounded through a grounding transformer, resistor, disconnect switch and neutral contactor located in the generator termination cubicle. To minimize the magnitude of fault currents, high impedance grounding is the preferred method of generator neutral to ground connection. The grounding transformer is a 1960's vintage 5 kVA oil-filled distribution unit. The resistor connected across the secondary of the grounding transformer is original. The size of the resistor required will be recalculated with the new power cables and surge capacitors. A properly sized resistor minimizes the transient overvoltage in the event of an arcing ground fault. A new dry-type neutral grounding transformer with secondary resistor will be installed in the generator termination cubicle. The neutral disconnect switch will be removed and the neutral contactor will be incorporated into the new grounding system.

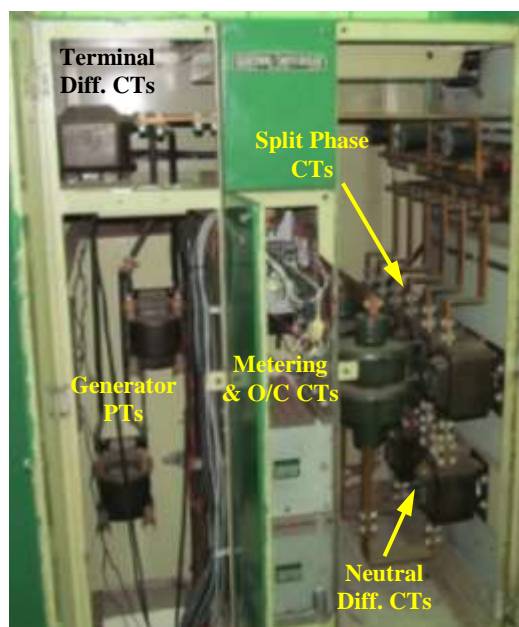
Figure 4 – Generator CTs and PTs

The generator protection and metering potential transformers (PTs) and current transformers (CTs), located in the generator termination cubicle, are original to the 1959 installation. The PTs and CTs are critical to the electrical protection of the generator and will be replaced.⁵ The six 400:5 CTs used for generator split phase protection will be replaced with three 100:5 split phase CTs with a rated ampacity of 800 amps. The three neutral-side differential protection CTs and three dual-secondary overcurrent protection and metering CTs will be replaced with three protection CTs, located in the generator termination cubicle, and three revenue class metering CTs, located in the new switchgear lineup. The three terminal side differential CTs and generator PTs will be replaced with new units located in the new switchgear. The single crosscurrent compensation CT will be removed since it will not be required for the new digital voltage regulator. The CT reconfiguration

⁵ PTs and CTs are all critical to electrical protection of the generators, and an in-service failure of these components could result in serious damage to the generator windings.

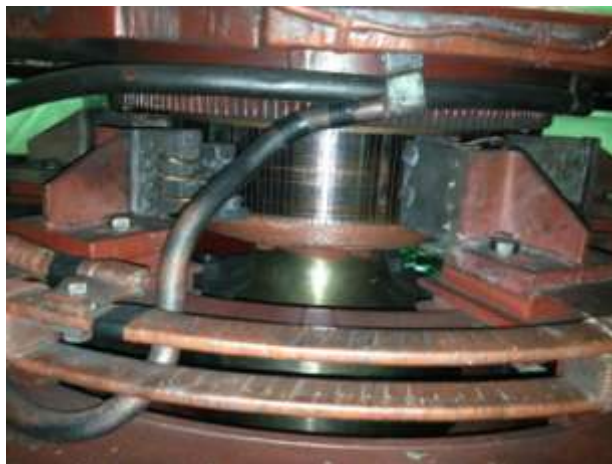
Figure 5 – Exciter Commutator

The pilot exciter and main exciter are the original units supplied with the Bruce Peebles & Co. Ltd. generator in 1959. The pilot exciter will no longer be required when the new digital voltage regulator is installed. The exciter commutator and the slip rings are scored and require resurfacing. The age of the exciter dictates that it should be rewound in conjunction with the generator rewind. Infrared brush temperature sensors will be added to the commutator and slip rings.

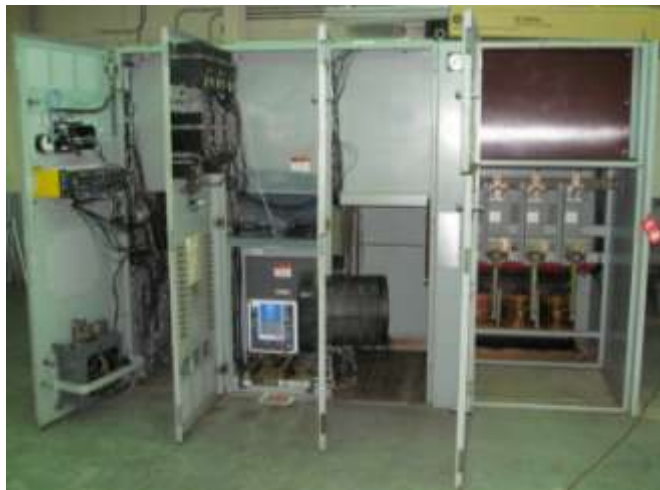
Figure 6 – Switchgear with Doors Open

The switchgear is original to the 1959 English Electric installation. Several upgrades have been completed over the years. The surge protection was replaced in 1986, the generator circuit breaker was replaced with a Cutler Hammer Type VPC vacuum unit in 2001 and the power cables from the generator to the switchgear were also replaced at that time. The non-standard 27-inch switchgear cubicles greatly limited the options for replacement breakers. A three-phase, 75 kVA, 120/208V station service transformer was installed in the switchgear in 2009. The remaining equipment, including the bus potential transformers and current transformers, are original.

As a result of the high energy fault levels at this location, there is a very high arc flash hazard associated with this switchgear requiring an arc flash boundary of 3 metres when all cubicle doors are fully secured and 14 meters when racking the breaker, necessitating the use of Level 3 arc flash personal protective equipment.⁶

The protective relays, meters and voltage regulator are incorporated into the switchgear doors, which greatly increase arc flash hazards for operating personnel. The high voltage compartments in the front of the switchgear are vented through the

The existing switchgear will be replaced with an arc flash rated assembly, equipped with an arc-flash protection system and containing a new vacuum breaker with closed-door racking capability. Higher accuracy instrument transformers for improved protection and metering will be supplied with the switchgear. The existing station service transformer will be incorporated into the new switchgear. The generator breaker and 3-phase capacitor will be removed from the existing switchgear and returned to inventory.⁷ The protective relays, meters and voltage regulator will be located in a new unit control panel to be located in the control room upstairs, providing additional employee safety.

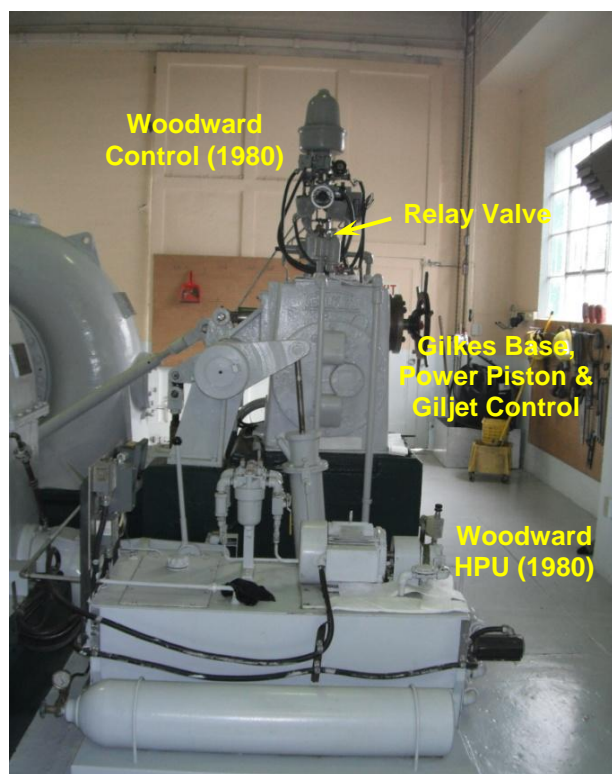
Figure 1 - Gilkes/Woodward Governor

The governor bases, power pistons and Giljet operating mechanisms are the original Gilkes units. The control heads and hydraulic pressure units were replaced with Woodward hydraulic retrofits in 1980.

The G1 governor was refurbished in 2003. The original equipment manufacturer discontinued supplying replacement parts for these units as of July 1, 2008. Due to its robust design with no parts exposed to excessive wear, the hydraulic power portion of the governor will remain serviceable for many years.³

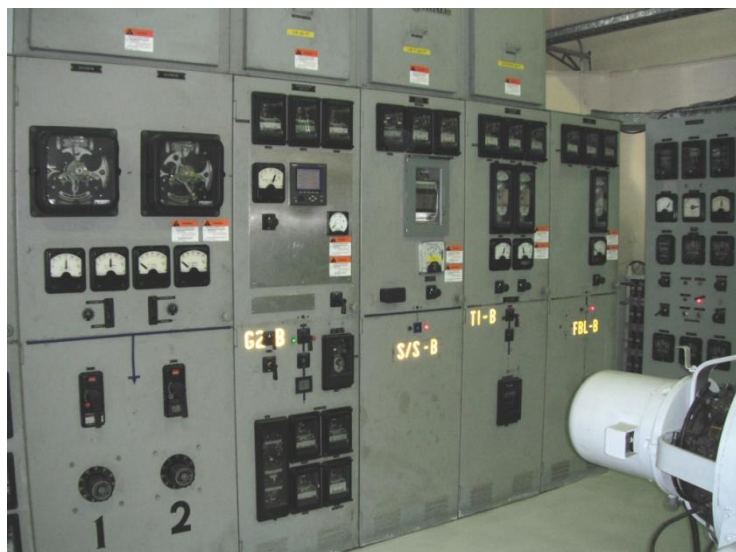
Figure 2 - Switchgear and Control Panels

switchgear cubicles, and the proximity of these cubicles to other equipment operated by employees.

The existing five-breaker switchgear line-up will be replaced with an arc flash rated assembly with three vacuum breakers, which requires minimum maintenance. As outlined below the normal station service will be relocated to the substation and the station service breaker will not be required. The forebay power line will be connected to the overhead section of the 6.9 kV line from the substation to the switchgear and the forebay line breaker will not be required. Higher accuracy instrument transformers for improved protection and metering will be supplied with the switchgear. The control switches and associated wiring

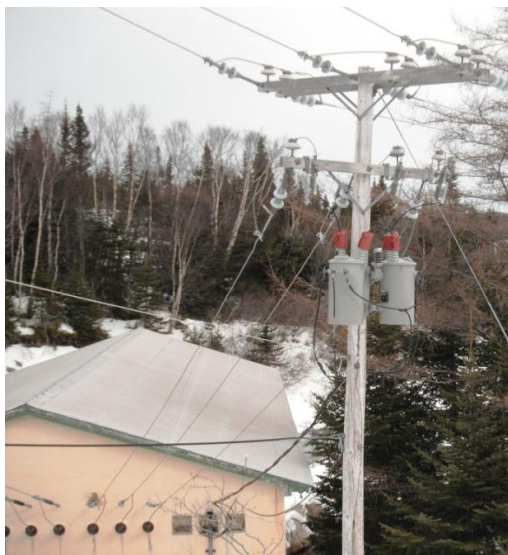
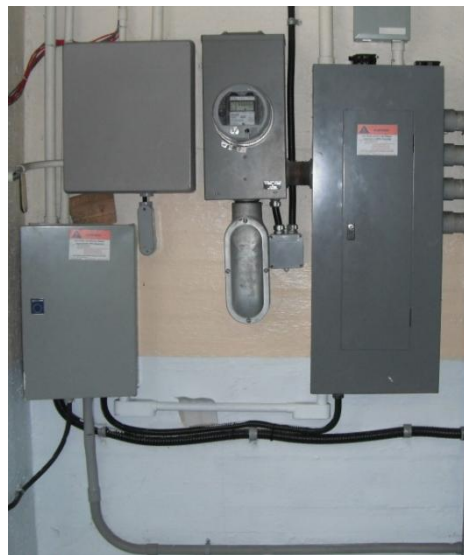
The transformer bank consists of two single phase 120/240 V transformers connected in a nonstandard open delta configuration. It will be replaced with a new transformer bank located in the substation. The existing single phase substation station service transformer connected to the 12.5 kV bus will be replaced with a three phase 120/208 V wye connect transformer bank. The service drop will be run overhead from the substation to the powerhouse.

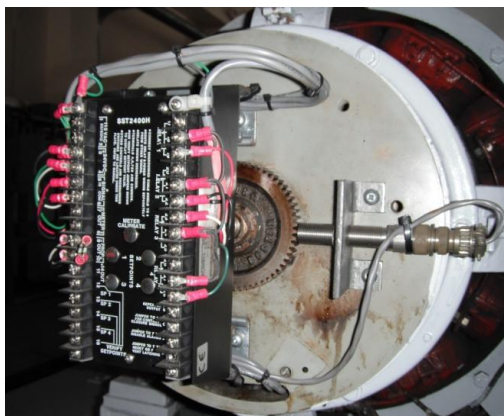
Figure 5 – Speed Switch, Sensor & Toothgear

The instrumentation has been upgraded over the past number of years with speed, bearing oil temperature and cooling water flow added in 1980 and vibration monitoring in 2007. Except for the speed switch on generator G1, all existing instrumentation will be maintained. The G1 speed switch will be removed and dual speed sensors installed on the existing toothgear to provide analog speed signals to the governor and unit control PLCs. The unit control PLC will perform the speed processing functions previously performed by the speed switch.

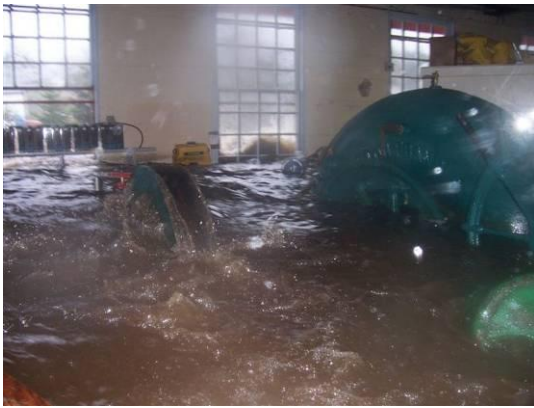
Figure 1 - 2m of water in the powerhouse
(Note: Turbine still spinning)

The generators, governors, switchgear, control panels, metering panel, battery bank, battery charger, DC distribution panel and AC distribution panel were partially or completely submerged by the approximate 2 metres of water that flowed through the powerhouse.

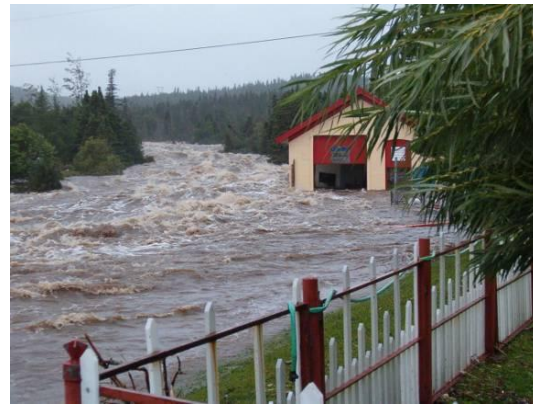
As water levels rose in the river adjacent to the plant, extensive damage was caused to the downstream plant access road. The flood waters also caused extensive damage to the Whirl Pond dam, the three Whirl Pond Freeboard dams and the Long Pond outlet structure.

Figure 2 - Flood Flows at Port Union Plant

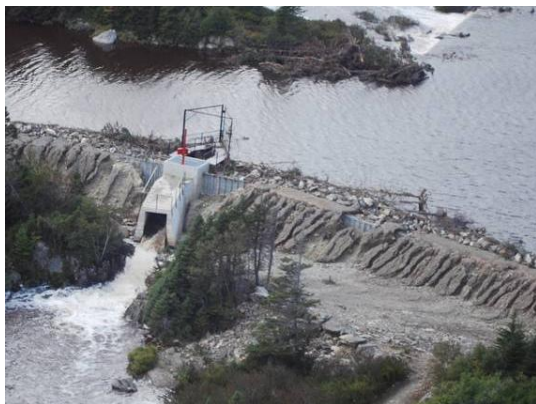
Figure 3 - Whirl Pond Dam

Storage structures on Whirl Pond and Long Pond also overtopped causing extensive damage. High flows eroded the abutments at the control gate on Long Pond. At Whirl Pond, the spillway capacity was exceeded by the flood flows that were 2.5 times the 1-in-1000 year flows. As a result Whirl Pond Dam overtopped eroding the crest and downstream side of the dam to the steel core as shown in Figure 3. The three freeboard dams on Whirl Pond were also damaged, with two being significantly eroded with overtopping flows and one receiving minor damage from wave action.

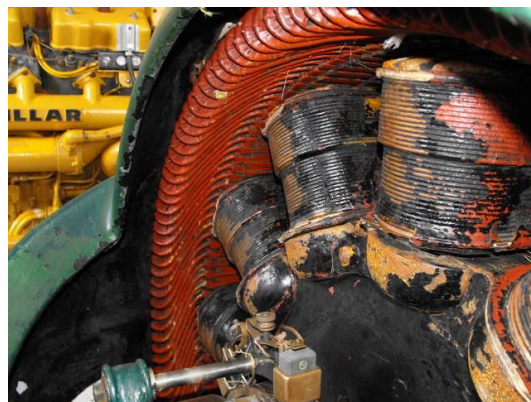
The two generators, G1 and G2, were disassembled, inspected and tested by a third party to determine the extent of the damage.² The stators have wood and grass embedded between the laminations. This damage is more extensive on G2 than G1. The G2 stator winding has short circuited to the steel casing. The G2 rotor poles and slip rings were damaged by impact with debris floating in the water. The G2 exciter windings are in poor shape with heat damage and visible burn marks suggesting the unit was energized as water levels rose. The commutator on the exciter has extensive copper damage.

Figure 1 - Damage to G1 Stator and Rotor

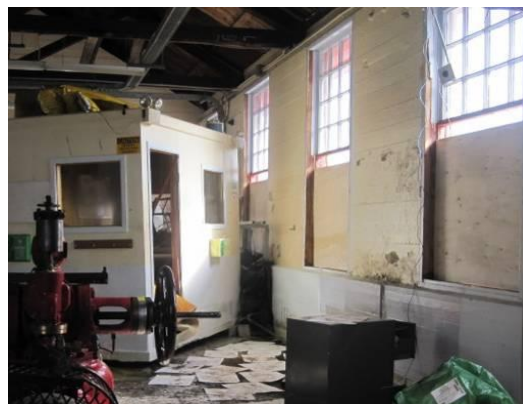
The powerhouse windows are used for ventilation when the generators are running. Flood waters entering the powerhouse damaged the lower portion of 15 windows as water passed through the plant. These wooden windows range in size from 1100 mm x 1400 mm to 1490 mm x 2775 mm. They were constructed in place with panes of glass measuring approximately 300 mm x 300 mm.

Figure 5 - Damaged Plant Windows

Immediately after the flood, the windows were temporarily boarded up to secure the plant and make it weather tight. The damaged windows are not repairable and therefore require complete replacement. The new sliding windows will be of vinyl construction.

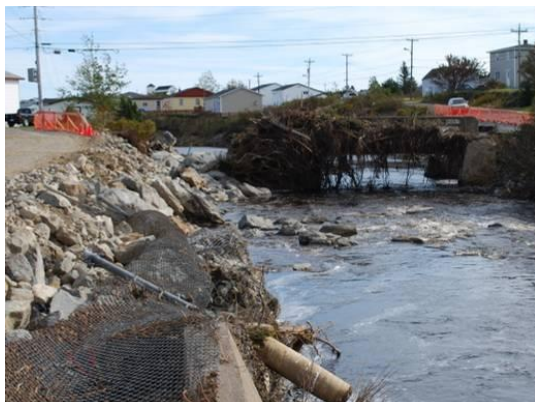
**Figure 6 - Erosion, Plant Access Road
(Downstream of Plant)**

The high flood waters in the channel adjacent to the powerhouse caused severe erosion of the access road. The road has been temporarily restored to allow access to the plant during the winter season. Additional work is required to permanently stabilize the road and provide long term access to the plant.

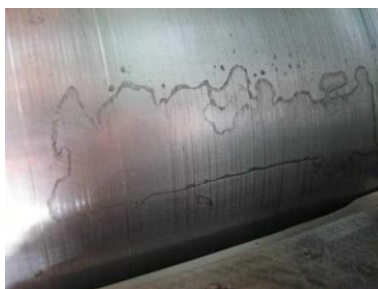
**Figure 7 - Turbine guide bearing
showing filiform corrosion. Depth of
defect is about 0.0005"**

As a result of the high water levels present, both units ran with no oil in the bearings for an extended period. Both units were disassembled, inspected and tested by a third party to determine the extent of the damage. Inspections revealed that water entered the bearings and caused corrosion and scoring. The bearings will be refurbished and bored to an adequate size. Bearing housings also show radial cracking of the threaded bolt holes, which will be repaired.

Some bearings were found to be misaligned by amounts that approach the allowable clearance. Bearing housings will be machined to correct alignment issues.

Both units will be reassembled using modern laser alignment techniques. This will ensure continued reliability of the refurbished components.

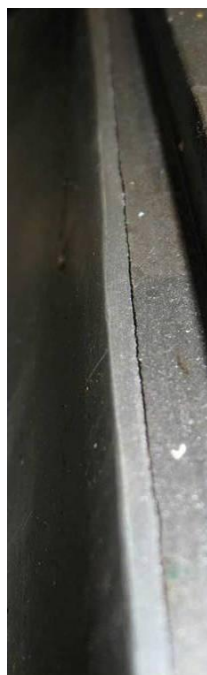
**Figure 9 –
Delaminating of
Babbitt**

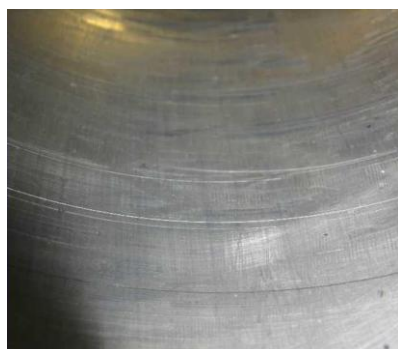
**Figure 8 – Scoring on
Babbitt**

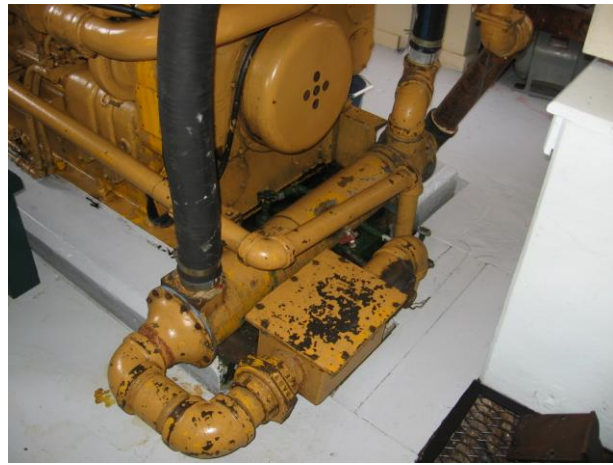
The February 2010 inspection identified oil leaks due to cracks in the cylinder head and oil pump housing, which required containment and absorbent materials in close proximity with the hot sections of the engine. Corrosion was prevalent, particularly on the exhaust system. Originally the engine cooling system used a mixture of water and glycol. Due to environmental concerns regarding the release of glycol into the local water system, the cooling system had previously been modified to use only water cooling. The modified cooling water system had experienced regular failures. The unit was last operated in 2007, at which time it had approximately 800 operating hours.

Engine Tube Cooler

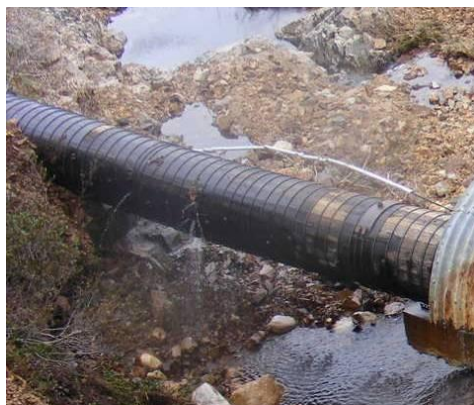
Figure 1 - Undermined Penstock

The flood washed out six of the original timber penstock supports and eroded the underlying fill. Immediately after the flood, the penstock was temporarily supported with timber cribbing, stabilizing the penstock and allowing the plant to operate safely.

The temporary timber cribbing will be replaced in 2011 with timber supports replicating the original design. The subgrade will be returned to its pre-storm elevation. These repairs will ensure the long term stability of the penstock.

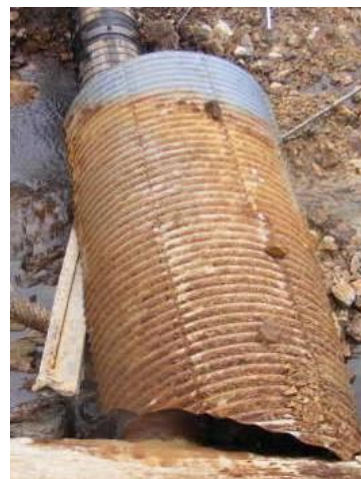
As the flood waters overtopped the Lawn dam, the rockfill was washed away and the culvert's concrete foundations were undermined, causing them to be displaced and damaging the culvert. The damaged concrete and culvert were removed as part of the temporary repair work in 2010.

**Figure 2 - Damaged multi-plate culvert
(Rust indicates extent of the rockfill)**

In 2011, new downstream rockfill and a new multi-plate culvert will be installed. The material used for the rockfill will be of sufficient size to withstand the wave overtopping that would result from a 1-in-500 year return period storm.

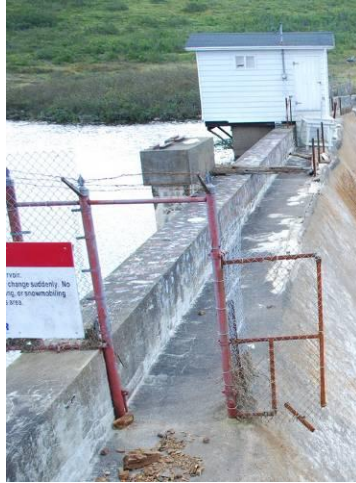
Figure 3 - Damage to Fence

The gatehouse support struts and cladding were damaged by the force of the water. The gatehouse will be refurbished to return it to structurally sound and weathertight condition. The security fence that limits public access to the dam was damaged and will require replacement.

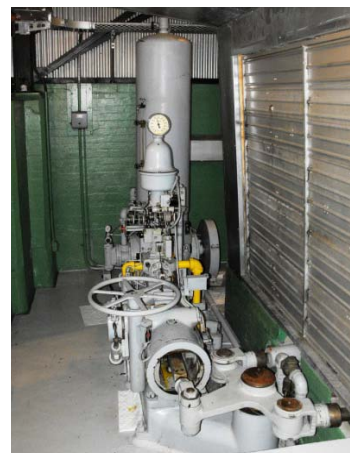
Figure 1 - Woodward Governor

The governor is a Woodward Model HR size 10 x 14 gate shaft hydraulic unit. It has a rated torque of 16,300 ft-lbs and pressure supplied by a size 27 gear pump. The unit was reconditioned in 2001. The original equipment manufacturer discontinued supplying replacement parts for these units as of July 1, 2008. Due to its robust design with no parts exposed to excessive wear, the hydraulic power portion of the governor will remain serviceable for many years.¹

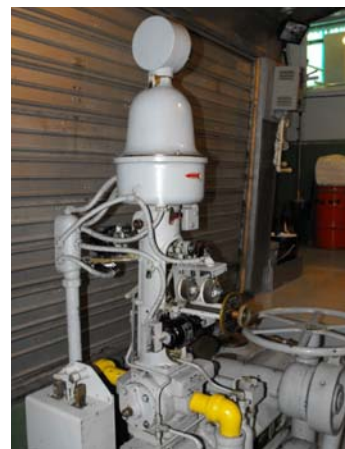
Figure 2 - Governor Control

The governor consists of two sections, the power piston and the control head. The power piston provides the force necessary to operate the wicket gates under load. The control head adjusts the position of the power piston to maintain system frequency through varying load conditions.

The control head will be replaced as far as the relay valve, which initiates the movement of the power piston, with a PLC based digital control system. The fly ball governor head, pilot valve assembly, mechanical restoring linkages and permanent magnet generator, used for speed sensing, will be removed. The new governor control system will facilitate the implementation of a water management system.

The existing hydraulic power piston assembly will be retained, along with the relay valve, hand wheel, and gate operating linkages. Reconditioning of all seals, bushings and other components, that have deteriorated over the past 48 years, will be required. This will eliminate leakage and extend the life of the power piston and relay valve assemblies.

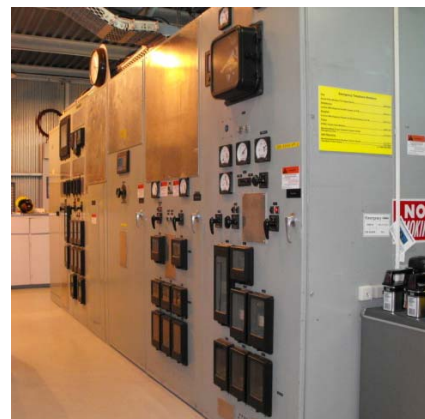
Figure 3 - Switchgear and Control Panels

The generator breaker, emergency station service transformer, potential transformers (PTs) and current transformers (CTs) are integral to the switchgear and are original units installed in 1963. Concerns of failure exist because of the condition and age of this equipment. The existing Westinghouse Type DH generator breaker is at the end of its service life and must be replaced. The PTs and CTs must also be replaced. They are all critical to electrical protection of the generator. The emergency station service transformer bank consists of two single phase 120/240 V transformers connected in an open delta configuration. This is no longer standard. It will be replaced with a three phase 120/208 V wye connect unit.

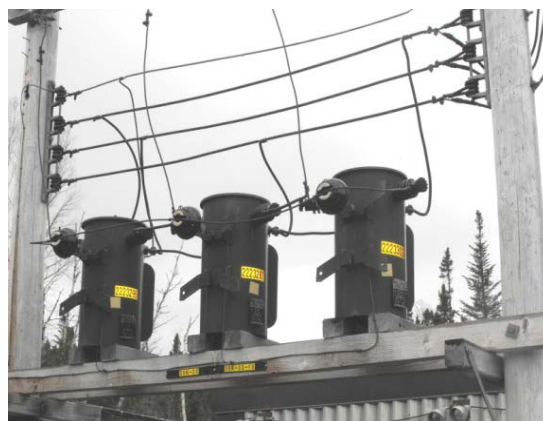
Figure 4 - Station Service Transformers

The main AC service entrance from the substation, the essential services panel and transfer switch were installed in 2000 and do not require any modification. The main service is supplied from the original 120/240 V closed delta transformer bank located in the substation, which will be replaced with a standard 120/208 V transformer bank.

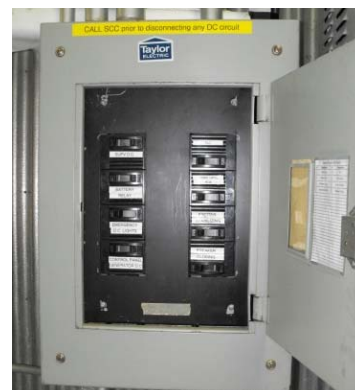
Figure 5 - DC Panel

The 8-circuit DC distribution panel with separate main breaker is original. Currently, there are not enough circuits to accommodate each device in the protection and control system. Items have been paralleled together which is not normal practice. A new 60-circuit panel will be installed to provide adequate capacity, improved circuit isolation and ensure the availability of replacement circuit breakers.

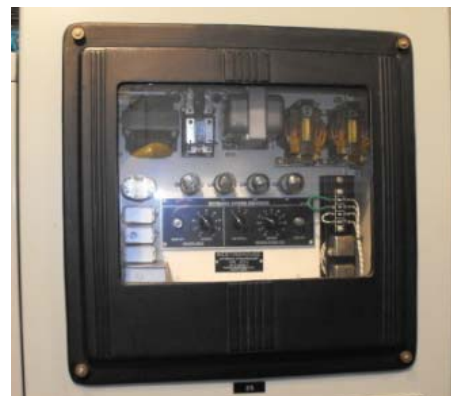
Figure 6 - XT7 Auto-synchronizer

The Westinghouse XT7 auto-synchronizer is an electromechanical relay utilizing vacuum tube technology included with the original installation. It is no longer supported by the manufacturer and will be replaced. A synchrocheck relay will be installed to supervise both automatic and manual synchronizing. It will ensure unit speed and voltage are within acceptable limits before the generator breaker closure is permitted. The synchronizing function will be incorporated in CGCM Module located in the unit control panel.
