1 **Q. Describe Newfoundland Power's asset management practices for its generating**
2 **facilities, including both maintenance and capital refurbishment programs and**
3 **practices, and how the generator maintenance programs are managed including the**
4 **use of maintenance management software. In the response provide copies of any**
5 **documents that describe the policies and practices followed.**

6
7 **A. 1. Generation Asset Management Practices**
8

2. Generation Capital Refurbishment Programs

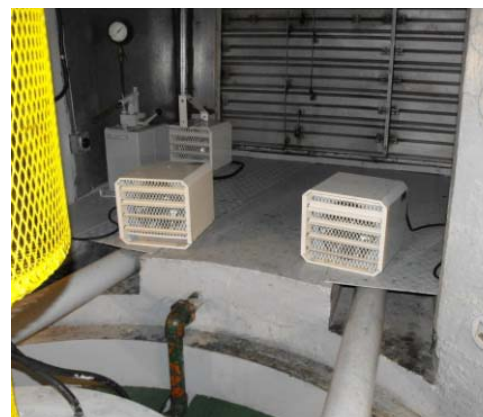
Figure 7 - Anti-condensation Heaters

There are no infrared heaters installed over the unit. The anti-condensation blower type heaters in the turbine pit are located in the air intake plenum and controlled by a humidistat located in the generator room. There are two exhaust fans located in the building that are in good condition.

The heat and ventilation controls will be consolidated into one plant control panel and integrated with the plant control PLC. Temperature and humidity sensors will be installed in the generator room and turbine pit. Infrared heaters will be installed and new blower heaters will be mounted under the generator windings. This will help prevent condensation on the generator windings when the unit is not operating.

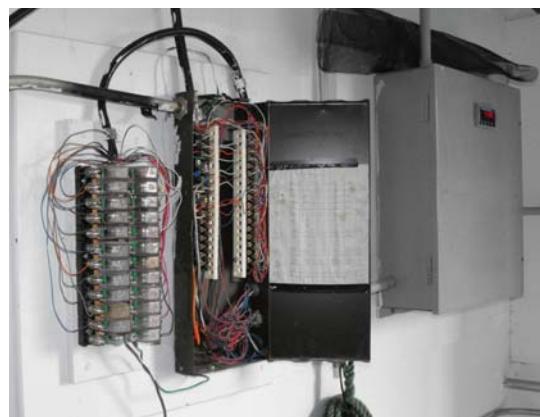
Figure 8 - Forebay Water Level System

The forebay water level system is critical to the implementation of the Water Management System in the PLC. The water level probe was replaced in 2006 and does not require any work. The water level and trash rack signals are transmitted to the plant utilizing pulse modulated and hard wired signals over a 25 year old copper communications cable which is susceptible to lightning damage. The communications cable has 3 of its 11 pairs made unusable by lightning. To improve reliability, eliminate legacy equipment with its inherent maintenance problems and to facilitate the use of more reliable technology, the copper cable will be replaced with a fibre optic cable. The existing communications system will be upgraded to technology compatible with the new control system.

The plant PLC will use the water level signals to control the Water Management System. High level (spill) and low level alarms will also be initiated when specified levels are reached.

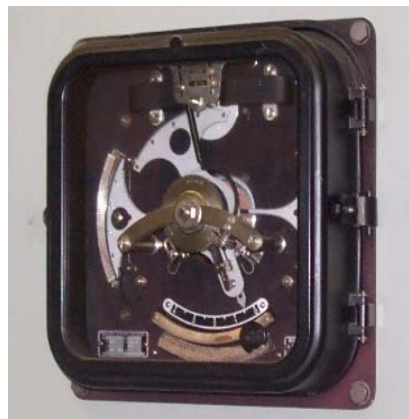
Figure 1 - BB Voltage Regulator

G3 has a Brown Boveri voltage regulator (Figure 1) with a mechanical operating mechanism. The mechanical operating mechanism is worn from 50 years of operation affecting responsiveness of the regulator. The voltage regulator is manufacturer discontinued and cannot be integrated into the upgraded control system. The existing voltage regulator will become redundant⁴ with the installation of a modern PLC providing plant control.

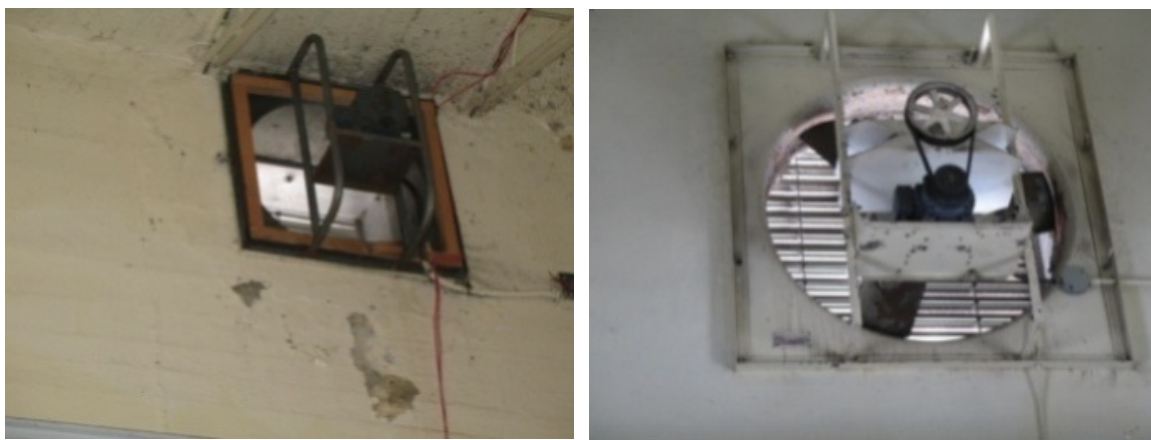
There are infrared heaters installed over each generator with both blower type and convection heat in the valve and generator pits. There are three exhaust fans (Figure 2) located in the building. The outside louvers have no operating mechanism, making it difficult to control plant heating and ventilation.

The amount of installed plant heat is inadequate due to the size of the electrical service and distribution panels.

The heating and ventilation controls will be consolidated into a common heating control panel and integrated with the plant control PLC. Additional heat will be installed to prevent condensation on the generators and freezing of the cooling water pipes in the winter when the units are not operating. Louvers will be replaced and controls added to better manage plant heating and cooling cycles.

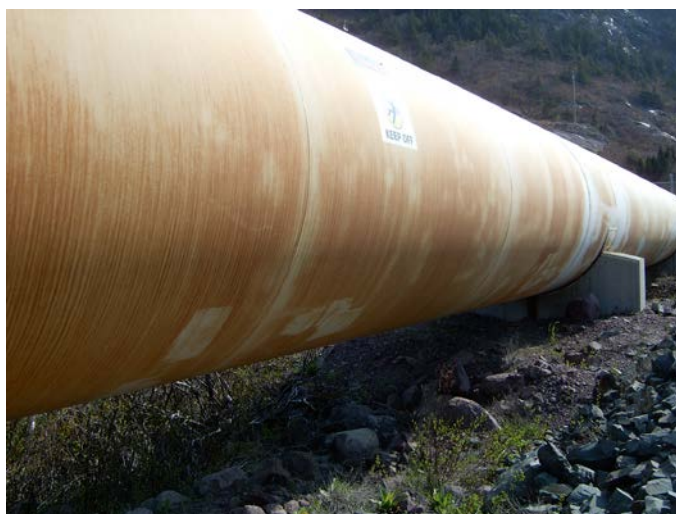
The penstock was replaced in 1999. In 2002 the penstock paint system started to show signs of deterioration and over the last year the level of deterioration has increased. Most of the surface area has significant rust staining indicating that the surface is permeable and not protecting the steel as intended. Water and oxygen are able to penetrate the coating system and are causing the penstock to rust. The entire steel penstock should be recoated.

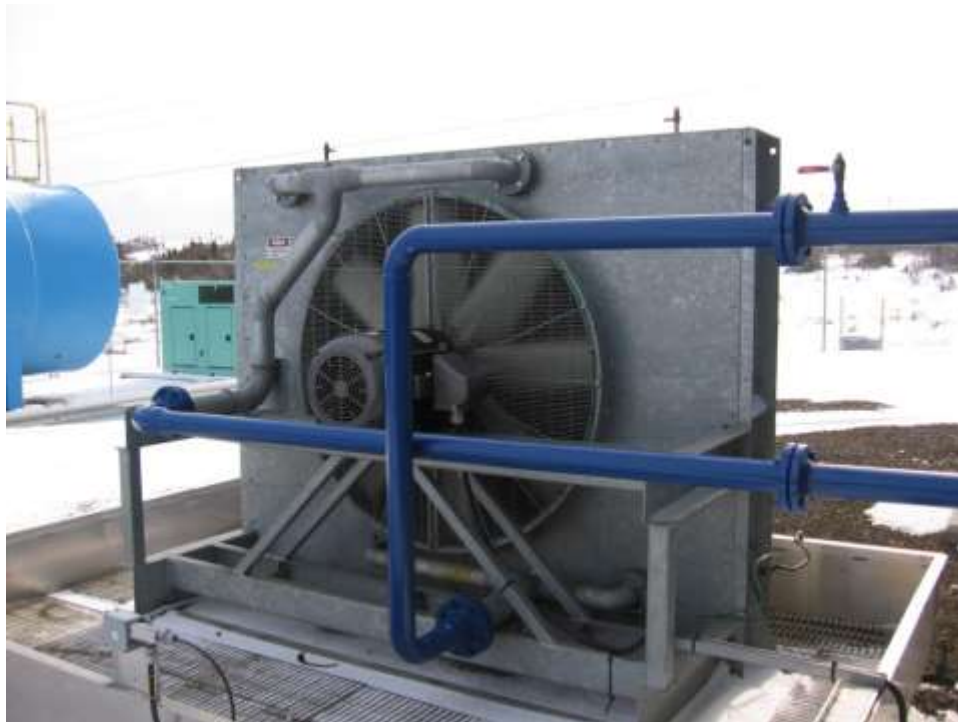
Figure 2 – Lubricating Oil Cooler

On January 5th, 2014 the lubricating oil cooler developed leaks in the junction between the core and the expansion tanks. Repairs were completed and the cooler returned to service on January 22nd, 2014. Since the cooler was returned to service, other leaks have developed. On that basis, it has been determined that the cooler must be replaced.

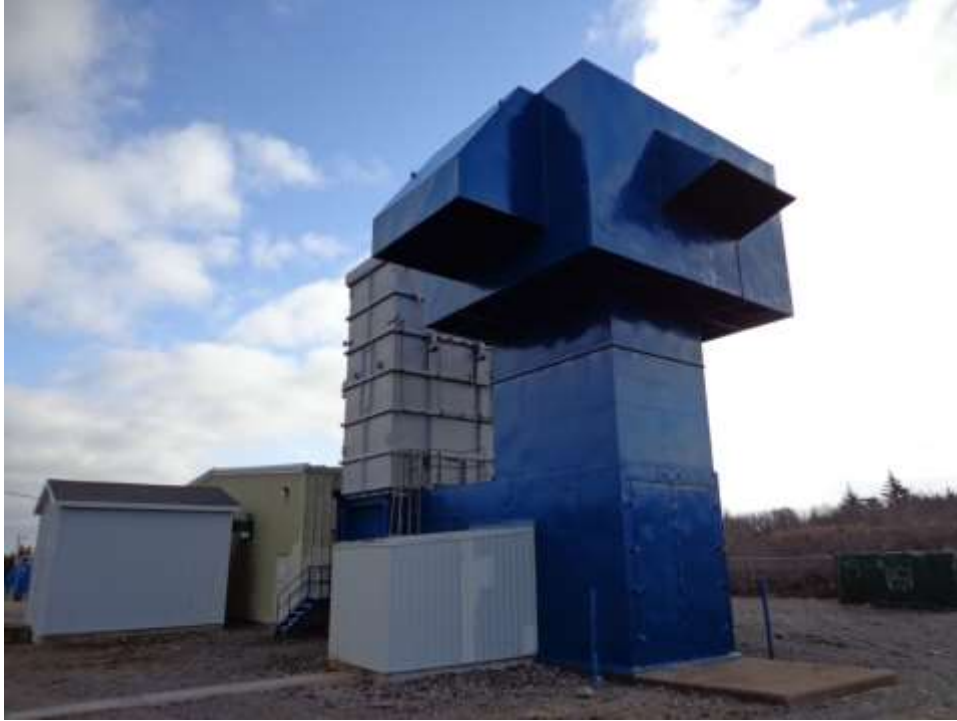
Figure 1 – Air Intake Plenum

A borescope inspection of the Rolls Royce OLYMPUS gas generator was completed on March 19th and 20th, 2014 on site at the Greenhill facility. Debris found in the air intake plenum is attributable to corrosion of the walls and other surfaces. This debris could enter the gas generator and cause impact damage. The internal inspection of the gas generator identified many areas where there is a loss of coating. Some corrosion was found in the HP compressor and on the stators. The combustion chambers are showing carbon buildup and experiencing corrosion. Blades in the turbine section have lost coating and the leading edges are showing signs of degradation. The signs of wear and extensive coating loss throughout are consistent with the amount of time since the last overhaul. However, if this deterioration is allowed to continue indefinitely, it could lead to catastrophic failure of the gas generator.

Based on the inspection results, the gas generator at Greenhill is serviceable in the immediate term; but, action will soon be required. It is therefore recommended that a plan be put in place for the gas generator be removed and transported to an authorized repair facility for a complete overhaul at an appropriate time subsequent to the next winter season.

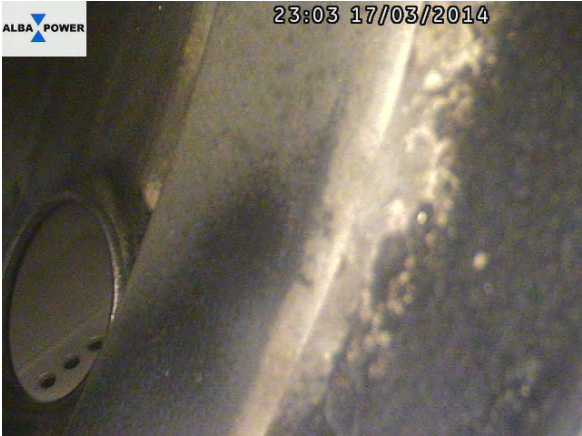
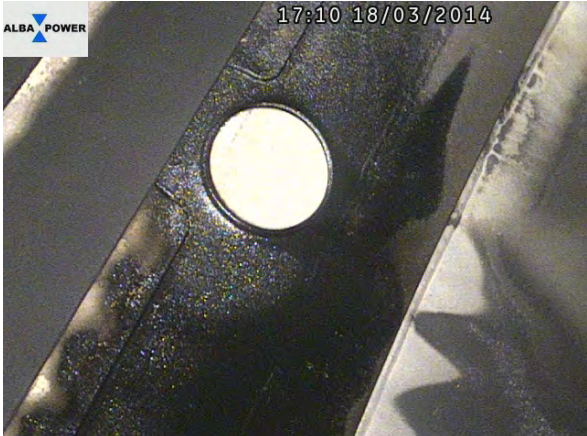
Carbon build up on combustion chamber	Carbon build up on combustion chamber

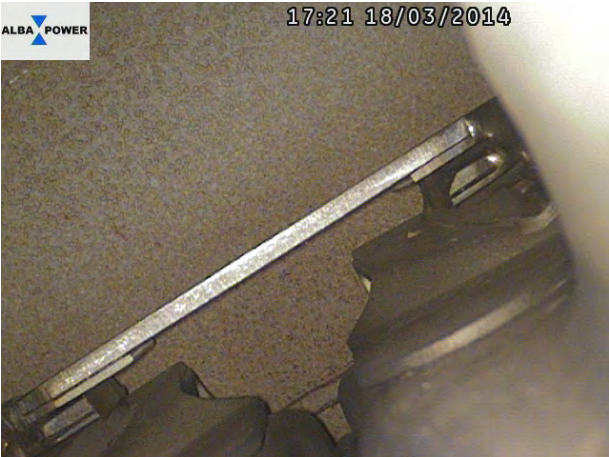
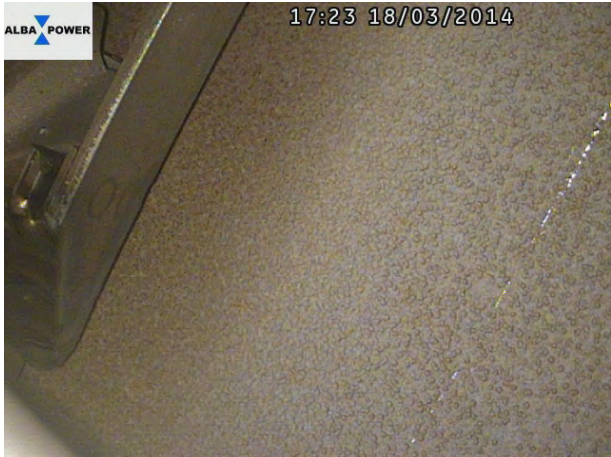
Bridge piece on the combustion chamber	Bridge piece on the combustion chamber

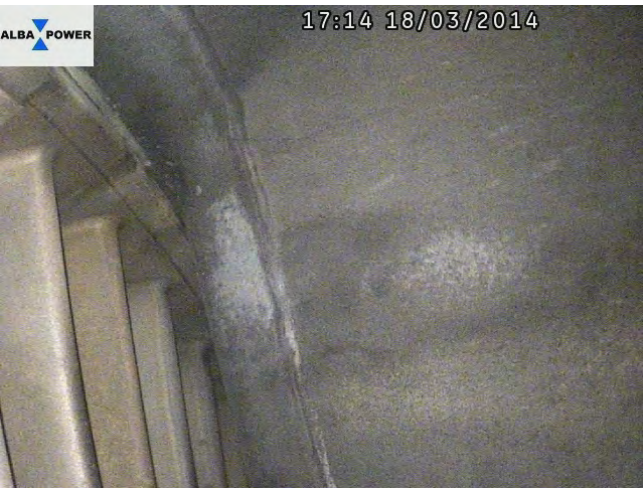
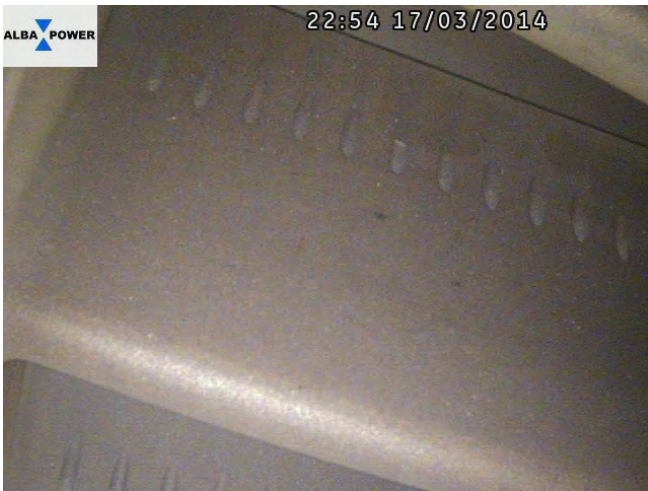
<p>Discharge nozzle and HP NGV</p>	<p>HP NGV</p>

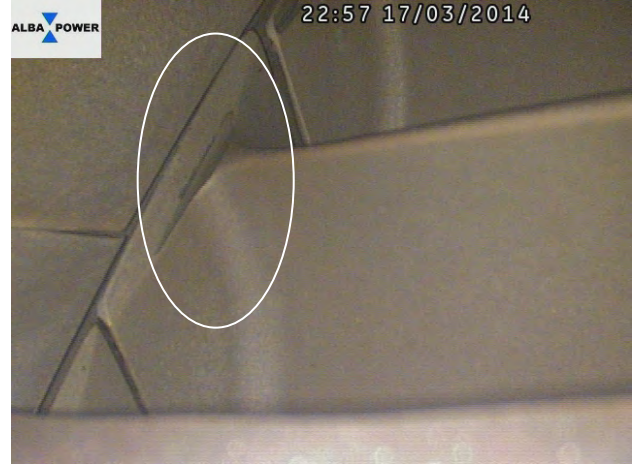
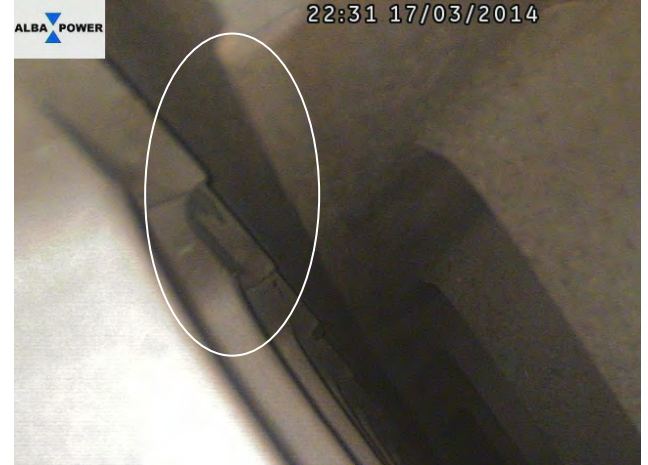
<p>Rub on HP turbine blade</p>	<p>Rub on HP turbine blade</p>

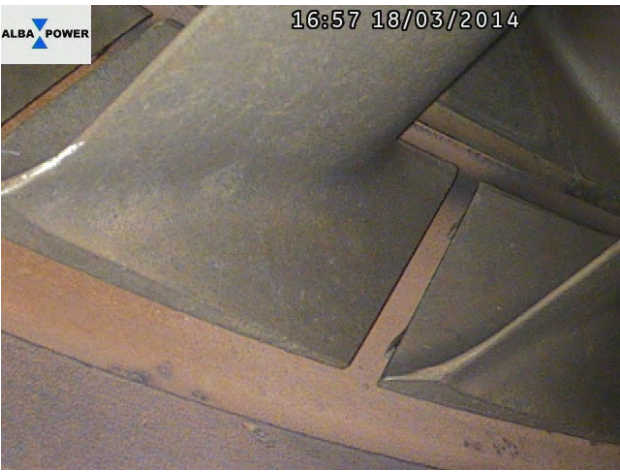
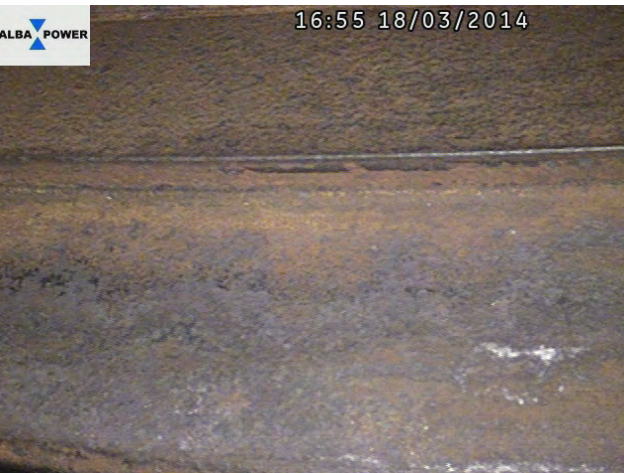
<p>16:55 18/03/2014</p>
<p>LP turbine blades (worn fir tree roots)</p>	<p>The hard face coating on the exhaust is very worn</p>

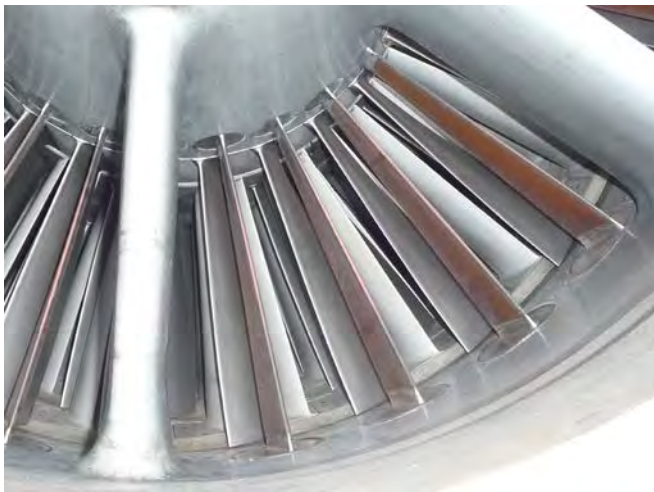
Air intake casing

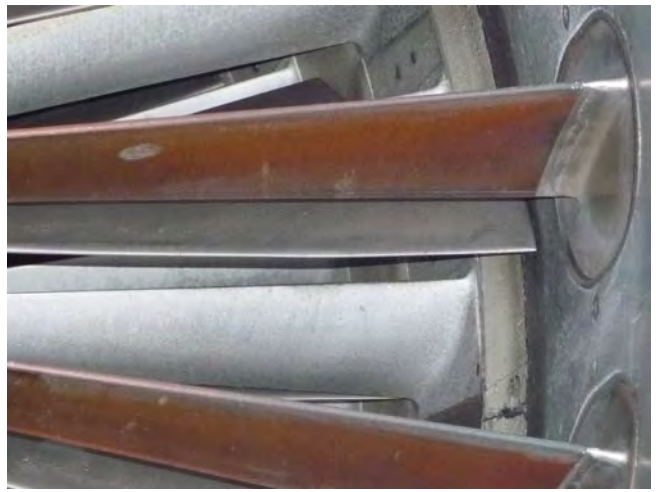
Air intake casing with IGV's

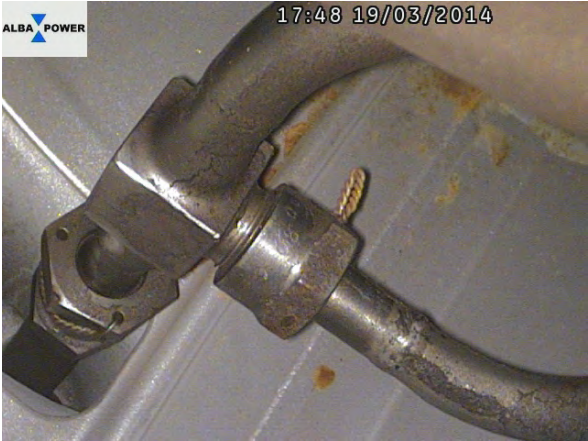
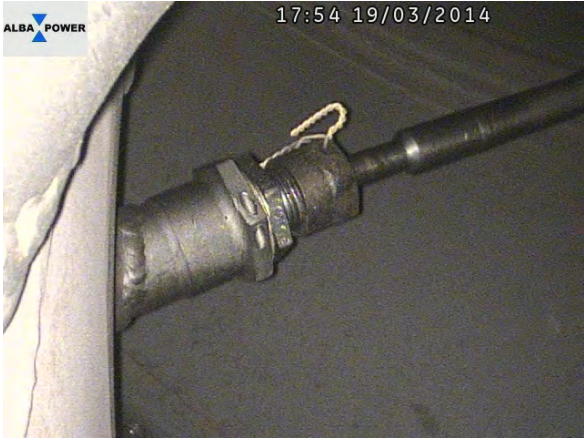
Oil pipes inside the delivery casing	Number 7 bearing oil feed pipe

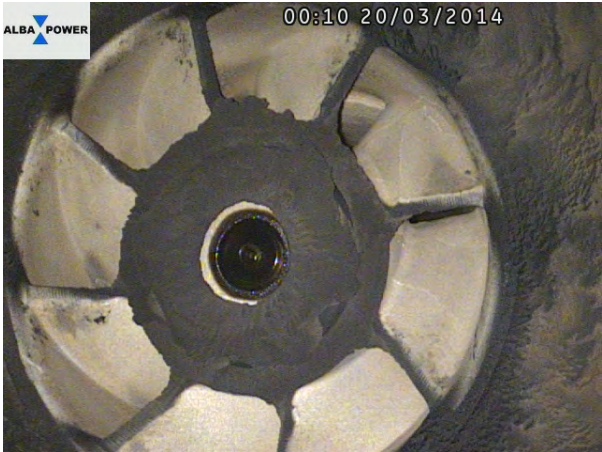
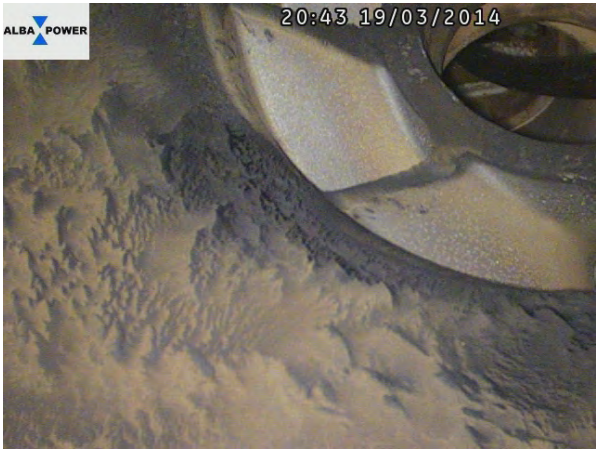
Carbon build up combustion chamber	Carbon build up combustion chamber

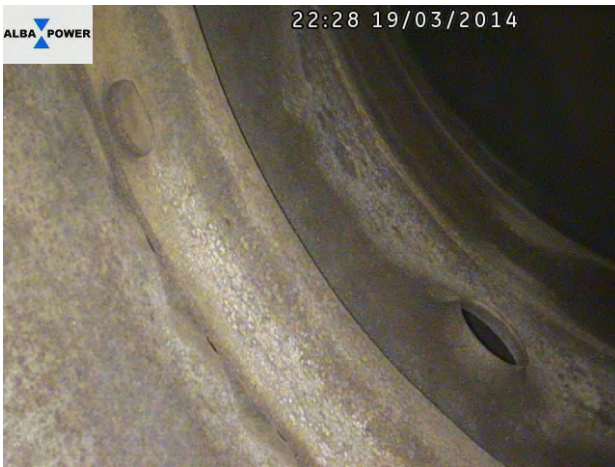
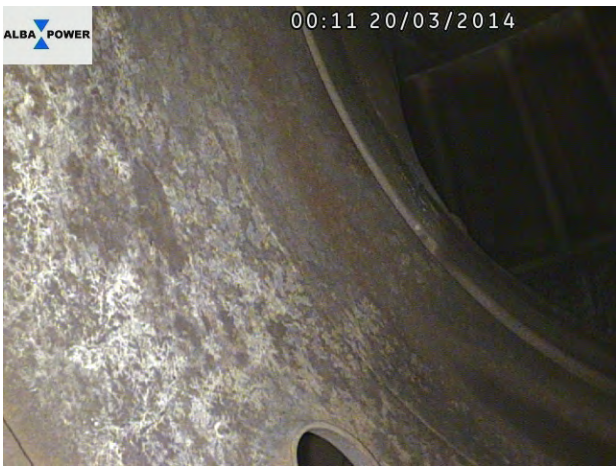
<p>00:11 20/03/2014</p> <p>ALBA POWER</p>
<p>Combustion chamber corrosion</p>	<p>Combustion chamber corrosion</p>

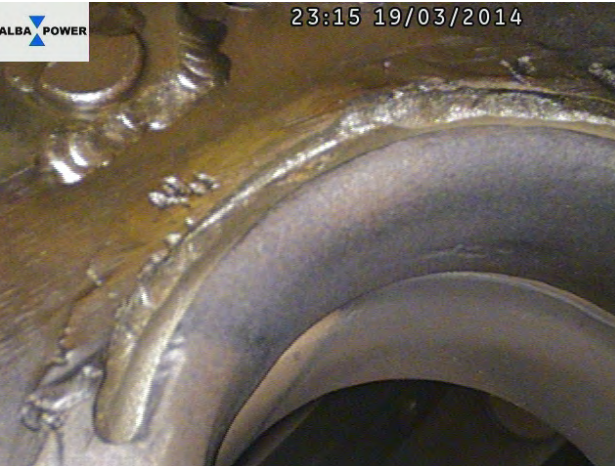
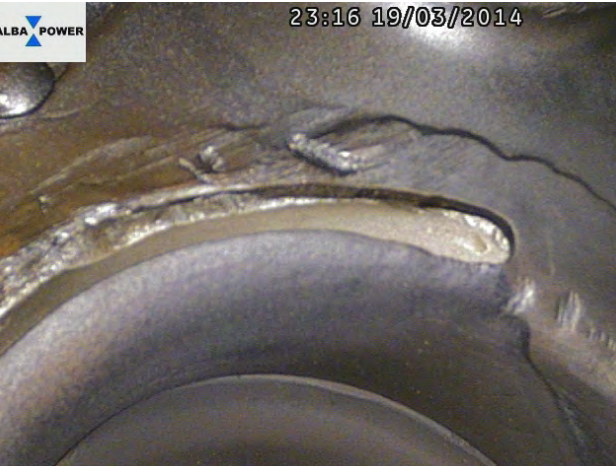
<p>23:16 19/03/2014</p> <p>ALBA POWER</p>
<p>Old repair on No.5 combustion chamber</p>	<p>Old repair on No.5 interconnector</p>

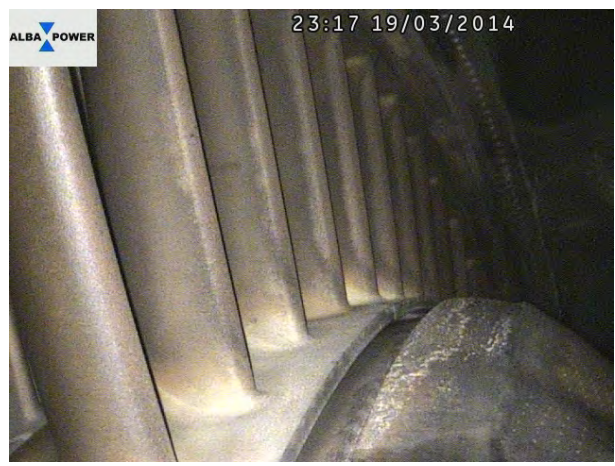
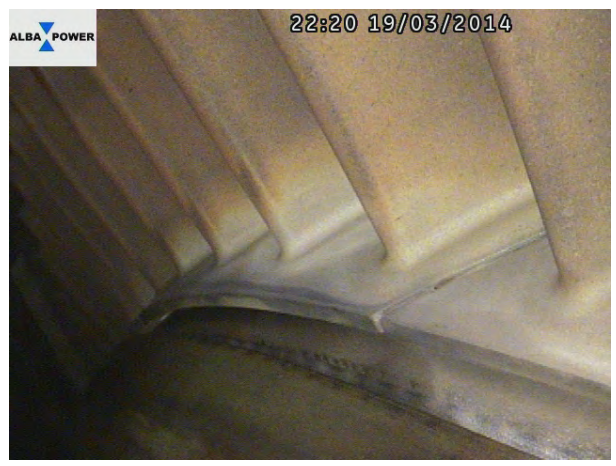
<p>22:20 19/03/2014</p> <p>ALBA POWER</p>
<p>Leading edge HP NGV</p>	<p>Leading edge HP NGV</p>
