1. Hydraulic Generation Refurbishment and Modernization (2019-2020)

Hydraulic Generation Refurbishment and Modernization

July 2018

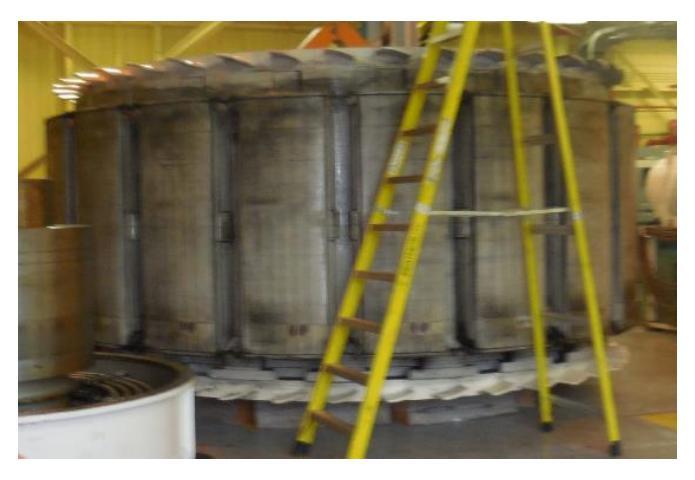
Figure 2: Hinds Lake Rotor – The rotor fans that circulate air to cool the Rotor and Stator are bolted to the top and bottom of the rotor

Any oil leaks or oil misting from the upper guide bearing assembly during operation ultimately
ends up on the rotor. This mixture of oil and carbon dust embeds in the rotor causing
deterioration of the rotor pole winding insulation. Regular cleaning of the rotor and stator
completed during the unit overhauls on the Hinds Lake Unit have proven to be ineffective in
achieving acceptable rotor test readings. Typically the readings should be above 500 Mohms⁴.
When the reading is below 0.1 Mohms it will be unsafe to operate the unit. Table 12 lists test
results that indicate a trend that the unit is approaching a critical operating state.

- 14 The scope of work includes:
- Dismantle of the top of the unit to expose rotor;
- 16 removal of rotor;
- removal of poles to transport to refurbishment site;
- 18 refurbishment of poles (rewind/replace insulator);
- testing of poles to ensure quality;
- reassembly of rotor;
- installation of the rotor on the unit;

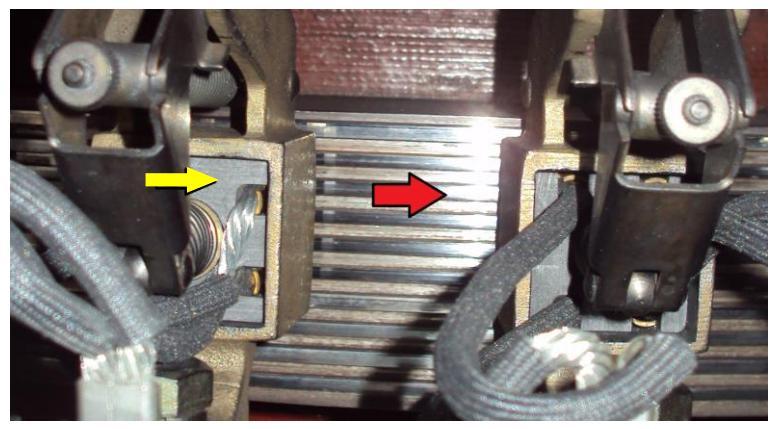
Figure 3: Slip ring (red arrow); Brushes (yellow arrow). There are 26 brushes and two rings

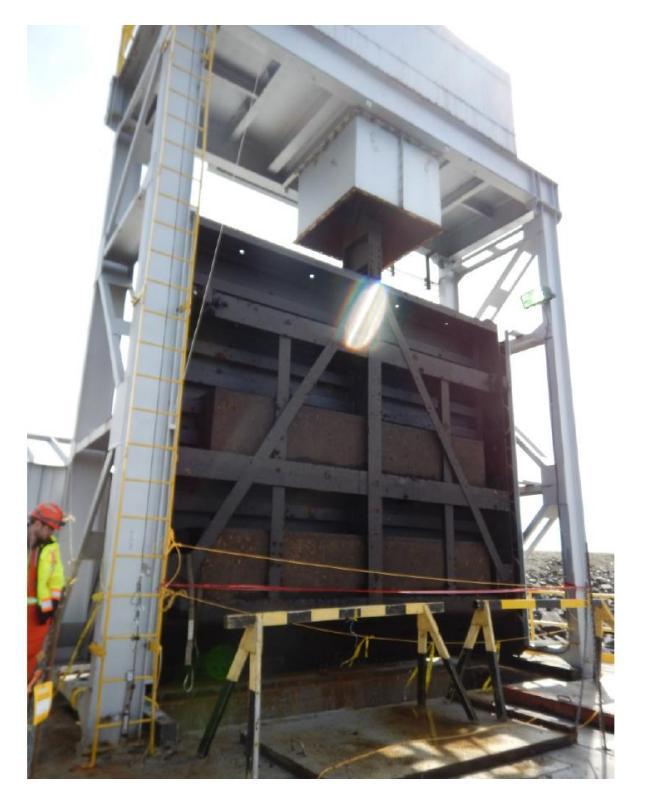
Figure 4: Bay d'Espoir Intake Gate 1

1 Existing State

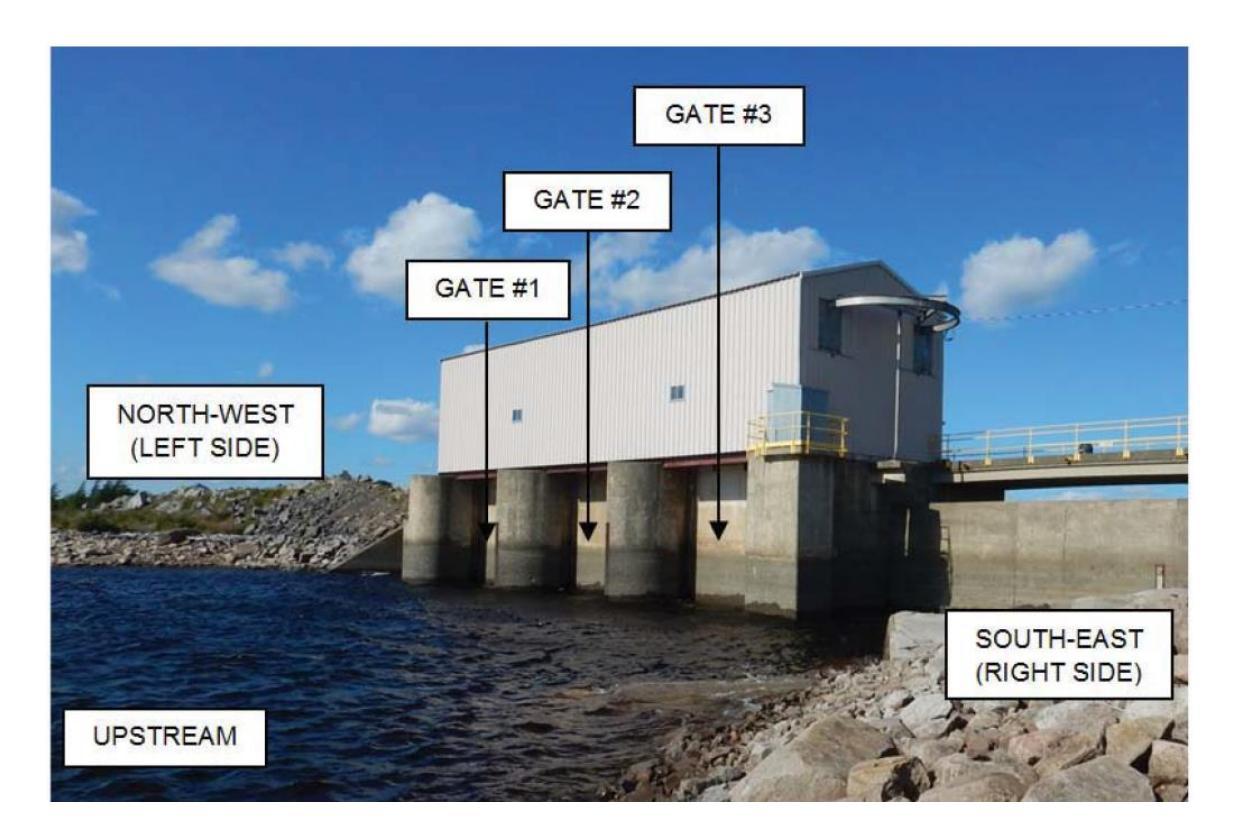
Figure 7: Ebbegunbaeg Control Structure

8 In 2017, a detailed condition assessment of the Ebbegunbaeg control structure was completed. 9 The assessment revealed operational issues with the gates, which include damage to the main 10 rollers, embedded parts and lifting systems. The assessment also identified concrete 11 deterioration on the piers, decking, and around the embedded parts. Figure 8, Figure 9, and 12 Figure 10 show some of the deteriorated conditions.

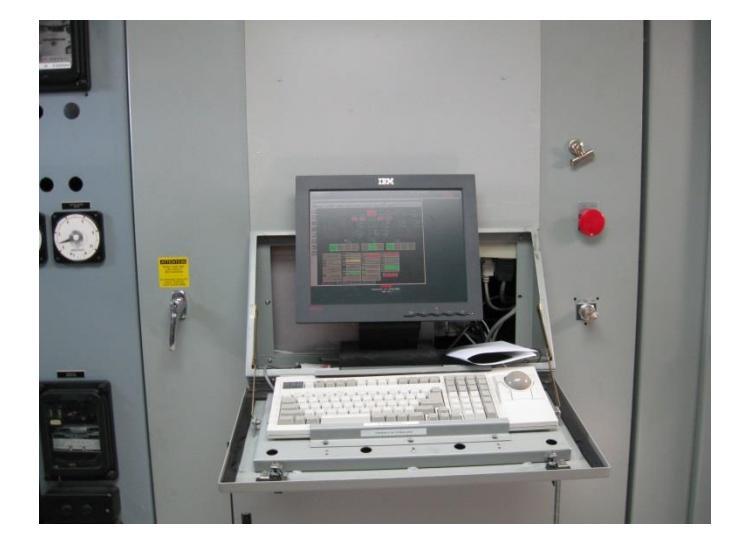
Figure 1: HMI Console

5 The HMI consists of specialized software called PCView and an operating system called QNX 6 (not a Windows compatible product) running on an obsolete computer that is connected to the 7 gas turbine control system. Communications modules reside in the control system cabinet that 8 connect to the HMI computer. Interactive graphics were developed by the manufacturer for the 9 HMI, which consist of graphics for control, monitoring, alarms, and trended data.

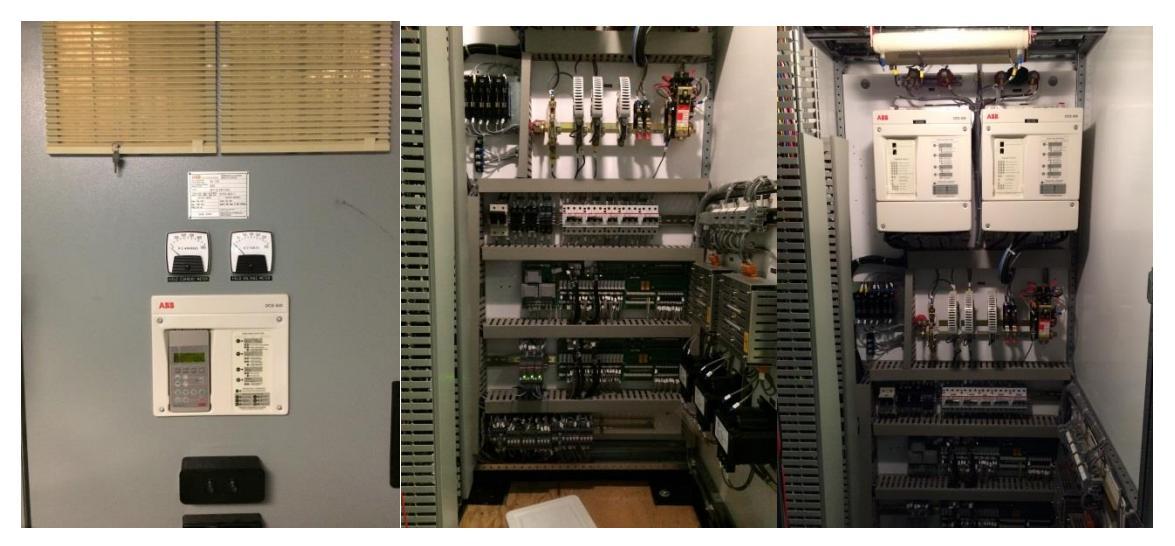
Figure 2: AVR Cabinet (Left to Right: Front, Inside Top, Inside Bottom)

This AVR was installed in 2006 and the manufacturer moved the model into the 'Limited' phase 1 2 of its life cycle in the beginning of 2017. This phase means the manufacturer cannot guarantee 3 life cycle services and support due to the scarcity of key components and technical knowledge. Therefore, a component failure may result in unavailability of the gas turbine for an extended 4 5 period due to scarcity of replacement components. As well, the AVR software used for 6 configuration and troubleshooting does not work with modern Windows operating systems, 7 restricting the ability of Hydro personnel to use computer-based tools for troubleshooting. As a 8 result, Hydro has to engage the manufacturer for troubleshooting activities, which increases 9 the time to correct problems.
