July 15, 2025

**Re: 2026 Capital Budget Application**

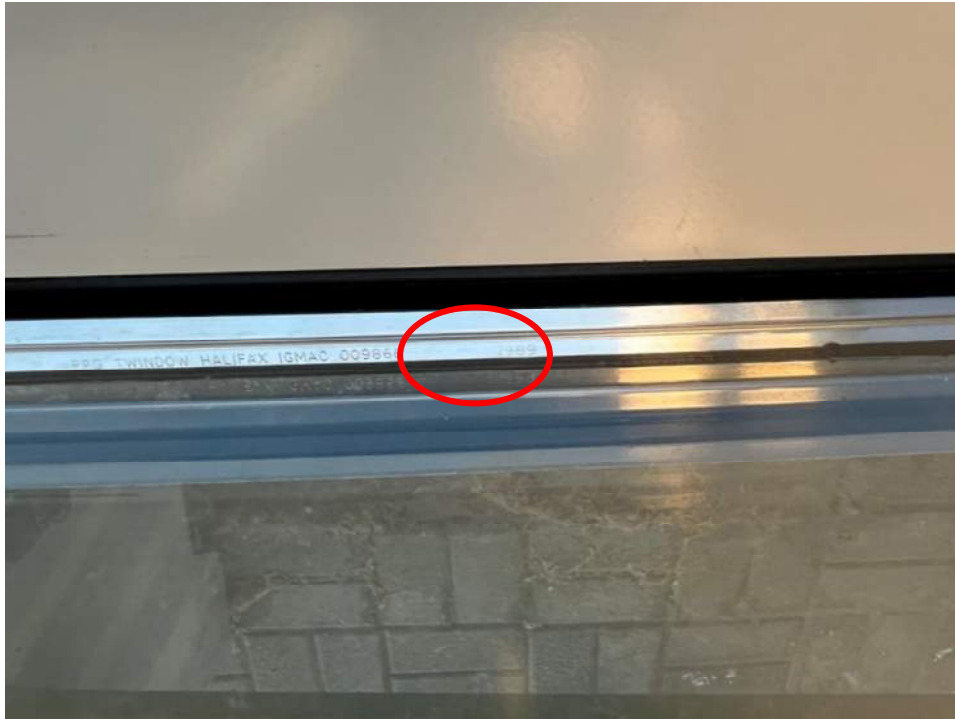
Photo No. 5: Typical view of a 1989 IGU date stamp (red circle)

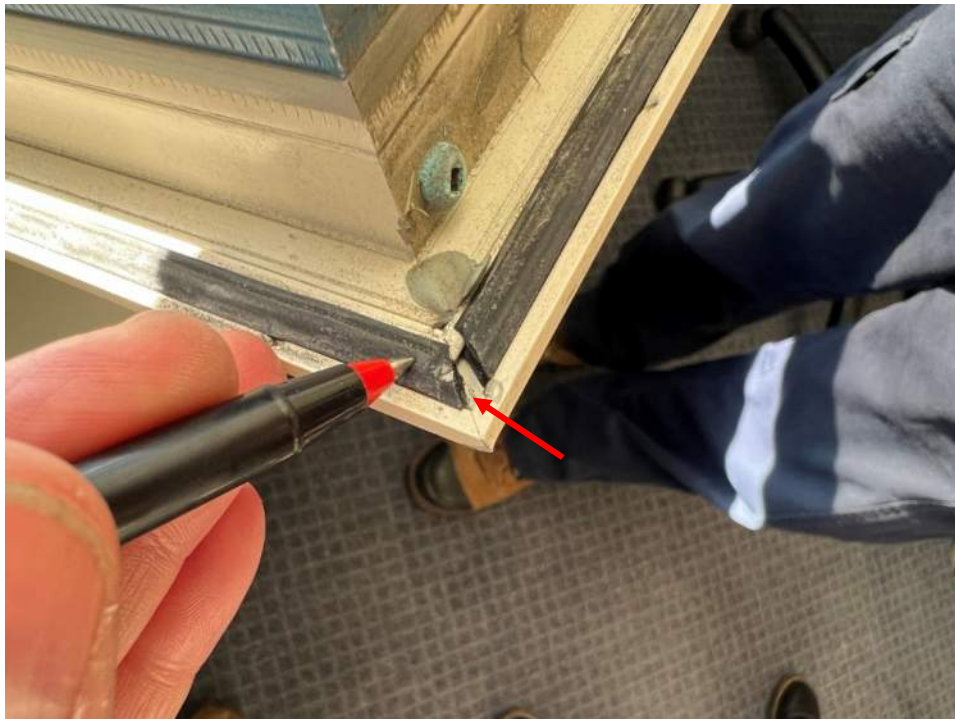
**Photo No. 12:** Typical view of weather stripping appears in poor condition with gaps

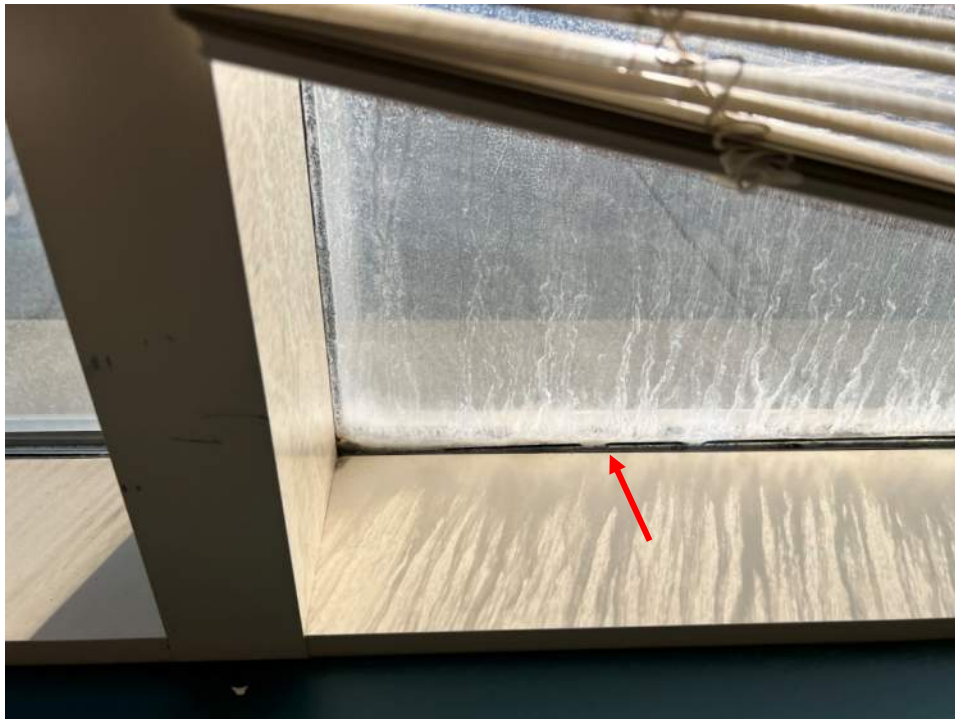
**Photo No. 14:** Typical view of interior glass-to-metal gasket is noted to be poor condition and failed IGU (red arrow)

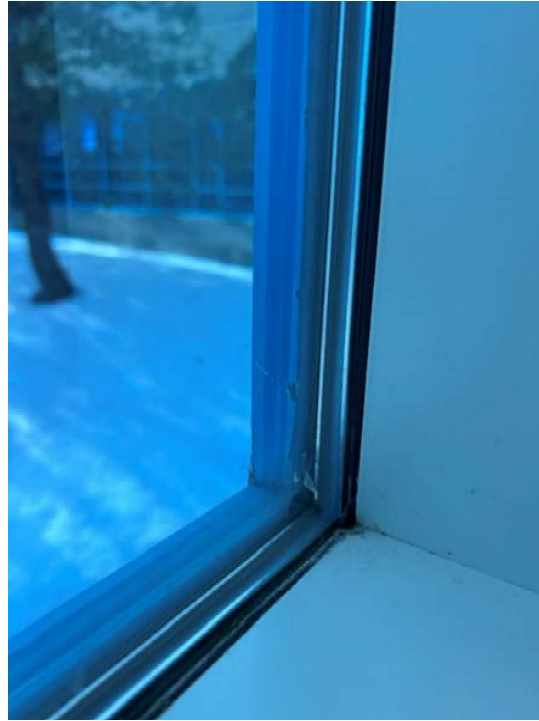
Photo No. 15: Typical view of interior glass-to-metal sealant is noted to be poor condition

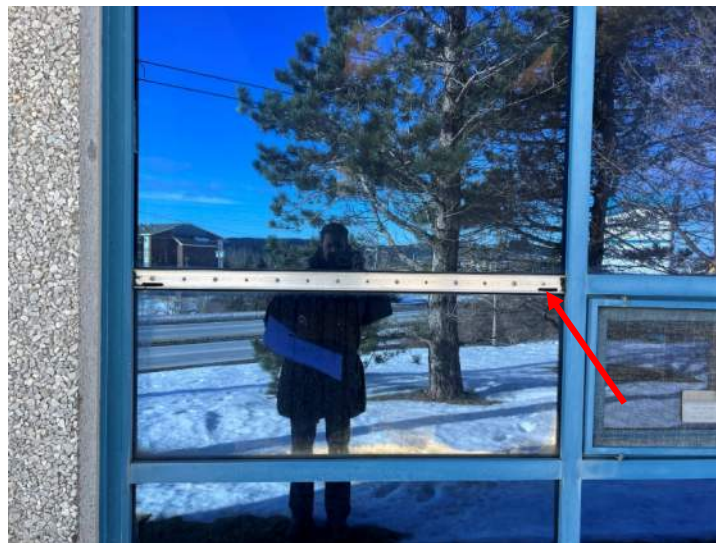
Photo No. 16: Typical view of pressure plates that have been installed upside down (red arrow)

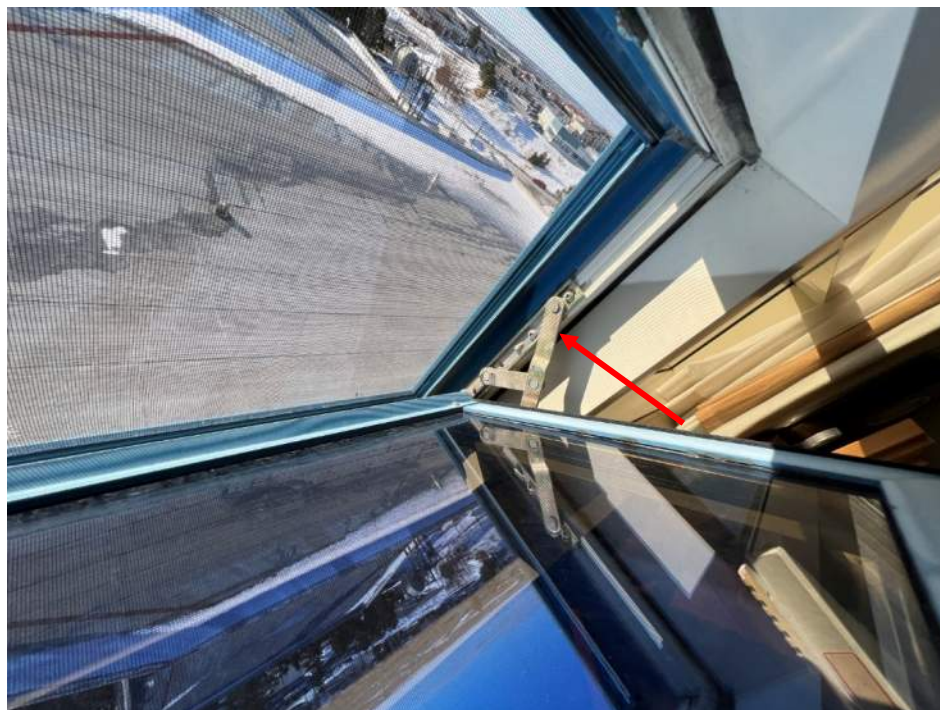
**Photo No. 18:** Typical view of rusted roto gear (red arrow)

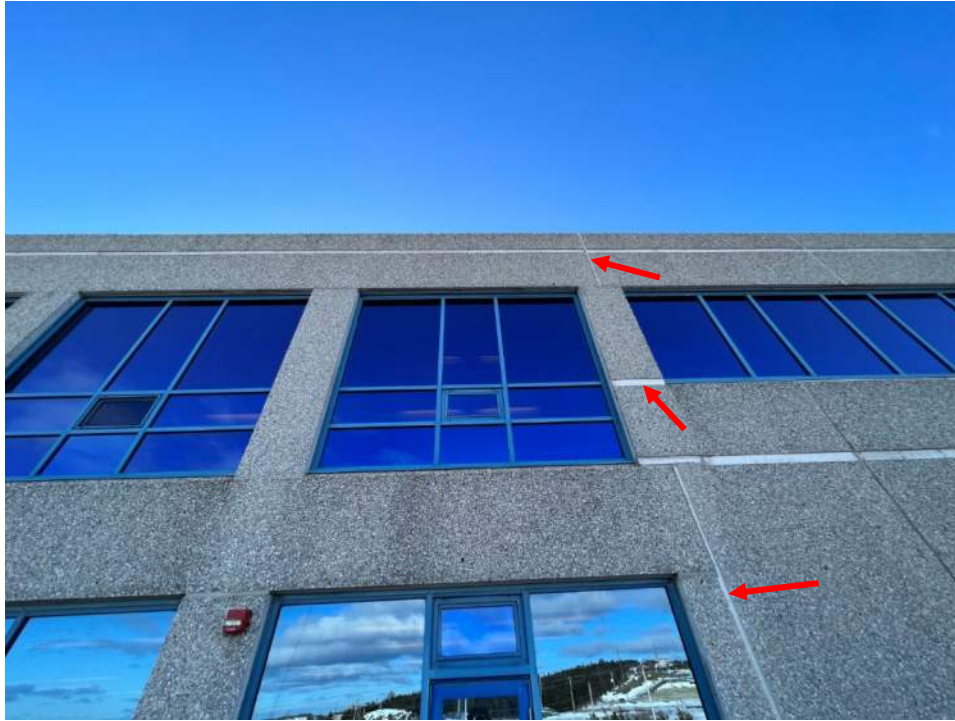
Photo No. 19: View of the localized precast panel joints has been repaired (red arrows)

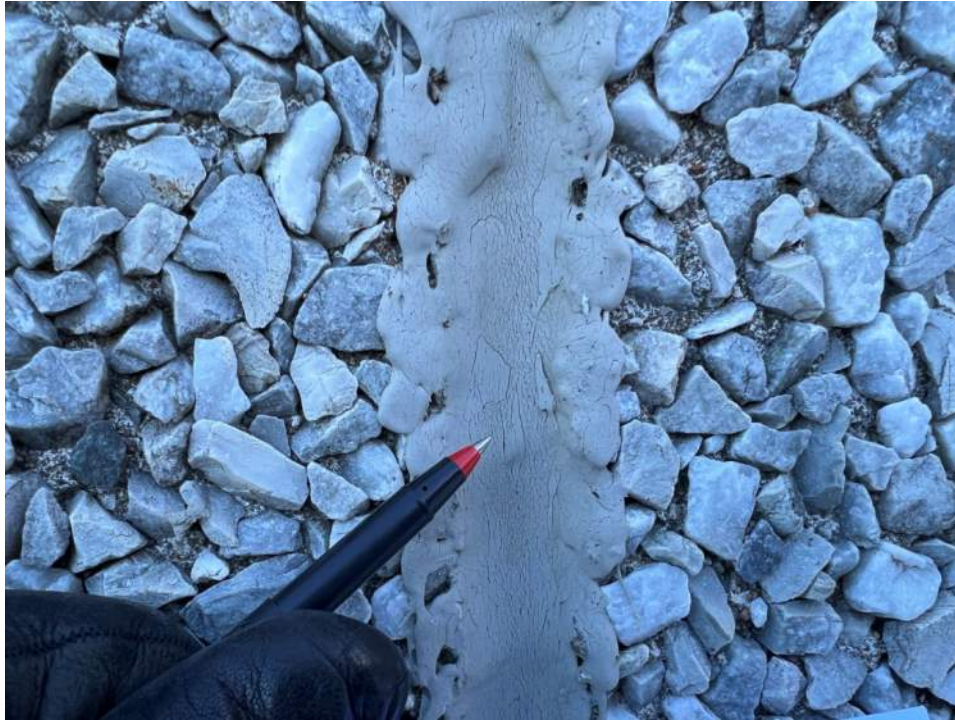
Photo No. 21: Typical view of localized precast panel joints crazing, and cohesive failures

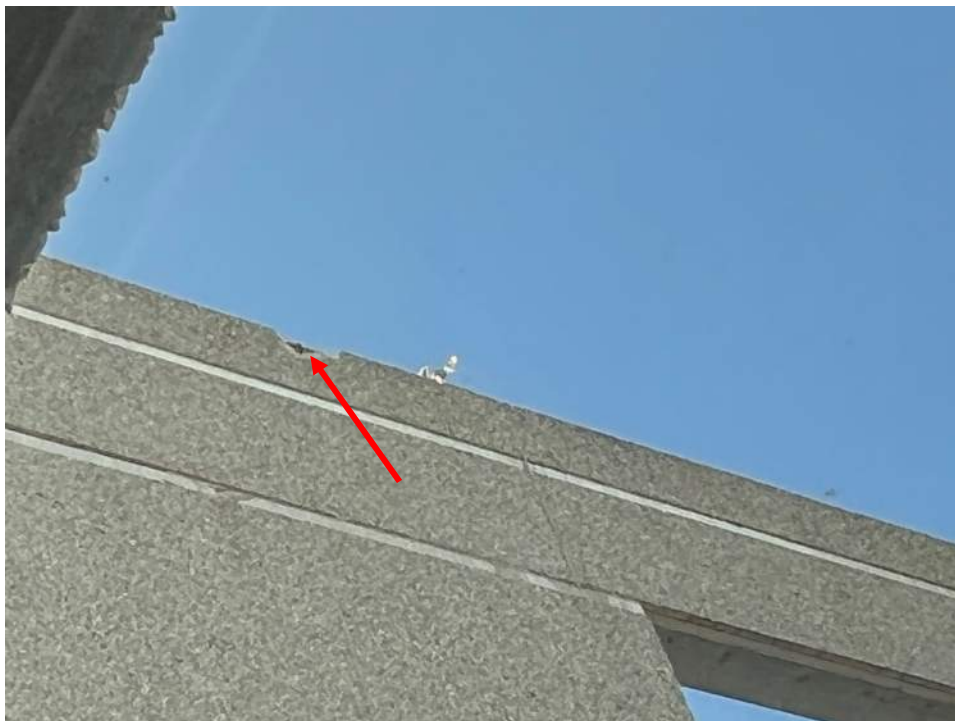
- .9 Local areas of spalled precast where noted during the review. (*Refer to Photo No. 22 in Appendix A*).
- .10 Overall, the sealants between the window and precast, as well as metal-to-metal seals, are in poor condition which increases risk of leaks (*Refer to Photo No. 26 and 27 in Appendix A*).

Photo No. 22: View of the precast panel surfaces was noted to be peeling or failing (red arrow)

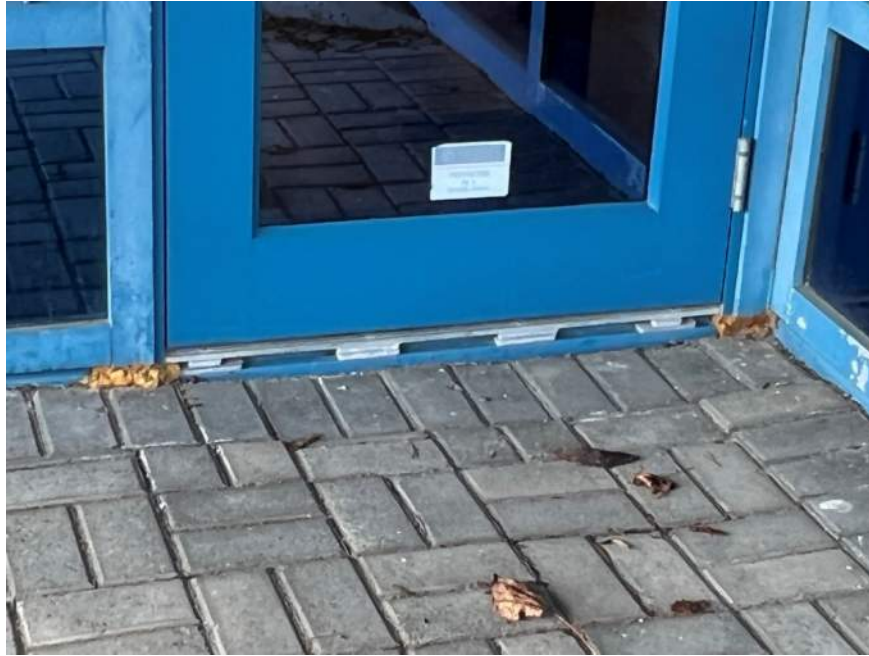
Photo No. 25: Typical view of aluminum storefront doors with exposed aluminum shims

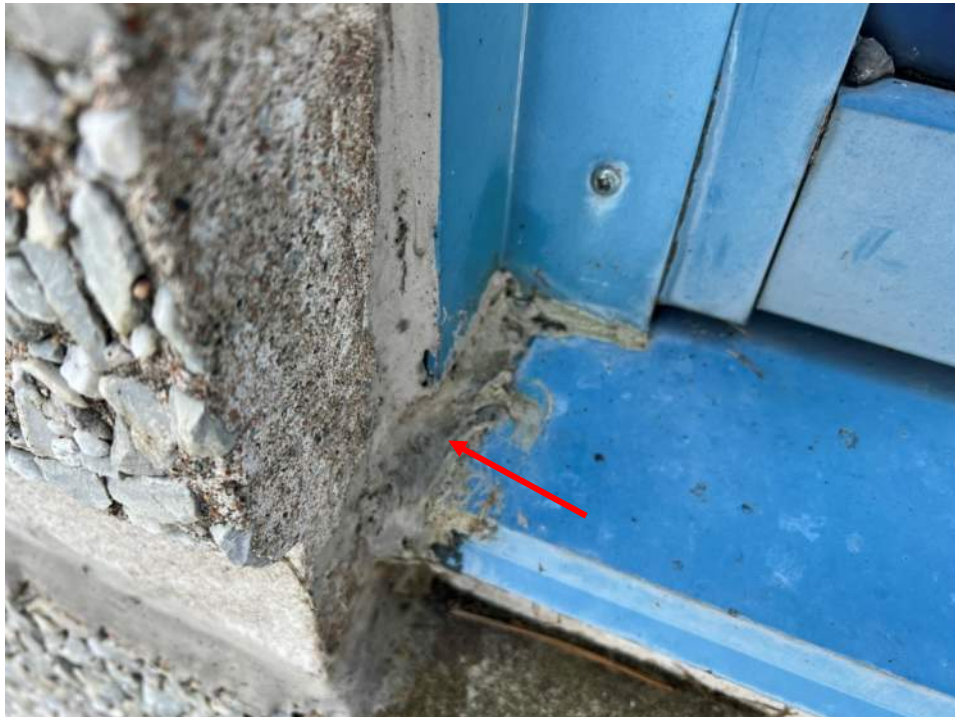
Photo No. 26: Typical view of sealant in poor condition (red arrow)

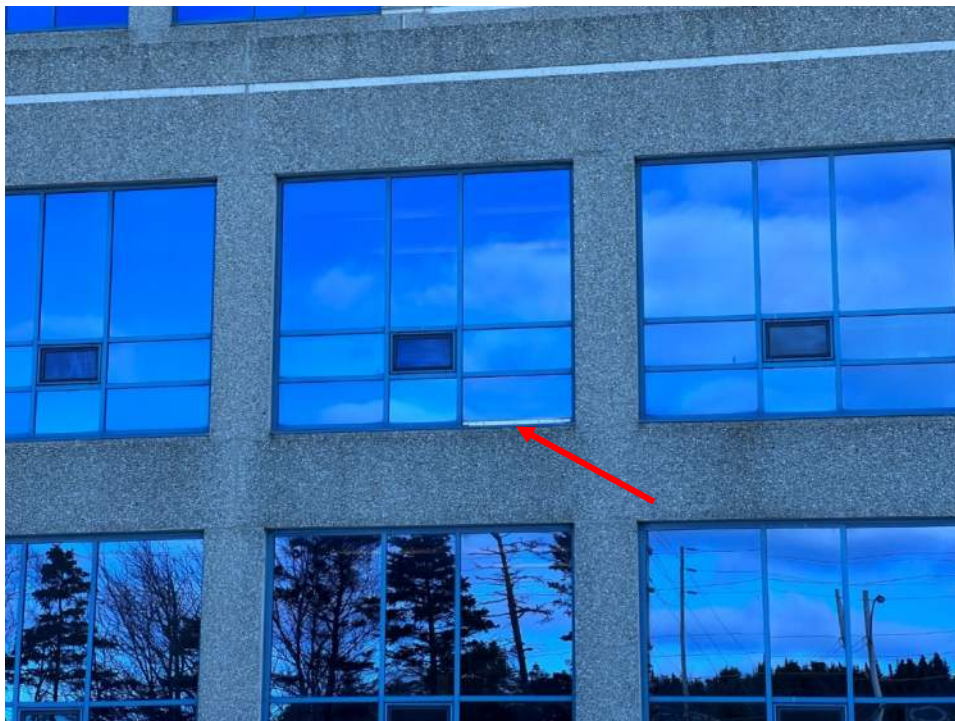
Photo No. 28: Typical view of punched windows in fair to poor condition with a missing snap cap (red arrow)

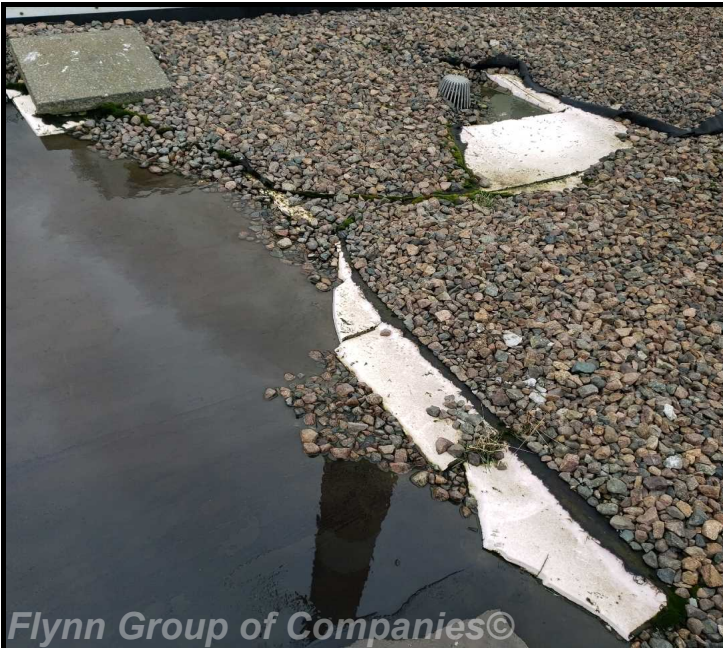
pump house #2:  
Area of wind swept ballast at  
corner of building

Minor preventative maintenance recommended immediately to fix open wind swept areas as well as additional minor preventative maintenance

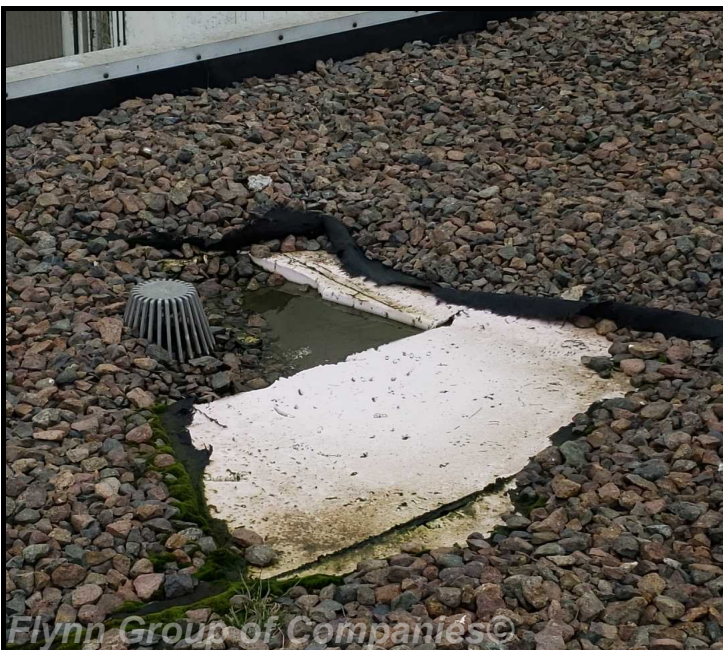
pump house #2:  
View of exposed insulation

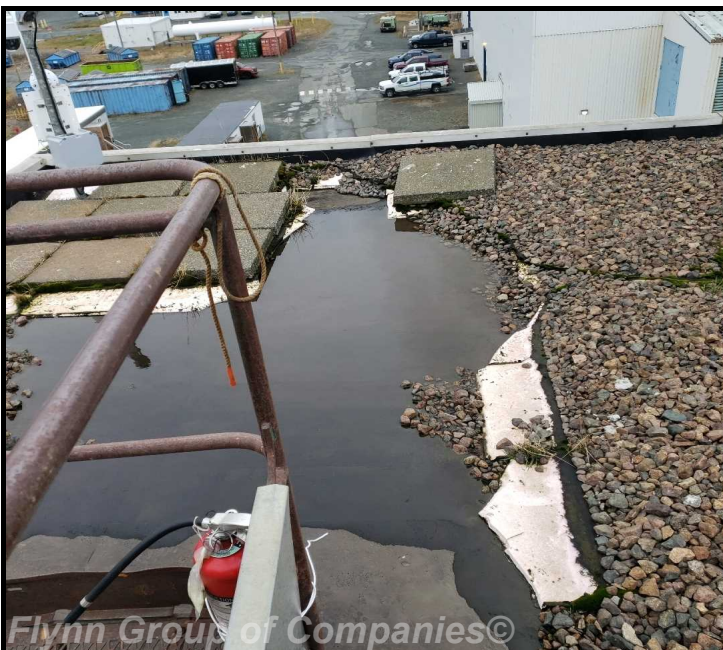
pump house #2:  
View of wind blown area to  
be addressed

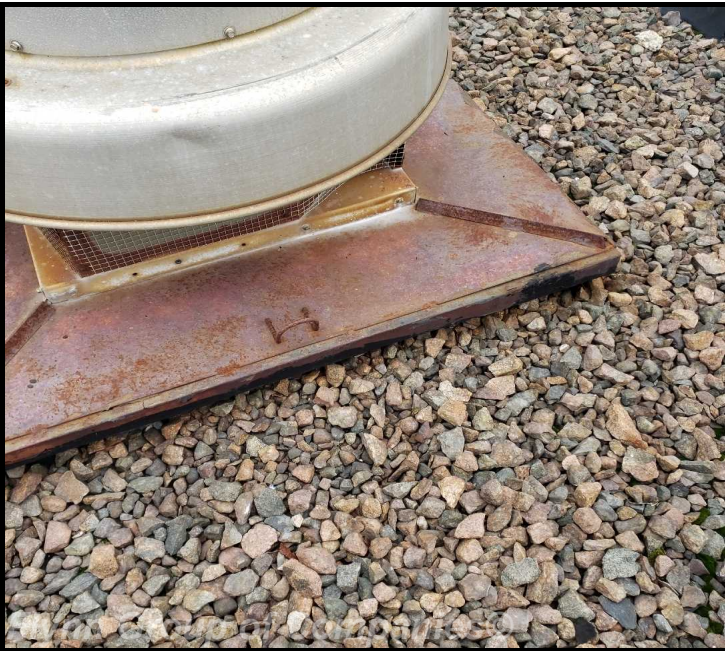
pump house #2:  
Areas of open seams to be  
caulked on fan curbs and  
parapet metal

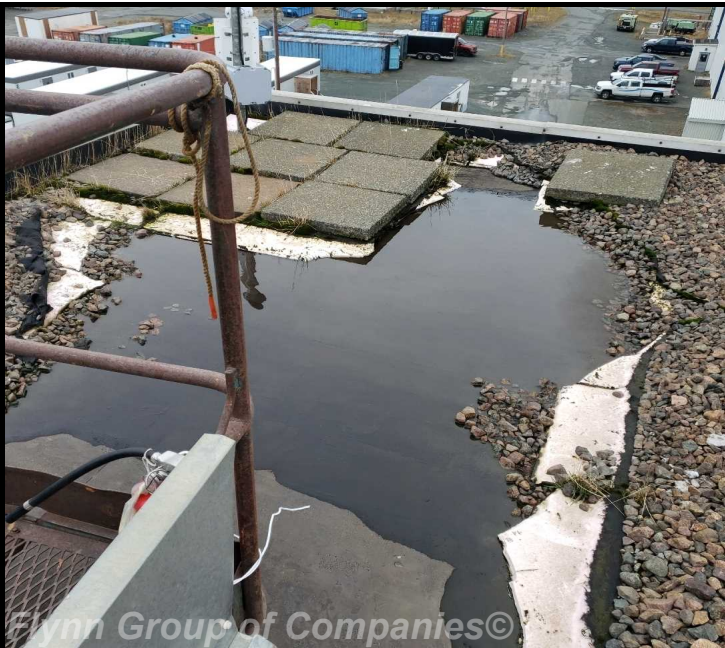
pump house #2:  
Area of wind damage

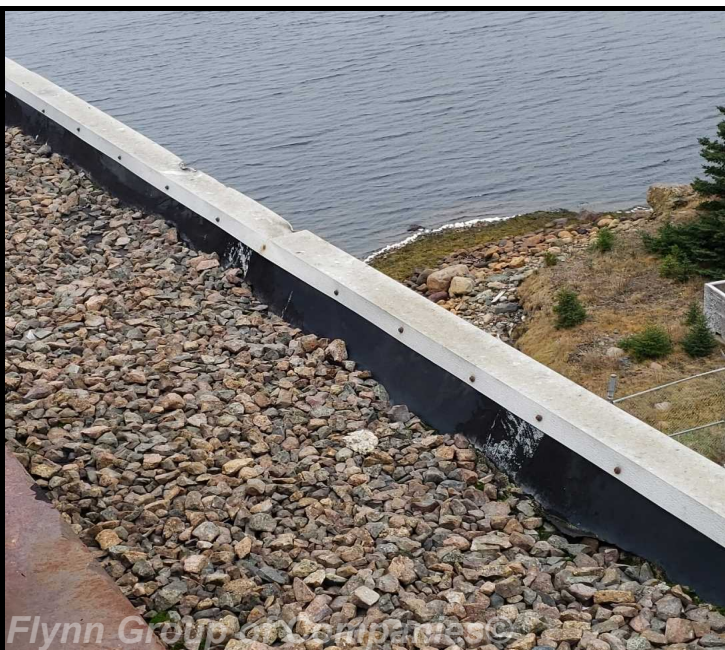
pump house #2:  
Areas of detail flashing with  
exposed mesh to be  
resealed

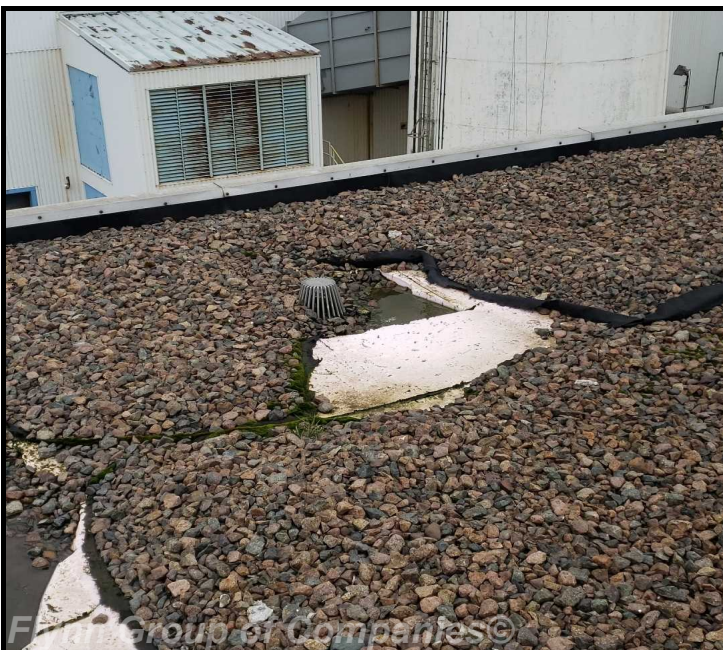
Section A:  
View of area of wind  
damage around one drain

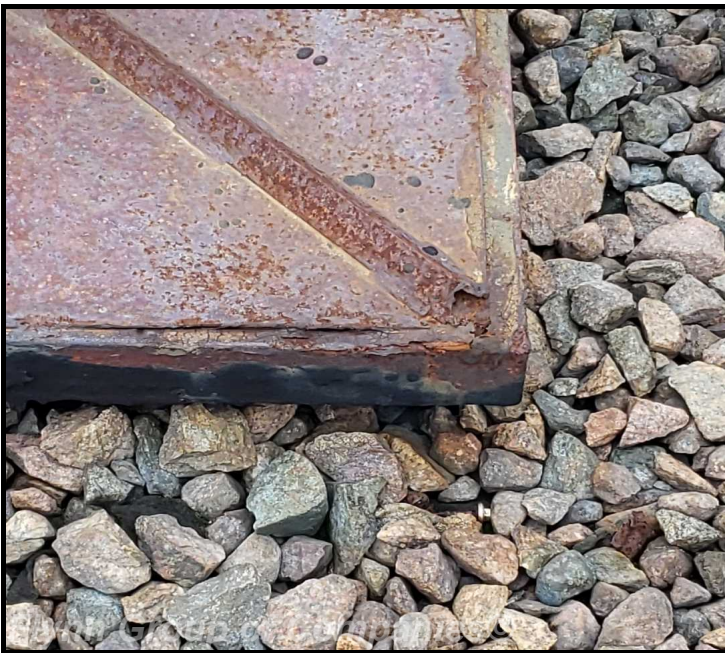
Section A:  
Area of rusted fan top

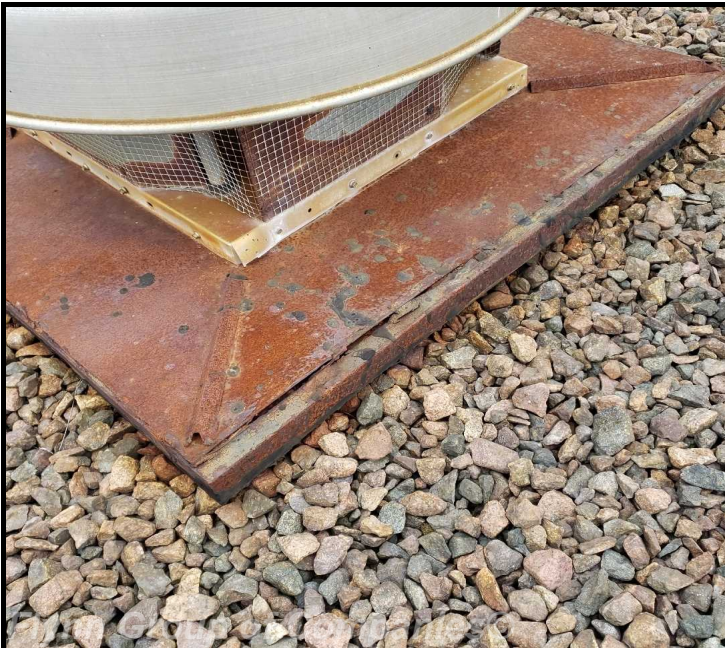
pump house #2:  
View of area of open seams  
around fan curb top

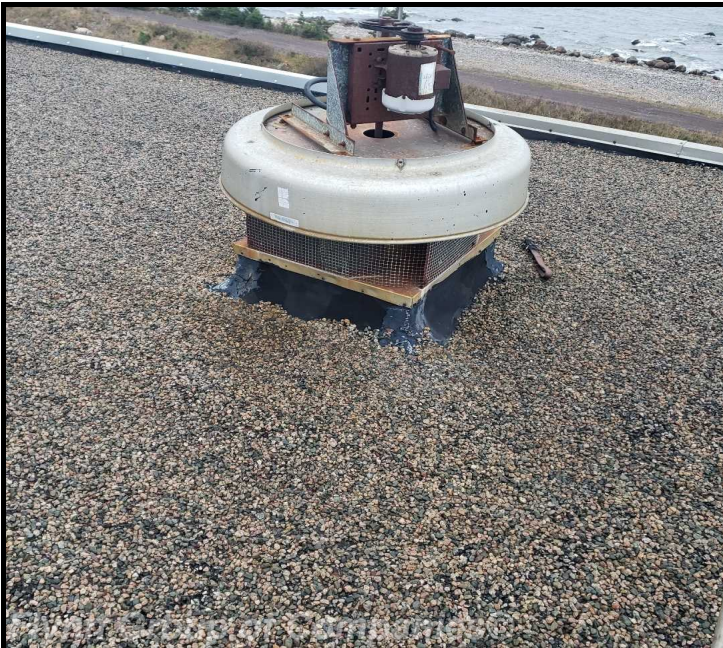
pump house #1:  
Areas of detail flashing in  
need of some sealant

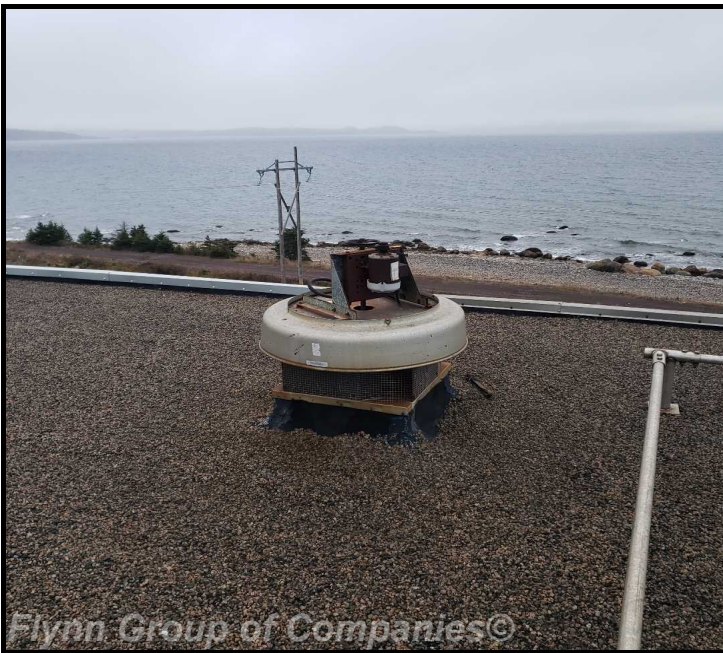
pump house #1:  
View of area of missing  
hood from fan unit to be  
addressed

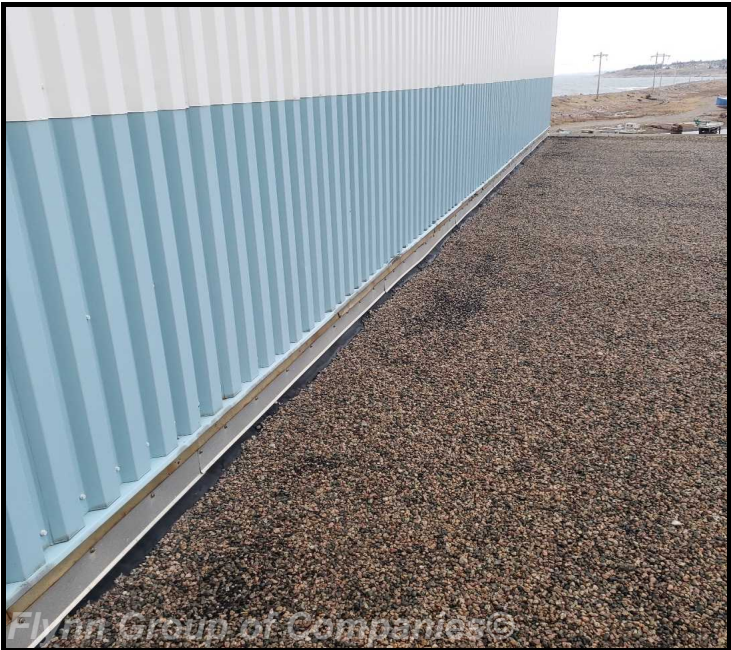
pump house #1:  
Area of lower roof level walls  
in good condition

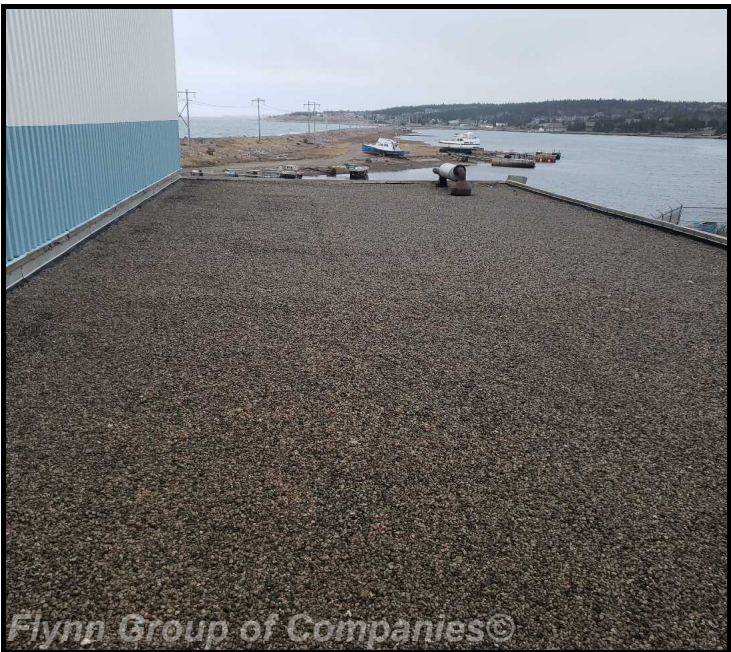
pump house #1:  
Overview of roof area - in  
good condition

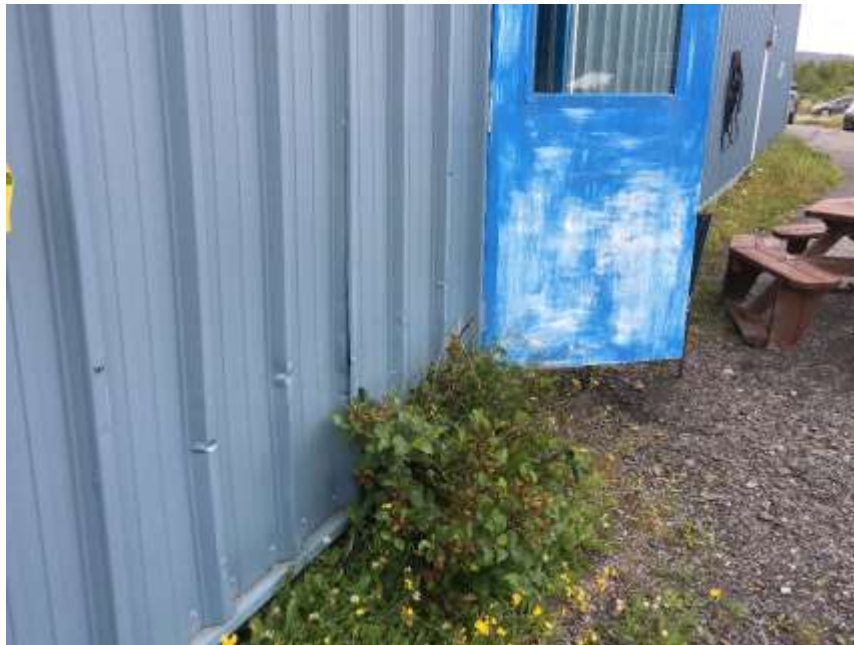
Left façade kitchen door and cladding damage.

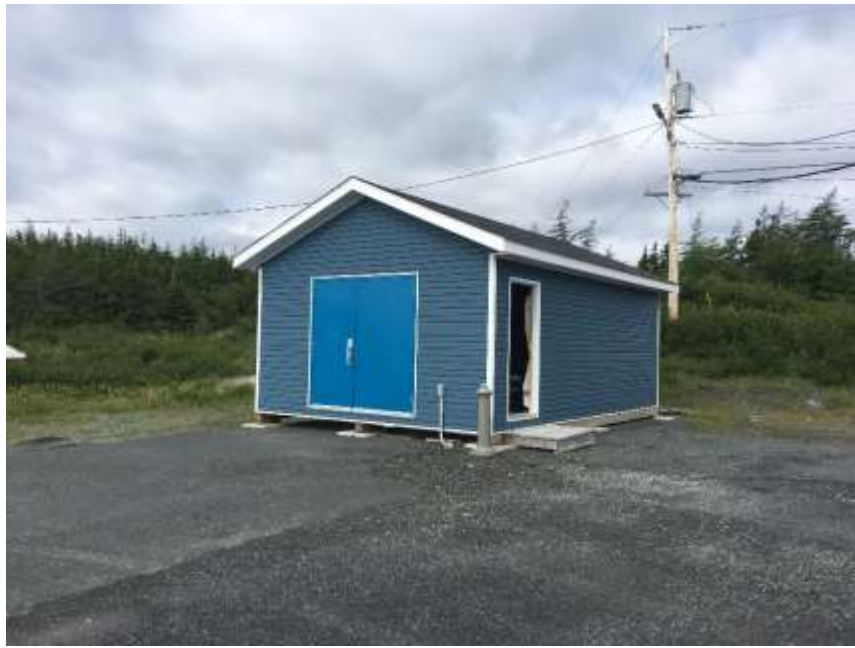
Front façade. Right side façade.

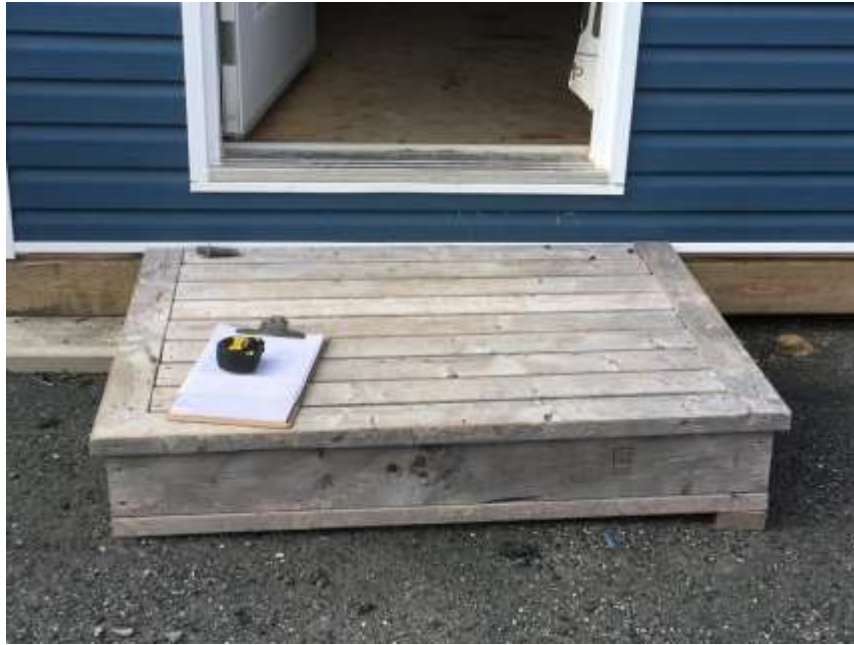
Entrance - note risers height.

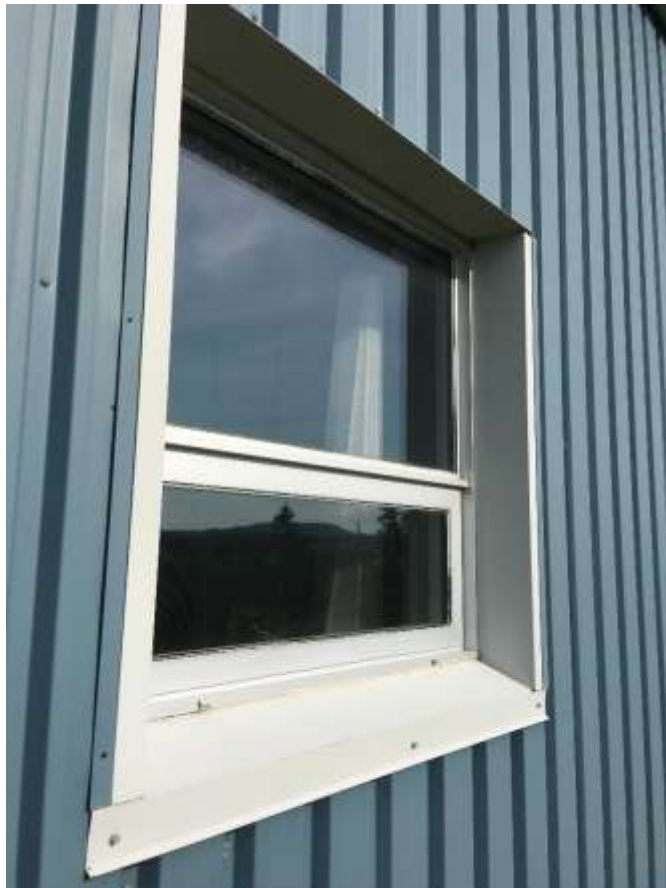
Typical window. Note deep reveal indicating added insulation and cladding.

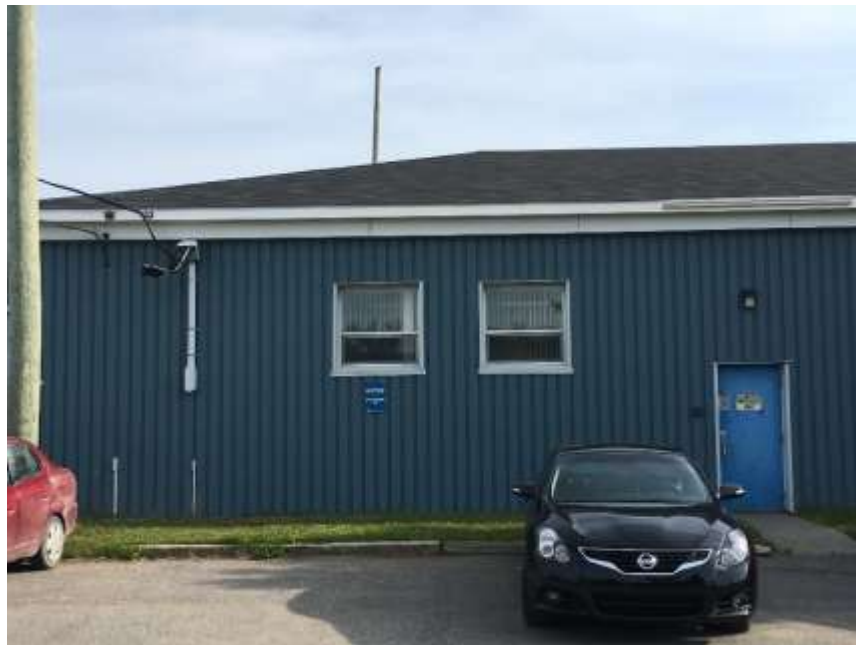
Hip roof above original roof.

- Access should be provided to the hip-truss roof attic in order to properly assess the condition of the roof structure.

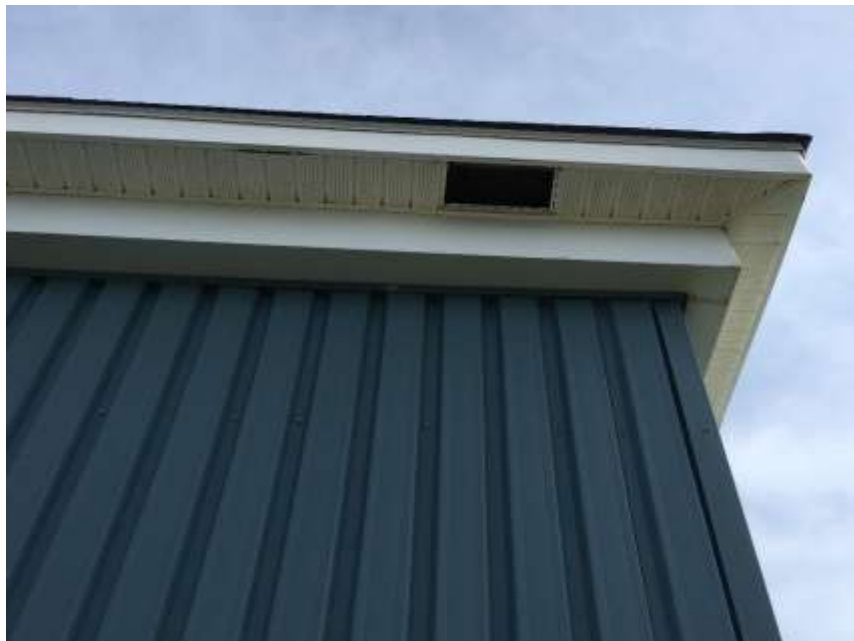
Soffit/fascia of double roof with unprotected soffit hole.

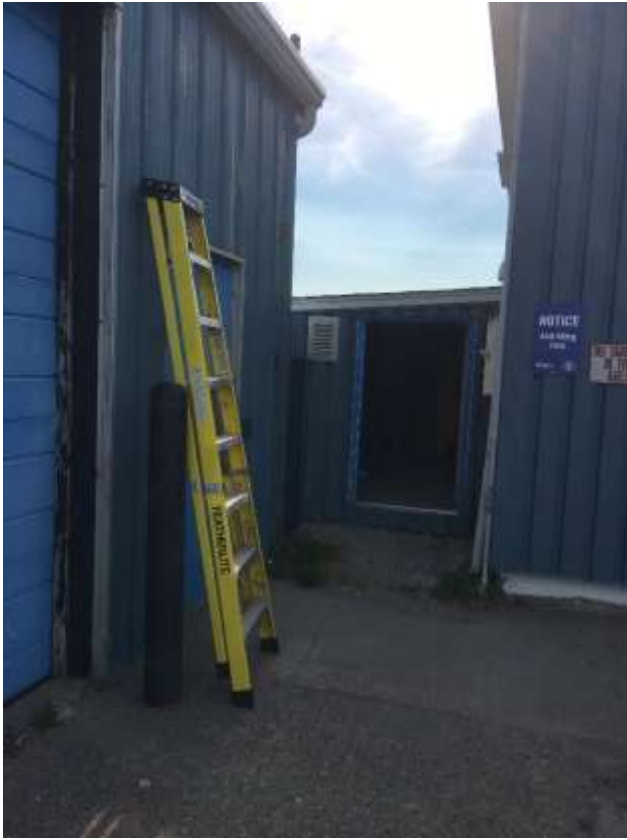
Proximity of lean-to flammable storage between main and storage buildings.

- Enclose janitorial supplies in 60 minute fire rated room.
- Continue main corridor through existing kitchen to create continuous dedicated exit path to eliminate current dead ending.
- Eliminate existing lean to flammable storage shed at rear of building.
- Replace male washroom and lunch flooring.
- Removed loose stored items from electrical and data rooms.
- Add upper area attic vents.
- Add attic access hatches.

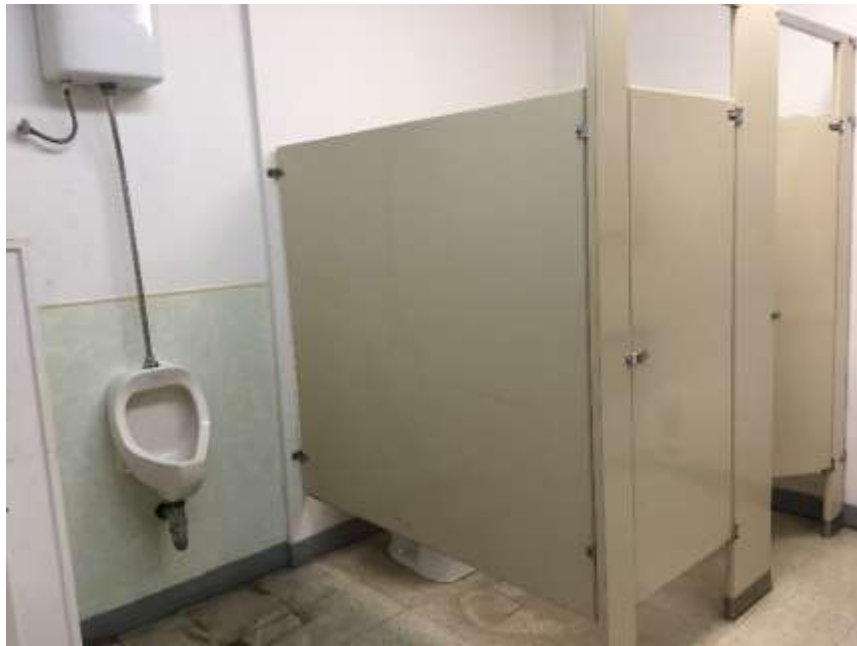
Male washroom. Note flooring condition.

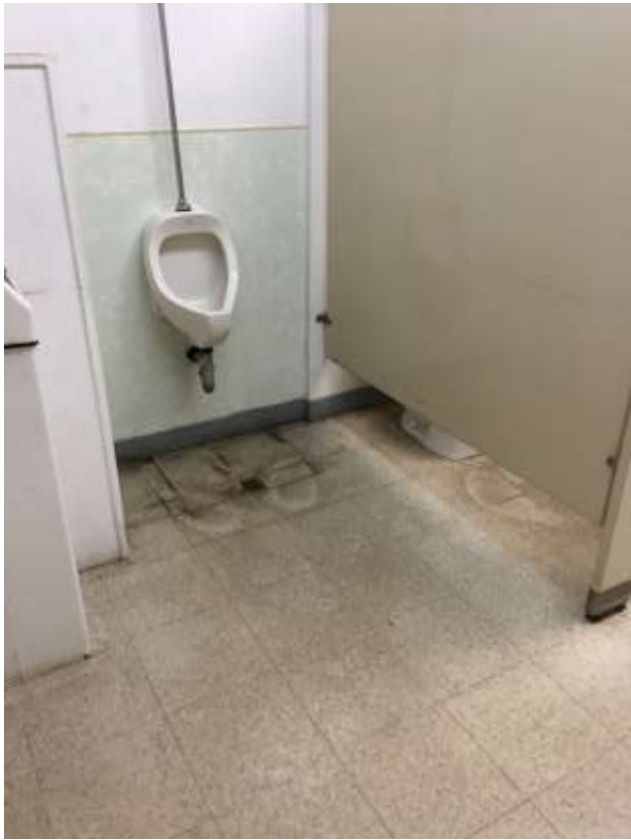
Male washroom. Note flooring condition.

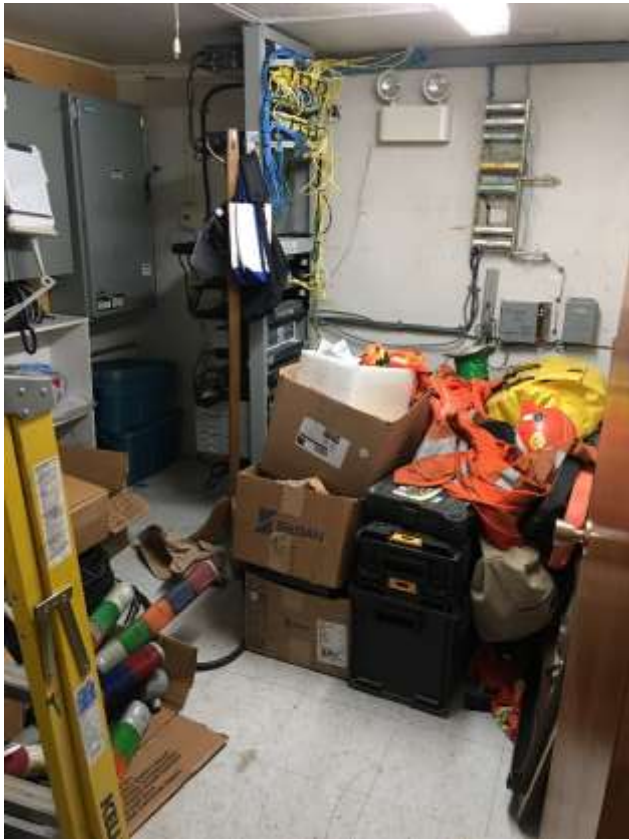
Electrical/communications room. Note stored items hazard.

- Consider installation of new fire alarm system panel with detectors and alarm devices. Reuse existing fire alarm pull stations.
- Remove the materials stored in the electrical room and install warning sign on electrical room door “Electrical Room – No storage permitted”.
- Install the panel cover on the panelboard in the space above the electrical room.
- Relocate the communication rack installed in front of the main disconnect to provide a 1 m working space.
- Replace missing acrylic lenses on wraparound fluorescent lighting fixtures.
- Replace both outdoor standard duplex receptacles and faceplates with new GFCI receptacles c/w weatherproof faceplates.

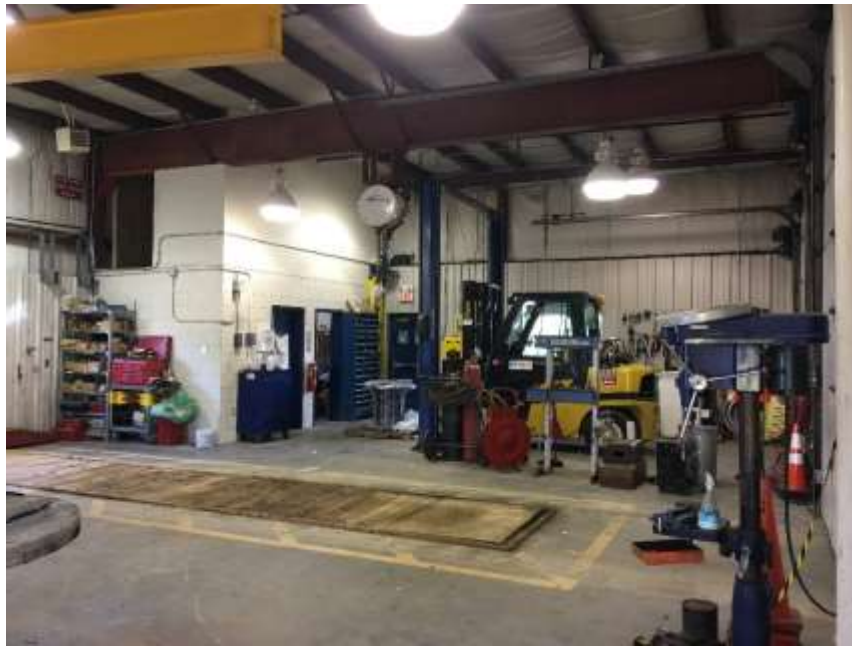
Interior - note service pit.

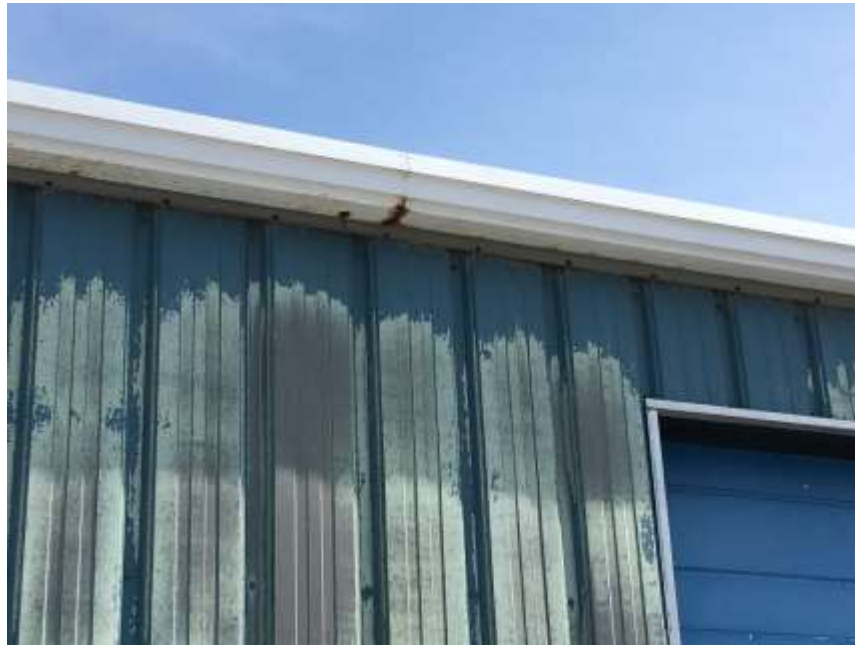
Corroded soffit and paint peeling from cladding.

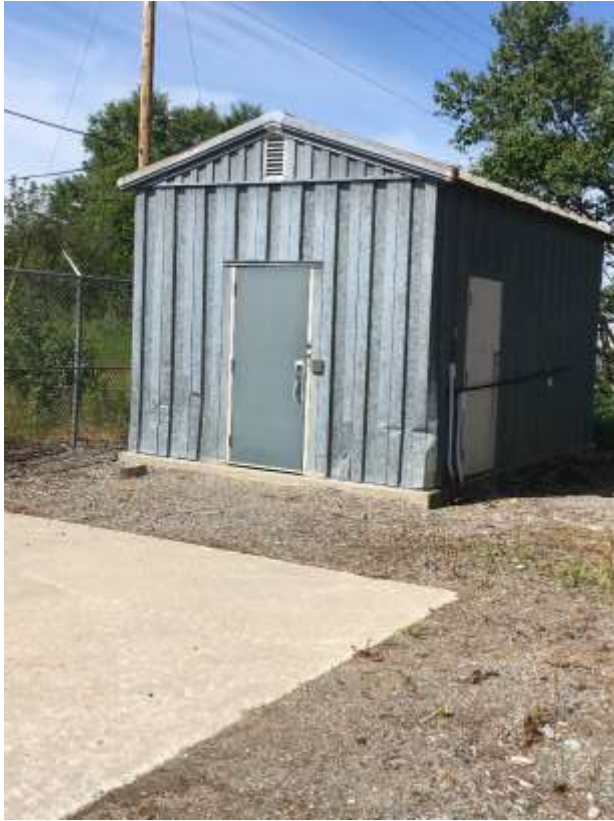
Exterior front and right facades.

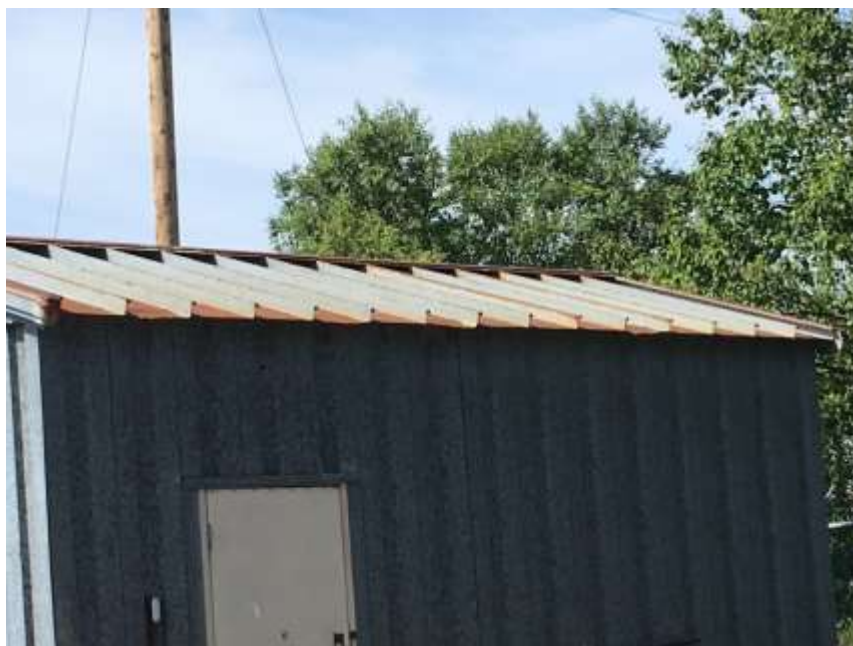
Surface corrosion on roofing panels.

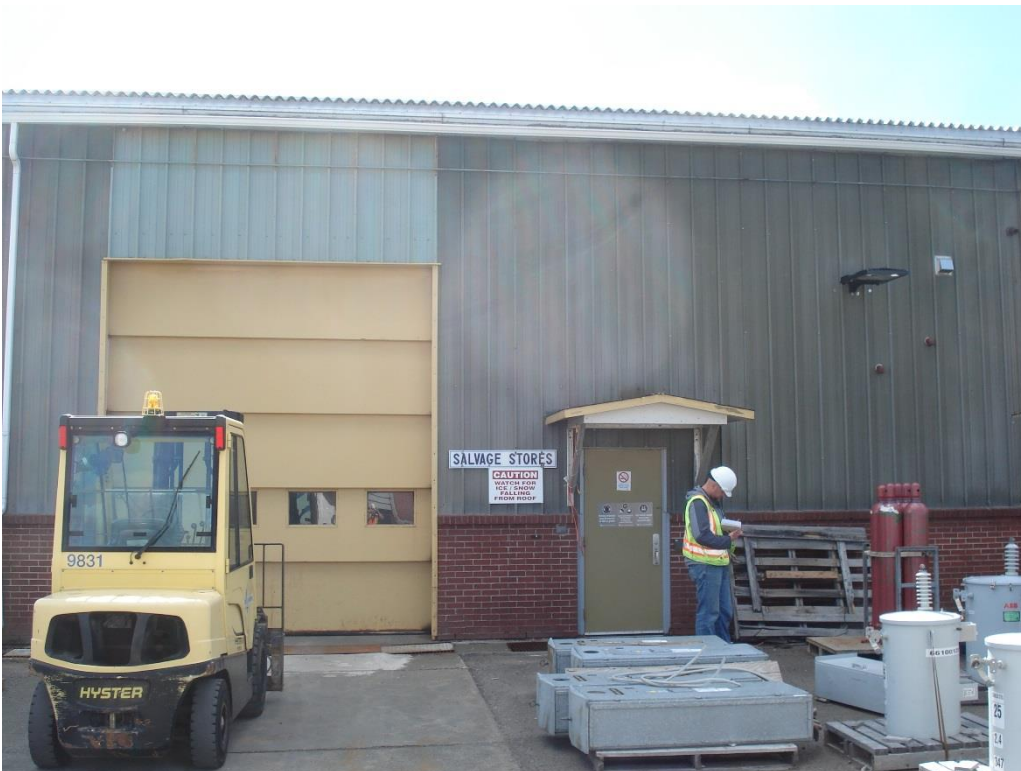
Photo 6 - Concrete Pad at Loading Door
