July 15, 2025

**Re: 2026 Capital Budget Application**

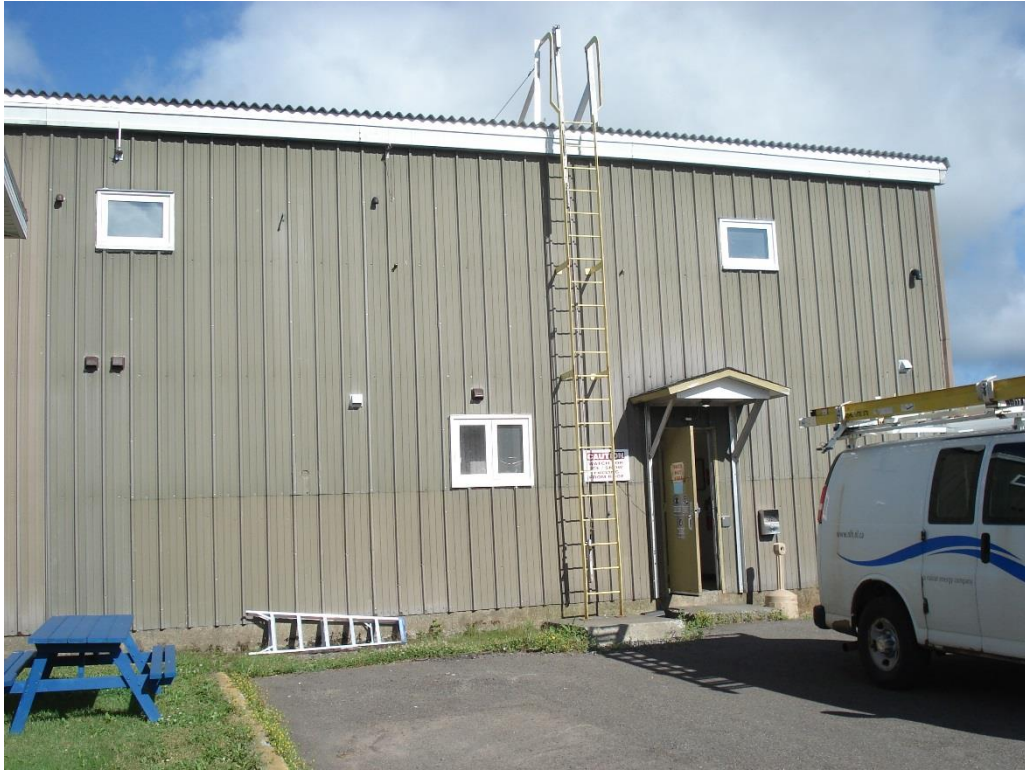
Photo 7 - Doorway and Equipment

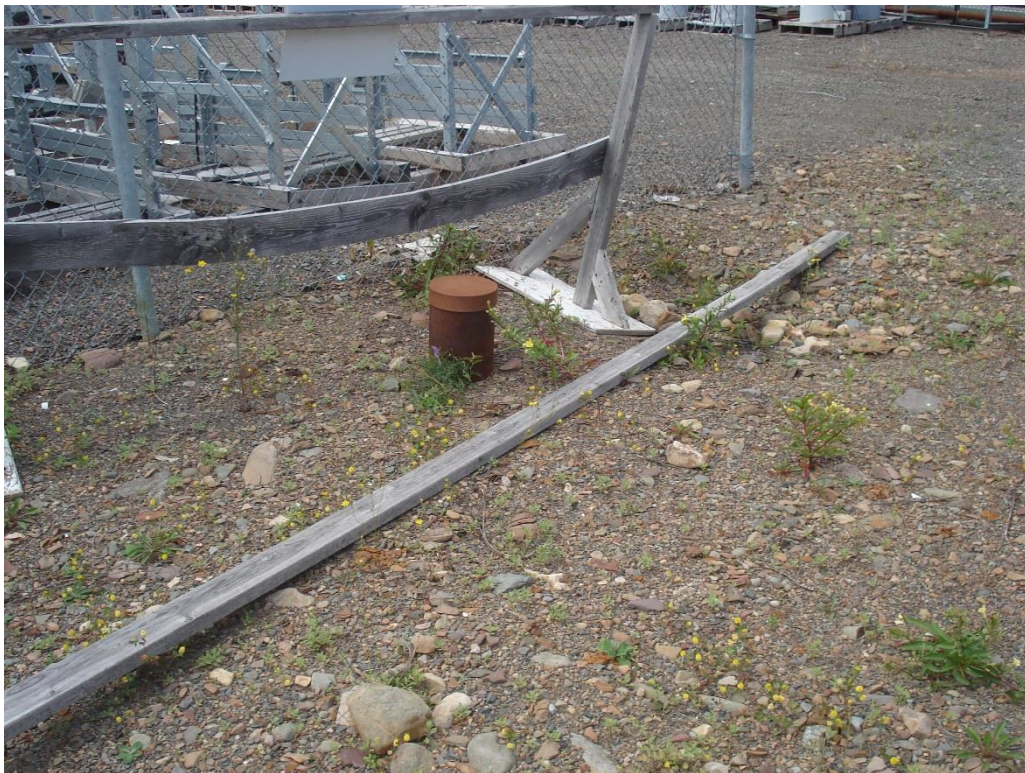
Photo 8 - Septic Tank Access

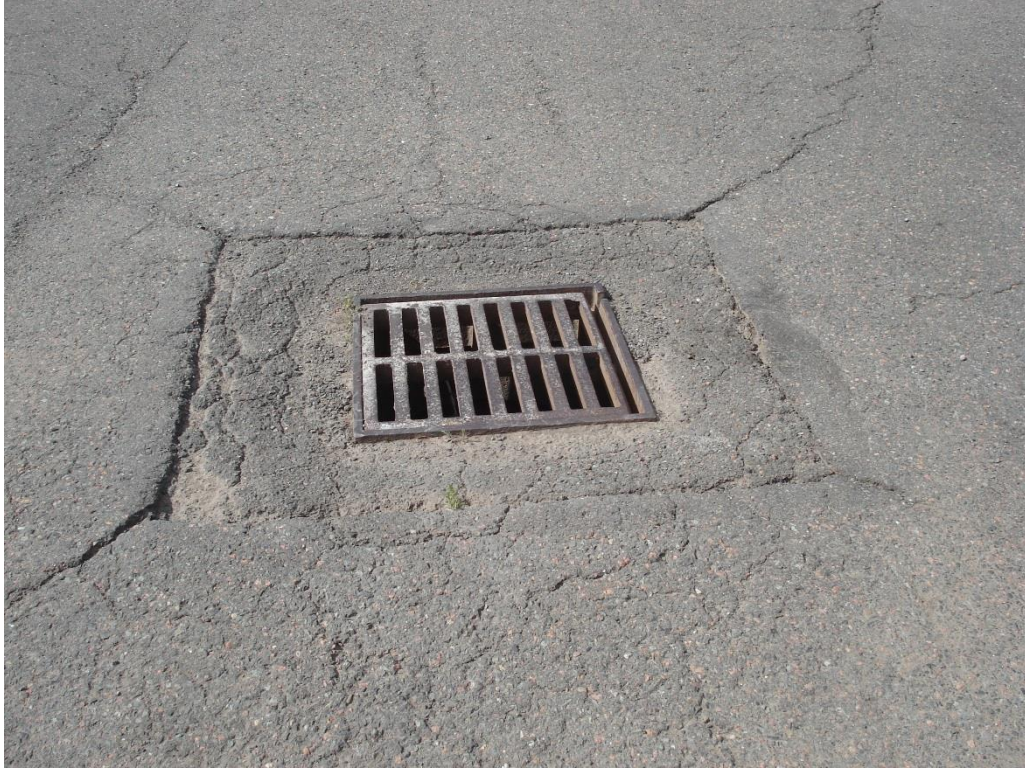
Photo 9 - Stormwater Catch Basin

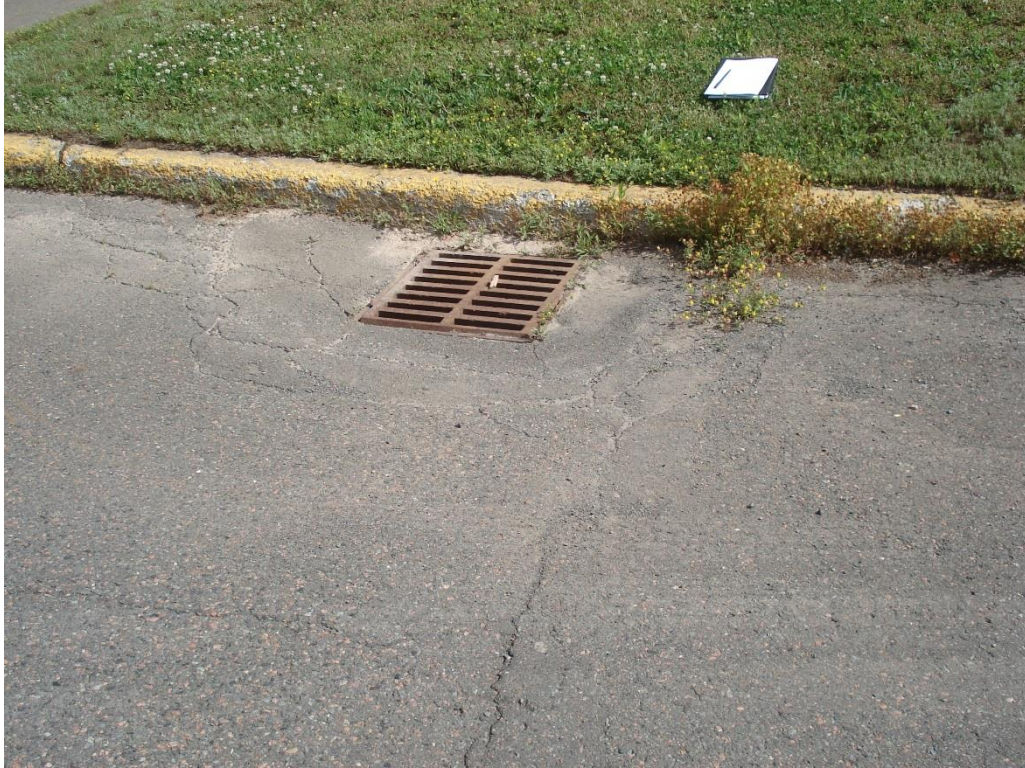
Photo 11 - Catch Basin Not Up To Grade

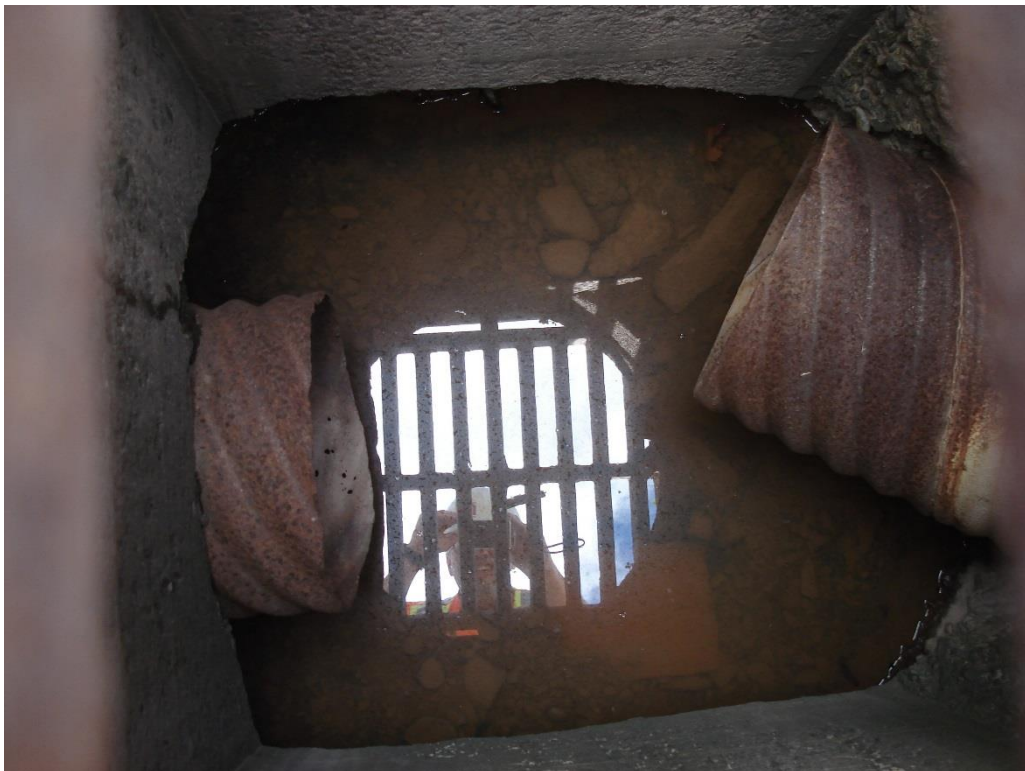
Photo 12 - Catch Basin Chamber Undermined

- Replace concrete curbs - \$135,000
- Replace storm water catch basins and CMP pipe - \$132,500

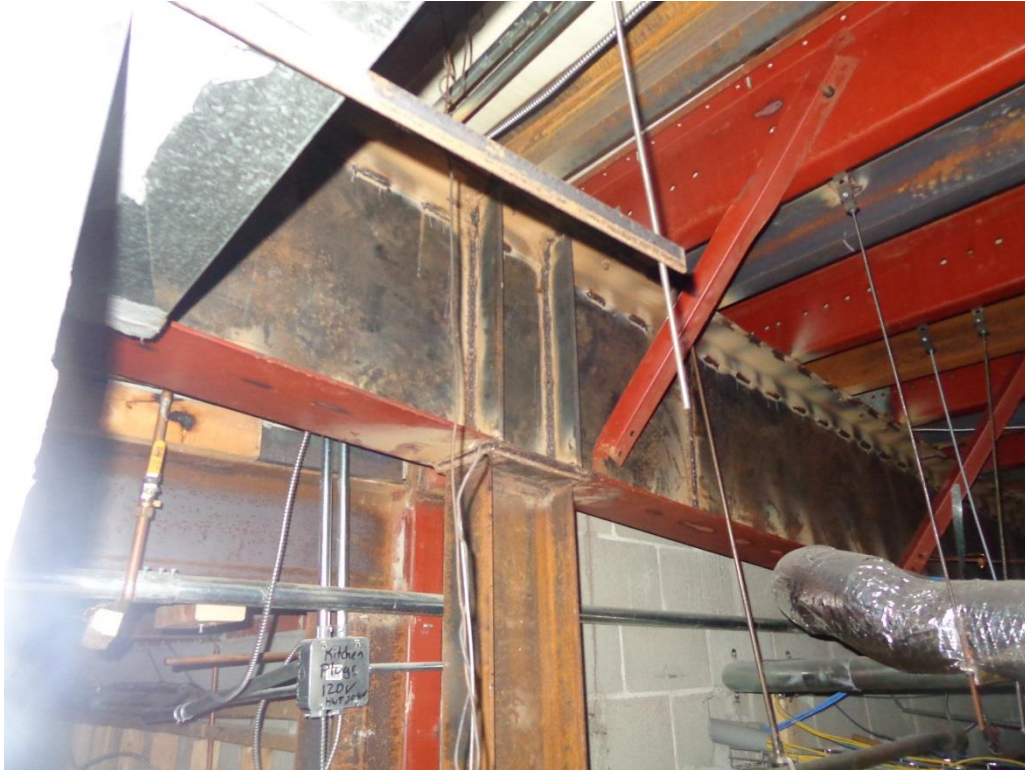
Photo 5 - Reinforced Building Frame

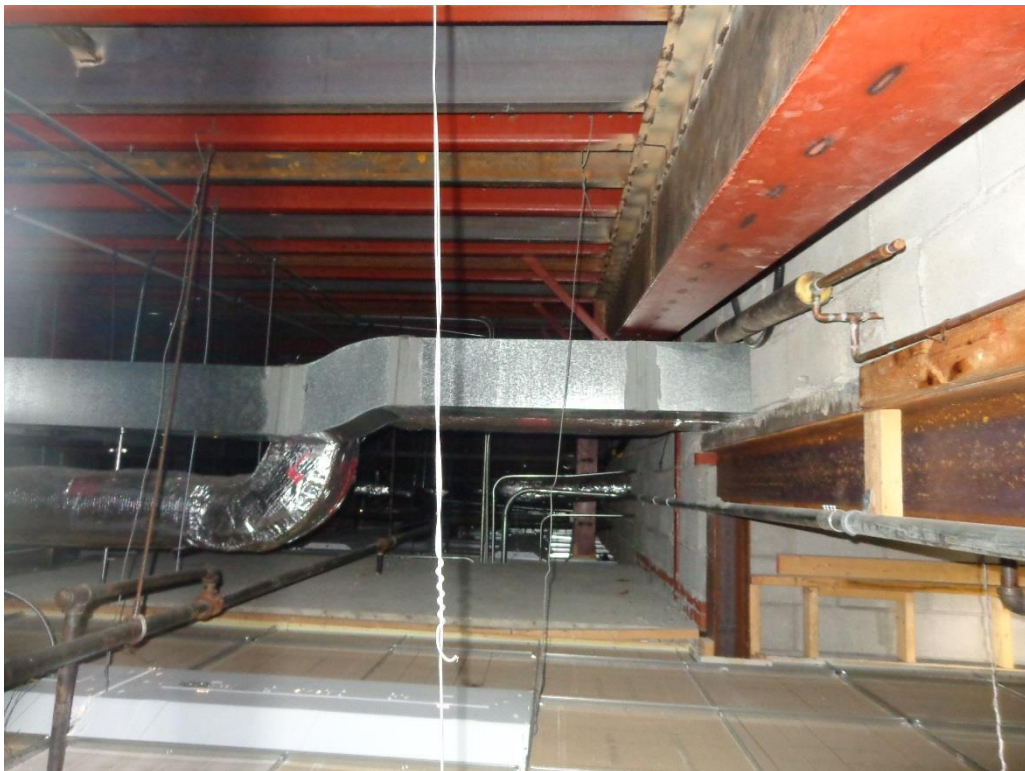
Photo 6 - Reinforced Building Frame and Additional Purlins

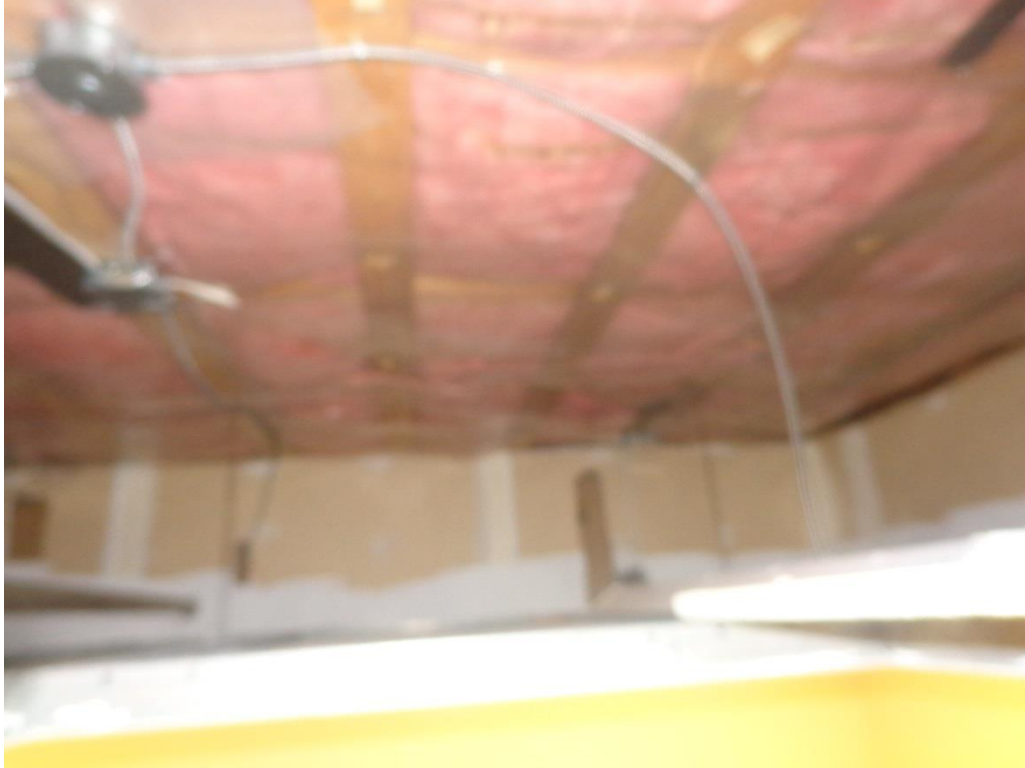
Photo 7 - Timber Trusses Concealed by Vapor Barrier and Insulation

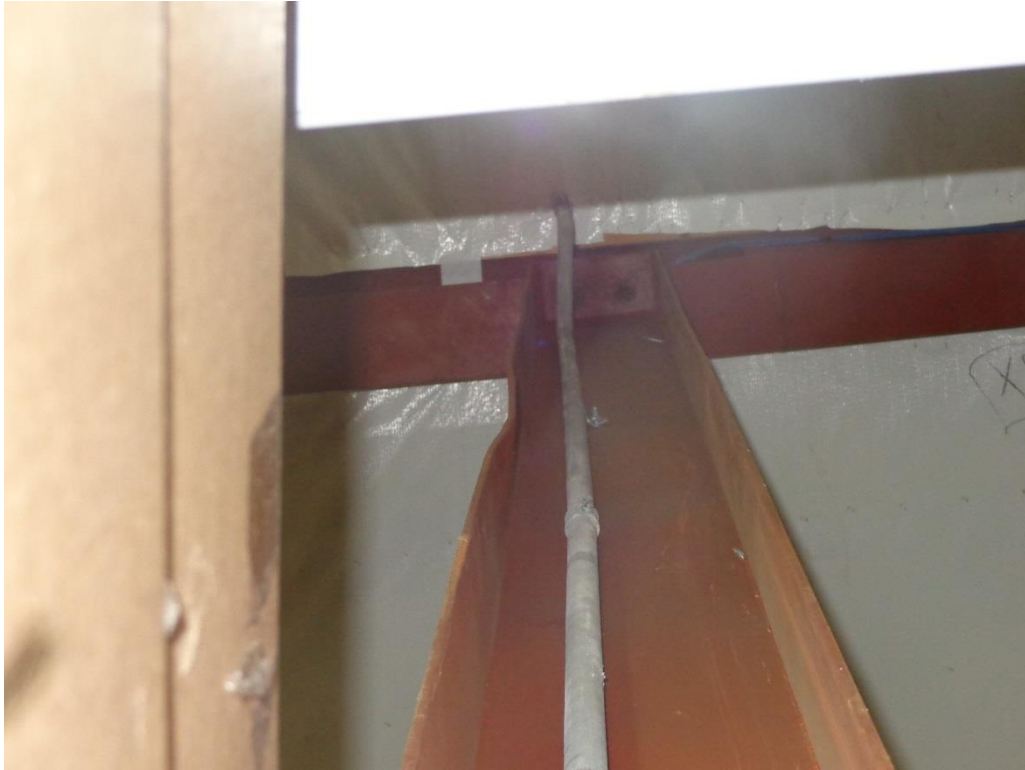
Photo 9 - Deformation on Column Due to Impact (1)

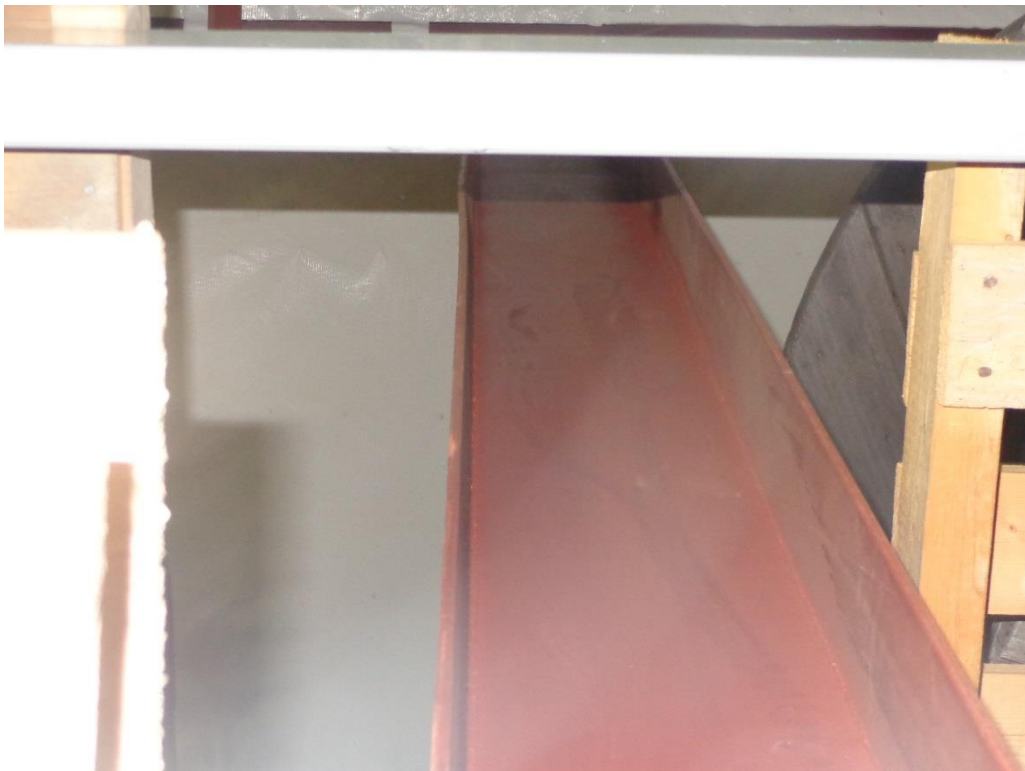
Photo 10 - Deformation in Column due to Impact (2)

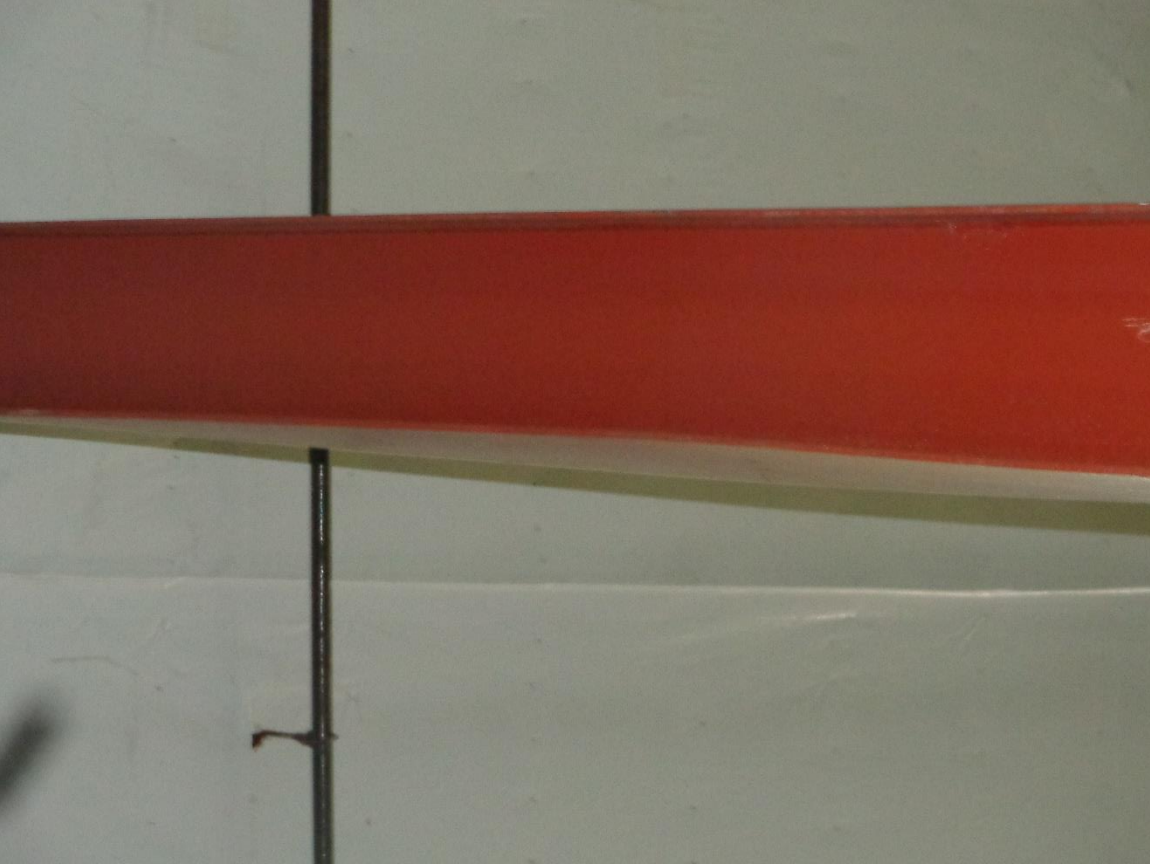
Photo 12 - Twist in Column Possibly Due to Overstress (1)

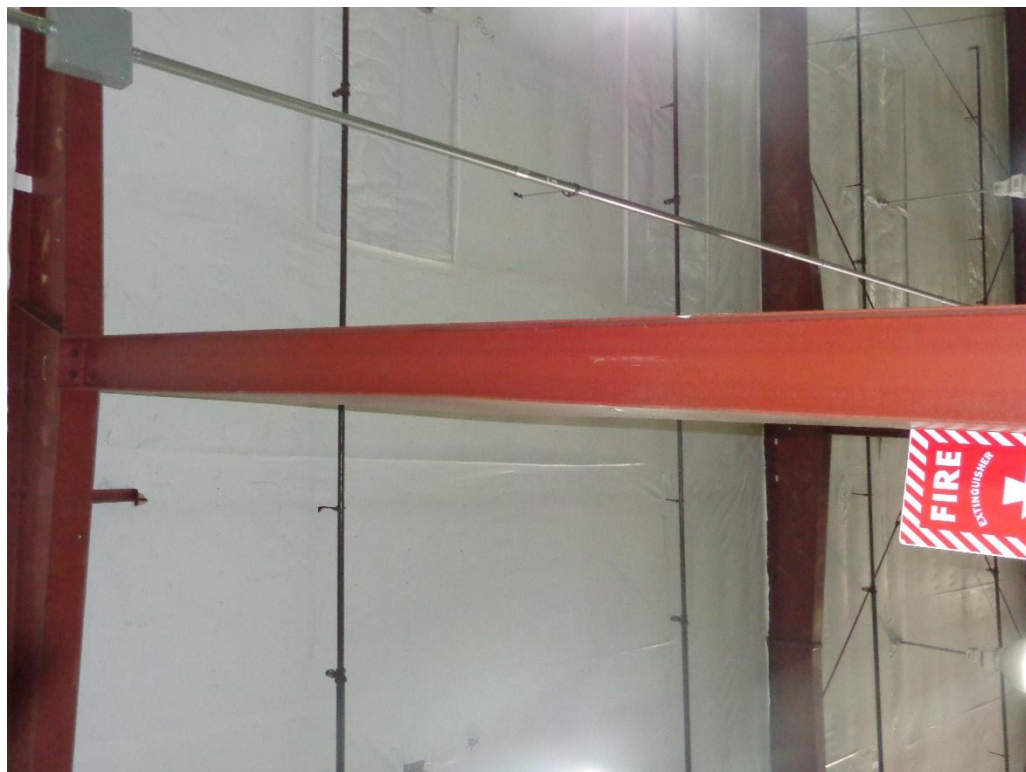
Photo 13 - Twist in Column Possibly Due to Overstress (2)

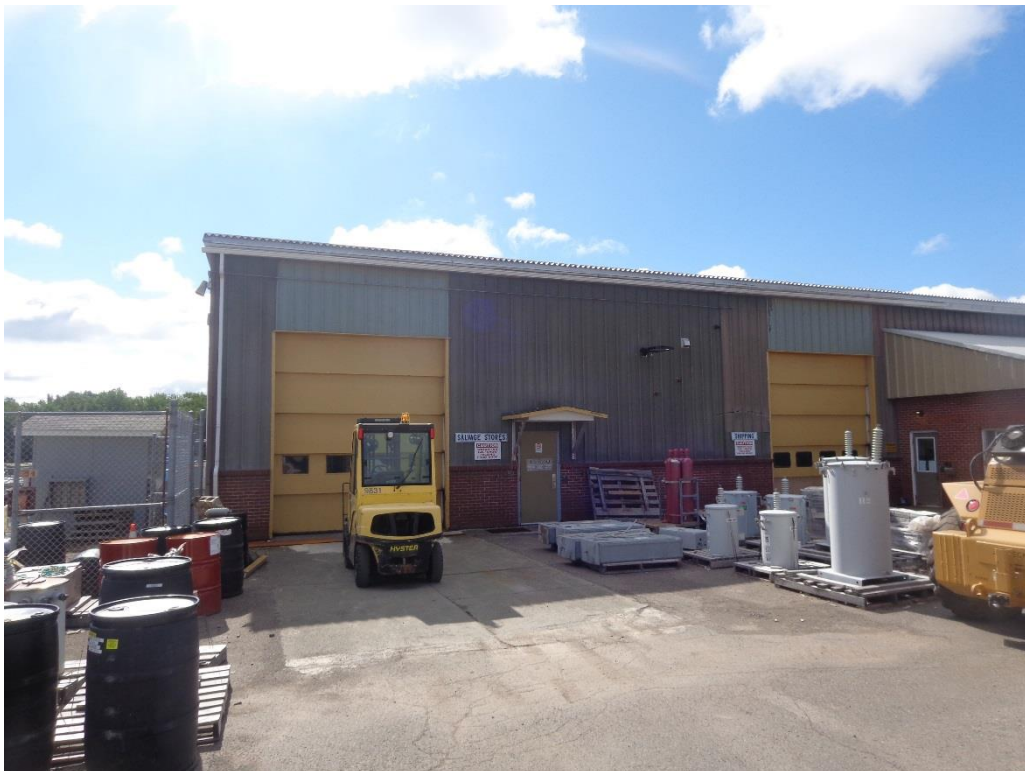
Photo 18 - Brick Veneer and Metal Cladding

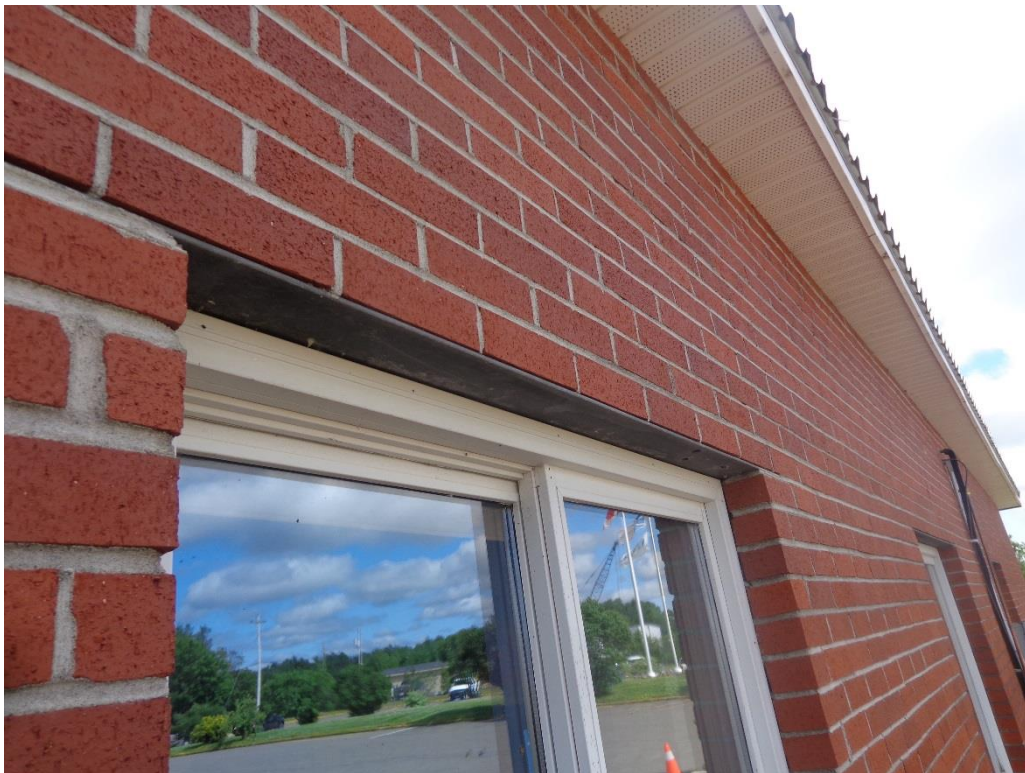
Photo 20 - Steel Lintel Over Window Openings

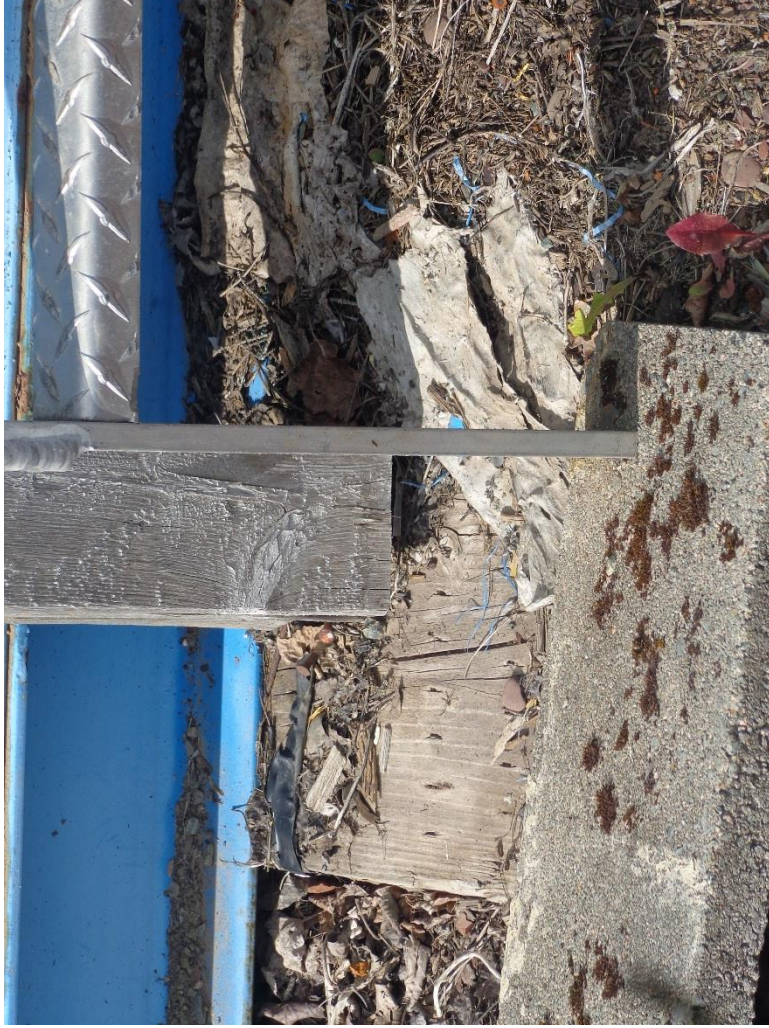
Photo 22 - Post Not Bearing on Ground

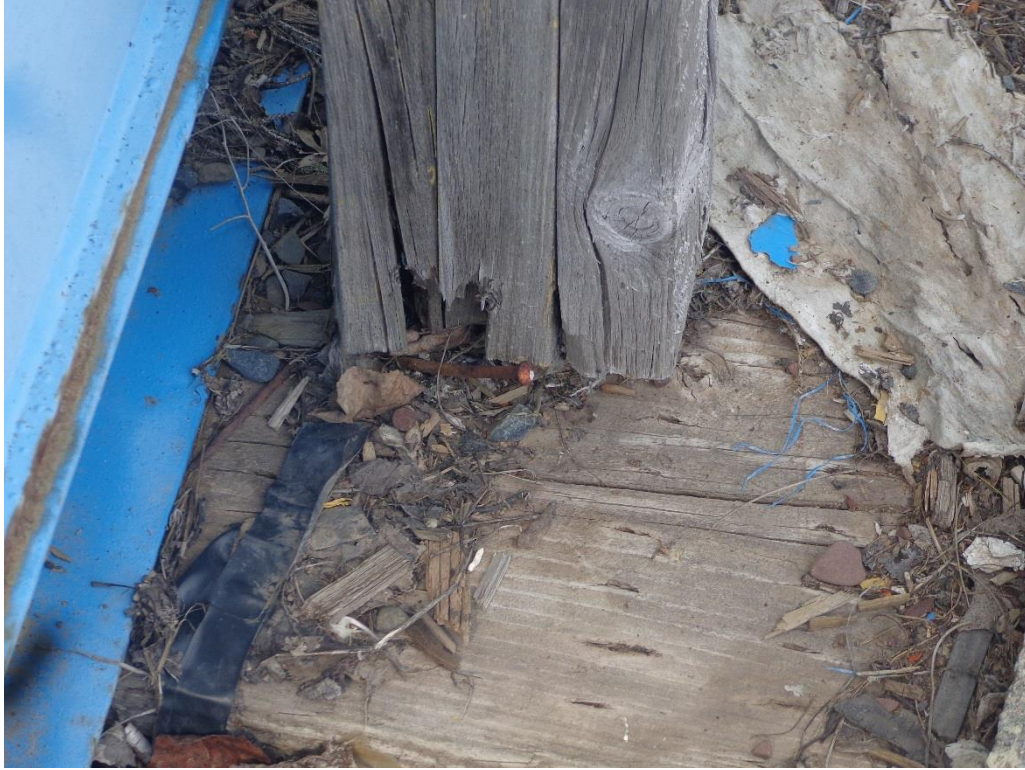
Photo 23 - Rotting Post of Equipment Platform

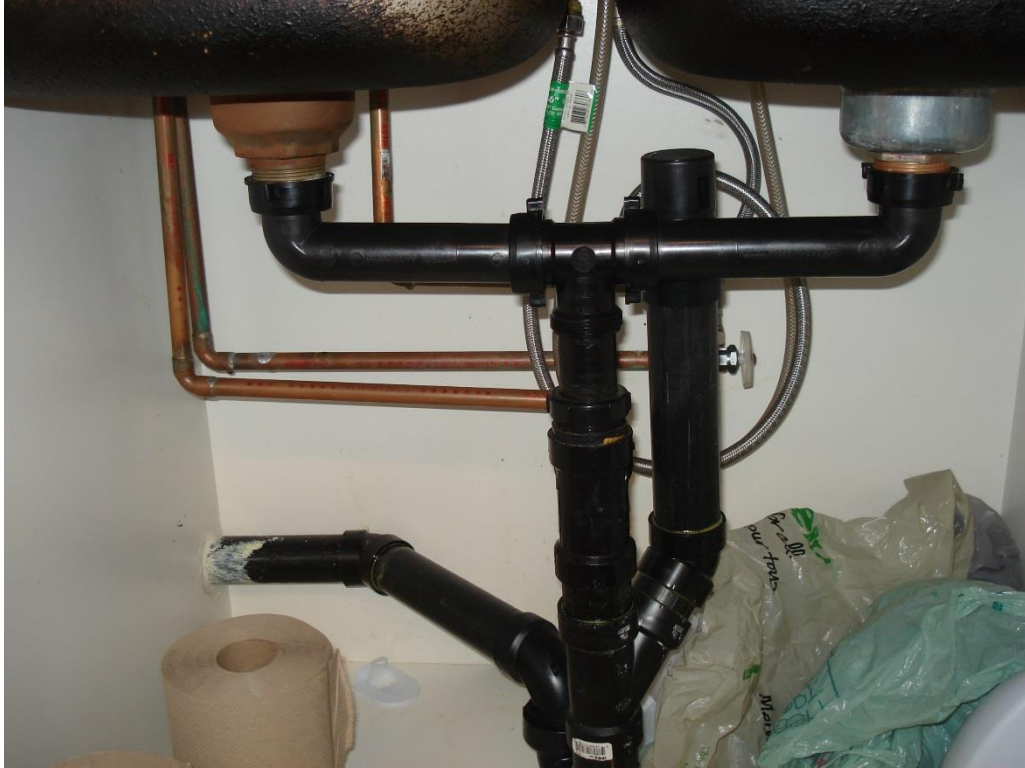
Photo 3 - Air Admittance Valve Mounted Incorrectly

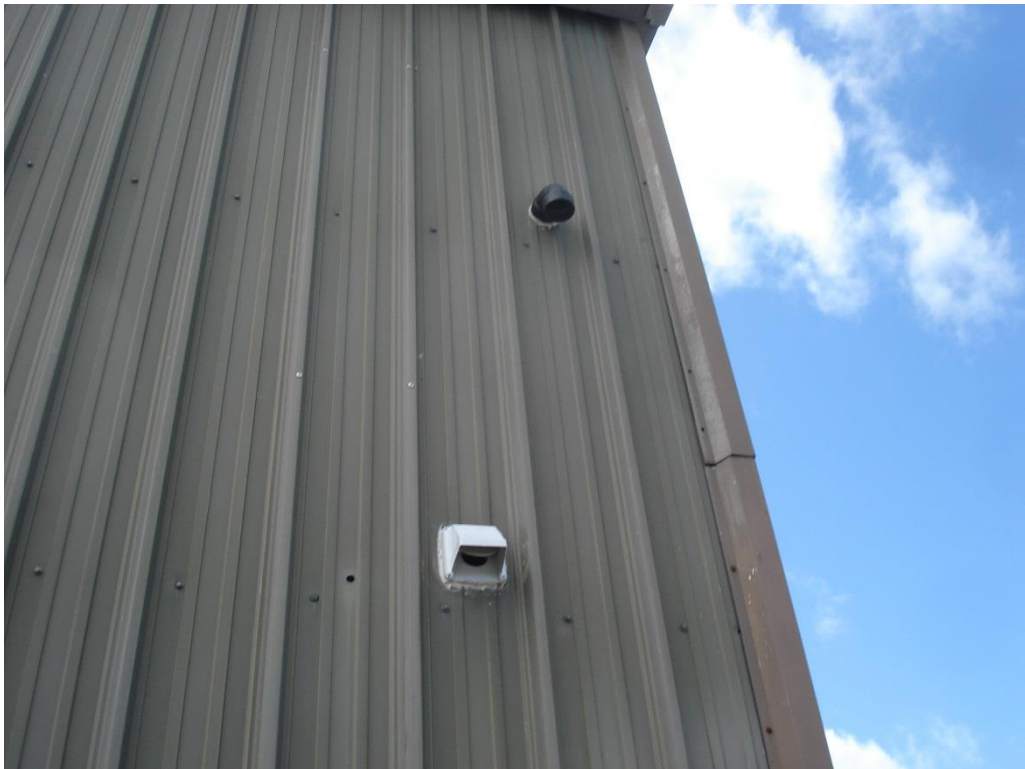
Photo 4 - Vent Piping Terminating Through Exterior Wall

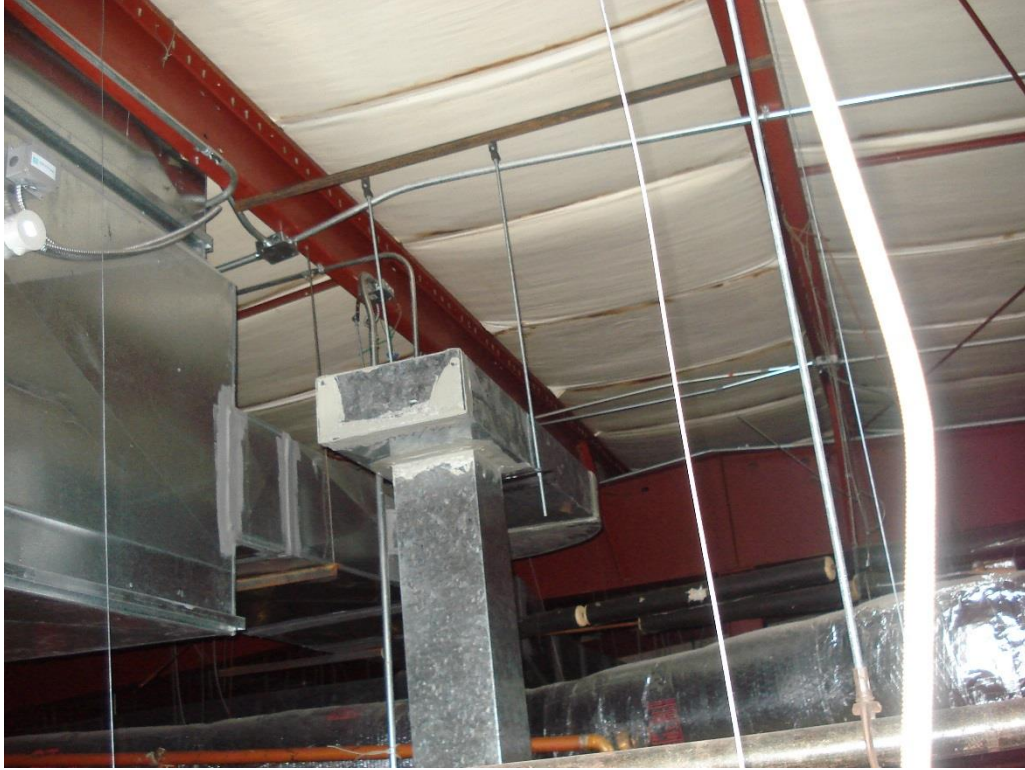
Photo 7 - Partially Insulated Domestic Water Piping

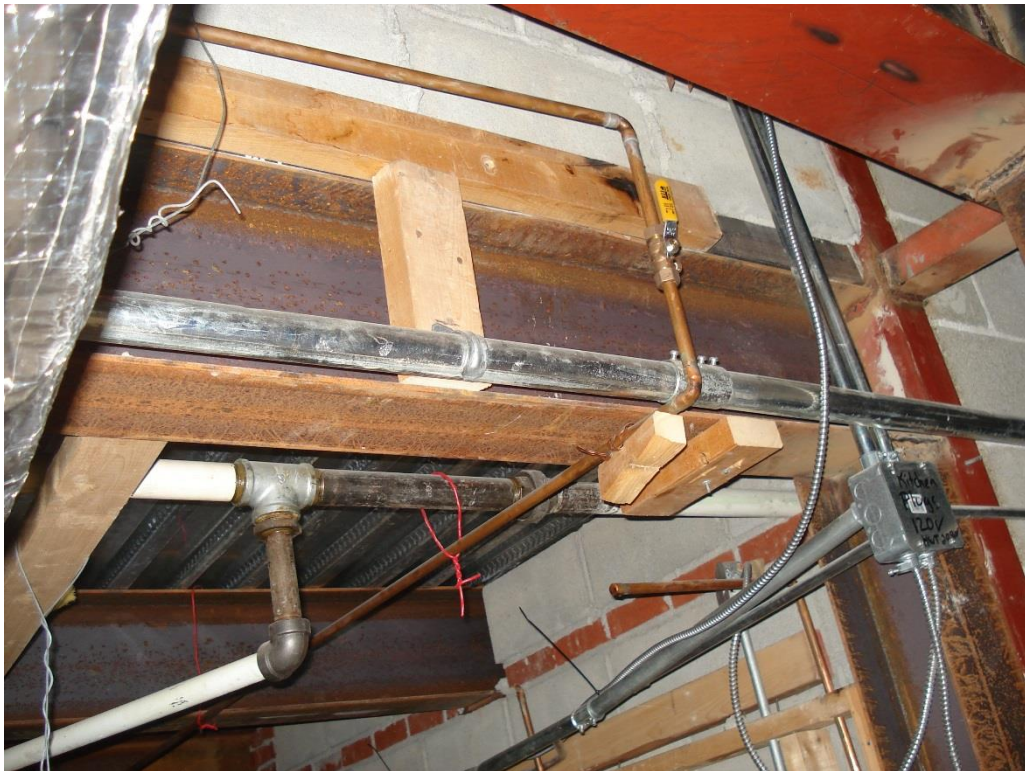
Photo 8 - Water Piping Not Properly Supported

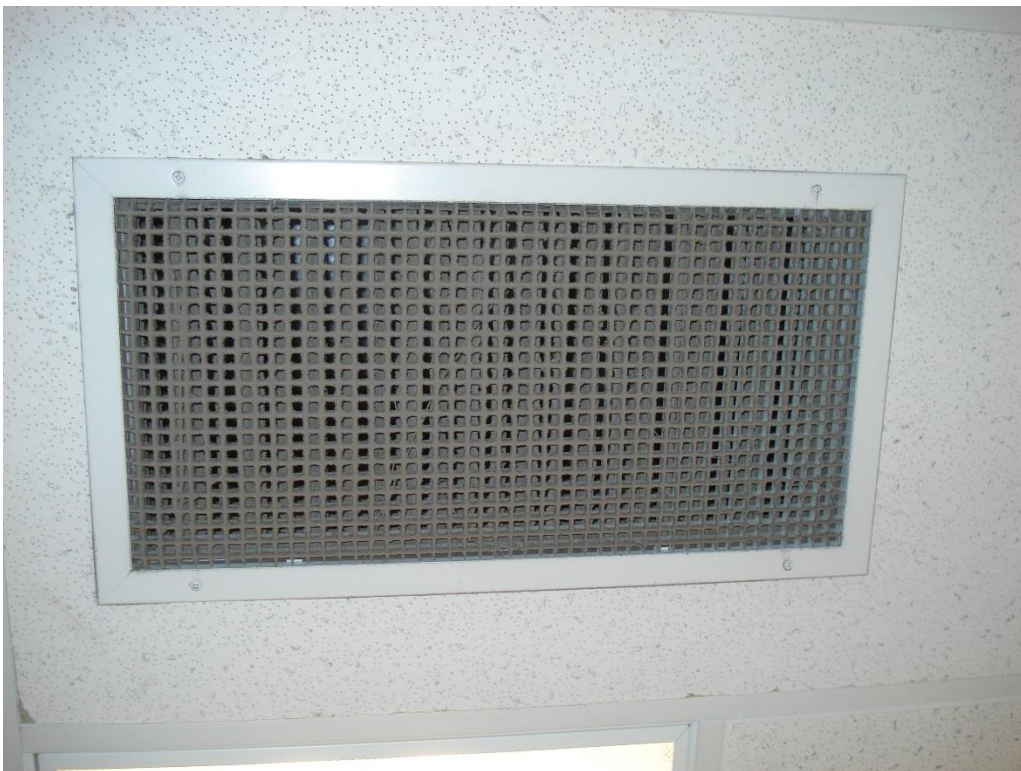
Photo 24 - Return Grilles Very Dirty

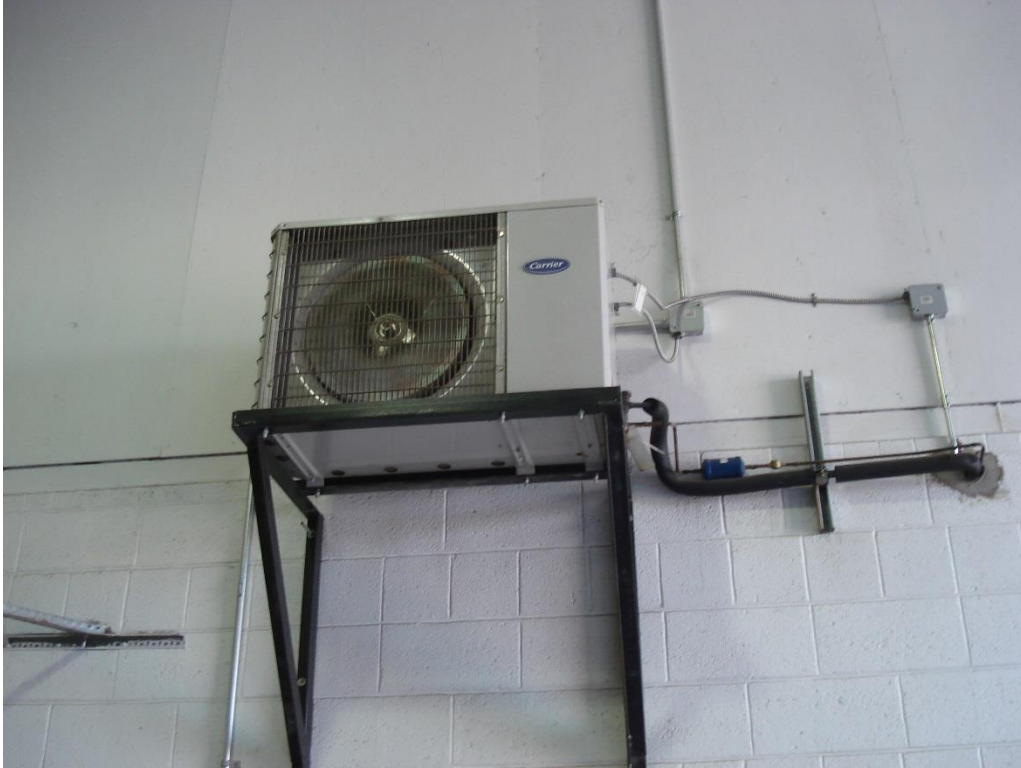
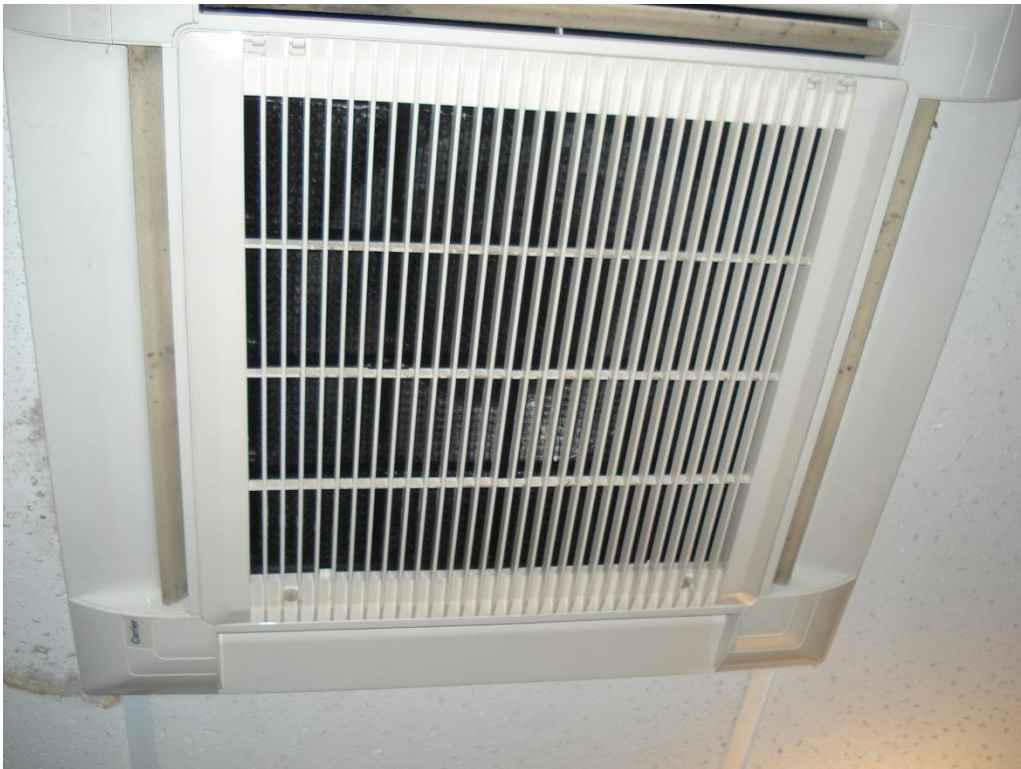
The server room located in the main office area is provided with a split air conditioning system (see Mechanical photos 25 and 26). The condenser is located in the warehouse area truck bay and the evaporator is a ceiling cassette style unit located in the server room. The condenser is a United Technologies Carrier model 38HDC018341 and has a nominal cooling capacity of 1.5 tons. The unit was manufactured in 1999 and was installed as part of the building upgrades made at that time. The unit utilizes R22 refrigerant. At 17 years of age this unit is approaching the end of its useful life.

Photo 25 - Server Room Condenser Unit

Photo 26 - Server Room Evaporator Unit

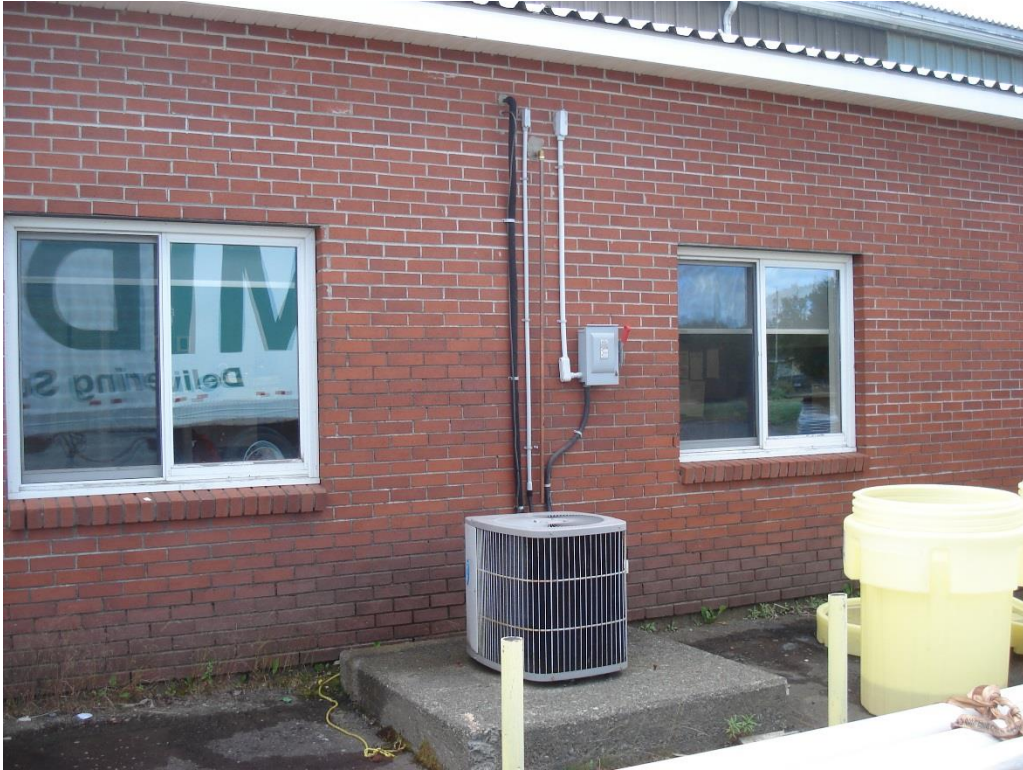
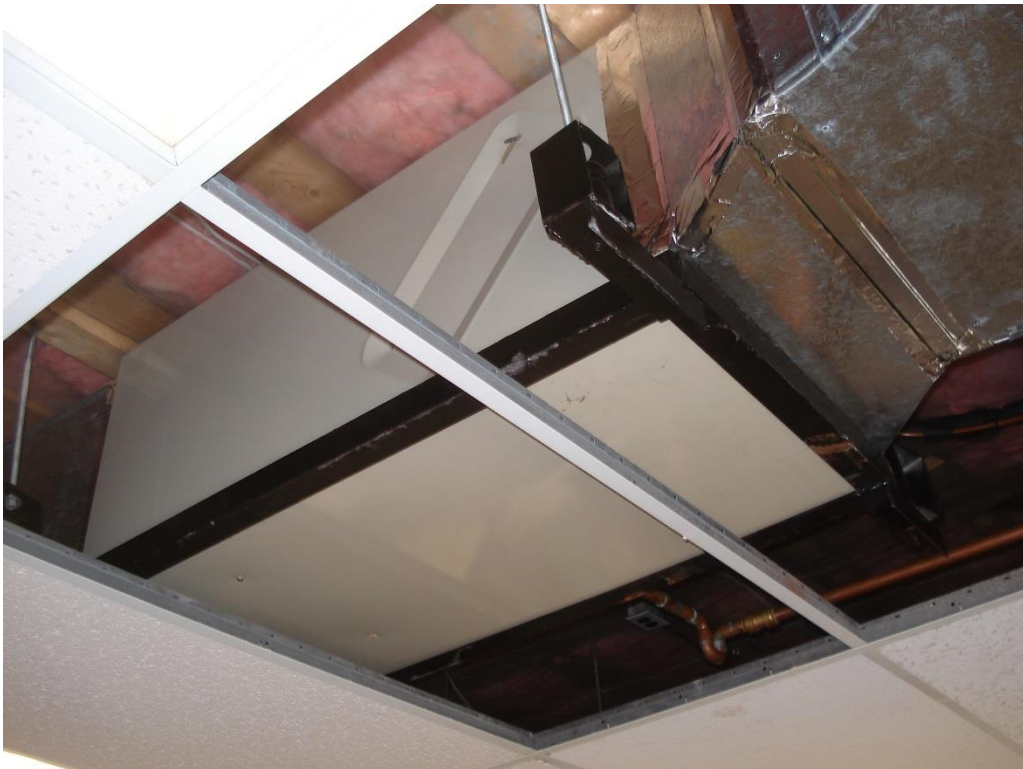
The front office extension is provided with a split air conditioning system (see Mechanical photos 27 and 28). The condenser is located outdoors adjacent to the large office area and the evaporator is an indoor air handler unit located in the ceiling of this large office. The condenser is a Carrier model 38TG030300 and has a nominal cooling capacity of 2.5 tons. The indoor unit is a Carrier model 40AQ030310BU. The units were manufactured in 1990 and utilize R22 refrigerant. This system is provided with supply ducting throughout this office area. Supply ducting is insulated with foil faced

Photo 27 - Front Office Area Condenser Unit

Photo 28 - Front Office Area Evaporator Unit

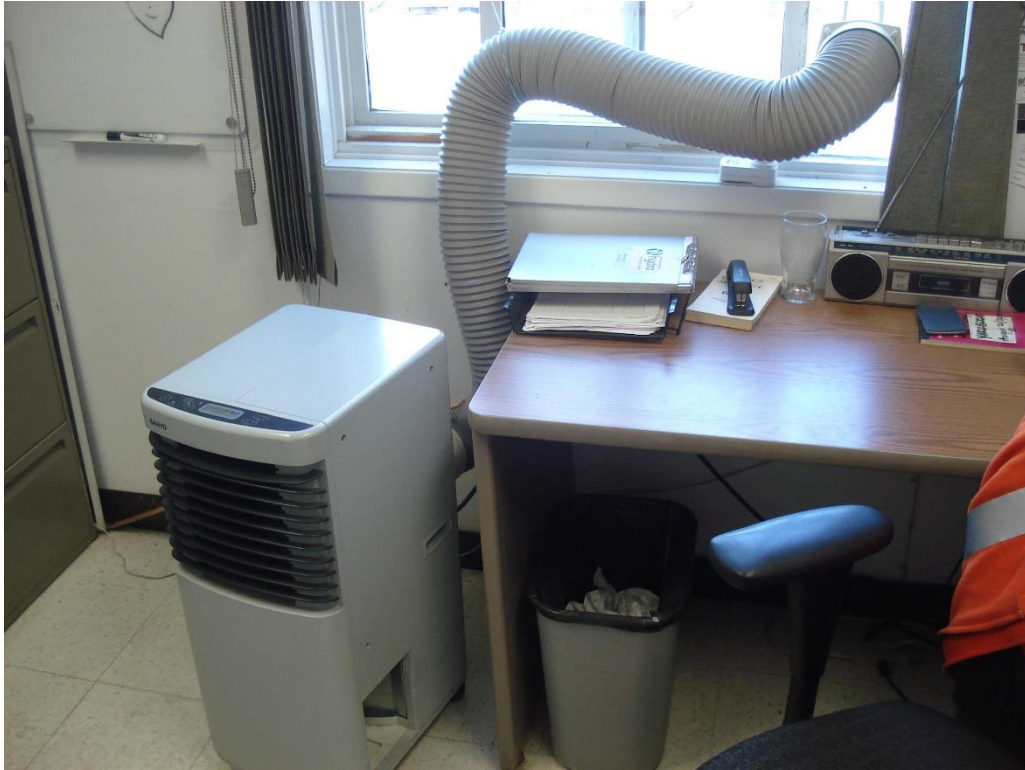
A portable air conditioning unit was observed in the far left office of the front office area extension (see Mechanical photo 29). This office is not served by the air conditioning system described above. The unit is the portable type with condenser venting through an operable window. The unit appears to be relatively new and operating properly.

Photo 29 - Portable Air Conditioning Unit

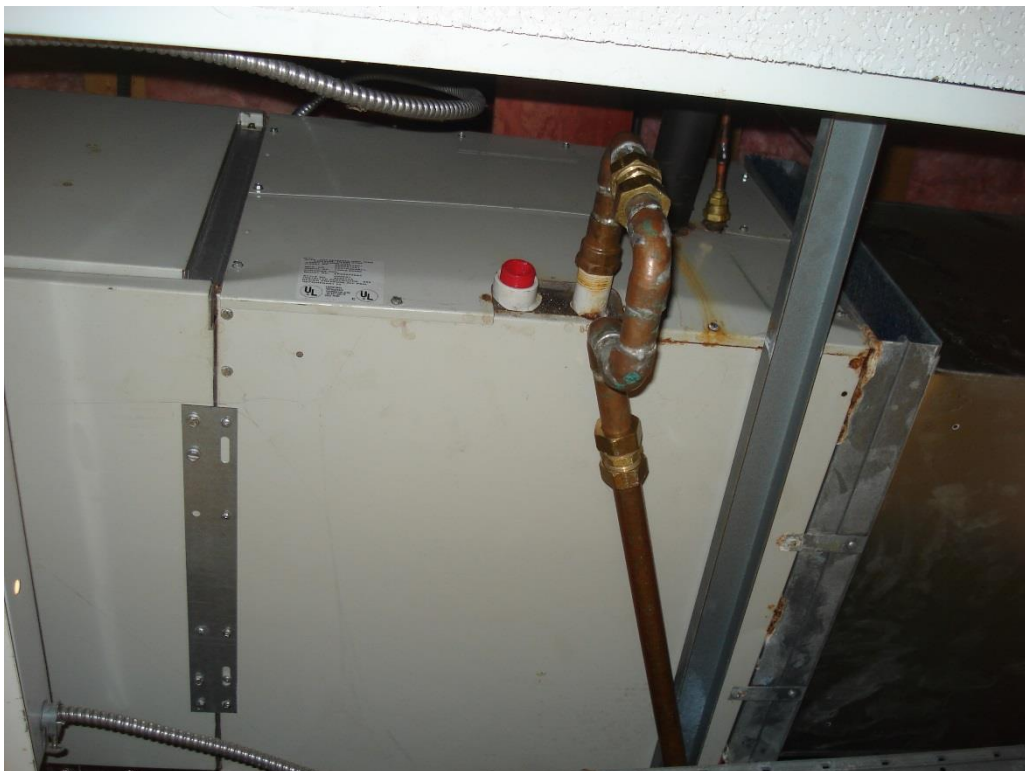
The second floor office and lunch room at the rear of the transformer shop is provided with a split air conditioning system (see Mechanical photo 30). The condenser is located outdoors on the roof above the evaporator and the evaporator is an indoor air handler unit located in the ceiling of the second floor corridor area. The evaporator is an Inter-City Products Corp model BMM024BKB. This company is no longer in operation. Based on its model number it has a nominal cooling capacity of 2 tons. The units were manufactured in 1996 and likely utilizes R22 refrigerant. This system is provided with ducted supply and return ducting throughout the office and lunch area. Supply ducting is insulated with foil faced blanket type insulation. Air distribution is through square cone type diffusers and return air grilles. The air distribution system appeared to be in good condition. No operational issues were observed during the site visit. At 20 years of age this unit is at the end of its useful life.

Photo 30 - Transformer Shop Offices Evaporator Unit
