July 15, 2025

**Re: 2026 Capital Budget Application**

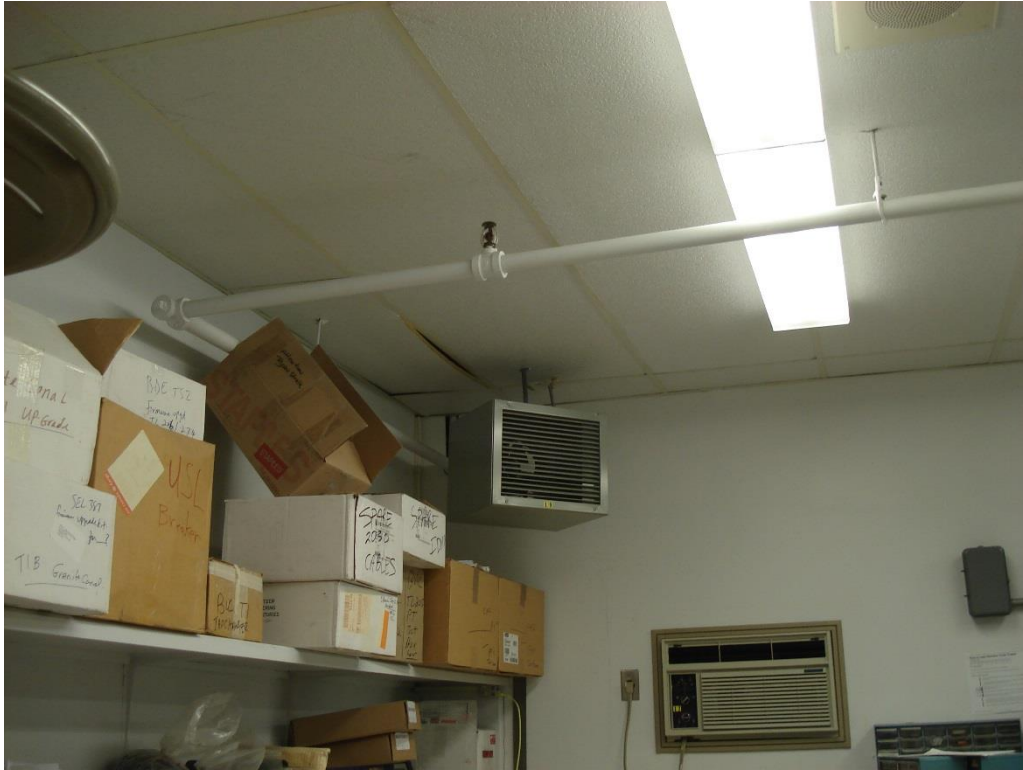
The Workshop located off of the main office area is equipped with a through the wall air conditioning unit manufactured by Electrohome. The unit operated however its cooling circuit does not appear to be operating properly. This unit should be replaced (see Mechanical photo 31).

Photo 31 - Workshop Wall AC Unit

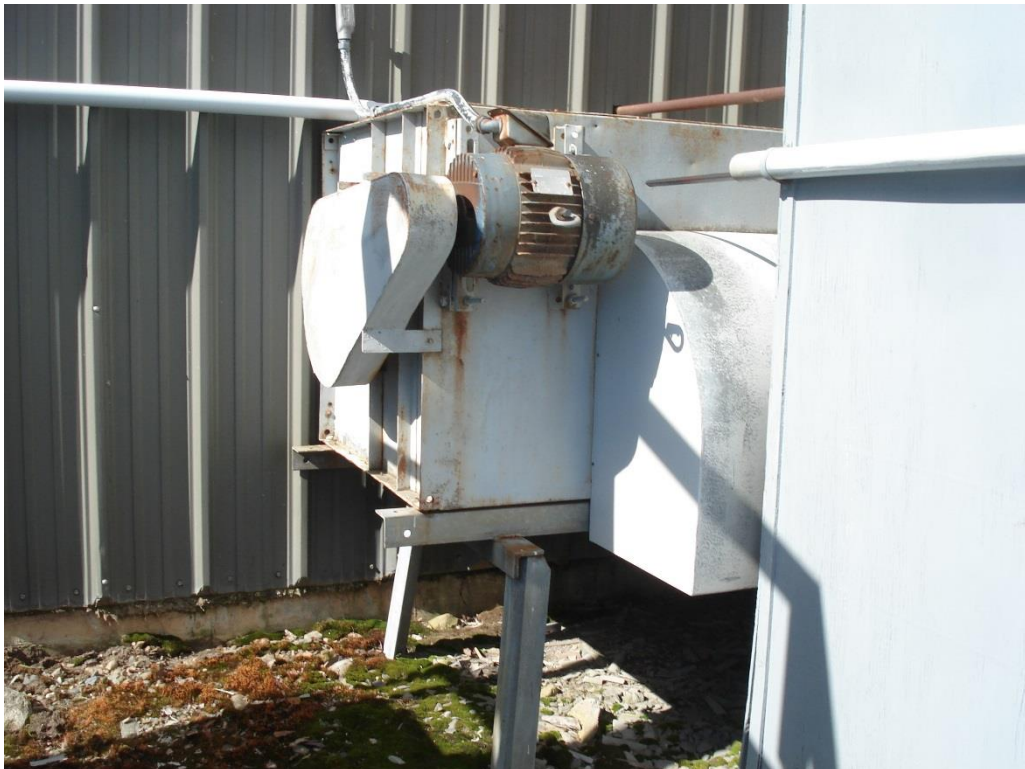
Located in the north corner of the facility is a paint room. The paint room is equipped with two wall mounted propeller exhaust fans and a make-up air unit (see Mechanical photos 33 and 34). The make-up air unit is a Trane Torrivent model 25-VF and is belt driven with a 7.5 HP motor. The unit is a large cabinet type centrifugal blower. This unit is located outdoors on a stand adjacent to the Paint Room. The unit is in poor condition with appreciable corrosion on its top panels and its casing deformed out of shape. The wall exhaust fans are direct drive and heavily coated in dust from the painting operations that went on in the space. The exhaust fan motors and their wiring do not appear to be explosion proof as is the other components in the room such as the unit heater and lighting. The age of this equipment is unknown but would be estimated to be 30 plus years of age. Personnel indicated that the space is no longer used for painting operations. As such the ventilation equipment here could be removed.

Photo 33 – Paint Room Propeller Exhaust Fans

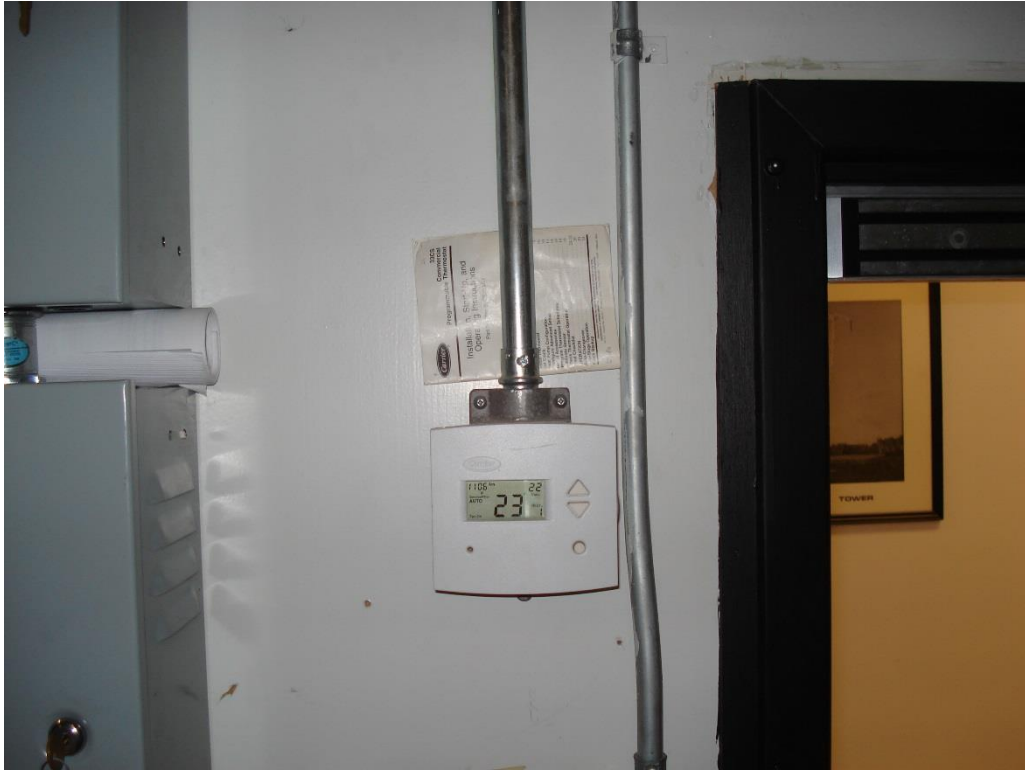
The building has a combination of stand alone controls and a Building Automation System (BAS). The BAS services the main office area of the building and second floor area and was installed during the renovation project of 1999. The BAS controls operation of the rooftop unit, zone duct heaters, baseboard heaters, and rooftop washroom exhaust fan. The BAS is composed of control panels, zone thermostats, sensors, and other end devices (see Mechanical photos 41 and 42). The main BAS panel is located in the office area server room.

Photo 42 - BAS Zone Thermostat

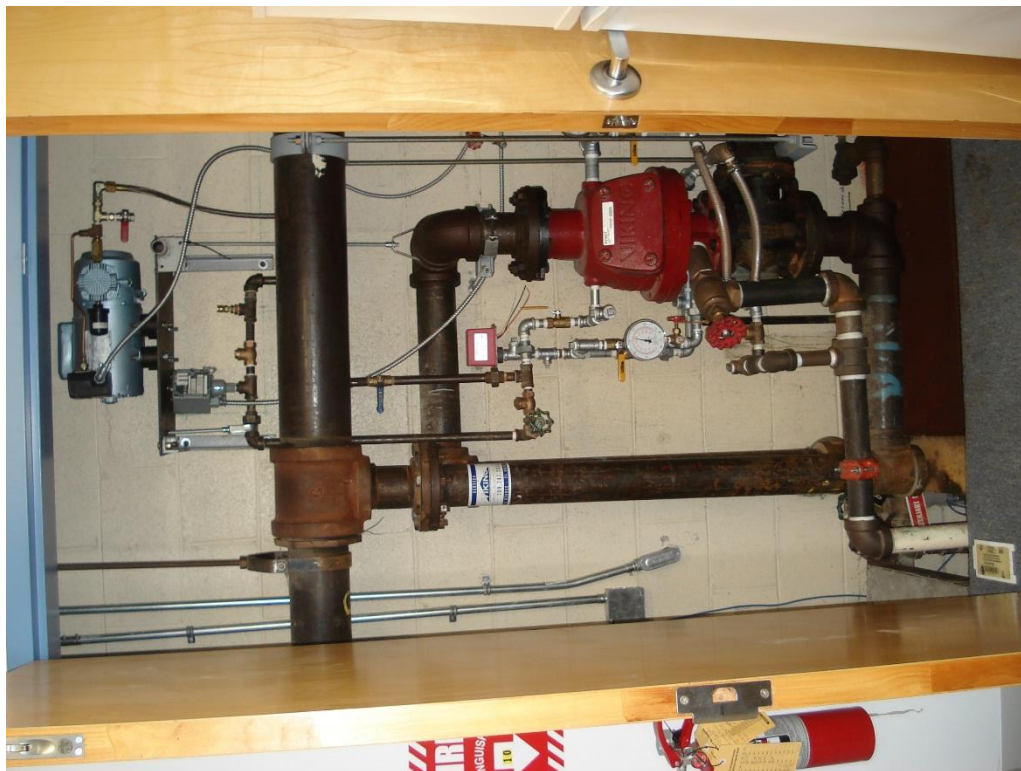
The building is fully protected by a combination wet and dry sprinkler system. The main water entrance is located in the building corner near the Truck Bay. Located at the water entrance is a wet system alarm valve (see Mechanical photo 44). No backflow prevention is present at the water entrance though by current practice it should as the system does have a glycol loop present. The fire department connection and bell are located on the adjacent exterior wall. A dry system valve and trim is located on the second floor in a closet space off of the coffee room (see Mechanical photo 46).

Photo 44 - Wet Sprinkler System Alarm Valve

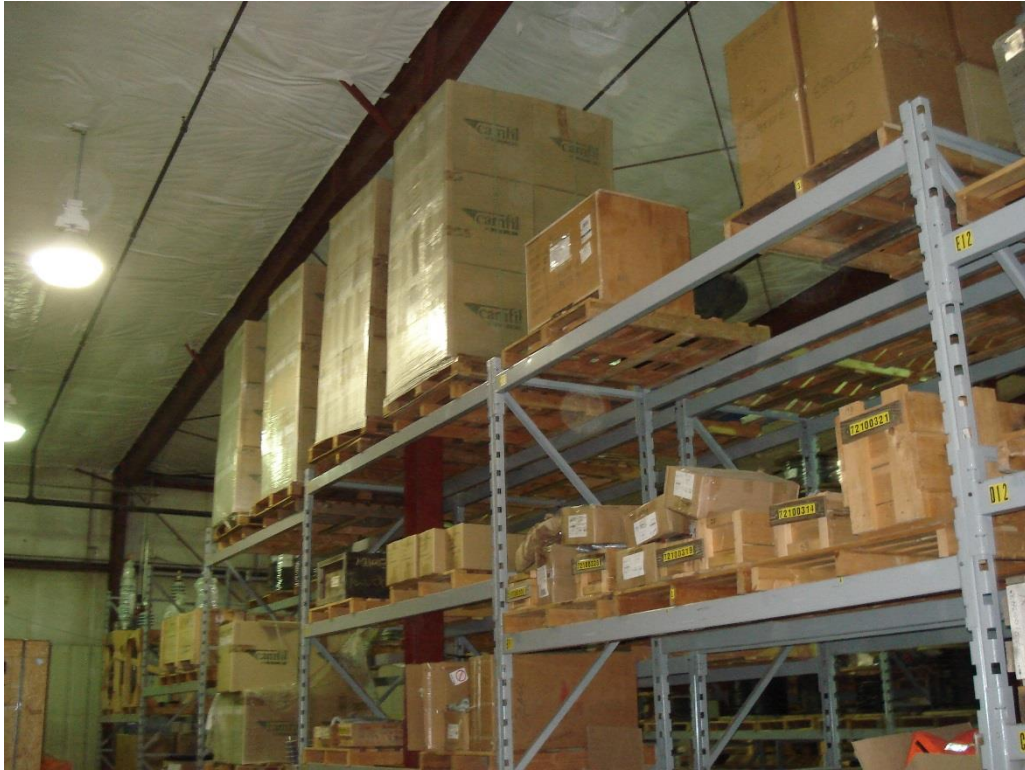
There were no rack storage sprinklers present. It was observed that storage was piled very high to the roof which can interfere with sprinkler effectiveness (see Mechanical photo 47). A review of what is stored, how it is stored, and to what height it is stored should be undertaken by a fire protection specialist to ensure it complies with NFPA 13 for the overhead sprinkler protection that is present. Specifically warehouse storage should be assessed from what classes of goods are present, if they are encapsulated or open, use of pallets and other rack obstructions, evaluation of maximum allowable storage height, and evaluation of aisle widths. The review should provide conditions for what can be stored, how it should be stored, and how high storage can be utilizing the existing overhead sprinkler protection. If the existing overhead protection does not serve the required storage needs then recommendations should be provided for rack sprinklers including their configuration and estimated cost to install.

Photo 47 - Rack Storage Very Close to Roof

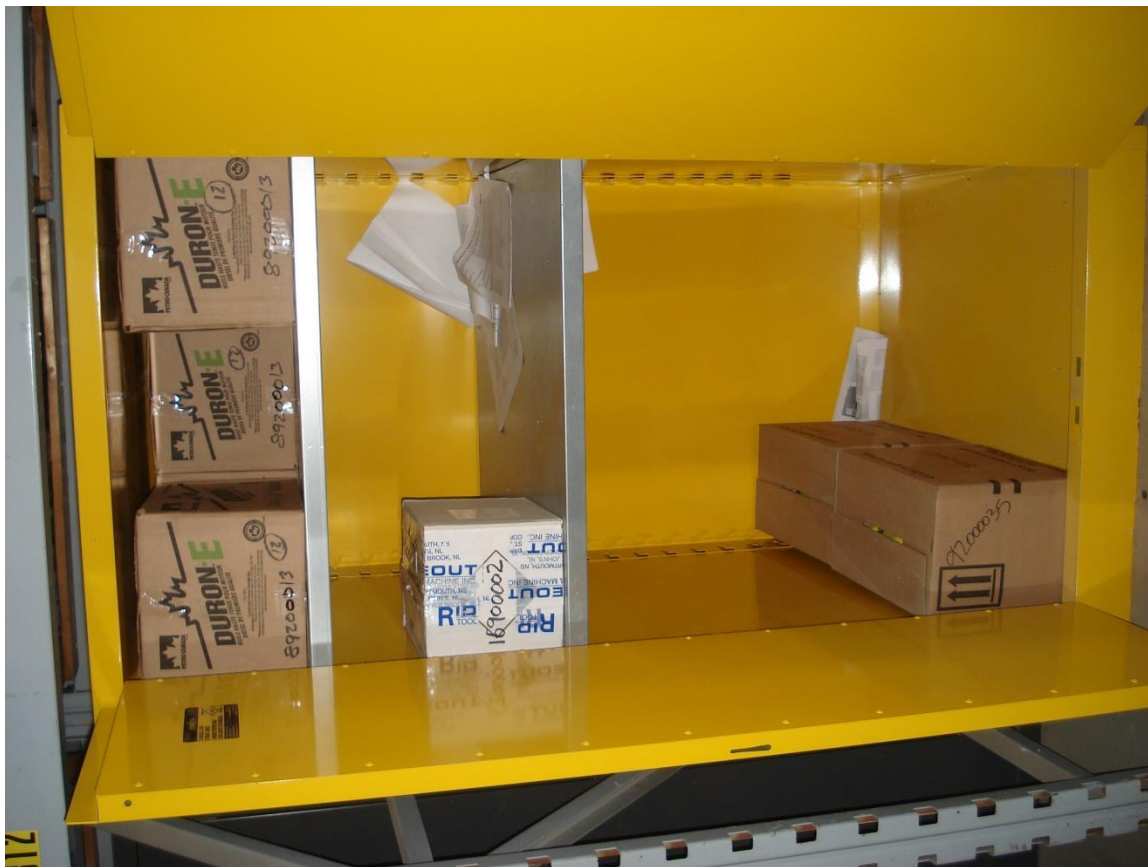
Photo 2 – Warehouse Safety Cabinet

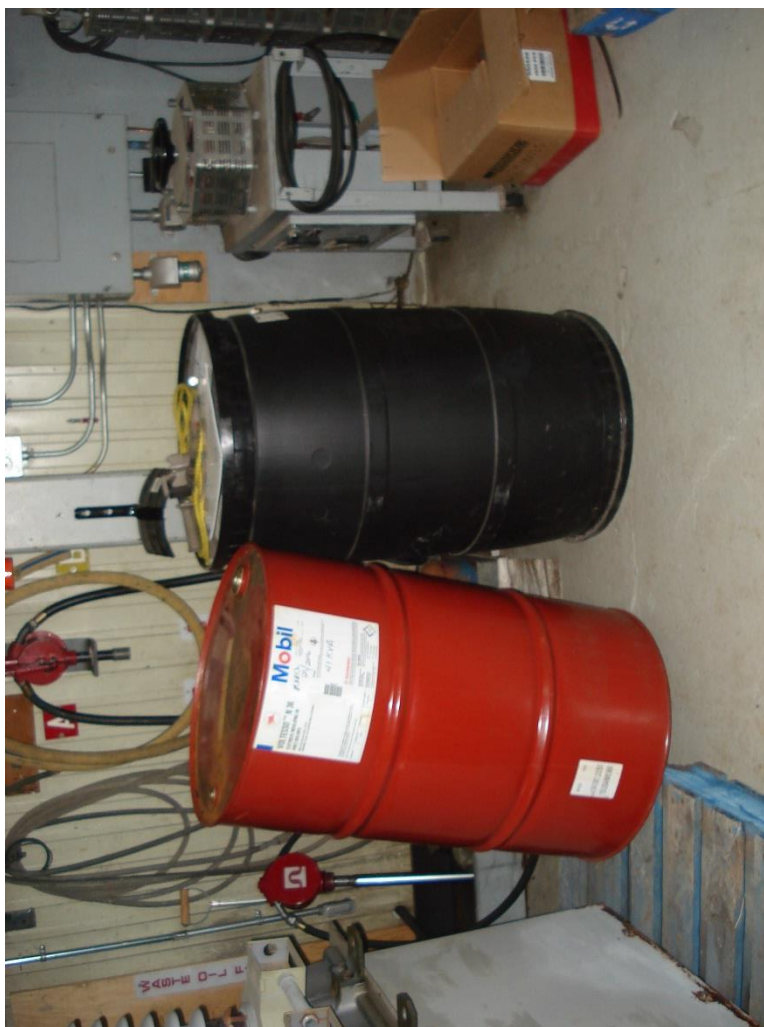
Photo 4 – Transformer Shop Oil Drums

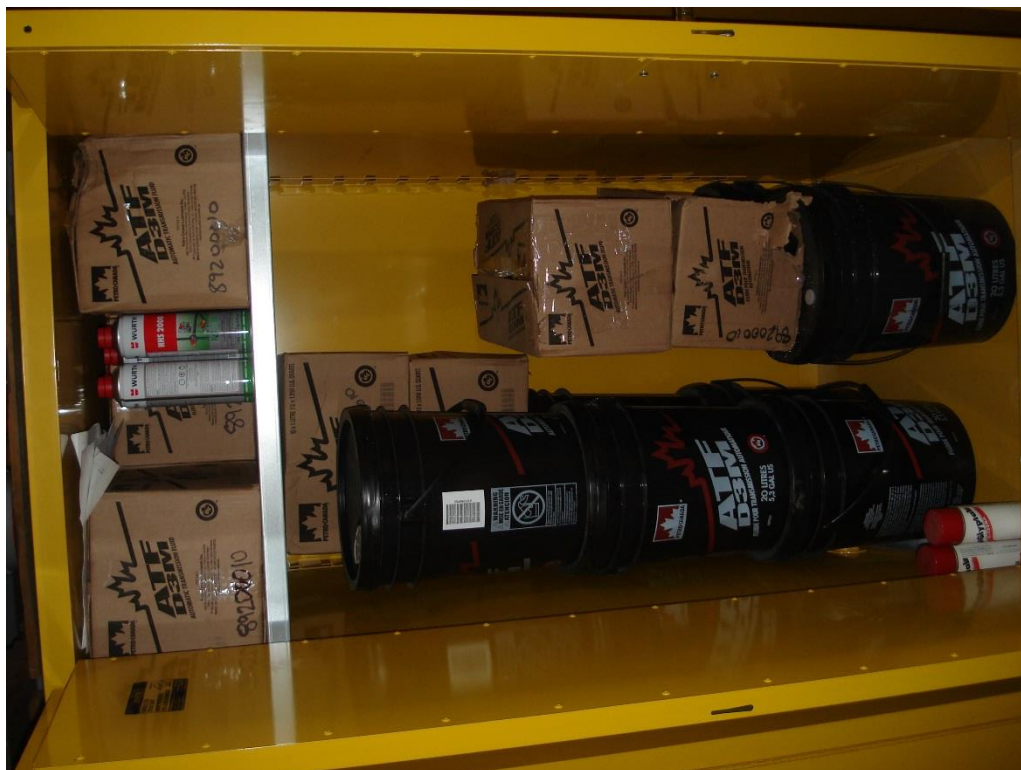
Photo 3 – Warehouse Safety Cabinet

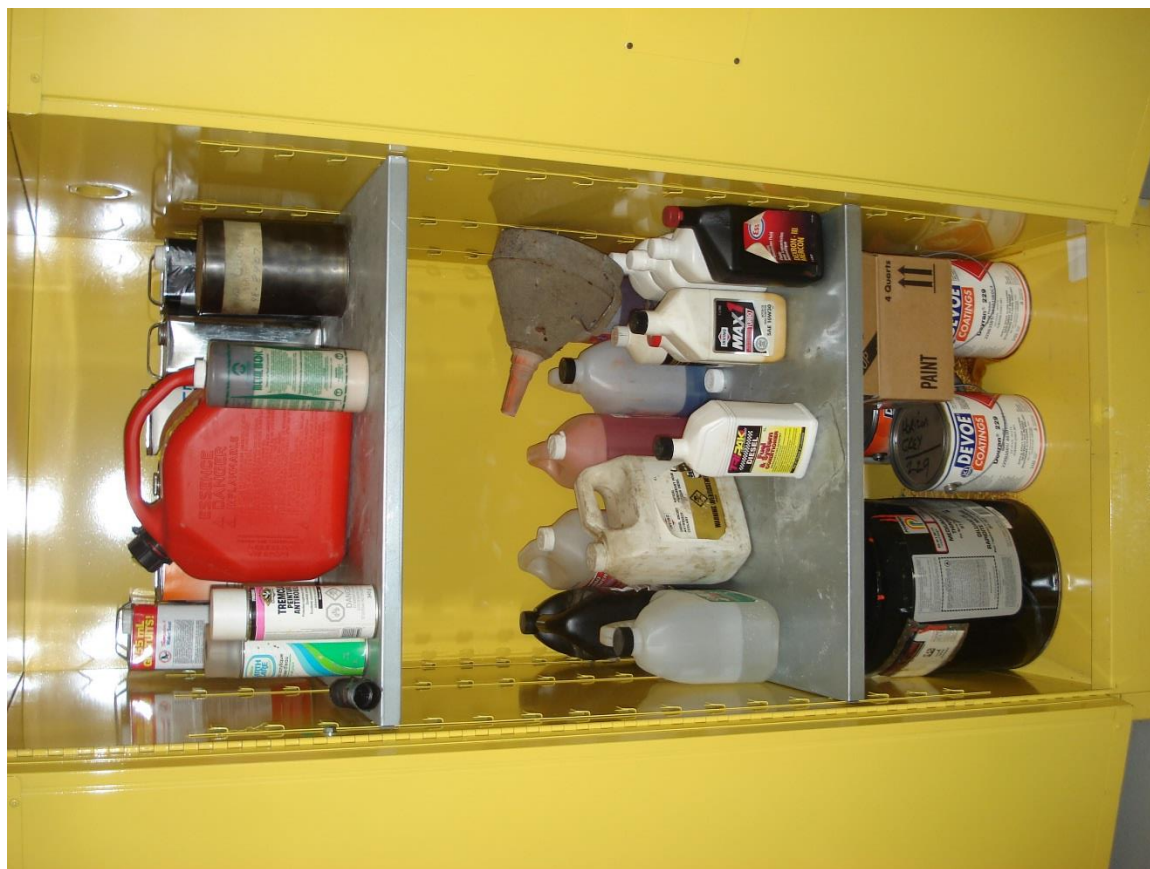
Photo 7 – Paint Storage Safety Cabinet

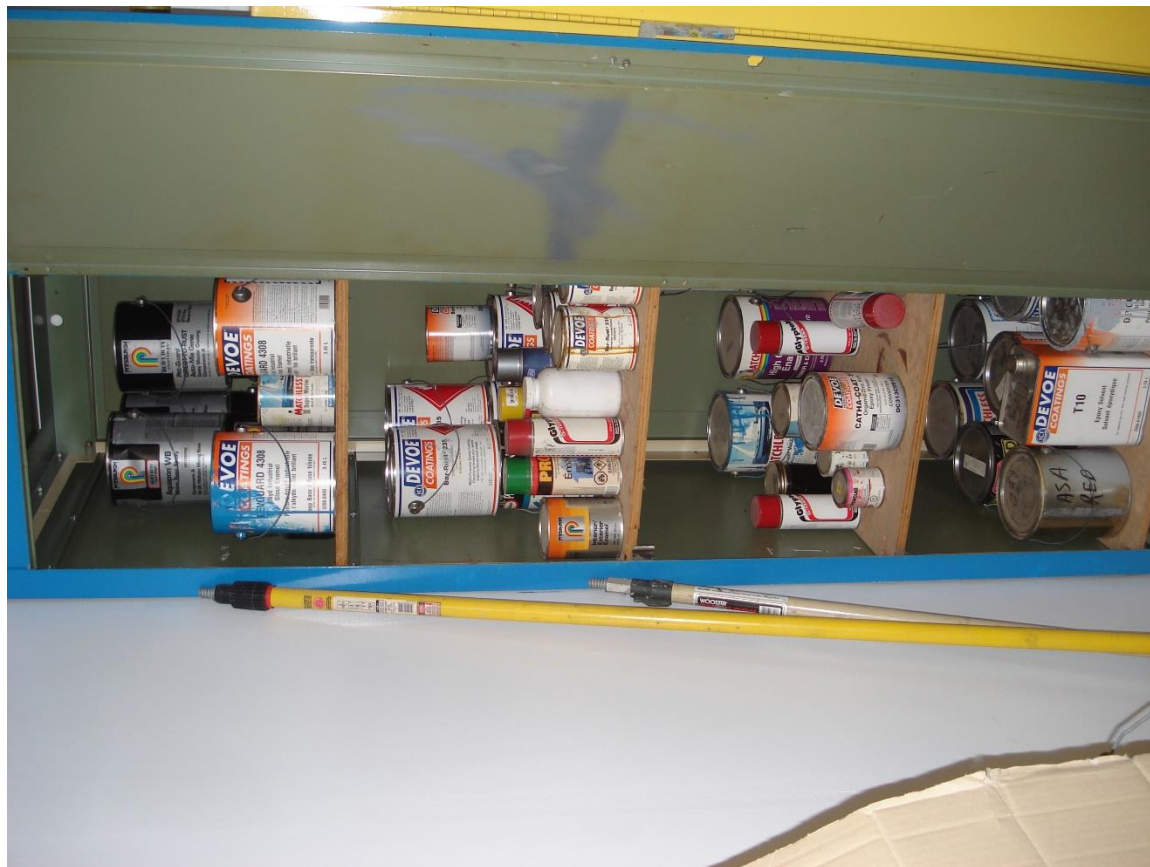
Photo 8 – Paint Storage Safety Cabinet

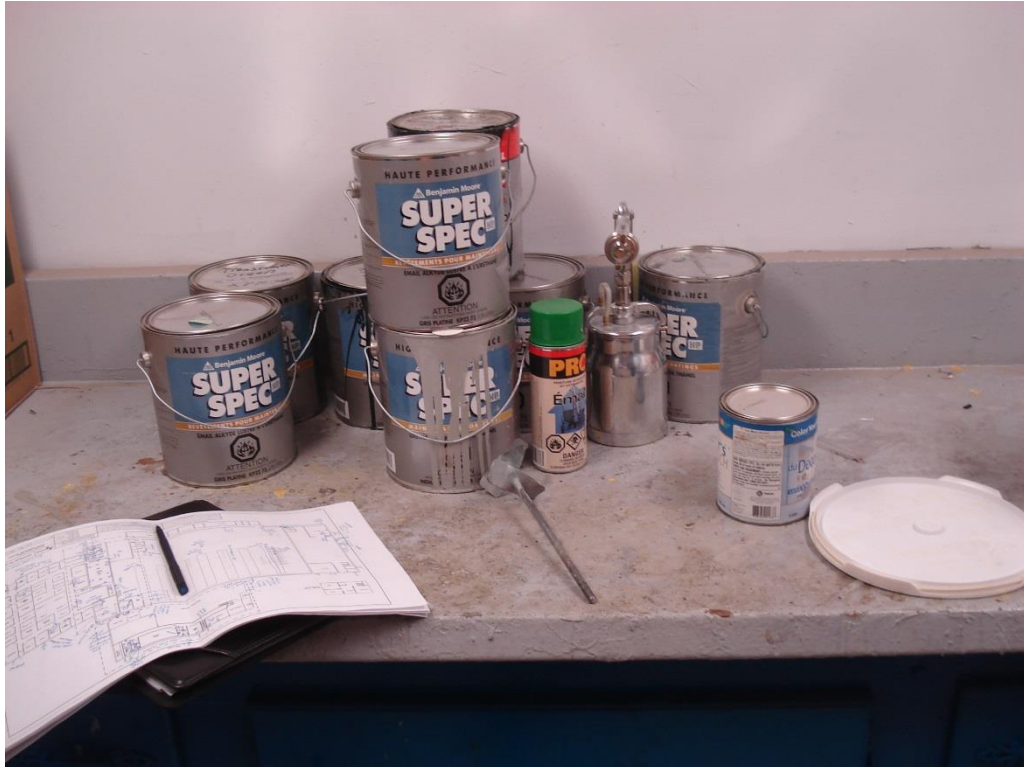
Photo 9 – Paint Storage Flammable Combustible Liquids

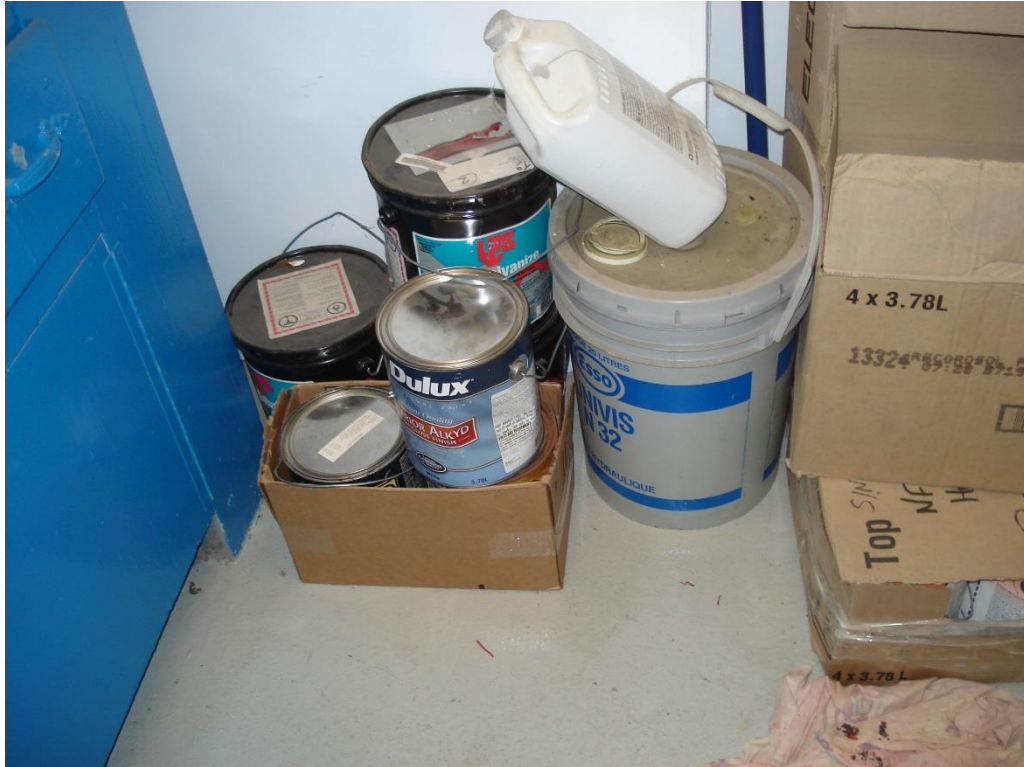
Photo 11 - Paint Storage Flammable Combustible Liquids

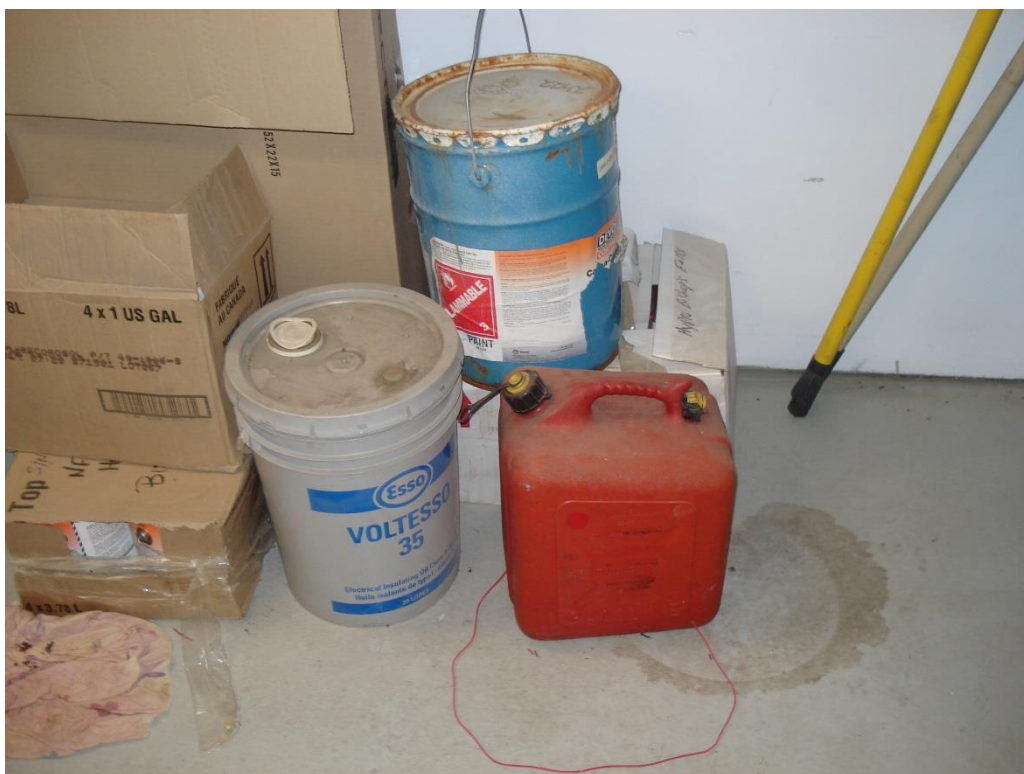
Photo 12 - Paint Storage Flammable Combustible Liquids

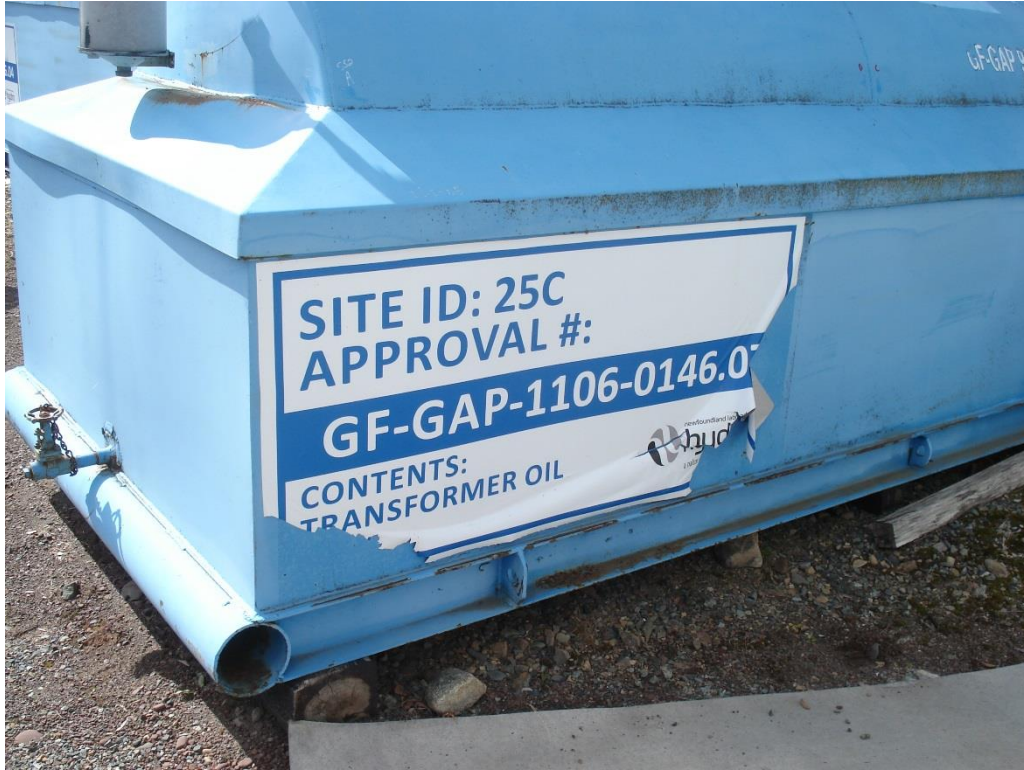
Photo 13 – 4,540 L Transformer Oil Tank

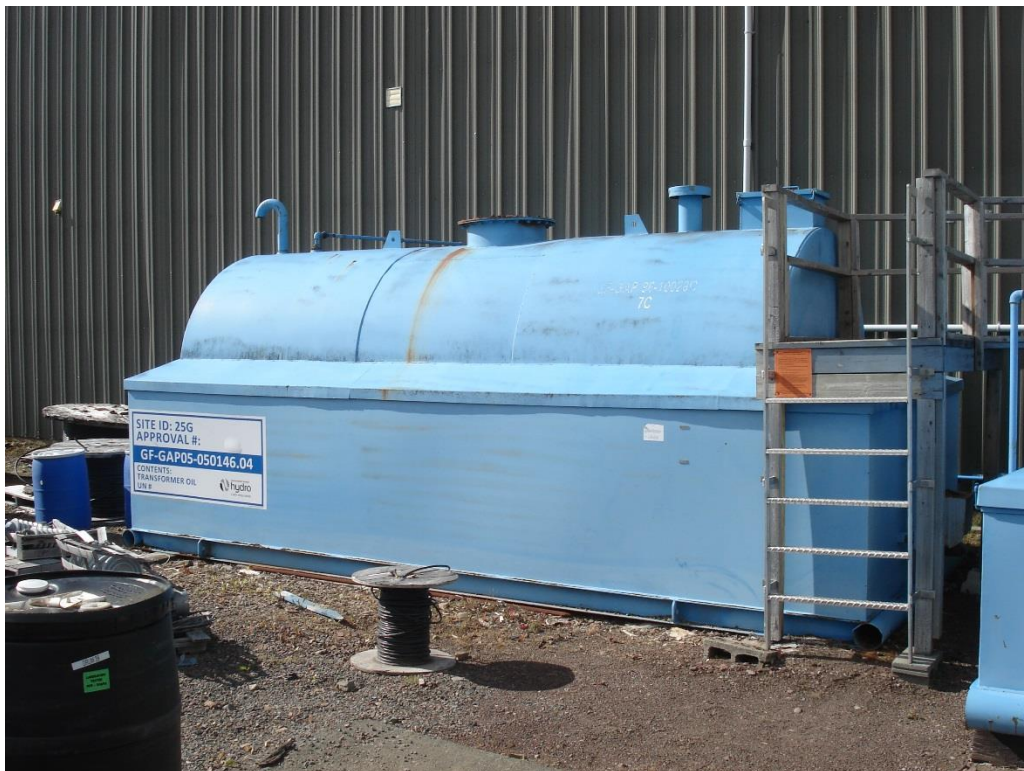
Photo 14 – 18,000 L Transformer Oil Tank (Used Oil)

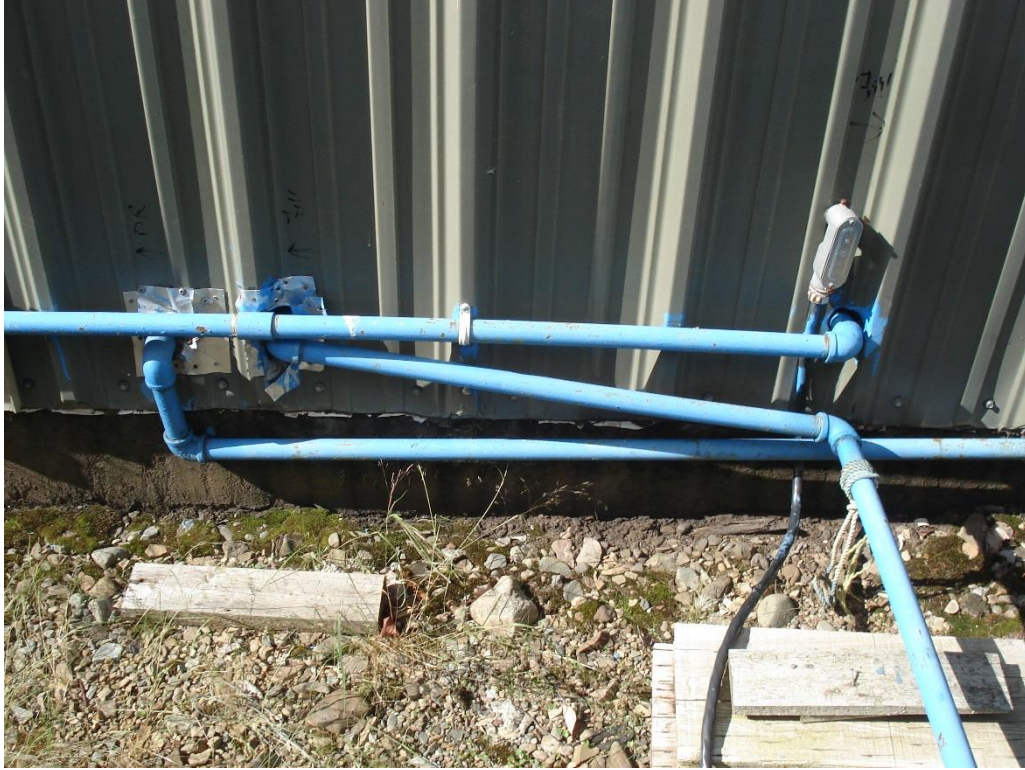
Photo 15 – Tank Piping Not Properly Supported

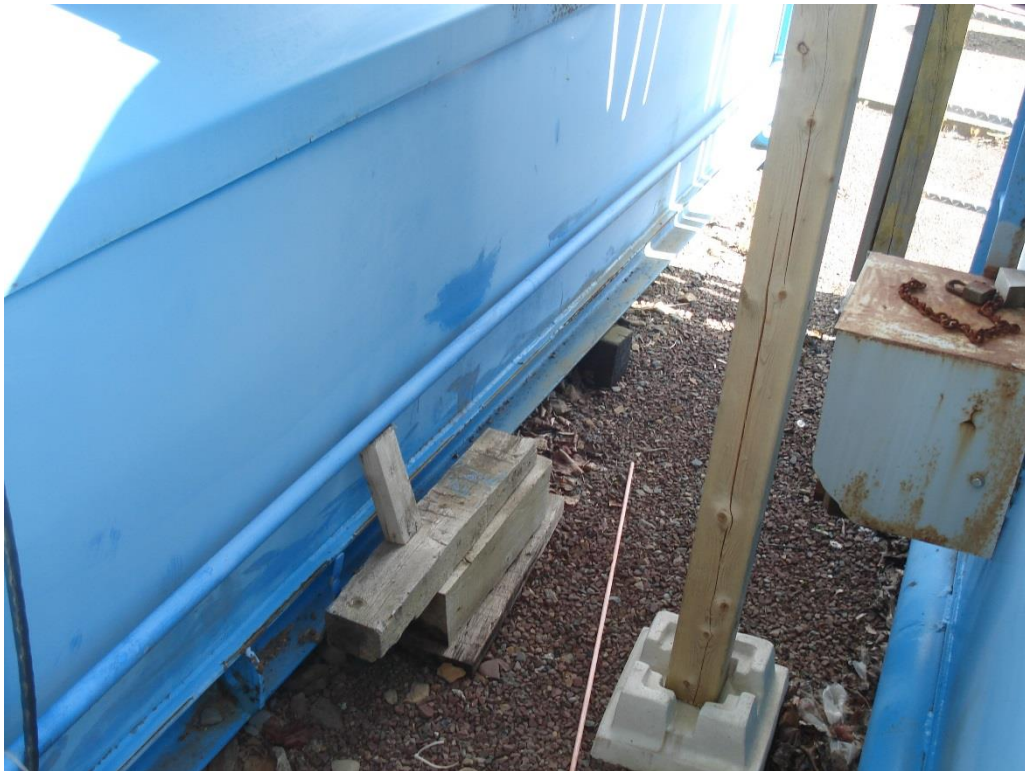
Photo 16 - Tank Piping Not Properly Supported

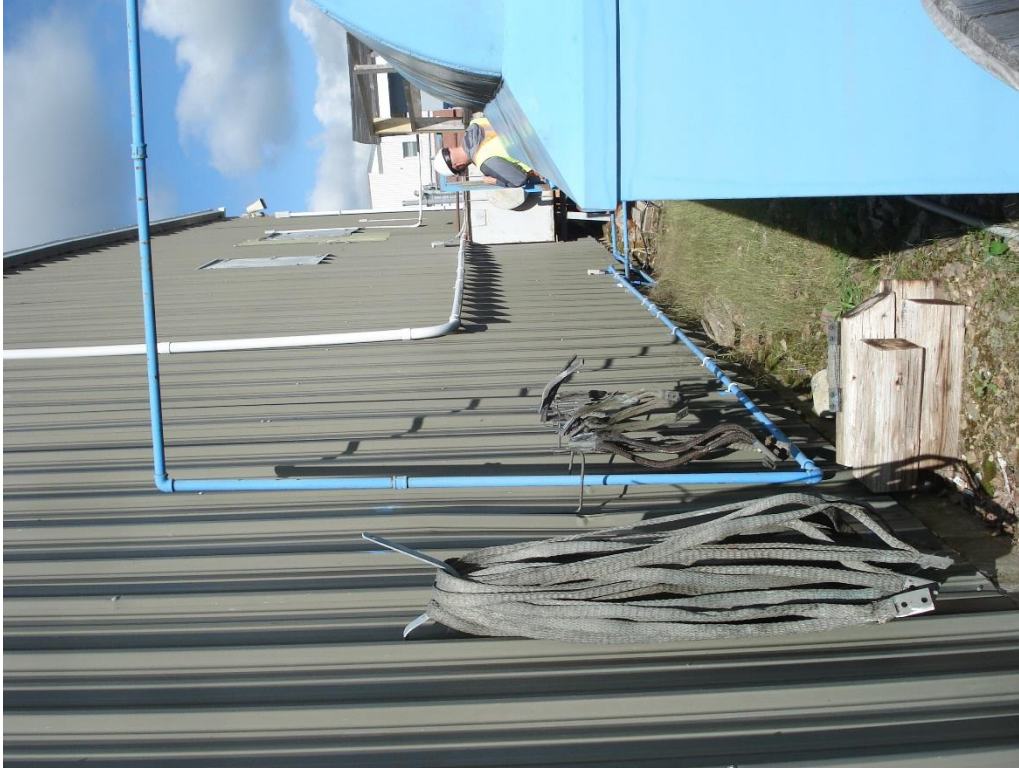
Photo 18 - Tank Piping Not Properly Supported

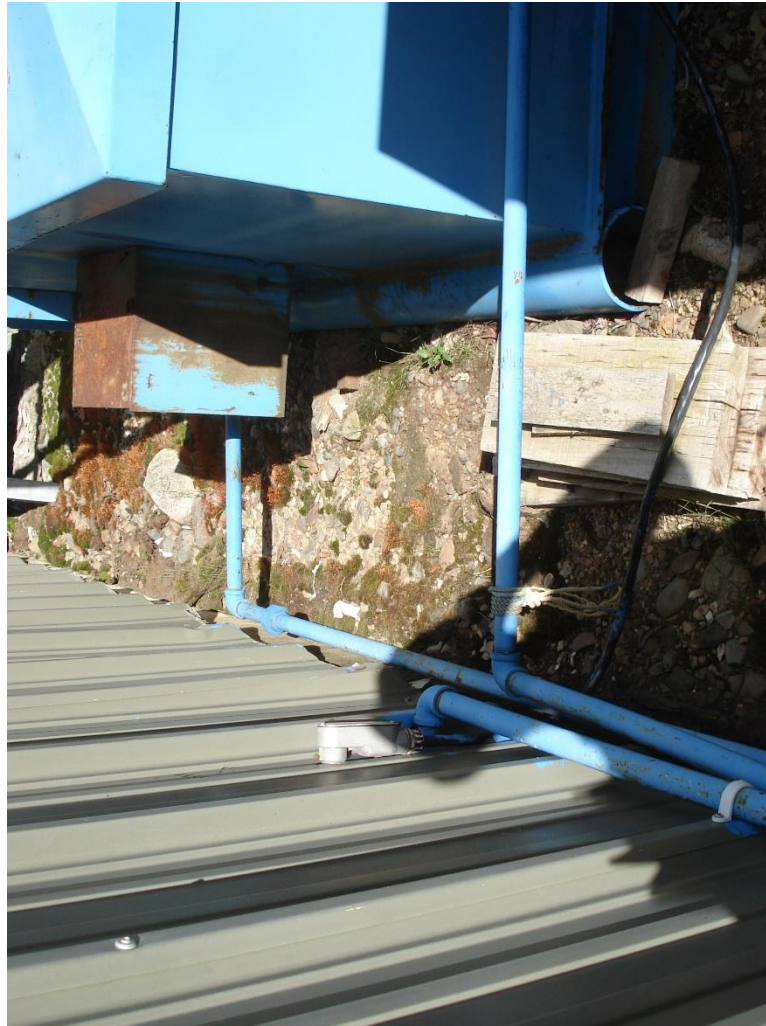
Photo 17 - Tank Piping Not Properly Supported

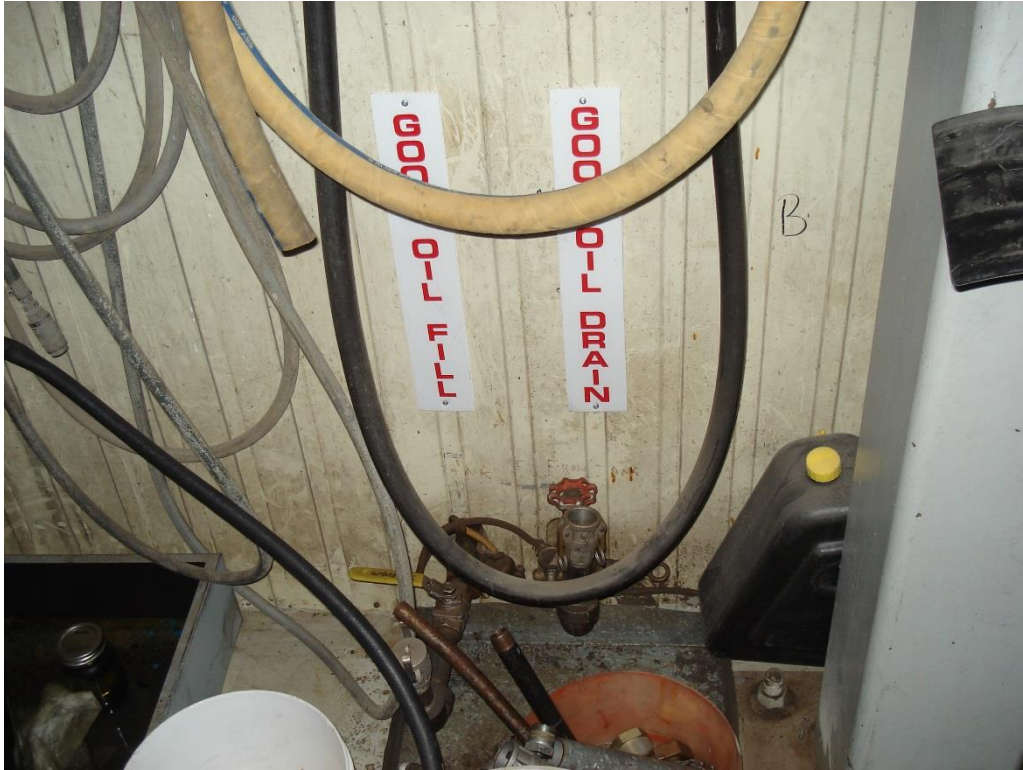
Photo 19 – Transformer Oil Supply and Fill Pipes

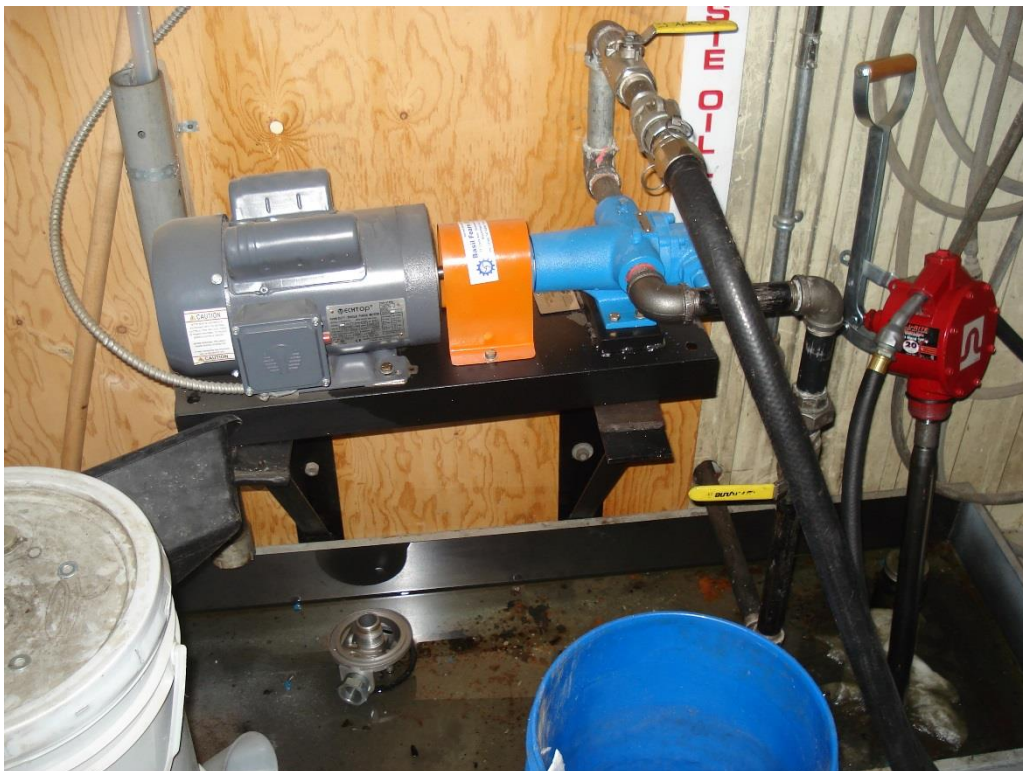
Photo 20 – Waste Oil Transfer Pump

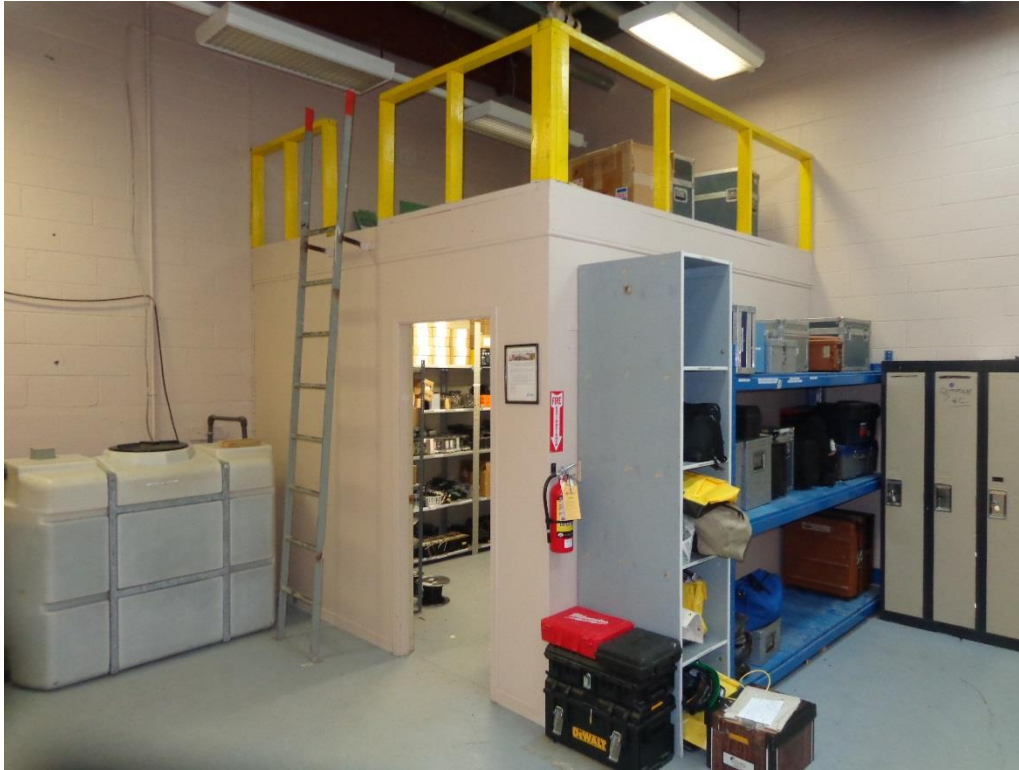
Photo 10 - Second Level Floor Framing

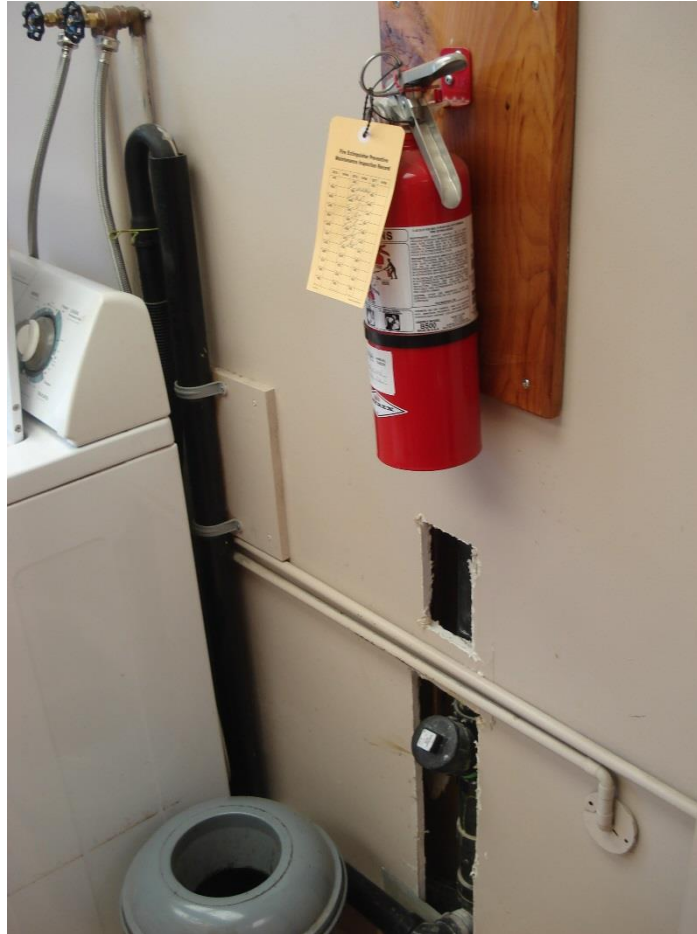
Photo 1 - ABS Drainage and Vent Piping

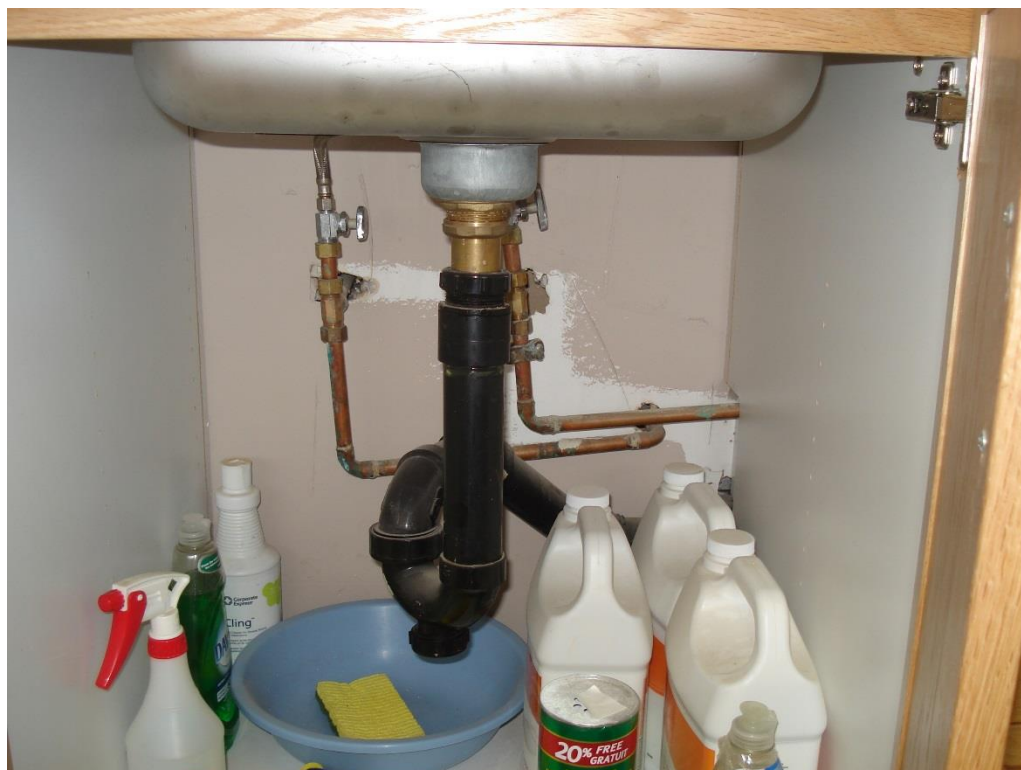
Photo 2 - ABS Drainage Piping

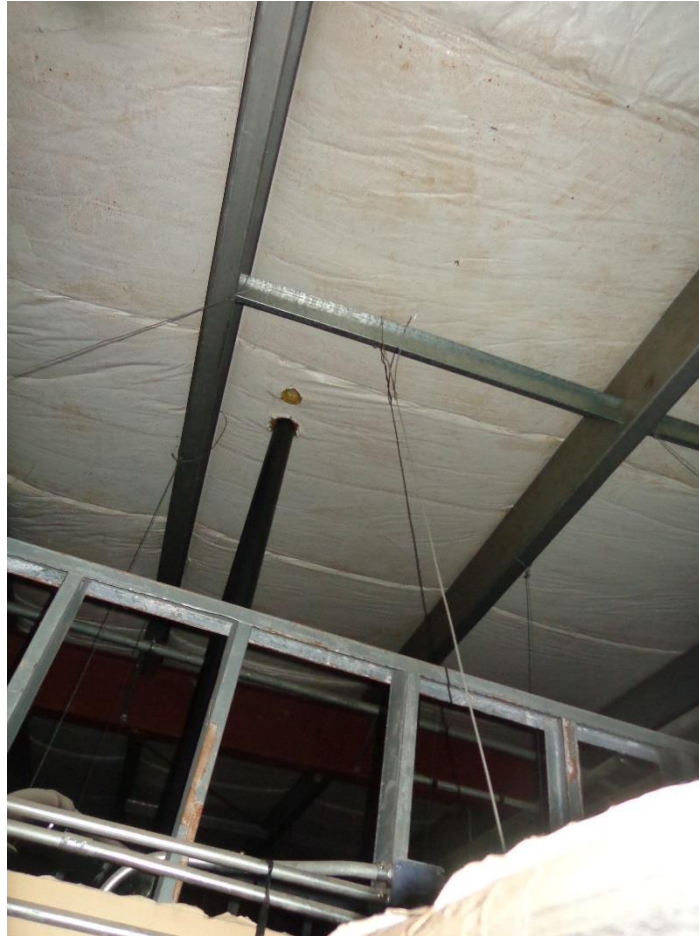
Photo 3 - ABS Vent Piping

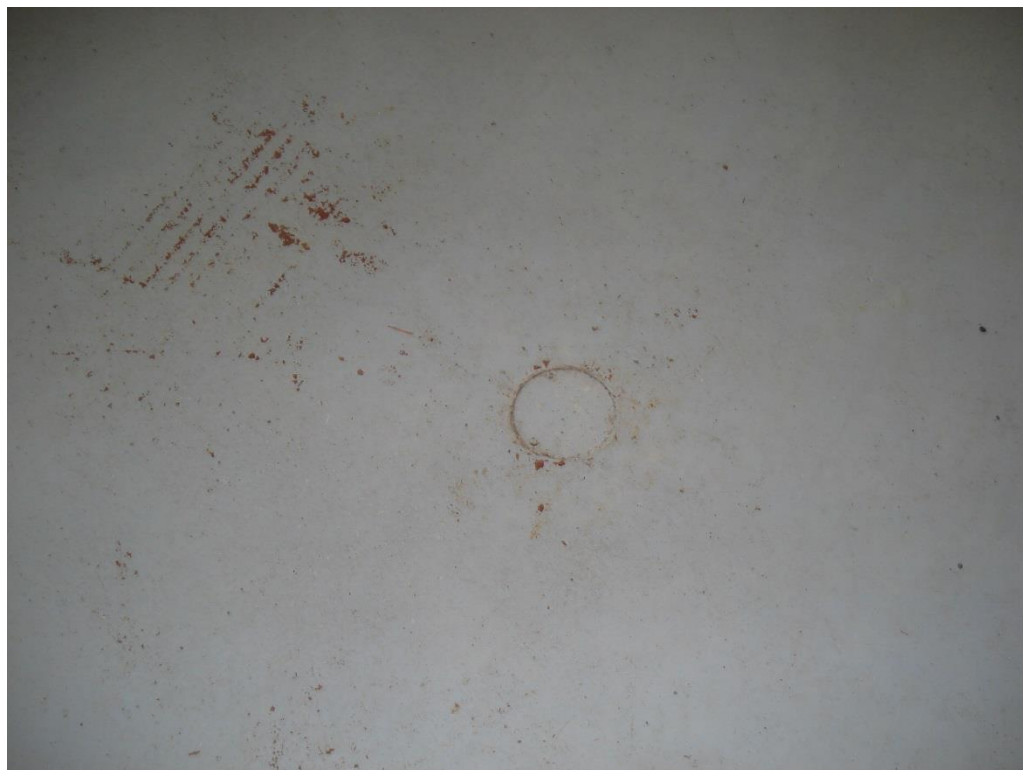
Photo 4 - Capped Floor Drain

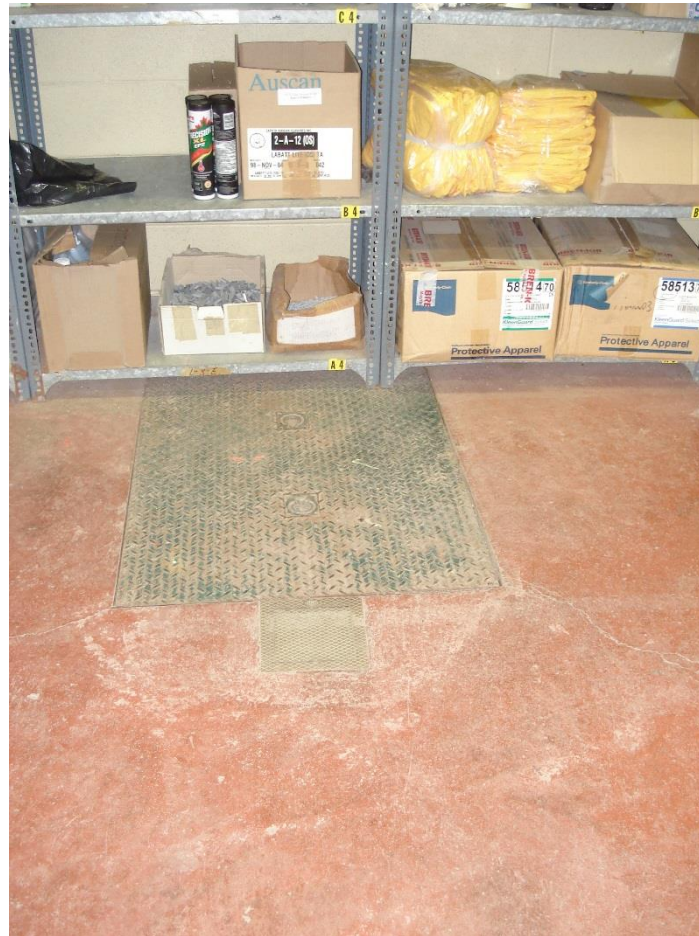
Photo 5 – Oil Interceptor Access Cover
