July 15, 2025

**Re: 2026 Capital Budget Application**

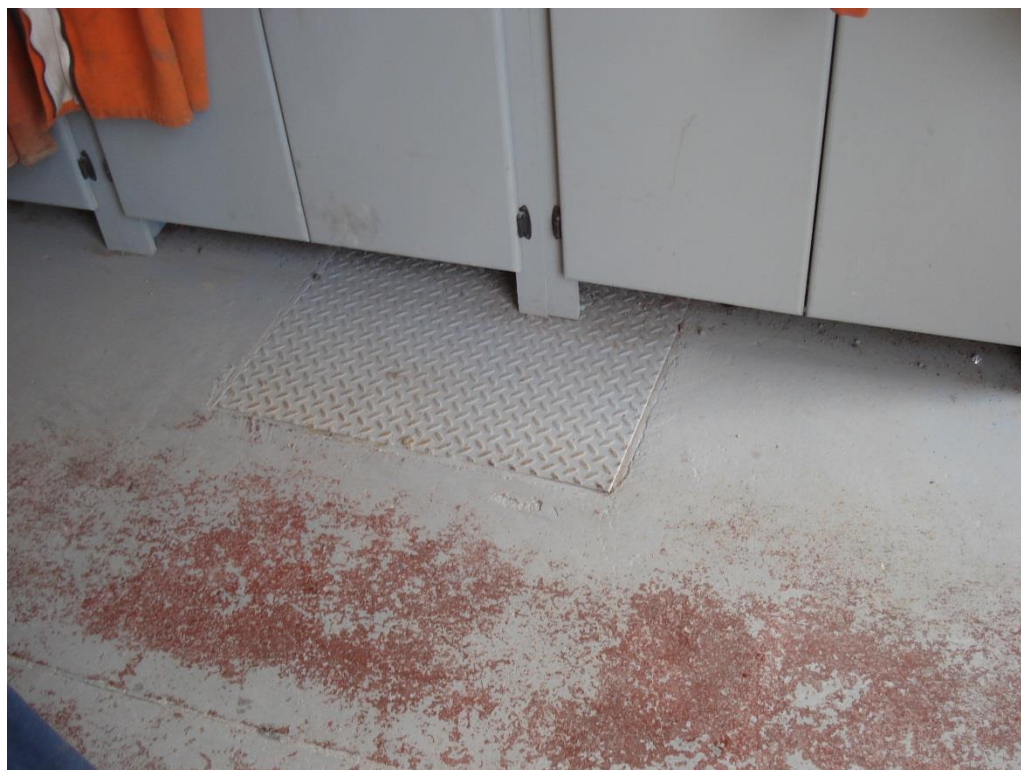
Photo 6 – Stabilizing Chamber Access Cover

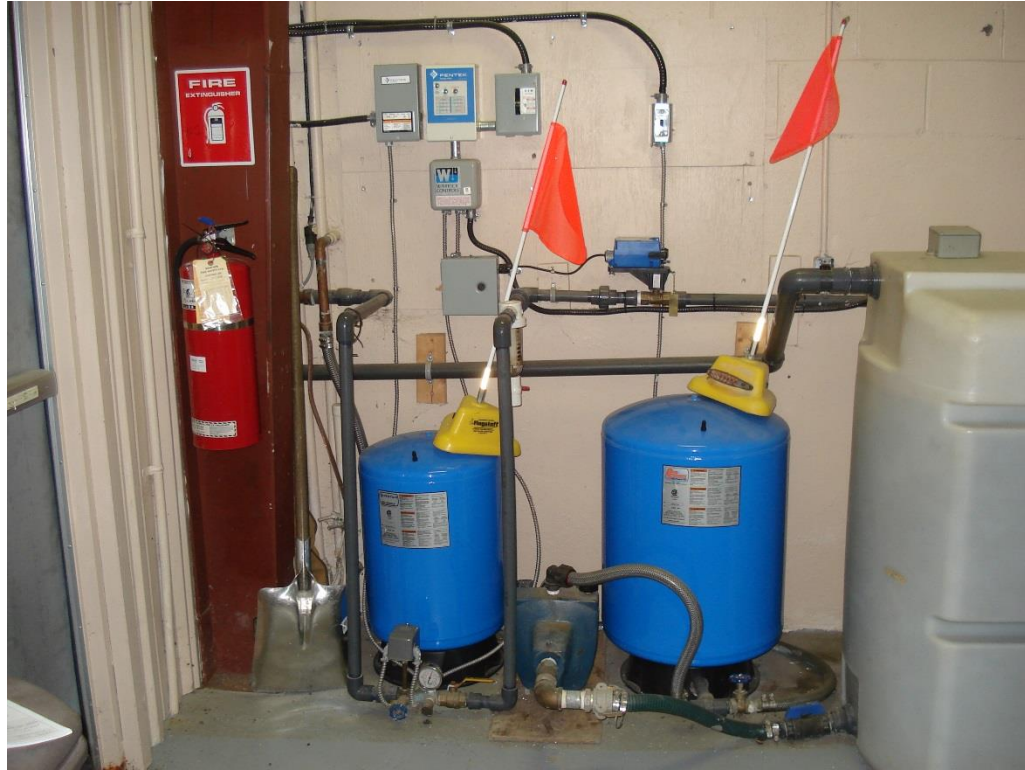
Photo 7 - Domestic Water Pressure Tanks and Piping

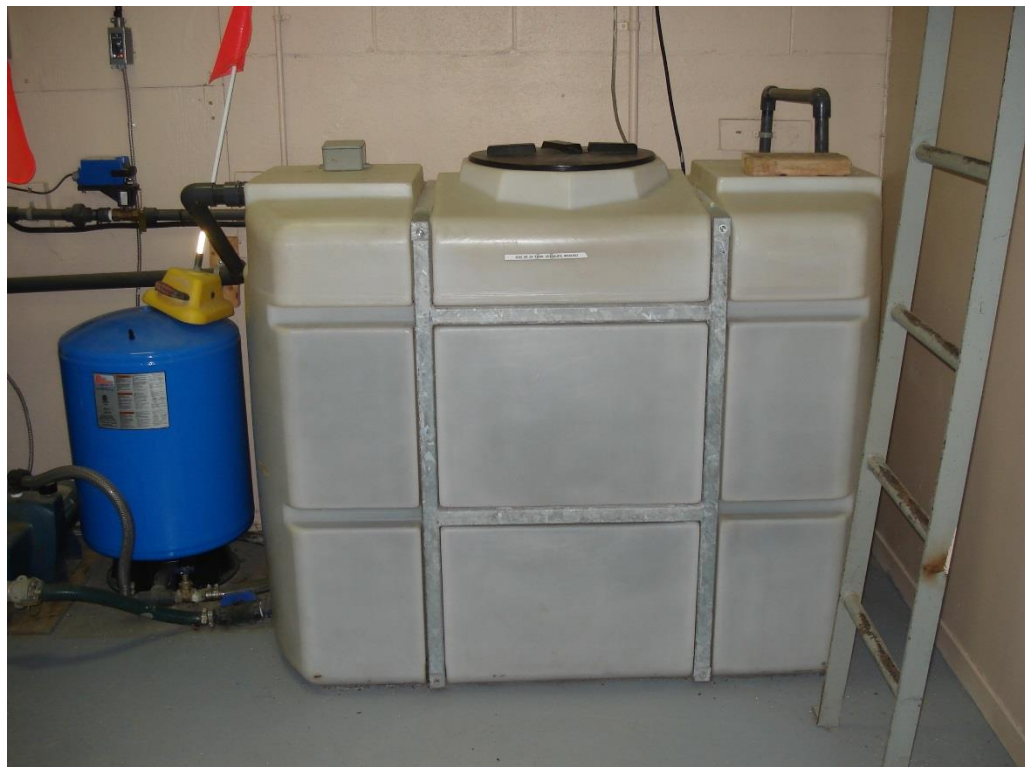
Photo 8 - Domestic Water Storage

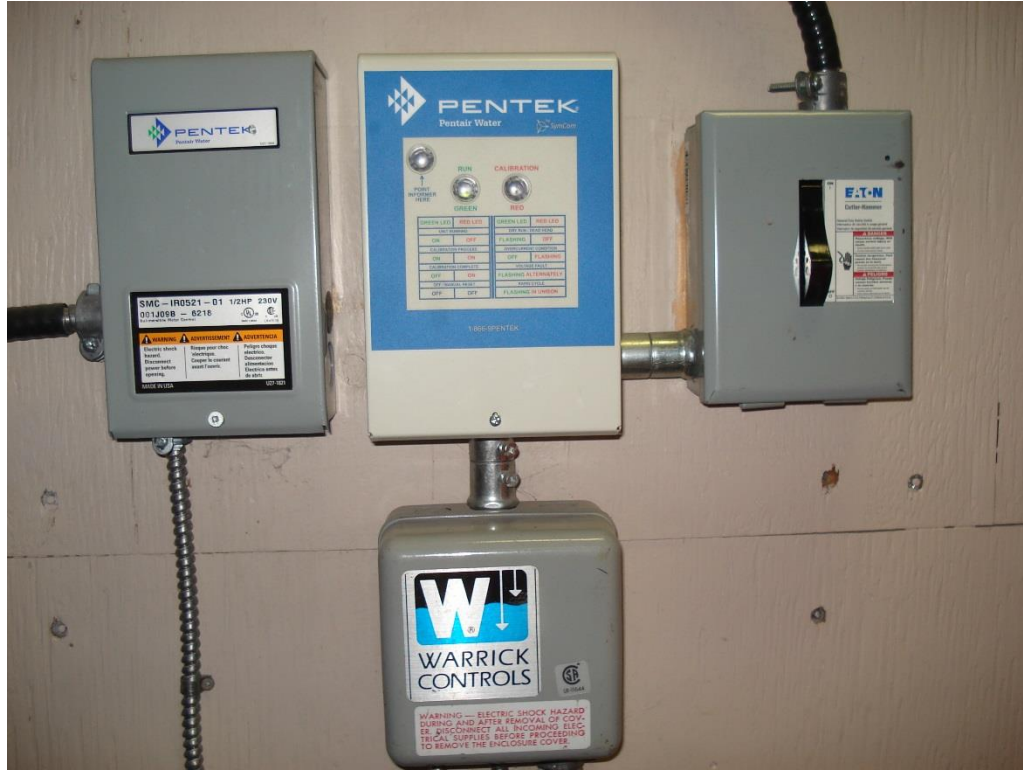
Photo 9 - Well Pump Controls

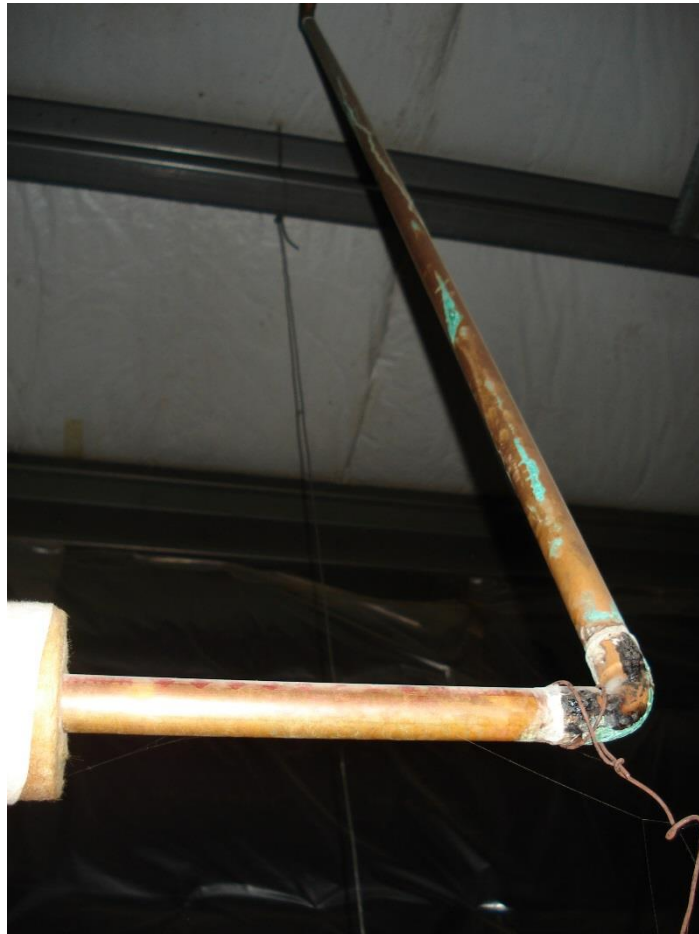
Photo 10 - Uninsulated Domestic Water Piping

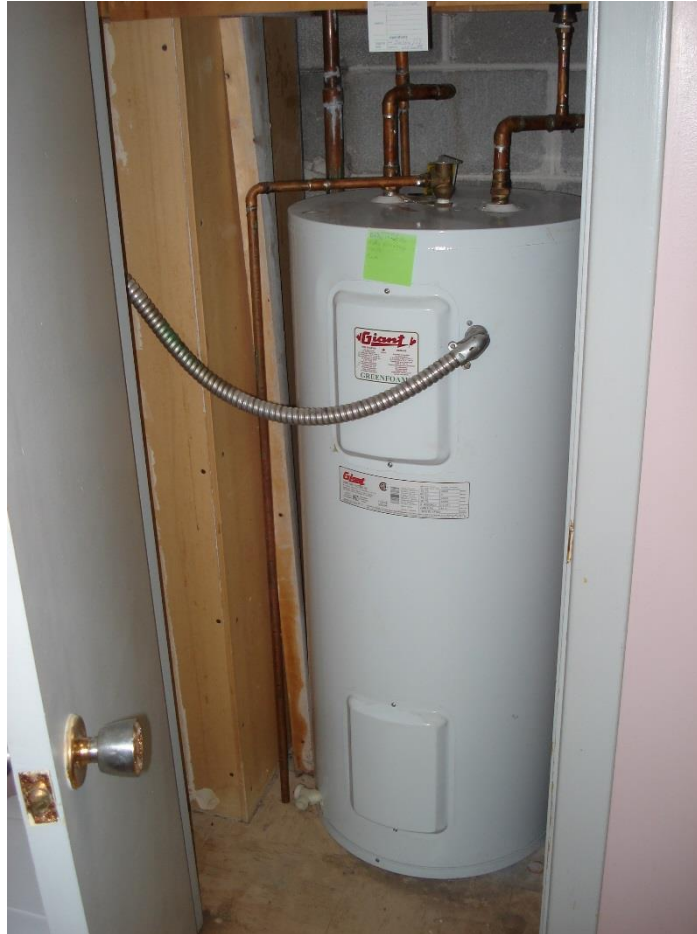
Photo 11 - Hot Water Tank

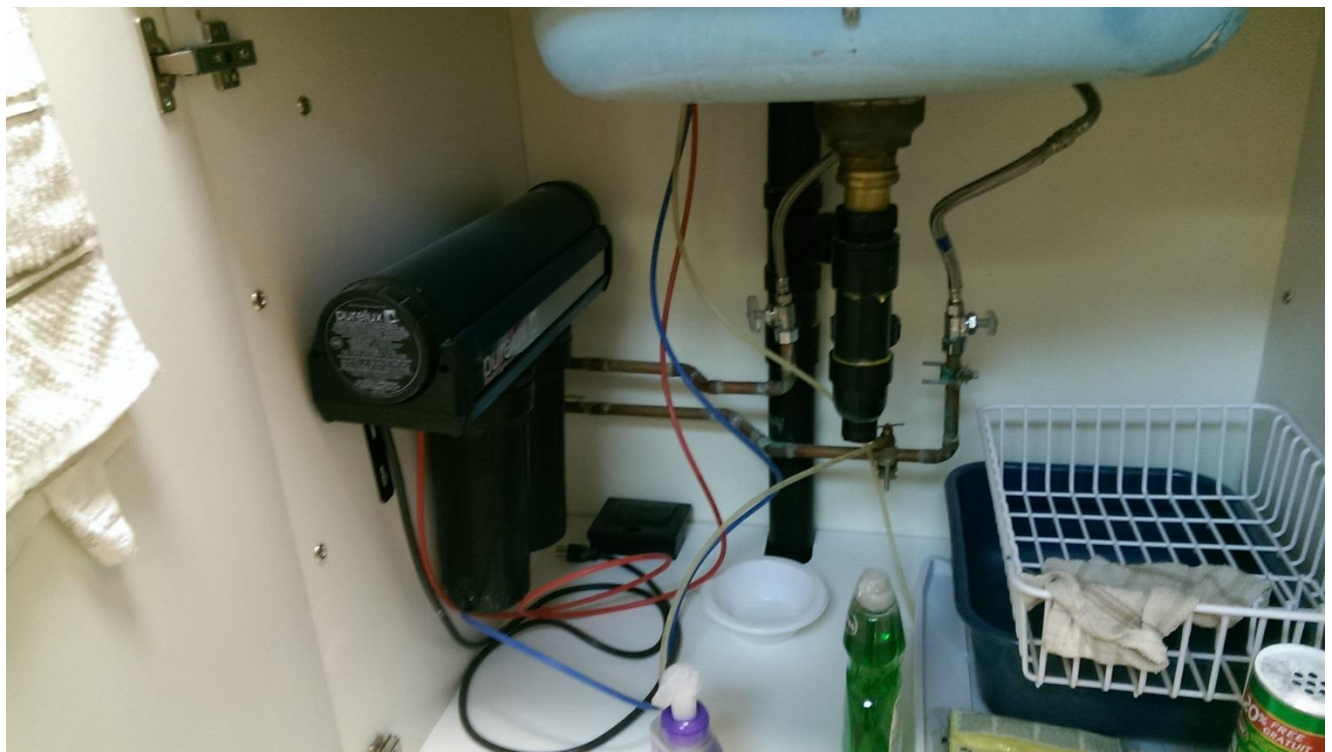
Photo 12 - Lunch Room Sink Water Filtration System

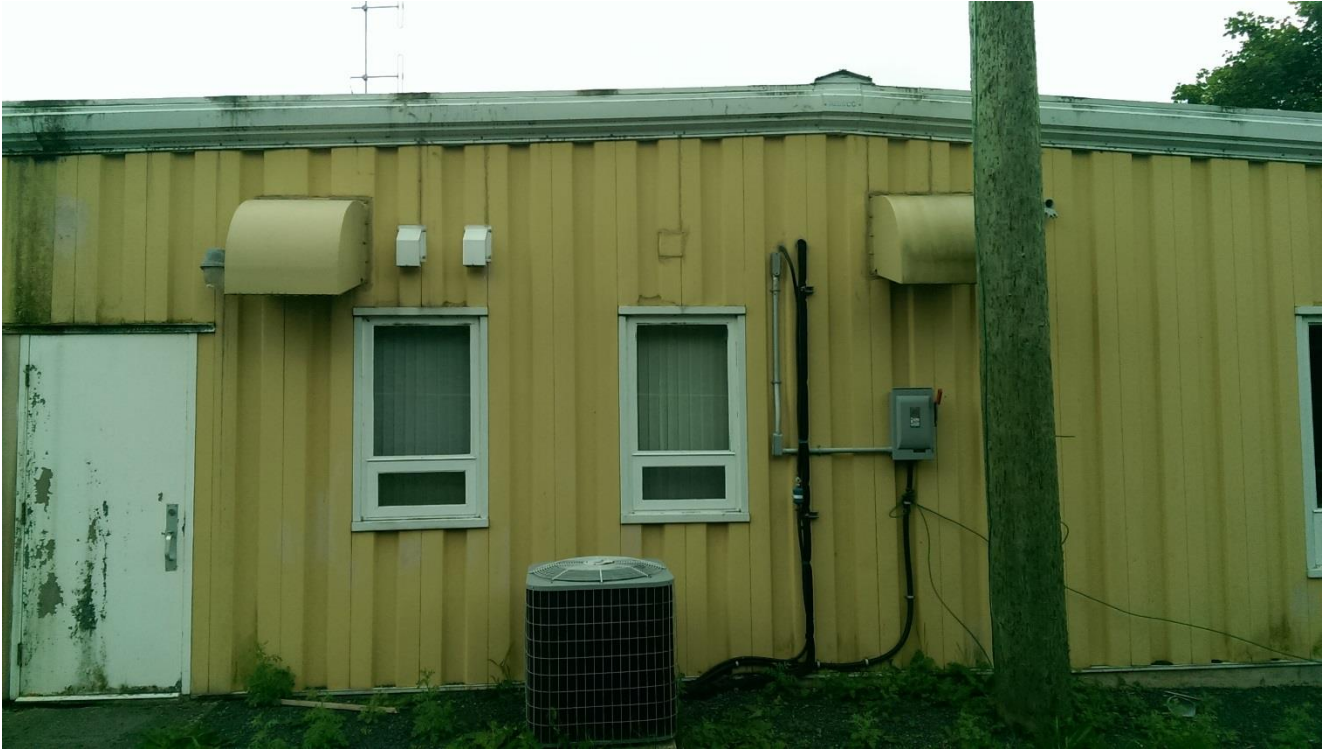
Photo 19 - AC Condenser and Air Intake and Exhaust Hood

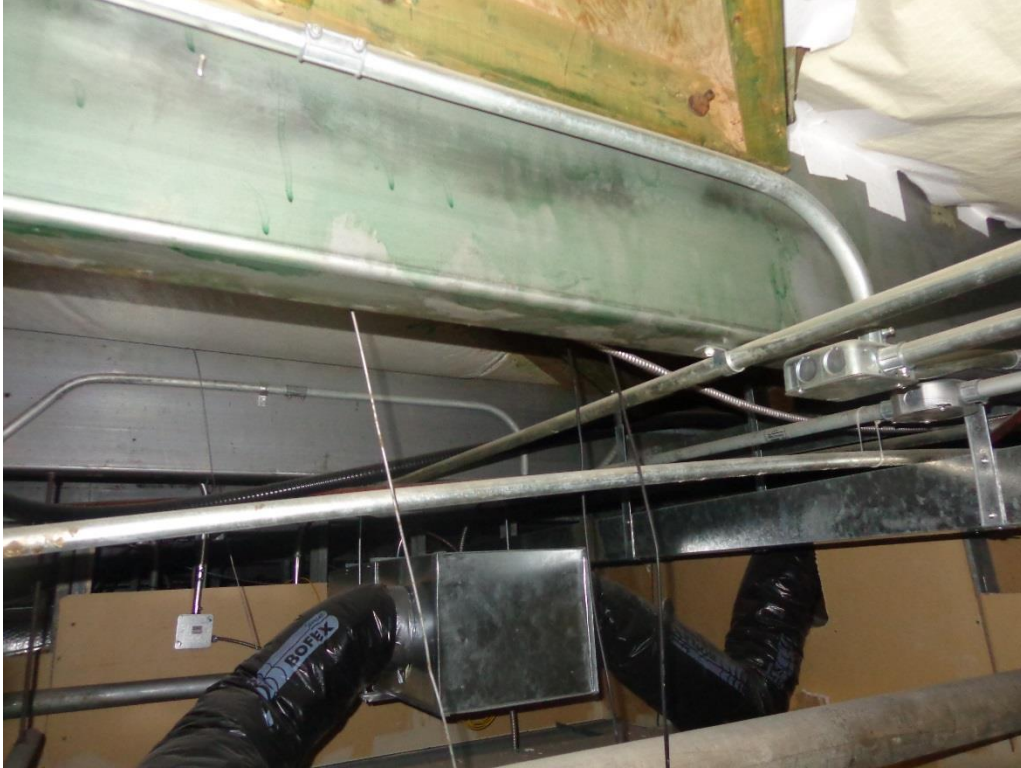
Photo 21 - Typical Bypass Terminal Unit

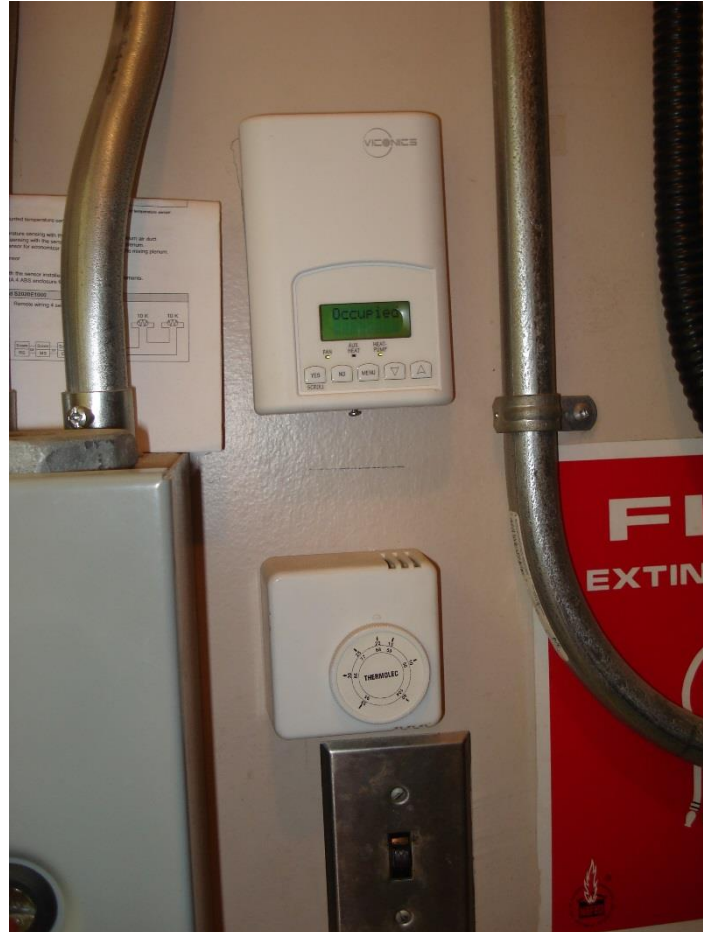
The office area air handling system is provided with a master control unit (Viconics T7652A1000) located in the janitor room as per part 2.1.3.4 (see Mechanical photo 22). System zone bypass terminal units and perimeter heat as described in part 2.1.3.4 are controlled by non-networked thermostats (see Mechanical photo 26). Refer to section 2.1.3.4 for a more detailed description of these controls.

Photo 22 - Main System Controller

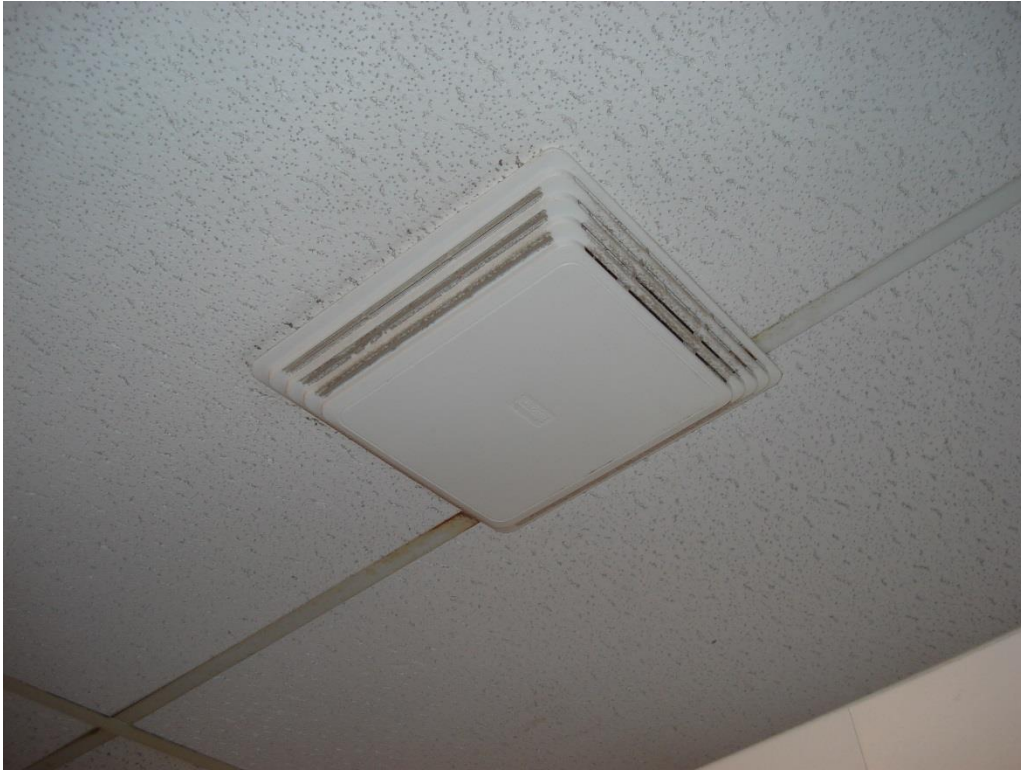
Washrooms are provided with ceiling mounted exhaust fans ducted to the outside (see Mechanical photo 25).

Photo 25 - Washroom Exhaust Fan

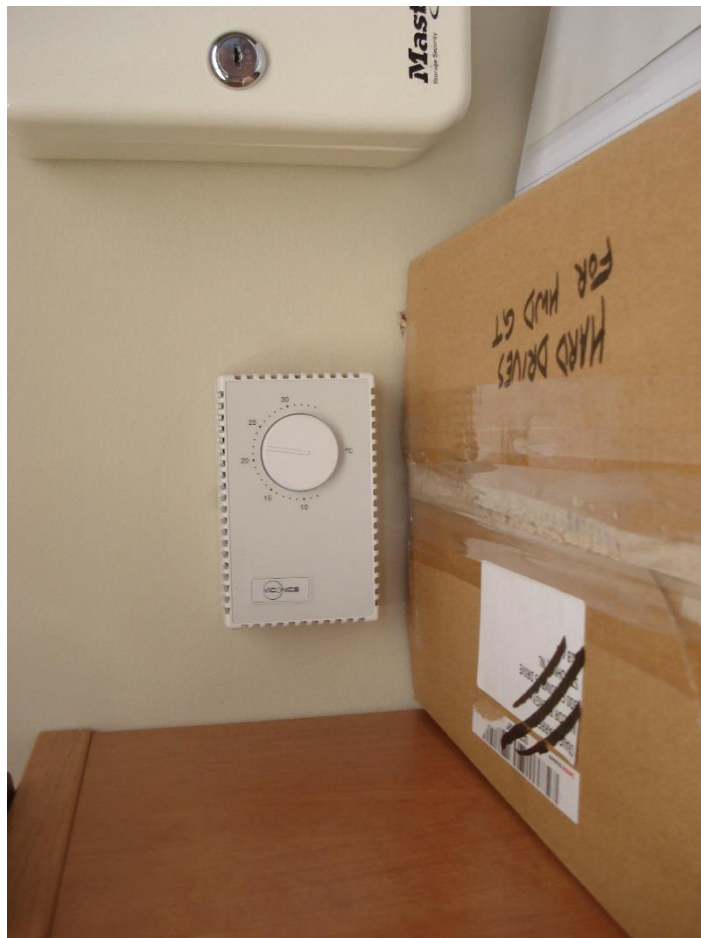
Photo 26 – Office Area Zone Thermostat

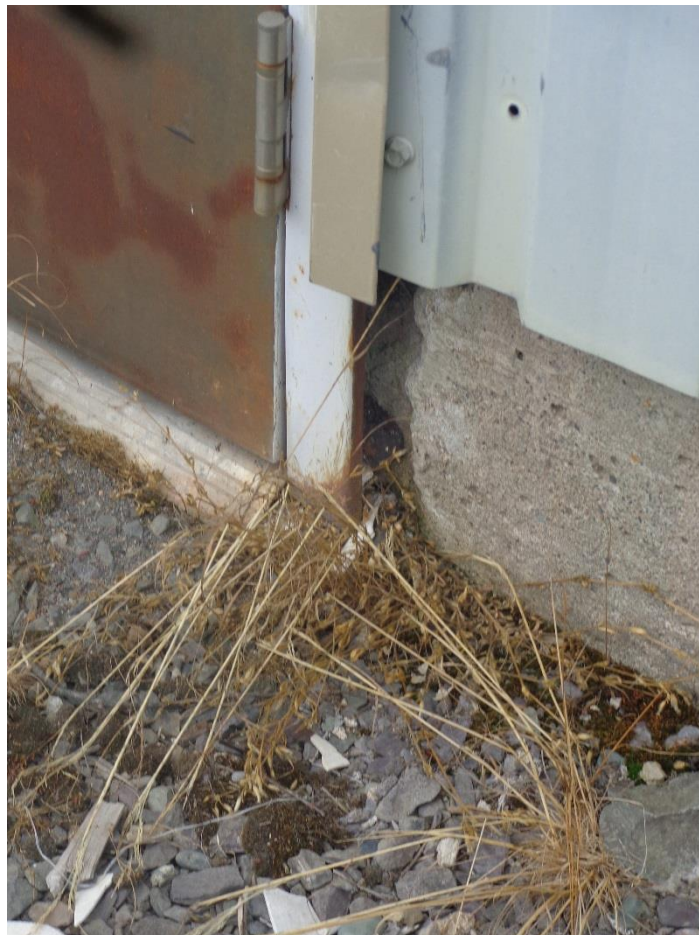
Photo 2 - Concrete Spall on Foundation Wall

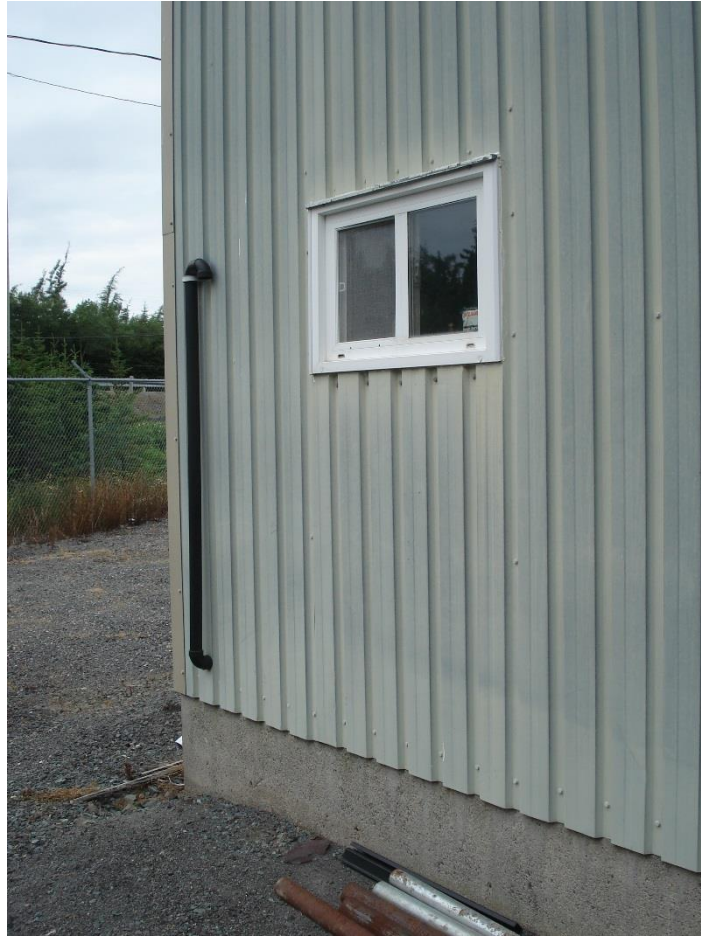
Photo 3 - Non Code Compliant Vent Piping

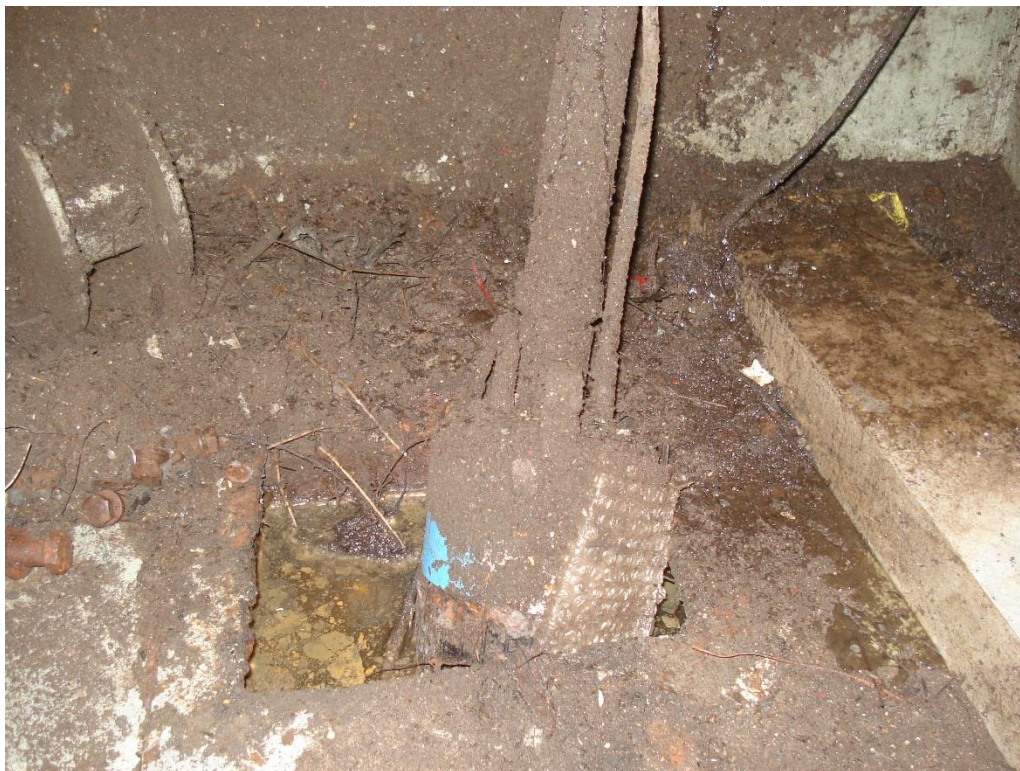
Photo 4 - Service Pit Sump Pump

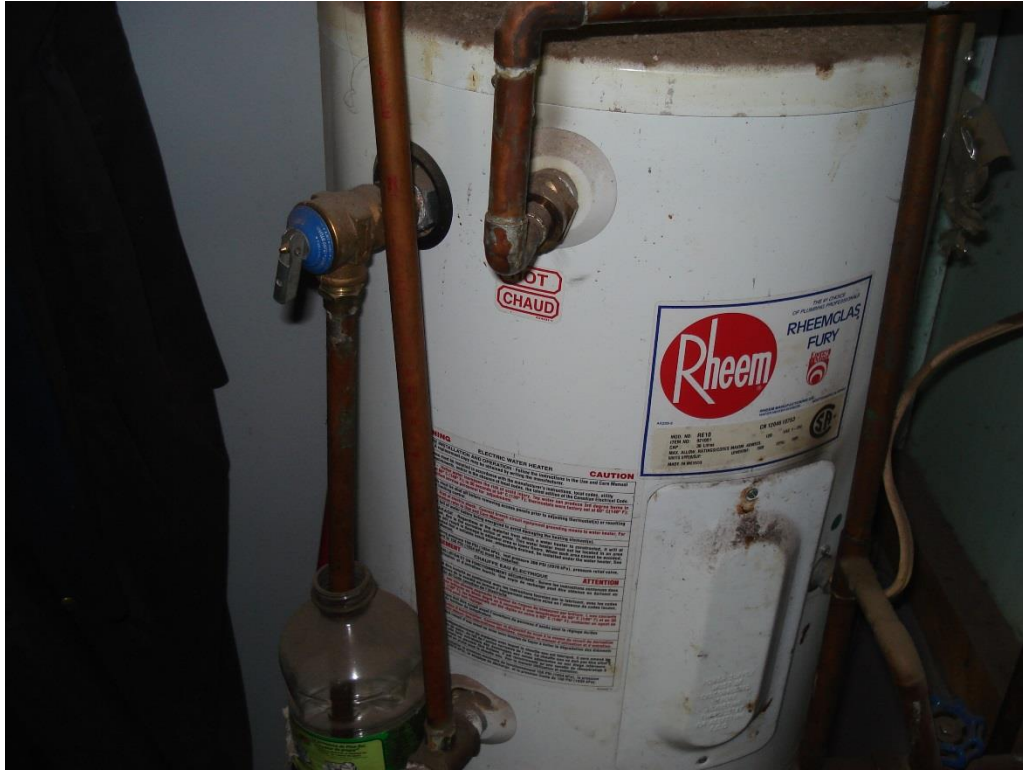
Photo 5 - Hot Water Tank

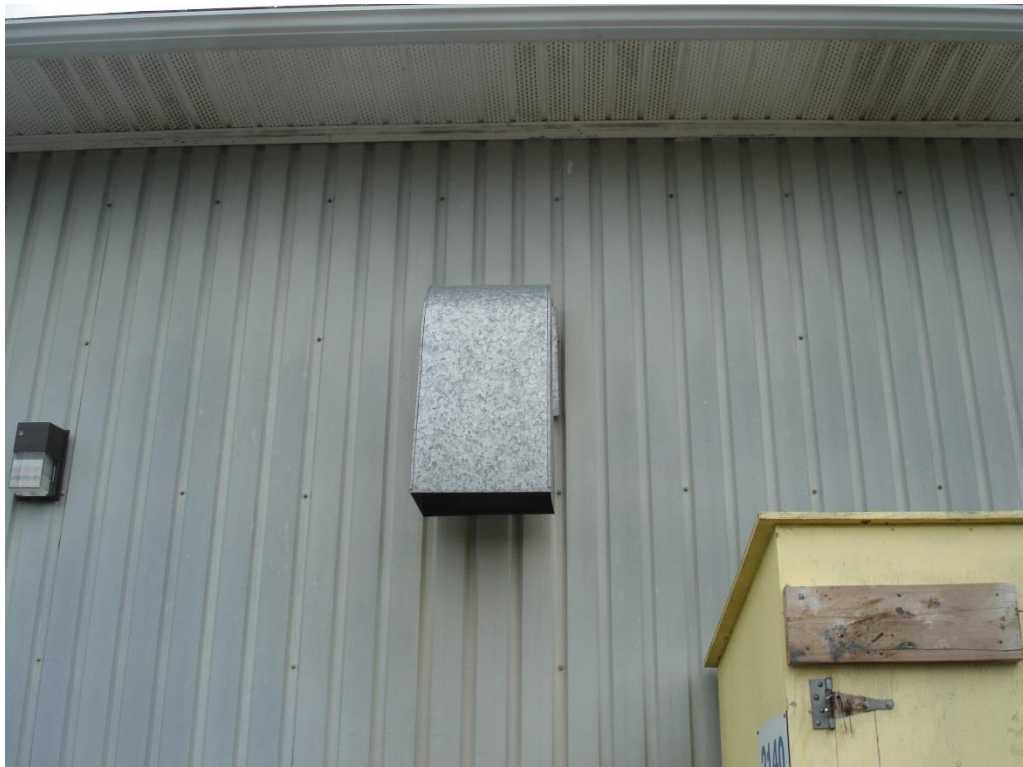
Photo 6 - Garage Exhaust Fan Hood

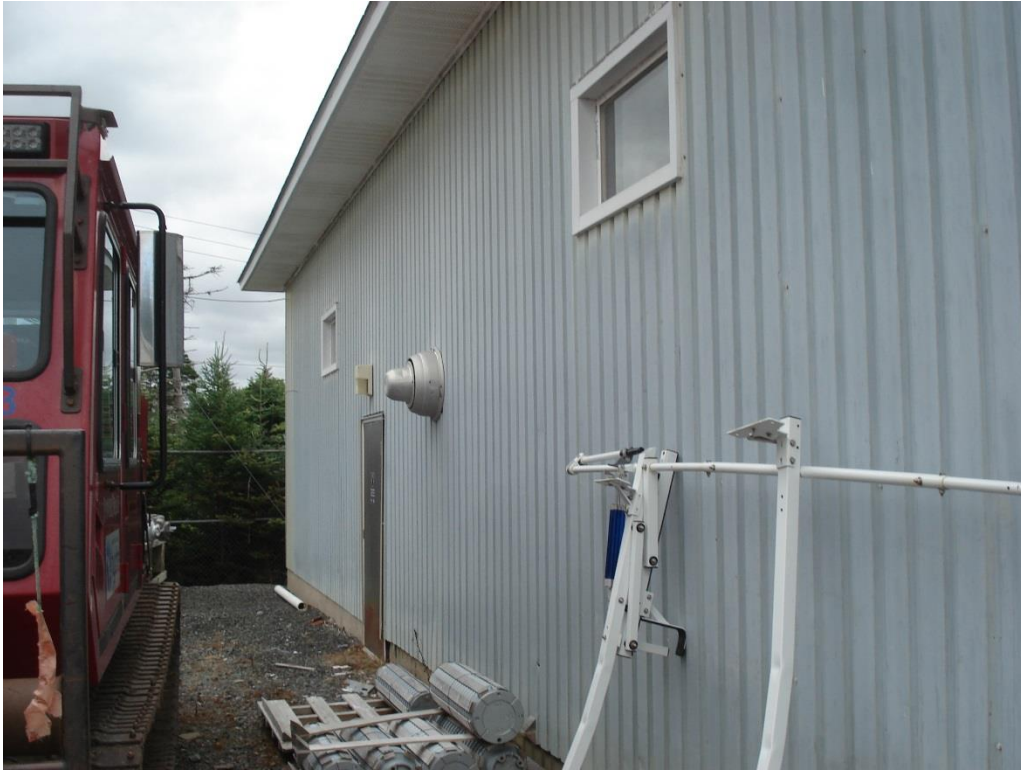
Photo 7 - Service Pit Sidewall Exhaust Fan

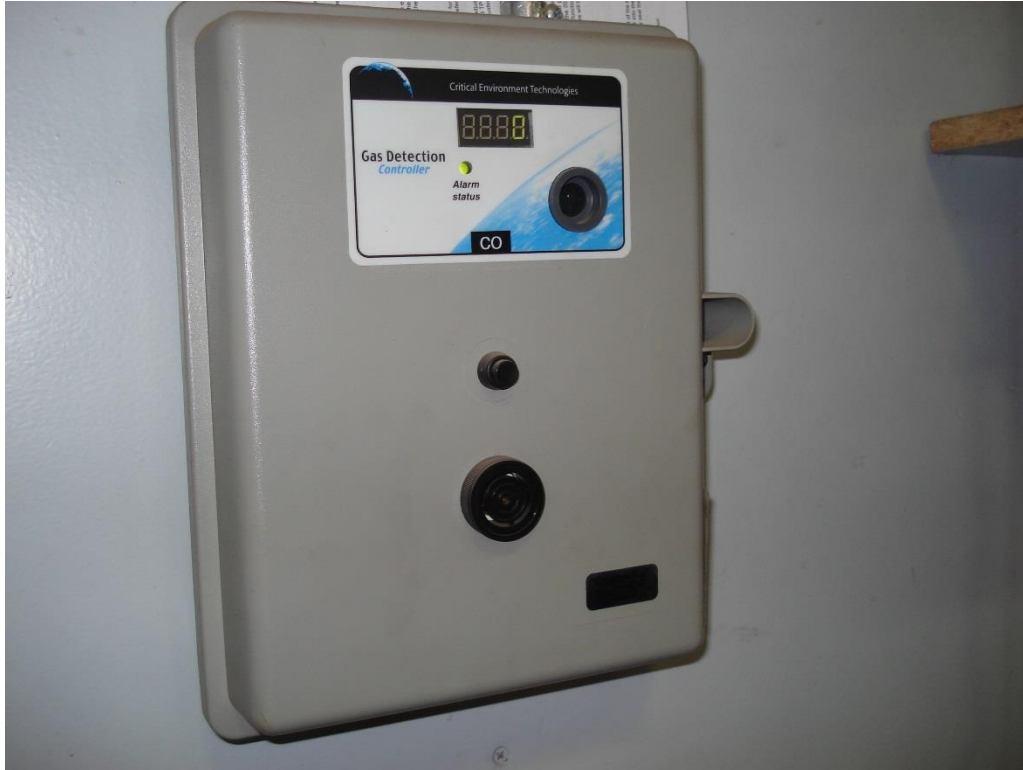
*Photo 9 - CO Gas Detection System*

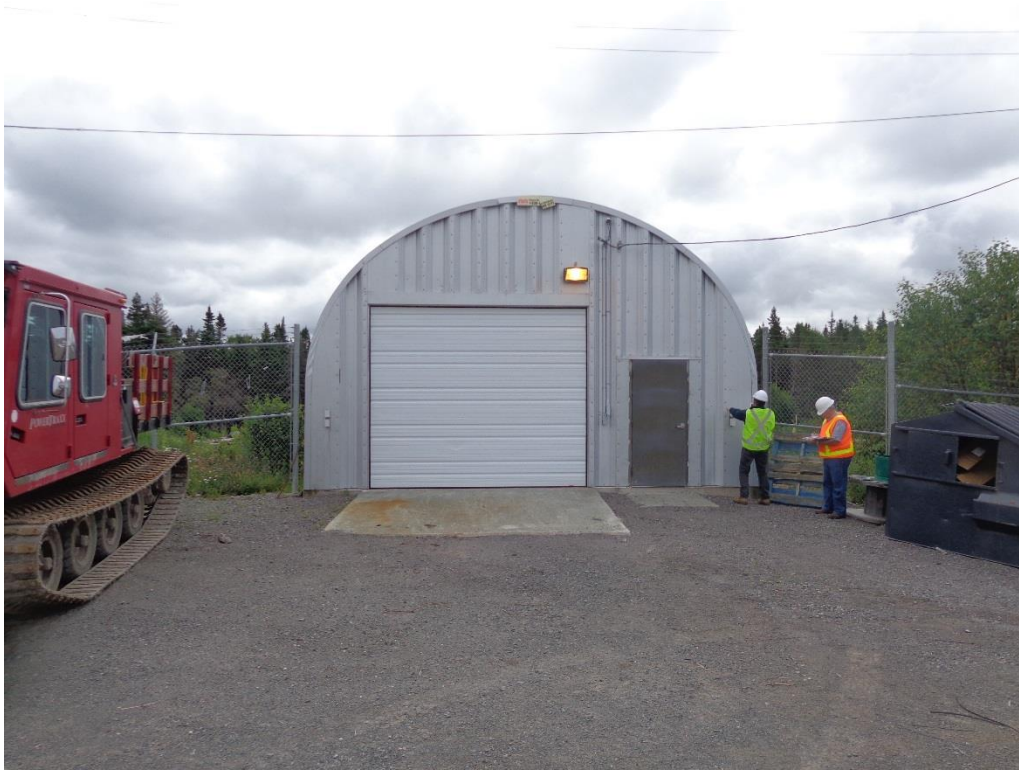
Photo 1 - Quonset Hut Structure

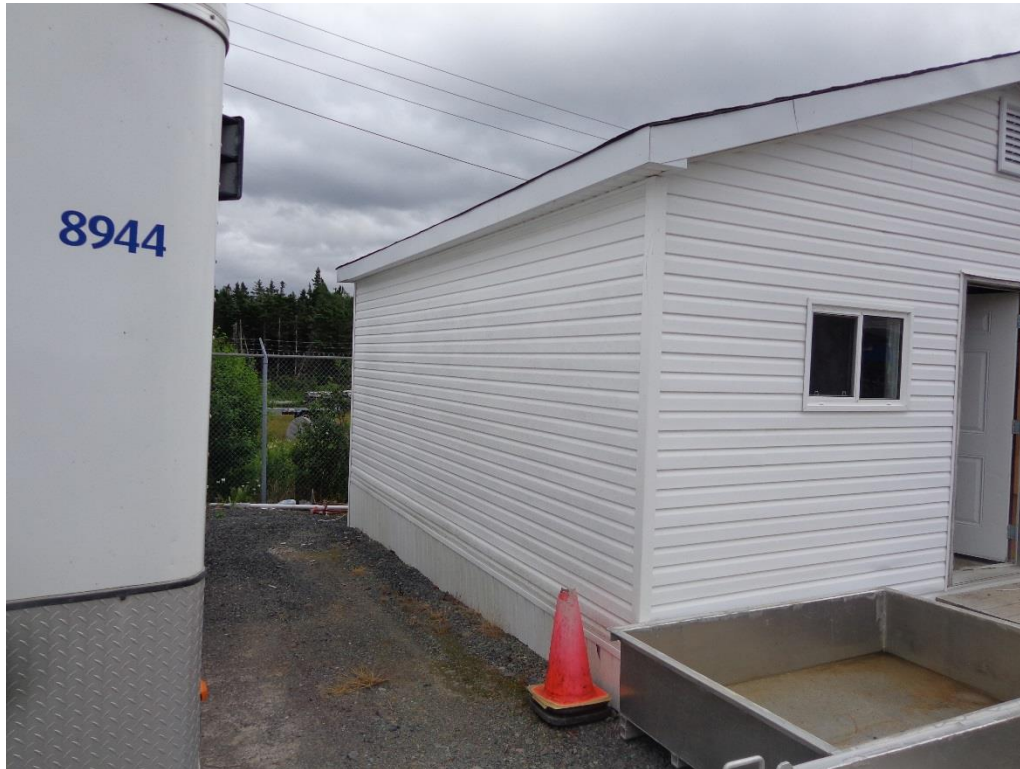
Photo 1 - Skirting Along Bottom of Building

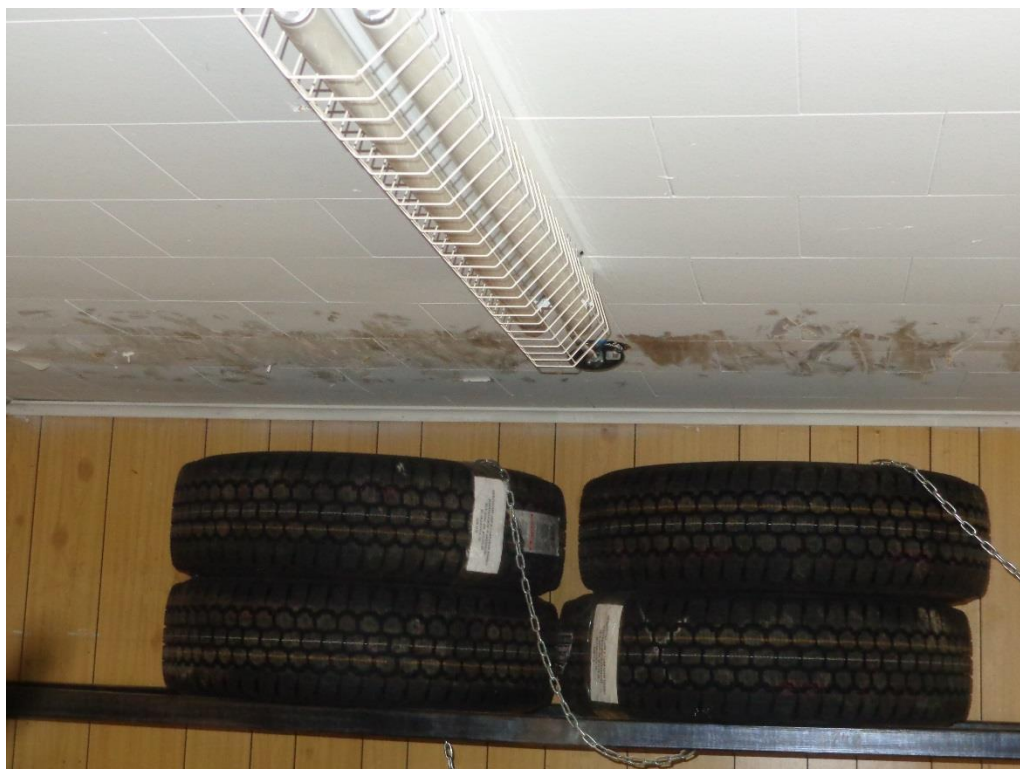
Photo 2 - Marks Made by Tires on Ceiling

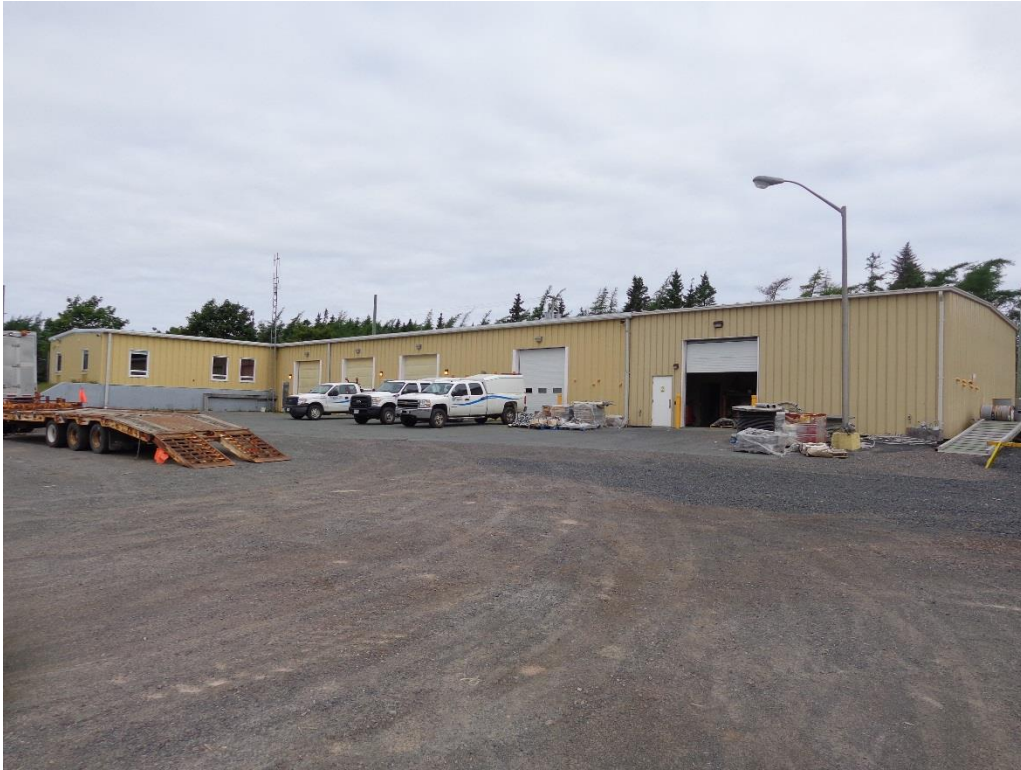
*Photo 3 - Yard South of Main Building*

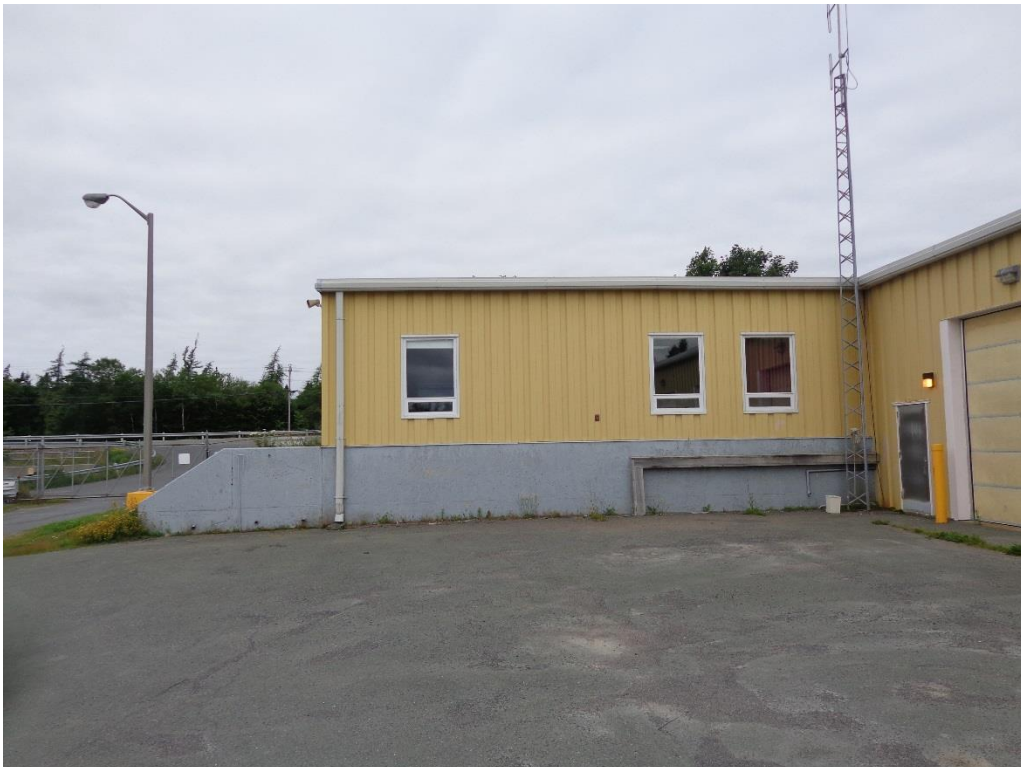
*Photo 4 - Office Leg of Building*

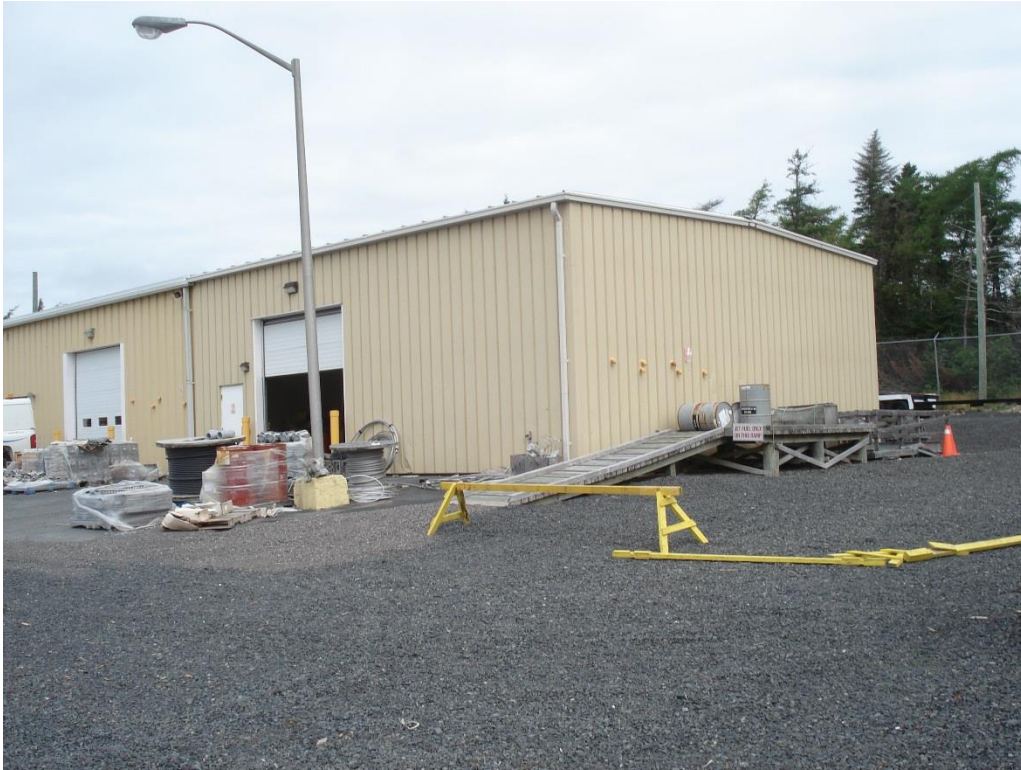
Photo 5 - East End of Main Building

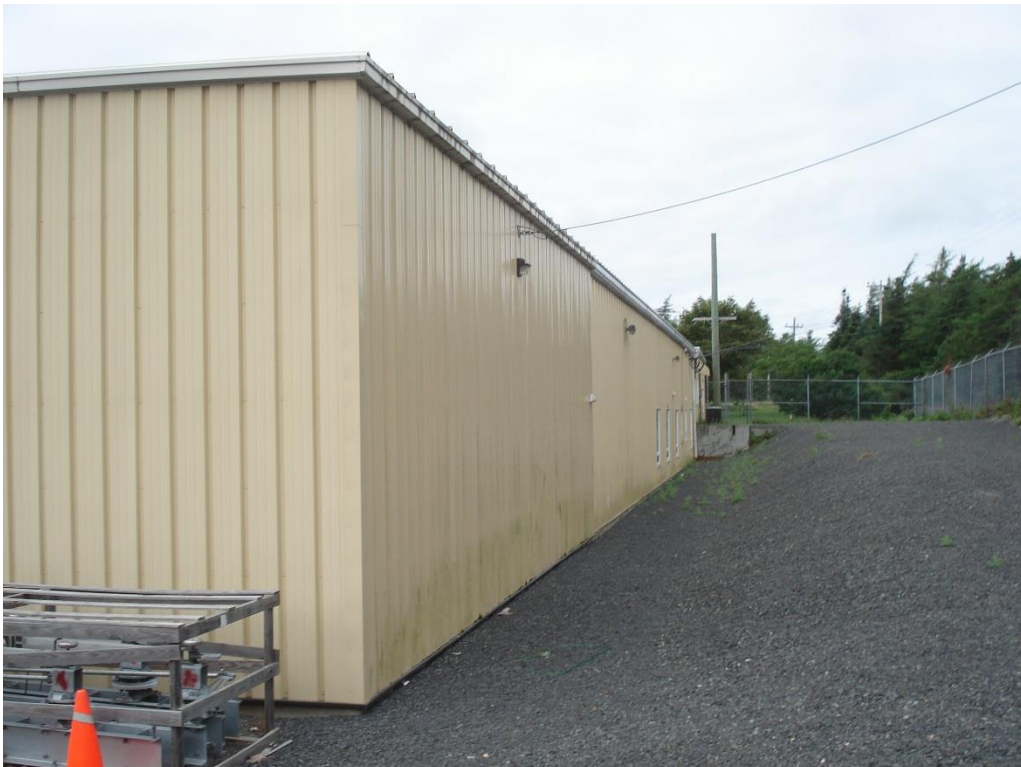
Photo 6 - Rear of Main Building

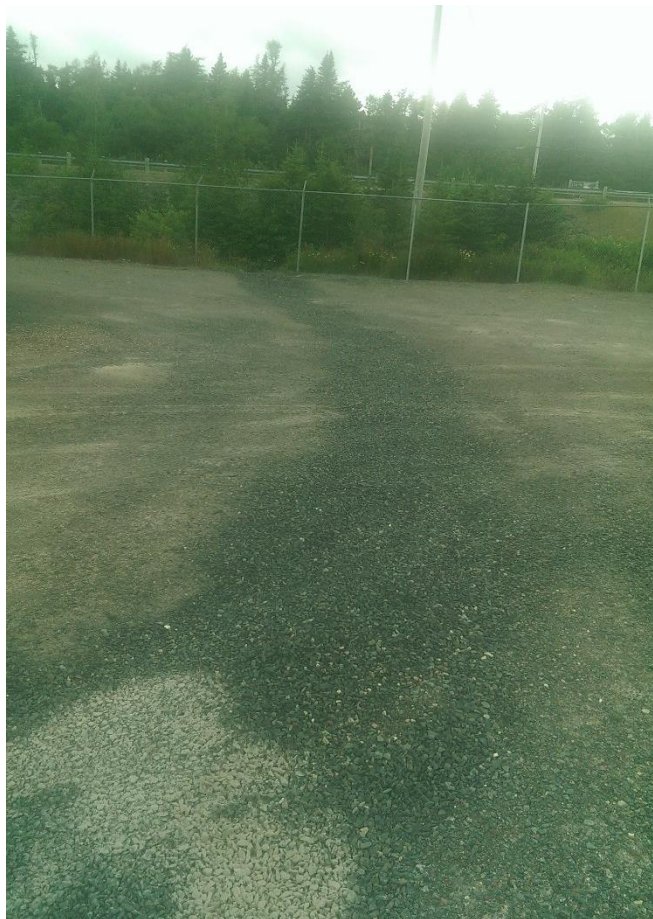
Photo 8 - Path of Storm Drainage

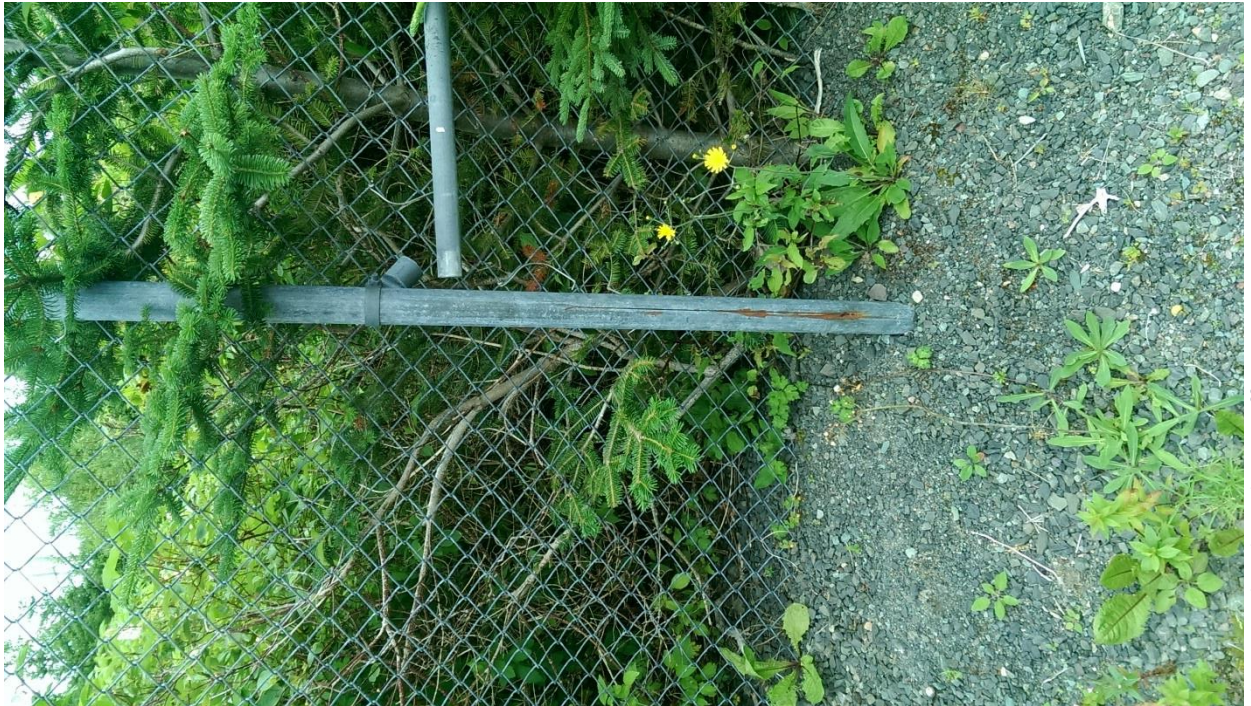
Photo 13 Pole Split and Brace Off

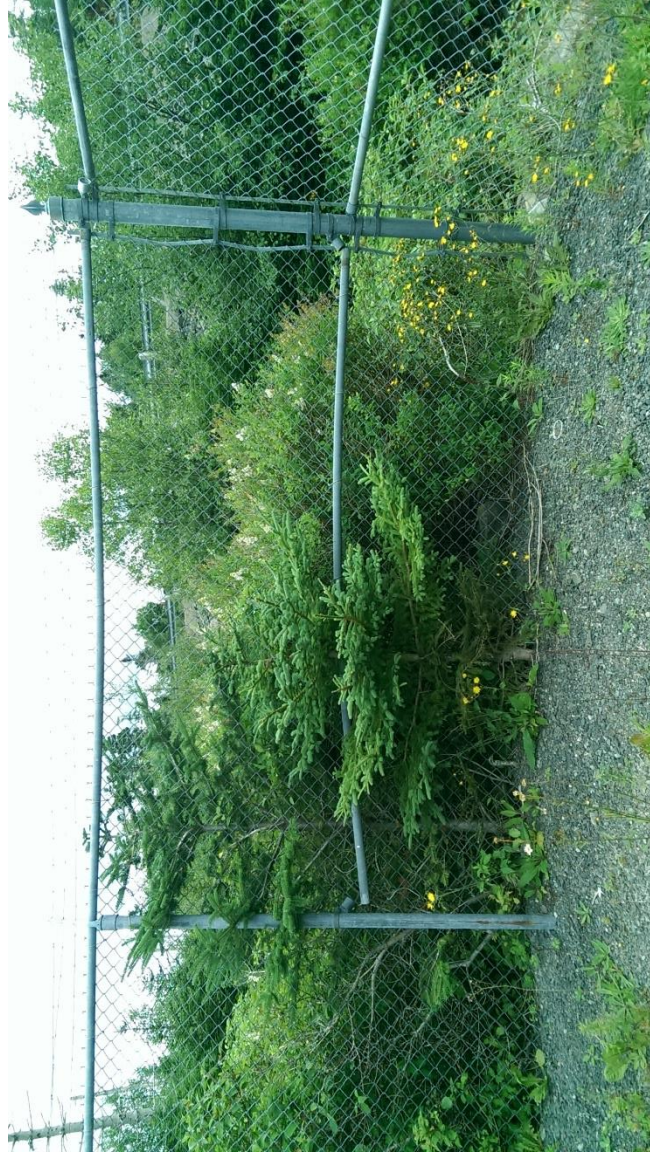
Photo 14 - Braces Bent and Off
