July 15, 2025

**Re: 2026 Capital Budget Application**

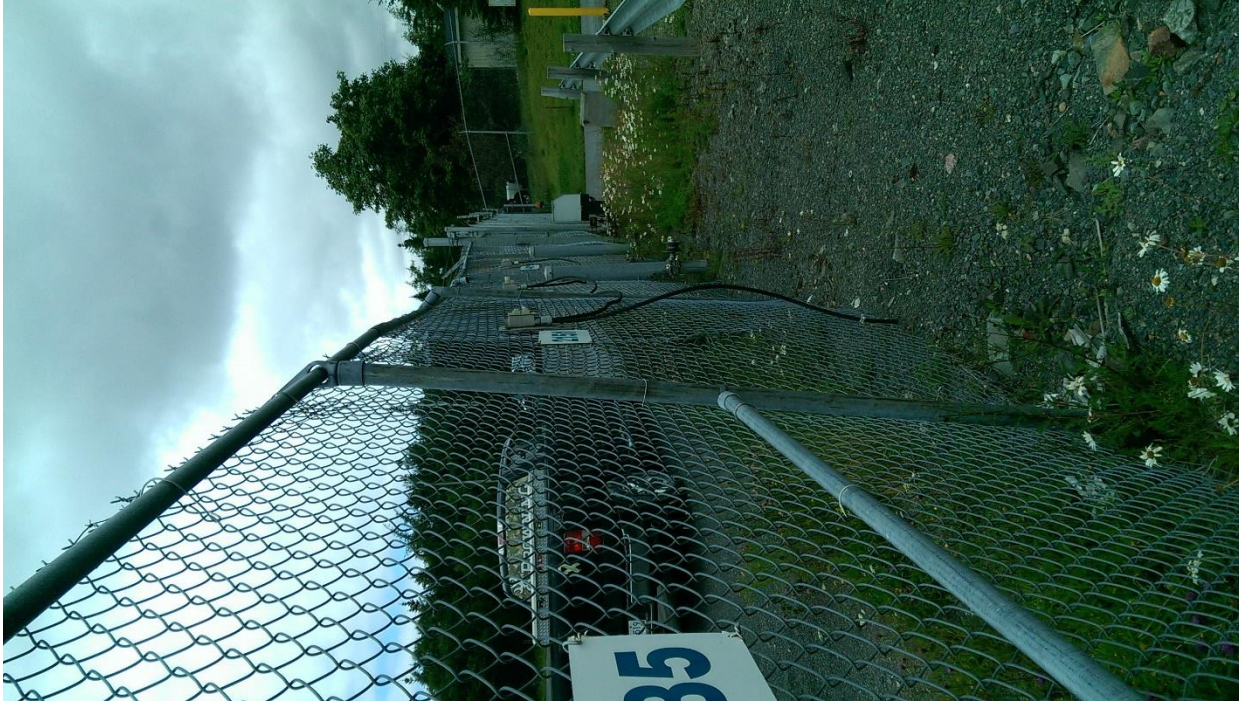
Photo 18 - Top Brace Bent and Fence Leaning

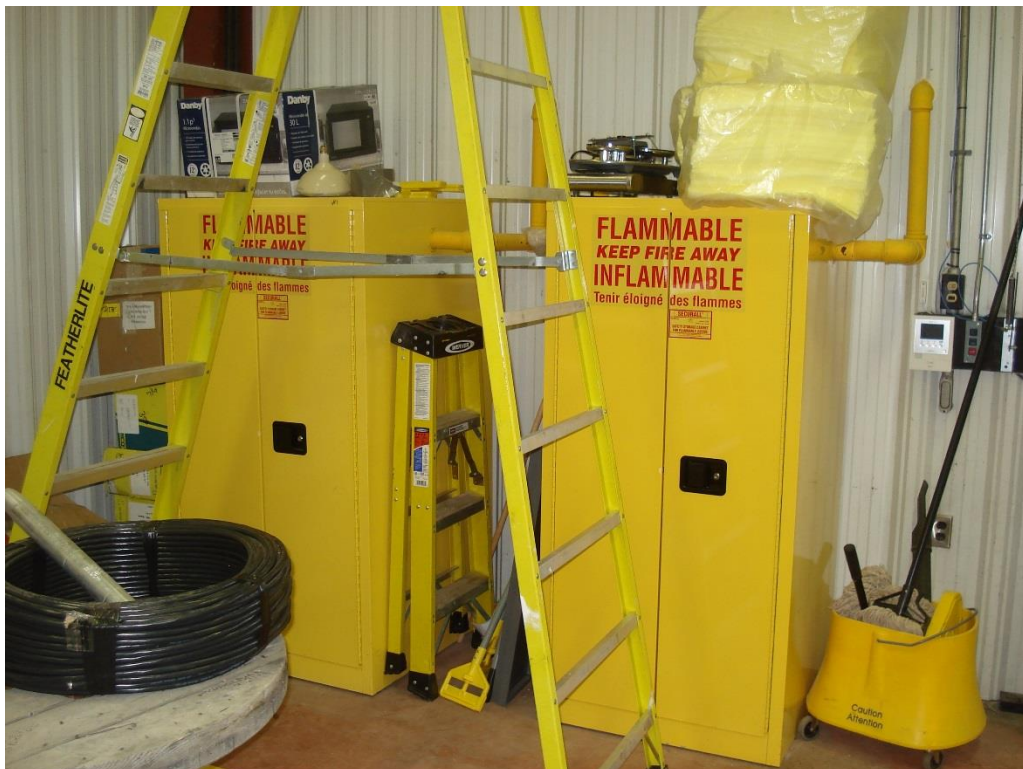
Photo 4 – Warehouse Safety Cabinets

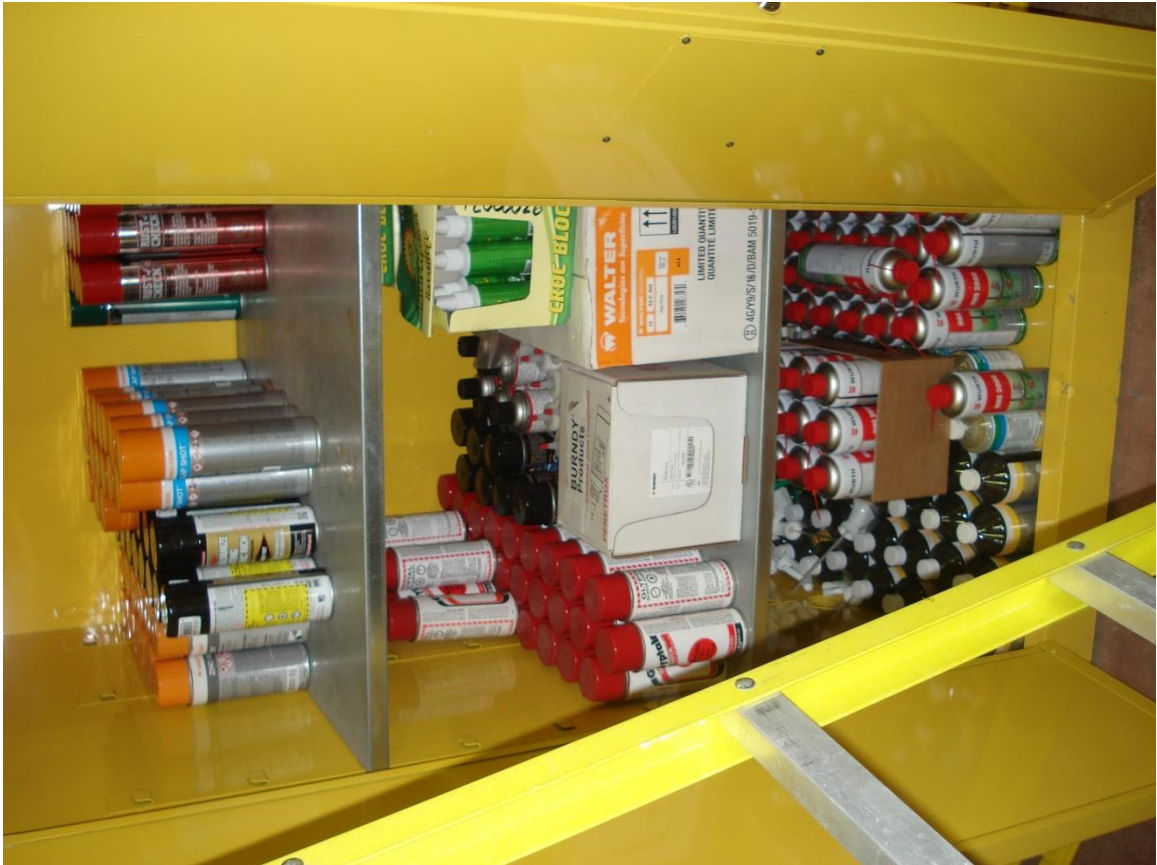
Photo 5 – Warehouse Safety Cabinet Contents

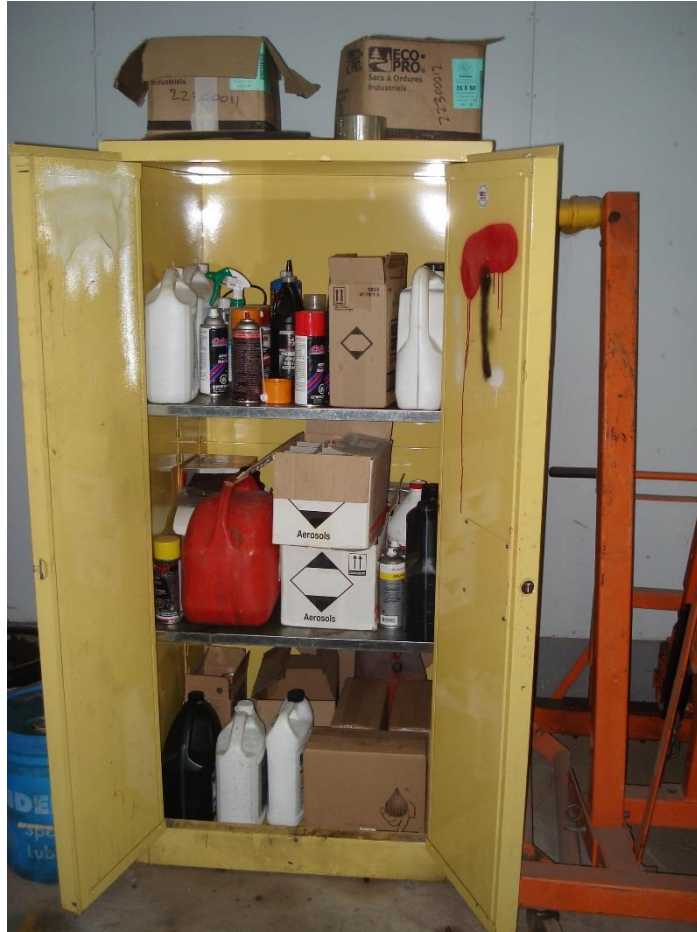
Photo 24 - Safety Cabinet Contents

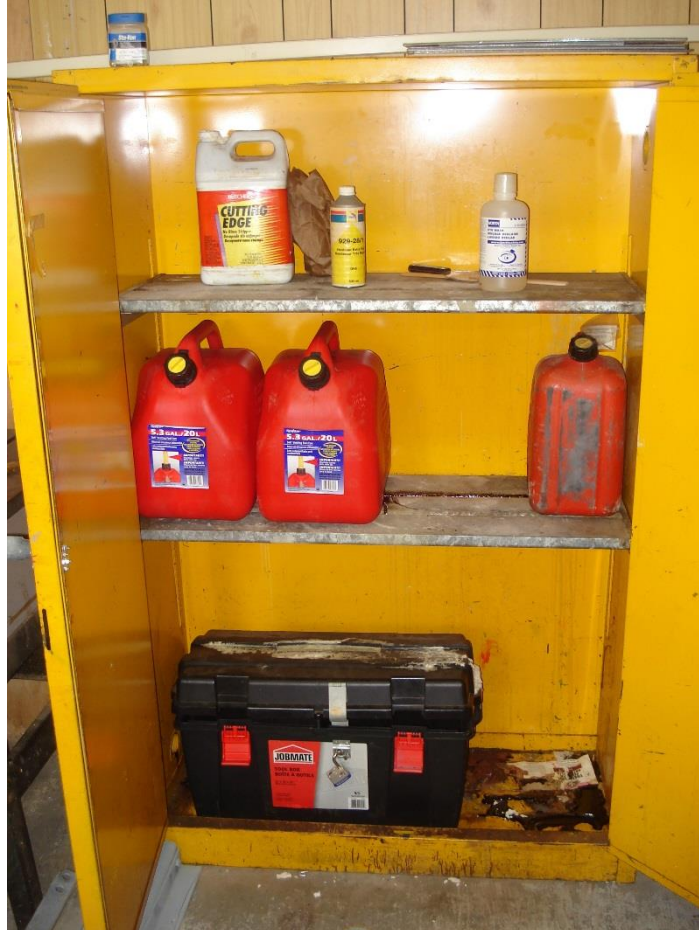
Flammable and combustible liquids were found to be present in the Carpentry Shop in the safety cabinet and around the building (see Environmental photos 32 to 34). Liquids found included:

Photo 32 - Safety Cabinet Contents

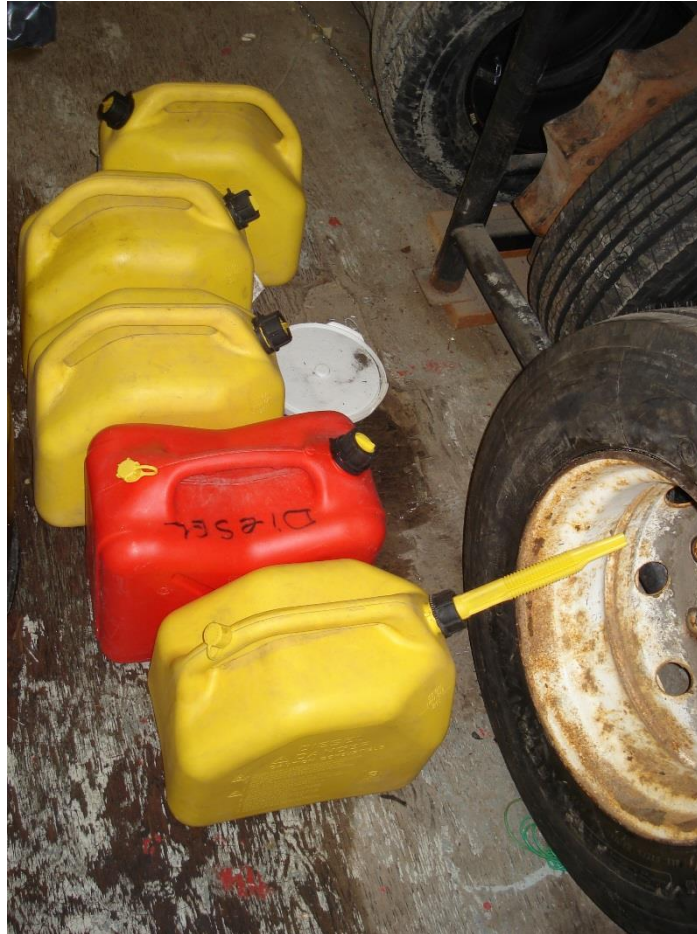
Photo 33 - Diesel Fuel Containers
