**Re: Quarterly Report on Asset Performance in Support of Resource Adequacy for the Twelve Months Ended March 31, 2025**

# Quarterly Report on Asset Performance in Support of Resource Adequacy

Attachment 1: L3501/2 Failure Investigation OPGW Tower Peaks – Central Newfoundland

Attachment 2: L3501/2 Failure Investigation Ice Storm Southern Labrador

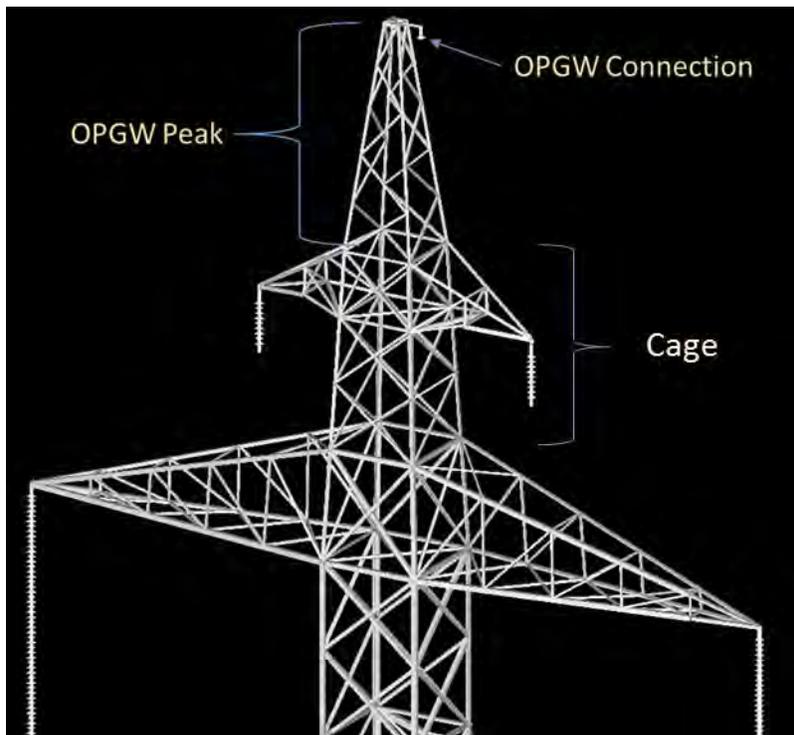
Figure 1: Tower Drawing showing OPGW Peak

14 During February of 2024, there were multiple failures on the Newfoundland and Labrador Hydro  
15 transmission line L3501/2. The failures occurred on eight structures in three groups: 2543–2545, 2596 to  
16 2599, and 2620. The failures of these structures were similar, the top peak of the tower where the  
17 OPGW is connected failed as shown in Figure 1. The OPGW wire itself did not physically fail, nor did the  
18 rest of the tower. There was internal damage to one section of OPGW near structure 2620, which  
19 affected the communications performance.

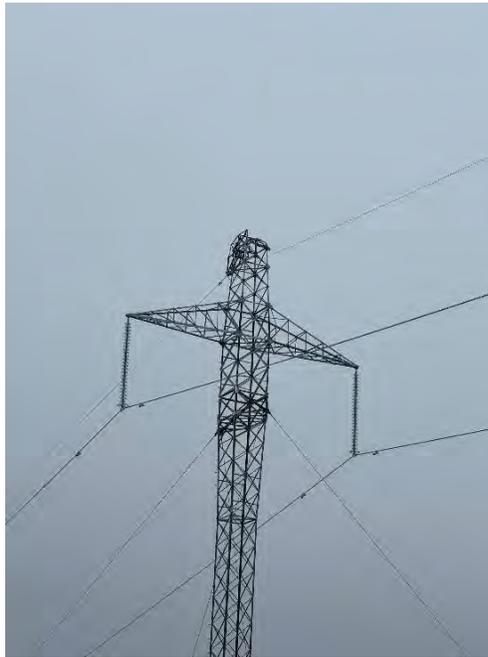
**Figure 4: Failed OPGW Peak**

17 damage to the cage section. The OPGW was still intact and connected to the towers, but the peak steel  
18 had bent significantly, as shown in Figure 4 and Figure 5. In addition to the failed OPGW tower peaks,  
19 the OPGW pulled through the suspension clamp at various locations in the surrounding structures. This  
20 occurred at 38 structures from 2540–2630, as shown in Figure 6.

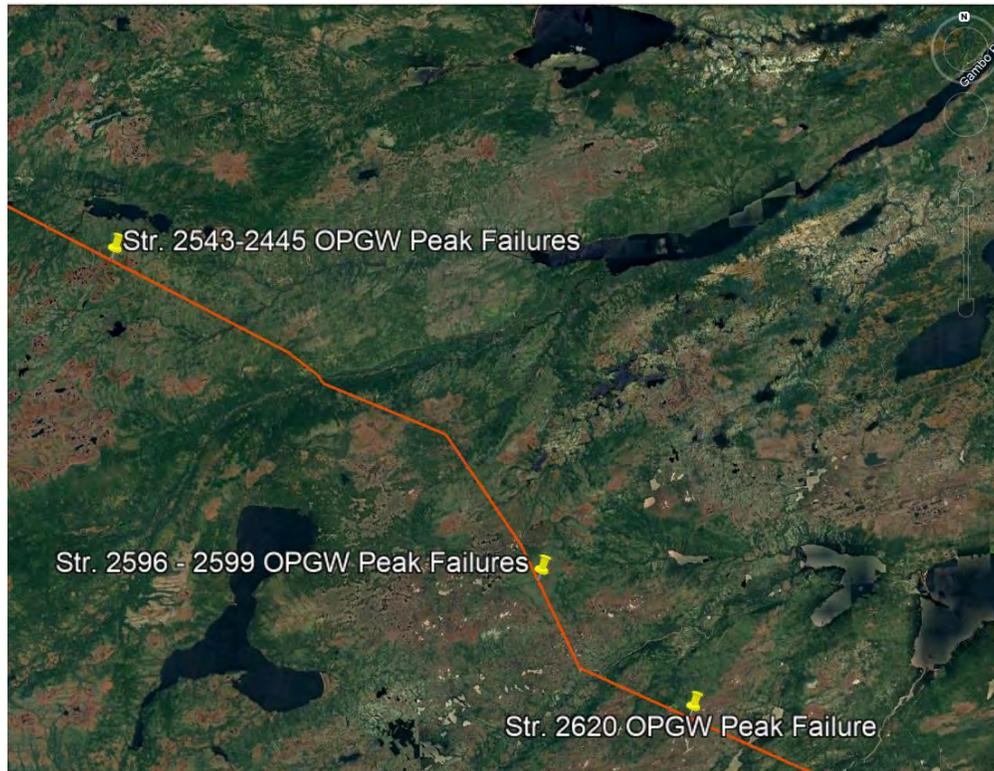
Figure 9: Location of OPGW Peak Failures

1 The eight damaged structures are all Type A1 tangent towers. The tower body extension, and OPGW  
2 attachment heights are summarized in Table 2 below. All towers had a suspension attachment. The  
3 tower failures are contained to three separate deadend to deadend sections. The section with towers  
4 2543, 2544, and 2545 is deadended at structures 2535 and 2546. The section with towers 2596, 2597,  
5 2598, and 2599 is deadended at structures 2589 and 2600. The section with tower 2620 is deadended at  
6 2616 and 2625. The line orientation is generally southeast. Figure 9 shows the location of OPGW peak  
7 failures.

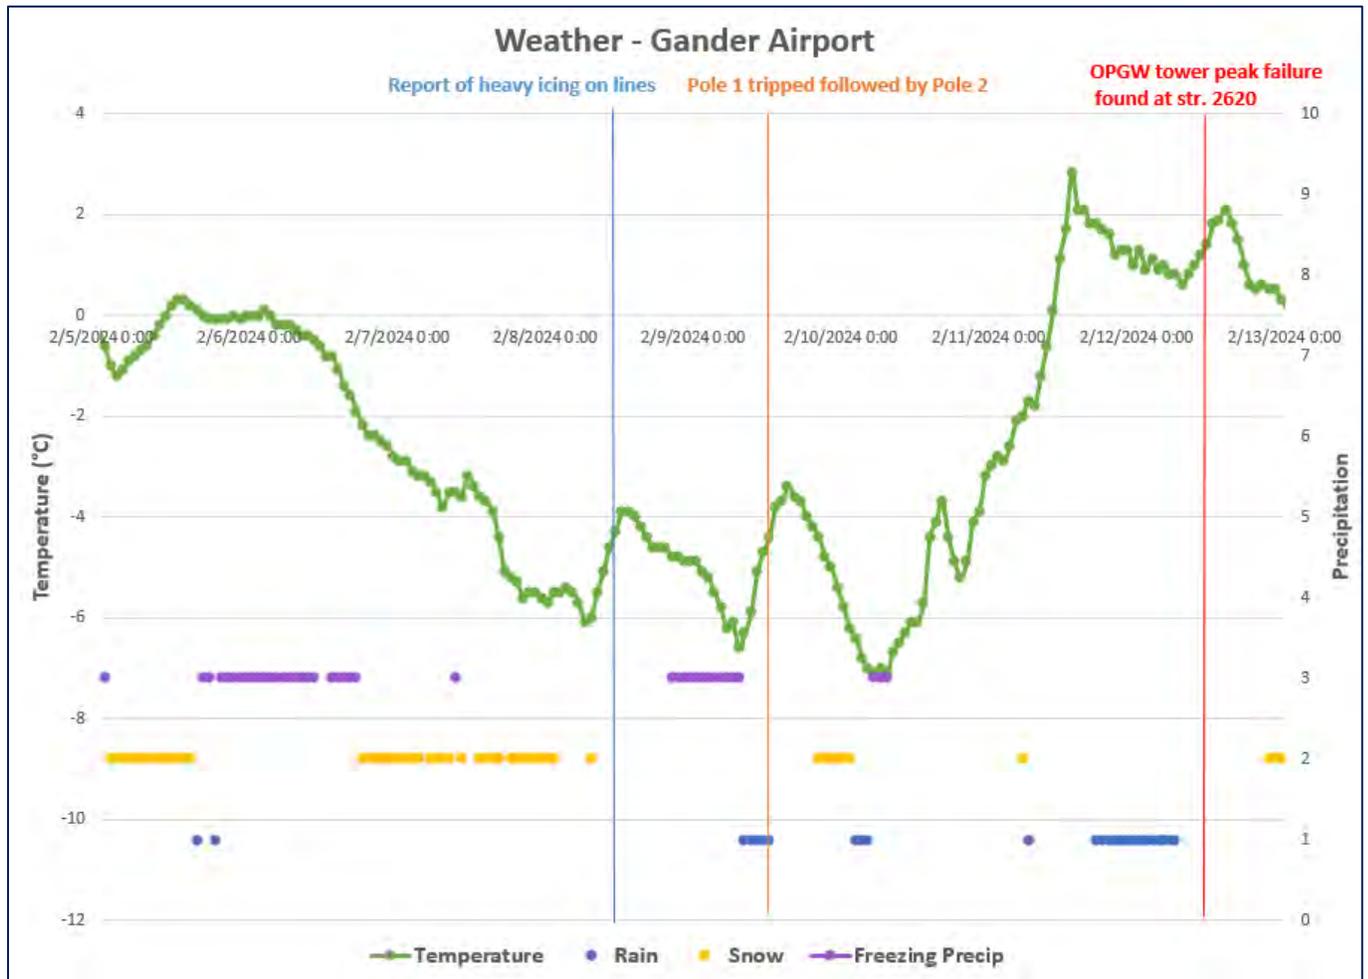
Figure 13: Temperature and Precipitation Recorded from 5-Feb-2024 to 13-Feb-2024

- 1 Figure 13 below is a graph of the temperature and precipitation captured at the Gander International
- 2 Airport weather station from February 5<sup>th</sup> to February 13<sup>th</sup>. A mixture of freezing rain and snow was
- 3 captured by the weather station for 4 days prior to the Poles tripping. The temperature also remained
- 4 below zero and reached a low of approximately -7°C before the trip. The towers are at a higher
- 5 elevation than the weather station. Therefore, they could have seen more freezing rain than snow
- 6 during those days prior to the trip.

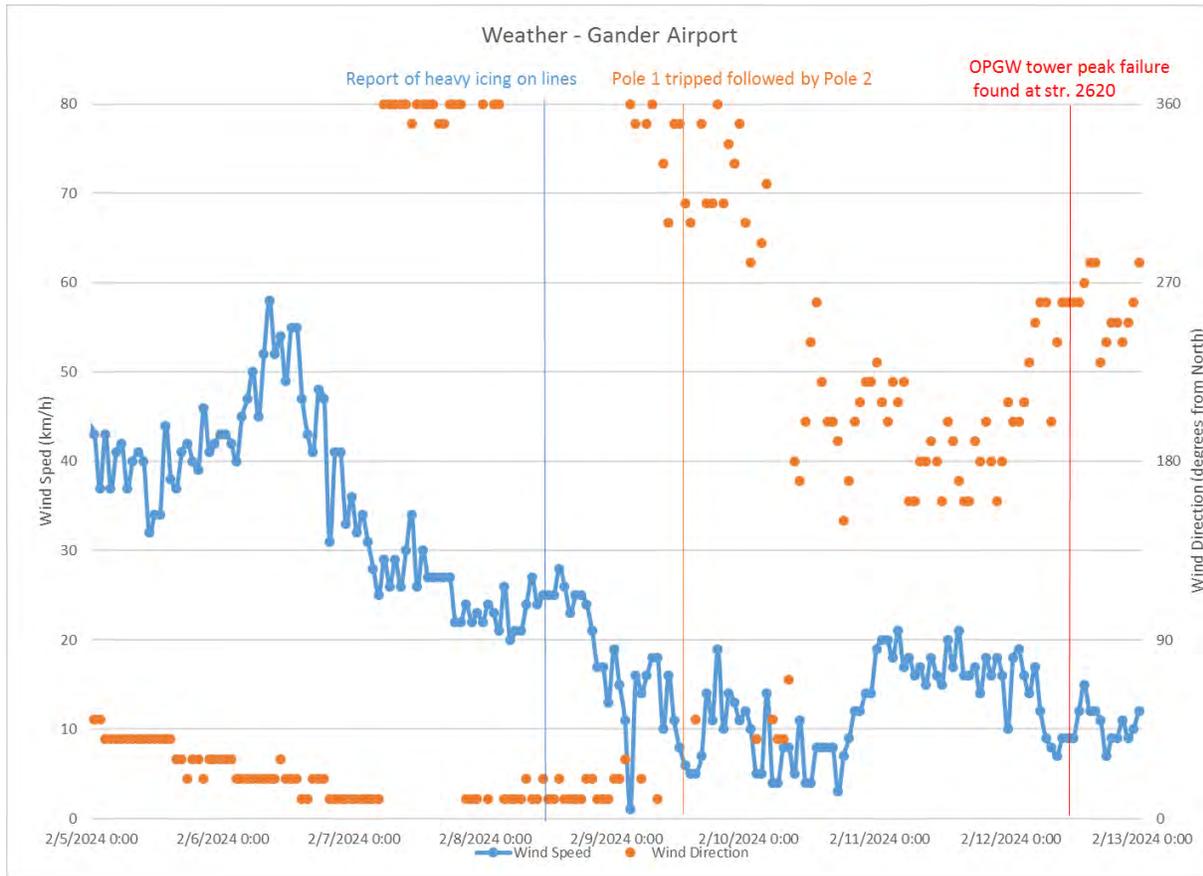
**Figure 14: Wind Speed (km/h) and Wind Direction (Degrees from North) from 5-Feb-2024 to 13-Feb-2024**

- 1 Wind speed and wind direction was also captured by the Gander weather station between February 5<sup>th</sup>
- 2 and February 13<sup>th</sup>, as shown in Figure 14. The wind peaked at 68 km/h 3 days before the trip and
- 3 dropped to around 10–25 km/h a day before the trip, and under 20 km/h the day the damage was
- 4 found. Reports from the site during the repairs indicated that the winds at the site of the failure were
- 5 consistently higher than the wind in nearby towns. Note that the Gander weather station is at an
- 6 elevation of 151 m above sea level, and the failed structures elevations range from 275–302 m.

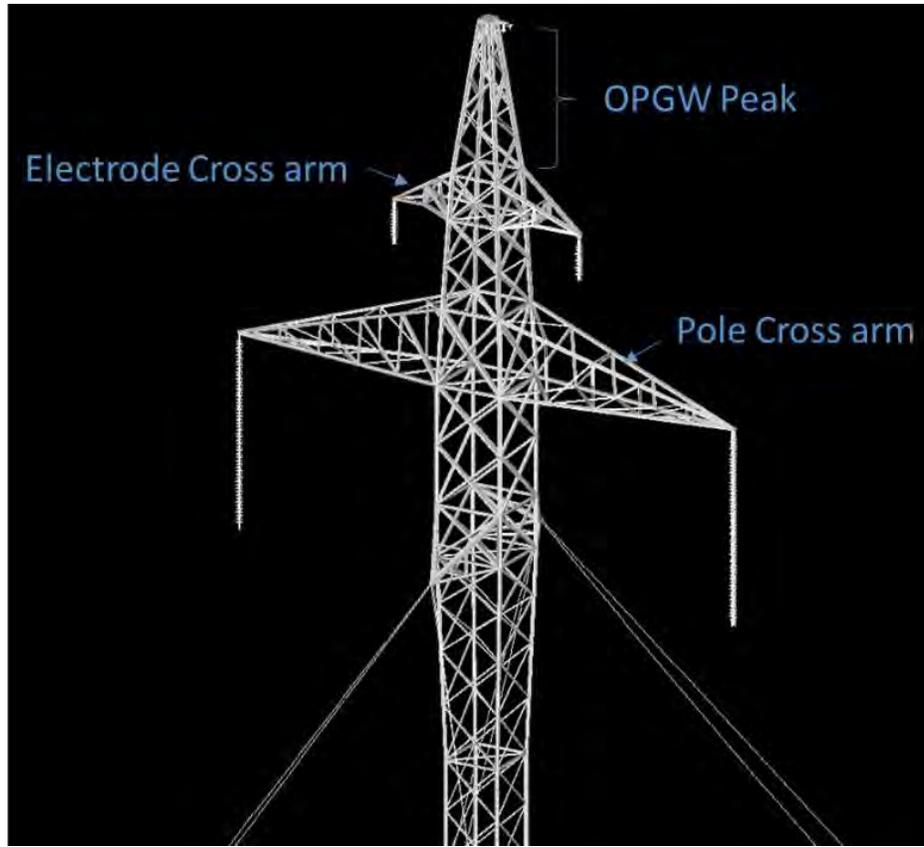
Figure 1: Tower Drawing Showing Sections

On Saturday March 30, 2024, Pole 2 tripped at 06:45. Pole 1 tripped at 06:52 on electrode line fault protection. From a patrol of the line it was discovered that the electrode conductor was broken and damaged at several locations between str. 1218–1228. In some locations, the electrode conductor was touching or close to the pole conductor which would explain the line trip. There was also damage to the steel lattice towers at the electrode crossarm and OPGW tower peaks as shown in Figure 1. There were a few strands of pole conductor damaged in one location. The line patrol noted there was significant ice on the lines before failures (and remaining in some locations).

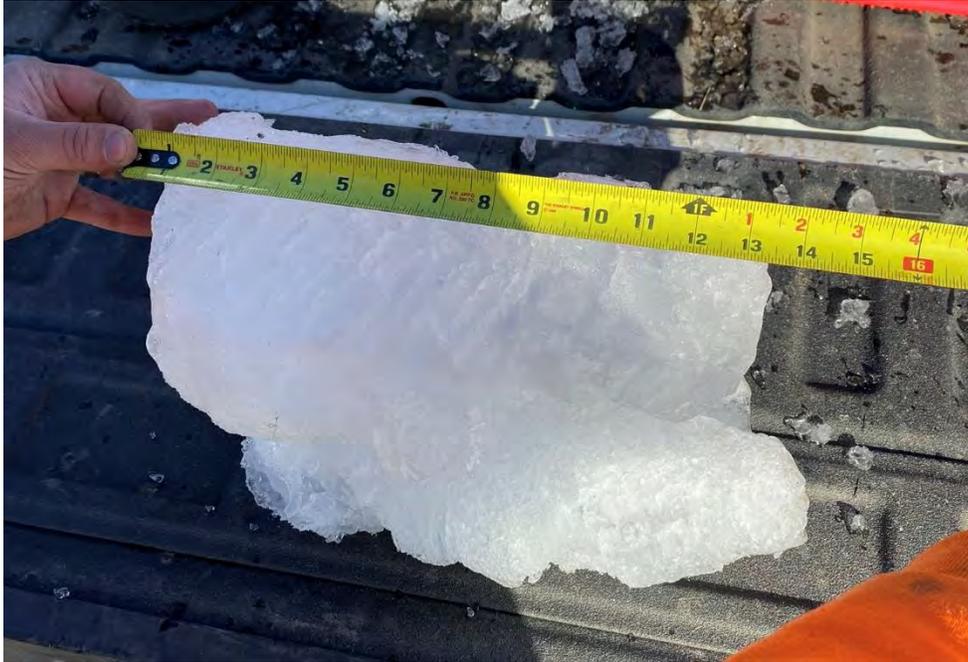
Figure 11: Ice Sample from OPGW

11 There were observations of significant icing on the lines on March 30<sup>th</sup>, as shown in Figure 10.  
12 Observations at site estimated the ice thickness on the conductor to be approximately 120–140 mm of  
13 radial ice. An ice sample that fell from the OPGW (see Figure 11) was collected, measured, and weighed.  
14 From this sample, the equivalent radial thickness was estimated to be 100–125 mm at a density of 0.6  
15 g/cm<sup>3</sup>.

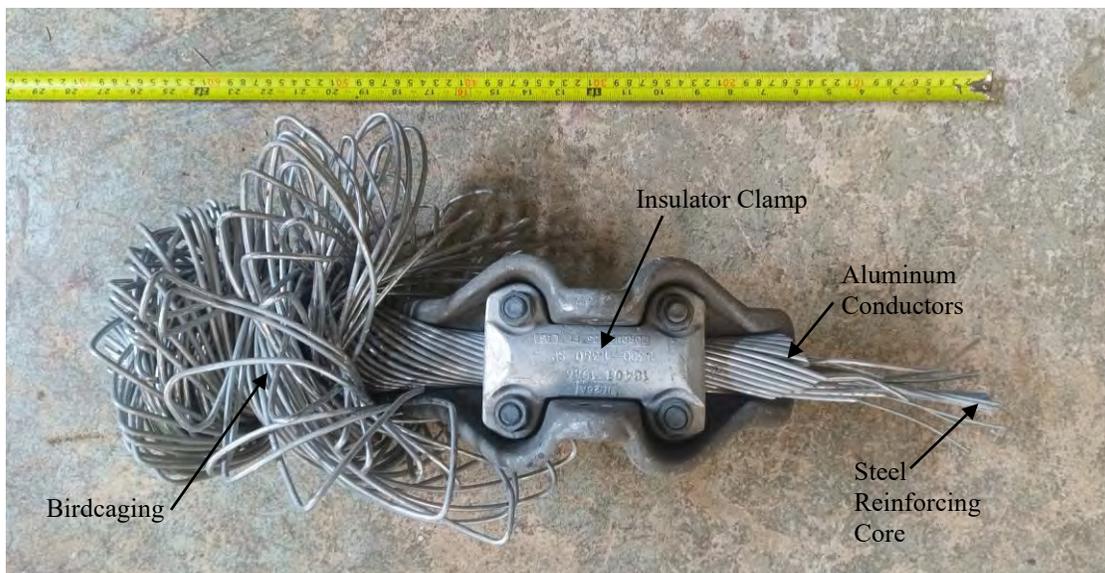
Figure 2-1: Top-down view of the wire clamp and failed section of the EL-1 conductor as received for analysis.

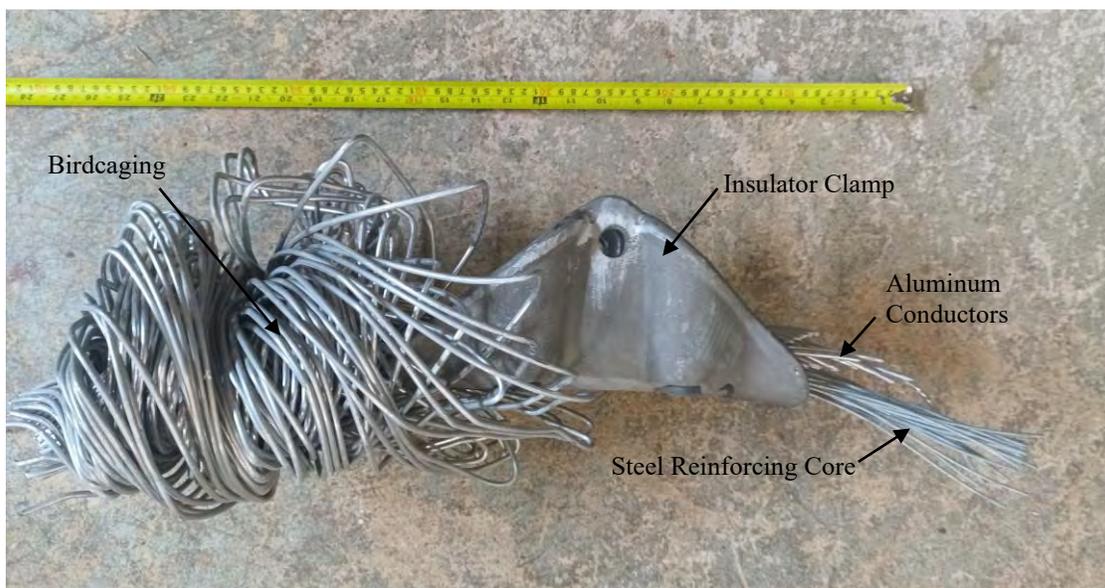
Figure 2-2: Side view of the wire clamp and failed section of the EL-1 conductor as received for analysis.

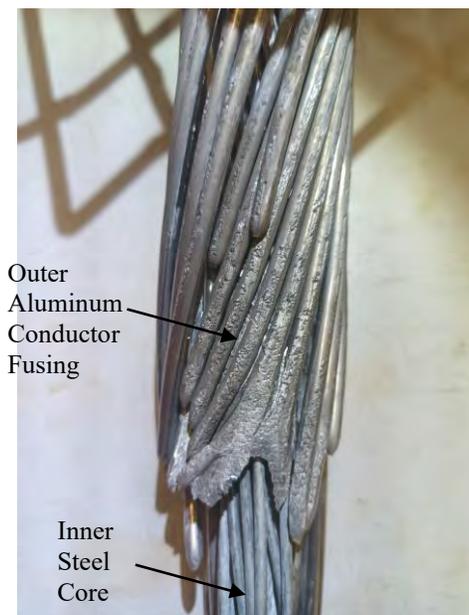
On the lower circumferential surface, evidence of significant aluminum strand to strand fusing was observed (Figure 2-4). The extent of the fusing was observed to increase towards the outboard axial end of the wire clamp. Figure 2-7 and Figure 2-8 show close-up views of representative examples of the strand to strand fusing subsequent to conductor disassembly. Evidence of complete and/or partial fusing together of all three aluminum strand layers was observed in conductor EL-1. Section 4.1 includes the metallurgical characterization of strand fracture failures, as well as the strand to strand fusing observed in conductor EL-1.

Figure 2-4: Photograph of the lower vertical external circumferential surface of conductor EL-1 as installed in the field. The image shows the significant aluminum strand to strand fusing observed on the lower circumferential surface.

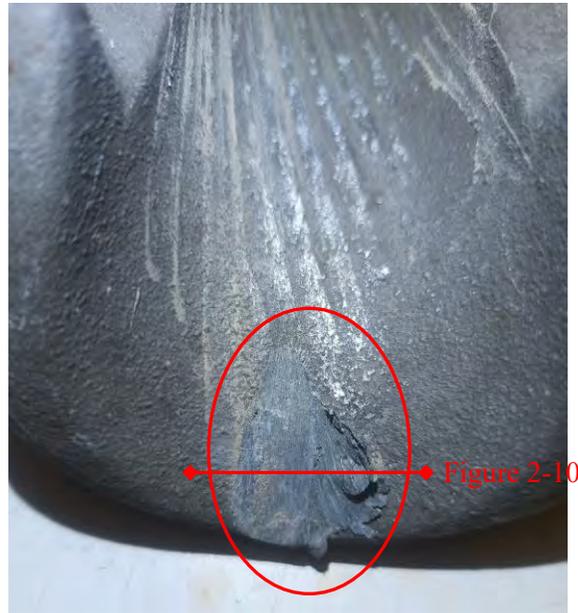
Figure 2-9 shows a top-down view of the lower circumferential surface of the wire clamp associated with conductor EL-1. Evidence of localized brinelling (plastic deformation) was observed adjacent to the outboard axial end (on the conductor failure side) of the clamp. The brinelling was located at the approximate bottom dead center circumferential position of the clamp as installed in the field. Figure 2-10 is a close-up sectional view of the localized brinelling observed. The image shows the approximately semi-circular morphology of the damage observed at the site. Section 4.1 includes the metallurgical characterization of the localized brinelling damage observed in the conductor EL-1 wire clamp.

*Figure 2-9: Top-down view of the lower circumferential surface of the wire clamp associated with conductor EL-1. The image shows the localized brinelling (ellipse) observed adjacent to the outboard axial end (on the conductor failure side) of the clamp. The image also shows the approximate cutline associated with the cross-sectional view of the brinelling in Figure 2-10.*

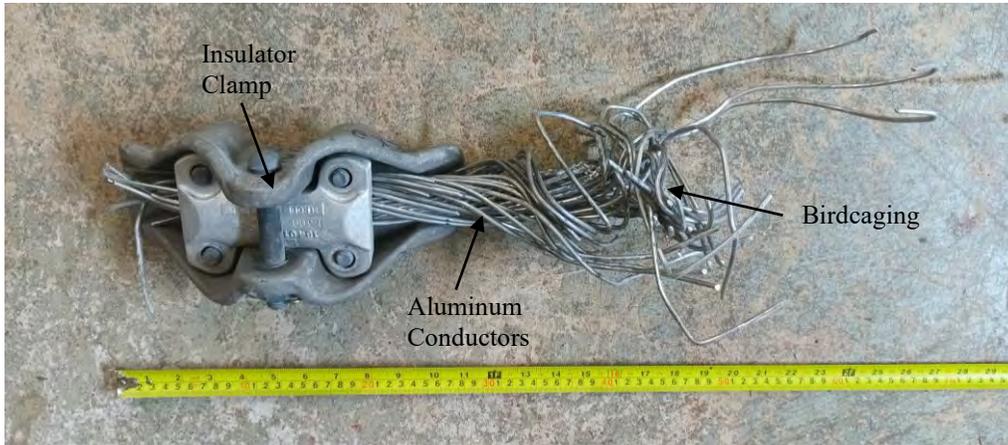
Figure 2-11: Top-down view of the wire clamp and failed section of the EL-2 conductor as received for analysis.

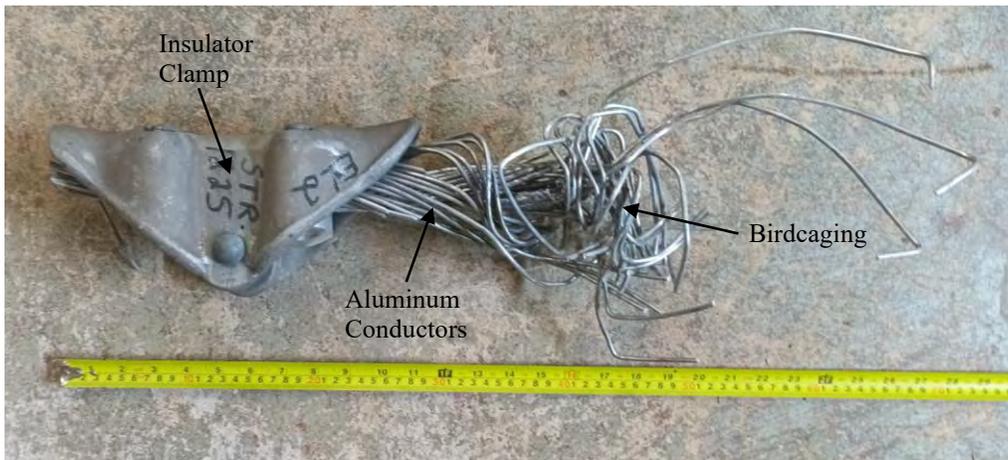
Figure 2-12: Side view of the wire clamp and failed section of the EL-2 conductor as received for analysis.

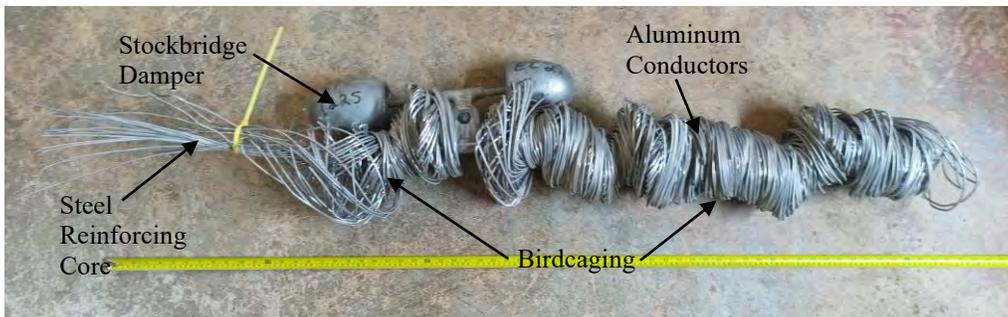
Figure 2-13: Photograph showing a view of the failed section of the EL-2 conductor with an attached Stockbridge damper as received for analysis.

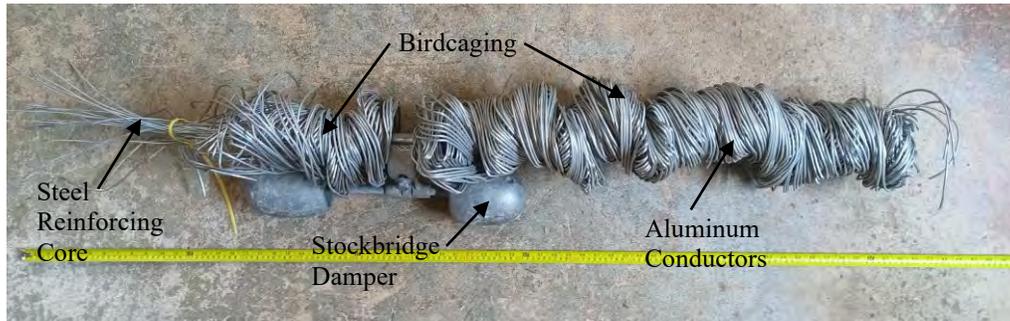
Figure 2-14: Photograph showing a second view of the failed section of the EL-2 conductor with an attached Stockbridge damper as received for analysis.

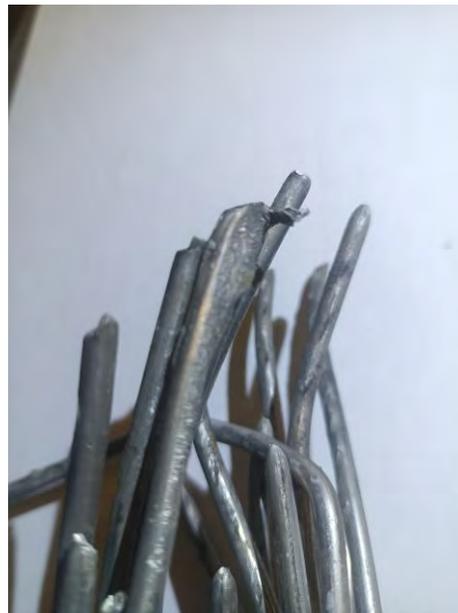
Figure 2-15: Photograph of the upper vertical external circumferential surface of conductor EL-2 as installed in the field. The image shows the fracture ends of the wire strands observed on the upper circumferential surface of the conductor.

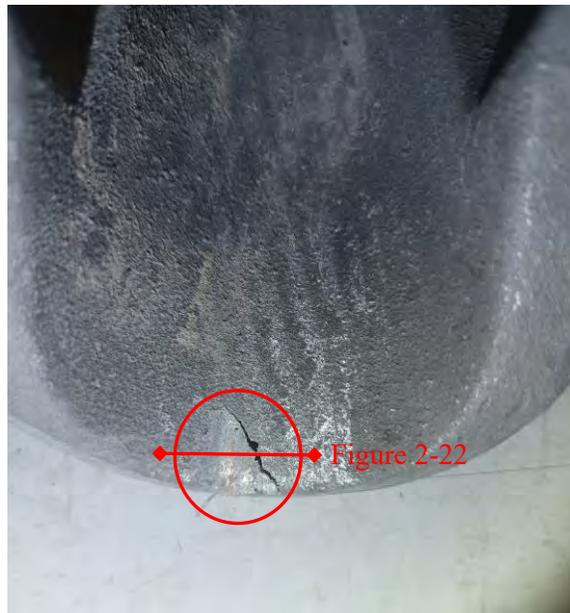
Figure 2-21 shows a top-down view of the lower circumferential surface of the wire clamp associated with conductor EL-2. Evidence of localized brinelling (plastic deformation) was observed adjacent to the outboard axial end (on the conductor failure side) of the clamp. The brinelling was located at the approximate bottom dead center circumferential position of the clamp as installed in the field. Figure 2-22 is a close-up sectional view of the localized brinelling observed. The image shows the approximately semi-circular morphology of the damage observed at the site. Section 4.2 includes the metallurgical characterization of the localized brinelling damage observed in conductor EL-2 wire clamp.

Figure 2-21: Top-down view of the lower circumferential surface of the wire clamp associated with conductor EL-2. The image shows the localized brinelling (ellipse) observed adjacent to the outboard axial end (on the conductor failure side) of the clamp. The image also shows the approximate cutline associated with the cross-sectional view of the brinelling in Figure 2-22.

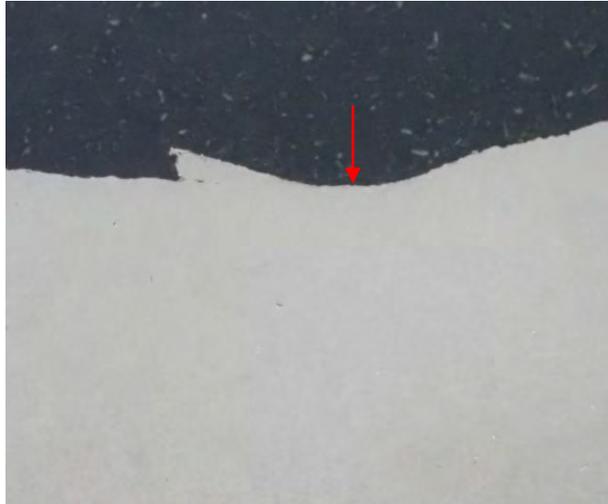
*Figure 2-22: Close-up sectional view through the localized brinelling (arrow) shown in Figure 2-21. The image shows the approximately semi-circular morphology of the damage observed at the site.*

Several samples were also sectioned from the insulator conductor clamp where evidence of localized brinelling was observed during the preliminary examination of conductor EL-2 (Figure 2-22). Figure 4-12 is a sectional view SEM backscatter image of a representative example of the clamp material immediately adjacent to the site of localized brinelling. Similar to Figure 4-11, the image shows the presence of a higher density phase embedded within the aluminum clamp material. The results of the analyses (Table 4-4) indicated that the higher density phase was comprised primarily of zinc (Zn). The presence of Zn embedded within the Al clamp material suggests that the Zn coated steel reinforcing strands (from the inner conductor core) were in contact with the intrados associated clamp housing at the site.

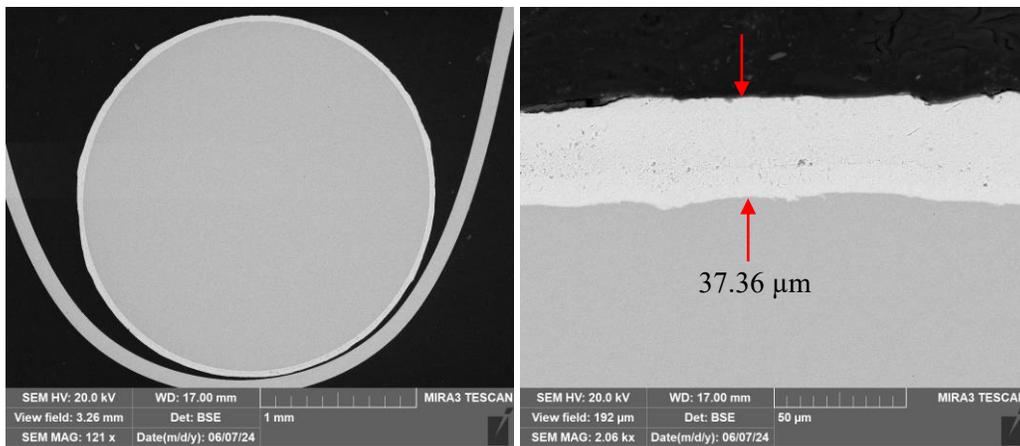
Figure 3-4 is a sectional SEM backscatter image of a representative example of a zinc coated steel reinforcing strand (additional representative examples are provided in Annex D). Similar to the failed conductors EL-1 and EL-2, the image shows the variation in the thickness of the zinc coating observed around the circumference of the steel reinforcing strand. The minimum thickness ranged between approximately 21.56  $\mu\text{m}$  and 37.36  $\mu\text{m}$  for the strands evaluated. A range of 21.56  $\mu\text{m}$  to 37.36  $\mu\text{m}$  in zinc coating thickness equates to a layer surface density of approximately 171.9  $\text{g}/\text{m}^2$  to 332.3  $\text{g}/\text{m}^2$ , respectively. While a variation in the thickness of the zinc coating was observed around the circumference of individual strands, it should be noted that a breach through the coating to the steel core was not observed at the sites (i.e. the cathodic protection provided by the zinc coating remained intact).

Figure 3-4: SEM backscatter image of a representative example of a zinc coated steel reinforcing strand for the intact service exposed conductor. The image shows the significant variation in the thickness of the zinc coating observed around the circumference of the steel reinforcing strand.

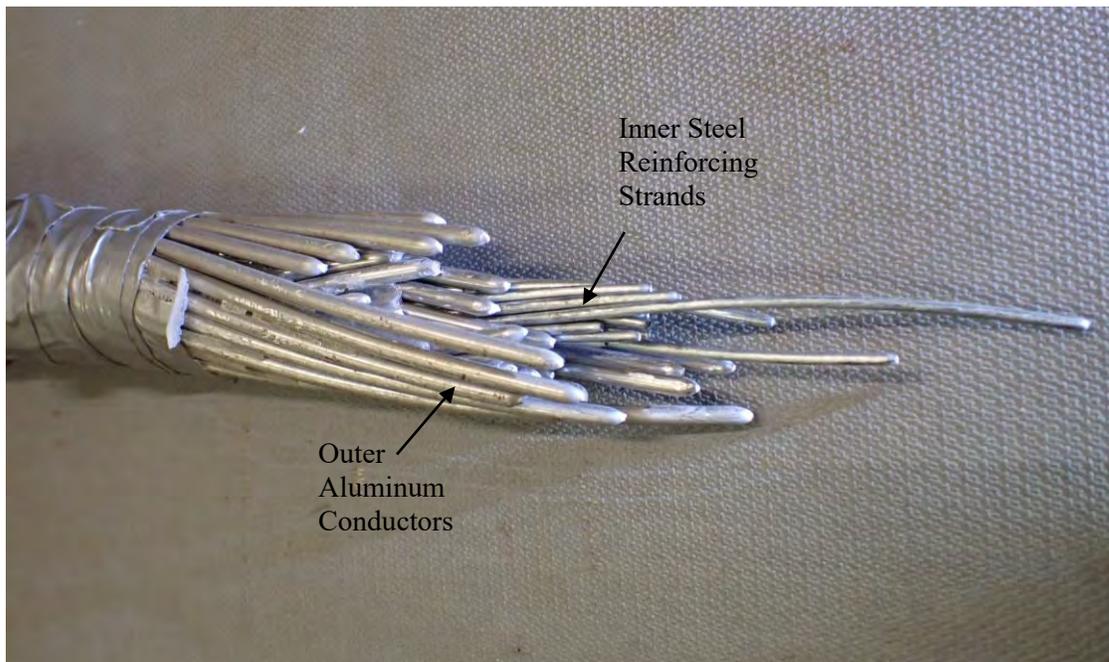
Figure 3-8 is a close-up view of the conductor showing the relative positions of the outer aluminum and the inner steel reinforcing wire strand failures, which is consistent with that expected for the failure of a Grackle ACSR conductor. Samples of the fractured ends of the outer aluminum wire strands were removed from the failed conductor for additional analyses using SEM fractographic imaging techniques. Figure 3-9 and Figure 3-10 contain a side view and end view fractographic images of a representative example of a fractured aluminum wire strand, respectively. For Figure 3-10, image (A) shows the cup and cone failure morphology and image (B) shows the void coalescence typically associated with a ductile, limit load fracture mechanism. The cup and cone failure morphology observed was consistent with that expected for the applied uniaxial tension force generated by the test procedure. Section 4.1 and Section 4.2 include the fractographic images for the fractured aluminum wire strands from conductor EL-1 and conductor EL-2 for comparison, respectively.

Figure 3-8: Close-up view of the conductor showing the relative positions of the outer aluminum and the inner steel reinforcing wire strand failures.

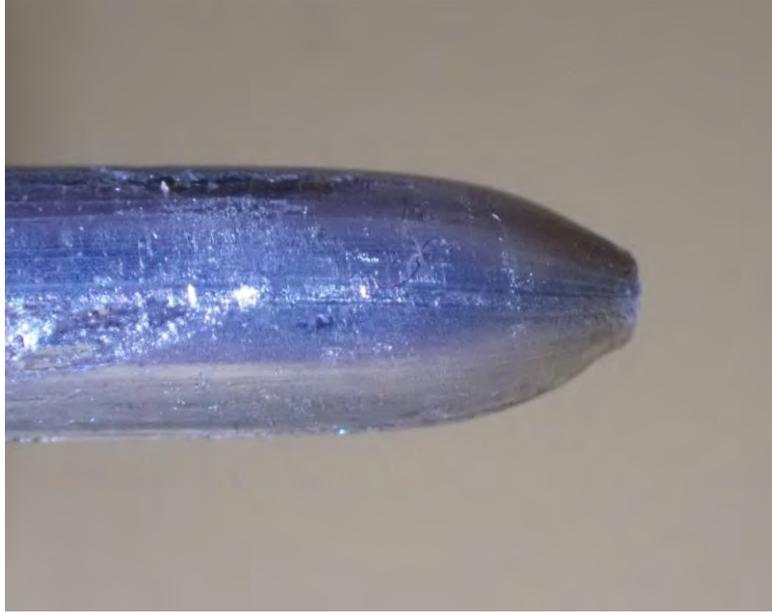
Figure 3-9: Close-up view of a representative example of the fracture failure morphology observed for the aluminum conductors associated with the uniaxial tension test. The morphology was characterized by a tapered (necked) interval immediately adjacent to the strand fracture surface.

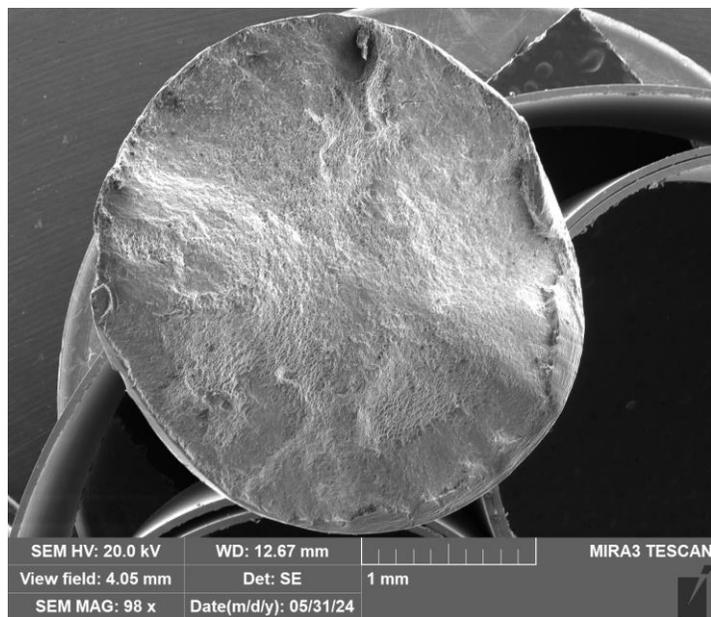
Figure 4-3: Low magnification SEM secondary image of a representative example of the fracture surface associated with the oblique geometry observed terminating the failed aluminum wire strands during the preliminary examination of conductor EL-1 (Figure 2-6).

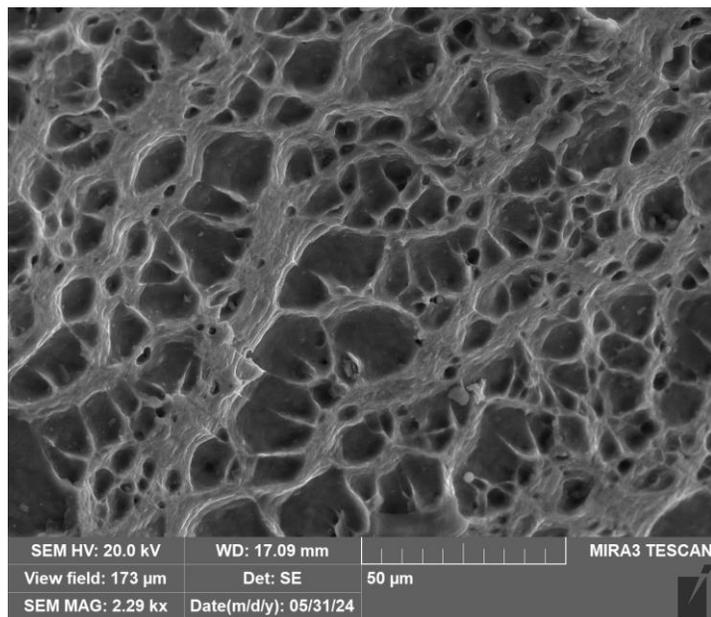
Samples from several of the outer aluminum wire strands, which included the fracture surface associated with the strand failure were removed from conductor EL-1. The samples were prepared for the characterization of the topological features associated with the fracture mechanism using SEM fractographic imaging techniques. Figure 4-1 is a low magnification SEM secondary image of a representative example of the fracture surface associated with the tapered-end geometry observed terminating the failed aluminum wire strands during the preliminary examination of conductor EL-1 (Figure 2-5). The image shows the general cup and cone morphology of the failed end of the wire strand. Figure 4-2 is a high magnification fractographic image within the proximity of the strand centroid showing the topological features associated with the strand fracture mechanism. The image indicates that the strand fracture mechanism was dominated by void coalescence (i.e. ductile fracture) at the site. Figure 4-3 is a low magnification SEM secondary image of a representative example of the fracture surface associated with the oblique geometry observed terminating the failed aluminum wire strands during the preliminary examination of conductor EL-1 (Figure 2-6). Figure 4-4 is a high magnification fractographic image within the proximity of the strand centroid showing the topological features associated with the strand fracture mechanism. Similar to Figure 4-2, the image suggests that the strand fracture mechanism was dominated by void coalescence (i.e. ductile fracture) at the site.

Figure 4-4: High magnification fractographic image within the proximity of the strand centroid showing the topological features associated with the strand fracture mechanism. Similar to Figure 4-2, the image suggests that the strand fracture mechanism was dominated by void coalescence (i.e. ductile fracture) at the site.

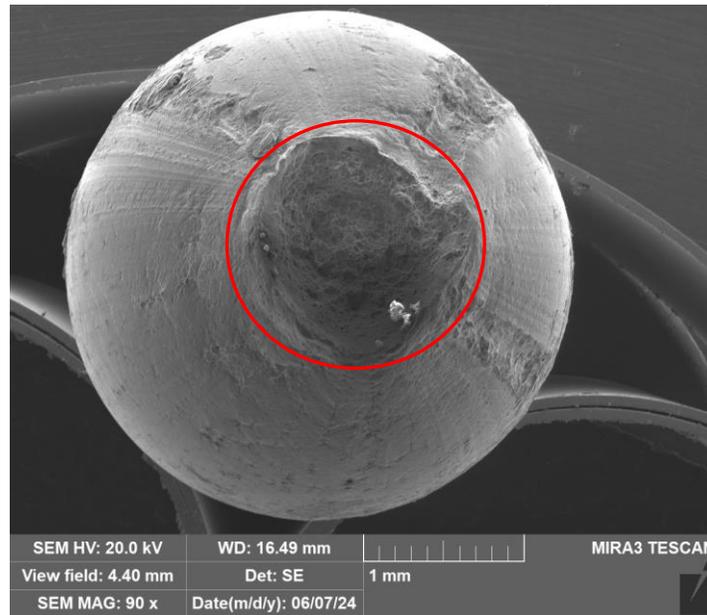
Samples from several of the outer aluminum wire strands, which included the fracture surface associated with the strand failure were removed from conductor EL-2. The samples were prepared for the characterization of the topological features associated with the fracture mechanism using SEM fractographic imaging techniques. Figure 4-7 is a low magnification SEM secondary image of a representative example of the fracture surface associated with the tapered-end geometry observed terminating the failed aluminum wire strands during the preliminary examination of conductor EL-2 (Figure 2-17). The image shows the general cup and cone morphology of the failed end of the wire strand. Figure 4-8 is a high magnification fractographic image within the proximity of the strand centroid showing the topological features associated with the strand fracture mechanism. The image indicates that the strand fracture mechanism was dominated by void coalescence (i.e. ductile fracture) at the site. Figure 4-9 is a low magnification SEM secondary image of a representative example of the fracture surface associated with the oblique geometry observed terminating the failed aluminum wire strands during the preliminary examination of conductor EL-2 (Figure 2-18). Figure 4-10 is a high magnification fractographic image within the proximity of the strand centroid showing the topological features associated with the strand fracture mechanism. Similar to Figure 4-8, the image suggests that the strand fracture mechanism was dominated by void coalescence (i.e. ductile fracture) at the site.

Figure 4-7: Low magnification SEM secondary image of a representative example of the fracture surface (ellipse) associated with the tapered-end (necked) geometry observed terminating the failed aluminum wire strands during the preliminary examination of conductor EL-2 (Figure 2-17). The image shows the general cup and cone morphology of the failed end of the wire strand.

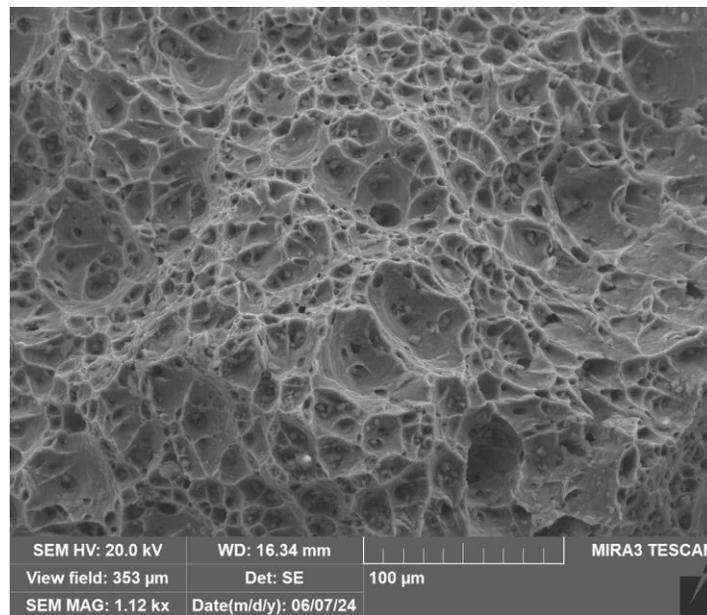
Figure 4-7: Low magnification SEM secondary image of a representative example of the fracture surface (ellipse) associated with the tapered-end (necked) geometry observed terminating the failed aluminum wire strands during the preliminary examination of conductor EL-2 (Figure 2-17). The image shows the general cup and cone morphology of the failed end of the wire strand. .... 32

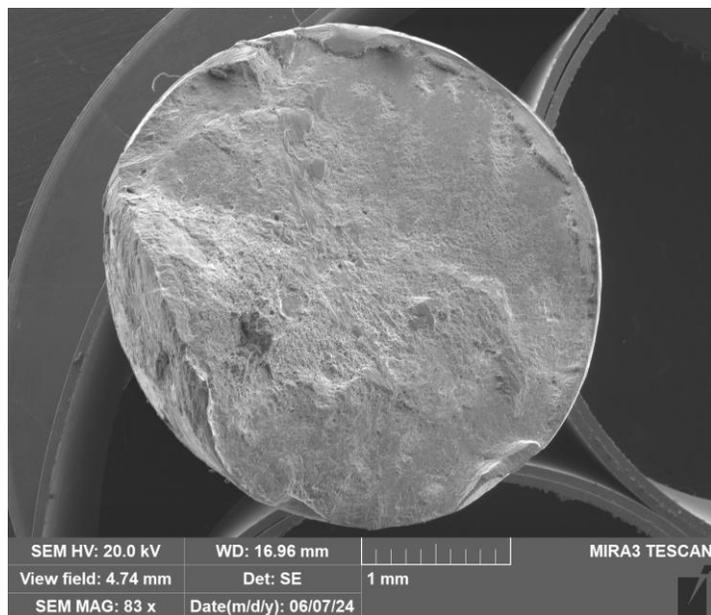
Figure 4-8: High magnification fractographic image within the proximity of the strand centroid shown in Figure 4-1. The image indicates that the strand fracture mechanism was dominated by void coalescence (i.e. ductile fracture) at the site.

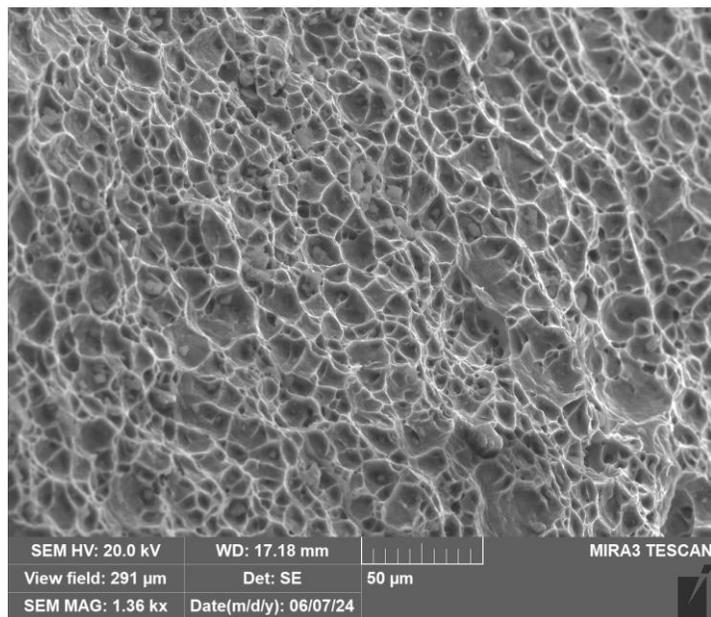
Figure 4-9: Low magnification SEM secondary image of a representative example of the fracture surface associated with the oblique geometry observed terminating the failed aluminum wire strands during the preliminary examination of conductor EL-2 (Figure 2-18).

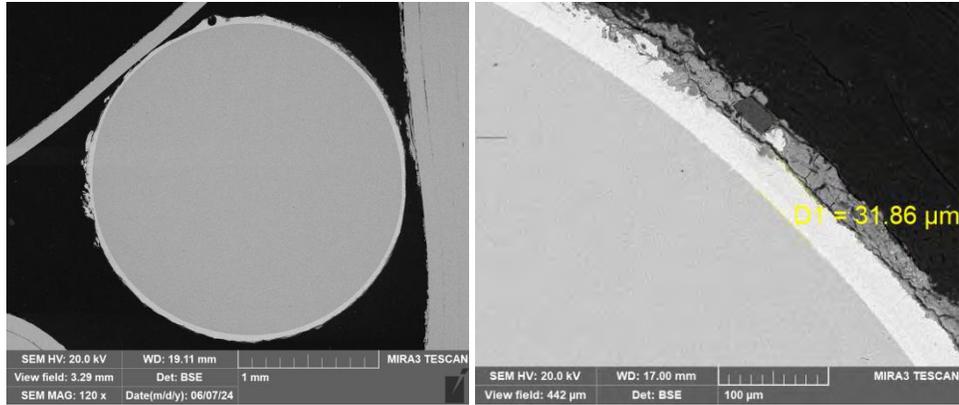
Figure B-1: SEM backscatter image of a representative example of a zinc coated steel reinforcing strand for failed conductor EL-1. The image shows the significant variation in the thickness of the zinc coating observed around the circumference of the steel reinforcing strand.

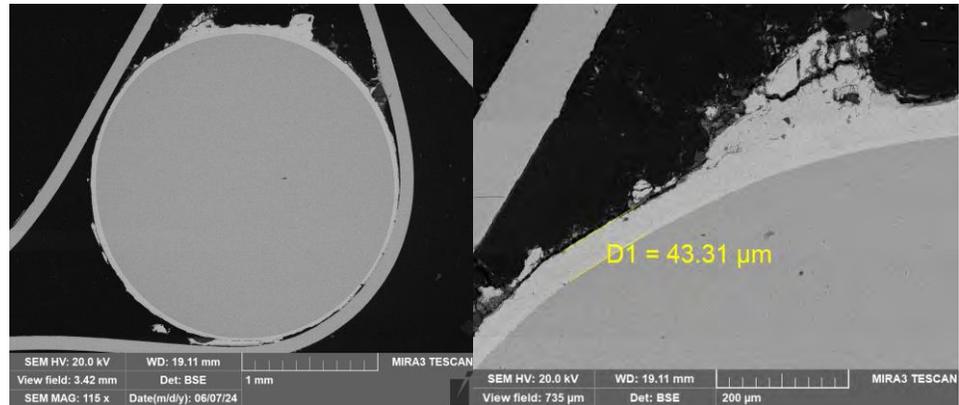
Figure B-2: SEM backscatter image of a representative example of a zinc coated steel reinforcing strand for failed conductor EL-1. The image shows the significant variation in the thickness of the zinc coating observed around the circumference of the steel reinforcing strand.

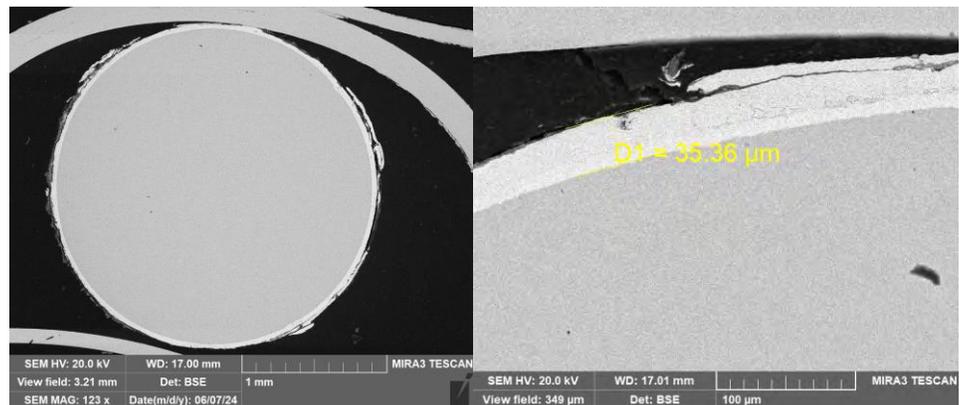
Figure B-3: SEM backscatter image of a representative example of a zinc coated steel reinforcing strand for failed conductor EL-1. The image shows the significant variation in the thickness of the zinc coating observed around the circumference of the steel reinforcing strand.

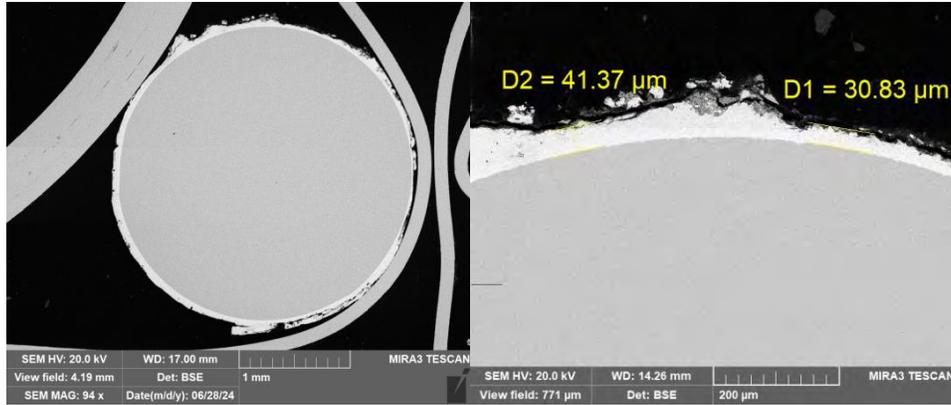
Figure C-1: SEM backscatter image of a representative example of a zinc coated steel reinforcing strand for failed conductor EL-2. The image shows the significant variation in the thickness of the zinc coating observed around the circumference of the steel reinforcing strand.

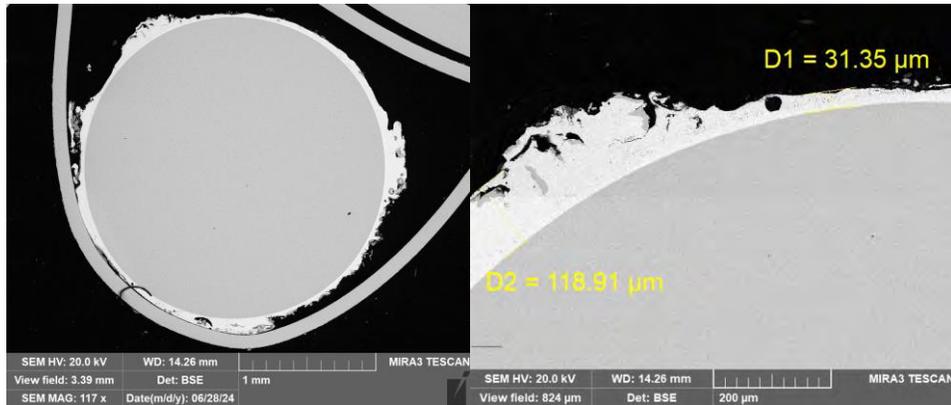
Figure C-2: SEM backscatter image of a representative example of a zinc coated steel reinforcing strand for failed conductor EL-2. The image shows the significant variation in the thickness of the zinc coating observed around the circumference of the steel reinforcing strand.

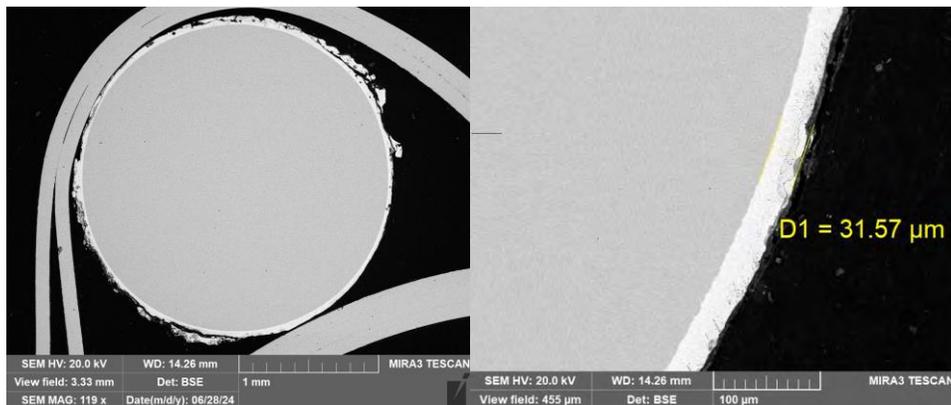
Figure C-3: SEM backscatter image of a representative example of a zinc coated steel reinforcing strand for failed conductor EL-2. The image shows the significant variation in the thickness of the zinc coating observed around the circumference of the steel reinforcing strand.

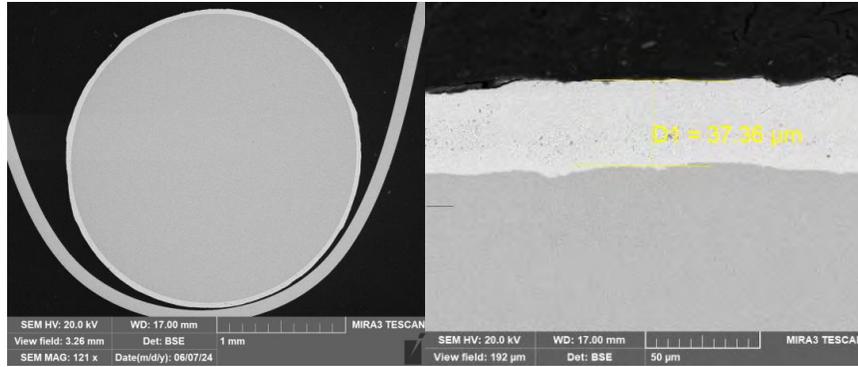
Figure D-1: SEM backscatter image of a representative example of a zinc coated steel reinforcing strand for the intact conductor. The image shows the significant variation in the thickness of the zinc coating observed around the circumference of the steel reinforcing strand.

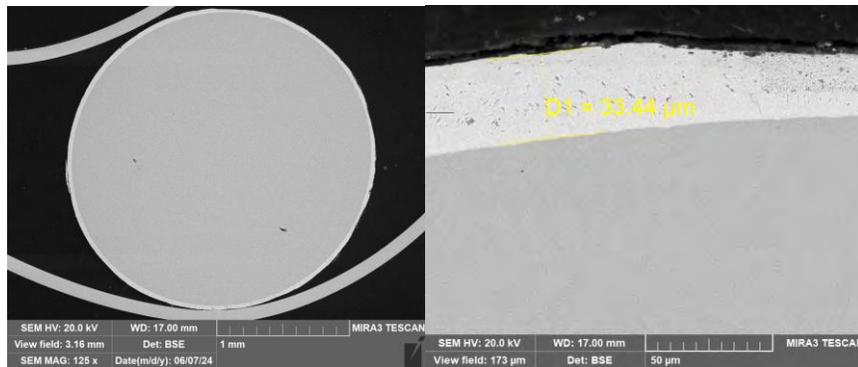
Figure D-2: SEM backscatter image of a representative example of a zinc coated steel reinforcing strand for the intact conductor. The image shows the significant variation in the thickness of the zinc coating observed around the circumference of the steel reinforcing strand.
