**Re: Quarterly Report on Asset Performance in Support of Resource Adequacy for the Twelve Months Ended March 31, 2025**

# Quarterly Report on Asset Performance in Support of Resource Adequacy

Attachment 1: L3501/2 Failure Investigation OPGW Tower Peaks – Central Newfoundland

Attachment 2: L3501/2 Failure Investigation Ice Storm Southern Labrador

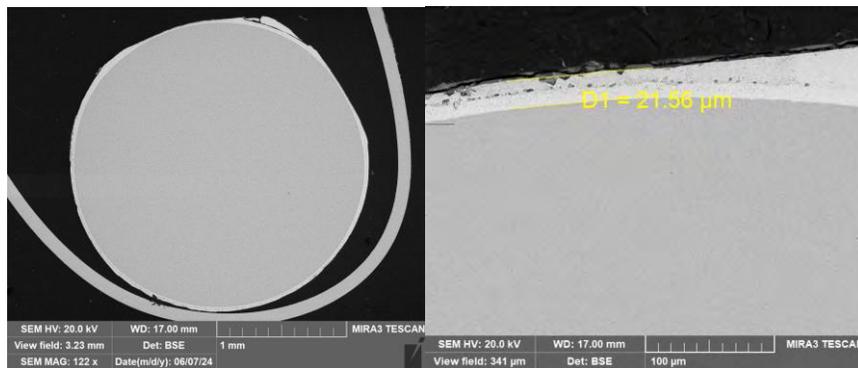
Figure D-3: SEM backscatter image of a representative example of a zinc coated steel reinforcing strand for the intact conductor. The image shows the significant variation in the thickness of the zinc coating observed around the circumference of the steel reinforcing strand.
