1 Q. At page 7 of Hydro's Report in support of its Application, Hydro relates that the
 2 "impedance mismatch" outlined therein results in a "loss" of transformer capacity
 3 in the magnitude of 31.8 MVA.

12
 13
 14 A. (i) The following table provides the impedance value of each 230/66 kV power
 15 transformer in the Hardwoods – Oxen Pond Loop.

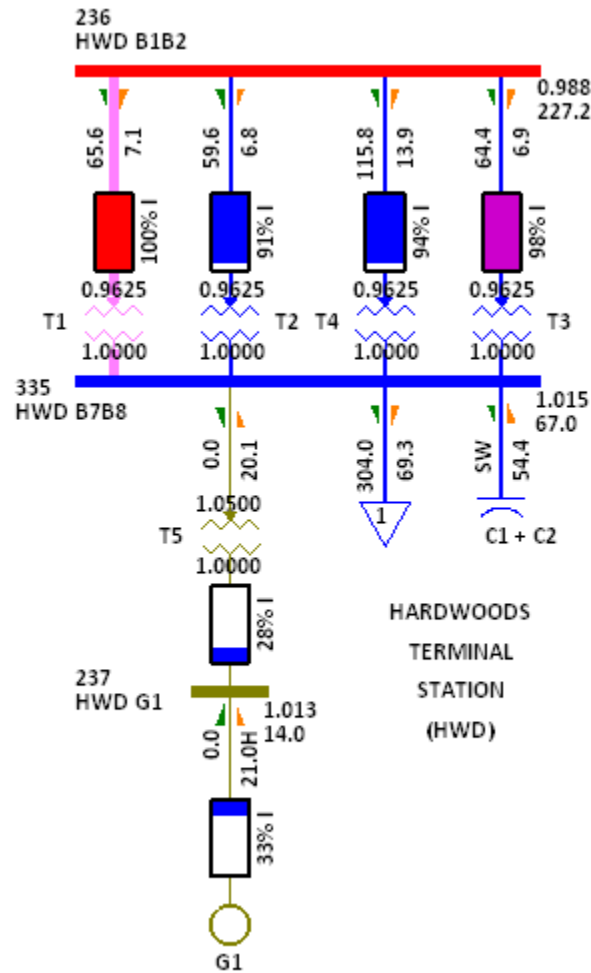
Figure 1: Hardwoods Maximum Transformer Loading

12
13 If one considers the transformers in the Hardwoods Terminal Station and
14 ignores the effects of the connected 66 kV transmission system and the
15 Oxen Pond transformers, Hardwoods T1 is expected to reach 100% of its
16 nameplate rating before T2 through T4. A simple load flow case with the 66
17 kV transmission disconnected and all the load being carried on the
18 Hardwoods 66 kV bus, provides an example of the effects of impedance
19 mismatch on station loading. Figure 1 provides a load flow plot of the
20 Hardwoods Terminal Station with 304 MW of load on the 66 kV bus. One
21 will note that transformer T1 is loaded to 100% of its nameplate rating,
22 while T2, T3 and T4 are loaded to 91%, 98% and 94% of their nameplate
23 ratings respectively. This mismatch in impedances results in approximately
24 16.8 MVA of transformer capacity being unavailable. Increasing the load on
25 the Hardwoods 66 kV bus will result in the loading on T1 exceeding 100% of

26 its nameplate rating before the remaining transformers reach 100% of
27 rating.

1 From these examples it can be seen that variations in impedance of
 2 transformers within the same station result in unequal loading on the units
 3 and consequently transformer capacity that is unavailable to accept load
 4 once the lowest impedance transformer reaches its nameplate rating before
 5 the higher impedance units. These examples show the maximum loading on
 6 the transformers in a station is also dependent upon which, if any, of the
 7 transformers are out of service. Extending this further, if the loads are
 8 moved away from the Hardwoods and Oxen Pond 66 kV buses, and
 9 distributed unevenly around the St. John’s Region by multiple 66 kV
 10 transmission lines with different lengths, paths and impedances, while the
 11 mismatch becomes more complex to calculate, unequal loading of the
 12 Hardwoods and Oxen Pond 230/66 kV transformers remains.

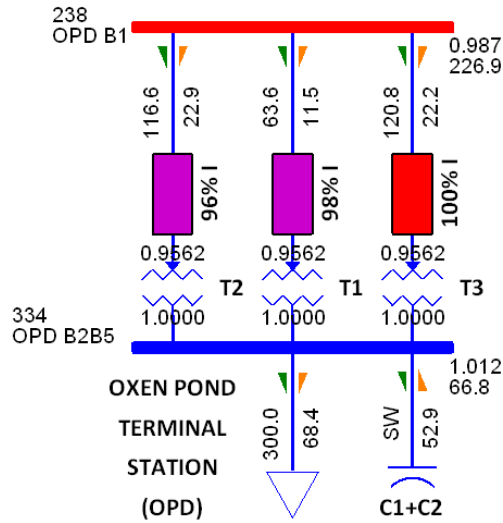
Figure 2: Oxen Pond Maximum Transformer Loading

1 A similar analysis can be completed for Oxen Pond Terminal Station. Figure 2
 2 provides a simple load flow plot of the Oxen Pond Terminal Station with a 66
 3 kV bus load of 300 MW. One will note that transformer T3 is loaded to
 4 100% of nameplate rating, while T1 and T2 are loaded to 96% and 98% of
 5 their nameplate ratings respectively. This mismatch in impedances results
 6 in approximately 8.2 MVA of transformer capacity being unavailable.
 7 Increasing the load on the Oxen Pond 66 kV bus will result in the loading on
 8 T3 exceeding 100% of its nameplate rating before the remaining
 9 transformers reach 100% of rating.
